THE HISTORY AND PRESERVATION  
OF THE COMMUNITY AUDITORIUM-GYMNASIUM  
Historic Structure Report

**MANZANAR**  
National Historic Site • California

April 1999

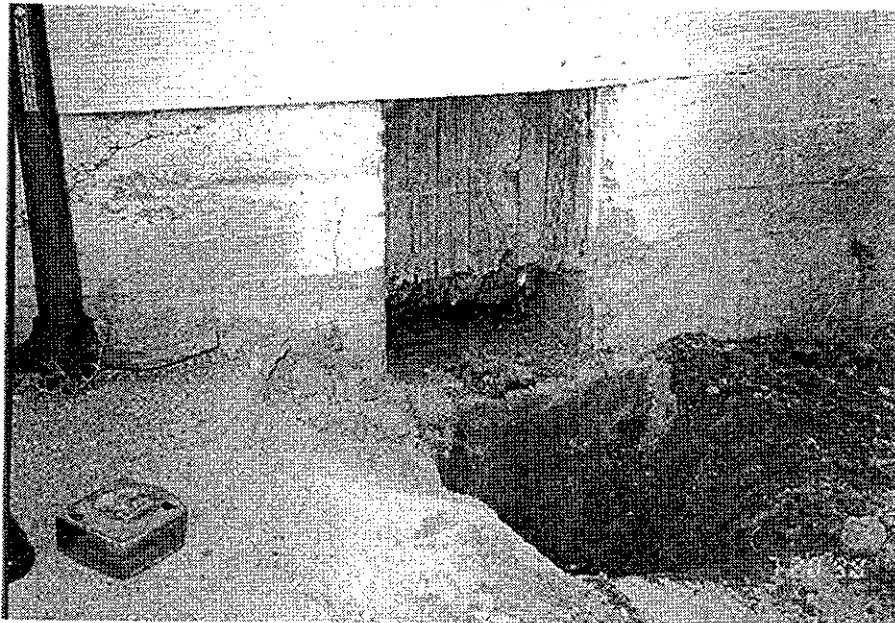
Photo No. 14  
Decayed Bottom of Column

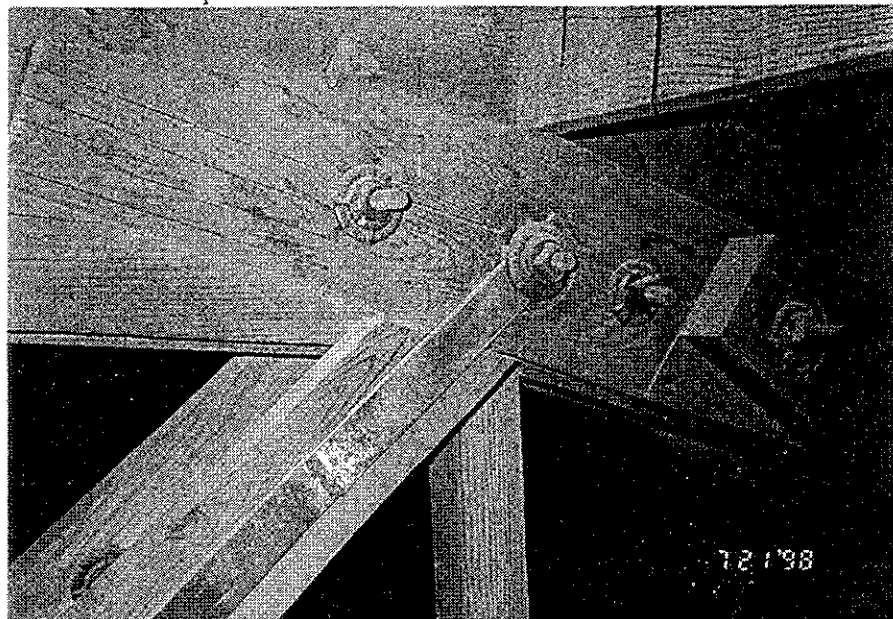
Photo No. 20  
Cracked Truss Top Chord at Diagonal Connection
