**OPERATIONAL EFFECTS ON CRASHWORTHY  
SEAT ATTENUATORS**

**Marvin Kent Richards**

**Simula Inc.  
Phoenix, Arizona 85044-5299**

**Final Report for Period September 1987 - November 1989**

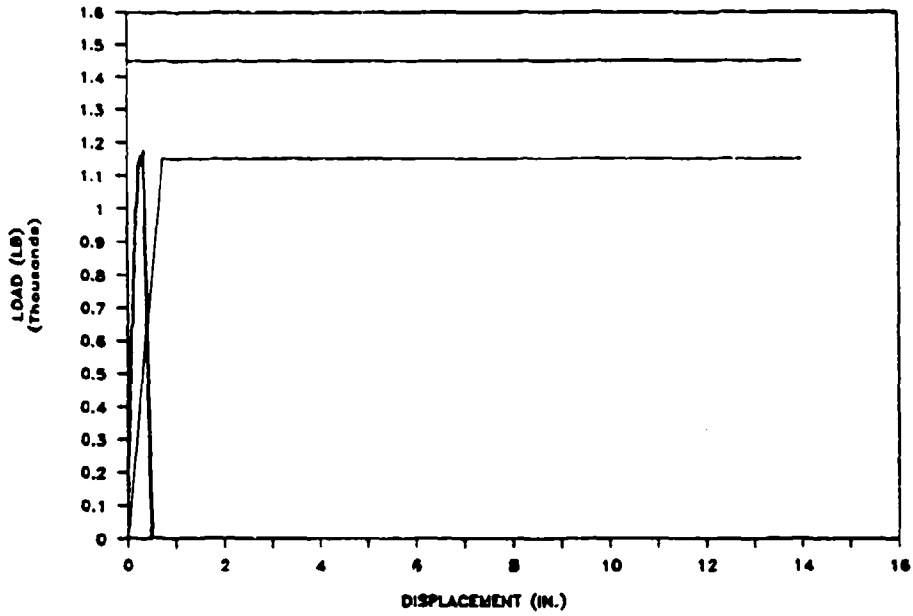
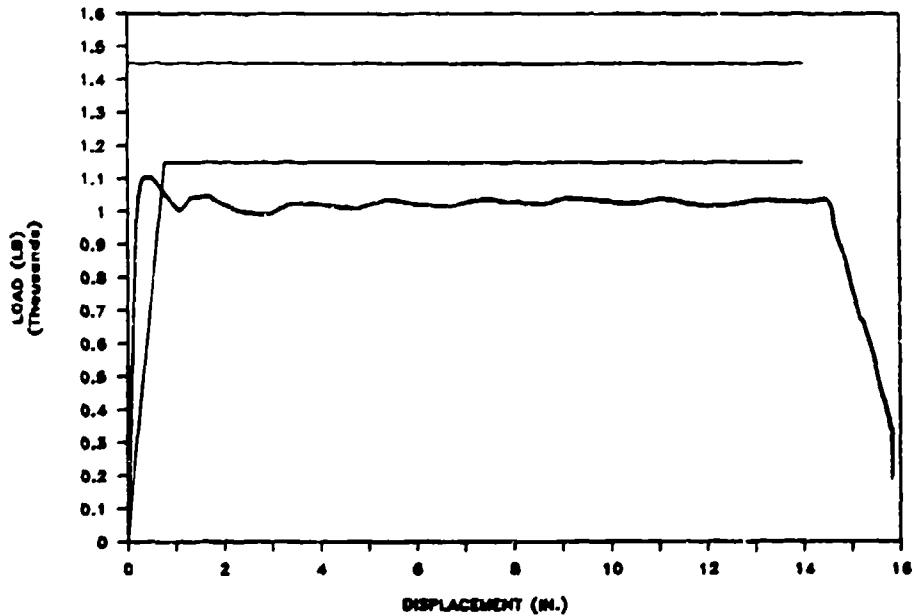
FIGURE 9. TYPICAL STATIC TEST RESULTS - TROOP SEAT, FIELDED ENERGY ABSORBER.

Two fielded energy absorbers from the same troop seat failed. Figure 9a shows the load-versus-displacement plot for one which failed at 1174 lb. The other energy absorber that failed (plot not shown) broke at 1087 lb. The two energy absorbers broke at the same location where the wire is suspended, as shown in Figure 10.

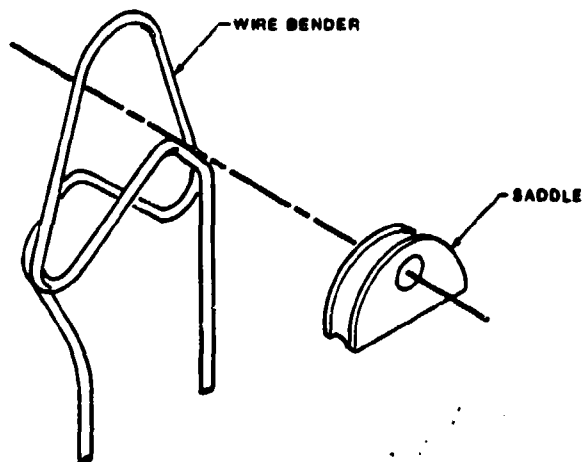
**FIGURE 11. LOAD DISTRIBUTING SADDLE - TROOP SEAT DYNAMIC TESTING.**

After the static testing was completed it was learned that new aircraft have a load-distributing saddle installed at the wire suspension point as shown in Figure 11. This modification was made to preclude wire failures at this location. Since the observed static test failures were at the suspension point, it was decided to test half of the remaining energy absorbers with the saddle installed to determine if this solution would alleviate dynamic failures.

All dynamic failures occurred where the wire wraps around the rollers, indicating that the load distributing saddles were not a factor (11 broke with the saddle, 12 without). None of the new energy absorbers failed. The average load of new energy absorbers were only slightly higher (2.6 percent) than the fielded energy absorbers that did not fail. The energy absorbers consistently stroked approximately 280 lb under the desired nominal load of 1300 lb, with the exception of aircraft 78-22971 (seats 4a and 9b), which stroked at an average load of 1302 and 757 lb, respectively.

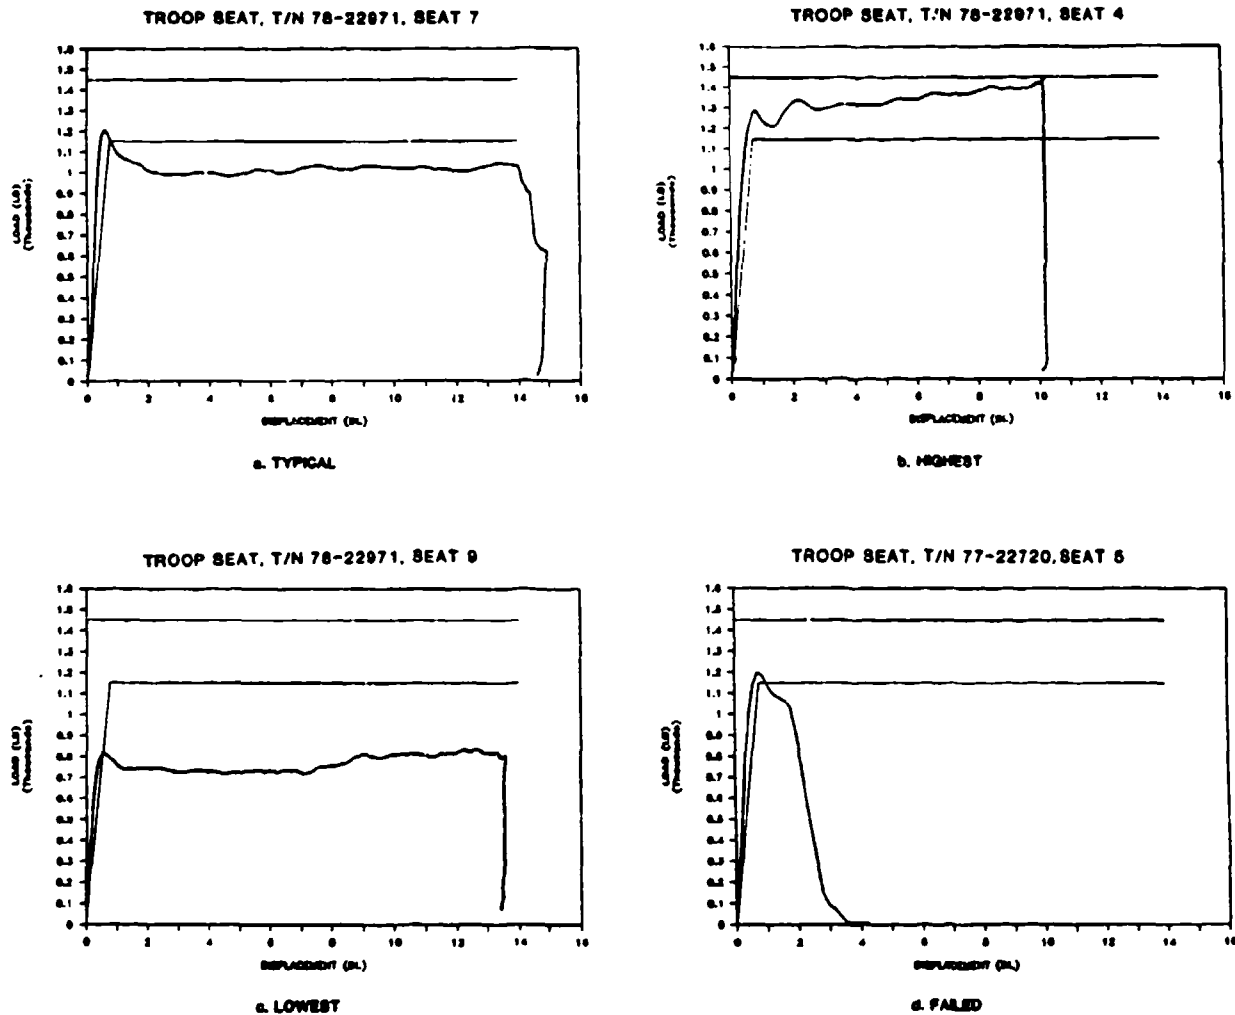
**FIGURE 14. TYPICAL DYNAMIC TEST RESULTS - TROOP SEAT, FIELDED ENERGY ABSORBERS.**

The remaining 20 energy absorbers failed with similar load-deflection characteristics as those shown in Figure 14d. Plots of the remaining energy absorbers can be found in Appendix B.

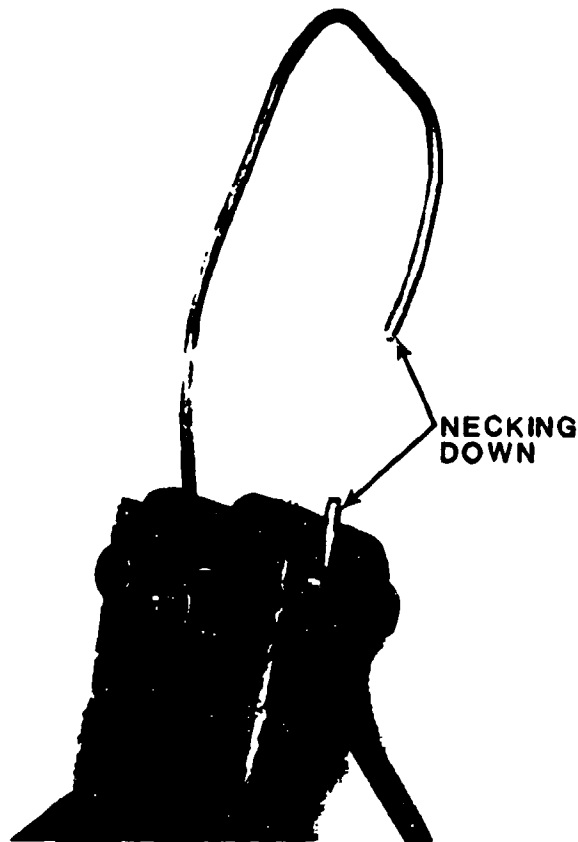
**FIGURE 15. TYPICAL WIRE FRACTURE DURING DYNAMIC TESTING - TROOP SEAT, FIELDED ENERGY ABSORBER.**

Figure 15 shows an example of a wire fracture. Breakage points of all failures were in the area where the wire wraps around the rollers. The wires experienced necking-down in the area of the fracture.

Two phenomena were noted upon posttest inspection of wires. The dynamically failed wires showed necking-down (severe deformation) of the wire diameter at the fracture point (see Figure 15). It was originally believed that the necking-down was only a result of the ductility in the wire and occurred as the wire was loaded to failure. However, inspection of wires that did not fail revealed some of these also had areas of necking-down as shown in Figure 16. Therefore, it appears that the initiation of the necking-down phenomenon occurred previous to, rather than during, the dynamic testing. The location of the neck-down area was measured and found to be approximately at the midpoint of the preformed minimum bend radius (0.19 in.) as shown in Figure 17. All of the dynamically failed wires broke in this area. The second phenomenon observed was localized flat spotting of wires due to contact with the rollers. This wear resulted at points of suspension due

Metallurgical inspection of the failed energy absorbers determined that all wire fractures were due to overstress. Table 8 compares the measured average peak load of the failed and successful energy absorbers for the three sources: T/N 720, T/N 971 and new (depot).

Since the peak load of the failed attenuators is approximately the same as the successful attenuators, it is concluded that the overstress was not caused by overload. The calculated direct tensile failure load of the attenuator is over 4000 lb, well above the loads experienced during these tests. This indicates that the overstress must be caused by some other mechanism such as a reduction in cross-sectional area, a reduction in the strength of the material, high localized bending stresses, or a combination of these factors.

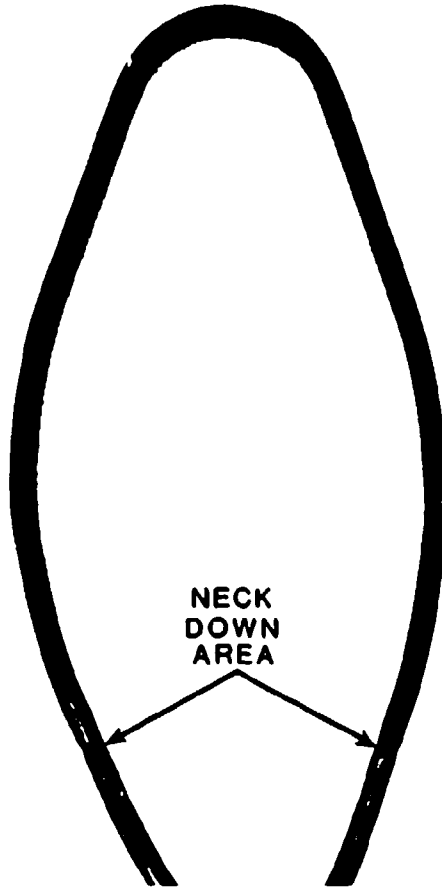
**FIGURE 16. TROOP SEAT WIRE NECKING-DOWN.**

to the normal movement of seats (occupied and unoccupied) in the aircraft while subjected to vibratory flight loads. This localized wear appeared to be more severe in the -971 wires. Measurements made in the areas of localized wear revealed diameter reductions as much as 0.0025 in. when compared to unworn areas. None of the wires failed in the worn area.

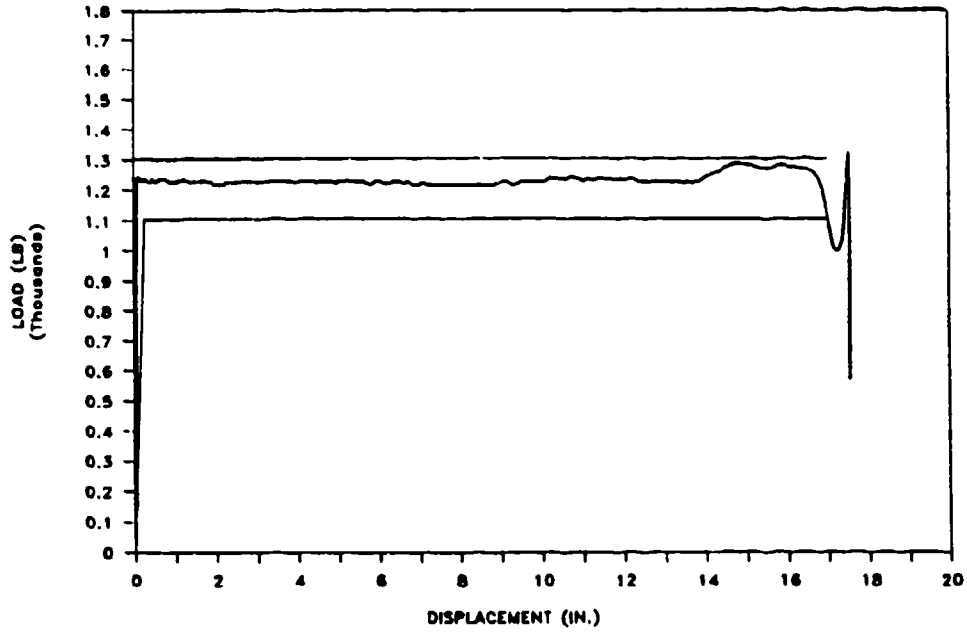
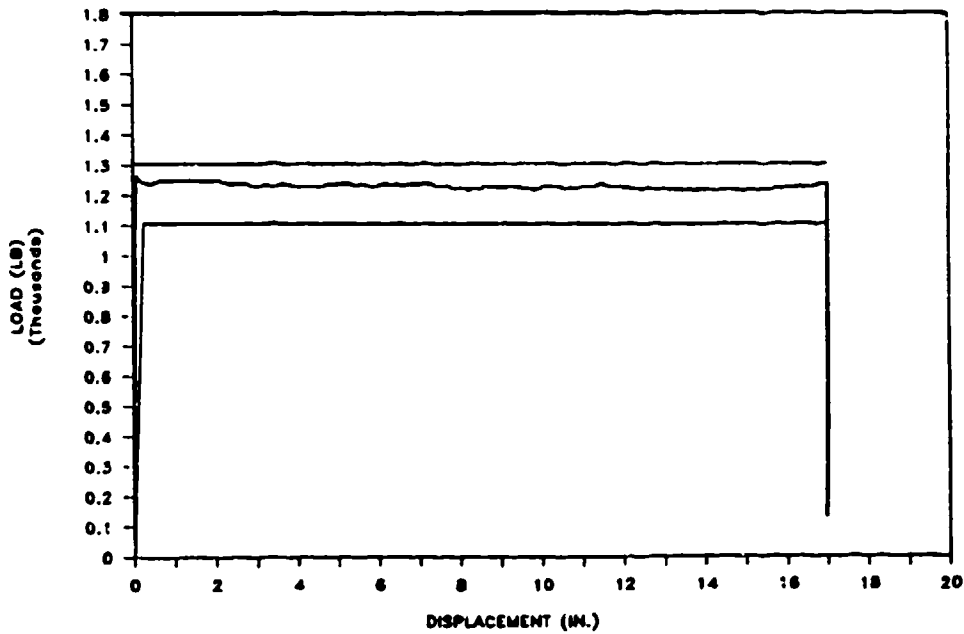
FIGURE 28. STATIC TEST RESULTS - SIMULA/NORTON CREW SEAT, FIELD ENERGY ABSORBER.

Plots of the static test results for the fielded Simula/Norton energy absorbers are shown in Figure 28. Both energy absorbers stroked within the desired corridor. Energy absorber S/N 014 had a slight load increase at the end of the stroke which was caused by the inversion tube rubbing on the housing.
