PHASE I INSPECTION REPORT  
NATIONAL DAM INSPECTION PROGRAM

Latrobe Reservoir

16 May 1978 (visual inspection)

PHASE I INSPECTION REPORT  
NATIONAL DAM INSPECTION PROGRAM  
LATROBE RESERVOIR  
NDI# PA-479, PENNDR# 65-66

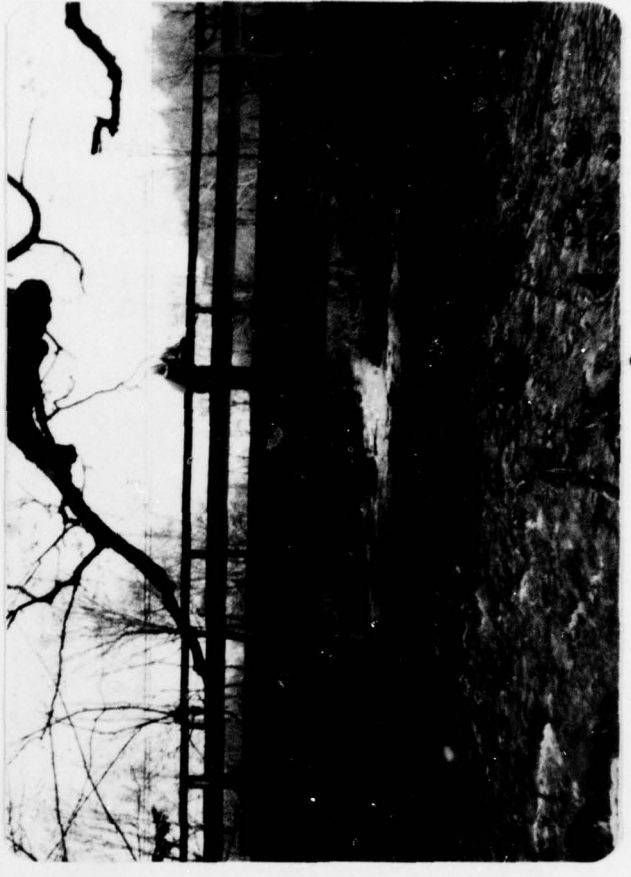
PHOTOGRAPH 8 View of a two-lane bridge located approximately one-half mile downstream of the embankment. It represents the first restriction downstream.

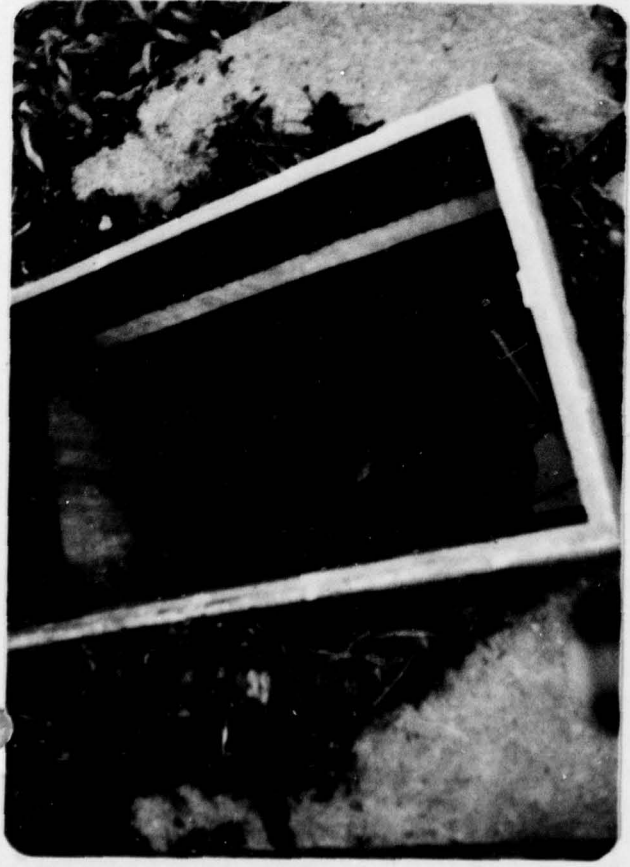
2. Gate House, Valves, and Supply Line. Access to the gate house is by boat, which was not available during our inspection, consequently, we were not able to assess condition of the mechanical systems within the gate house. According to a representative of the Water Authority the system is in good working order. The downstream gate valve which regulates flow from the supply line to a 24-inch blow-off line was observed (see Photograph 5). The valve is located in a concrete pit approximately 250 feet downstream of the dam. The valve was greased and appeared in good order.

PHOTOGRAPH 5 View of the valve on the 24-inch blow-off pipe located approximately 250 feet downstream of the center of the embankment.
