Name Of Dam: BEAVER CREEK DAM

Location: MARTINSVILLE, VIRGINIA

Inventory Number: VA ████ 08903

PHASE I INSPECTION REPORT NATIONAL DAM SAFETY PROGRAM

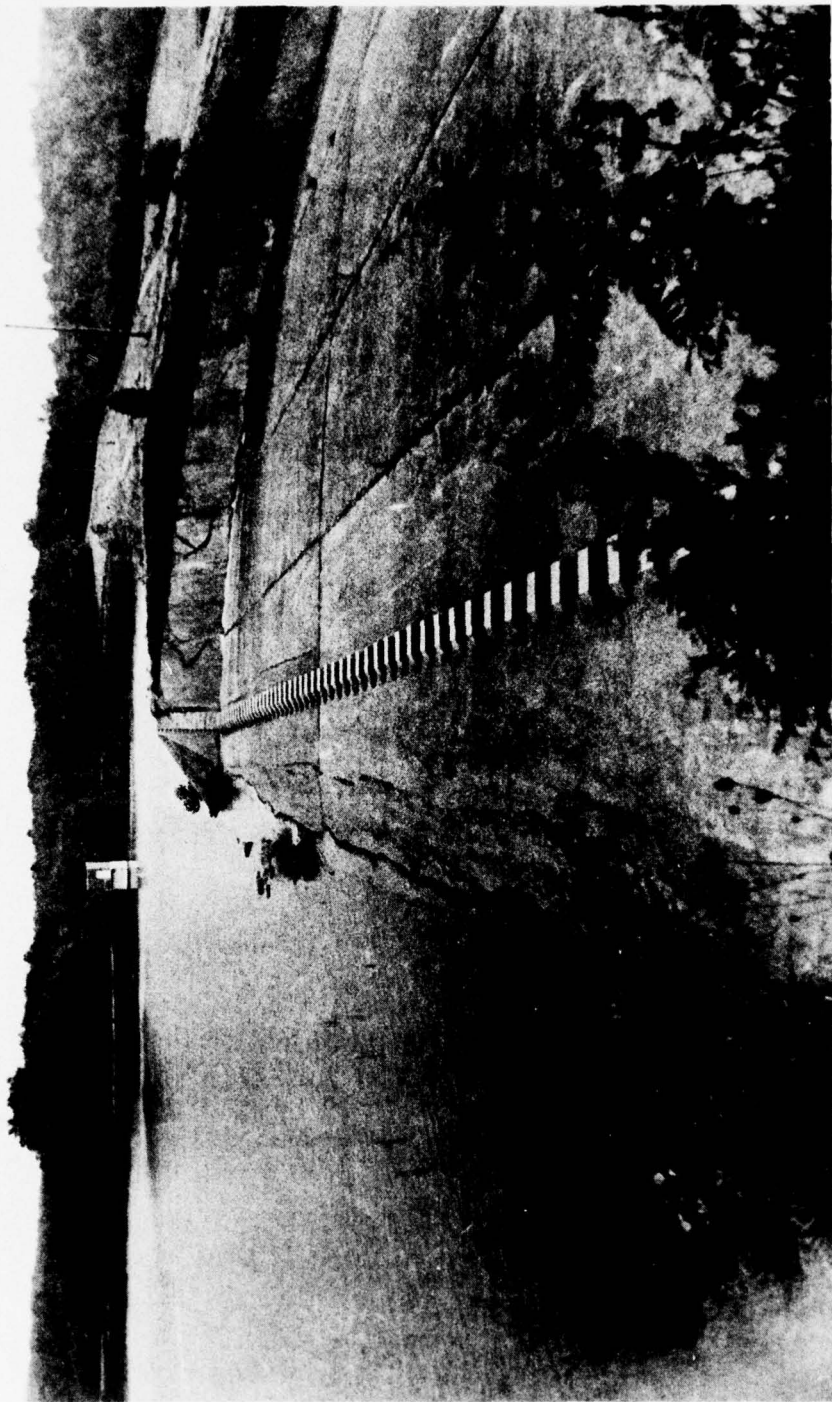
OVERVIEW OF EMBANKMENT AND SPILLWAY ENTRANCE - BEAVER CREEK DAM

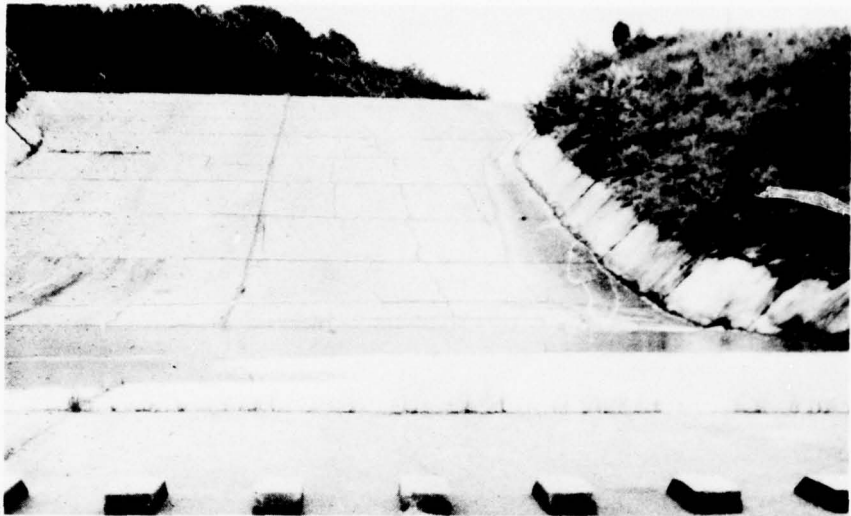
BEAVER CREEK DAM - SPILLWAY CHUTE

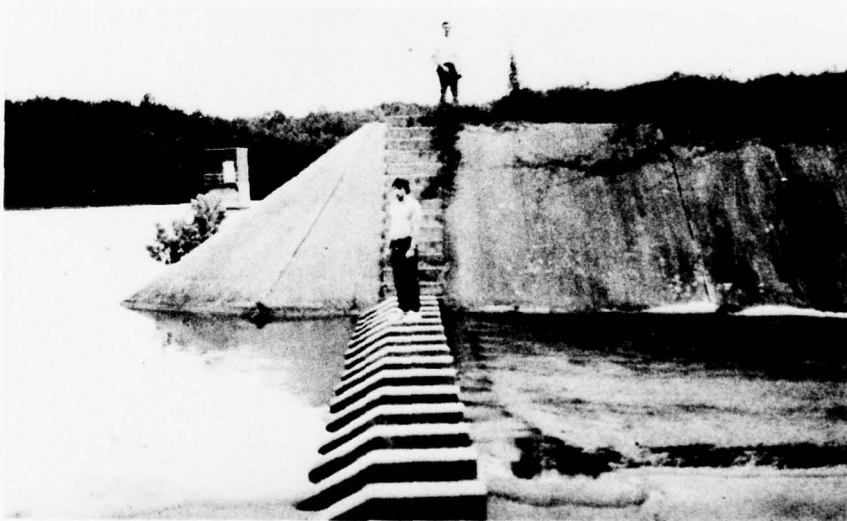
The spillway appeared to be in good condition. There were no cracks in the concrete and the construction joints had recently been sealed with a bituminous material.

BEAVER CREEK DAM - SPILLWAY CREST

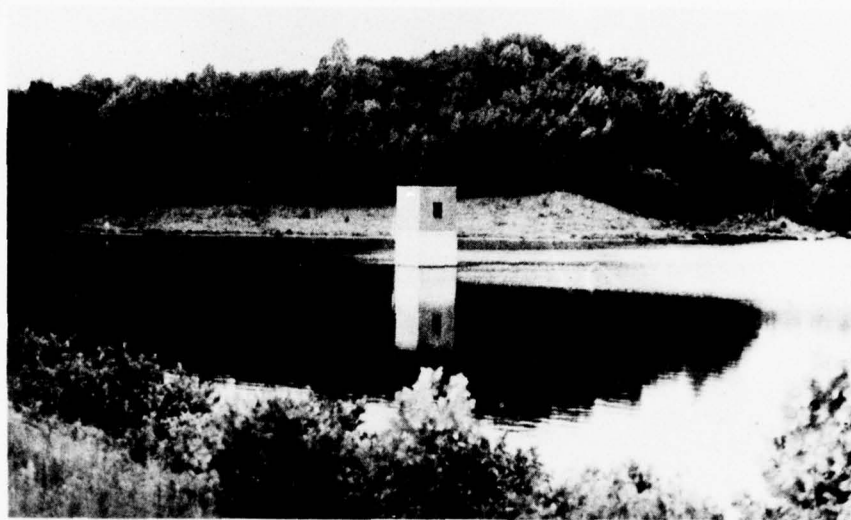
BEAVER CREEK DAM GATE TOWER

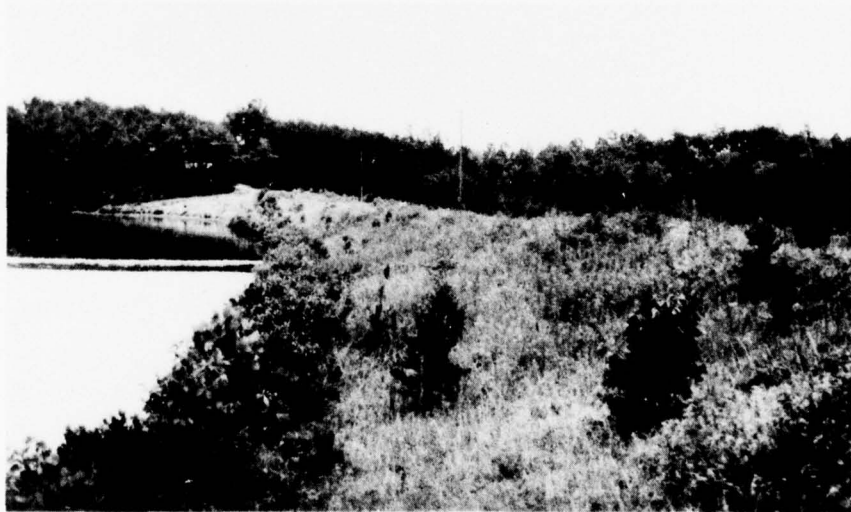
UPSTREAM SLOPE OF THE EMBANKMENT FROM THE RIGHT ABUTMENT

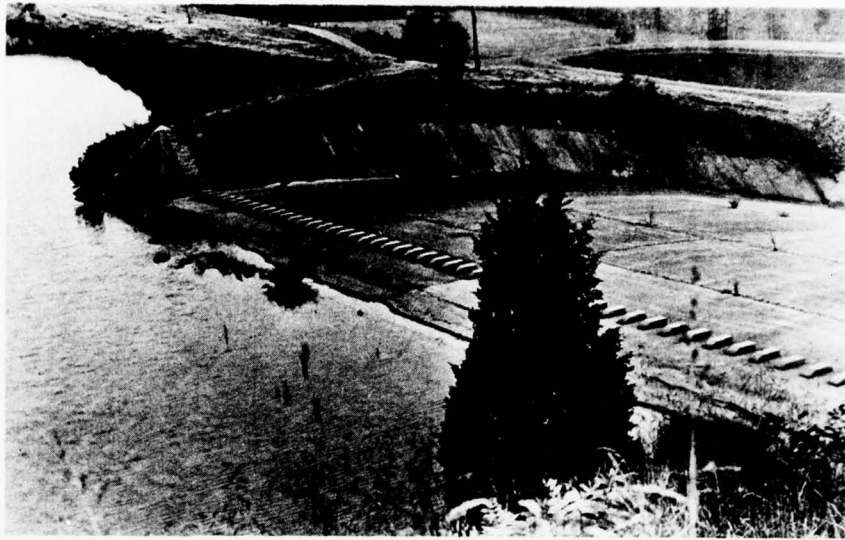
VIEW OF EMBANKMENT AND SPILLWAY FROM RIGHT ABUTMENT

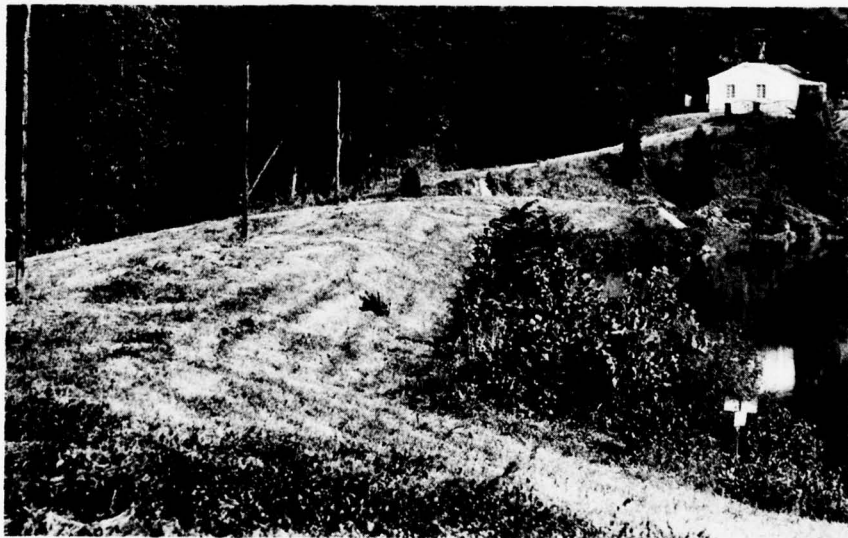
UPSTREAM FACE OF EMBANKMENT FROM LEFT ABUTMENT
