# 9710 W Outer Dr

## Existing Condition Photos

# 9730 W Outer Dr

# Detailed Scope of Work

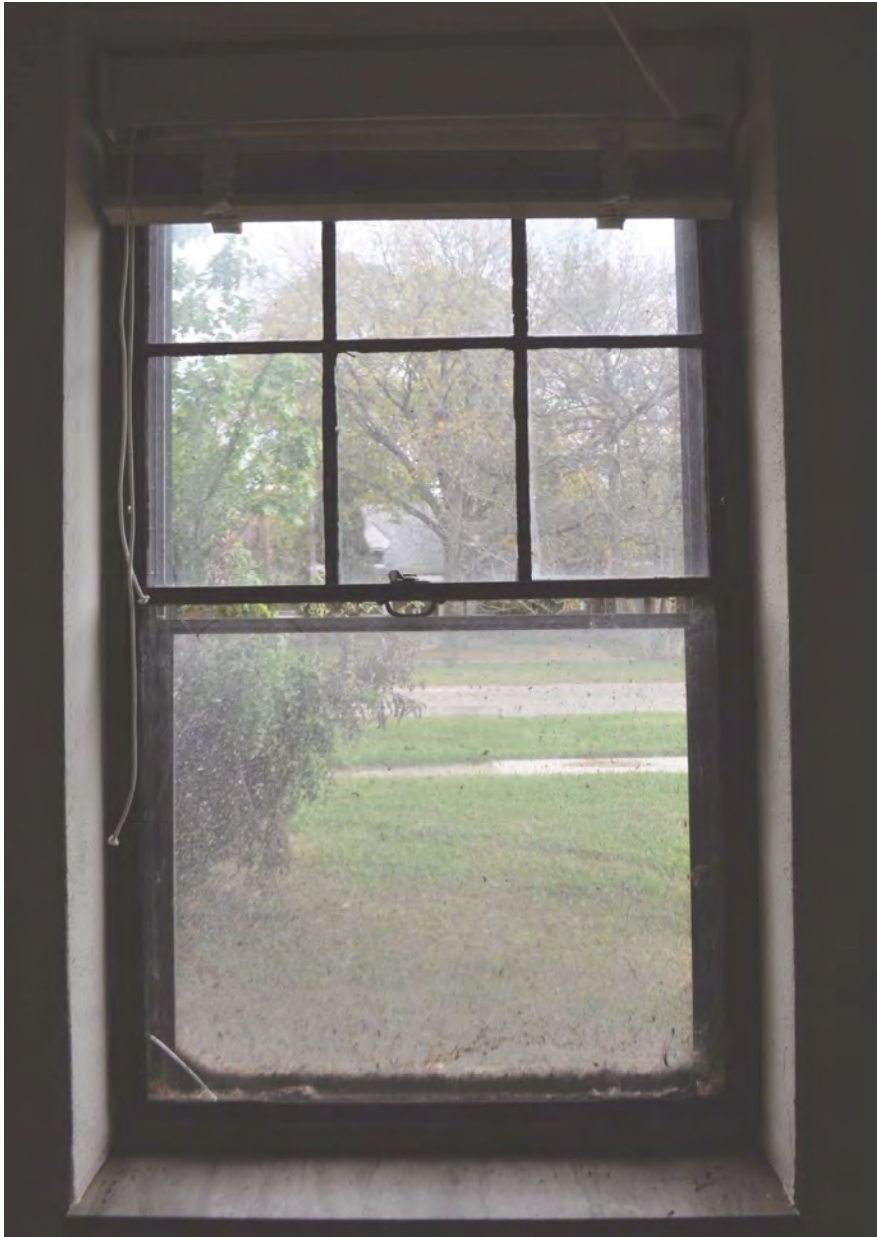
### Window S1, Type M1

- Badly Corroded
- Broken Glass
- Note: Extent of exterior deterioration, corrosion, and loss of operability is not fully apparent in interior photos. Replacement parts for existing windows are unavailable, making restoration of thermal and operable functionality impossible, and long-term maintenance infeasible. Recommendation is for replacement, for quality of life of future tenants and for feasibility of long-term maintenance.
- See Window Assessment (Blackberry) in appendix for further detail and information, including further notes on deterioration beyond repair
- See Appendix for Window Schedule & Measurements

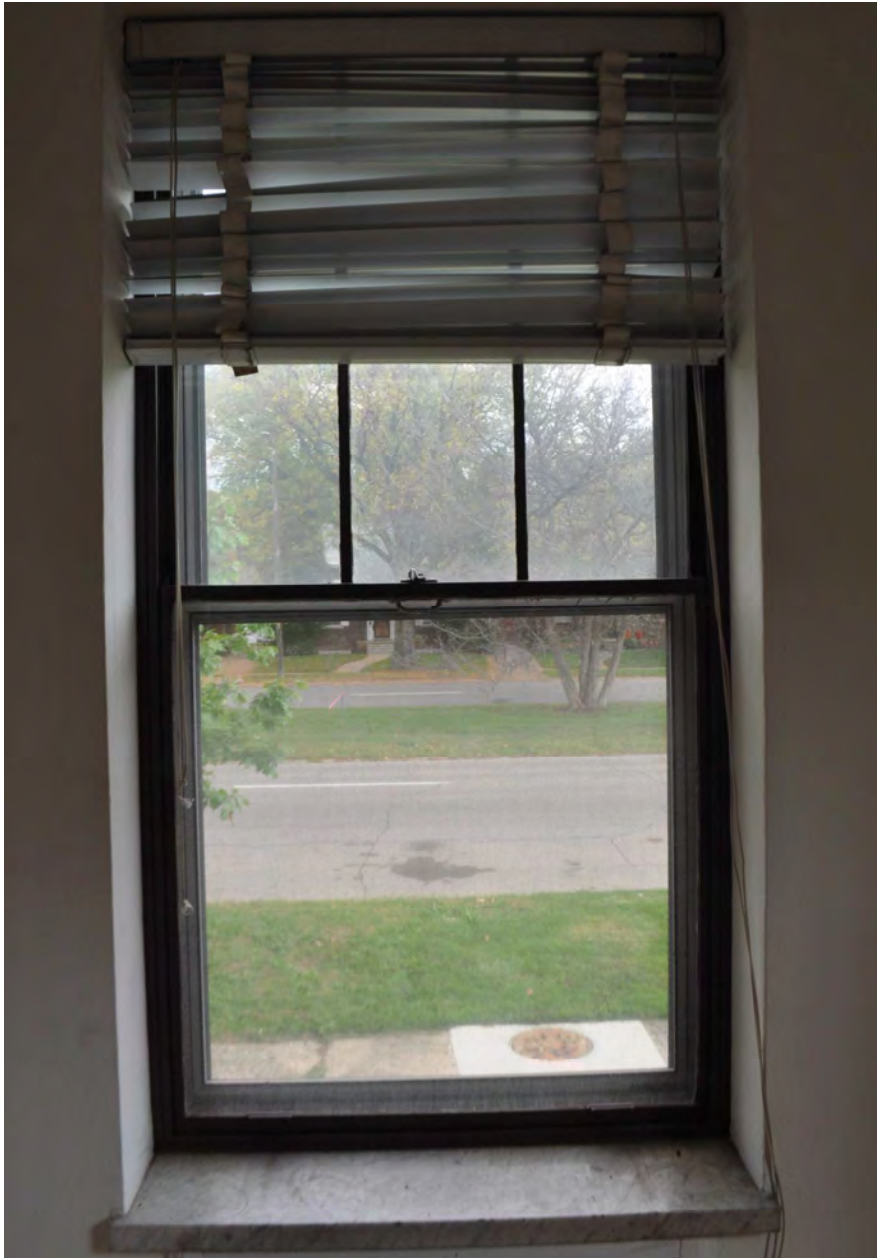
### Window T1, Type N1

- Note: Extent of exterior deterioration, corrosion, and loss of operability is not fully apparent in interior photos. Replacement parts for existing windows are unavailable, making restoration of thermal and operable functionality impossible, and long-term maintenance infeasible. Recommendation is for replacement, for quality of life of future tenants and for feasibility of long-term maintenance.
- See Window Assessment (Blackberry) in appendix for further detail and information, including further notes on deterioration beyond repair
- See Appendix for Window Schedule & Measurements

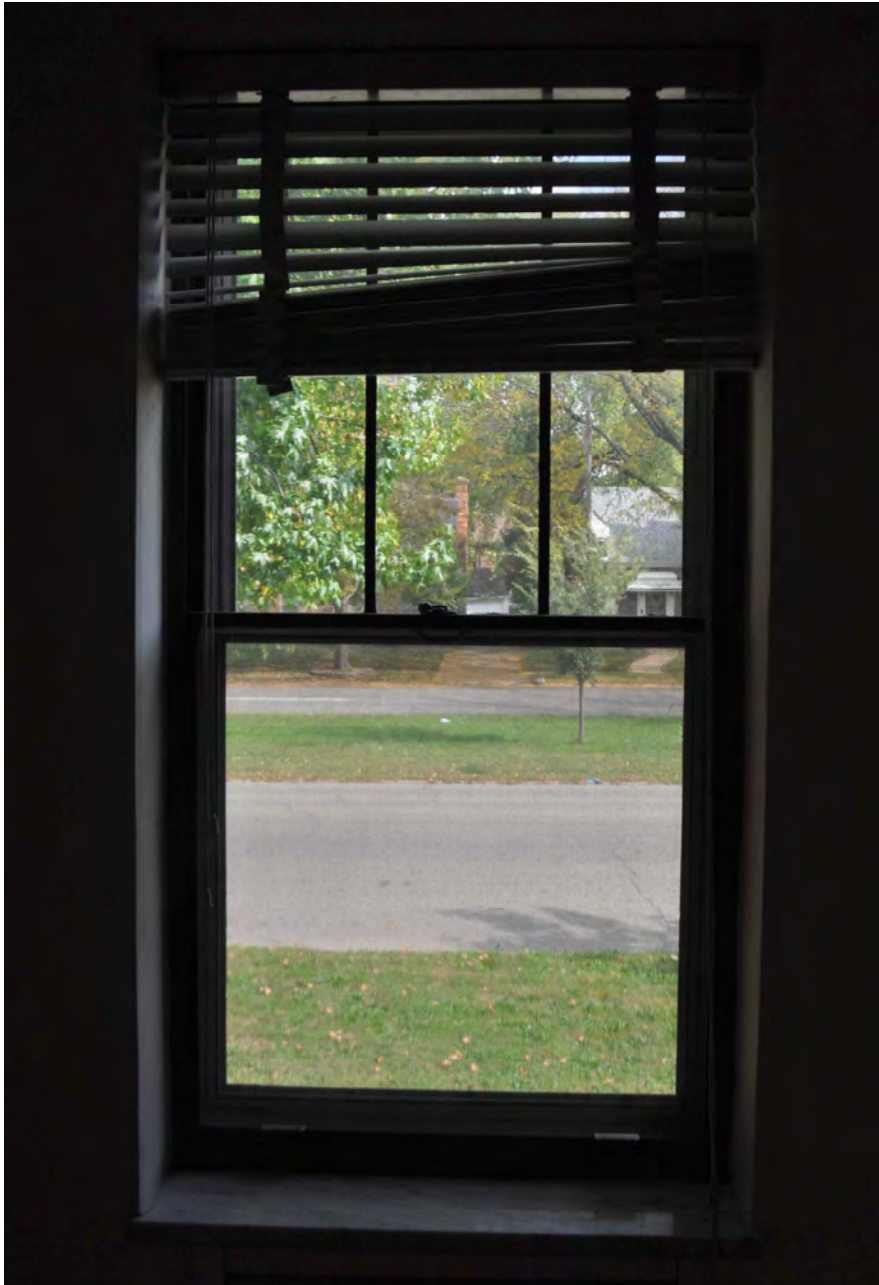
### Window T4, Type N1

- Note: Extent of exterior deterioration, corrosion, and loss of operability is not fully apparent in interior photos. Replacement parts for existing windows are unavailable, making restoration of thermal and operable functionality impossible, and long-term maintenance infeasible. Recommendation is for replacement, for quality of life of future tenants and for feasibility of long-term maintenance.
- See Window Assessment (Blackberry) in appendix for further detail and information, including further notes on deterioration beyond repair
- See Appendix for Window Schedule & Measurements

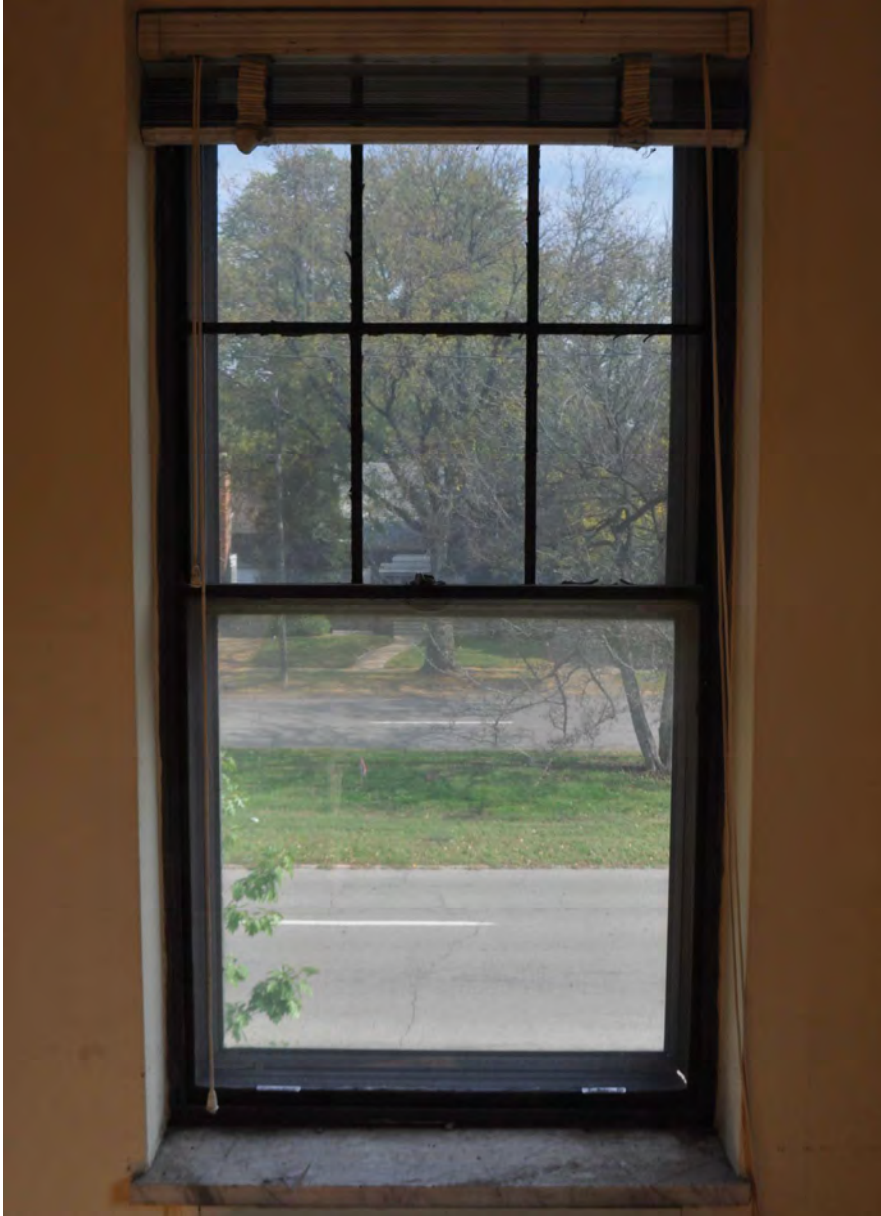
### Window U1, Type N1

- Note: Extent of exterior deterioration, corrosion, and loss of operability is not fully apparent in interior photos. Replacement parts for existing windows are unavailable, making restoration of thermal and operable functionality impossible, and long-term maintenance infeasible. Recommendation is for replacement, for quality of life of future tenants and for feasibility of long-term maintenance.
- See Window Assessment (Blackberry) in appendix for further detail and information, including further notes on deterioration beyond repair
- See Appendix for Window Schedule & Measurements

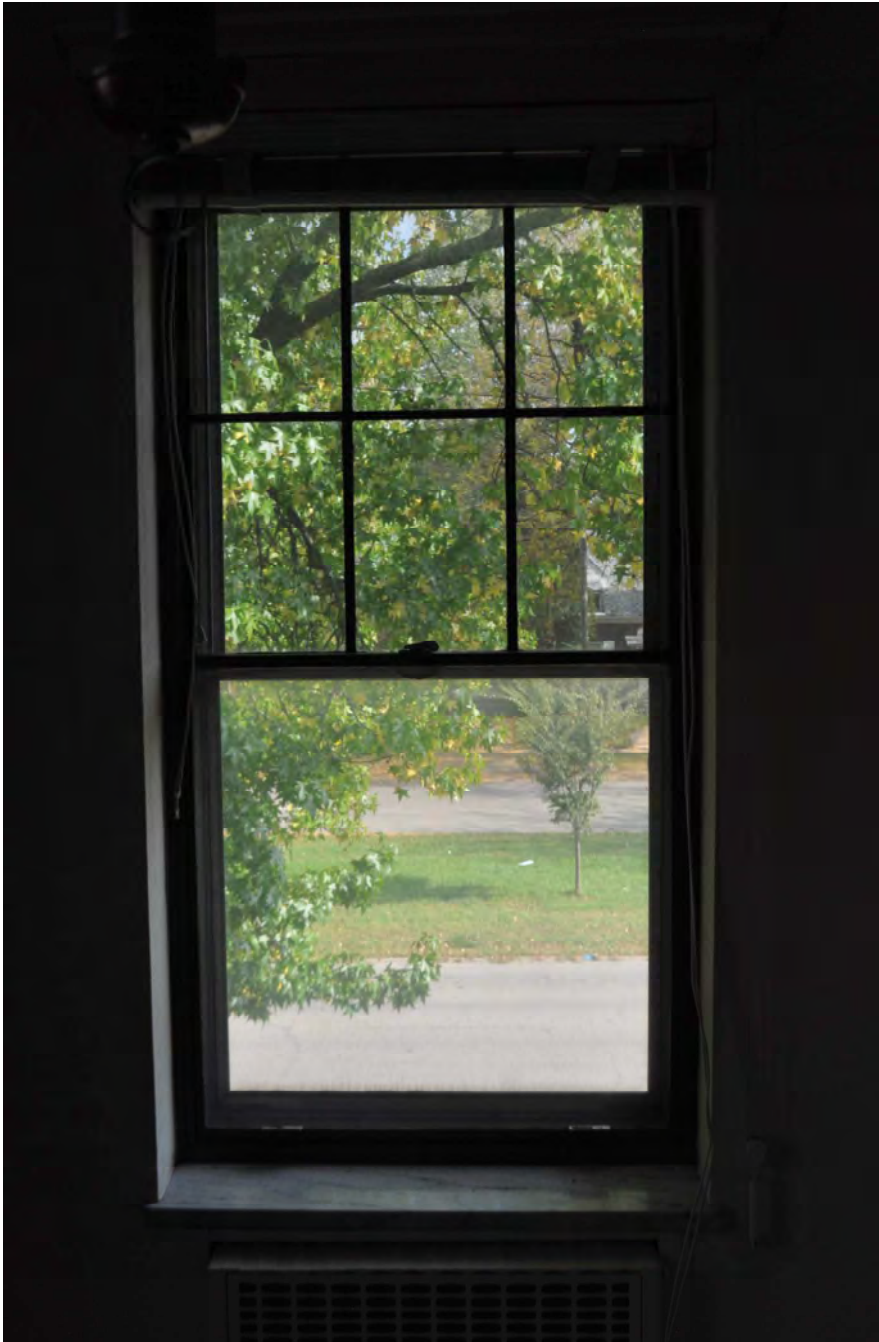
### Window U4, Type N1

- Note: Extent of exterior deterioration, corrosion, and loss of operability is not fully apparent in interior photos. Replacement parts for existing windows are unavailable, making restoration of thermal and operable functionality impossible, and long-term maintenance infeasible. Recommendation is for replacement, for quality of life of future tenants and for feasibility of long-term maintenance.
- See Window Assessment (Blackberry) in appendix for further detail and information, including further notes on deterioration beyond repair
- See Appendix for Window Schedule & Measurements

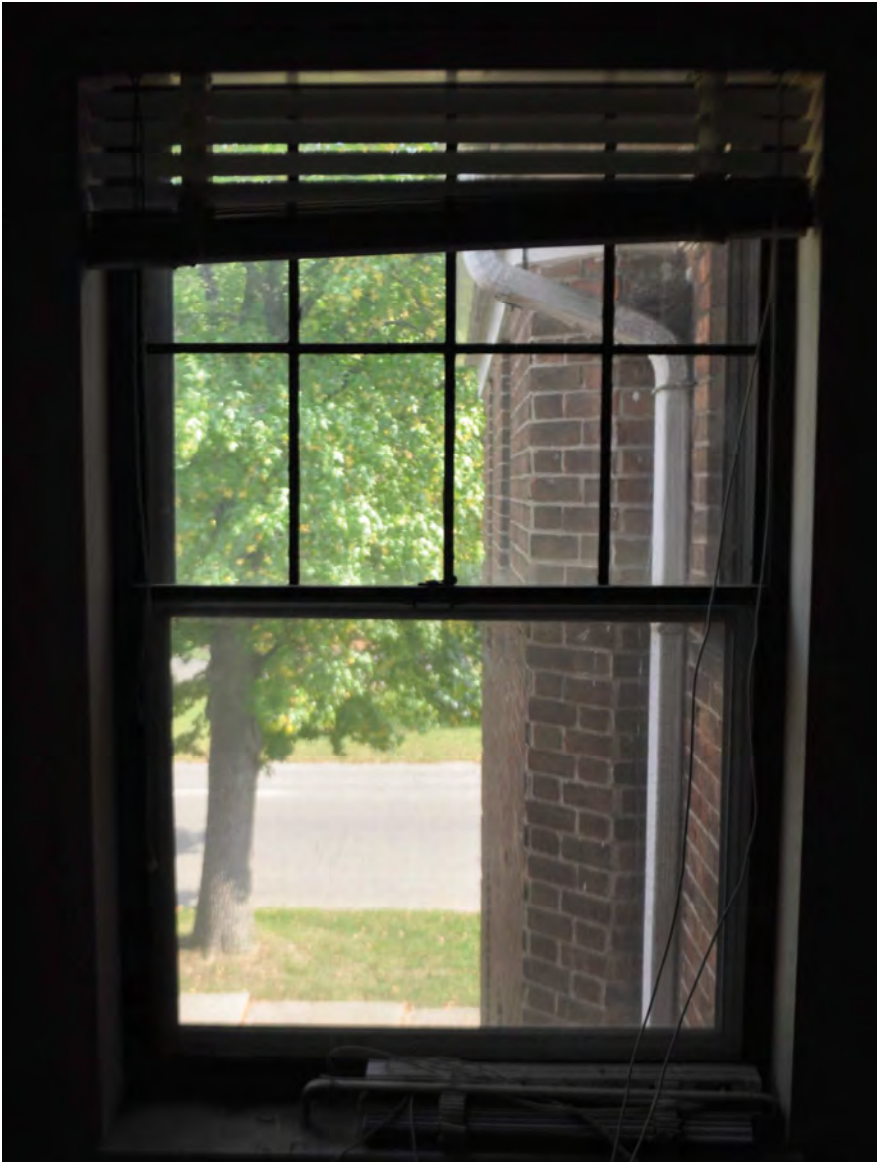
### Window U8, Type R1

- Note: Extent of exterior deterioration, corrosion, and loss of operability is not fully apparent in interior photos. Replacement parts for existing windows are unavailable, making restoration of thermal and operable functionality impossible, and long-term maintenance infeasible. Recommendation is for replacement, for quality of life of future tenants and for feasibility of long-term maintenance.
- See Window Assessment (Blackberry) in appendix for further detail and information, including further notes on deterioration beyond repair
- See Appendix for Window Schedule & Measurements

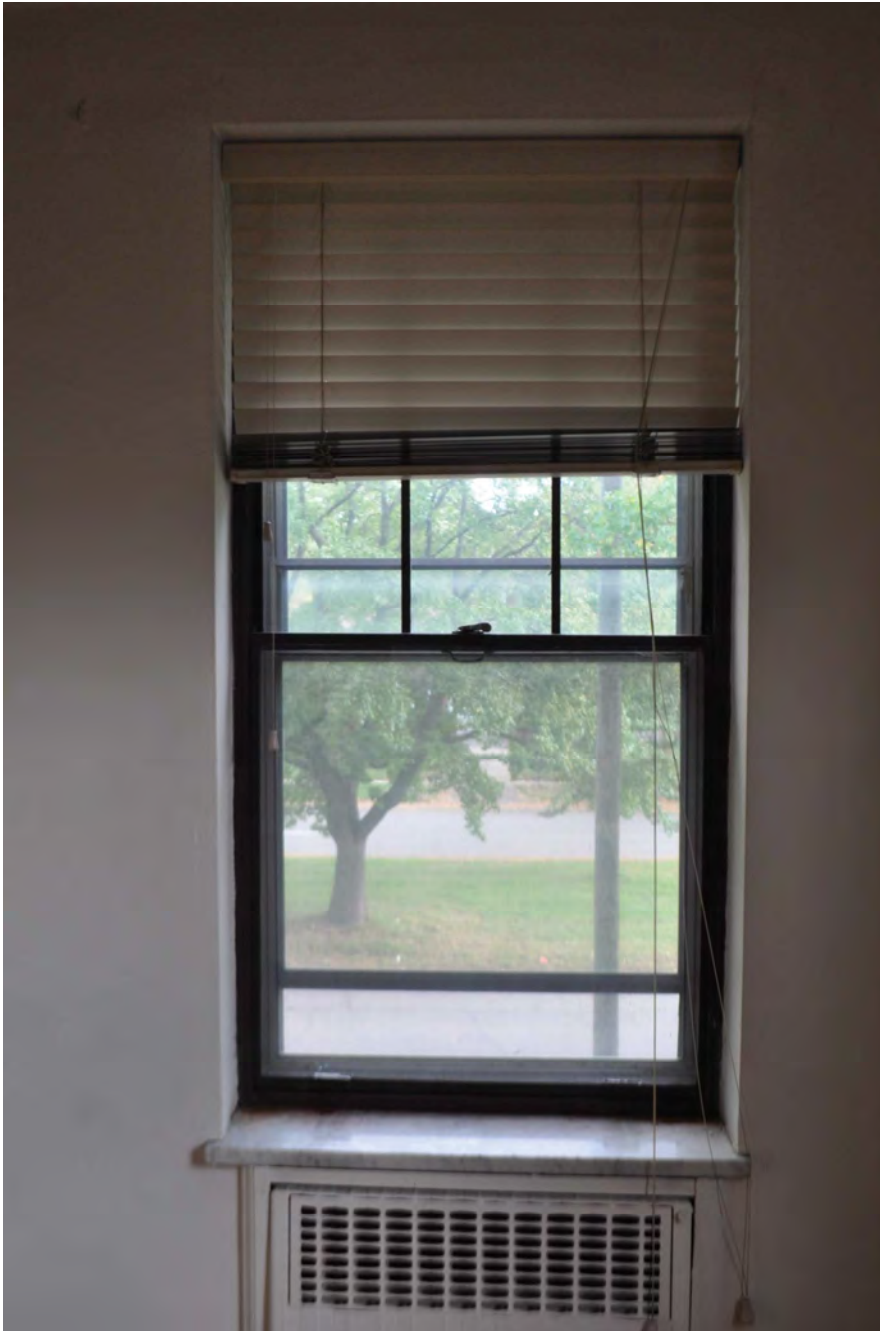
### Window U16, Type N1

- Note: Extent of exterior deterioration, corrosion, and loss of operability is not fully apparent in interior photos. Replacement parts for existing windows are unavailable, making restoration of thermal and operable functionality impossible, and long-term maintenance infeasible. Recommendation is for replacement, for quality of life of future tenants and for feasibility of long-term maintenance.
- See Window Assessment (Blackberry) in appendix for further detail and information, including further notes on deterioration beyond repair
- See Appendix for Window Schedule & Measurements

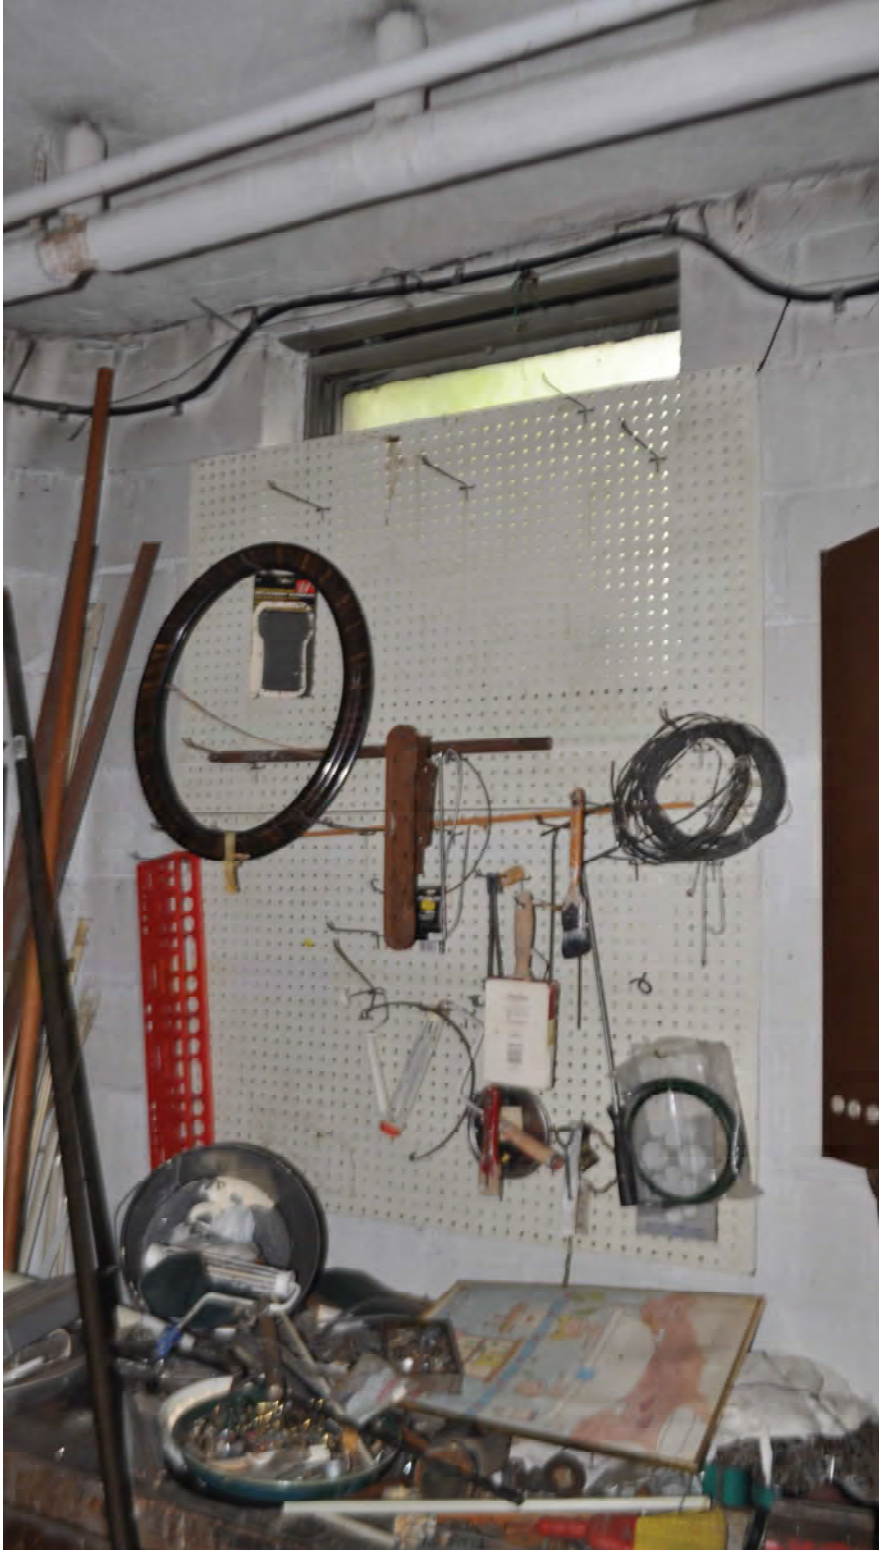
- Badly Corroded
- Note: Extent of exterior deterioration, corrosion, and loss of operability is not fully apparent in interior photos. Replacement parts for existing windows are unavailable, making restoration of thermal and operable functionality impossible, and long-term maintenance infeasible. Recommendation is for replacement, for quality of life of future tenants and for feasibility of long-term maintenance.
- See Window Assessment (Blackberry) in appendix for further detail and information, including further notes on deterioration beyond repair
- See Appendix for Window Schedule & Measurements

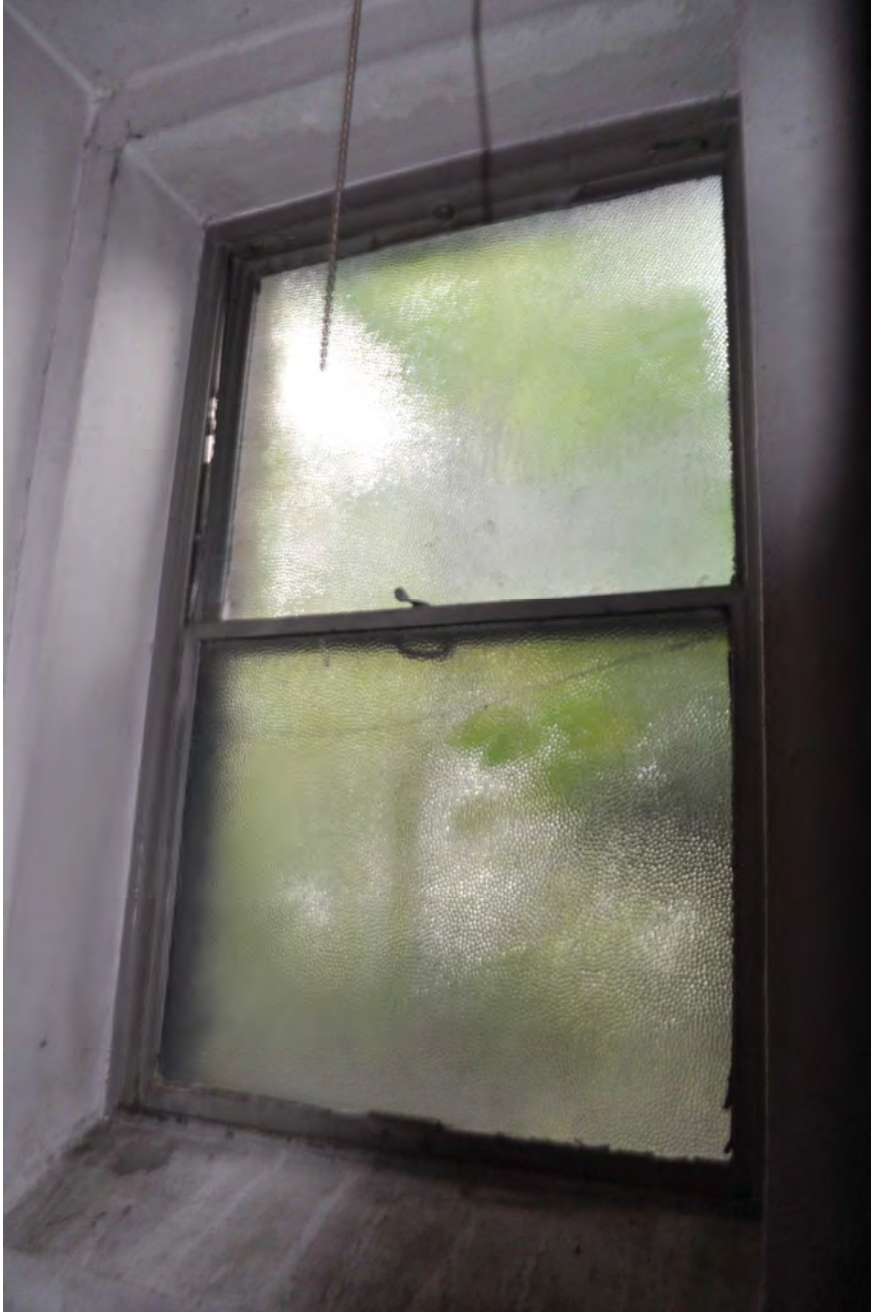
- Badly Corroded
- Note: Extent of exterior deterioration, corrosion, and loss of operability is not fully apparent in interior photos. Replacement parts for existing windows are unavailable, making restoration of thermal and operable functionality impossible, and long-term maintenance infeasible. Recommendation is for replacement, for quality of life of future tenants and for feasibility of long-term maintenance.
- See Window Assessment (Blackberry) in appendix for further detail and information, including further notes on deterioration beyond repair
- See Appendix for Window Schedule & Measurements

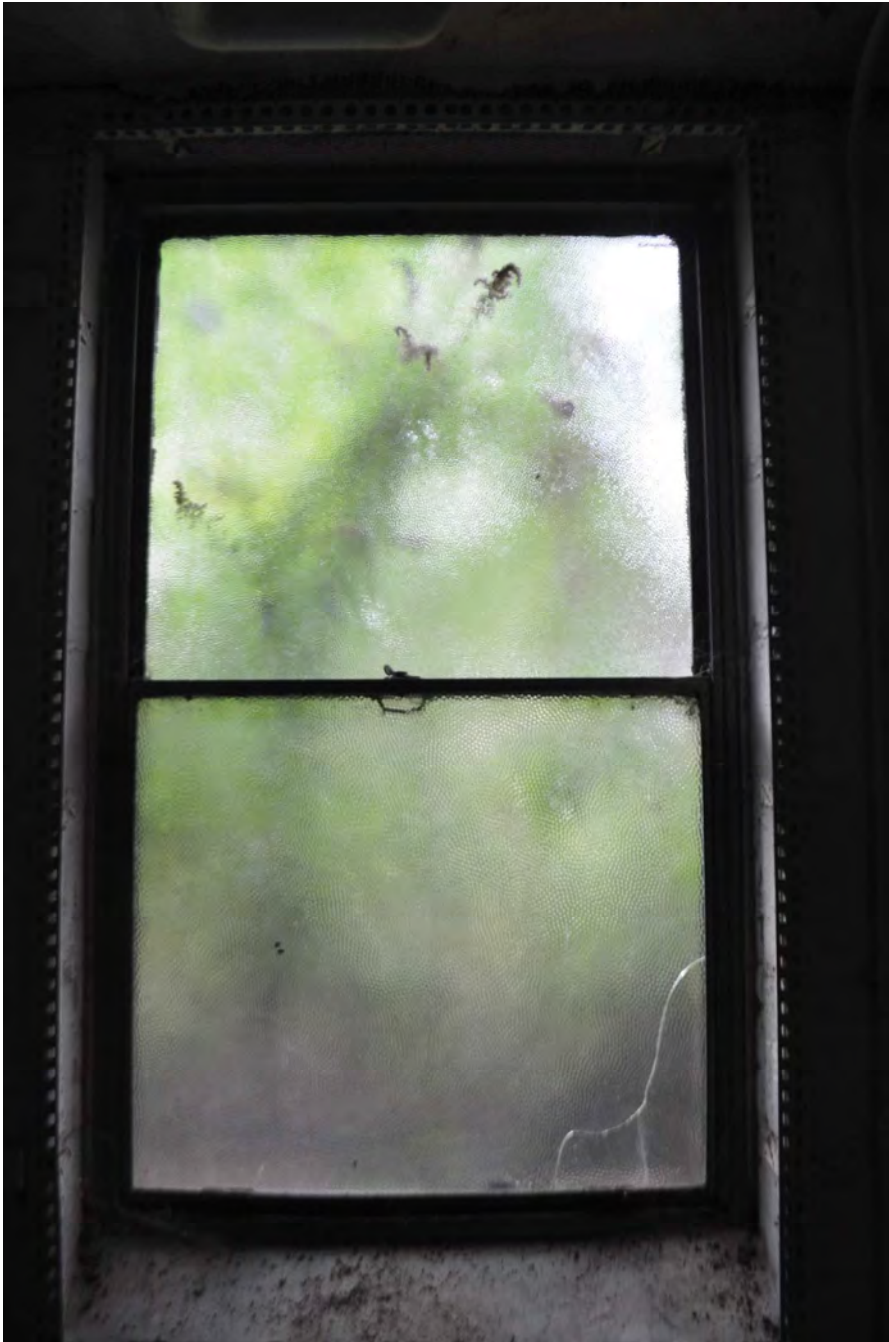
### Window V9, Type M2

- Broken Glass
- Badly Corroded
- Note: Extent of exterior deterioration, corrosion, and loss of operability is not fully apparent in interior photos. Replacement parts for existing windows are unavailable, making restoration of thermal and operable functionality impossible, and long-term maintenance infeasible. Recommendation is for replacement, for quality of life of future tenants and for feasibility of long-term maintenance.
- See Window Assessment (Blackberry) in appendix for further detail and information, including further notes on deterioration beyond repair
- See Appendix for Window Schedule & Measurements

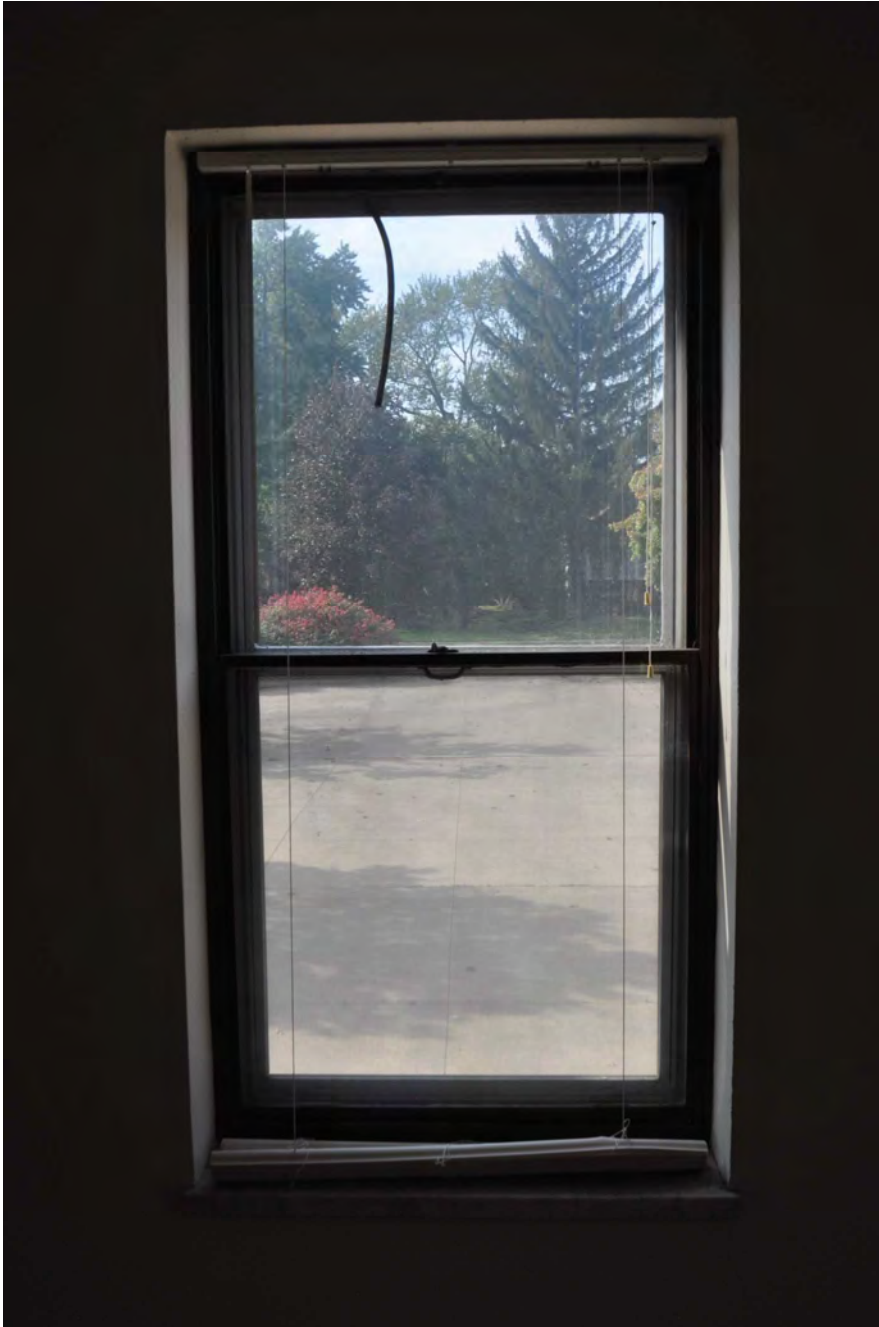
### Window W1, Type N2

- Broken Glass
- Note: Extent of exterior deterioration, corrosion, and loss of operability is not fully apparent in interior photos. Replacement parts for existing windows are unavailable, making restoration of thermal and operable functionality impossible, and long-term maintenance infeasible. Recommendation is for replacement, for quality of life of future tenants and for feasibility of long-term maintenance.
- See Window Assessment (Blackberry) in appendix for further detail and information, including further notes on deterioration beyond repair
- See Appendix for Window Schedule & Measurements

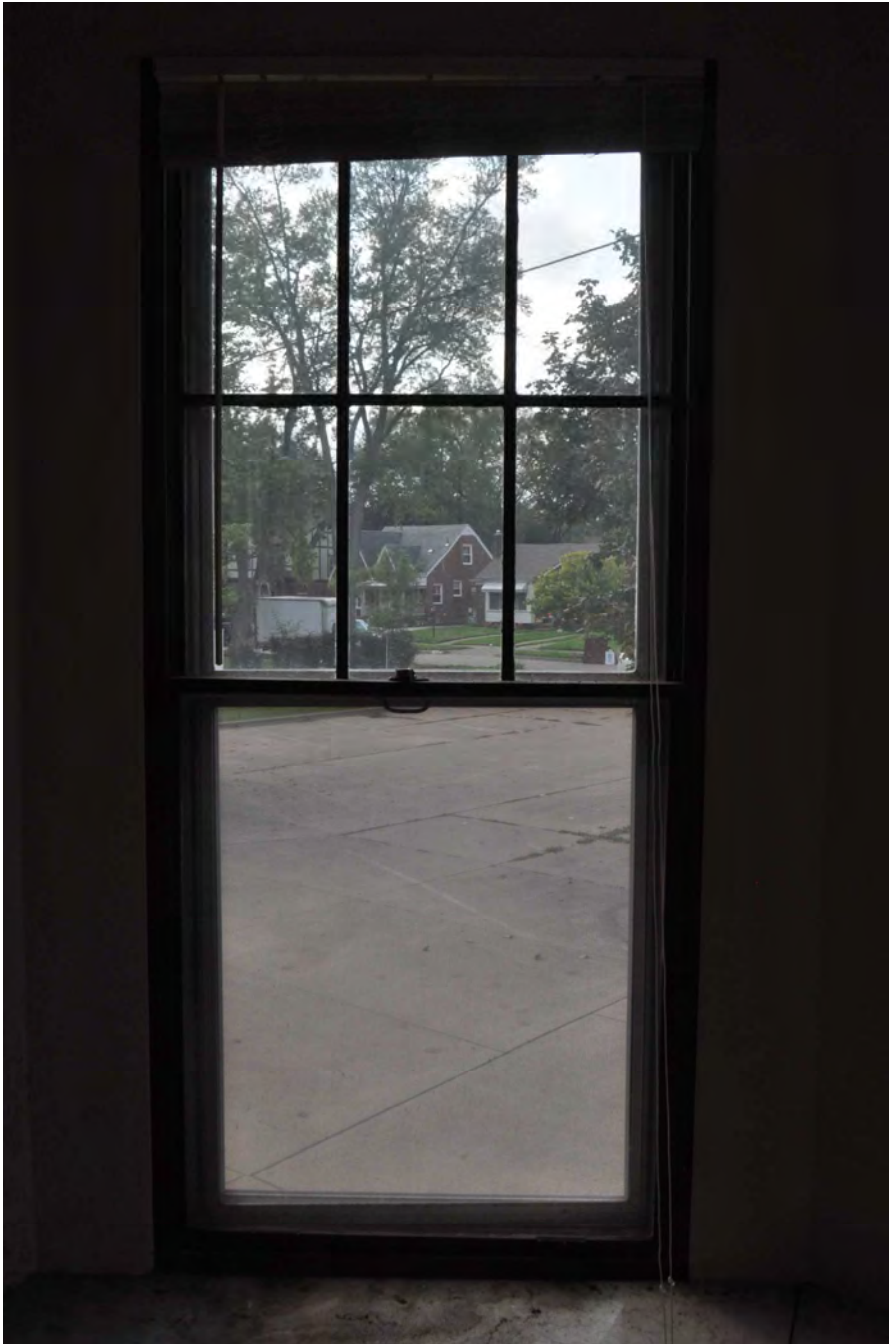
### Window W5, Type V1

- Missing Balance
- Note: Extent of exterior deterioration, corrosion, and loss of operability is not fully apparent in interior photos. Replacement parts for existing windows are unavailable, making restoration of thermal and operable functionality impossible, and long-term maintenance infeasible. Recommendation is for replacement, for quality of life of future tenants and for feasibility of long-term maintenance.
- See Window Assessment (Blackberry) in appendix for further detail and information, including further notes on deterioration beyond repair
- See Appendix for Window Schedule & Measurements

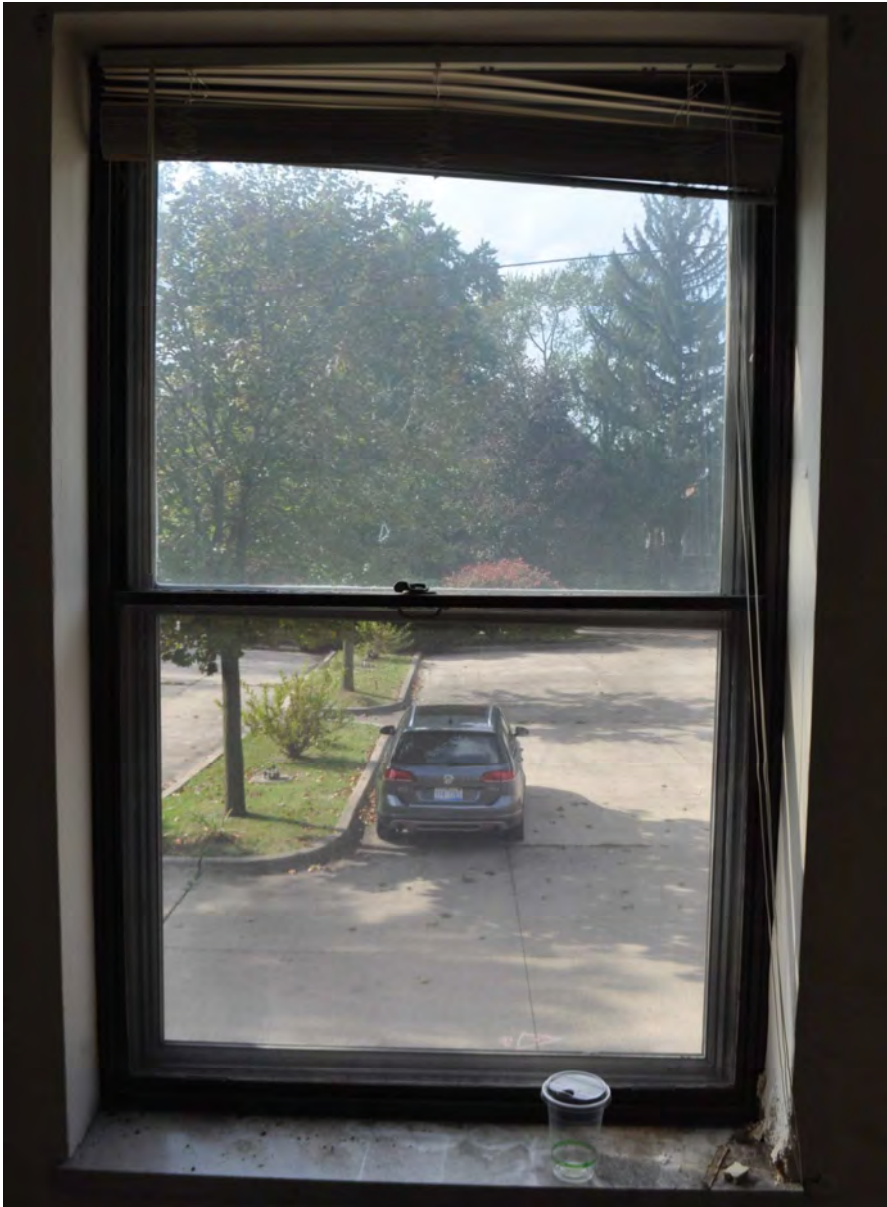
### Window W6, Type R2

- Note: Extent of exterior deterioration, corrosion, and loss of operability is not fully apparent in interior photos. Replacement parts for existing windows are unavailable, making restoration of thermal and operable functionality impossible, and long-term maintenance infeasible. Recommendation is for replacement, for quality of life of future tenants and for feasibility of long-term maintenance.
- See Window Assessment (Blackberry) in appendix for further detail and information, including further notes on deterioration beyond repair
- See Appendix for Window Schedule & Measurements

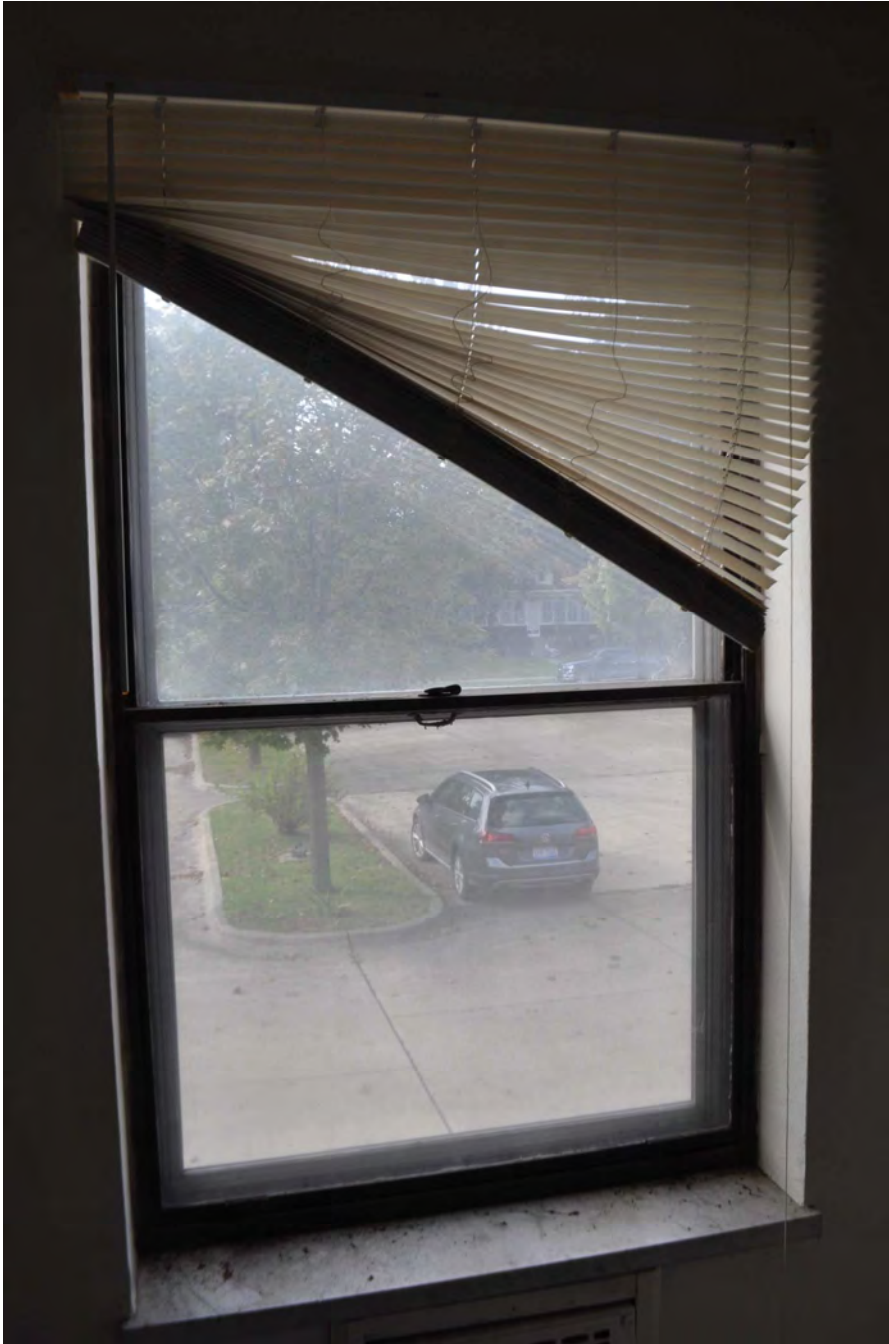
### Window W7, Type R2

- Note: Extent of exterior deterioration, corrosion, and loss of operability is not fully apparent in interior photos. Replacement parts for existing windows are unavailable, making restoration of thermal and operable functionality impossible, and long-term maintenance infeasible. Recommendation is for replacement, for quality of life of future tenants and for feasibility of long-term maintenance.
- See Window Assessment (Blackberry) in appendix for further detail and information, including further notes on deterioration beyond repair
- See Appendix for Window Schedule & Measurements

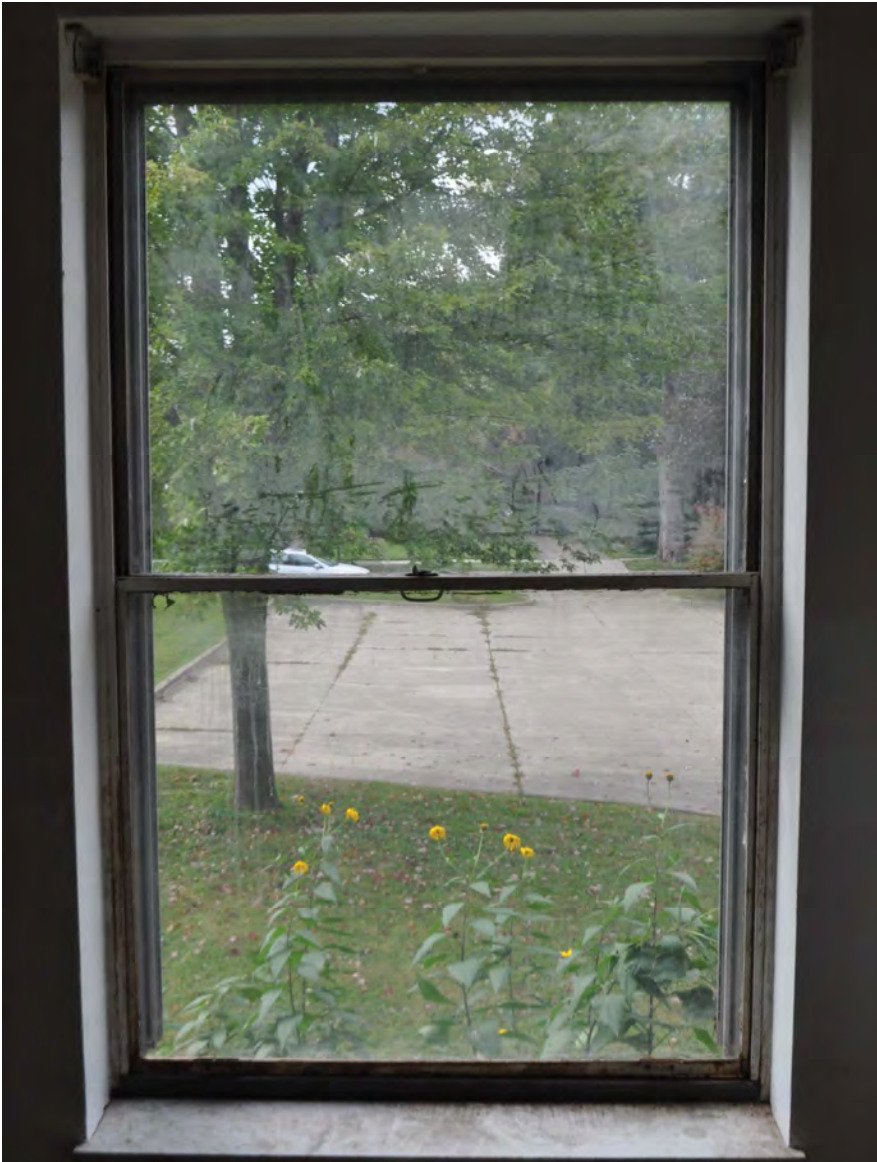
### Window W15, Type R2

- Badly Corroded
- Note: Extent of exterior deterioration, corrosion, and loss of operability is not fully apparent in interior photos. Replacement parts for existing windows are unavailable, making restoration of thermal and operable functionality impossible, and long-term maintenance infeasible. Recommendation is for replacement, for quality of life of future tenants and for feasibility of long-term maintenance.
- See Window Assessment (Blackberry) in appendix for further detail and information, including further notes on deterioration beyond repair
- See Appendix for Window Schedule & Measurements

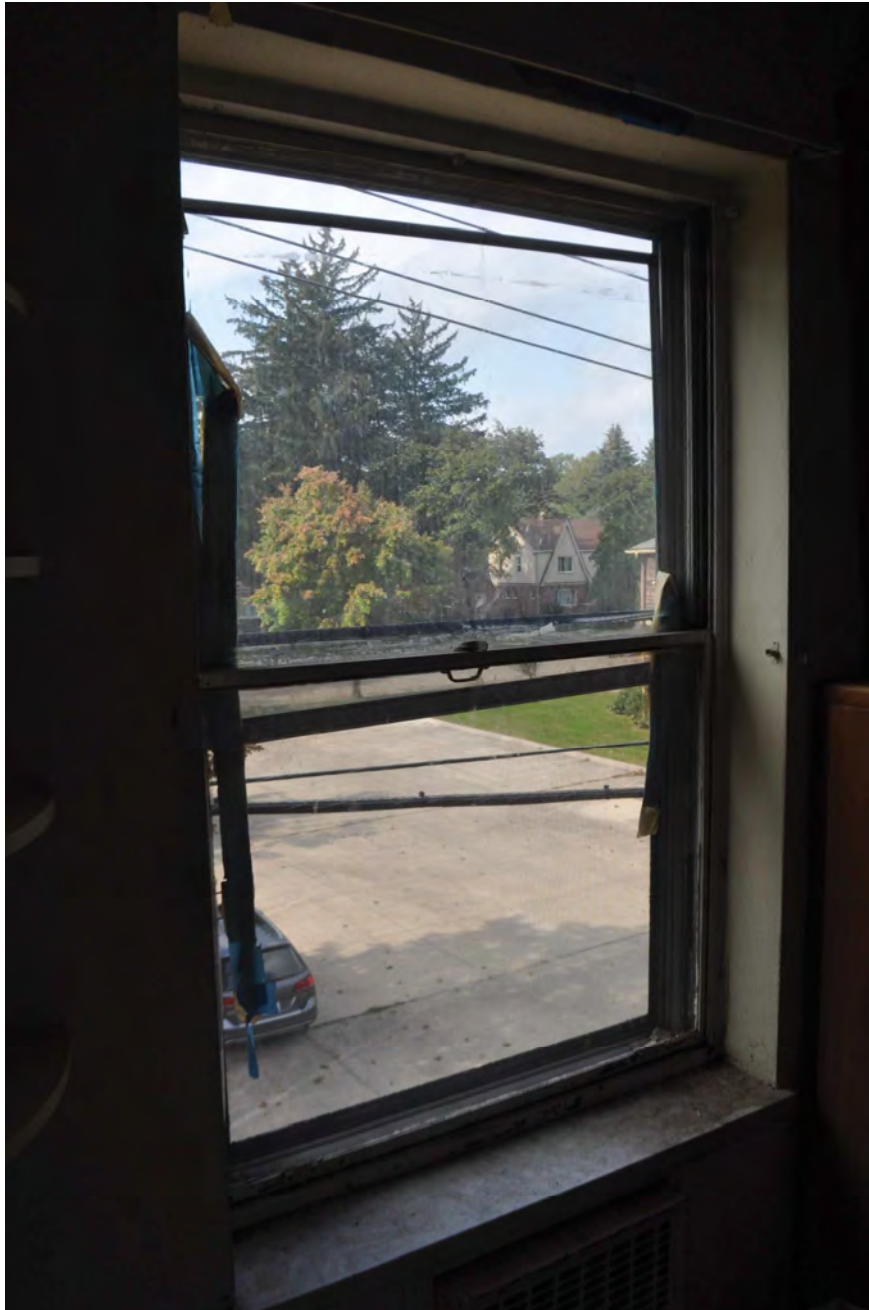
- Note: Extent of exterior deterioration, corrosion, and loss of operability is not fully apparent in interior photos. Replacement parts for existing windows are unavailable, making restoration of thermal and operable functionality impossible, and long-term maintenance infeasible. Recommendation is for replacement, for quality of life of future tenants and for feasibility of long-term maintenance.
- See Window Assessment (Blackberry) in appendix for further detail and information, including further notes on deterioration beyond repair
- See Appendix for Window Schedule & Measurements

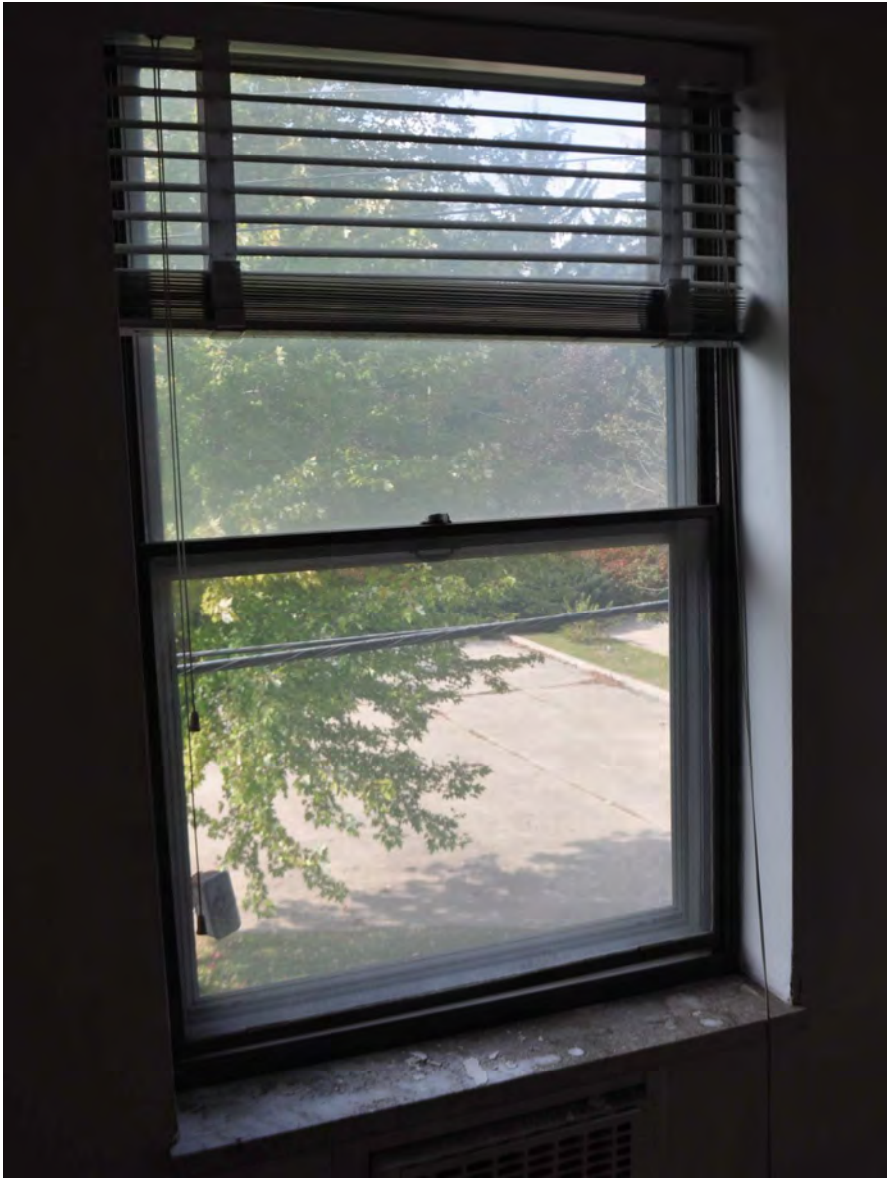
### Window X11, Type R2

- Note: Extent of exterior deterioration, corrosion, and loss of operability is not fully apparent in interior photos. Replacement parts for existing windows are unavailable, making restoration of thermal and operable functionality impossible, and long-term maintenance infeasible. Recommendation is for replacement, for quality of life of future tenants and for feasibility of long-term maintenance.
- See Window Assessment (Blackberry) in appendix for further detail and information, including further notes on deterioration beyond repair
- See Appendix for Window Schedule & Measurements
