Wheelchair Lifts on Transit Buses

Prepared by:
Ketron Inc.

January 1983

Summary of U. S. Experience

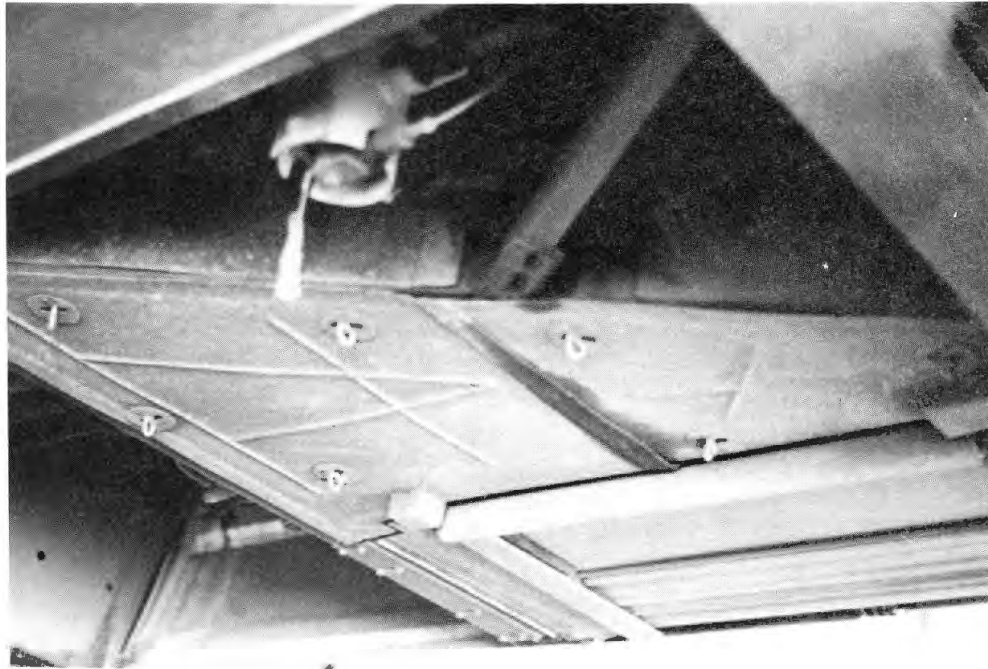
FIGURE 3.3-2: GMC LIFT UNDERSHIELD LOOKING TOWARDS LIFT, FORWARDS IS TO THE LEFT

- 1) Providing locking pins with a hardened, plated surface to counter corrosion and sticking problems with the locks.
- 2) Development of an undertray to provide protection from road spray, mud, snow, ice, and salt (Figure 3.3-2).
- 3) Replacing push connectors with a screw type on low voltage microswitch circuits to overcome corrosion problems.
- 4) Installation of an elongated hole and sensing microswitch on the platform erecting arms. This was designed to shut off power to the lift and prevent it from jacking the bus if the ground contact sensitive strip fails to stop the lift.

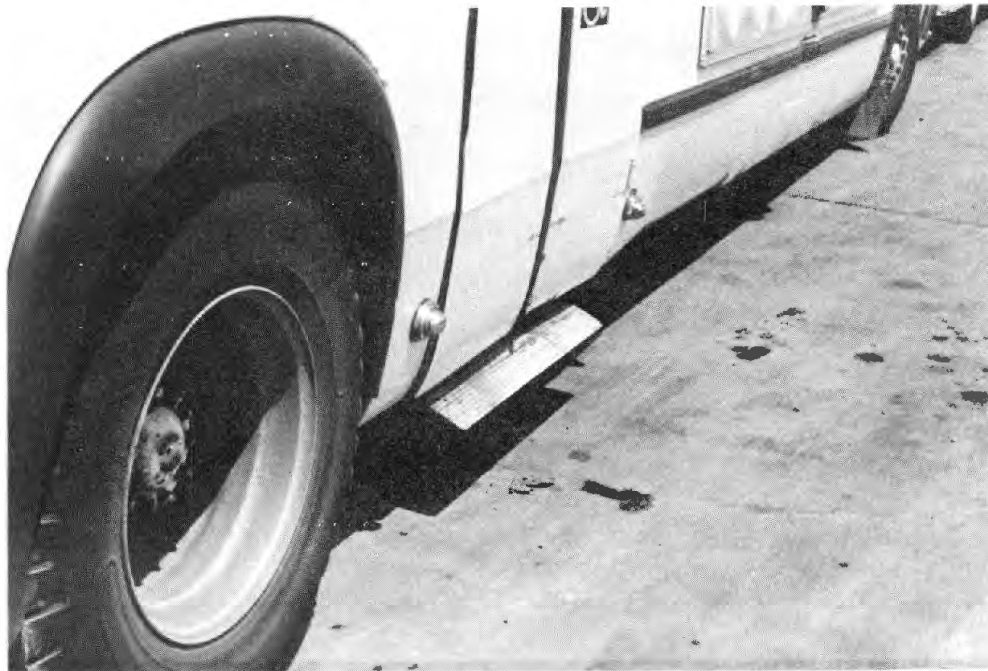
- 5) Modifying the circuitry to remove pressure from the safety barrier system in the stowed position which would cause it to drift out (Figure 3.3-3). At the same time, an extra spring was incorporated in the underside closure doors then acts to mechanically restrain the safety barrier.
- 6) Providing a revised locking pin configuration during 1981 production to overcome persistent sticking problems with the locks. The system incorporated improved alignment and wedge action.

FIGURE 3.3-3: DRIFTING SAFETY BARRIER ON GMC LIFT

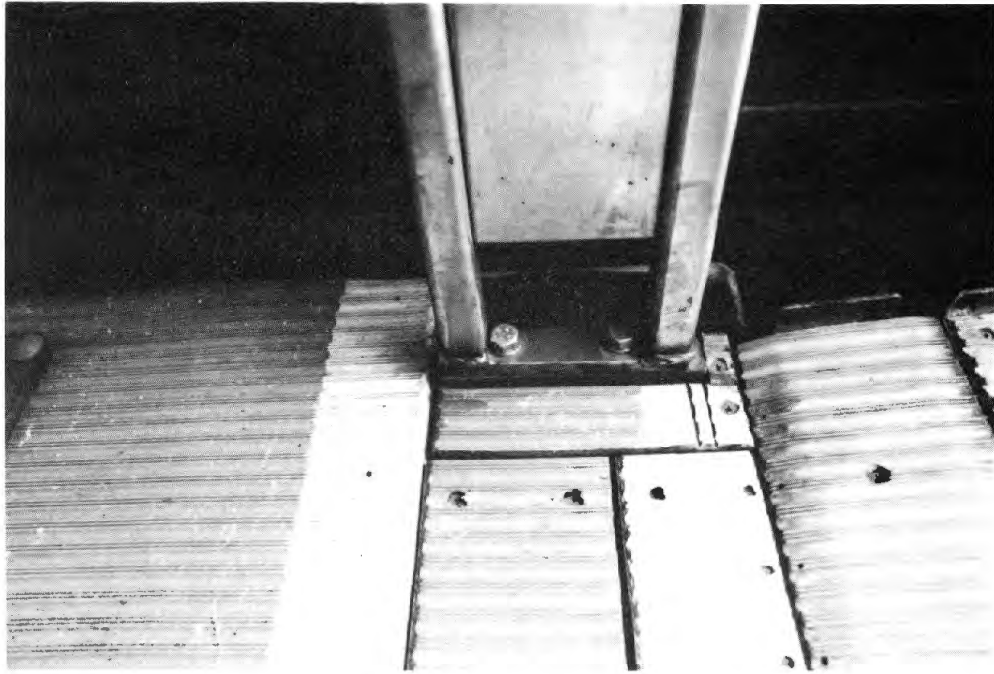
Failures of expensive items included the pump (\$1,700), control box (\$1,525), and control valves (\$236). Fatigue failures of the handrails at the point where they are welded to the baseplate were also reported, along with wiring failures due to bad routing and hose failures due to excessive hydraulic pressure.

FIGURE 4.2-1: HANDRAILS REWELDED AT THEIR BASE ON EEC 120B LIFT

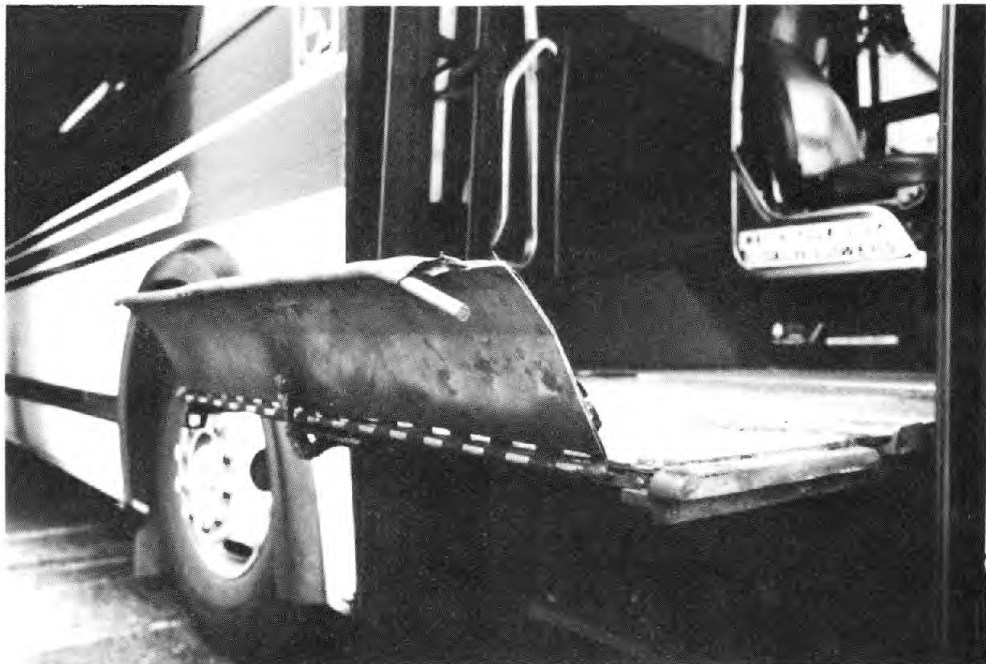
FIGURE 4.2-2: ROAD DAMAGE TO DRIFTING SAFETY BARRIER ON EEC 120B LIFT

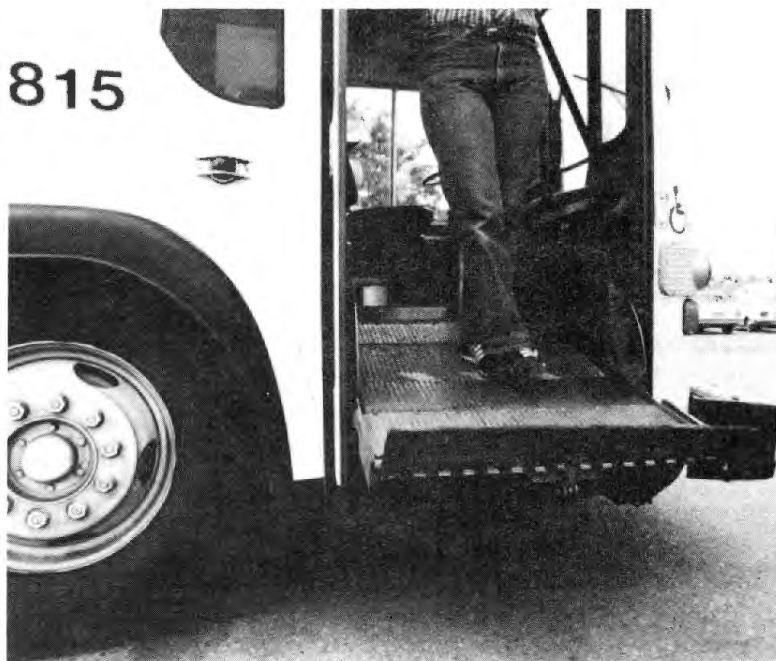
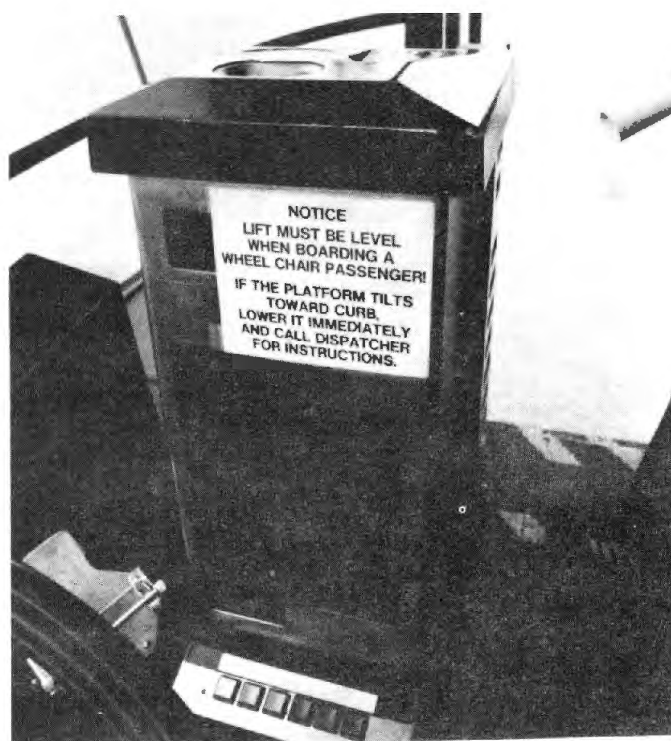
The model series outlined above represents the major EEC lift developments. A number of modifications made by properties were observed in the field. These included improved undershielding and sealing (Grand Rapids), a modified outer safety barrier (Champaign-Urbana) on their 120B lifts, and stops to relieve the wheelchair loads on the outer platform panels (RTD Denver) on their 140 series of lifts. RTD also reset the platform level sensors from a $\pm 2 \frac{1}{2}$ " setting to a - zero to 5" range to avoid negative platform slopes.

FIGURE 4.3-2: NEGATIVE PLATFORM SLOPE CONDITION AND WARNING POSTED BY RTD

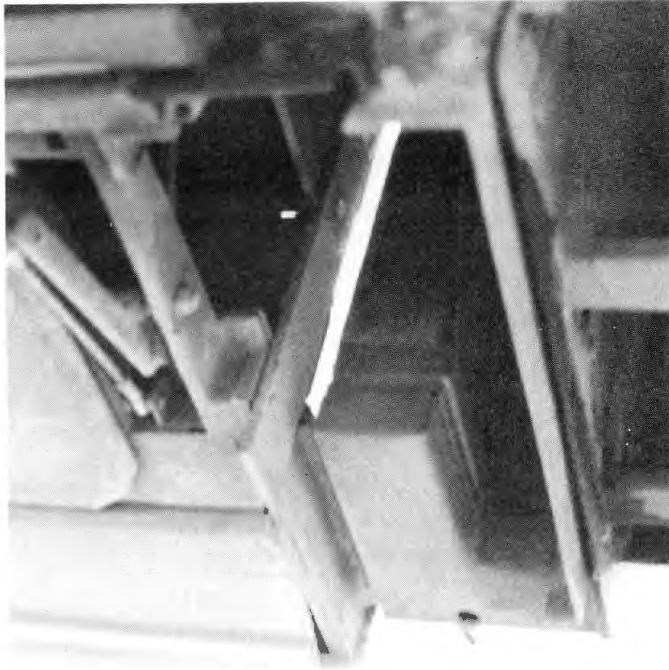
KMTS experienced a number of problems with the installation including leakage of dirt into the system and into the bus itself (Figure 4.9-1), improper deployment of the endgate, buses delivered with seals missing, and the breaking of pivot pins. They undertook a number of modifications including:

VIEW FROM UNDERSIDE SHOWING GAP INTO INTERIOR OF BUS

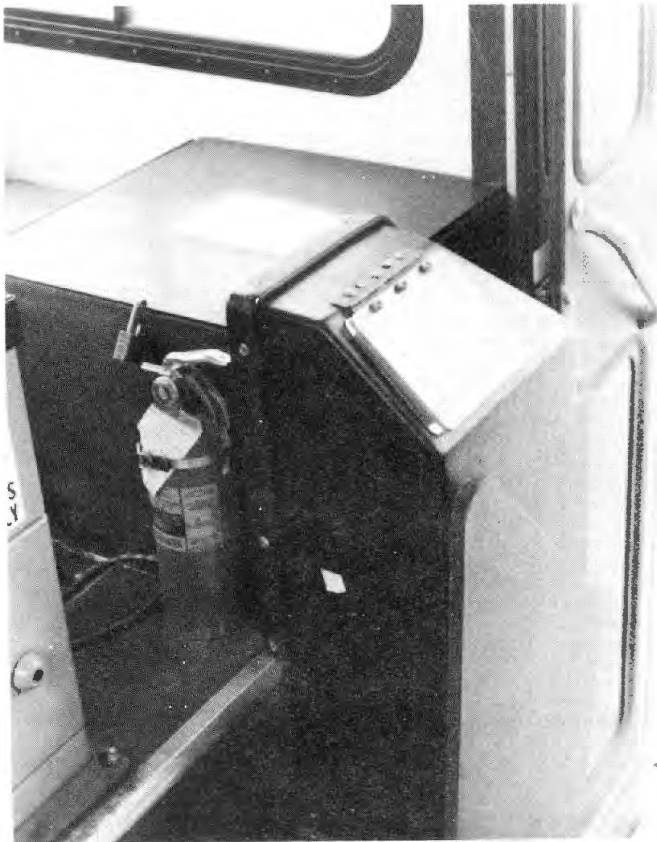
CONTROL PANEL WITH COVER AND LOCKED MANUAL CONTROL BOX

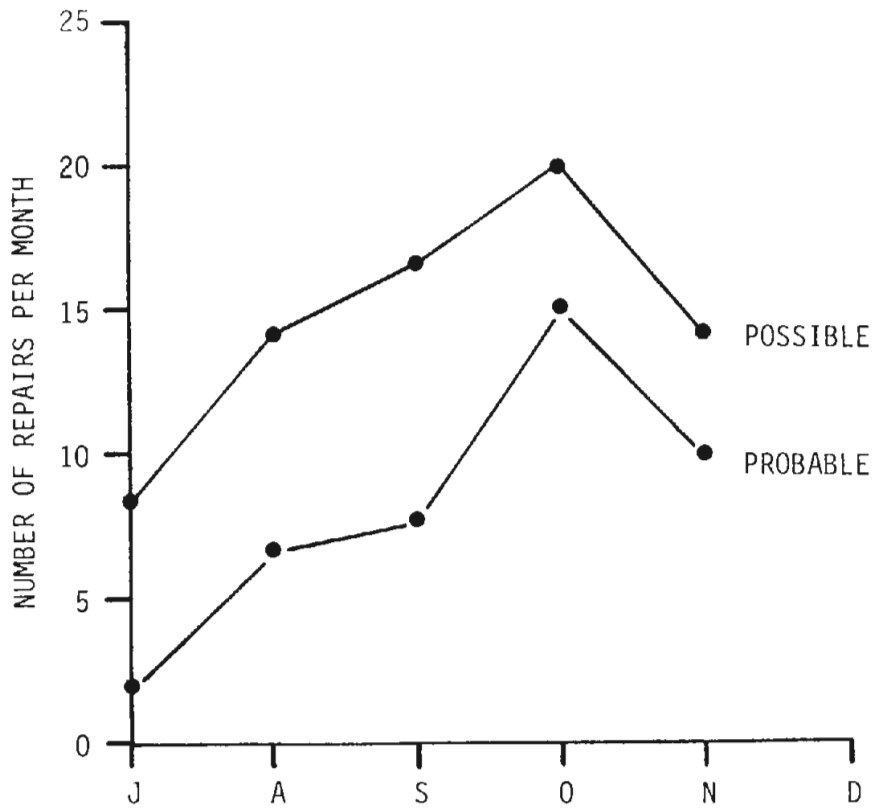
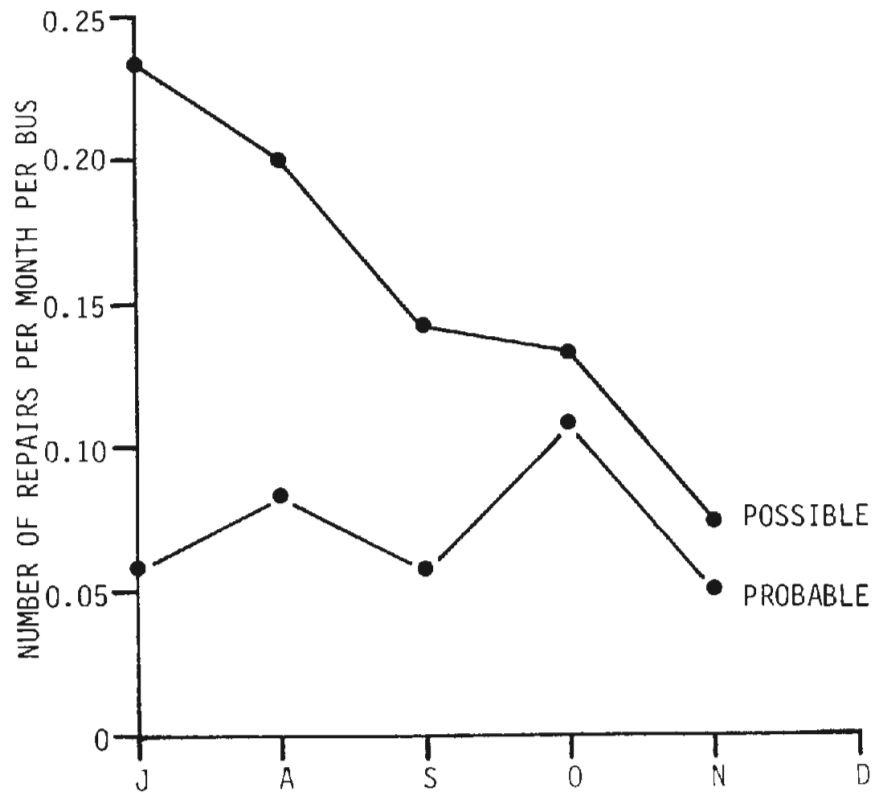
FIGURE 4.15-1: TRENDS OF CURBING REPAIRS ON GFC 870 BUSES FOR JULY THROUGH NOVEMBER 1981 AT SCCTA

The experience at SCCTA also indicates that any sensitivity to curbing can be eliminated by placing a local bumper ahead of the lift at the outboard edge. This was done on the Gillig buses (#600-681) that were retrofitted with the TDT-50 lift early in 1981. The bumper, which in this case consists of a solid steel ball, was retrofitted to these buses over the summer of 1981 and dramatically reduced the number of sensitive edge repairs in the subsequent months as follows:
