Research & Technology Implementation

RESEARCH UPDATE

U2013-03

Assessment of Detectable Warning Products

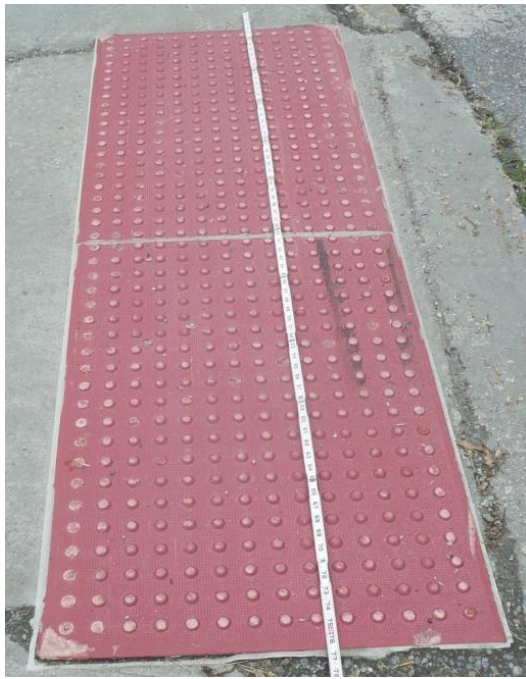
2009

The panel system was still fairing well. The domes on the leading and trailing edges of the panel were missing. The corners show additional wear from the 2006 observations. The joints began to show some wear. Since this is the only surface applied panel on the APL and the overall condition is fair, the product was listed on the APL with conditional approval. It was determined that annual monitoring will be conducted.

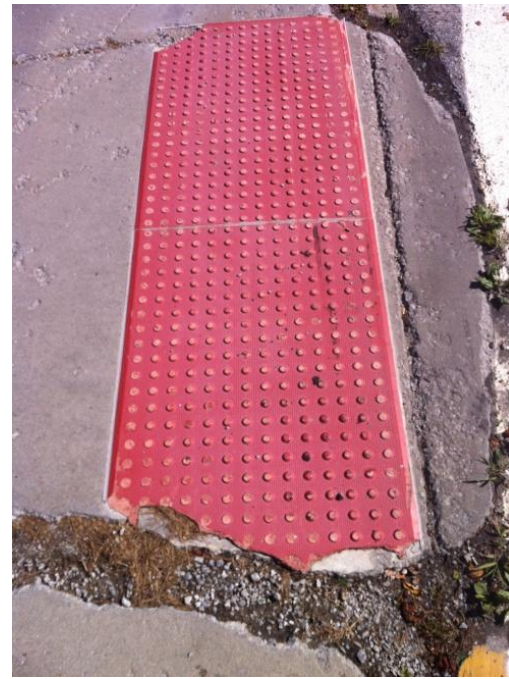
2013

The site visit revealed some significant corner and edge loss. Since the panel is surface applied, the updated pictures reveal the pieces of the panel are missing along where the cracked sidewalk has been removed. The domes are in fairly good shape except for ones closer to the edge which experienced much more wear. The panel continues to exhibit satisfactory friction. The years have faded the color slightly, but overall the panel is in fair shape. The panel could be a viable option if more care was taken during construction.

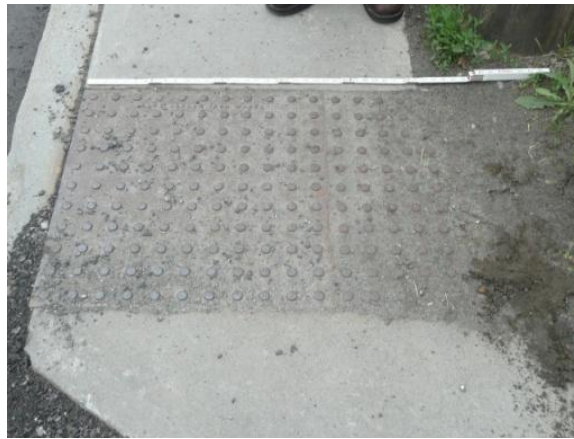
Figure 3: East Jordan Works – Detectable Warning Plate in 2009

The panels were in good condition with some domes sheared on the perimeter. There were some concerns over color contrast. It was recommended to leave the product with full approval on the APL. Annual monitoring will continue to be conducted with special attention to the color.

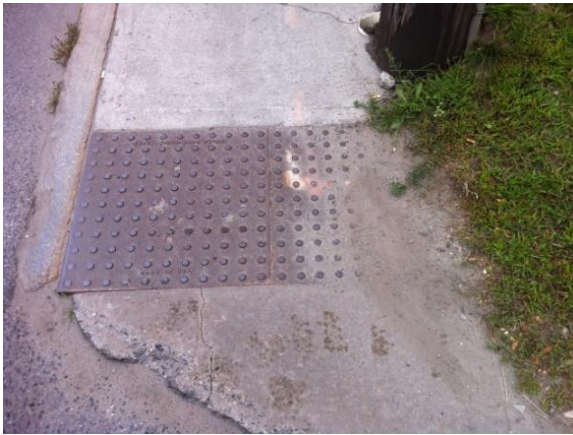
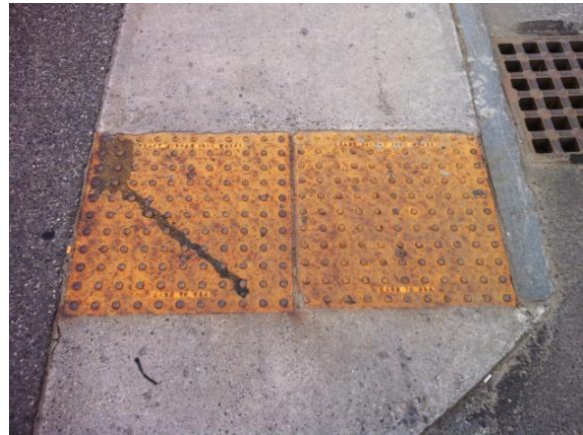
Figure 4-5: East Jordan Works – Detectable Warning Plates 2013

After 8 years of its installation, one of the panels is structurally in good condition. The other panel appears to have been replaced between the years of 2009 and 2013 for unknown reasons. The sidewalk has begun to crack and wear away on its edges and is beginning to wear underneath the panel. Dirt and grass are also covering approximately $\frac{1}{4}$ of the panel. Both panels have experienced wear and are slightly slick on the domes. Slight rust bleeding has occurred and the color is all but gone on the original panel. The replaced panel still has some of its yellow coating.

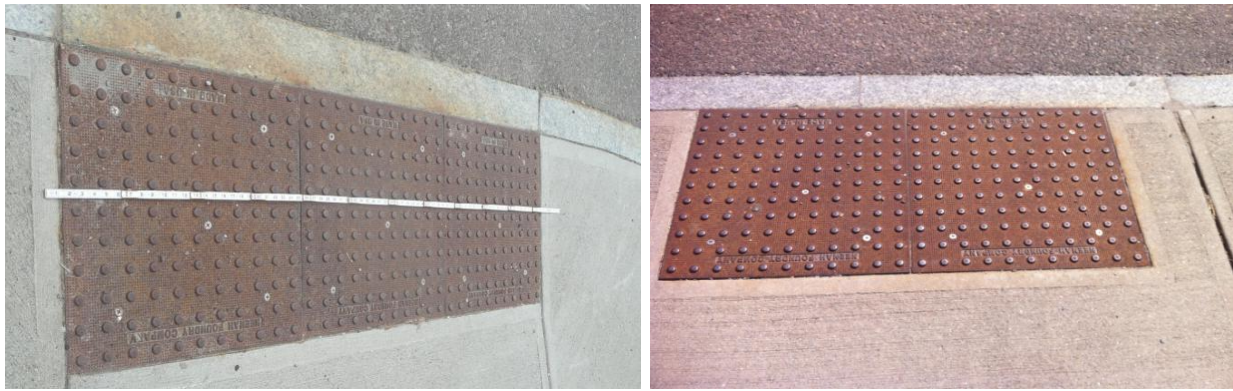
Figures 6-7: Neenah Foundry Co. – Detectable Warning Plate.

The panels were in great condition. The rust bleeding has diminished and all domes are intact. It is recommended to keep the product as approved without conditions on the APL. Annual monitoring will be conducted.

Still in excellent condition, the panels show little wear and only minor rust bleeding. The texture on top of the domes is slightly worn away making it possibly slippery in wet conditions. The brown rust colors of the panels stand out well against the pale grey sidewalk. The panel will be continued to be monitored.

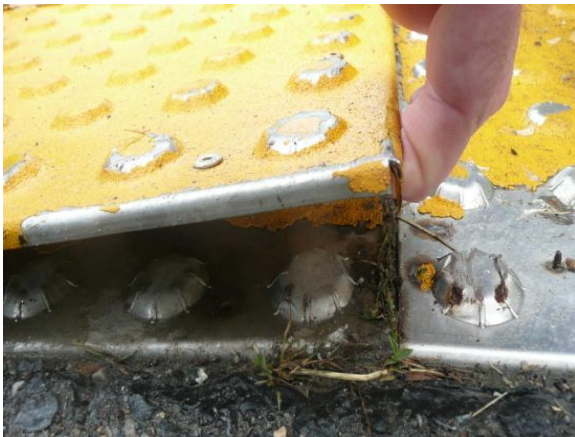
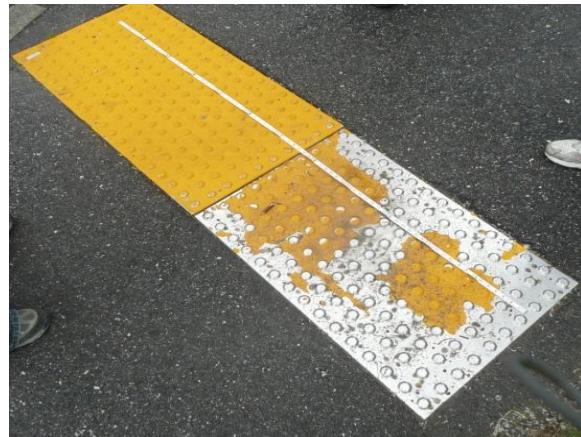
Figures 8-9: MetaDome, LLC. – Asphalt. 2009

The original panels were in poor condition. Additional panels had been added to three of the four original panels. The new panels were not bonded well to the underlying panels, causing the panels to deflect. This could potentially cause a safety hazard. The coating had severely diminished, causing the panels to be extremely slippery when wet. At the time it was recommended that the product be removed from the APL. This was the only asphalt panel that was on the APL.

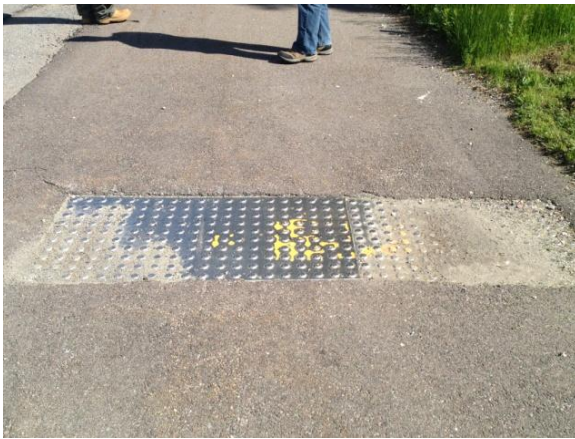
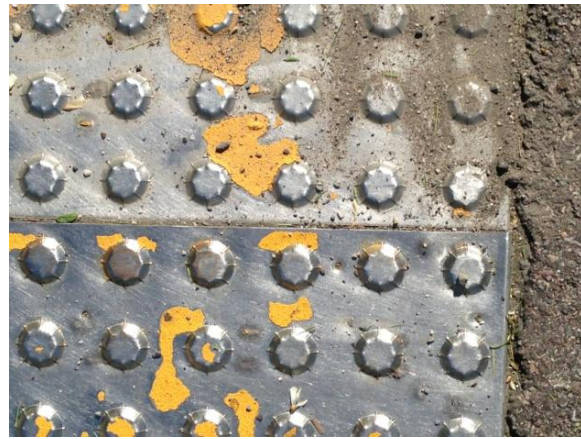
Figures 10-11: MetaDome, LLC. – Asphalt. 2013

Site visited in early June. Panels have lost virtually all color and covered with sand and gravel. Roughnesses of panels are low and quite slick. It appears the underlying panels are still not bonded well and in some places can be pulled up. Since 2009, the product has been removed from the APL.

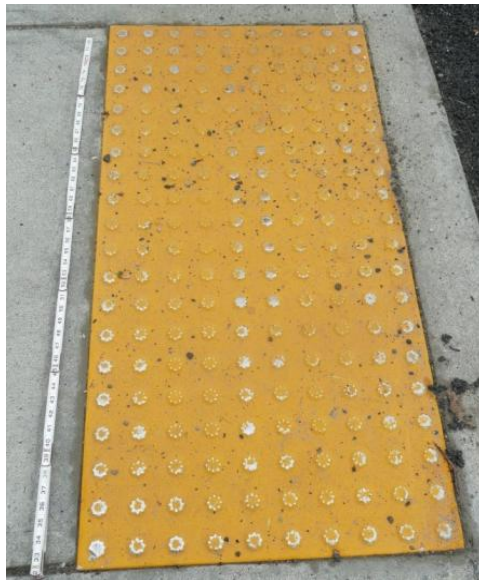
2009

Although much of the surface coating had delaminated, the panels were considered to be in good condition. The panels were accumulating a fair amount of dirt and debris. This is presumably due to the nearby construction project. It is recommended that the product remains conditional on the APL. It was decided that annual monitoring would be conducted.

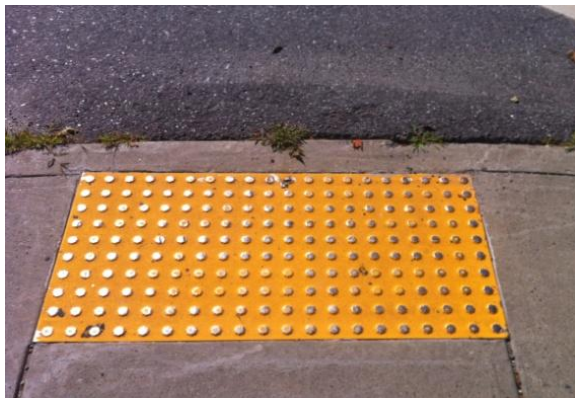
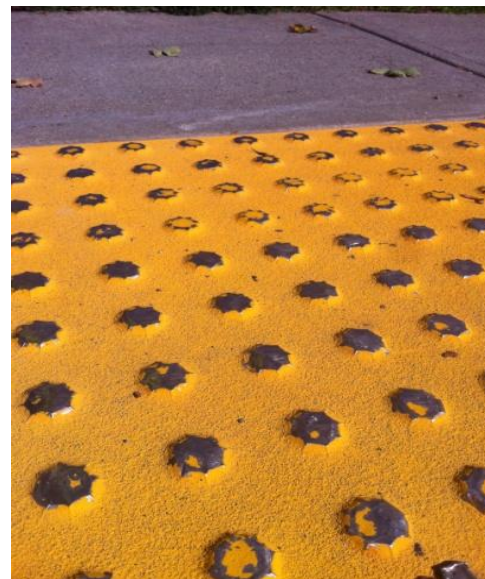
2013

The panels are in fairly good shape. The prominent yellow color has retained its vibrancy on the face of the plate. Most of the color has worn off of the domes, making them significantly more visible. The plate appears to provide some friction, but with rain the panels could

potentially become slightly more slippery due to the steel. Just about all edges are intact though they display slightly more wear than the middle of the panel. A few of the domes experienced significant removal most likely due to a sidewalk plow. Overall the panel has endured excellently.

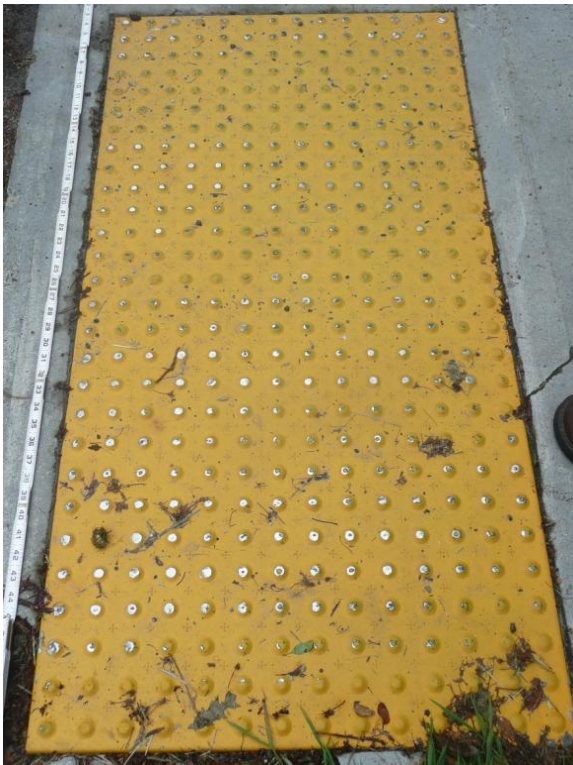
2009

The panels received minimal additional wear. The coating was faring well and had little delamination since 2006. It was recommended to leave the product as conditional approval on the APL. Annual monitoring would be conducted.

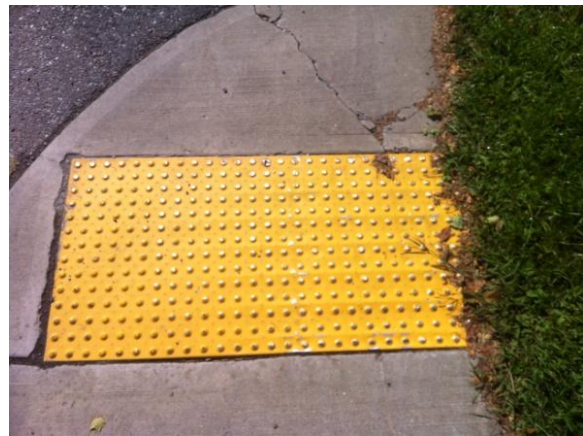
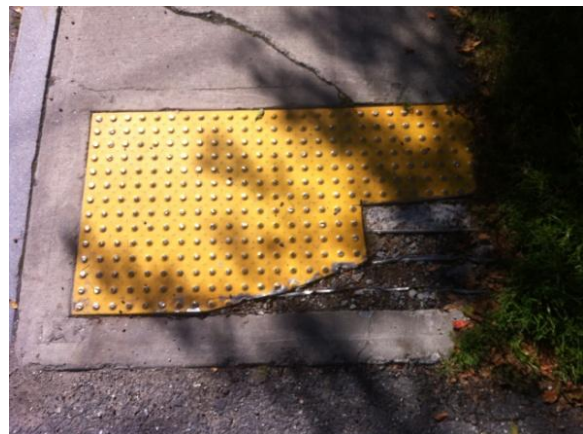
2013

The two panels on the side street have mixed results. One panel is in fairly good condition with excellent color and structural intactness. The other panel appears to have been slightly ripped up possibly due to plowing, and then was cut out. The color and dome integrity is still good on the rest of the panel. Both panels have good roughness and are not that slippery, though conditions could be different when wet. If placed in another location, these panels have potential to a viable product.
