**Blue iQ Cummins B6.7L CNG
De-rate and Hours to Empty Calibrations
ENP-733
April 27, 2020**

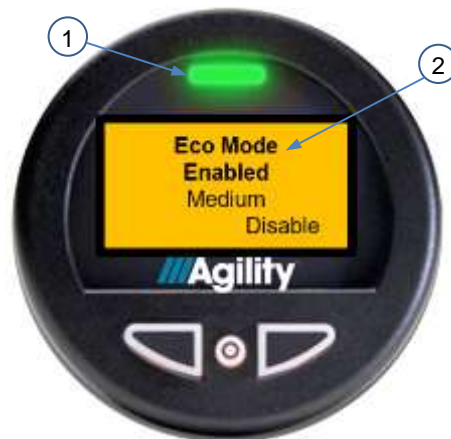
Figure 1.

Issue 1: Zero throttle response when Eco Mode is enabled. *Figure 1*

Smart Gauge green LED (1) illuminated and “Eco Mode Enabled” message (2) displayed.

ACTION: Press and hold the right Smart Gauge function button until the display changes to “Eco Mode Disabled” and the red LED illuminates to disable Eco Mode. *Figure 2*

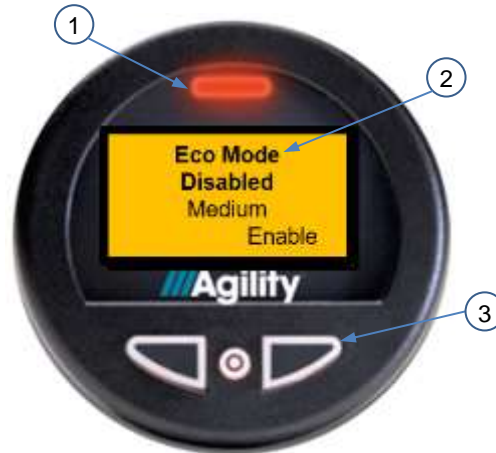
Figure 2.

Smart Gauge right function button (3), red LED (1) illuminated, and “Eco Mode Disabled” message (2) displayed.

The Smart Gauge should display “Eco Mode Disabled” during unit operation until the ECU calibration update is released. *Figure 2*

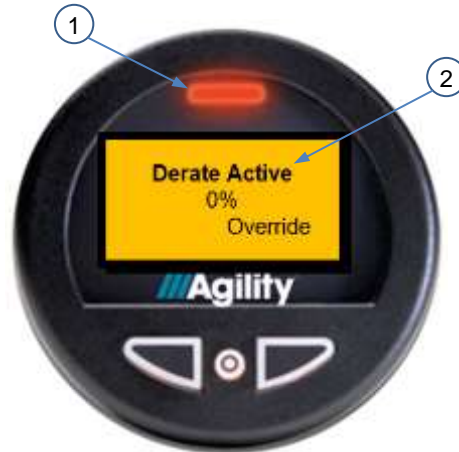
Figure 3.

Issue 2: Zero throttle response at low fuel levels less than 5-10%.

Smart Gauge red LED (1) illuminated and “Derate Active” message (2) displayed.

ACTION: Unit must refuel to disable the derate condition automatically.

ALTERNATIVE ACTION: Temporarily disable derate by holding down the Override button; this allows units to be operated on CNG pony tanks.
