MEMORANDUM

DATE July 20, 2020
TO Patti Johnson, Kittitas County
FROM Ryan K. Mathews, CIH, CHMM, Fulcrum Environmental Consulting, Inc.
RE Inspection Results Unit 23
SUBJECT Shady Brook Mobile Village, Ellensburg, WA

Shady Brook Mobile Village Hazardous Building Materials Summary – Unit 23

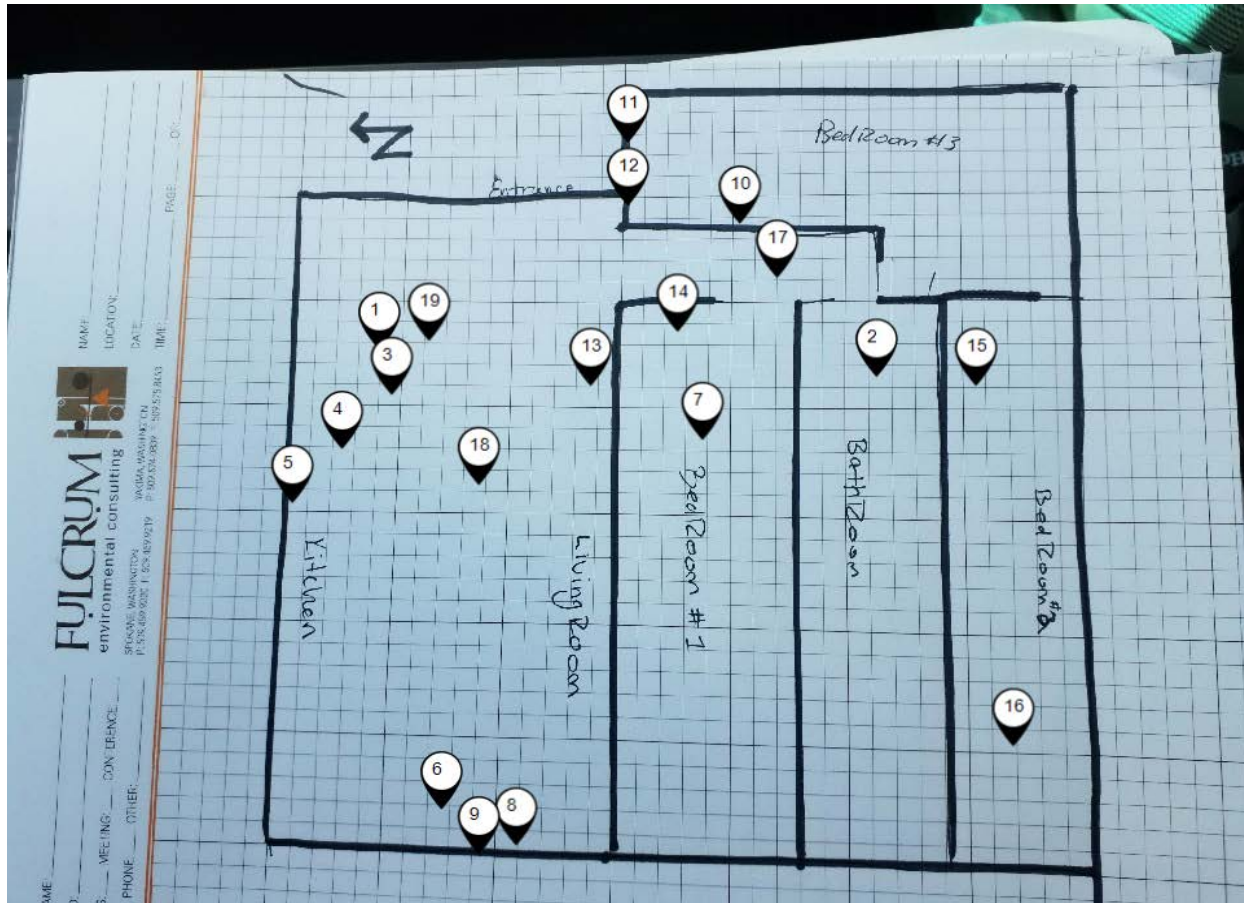
AH.2.1 ACM Sample Location Map – Unit 23 Interior

Map ID	Sample ID	Index	Location	Material
19	71020-001	SVF-01	Kitchen	Tan sheet vinyl flooring with black adhesive
1	71020-002	SVF-01	Kitchen	Tan sheet vinyl flooring with black adhesive
2	71020-003	SVF-01	Bathroom	Tan sheet vinyl flooring with black adhesive
3	71020-004	SVF-02	Kitchen	Pink sheet vinyl flooring with black adhesive
3	71020-005	SVF-02	Kitchen	Pink sheet vinyl flooring with black adhesive
4	71020-006	SVF-02	Kitchen	Pink sheet vinyl flooring with black adhesive
5	71020-007	SVF-03	Kitchen	Tan cobblestone pattern sheet vinyl flooring with black adhesive
6	71020-008	SVF-03	Living Room	Tan cobblestone pattern sheet vinyl flooring with black adhesive

Map ID	Sample ID	Index	Location	Material
7	71020-009	SVF-03	Bedroom 1	Tan cobblestone pattern sheet vinyl flooring with black adhesive
8	71020-010	WP-01	Living Room	White window putty on living room windows
8	71020-011	WP-01	Living Room	White window putty on living room windows
9	71020-012	WP-01	Living Room	White window putty on living room windows
10	71020-013	DP-01	Bedroom 3	White door putty over insulation on the east facing door
10	71020-014	DP-01	Bedroom 3	White door putty over insulation on the east facing door
10	71020-015	DP-01	Bedroom 3	White door putty over insulation on the east facing door
11	71020-016	DP-02	Bedroom 3	White door putty on north facing door
11	71020-017	DP-02	Bedroom 3	White door putty on north facing door
12	71020-018	DP-02	Bedroom 3	White door putty on north facing door
13	71020-019	MSC-01	Living Room	White sealant under floor vents
14	71020-020	MSC-01	Bedroom 1	White sealant under floor vents

15	71020-021	MSC-01	Bedroom 2	White sealant under floor vents
16	71020-022	CT-01	Bedroom 2	White fiberboard ceiling material
17	71020-023	CT-01	Hallway	White fiberboard ceiling material
18	71020-024	CT-01	Living Room	White fiberboard ceiling material

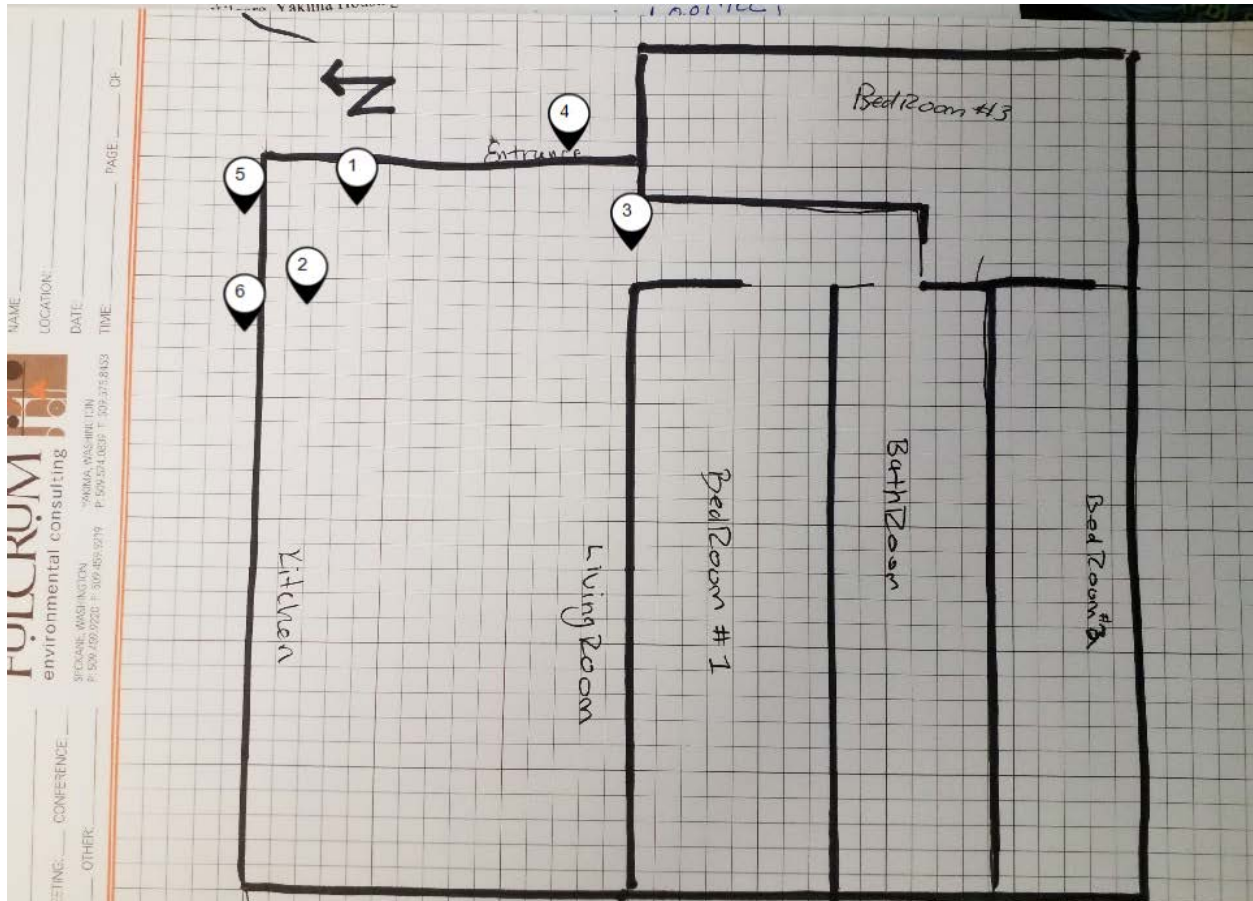
AH.2.2 ACM Sample Location Map – Unit 23 Exterior

Sample Number	Index	Material	Location	Comment
71020-025 71020-026 71020-027	RFM-01	White rolled on roofing material with black adhesive	Roof	5% Chrysotile in black adhesive

The black adhesive is located over the metal roof of Unit 23.

Map ID	Sample ID	Index	Location	Material
1	71020-025	RFM-01	Roof	White rolled on roofing material over silver layer over black adhesive
2	71020-026	RFM-01	Roof	White rolled on roofing material over silver layer over black adhesive
3	71020-027	RFM-01	Roof	White rolled on roofing material over silver layer over black adhesive
4	71020-028	RFM-02	Roof	White/black sealant along edges of roof
5	71020-029	RFM-02	Roof	White/black sealant along edges of roof
6	71020-030	RFM-02	Roof	White/black sealant along edges of roof

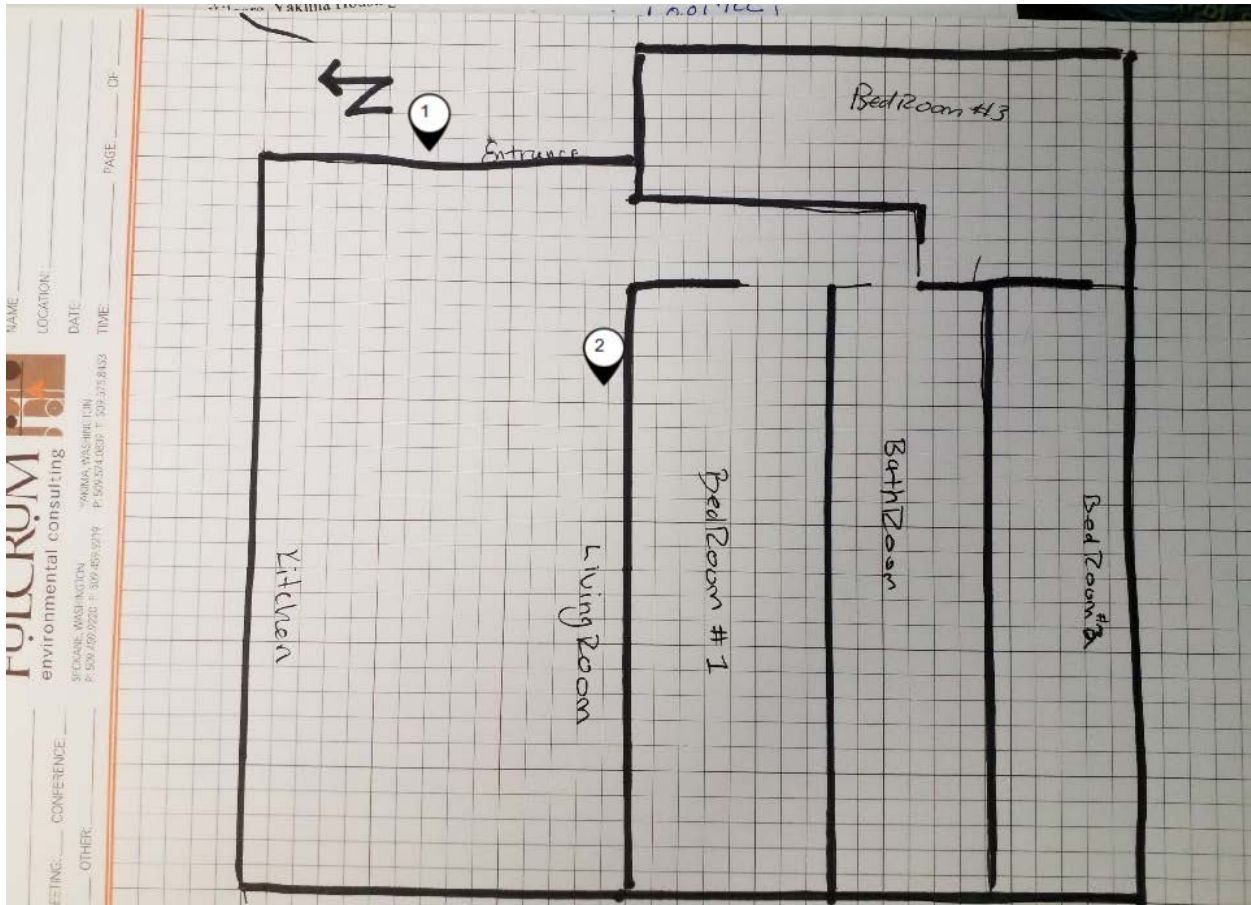
AH.2.3 Paint Chip Sample Location Map – Unit 23

Sample Number	Location	Paint Color	Reporting Limit (mg/Kg)	Results (mg/Kg)
U23PC-01	Metal Siding	White/Blue	430	<430
U23PC-02	Wood Wall	Purple	68	<68

Map ID	Sample ID	Location	Color	Substrate
1	U23PC-01	Unit 23	Blue/White	Metal
2	U23PC-02	Unit 23	Purple	Wood
