## Learning from Earthquakes

# Reconnaissance Report on the Umbria-Marche, Italy, Earthquakes of 1997

*Submitted by the EERI reconnaissance team: Stephen Tobriner, team leader, and Mary Comerio, both of the Architecture Department at the University of California, Berkeley, and Mel Green, President of Melvyn Green & Associates in Torrance, California.*

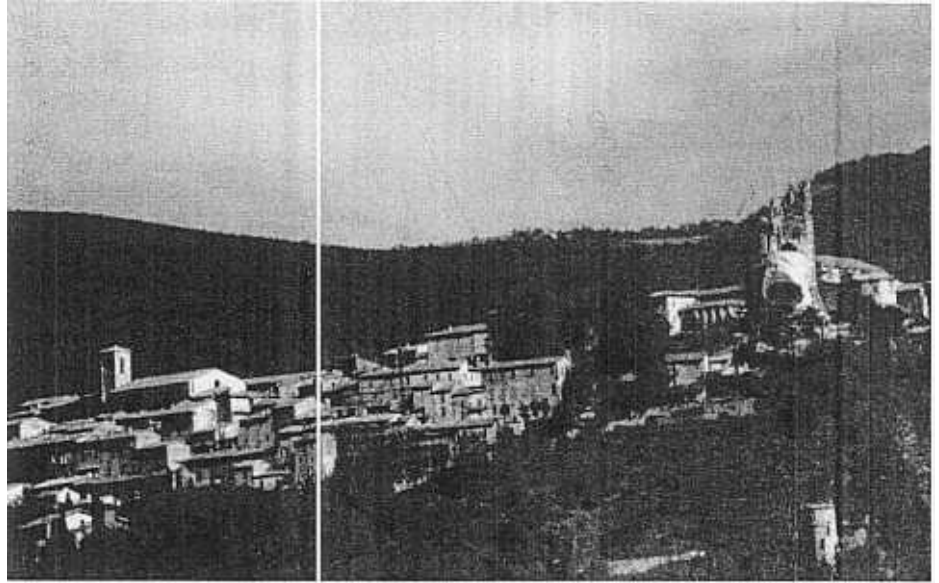
*Figure 1 - Nocera Umbra, the old city. The city tower at the right collapsed in the earthquake. Seen from afar, the town seems largely intact, but in fact many of the structures are damaged. Most exterior walls remain upright, but many are cracked. Roof tiles have fallen, and some roofs have collapsed. In general, the interior damage in each building is far greater than the exterior damage.*

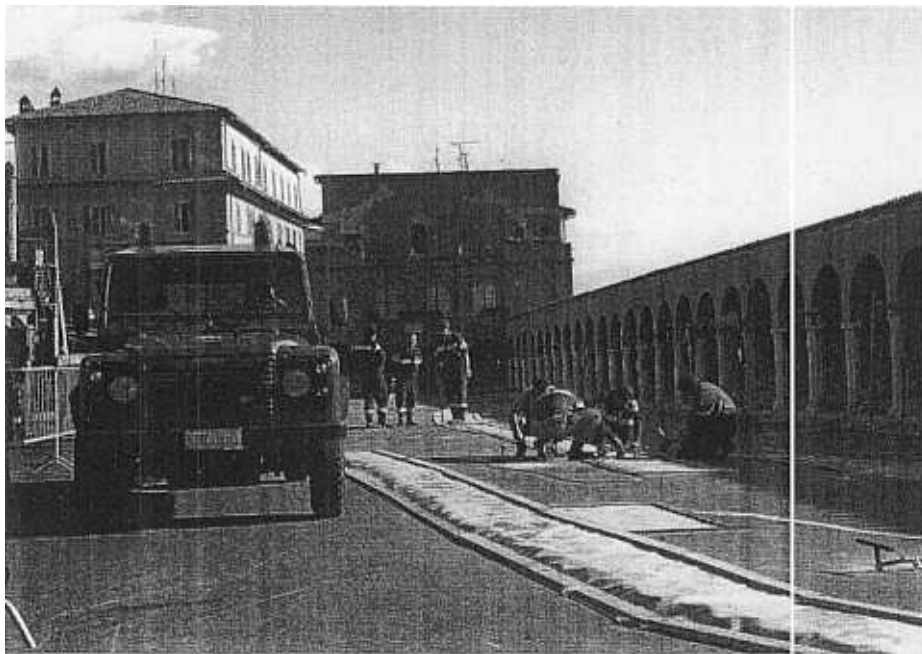
*Figure 4 - In Assisi, significant cracks had opened in the Piazza Inferiore di S. Francesco, indicating earthquake-caused subsidence. The cracks had been covered with plastic (foreground). In this photo, soldiers are beginning to string cables to stabilize the arcade to the right in the photo.*

Subsidence apparently occurred in the town of Assisi, where significant cracks had opened in the Piazza Inferiore di S. Francesco (Figure 4). The west side of the outcrop on which the old town of Nocera Umbra is built appears to be slipping. Cracks have opened in the pavement and along the arches of the arcade on the hillside.

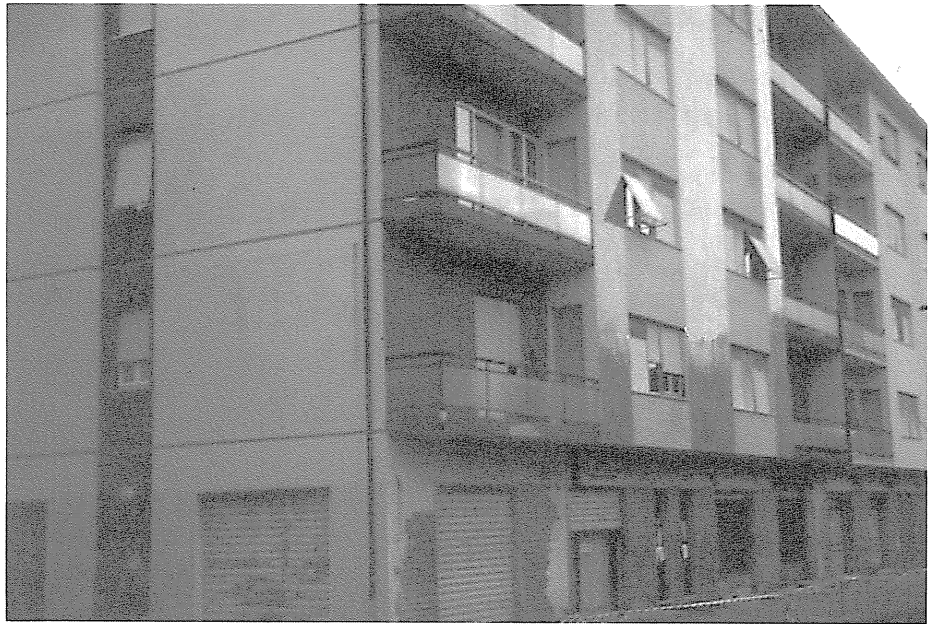
In Fabriano in the Marche Region, several four- to six-story structures in public housing projects (representing 300-500 units) had this type of damage and the buildings had been vacated (Figure 6). One of the vacated buildings in Fabriano had a vertical crack in a column. This might have been a pending spall. At a beam-column joint, the reinforcing steel was exposed and spalling occurred.

*Figure 6 - These modern concrete apartment buildings had been vacated. Exterior damage consisted of spalled and cracked concrete. (photo: Tobriner)*

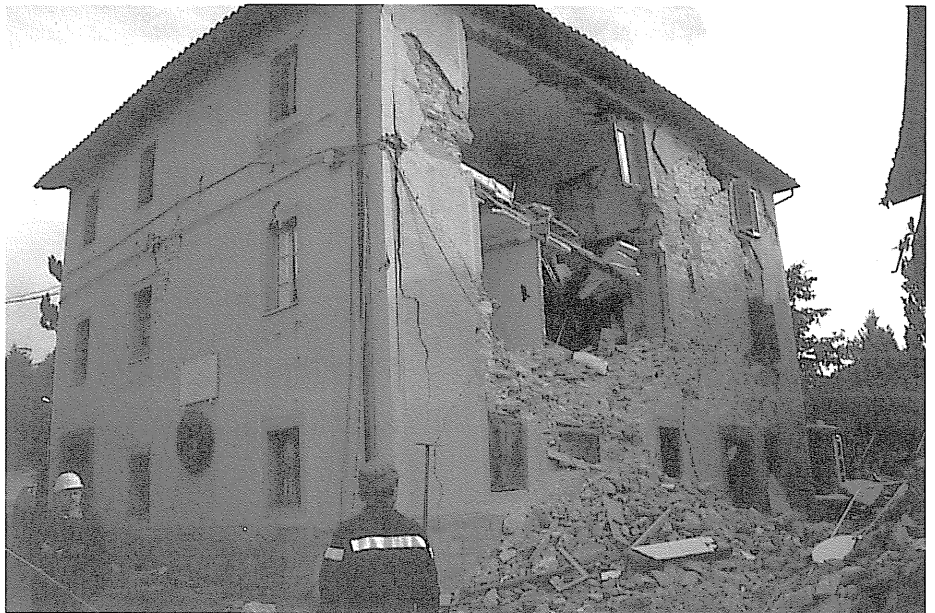
**Typical Damage:** There was extensive damage to buildings of this type of construction (*Figure 7*). In some cases only individual struc-

*Figure 7 - This building in Cesi illustrates typical damage suffered by the area's vernacular architecture: exterior wall failures in stone masonry buildings. (photo: Tobriner)*

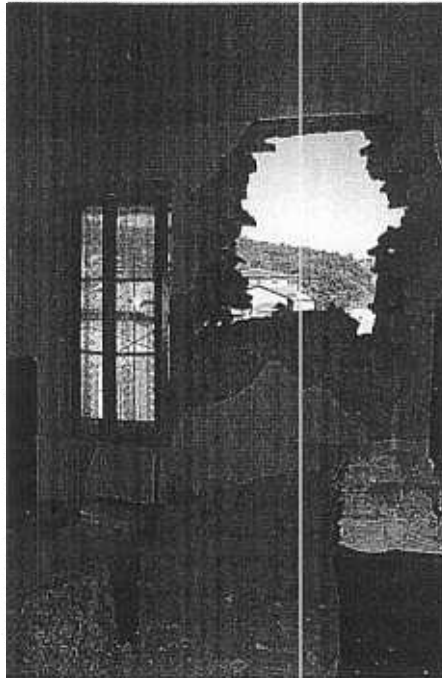
*Figure 8 - An example from the town of Valtopina of the collapse of an exterior wall from the roof line to a level above the floor line.*

coupled with inadequate anchorage between the walls and roof, resulted in the wall collapse. Typically the collapse was from the roof to a point above the floor line (*Figure 8*). In some cases portions of the walls were blown outward. With a collapse of this type, when there was major loss of support for the roof due to wall failure, portions of the roof also collapsed.

**Findings:** Simple and traditional retrofits do work to improve life safety. Wall anchors to control out of plane damage should be encouraged for masonry buildings. Chimneys constructed in masonry walls should be carefully considered by the engineer as to the appropriate type of retrofit. The damage observed to vernacular buildings could be lessened by simple life safety retrofits that are applicable in all seismic zones and for all buildings other than bonded masonry construction.

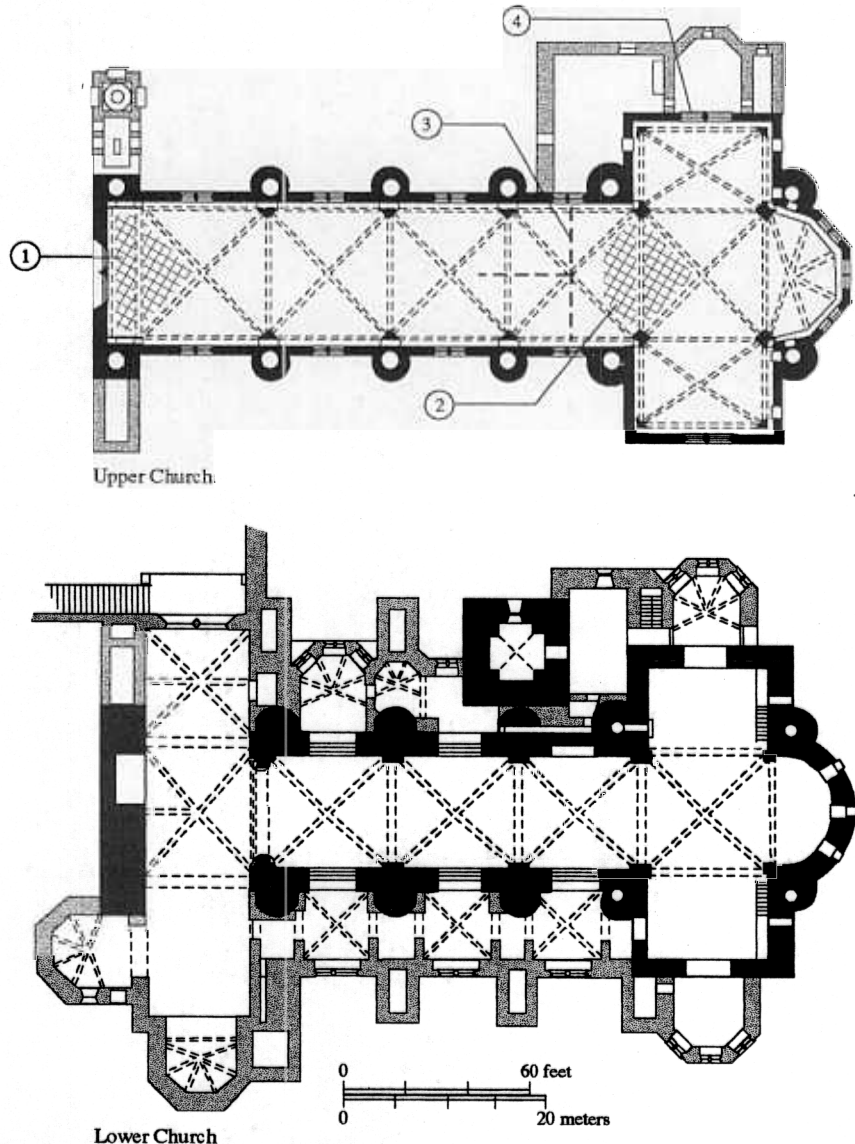
The worst damage occurred at the ceiling and roof levels. The webbing or infill of the east quadrant or cell of the quadripartite vault adjoining facade broke in the second earthquake (Figure 10). On the vault was a priceless Cimabue fresco which crashed to the floor killing four people. Down the nave, the webbing of the

**Figure 9** - The upper and lower churches of S. Francesco in Assisi  
**Diagram key:** (1) Collapsed vault adjacent to entrance portal (where four people were killed). (2) Collapsed vault at crossing. (3) Major cracks in vault. (4) Cracked pediment, now braced by steel cage.

Large cracks appeared in the centers of the nave vaults which still survive. The south transept pediment cracked. The question is whether the roof and side wall retrofits helped the structure or contributed to the local failures.

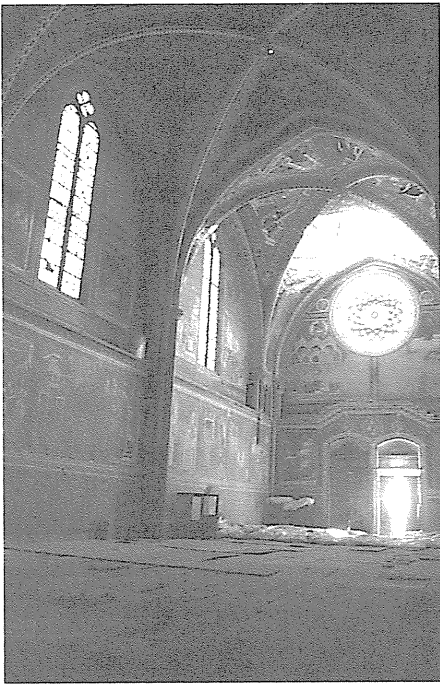
**Figure 10** - The interior of S. Francesco in Assisi, showing the collapsed first vault (above the rosette window). (photo: Tobriner)

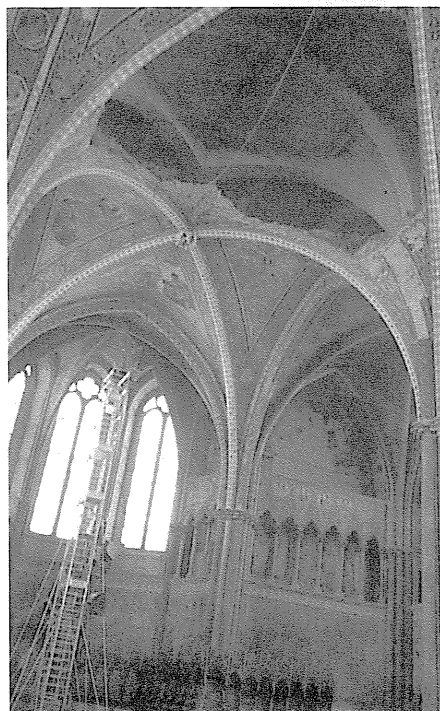
quadrant of the vault immediately in front of the crossing, the supporting cross vault, and the webbing of the east quadrant of the crossing vault, all fell (Figure 11).

**Figure 11** - The collapsed vault between the nave and the crossing at S. Francesco in Assisi.

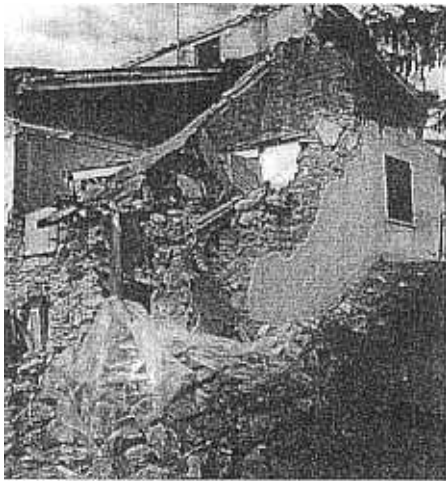
**Figure 12** - Typical damage to vernacular architecture in Umbria-Marche, Italy. (photo: Tobriner)
