Learning from Earthquakes

Reconnaissance Report on the Umbria-Marche, Italy, Earthquakes of 1997

Submitted by the EERI reconnaissance team: Stephen Tobriner, team leader, and Mary Comerio, both of the Architecture Department at the University of California, Berkeley, and Mel Green, President of Melvyn Green & Associates in Torrance, California.

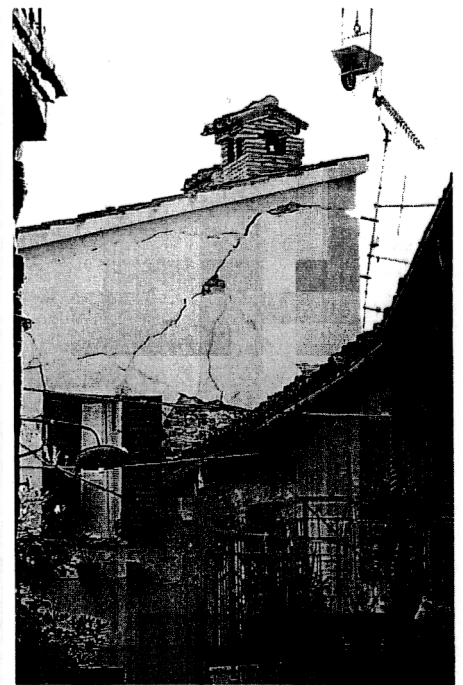
Figure 3 - This building in Nocera Umbra illustrates typical damage to stone buildings in the region.

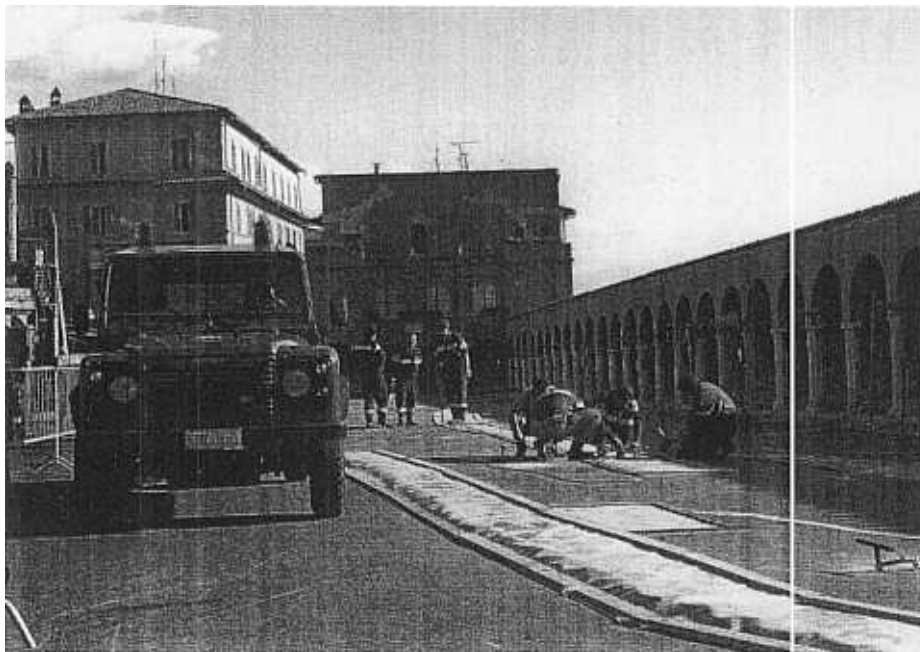
Figure 4 - In Assisi, significant cracks had opened in the Piazza Inferiore di S. Francesco, indicating earthquake-caused subsidence. The cracks had been covered with plastic (foreground). In this photo, soldiers are beginning to string cables to stabilize the arcade to the right in the photo.

Subsidence apparently occurred in the town of Assisi, where significant cracks had opened in the Piazza Inferiore di S. Francesco (Figure 4). The west side of the outcrop on which the old town of Nocera Umbra is built appears to be slipping. Cracks have opened in the pavement and along the arches of the arcade on the hillside.

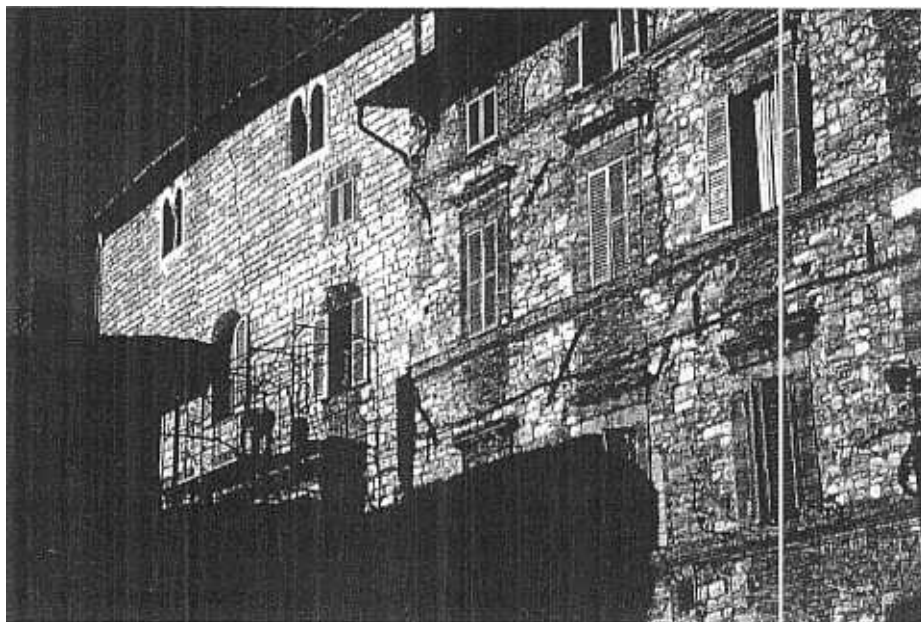
Assisi is famous for its beautiful ironwork which decorates the exterior of most masonry buildings, another mitigation technique (Figure 5). Iron tie bars (*tiranti* or *catene*) and exterior wall anchors (*chiavi*) were in use in the middle ages to insure structural stability. Documents record that they were used to repair seismically damaged structures after the Gualdo Tadino earthquake of 1751 and the Camerino earthquake of 1799. By the time of the Valle del Topino earthquake of January 13, 1832, *tiranti* and *chiavi* were standard repairs and mitigation. Both were liberally used on the badly damaged church and Basilica and convent of S. Maria degli Angeli below the old town of Assisi.

Figure 5 - Exterior anchors and tie bars on masonry buildings are a distinctive feature of Assisi vernacular architecture. These early mitigation efforts demonstrated their effectiveness in this quake. In this photo, the wall on the right, with anchors and tie bars, is intact and plumb, while the un-anchored wall on the left is cracked and bowing outward.

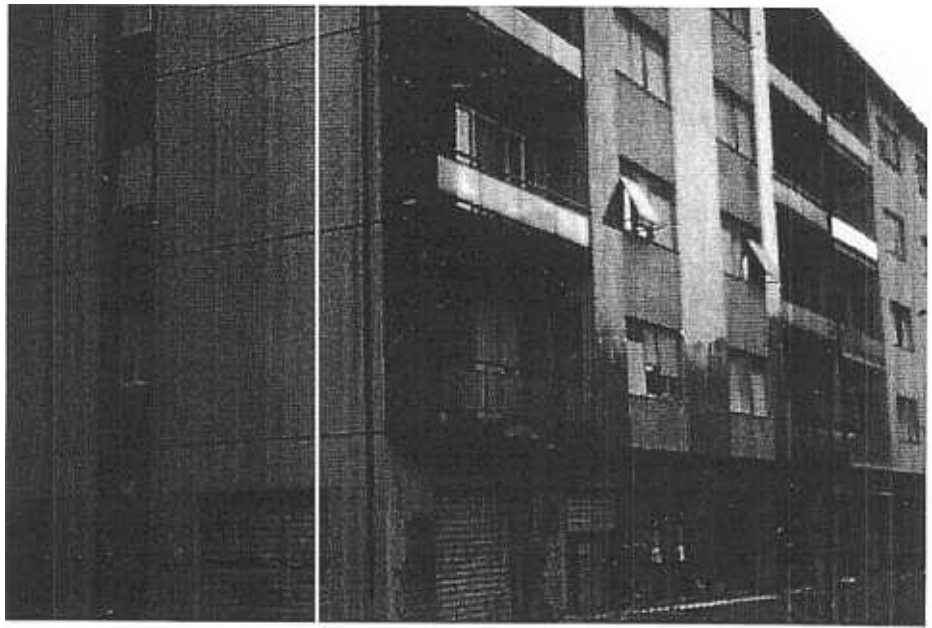
In Fabriano in the Marche Region, several four- to six-story structures in public housing projects (representing 300-500 units) had this type of damage and the buildings had been vacated (Figure 6). One of the vacated buildings in Fabriano had a vertical crack in a column. This might have been a pending spall. At a beam-column joint, the reinforcing steel was exposed and spalling occurred.

Figure 6 - These modern concrete apartment buildings had been vacated. Exterior damage consisted of spalled and cracked concrete. (photo: Tobriner)

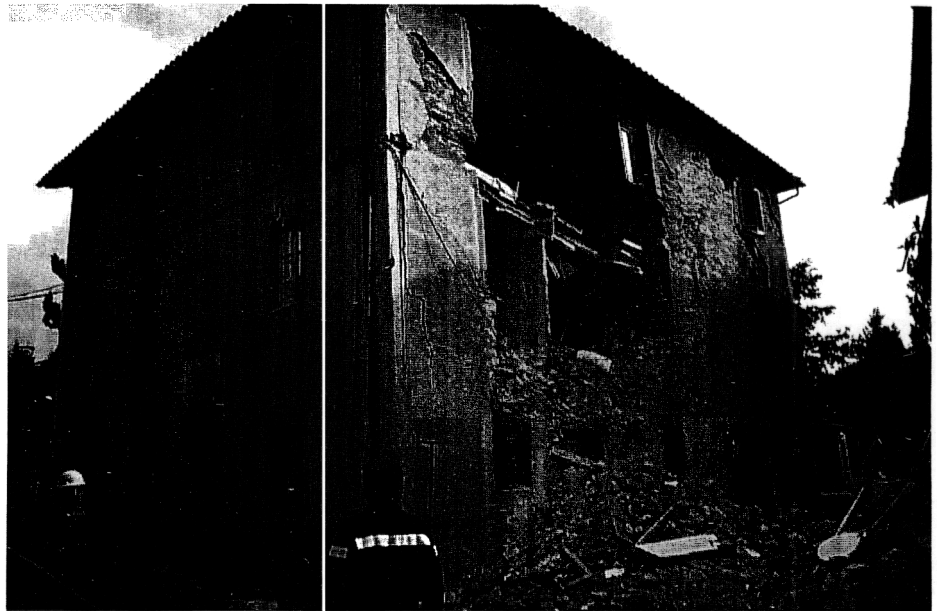
Typical Damage: There was extensive damage to buildings of this type of construction (*Figure 7*). In some cases only individual struc-

Figure 7 - This building in Cesi illustrates typical damage suffered by the area's vernacular architecture: exterior wall failures in stone masonry buildings. (photo: Tobriner)

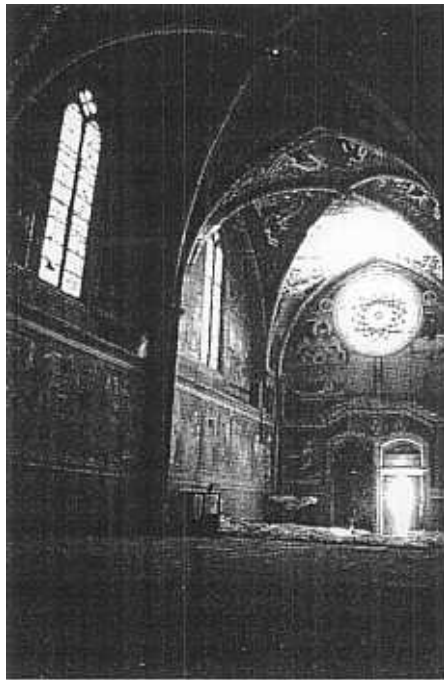
Figure 10 - The interior of S. Francesco in Assisi, showing the collapsed first vault (above the rosette window). (photo: Tobriner)

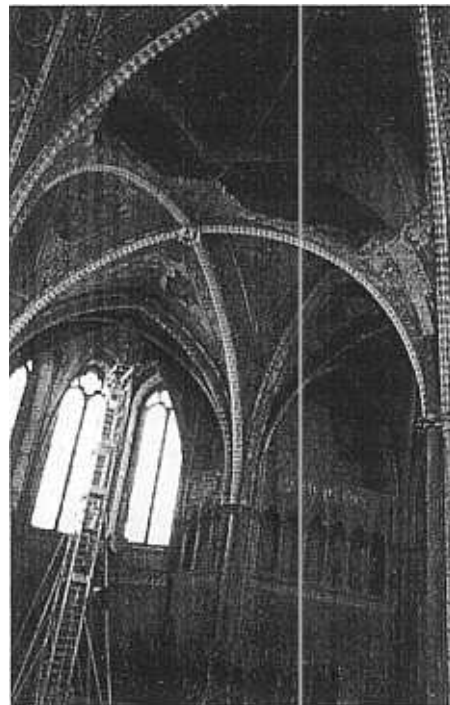
quadrant of the vault immediately in front of the crossing, the supporting cross vault, and the webbing of the east quadrant of the crossing vault, all fell (Figure 11).

Figure 11 - The collapsed vault between the nave and the crossing at S. Francesco in Assisi. (photo: Tobriner)

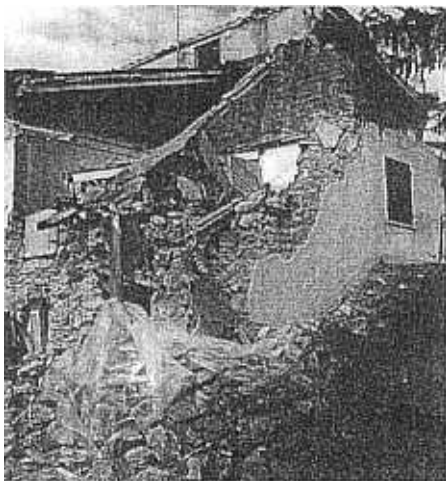
Figure 12 - Typical damage to vernacular architecture in Umbria-Marche, Italy. (photo: Tobriner)
