USACE SAVANNAH IDIQ TASK ORDER 01

Guantanamo Bay
CHU Facility Condition Assessment
Final Recommendation Report

13 APRIL 2020

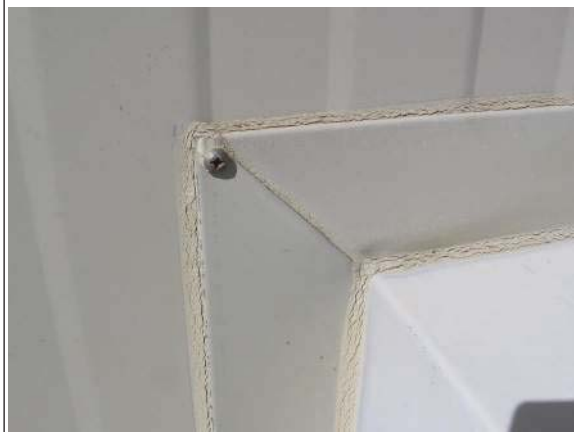
Photo #17: All exterior penetrations need to be re-caulked

- The overall condition of the exterior walls are in fair condition. Based on the estimated Remaining Useful Life (RUL) they will not require replacement during the evaluation period.
- Remove and re-caulk around all exposed interior and exterior transition joints will be required during the evaluation period. The estimated cost of this work is included in the Deficiency Cost Tables.

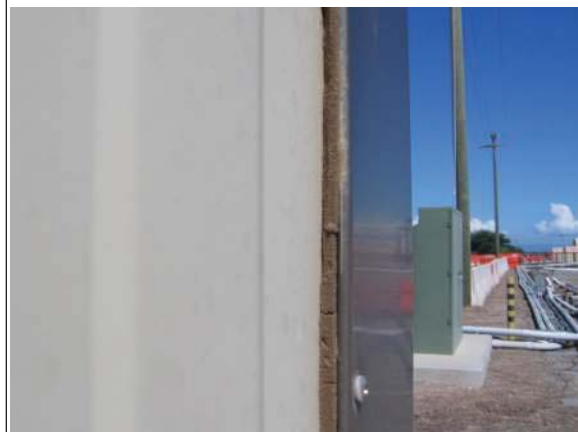
Photo #18: All exterior wall panels and aluminum trim intersections need to be re-caulked

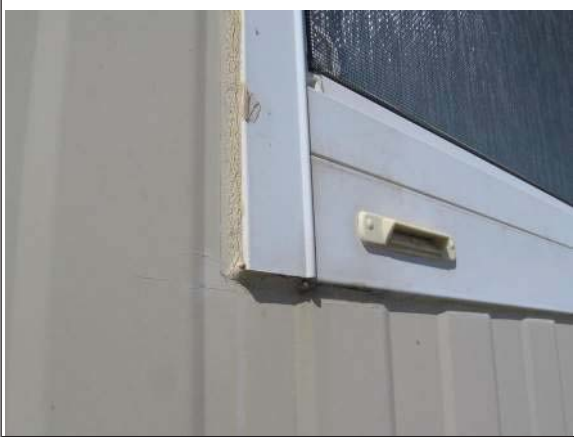
<p>Photo #19: All exterior penetrations need to be re-caulked</p>		<p>Photo #20: Re-paint all exterior doors and trim</p>

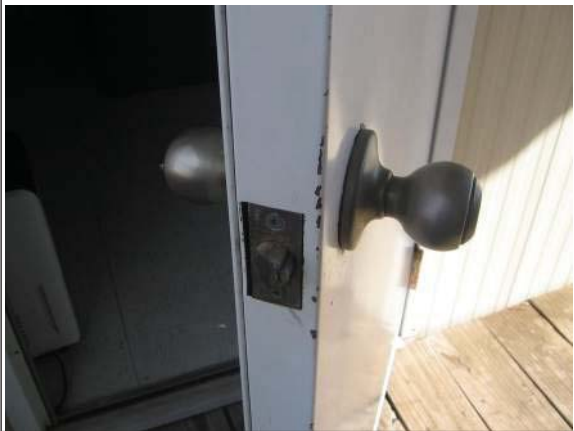
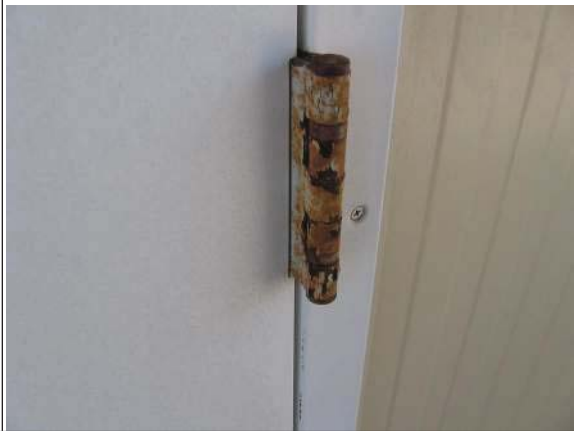
<p>Photo #21: Replace all door hardware</p>		<p>Photo #22: Replace all door hardware</p>

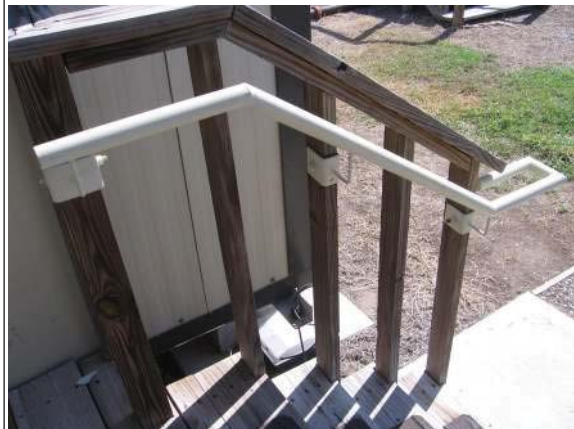
Photo #27: Re-paint all metal pipe handrails

- For CHUs No 1-25, re-paint all metal pipe handrails will be required during the evaluation period. The estimated cost of this work is included in the Deficiency Cost Tables.

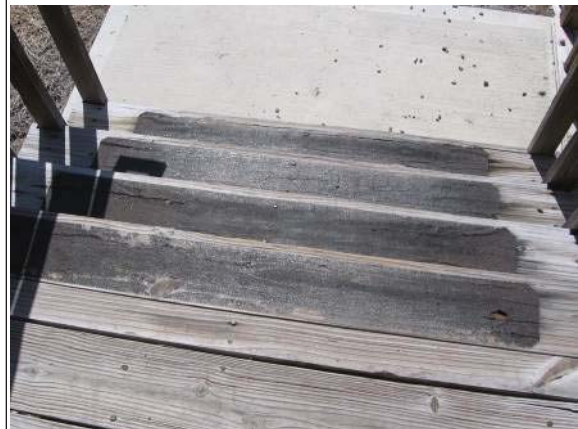
Photo #28: Replace all slip resistant stair tape

- Remove and replace the existing corrugated metal roof panels. The estimated cost of this work is included in the Deficiency Cost Tables.
- Remove and replace all of the stair tread slip resistant tape at all stairs. The estimated cost of this work is included in the Deficiency Cost Tables.

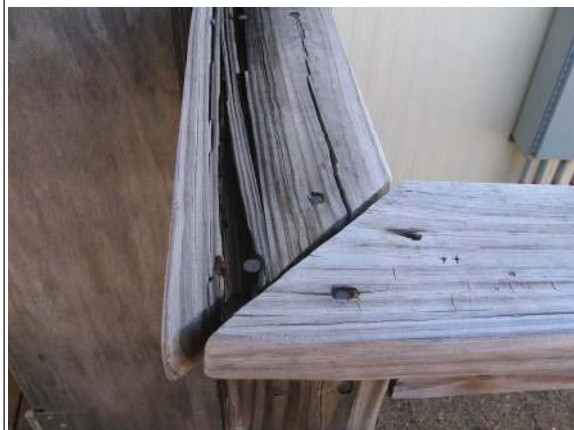
Photo #29: Replace all pressure treated wood railings

- Remove and replace all of the unfinished pressure treated wood handrails with new sealed pressure treated wood railings and handrails. The estimated cost of this work is included in the Deficiency Cost Tables.

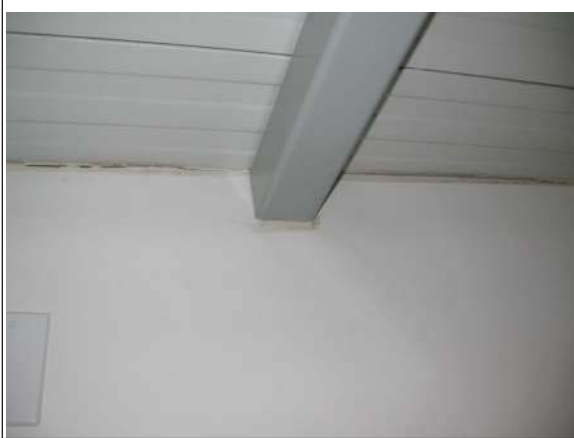
<p>Photo #39: Re-paint all interior gyp. Board interior walls</p>		<p>Photo #40: Re-caulk complete interior at intersection of metal/gyp board walls and roof panels</p>

- Interior drywall painting will also be required during the evaluation period. The estimated cost of this work is included in the Deficiency Cost Tables.

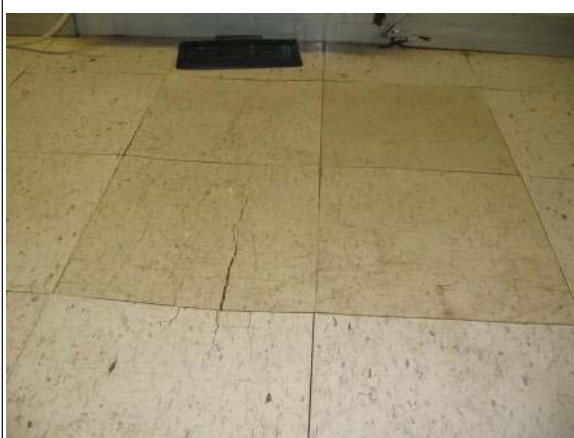
<p>Photo #41: Replace damaged toilet seats</p>		<p>Photo #42: Remove/replace complete sub-floor and re-install new floor tile</p>

- The plywood subfloor and vinyl flooring within the CHUs bathrooms are in fair to poor condition. Based on its estimated Remaining Useful Life (RUL) and the exposure to adverse weather conditions, with the exception of CHU No. 26, the plywood subfloor and vinyl floor tiles will require immediate replacement and then all CHUs will require the same replacement every 2-3 years during the evaluation period. The plywood subfloor replacements will also need to include applying waterproof spray foam insulation to the exposed underside to protect the exposed plywood from the elements. The estimated cost of this work is included in the Deficiency Cost Tables.

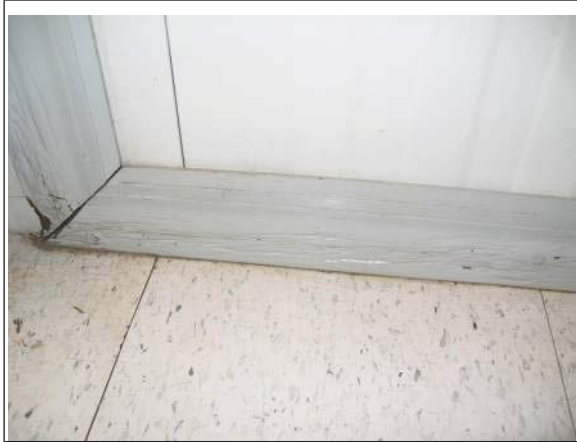
<p>Photo #43: Replace all painted wood baseboards</p>		<p>Photo #44: Re-caulk around all aluminum windows</p>

- Replacement of the painted wood baseboard trim will also be required during the evaluation period. The estimated cost of this work is included in the Deficiency Cost Tables.

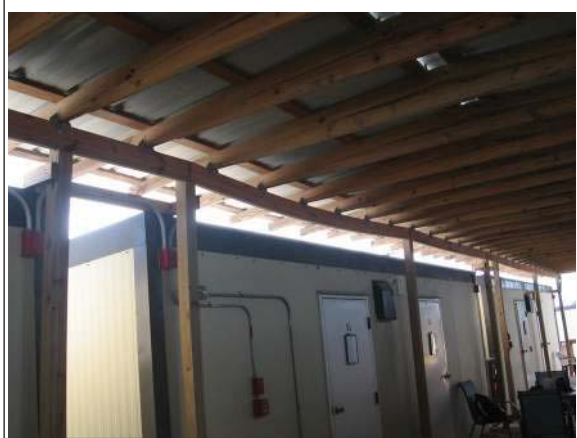
- The pressure treated wood decks, railing, handrails and the pressure treated wood post and roof truss system and metal roof is in fair to poor condition. Based on their individual estimated Remaining Useful Life (RUL), all of the stated components will require replacement during the evaluation period.

<p>Photo #45: Replace exterior covered pressure treated wood truss and metal roof system</p>		<p>Photo #46: Typical slip resistant tape at all pressure treated wood stairs</p>

- Remove and replace all of the unfinished pressure treated wood posts and roof trusses with new sealed pressure treated wood posts and roof trusses. The estimated cost of this work is included in the Deficiency Cost Tables.

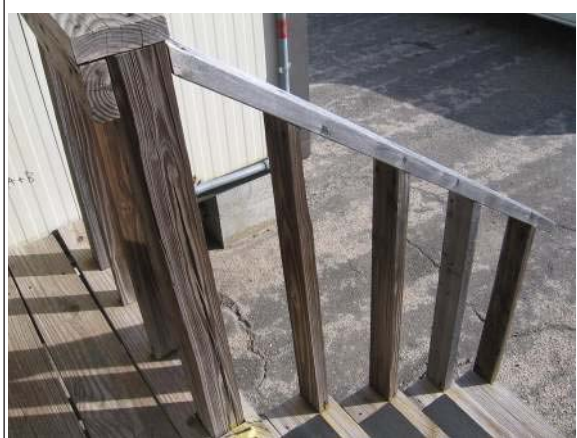
<p>Photo #47: Replace all pressure treated wood railings</p>		<p>Photo #48: Replace all pressure treated wood decking</p>

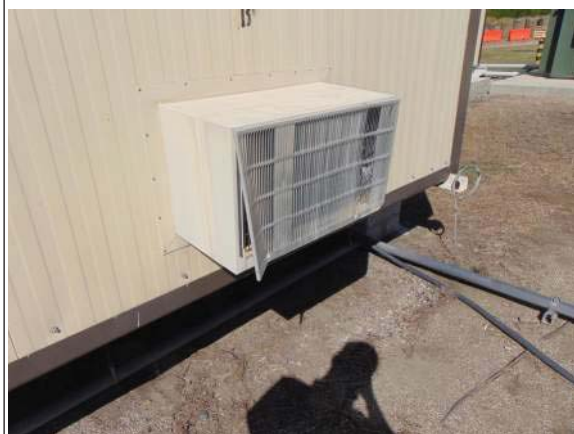
Photo #57: Typical Deficiency: air conditioner fins bent and obstructed
