HVAC Controls Analysis

Springfield Township
Administration/Police Building
Free Library
Wyndmoor, PA

October 7, 2022

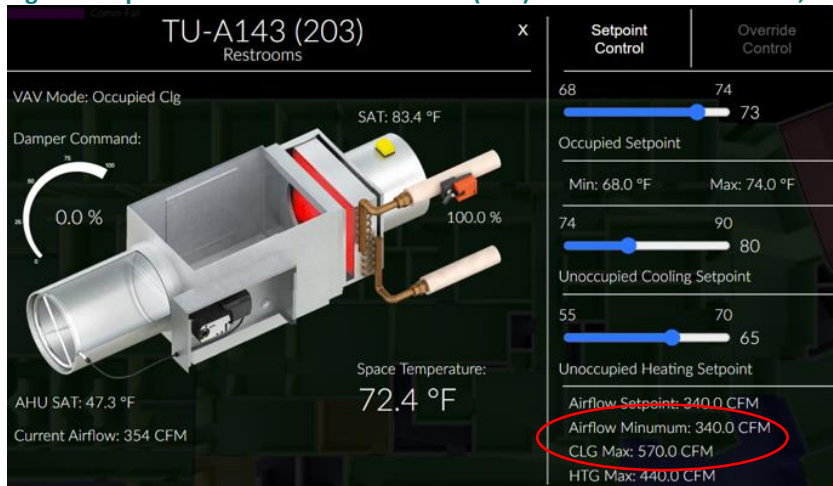
Rationale: During our first (2019/2020) assessment, minimum airflow was set to ~60% of maximum cfm at all VAVs. During heating season, this continuous, high flow of heated air into the building results in unnecessary heating. We therefore recommended setting minimum airflow in all VAV boxes to zero and setting the CO₂ threshold at standard recommended levels (1,000-2,000 ppm) to allow the system to function as it is designed to perform; that is, allow space temperatures and occupancy levels to control ventilation. Our current assessment shows that, as a result of our recommendation, the Township reset minimum airflows to ~30% of maximum in the PD only [13 of

However, significant energy is still being wasted during both heating and cooling seasons as a result of the high minimum airflow settings. In the summer, constant influx of conditioned air into the building leads to overcooling, which forces the boiler to run so the VAV boxes can reheat the air to bring indoor air temperatures back up to setpoint. This simultaneous cooling and heating wastes boiler, hot water pump, and AHU fan energy. During our current analysis, six VAV boxes were in active reheat mode despite the warm outdoor temperature. Figure 2 shows active heating on a warm summer day due to the continuous influx of 47°F conditioned air from the AHU.

Fig. 2. Sample VAV with minimum airflow (cfm) set to 60% of maximum, in reheat mode

VAV minimum airflow control. Set minimum airflow to 15% of maximum airflow for all VAVs. Allow space temperature and demand-controlled ventilation (DCV) sequence (CO₂ ppm) to influence airflow based on occupancy and space temperature setpoints.

We realize the Township wanted to retain high ventilation rates due to the pandemic. Therefore, rather than setting minimum cfm to zero, we suggest taking another step to improve efficiency while still retaining higher-than-normal ventilation rates by resetting airflow to 15% of maximum in all VAV boxes throughout the facility (Admin and PD) and keeping CO₂ concentrations at the current, low threshold. This will help retain airflow even during relatively low occupancy levels, while further reducing simultaneous heating and cooling.

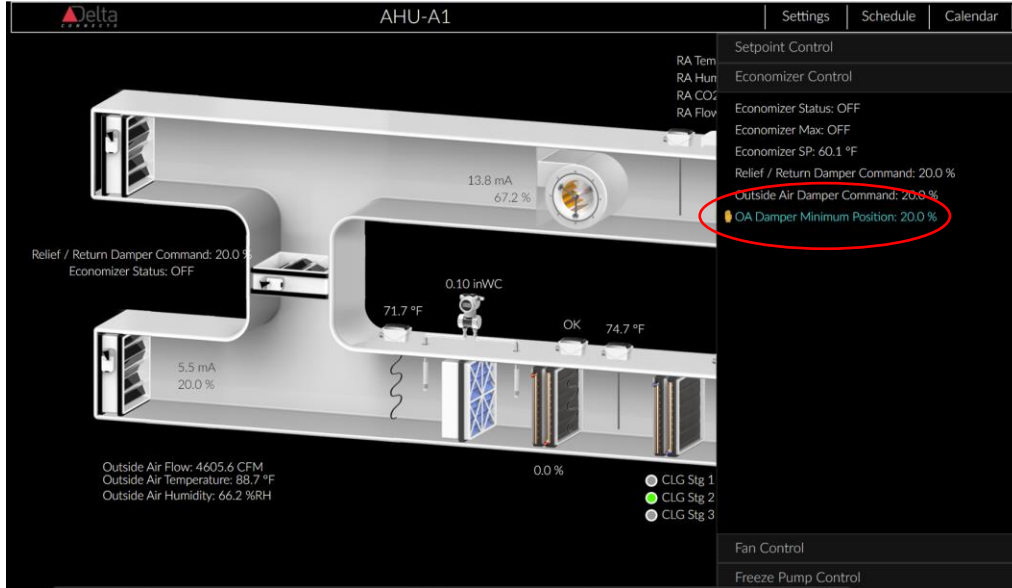
Rationale: The Administration AHU-A1, Meeting Room AHU-A2, and PD AHU-P1 have minimum OA damper positions set to 20%, 10%, and 10%, respectively. Setting the Administration AHU-A1 to a minimum open OA damper position consistent with the others (10%) will reduce OA intake on hot days and reduce cooling demands while better achieving temperature setpoints and controlling humidity. The low CO₂ threshold will ensure that the damper opens up and additional OA is ventilated into the building during occupied hours. (See Figure 3, next page.)

Fig. 3. Admin AHU-A1 with 20% OA minimum damper setting

OA control. Reset AHU-A1 (Administration) minimum OA damper position from its current 20% open position to 10% open position. Reset cooling discharge air temperature from 50°F to 55°F for consistency with other AHUs and current standards.

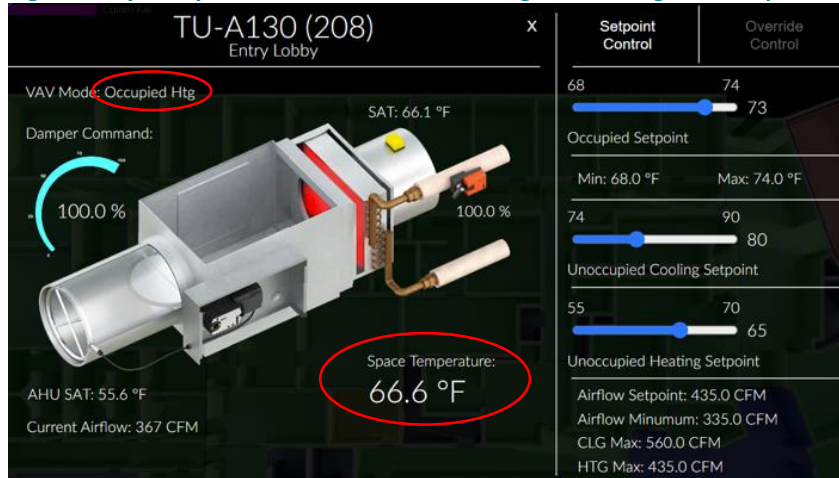
VAV TU-A130(208) malfunction. Investigate reasons why this space reports unusually low temperatures (66.6°F on an 88.4°F day) and remains in occupied heating mode in an attempt to restore temperature to the 74°F setpoint.

Rationale: This VAV is continually in heating mode despite warm outdoor temperatures and proximity to the front door. Reducing the airflow setpoint from 60% of maximum cfm to 15% will help reduce the need for reheating, although we suspect the temperature sensor may be malfunctioning, or some other issue is causing the simultaneous cooling and heating. Several spot checks at different times of day showed the BAS consistently reporting space temperatures far below setpoint relative to other spaces in the building. (See Figure 4, next page.)

Fig. 4. Entry lobby VAV in simultaneous heating and cooling, 66.6°F space temperature

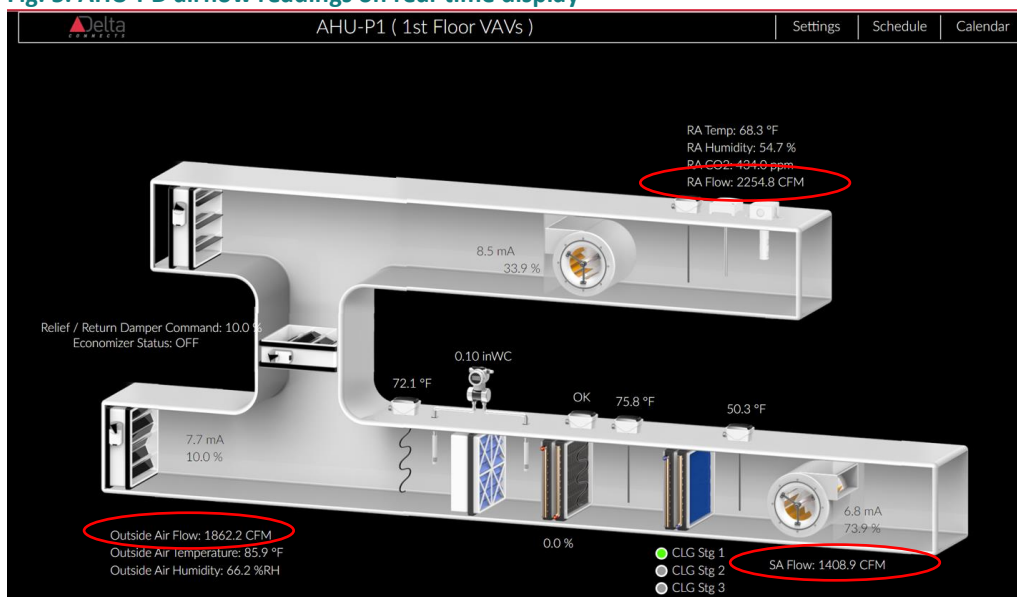
Address AHU airflow readings. Airflow readings are incorrect on the actual AHU displays. During our assessment, the BAS system reported the following:

- AHU-A1: OA=SA and RA>SA
- AHU-PD: OA>SA, RA>SA

Fig. 5. AHU-PD airflow readings on real-time display

Rationale: The incorrect airflow readings on the AHU real-time display screens should be fixed to ensure proper monitoring and maintenance of the system setpoints and building pressurization.

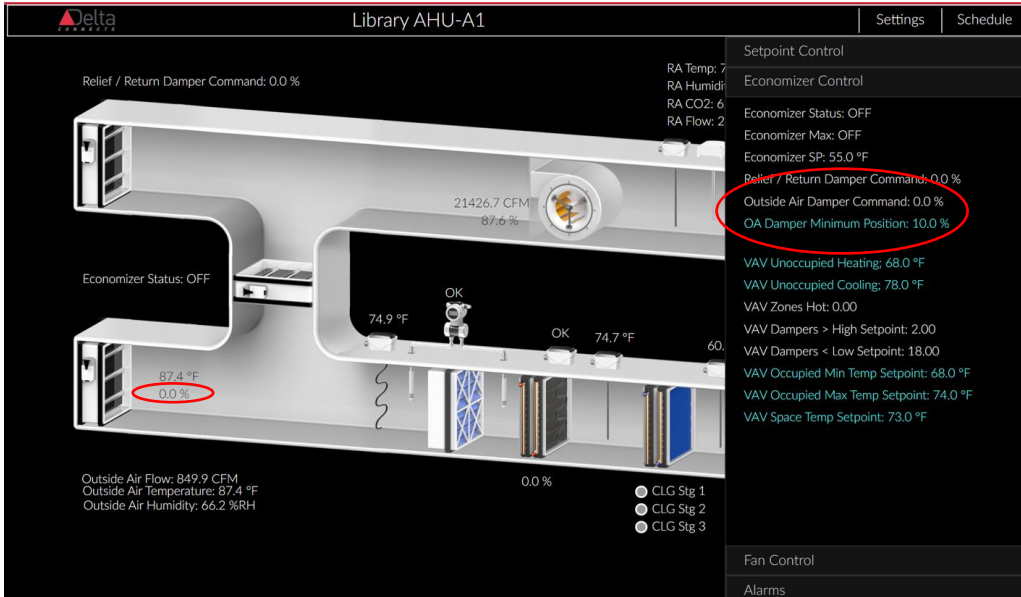
OA damper readings. OA damper commands consistently read 0% despite an OA damper minimum position setpoint of 10%. Evaluate and correct.

Fig. 6. AHU-A1 OA damper position and command on real-time display

Rationale: Fixing the incorrect readings/commands will ensure proper monitoring and maintenance of system setpoints, OA intake, and building pressurization.

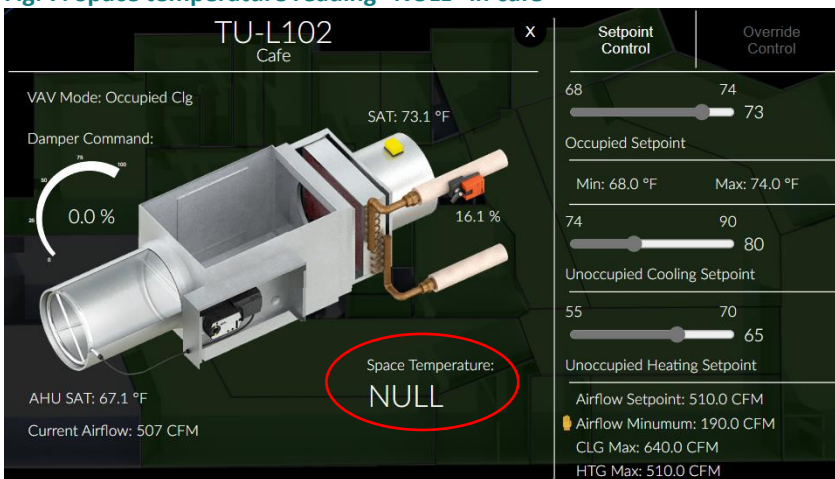
Space temperature readings. Space temperature readings in the café (TU-L102) and IT office/work area (TU-L119) are reading “NULL” (Fig. 7). Assess and correct.

Fig. 7. Space temperature reading “NULL” in café

Rationale: Proper space temperature readings/functioning sensors are necessary to maintain control of temperatures and system functionality.
