Number	A.1.
Section	General Information
Sheet	1 (of 1)
Date	January, 1960

PRELIMINARY INFORMATION

(Mark 2 Models)

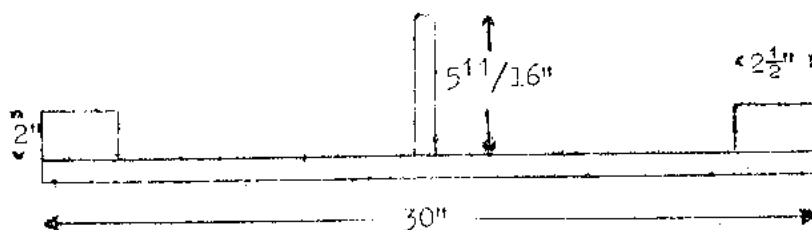
Check the distance from the bottom of the front flange of the front propeller shaft to the bottom faces of the longitudinal chassis side members. This distance should be $3.11/16" \pm 1/16"$ ($93.5 \text{ mm} \pm 1.5 \text{ mm}$). A simple checking jig can be made for checking this distance as shown in the following sketch.

If the propeller shaft flange is too LOW suitable packings can be fitted between the rear engine mounting rubbers and the mounting brackets at the top or bottom of the rubbers.

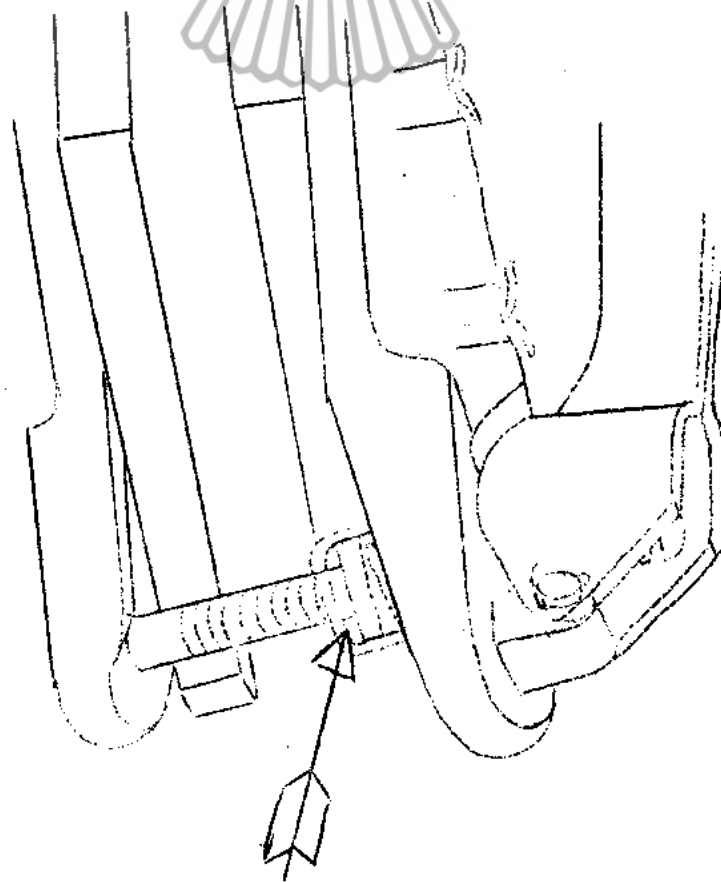
Insert screwdriver here

Prior to screwing the adjuster bolt into the self locking nut, insert a screwdriver between the square spring retaining nut and the spring cage to partly compress the spring. Hold the locknut firmly against the trunnion and ensure that the adjuster bolt engages the threads of the locknut at the first turn. After screwing in the adjuster bolt three or four turns the screwdriver can be released from the spring cage and the normal adjustment carried out.
