Rotor Tips

JANUARY-FEBRUARY, 1974

Volume VIII No. 1

TECHNICAL SECTION

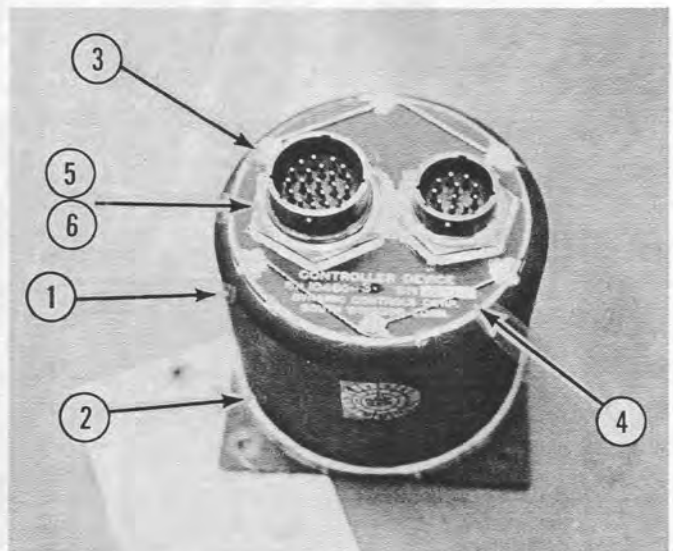
Experience has indicated that one of the principal causes of generator controller panel malfunction is entry of moisture due to improper sealing. The proper method of sealing these panels (P/N 10300-6, FSN RH6110-948-5384BH; and 10460-3, FSN RH6110-944-5592BH) is described as follows and is shown in the accompanying photo.

- A. Remove the housing (1) and inspect the interior of the panel for evidence of water entry and/or corrosion. Clean and dry as necessary.
- B. Replace and secure the cover.
- C. Apply a bead of sealant, such as RTV-731, completely around the base of the housing (2) at the point where the housing contacts the base plate.
- D. Apply sealant to the six housing screws (3) located at the top of the panel.
- E. Apply sealant completely around the panel at the point where the housing and the nameplate meet (4).

- F. Finally, apply a bead of sealant around the connector hex mounting nut where it contacts the nameplate (5), and also at the top where the connector threads are visible (6).

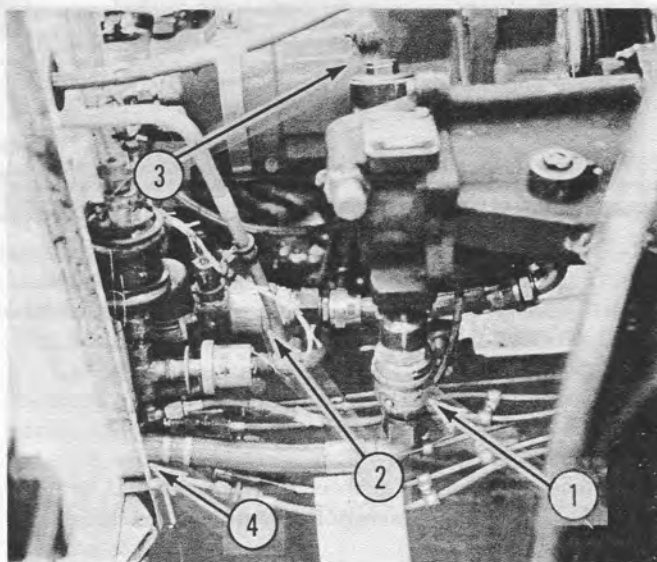
Photo A

If the longer 20343-1B quick-disconnect (item 2) is used in the inlet line where item 1 belongs, it will force the K678747-17 speed deceiver gearbox oil inlet hose assembly downwards, and cause chafing as it passes through the firewall (see item 4 both photographs). Conversely, if the shorter 20343-1 quick-disconnect (item 1) is used in the outlet line where item 2 belongs, the result will be a stretched and pre-loaded hose assembly.

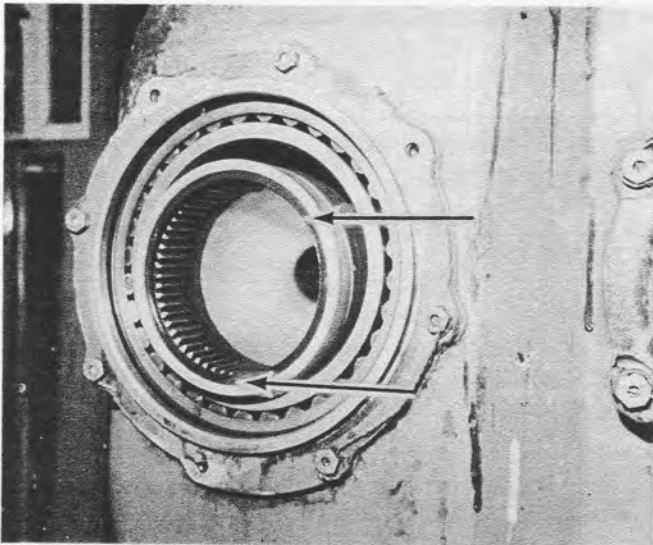
Forward side of combining gearbox
(Right hand input seal shown)

During engine removal/installation, input shaft oil dam seals are exposed to possible damage when mating the speed decriaser and combining gearbox drive splines. Seal replacement procedures require the use of special sockets and tooling, making it necessary to return the gearbox to overhaul for seal replacement. (One input shaft oil dam seal is installed on each side of the forward face of the CGB; see arrow in the photo.)

Oil dam seals (P/N K674853-13) must be replaced when any of the following is discovered:

1. Any missing segment of seal, exceeding 2 inches.
2. Three or more missing segments, which, when added together totals more than 5 inches.
3. Separation between adjacent missing segments (segment A on illustration) is less than shortest adjacent missing segment.

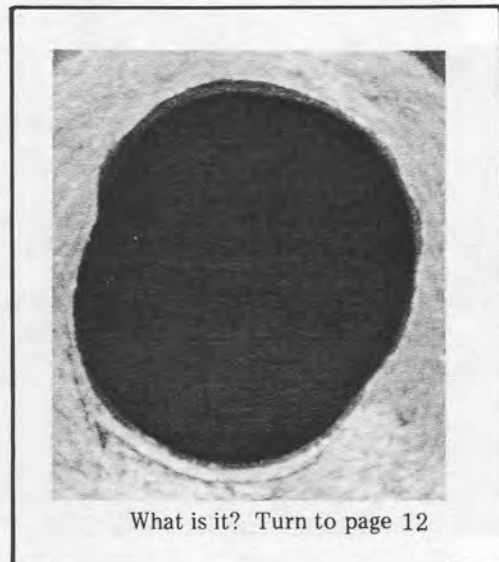
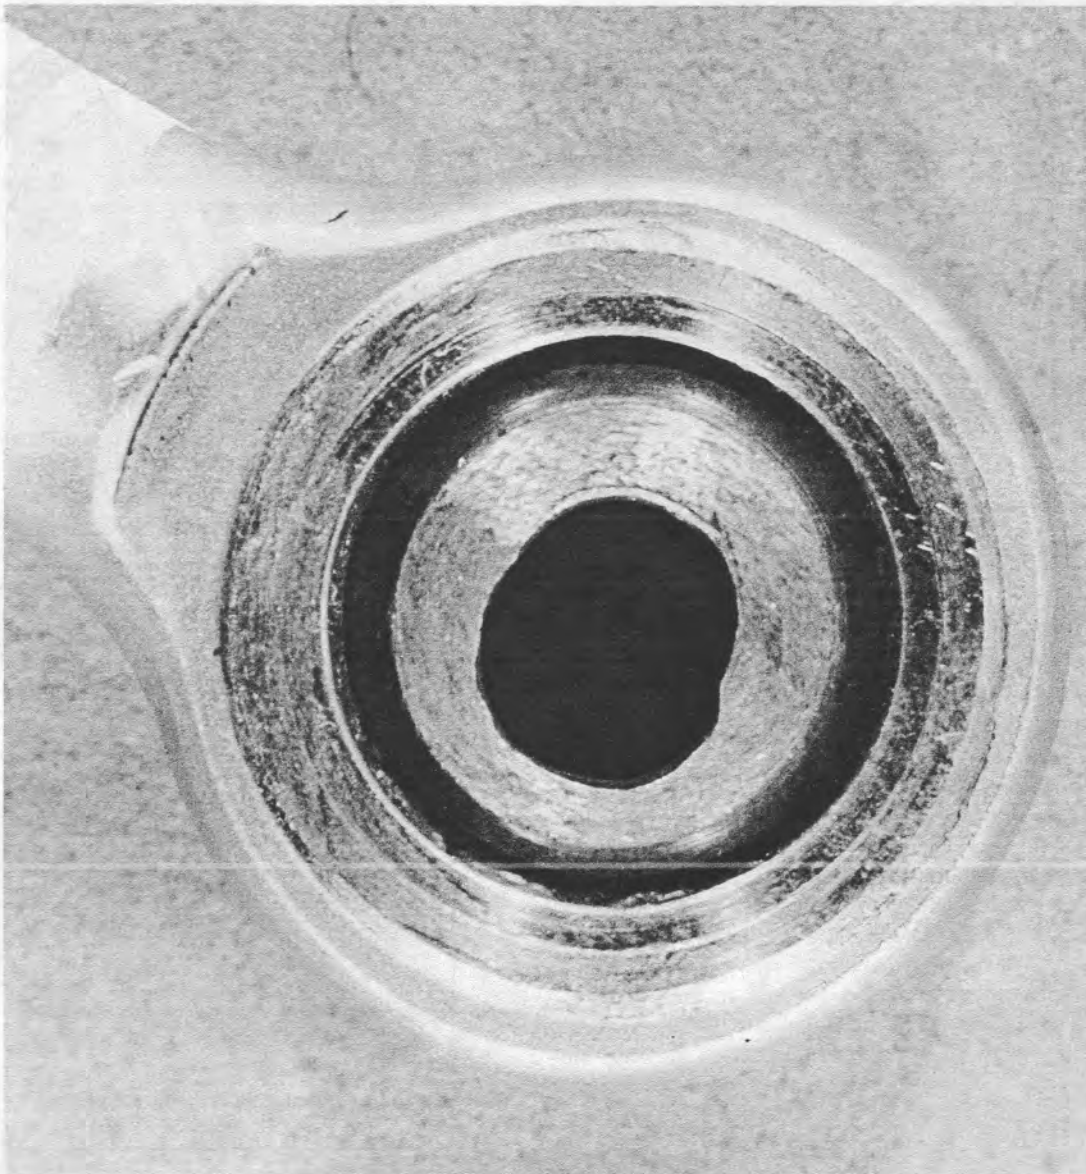
What is it? Turn to page 12

It may be difficult to believe, but that black, elongated blob shown on page 11 was once a perfect circle contained in the rodend shown in the accompanying photo. The damage inflicted illustrates the results of insufficient torque applied to the attaching hardware. This particular rodend was installed at the lower end of an azimuth-to-hub rod assembly, P/N K659027-5. While all bolts and nuts must be properly torqued, the azimuth rod installation is considered to be a critical torque connection.

What we are stressing here is that all attaching parts should be tightened to the proper torque in order to prevent damage such as that shown in the photos. Furthermore, **CRITICAL TORQUE** requirements must be complied with for safety's sake.

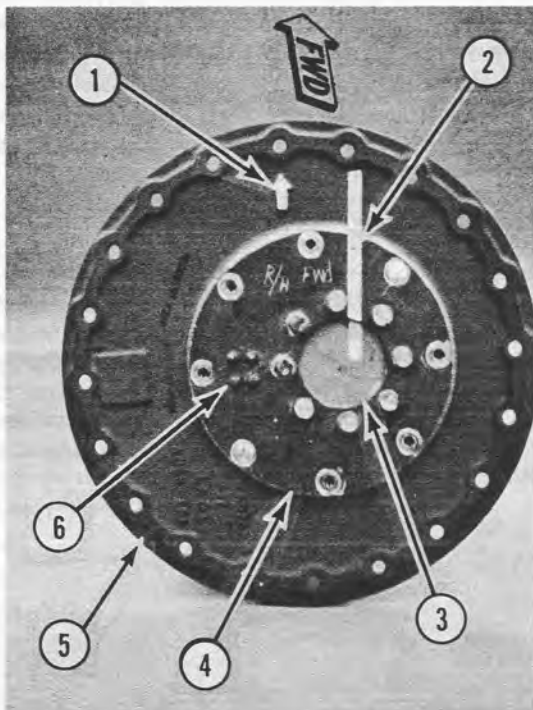
Photo 1—RH FWD

Proper installation of a probe begins with the use of the correct fuel cell covers: P/N K679104-5 for the right-hand cell; and, K679104-1 for the left-hand cell. Fuel cell probes, P/N 381097-16398, are used in both the RH and LH cells. The probe covers, P/N K679019-3, are also useable in either the LH or the RH cell. Cell covers incorporate an embossed arrow (Photo 1) which, when the cover is installed, must point forward.

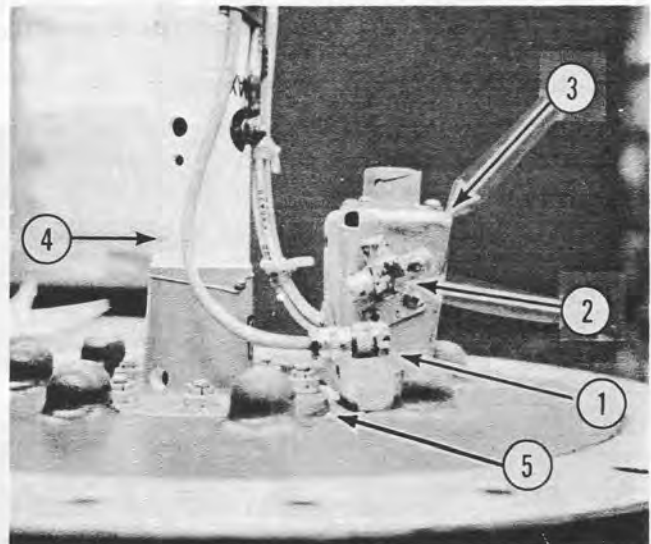
Photo 2

The probe must be secured to the probe cover in a position which places the probe harness connector adjacent to the connector mounted on the probe cover bracket as shown in Photo 2. Installation of the probe assembly (probe and cover) into the cell cover is the critical step in the installation procedure. Precise positioning is required because of the close proximity of the probe to internal fuel cell components.

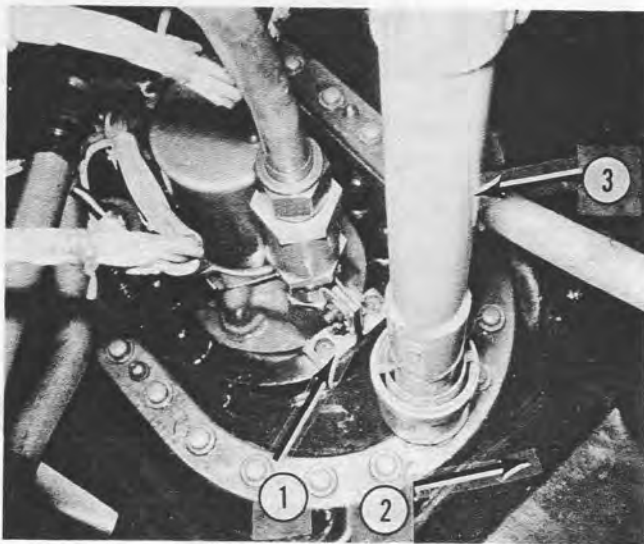
Photo 3—RH FWD Cell

brackets are found to be cracked, they must be replaced. If the brackets are serviceable, move the sump as far as possible (within the limits of the bracket bolt holes) in the direction which will increase the clearance between the probe and the sump wall. Hold the sump in this position and tighten the bolts. If the lower end of the probe appears to have been chafing against the boost pump slip joint coupling adapter support bracket (Photo 3) remove the clamp and the support. Prior to removal, note that one corner of the support (together with the clamp) is adjacent to the probe; with a hand file, round off this corner of the

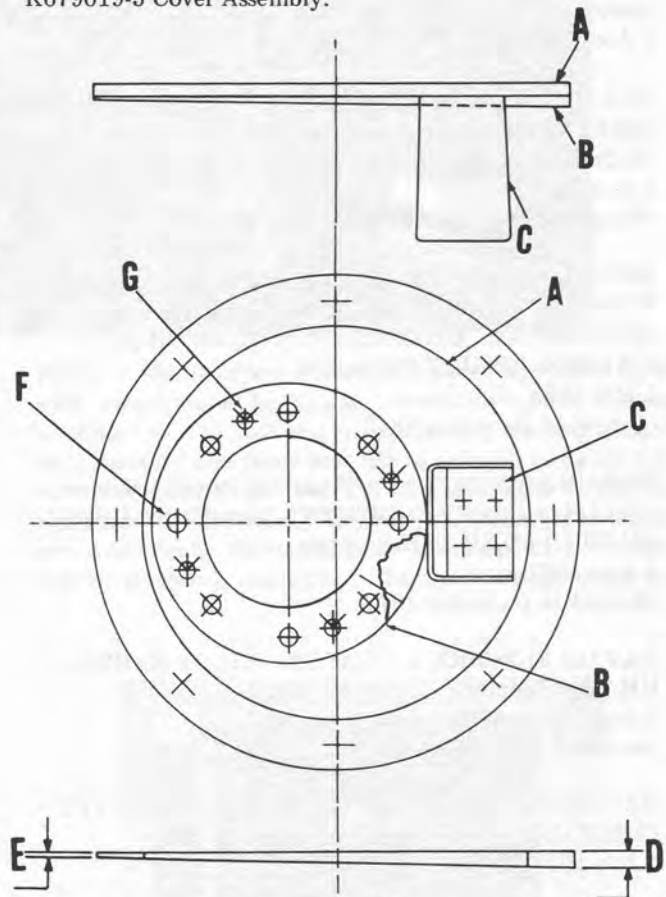
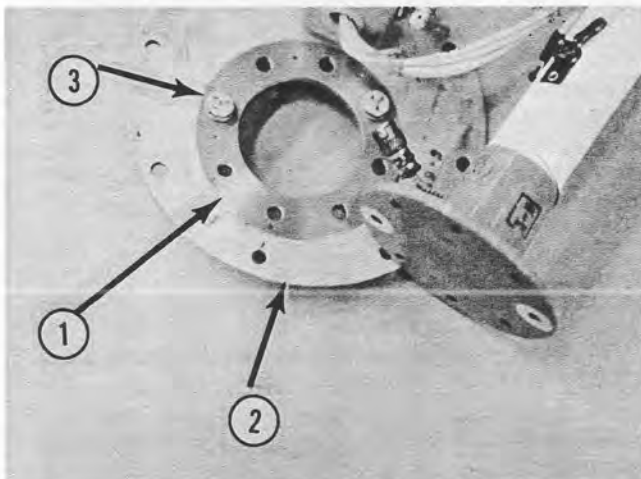
A recent drawing change has authorized use of the K679019-5 probe cover assembly (LH forward fuel cell) on all H-2 aircraft. The K679019-5 cover assembly differs from the K679019-3 cover in that a spacer, part number K679019-25 is riveted to the K679019-3 cover as shown in the accompanying illustration and re-identified to the K679019-5 assembly. The spacer, when installed, causes the fuel probe assembly (K679067-107) to tilt away from internal fuel cell sump wall. This positive positioning will preclude interference and subsequent chafing of the probe assembly.

Photo 5 shows the K679019-25 Spacer attached to the K679019-3 Cover, which is now re-identified as the K679019-5 Cover Assembly.

The probe cover assembly, P/N K679019-5, is used ONLY in the FWD LH cell. As in the other cells— it is important that the cell cover be installed with the embossed arrow pointing directly forward, prior to installing the probe and probe cover assembly. The tapered spacer, P/N K679019-25, riveted to the -3 probe cover (K679019-5 probe cover assembly) will provide the required clearance ONLY if the cell cover is properly installed.
