KAMAN

Rotor Tips

MARCH - APRIL 1975

Volume VIII No. 9

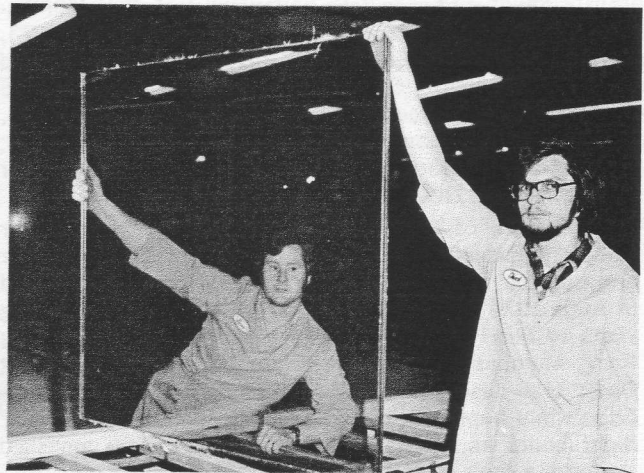
Mr. Dave Geibel, left, General Electric Tech representative, inspects a completed window. While this window is tinted or colored bronze, it is also available in clear and gray. This is the only all-plastic window currently "listed" by the Underwriter's Laboratories as meeting U.L. 752 Class III, the laboratory's standard for bullet resistant glazing (windows) tested for protection from .44 Magnum Super Power small arms.

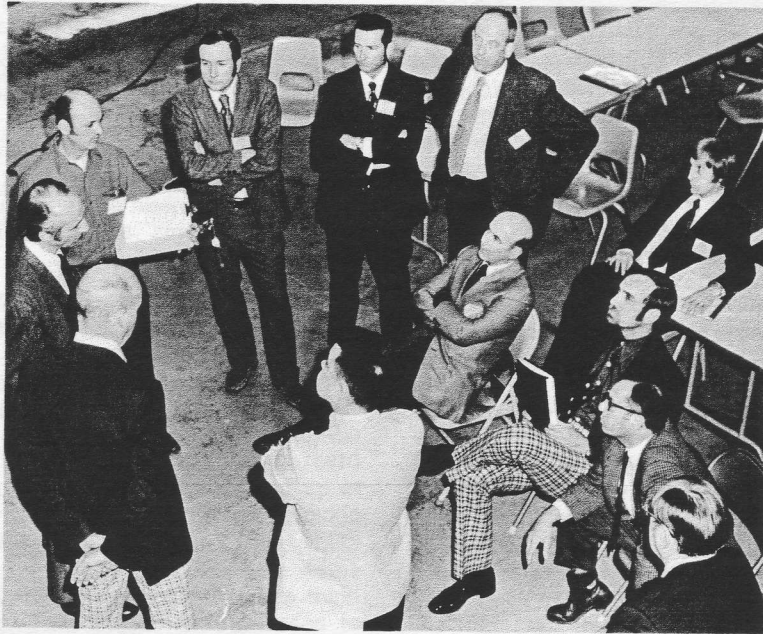
In photo below, a general discussion of one of the demonstrations and the time required to complete a blade repair using the Kaman-developed system. Standing, clockwise from 6 o'clock, F. E. Starses, KAC Maintainability Engineer; J. F. Wynkoop, Airline Systems; Paul Maloney, KAC Program Manager; Conrad Clendenin, KAC Maintainability Technician; C. E. Covington, Bell Helicopter Company, Research Engineer; B. J. Hunter, Bell Helicopter Company, Methods and Materials Engineer; W. I. LaRoza, Hughes Aircraft Company, Reliability and Maintainability Engineer. Seated front row, from left, E. Keast, Boeing-Vertol, Product Assurance; J. N. Sobczak, U.S. Army Reliability and Subsystems Engineer, AAMRDL (Army Air Mobility Research and Development Laboratory); J. A. Longobardi, Sikorsky Aircraft Company, Rotor Systems Division, and Stanley Barlow, Airline Systems. Seated rear, R. J. Spitko, Boeing-Vertol, Rotor System Designer.

damage resistance), an aluminum trailing edge spline, and an aft structure of fiberglass skins and Nomex Core for ease of repair. A complete coordinated maintainability and repair concept was developed concurrently with the blade design and was allowed to influence the design to meet established maintainability objectives. The main element of the repair concept was development of a special piece of Ground Support Equipment called the Pressure/Heat Pack with corresponding repair kits. The contract requirement for bonded repairs to the aft structure was that 95% of all repairs be accomplished in 3 hours by 2 mechanics (6 man-hours) without blade removal.

That this goal was met was conclusively demonstrated during the Maintainability Demonstration conducted at Kaman in January, 1975. Two appropriately rated Army helicopter mechanics, selected at random, were trained in the Kaman-developed procedures for one week. These men then demonstrated to an Army and industry panel that all repairs could be satisfactorily accomplished by one man in less than three hours (3 man-hours) on the aircraft. Blades repaired by the Army mechanics during the demonstration were subsequently whirl tested and showed no adverse effect on structural integrity, rotor track or vibration.
