## **Comparison and Analysis of Energy Performance of Baseline and Enhanced Temporary Army Shelters**

September 2015

Final Report

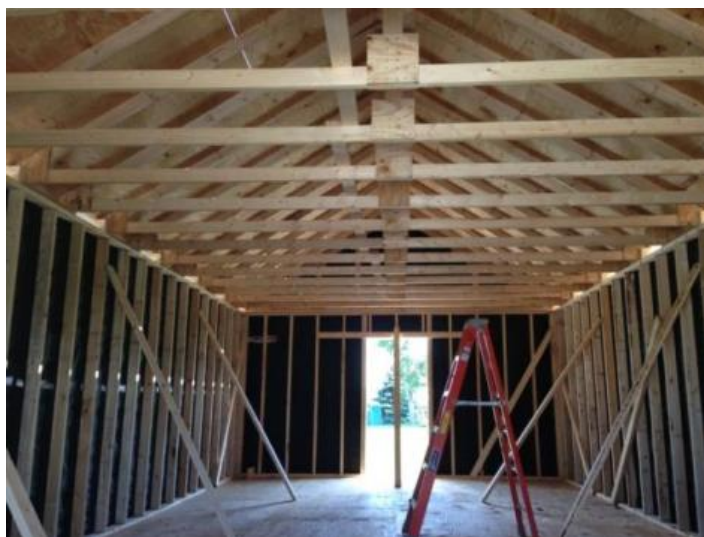
Figure 2-6. Interior view of the Enhanced Shelter and the installation of the wall felt air barrier.

The development of the baseline (control) Army shelter into an “Enhanced Shelter” involved several improvements to the envelope system. The first improvement was the installation of a continuous air barrier of #15 asphalt saturated organic felt around the exterior of the wall stud assembly and floor assembly, and above the roof sheathing. Felt was selected as an air barrier due to its availability, low cost as compared to typical air barriers, and ease of installation in the field. A comparison of air barrier costs per square foot (Table 2-2) revealed that #15 felt is 48% less expensive per square foot than the next least expensive comparable material. The wall felt was installed where the exterior side of the stud wall layer meets the interior side of the exterior plywood sheathing. This placement was chosen to provide the optimum performance of the material to enhance the assembly, and to protect the integrity of the material during installation and occupancy. Figure 2-6 shows this configuration.

Felt was also installed at the floor plane, across the top of the floor joists and wrapped down the rim joist, and was then covered by  $\frac{3}{4}$ -in. plywood flooring. The roof felt installation followed standard construction conventions, and was installed above of the roof sheathing to prevent water from entering into the interior of the shelter.

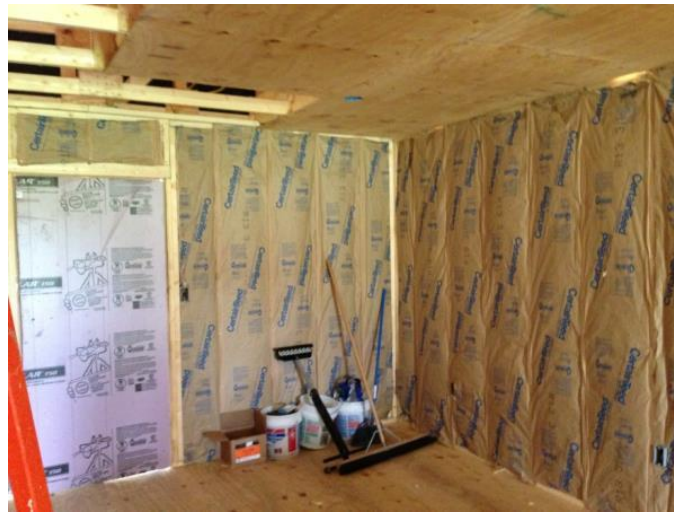
Figure 2-7. Interior view of the Enhanced Shelter showing the wall and door insulation applications.

The wall envelope was enhanced with 3.5-in. of Kraft-faced fiberglass batt insulation within the wall cavity (Figure 2-7), which provides an R-value of 13 within the wall. The shelter floor cavity was insulated with 6-in. of Kraft-faced fiberglass batt insulation, which provides an R-value of 25.

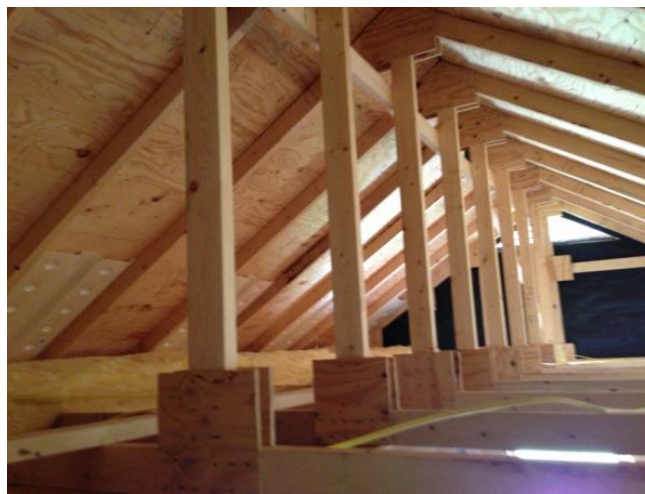
Figure 2-8. View of attic insulation and baffles in the Enhanced Shelter.

The attic above the ceiling plane was insulated with 16 in. of unfaced fiberglass batt insulation, which provides an R-value of 39. ADO DuroVent Insulation baffles were also installed in the Enhanced Shelter attic to ventilate the unconditioned attic space and prevent moisture from penetrating into the interior. Figure 2-8 shows the insulation and attic baffles.

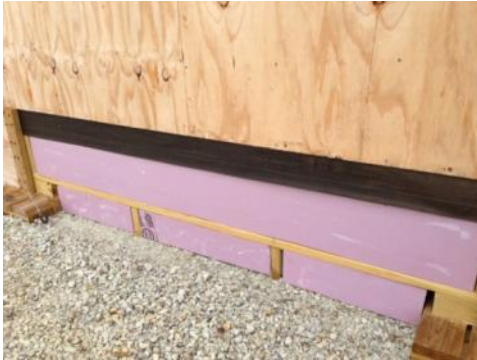
Figure 2-9. Enhanced Shelter skirting XPS insulation behind panel.

To further improve performance, insulation was added to the perimeter of the crawl space at the base of the Enhanced Shelter. Each skirting panel that encloses this space received two layers of 1.5 in. of XPS rigid insulation, for a total of 3 in. of insulation (Figure 2-9), which provides an R-value of 15. The entrance doors also received two layers of XPS insulation, which provides an R-value of 15 (Figure 2-10).

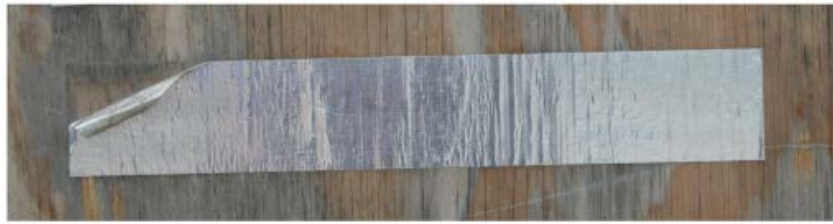
Figure 2-19. Tape D after Outdoor Exposure: Tape D after 8 months of outdoor exposure in the horizontal SW (right) locations.

Tape D had peeled from the plywood substrate (Figure 2-19). Two of the four Tape D samples failed completely while other two had begun to peel. The two vertical strips that failed completely had begun peeling within the first month of application, and failed completely within 2 months of application. While this tape was a top performer for Set I, its adhesion performance was largely compromised over time during the outdoor tests.

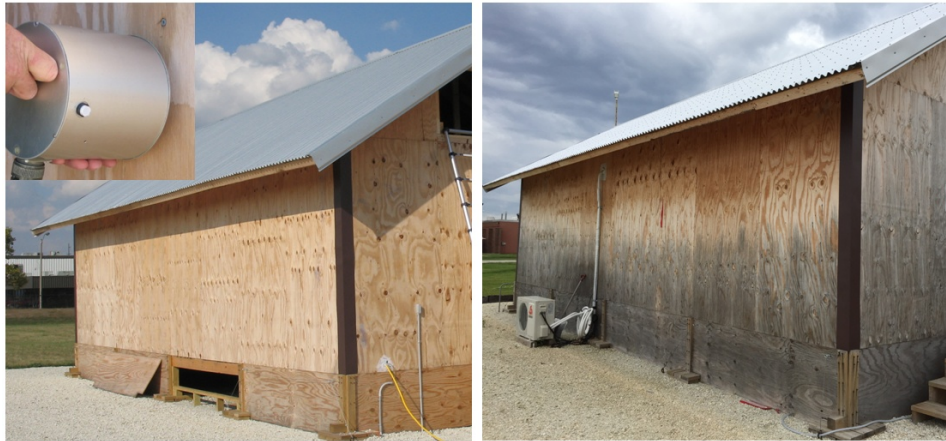
Figure 4-6. Discoloration of the exterior walls (left new, right after 20 months) and wide variation in SR on the same side of the wall (as evidenced by the color difference).

It is essential to use accurate material properties to build a good energy simulation model. Thermal and physical properties such as thermal conductivity, specific heat, thickness, density, solar reflectance (SR), and thermal emittance (TE) of building materials were either measured on site, determined by conducting laboratory tests at ORNL, gathered from the ASHRAE Handbook, or obtained from manufacturers' data sheets. Each type of envelope system was then assigned one or more layers of materials based on the actual construction, and each surface was assigned its respective construction, outside boundary condition, and relative geometry. Building geometry was set up using architectural drawings while important parameters such as the exact location of the HFTs, and shading surfaces were verified with field measurements. Figure 4-5 shows renderings of an EnergyPlus model of the B-hut. Each B-hut model has three zones: a conditioned space, an unconditioned attic and an unconditioned crawlspace. Unpainted exterior plywood surfaces that are exposed to weather conditions became discolored over time, which changed its SR values. To evaluate the change, SR of exterior surfaces were measured three times at 10-month intervals, using a Devices and Services Solar Spectrum Reflectometer (DS 2014). Multiple measurements were taken at each side of the walls as SR values widely vary even on the same side of the hut (Figure 4-6). Table 4-4 lists the average values, which indicate a decrease in SR between 26 September 2013 and 2 May 2015 range from 14 to 50%.

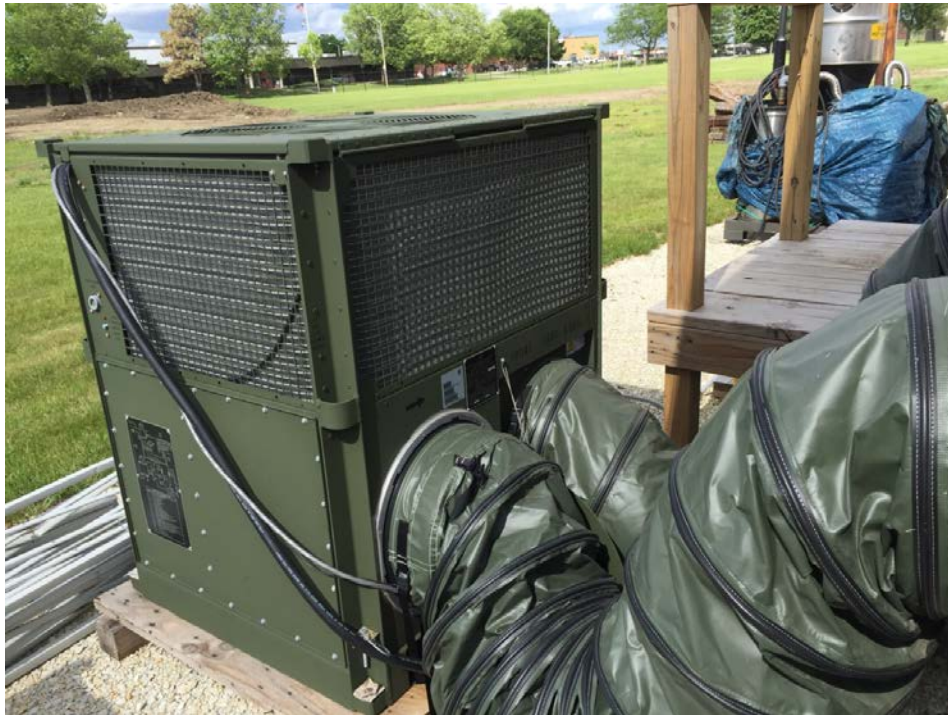
Figure 4-45. IECU serving the B-hut and the flexible ducts used as supply and return ducts.

Supply and return air ducts between the huts and IECUs were connected using flexible ducts (Figure 4-45). The ducts were uninsulated and connections were not airtight. Blower fans on the IECUs run constantly, even when there is no heating load. Therefore, the infiltration rate and heating load increases when IECUs are used.

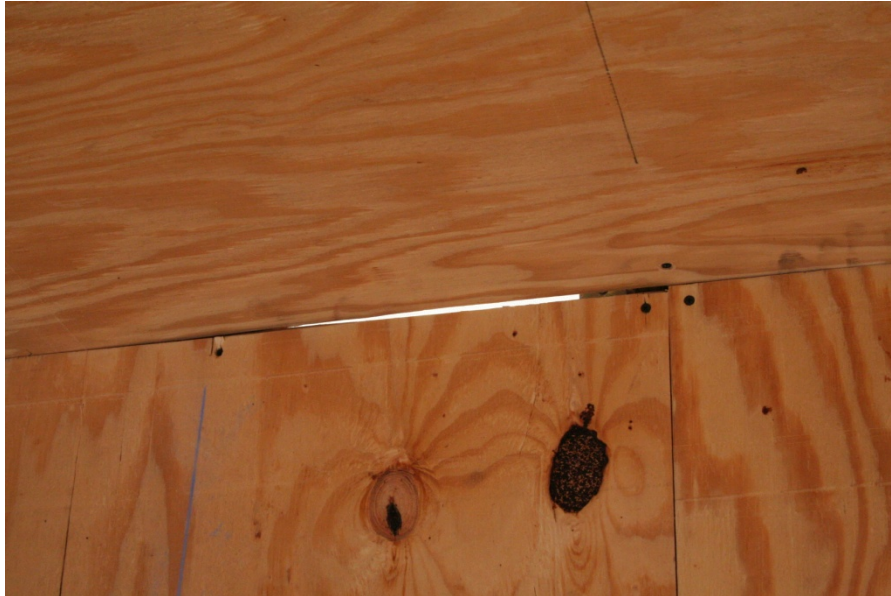
Figure 5-1. Gap in ceiling/wall connection as shown by light entering the space.

B-huts are commonly used at COBs due to their simple design, ease of construction by unskilled workers, and adaptability to a wide variety of uses. Because they are of all wood construction, locally sourced materials can often be used to build them. Unfortunately, the quality of B-huts can vary considerably due to the use of unskilled labor. Even the EFOB-L B-huts, which were built by a local contractor's skilled workers, were found to have gaps in the building envelope (Figure 5-1).

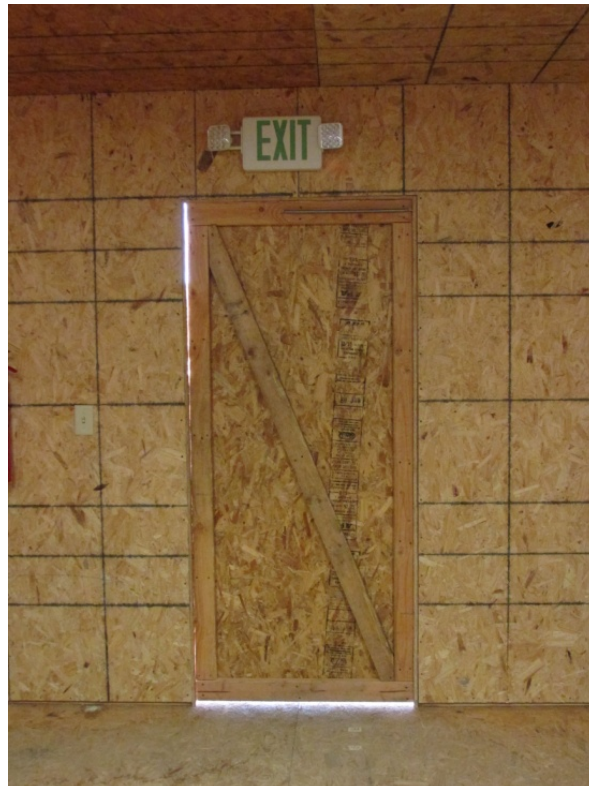
Figure 5-2. Typical B-hut leaky door.

After the sealing of seams and openings in the enhanced B-hut, the only remaining major source of air leakage are the two exterior doors on either end of the structure. These doors are made on site and do not seal well (Figure 5-2). Besides allowing a high amount of air leakage, they also allow the entry of rainwater (Figure 5-3) and blown in snow (Figure 5-4) during inclement weather. This unwanted intrusion of water into a B-hut can increase interior space humidity, allow the growth of mold, and damage the plywood materials through delamination and rot.

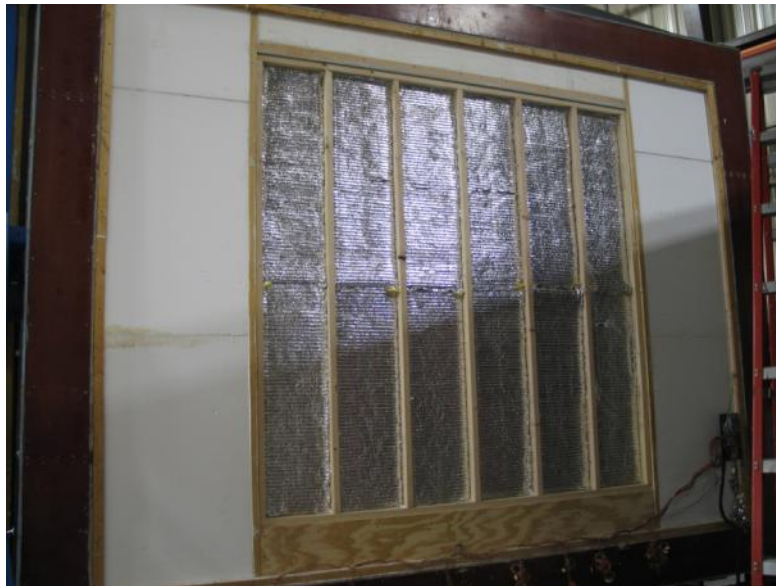
Figure B-1. Test wall with GFPs in the cavity.

The GFPs were inflated with compressed air with a pressure regulator set at 7 psig. Some of the GFPs bulged during inflation. Severely bulged GFPs were not used in this test. One GFP was punctured by a splinter while being installed on the test wall and was replaced. The honeycomb structure of the GFP was visually inspected (Figure B-2) by cutting one panel. Thickness of the inflated GFP was about 1.5-in., thus two layers of GFPs fills the cavities between 2x4 studs.

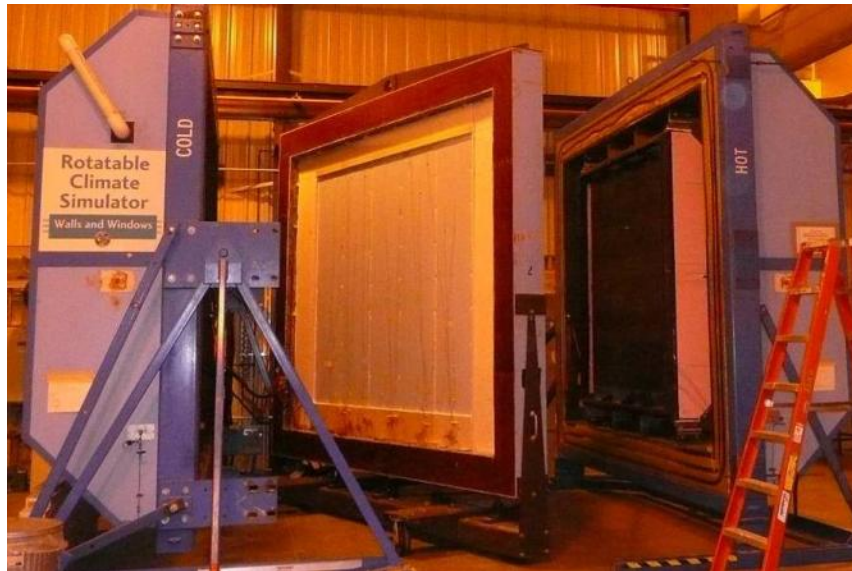
Figure B-3. ORNL RGHB.

ORNL operates and maintains a guarded hot-box that is used to measure the effective thermal resistance (R-Value) and thermal transmittance (U-Factor) of full size wall and window assemblies. The hot-box operates under the requirements of ASTM C 1363. Figure B-3 shows the RGHB. Test assemblies are installed in a specimen frame mounted on a moveable dolly. The specimen frame has an aperture 13-ft long by 10-ft high. The specimen frame/test assembly is inserted between two “clam-shell” chambers of identical cross section. The placement of the test wall assembly between the chambers allows the chamber temperatures to be independently controlled, thus creating a temperature difference across the specimen. The chambers are designated as the climate (cold) and metering/guard (hot) chambers. Figure B-4 shows a typical wall specimen installed in the test frame. The central 8x8-ft wall section, which aligns with the metering chamber boundary, is used for the actual test.
