## **Proceedings of the Multidisciplinary Conference on the Sinai Desert**

The conservation of the 6<sup>th</sup> century mosaic of the Transfiguration in the  
Monastery of Saint Catherine in the Sinai <sup>1</sup>  
R. Nardi, C. Zizola, Centro di Conservazione Archeologica (CCA), Roma

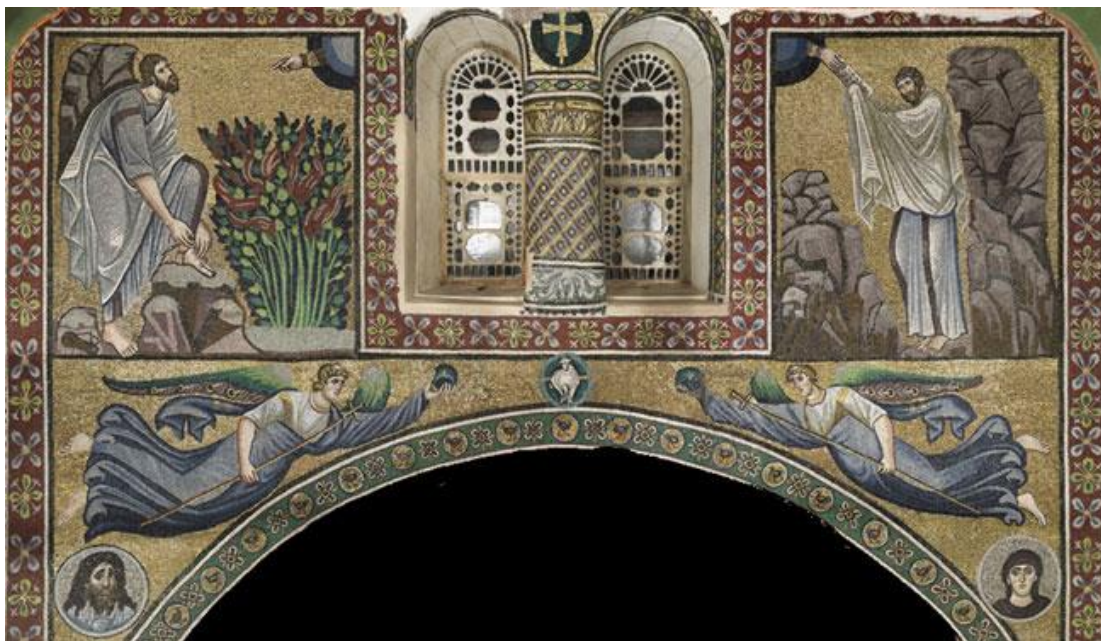
*Illustration 1. General view of the main arch (Foto Araldo De Luca - CCA)*

On the arch of the apse, two angels are represented in flight converging towards the centre where, in a *clipeo* of turquoise bands, the Lamb in front of the cross can be seen. On the wall above, on either side of the two single light windows, are scenes of the Consignment of the Laws (Commandments) and the Burning Bush, see illustration 1.

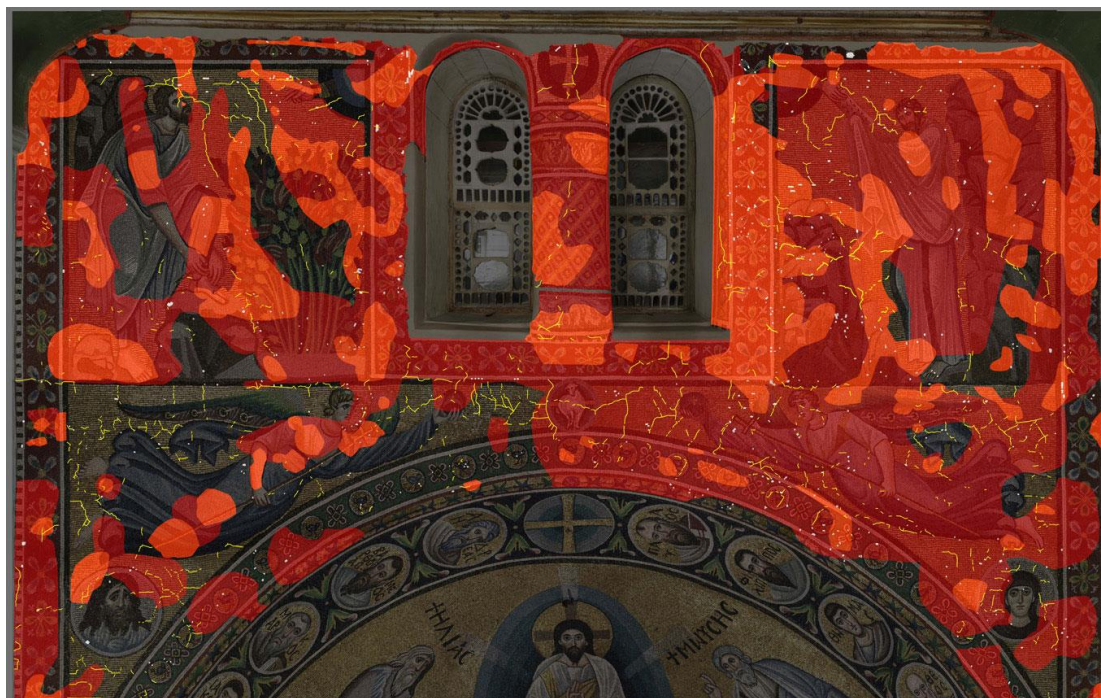
*Illustration 2. Graphic documentation of mosaic detachments from the wall of the main arch. In red the surfaces completely detached.*

The current history of the conservation of the mosaic of the Transfiguration began in 2000, when the Getty Conservation Institute<sup>2</sup> of Los Angeles asked the Centro di Conservazione Archeologica (CCA)<sup>3</sup> to carry out a two-week inspection to assess the mosaic's condition. Although we knew something about the splendor and holiness of the place, we were stunned after arriving on site, principally for two reasons: on the one hand, we hadn't expected such a rich and magnificent mosaic; on the other hand, we hadn't expected such a serious problem and the mosaic's desperate condition. In fact, when we moved close to it at the top of a wooden tower, we found that the problem of detachment of the preparatory layers from the granite structure underneath affected more than 50% of the surface, see illustration 2. It was so extensive that, at first, we could not tell whether the movement triggered by merely touching the mosaic was due to the tower's wobbling or to the mosaic's moving. It was actually the mosaic, which rippled like a sail.

To make matters worse, the central part of the apse, corresponding to the face of Christ, was convex instead of concave. It probably was still standing only because of the plant fibers inserted in the setting bed, to the friction of one tessera against another because of the vault curvature, and to the metal pins inserted by Father Samuel and the American team. At that point, among other things, we grasped the true significance of the public appeal published in the early 1960s in the *National Geographic* by Forsyth and Weitzmann to mobilize the scientific community to save the mosaic from such serious risk.<sup>4</sup>

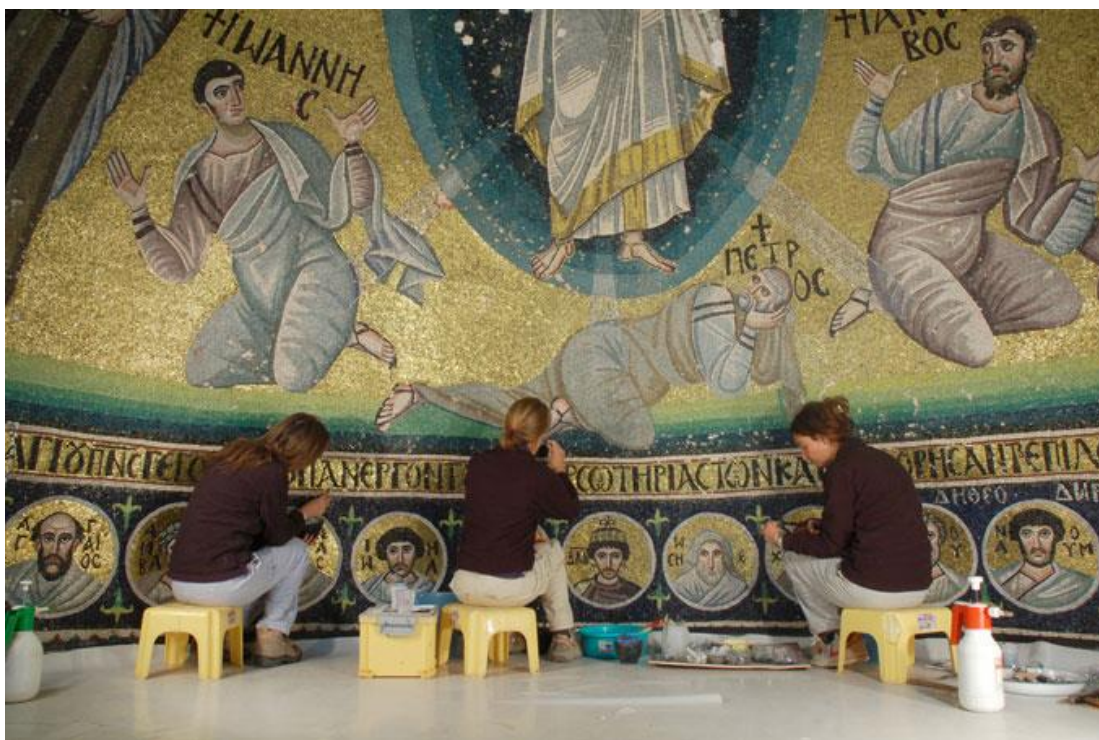
*Illustration 4. A view of the apse during the conservation work. (Foto Araldo De Luca - CCA)*

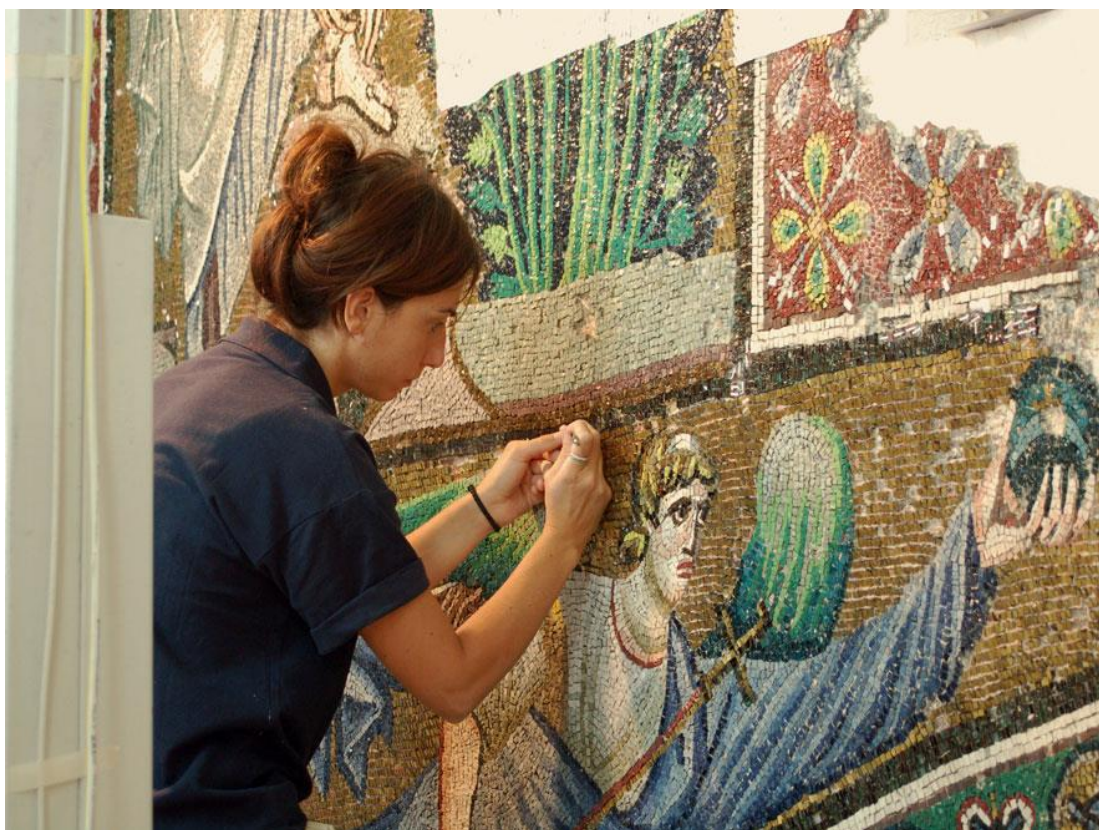
*Illustration 5. A view of the arch during the conservation work. (Foto Araldo De Luca - CCA)*

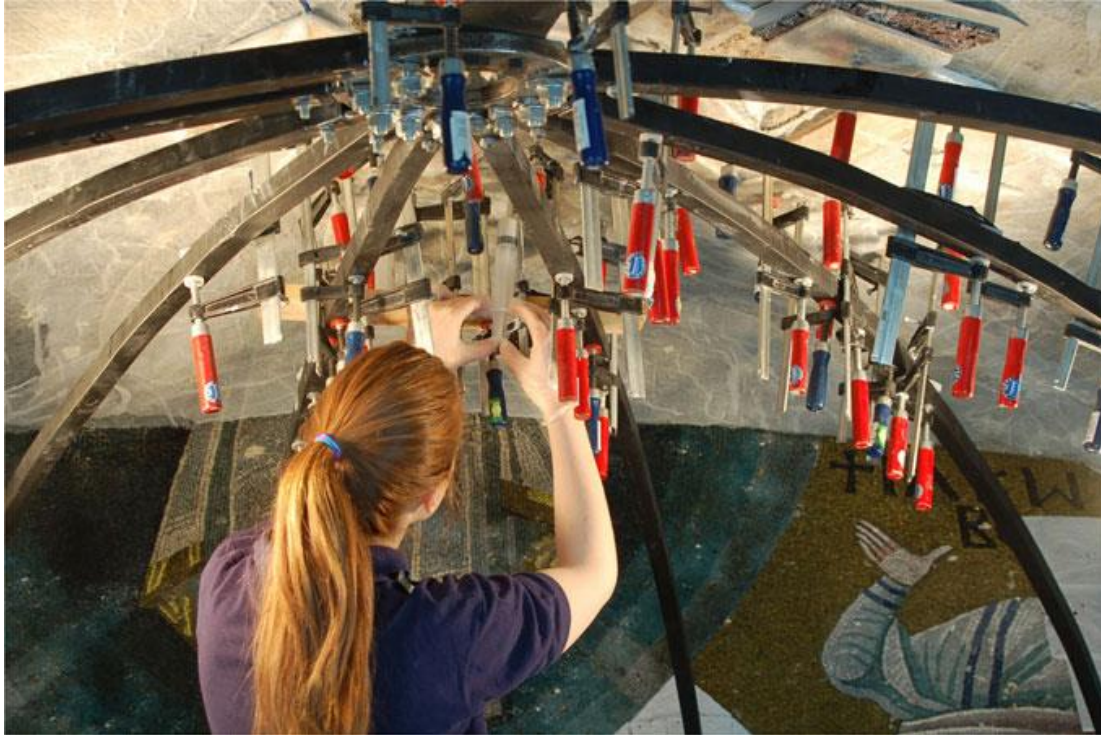
*Illustration 6. The metal structure (the “spider”) supporting the mosaic in the apse during consolidation (Foto Araldo De Luca - CCA)*

Given the serious detachments of the mosaic, the first operation was to plan and construct a structure (known as the "spider") in the curve of the apse, see illustration 6. It is made of

hollow metal and completely separate from the scaffolding, as it is anchored directly to the walls of the church and the base of the mosaic. It is a sort of framework that allows supporting props to be applied to any part of the mosaic. This structure is composed of a

central node at the top, at the center of the apse near the central cross at the peak of the under arch; eight arms depart from the node and follow the curve of the mosaic. The node is fixed to a cross-bar soldered to a larger metal structure that spans the church from one side to the other.

The arms are anchored on one end to the node, and on the other to a track on the stone frame at the base of the mosaic. They can move to the right or left as needed. Fixed to the arms are the telescoping supports with which the mosaic was supported during the work and which we used during the entire consolidation of the mosaic while waiting for the injected mortar to set. It was of crucial importance that these supports not be anchored to the scaffolding because the vibrations would have been extremely dangerous for the mosaic and for the proper hold of the consolidant.
