INSPECTION AND PREPARATION FOR TESTING OF THE ROAD OVERPASS OF THE ALMATY-KAPSHAGAI HIGHWAY AFTER THE VEHICULAR IMPACTS

The 33.0 m long reinforced concrete bridge beams of the overpass superstructure after vehicular impacts were taken as a research object.

The present article brings the survey results of the bridge beams damages of a prestressed concrete girders double-span structure of a length of 33 m, caused by vehicle impacts in the Almaty-Kapshagai highway overpass section.

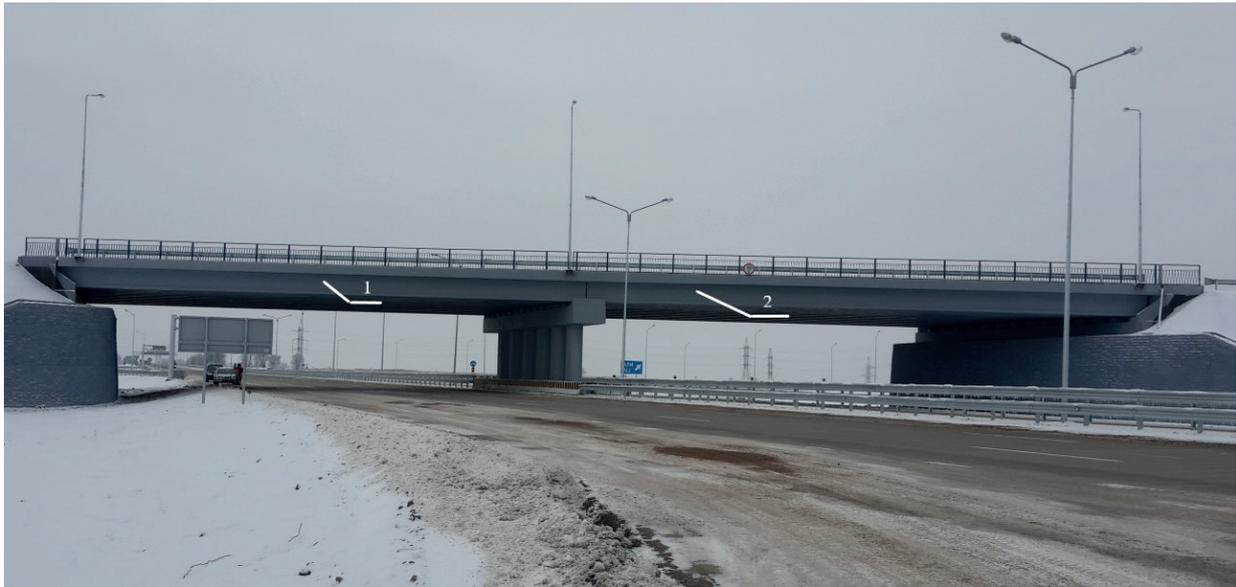
Figure 1 The general view of the overpass from the Kapshagai city side: 1 and 2 - superstructure numbers

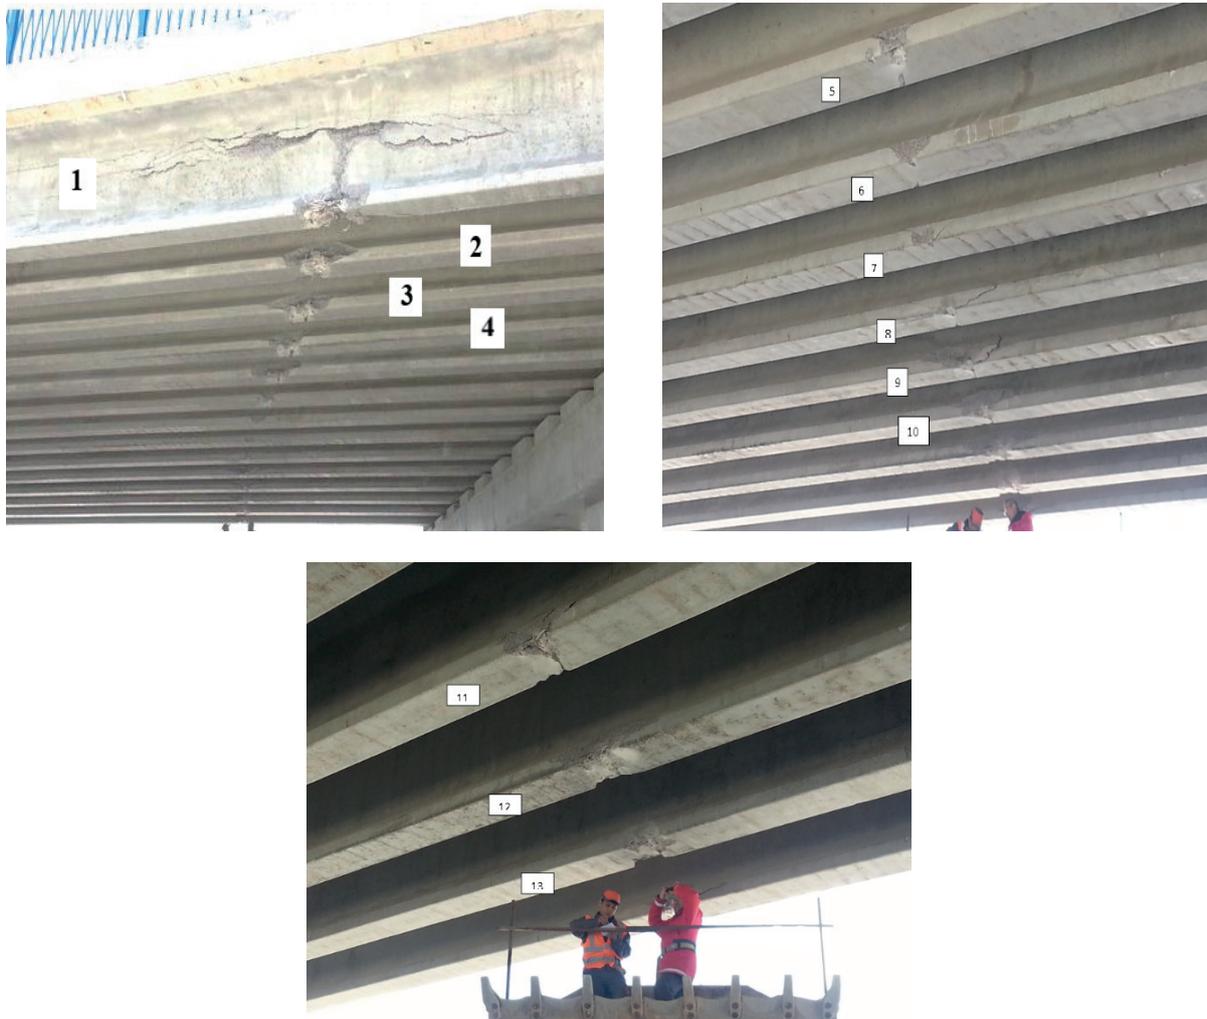
A detailed examination of the damaged VTK-33 beams at the superstructure No. 1 was performed after the accident. As can be seen from Figure 2, most of the VTK-33 beams were significantly damaged.

Figure 2 shows that all fourteen VTK-33u beams were damaged as a result of vehicle impacts. Along with the destruction of the widened lower part of the beams, the destruction of the bottom flanges of the beams took place with the formation of cracks in them along the longitudinal axis of the beams.

Figure 2 The general view of the damaged superstructure No. 1 from the Kapshagai city side

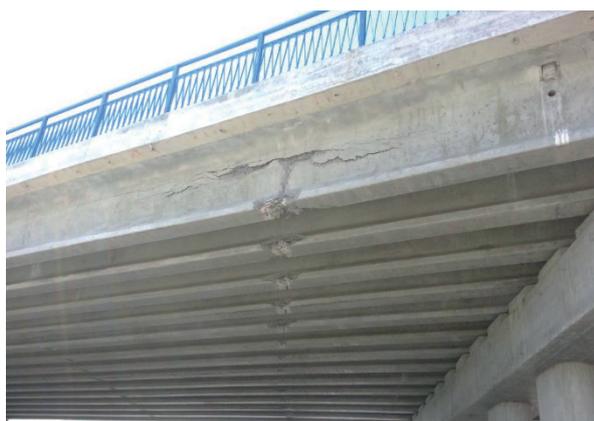
The destruction of the widened lower part and the flange of the beam No. 1 are present with a rupture of the wire of the ropes K-7 (Figures 3 and 4).

Figure 3 A general view of the destruction in beam No. 1 from the Kapshagai side (Destruction of the bottom flange of beam and its widened lower part. A longitudinal crack was revealed in the upper part of the beam flange of a length of about 8.6 m)

Damaged beams, excluding the beam No. 1, could be repaired. At the same time, in the beams No. 1, 2, 3, 4, 11, 12, 13 and 14, along with the damage to the lower widened part, there were longitudinal cracks of various lengths in the bottom flange of the beams, at the base of the upper sides. The presence of those cracks significantly reduced the bearing capacity of those beams. Given the presence of such damage, it

was recommended to dismantle these beams, which was done.

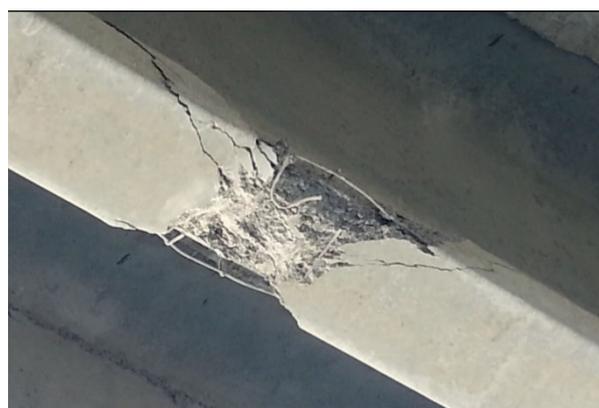
A significant damage in beams 2, 3, 4 and 11 are present (Figures 5-8). In them, the bottom flange is

destroyed, ruptures of the reinforcement of a smooth and periodic profile took place. Longitudinal cracks of various lengths were revealed in the flanges of those beams.

Figure 5 A general view of the destruction of the bottom flange of the beam No. 2 (The reinforcement of the smooth and periodic profile is damaged. The bundle of prestressed reinforcement is exposed)

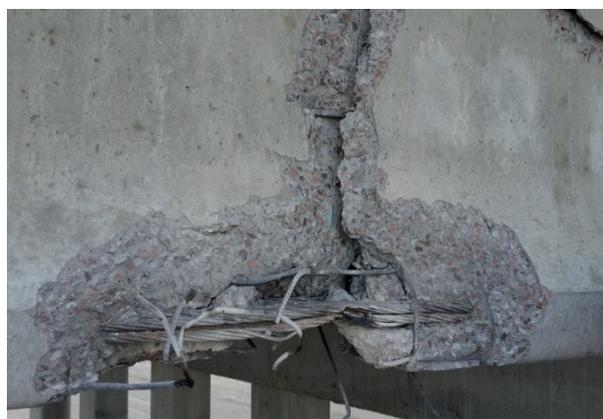
Figure 4 Fragment of destruction in beam No. 1 and damage with wire rupture of K-7 ropes from the Kapshagai side

1. A close inspection of the VTK-33u beams of the superstructure No. 1 of the Almaty-Kapshagay highway, damaged by vehicle impacts, was carried out.
2. In beam 1, a rib is destroyed, the lower part is widened and breaks in wires and K-7 strands are found. Beam 1 was not subjected to repair and was dismantled.

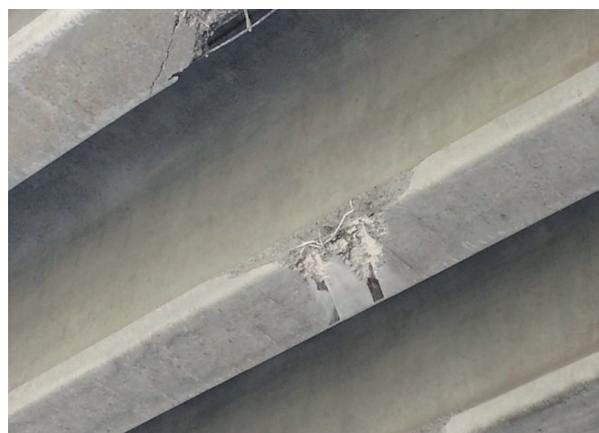
Figure 6 Destruction of the widened lower part of beam No. 3 from the Kapshagai side (Smooth and periodic profile reinforcement was torn. A longitudinal crack was revealed in the upper part of the beam rib of a length of about 9.2 m)

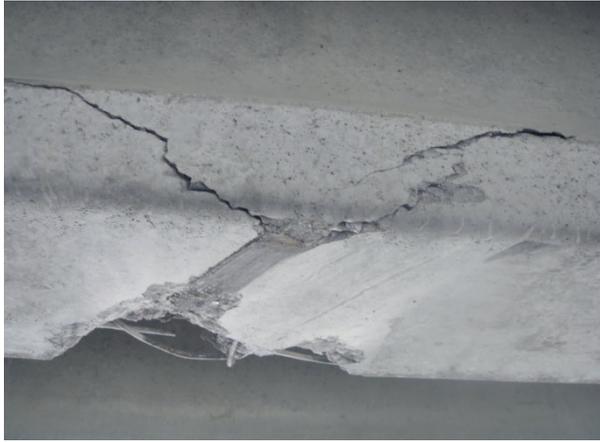
Figure 7 Destruction of the widened lower part of the beam No. 4 from the side of Almaty (The reinforcement of the smooth and periodic profile is torn. A longitudinal crack was revealed in the upper part of the beam rib of a length of about 3.3 m)

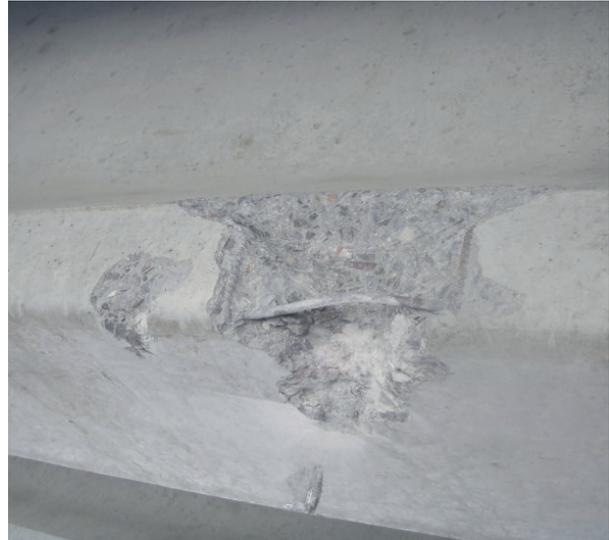
Beams 5, 6, 7 and 8 have a lower degree of damage (Figures 9-12). In them, the destruction of the widened lower part of the beams is mainly present.

Figure 10 Damage of the protective concrete cover in the widened lower part of beam No. 6 from the Kapshagai side (The longitudinal smooth reinforcement is damaged)

In beams No. 5, 6, 7, 8, 9 and 10, only the lower broadened part of the beams was damaged, caused by the destruction of the protective layer of concrete. A detailed examination revealed that the bundles of stressed reinforcement in the lower widened part of the beams were not damaged, which did not cause the reduction of the bearing capacity of these structures, the presence of such damage gave reason to recommend the repair of those beams.

For repairment of beams No. 5, 6, 7, 8, 9 and 10, BASF's EMACO FAST TIXO was recommended. This material is a non-shrinking, fast-hardening dry mix of a thixotropic type, containing polymer fibers, intended for structural repairs of concrete and reinforced concrete.

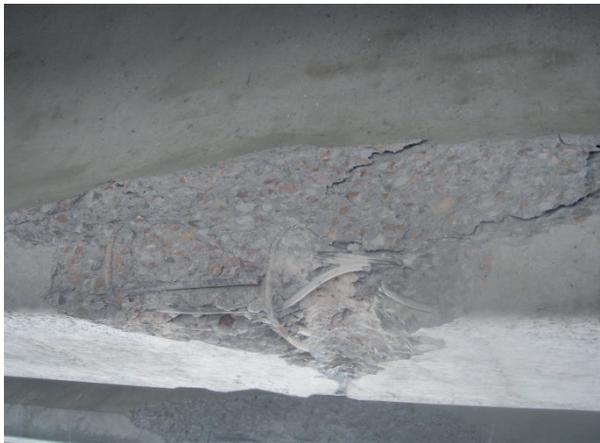
Figure 8 Destruction of the widened lower part of the beam No. 11 from the Kapshagai side (The reinforcement of the smooth and periodic profile is damaged. A longitudinal crack was revealed in the upper part of the beam rib of a length of about 3.9 m)

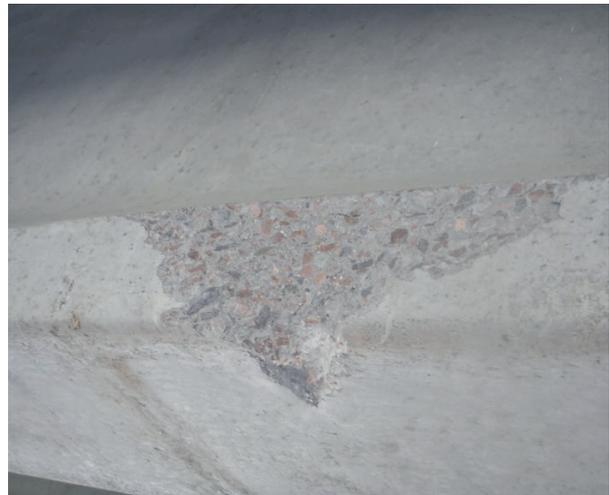
Figure 11 Damage of the protective concrete cover in the widened lower part of beam No. 7 from the Kapshagai side

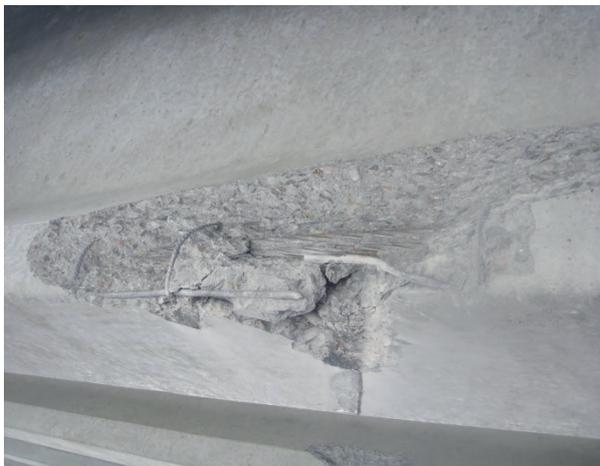
Figure 9 Fragment of the destroyed widened lower part of beam No. 5 from the Kapshagai side (The reinforcement is torn; the bundle of prestressing reinforcement is exposed)

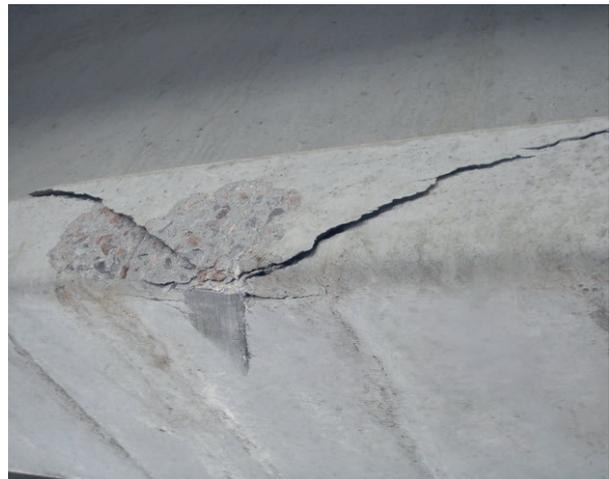
Figure 12 Destruction of the widened lower part of the beam No. 8 from the Kapshagai side

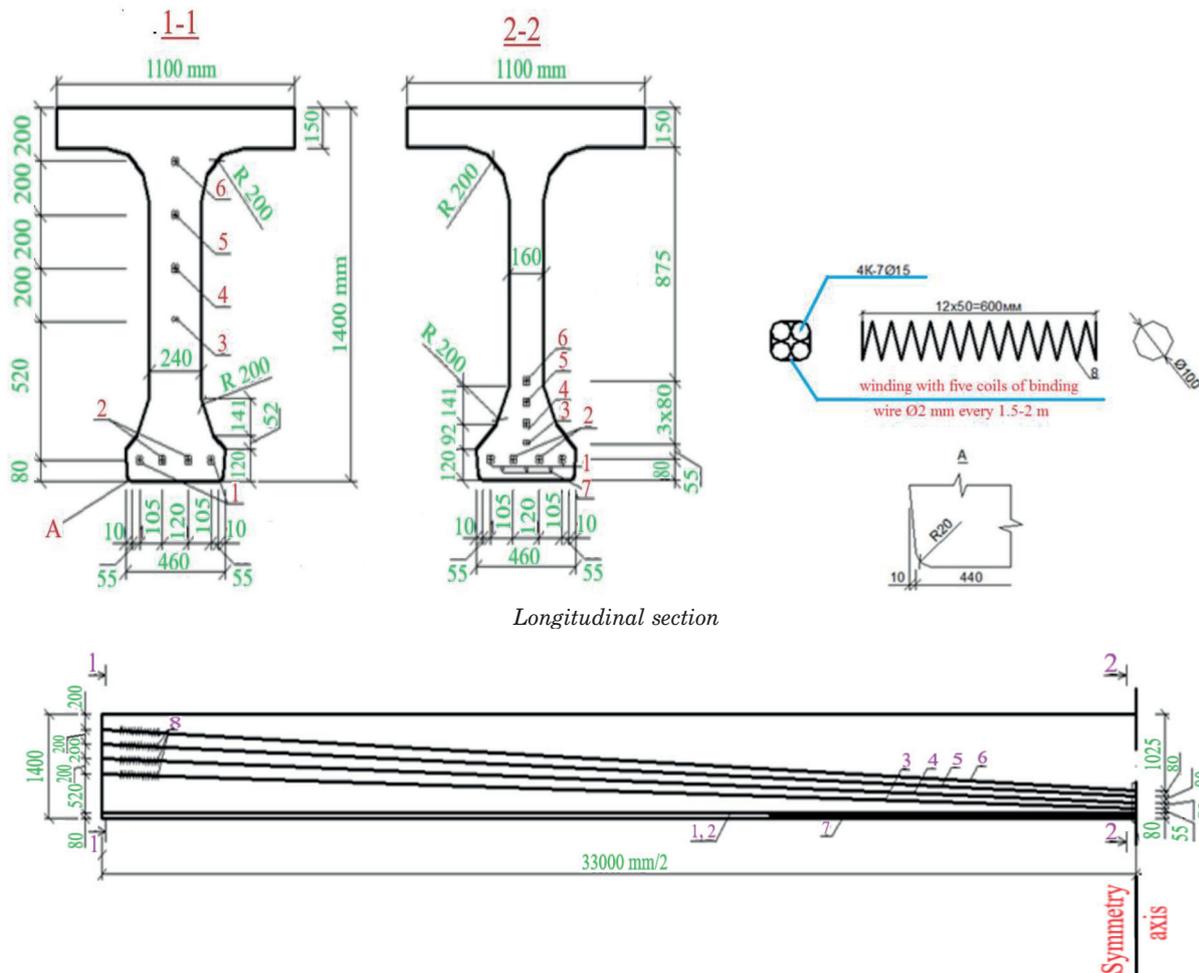
As per the project, the VTK-33u beam concrete class is B35 according to [13]. Figure 13 demonstrates a longitudinal section and cross sections of the VTK-33u beam. Seven-wire strands K-7 with a diameter of 15 mm according to GOST 13840-68 "Steel reinforcing ropes 1x7. Specifications" [14], combined by four strands into a cables (7 wires) and two strands, combined into one cables (Table 2, Figure 13). The area of the prestressing tendons, adopted in the project when reinforcing the beam, is $A_p = 4170 \text{ mm}^2$. Three rods with a diameter of 14 mm of class A 400 according to GOST 34028-2016 are accepted as working longitudinal non-stressed reinforcement [15]. The area of the non-stressed reinforcement adopted in the project when reinforcing the beam is $A_s = 462 \text{ mm}^2$.

Figure 13 Longitudinal section and cross sections of the VTK-33u beam

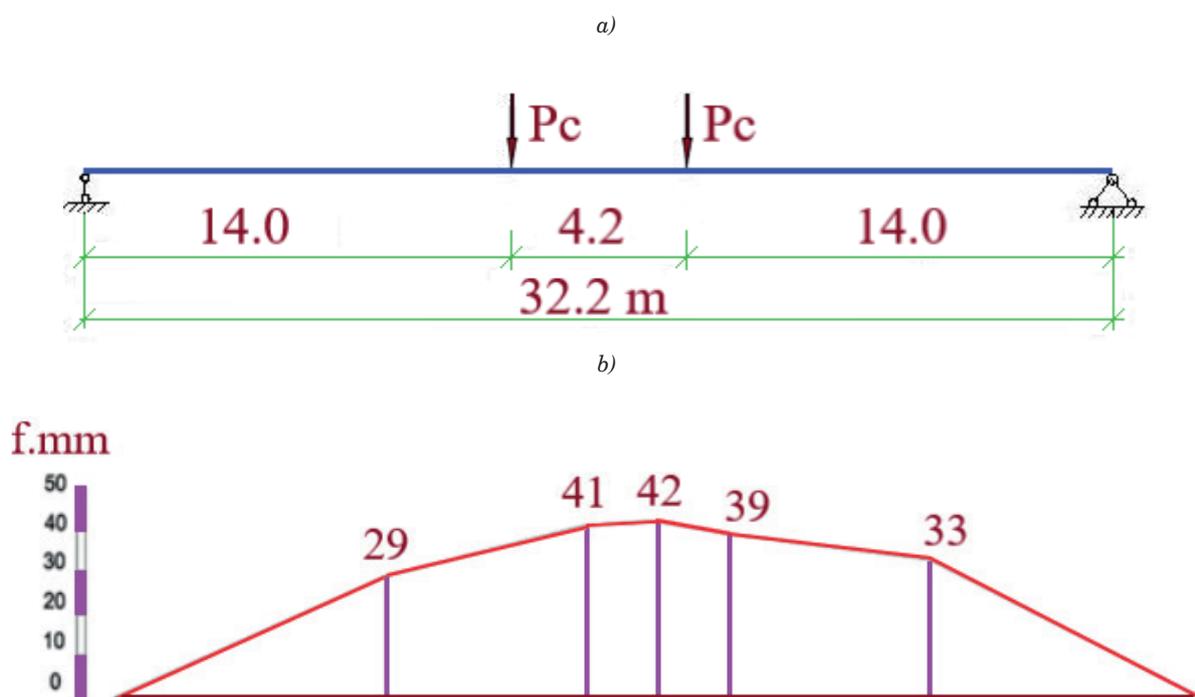
Figure 14 demonstrates the design scheme of the experimental product and the outline of the beam bottom in the presence of loading devices on it. Review of the beam deflection curve indicates a satisfactory shape of the formwork bottom.

Figure 14 The design scheme of a 32.2 m long composite beam (a) and the outline of its lower face, loading devices weight included (b)

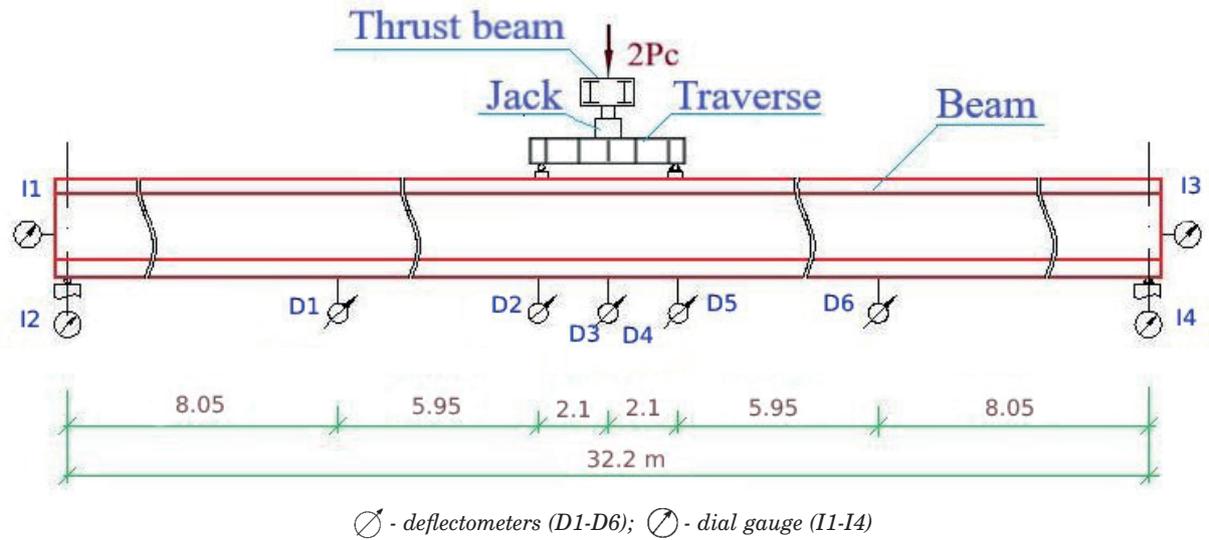
During the tests, the deflections of the beam were determined in the middle of the span, under two loads P and at a distance of 8.05 m from the axis of the beam supports. Beam deflections were recorded using deflectometers of Aistov system and Kucherenko Central Research Institute of Building Structures (Moscow, Russia). The subsidence of the supports was controlled using dial indicators with a division value of 0.01 mm.

Figure 15 Experimental product scheme with the loading equipment and mechanical devices

of prestressing reinforcement beams relative to the concrete of the beam was controlled using dial indicators with a division value of 0.01 mm, installed at the ends of the beam. Figure 15 shows the design scheme for testing the VTK-33u beam and the scheme of an experimental product with loading devices.

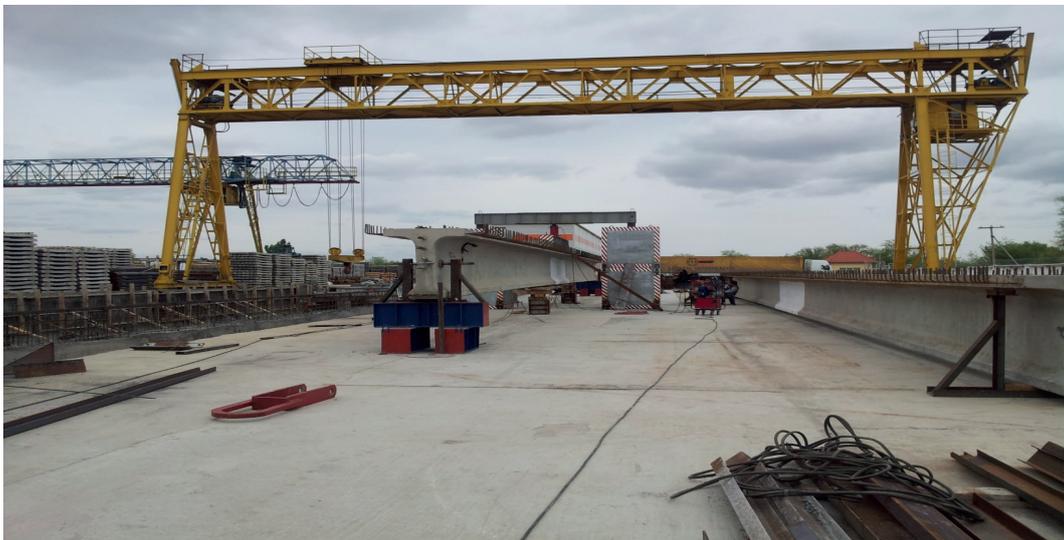
Figure 16 General view of the power stand and the VTK-33u tested beam

Figure 16 shows a general view of the beam being

tested and the certified power bench during the testing and Figure 17 shows the support area of the beam with dial gauges.

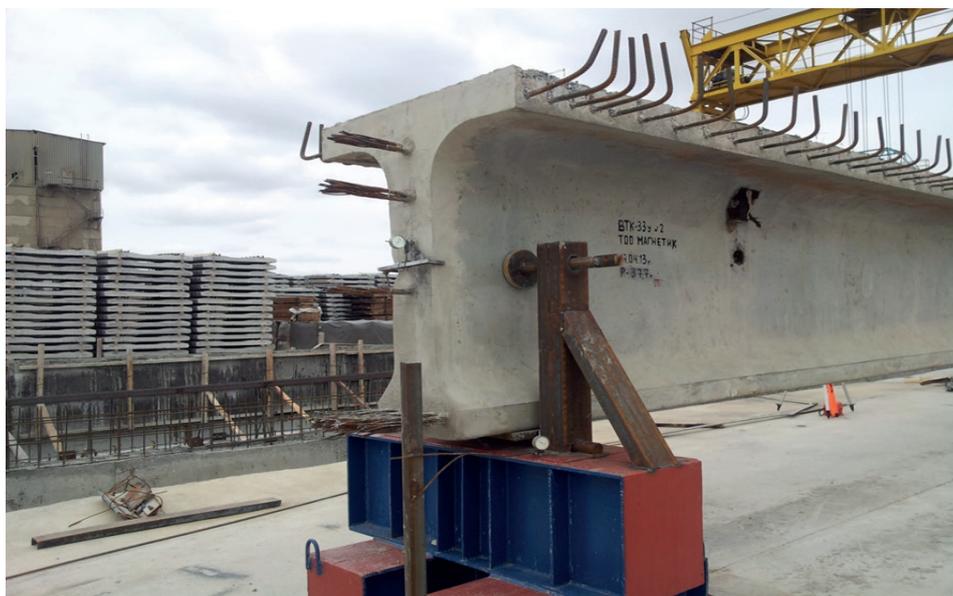
Figure 17 The support zone of the VTK-33u beam with dial indicators

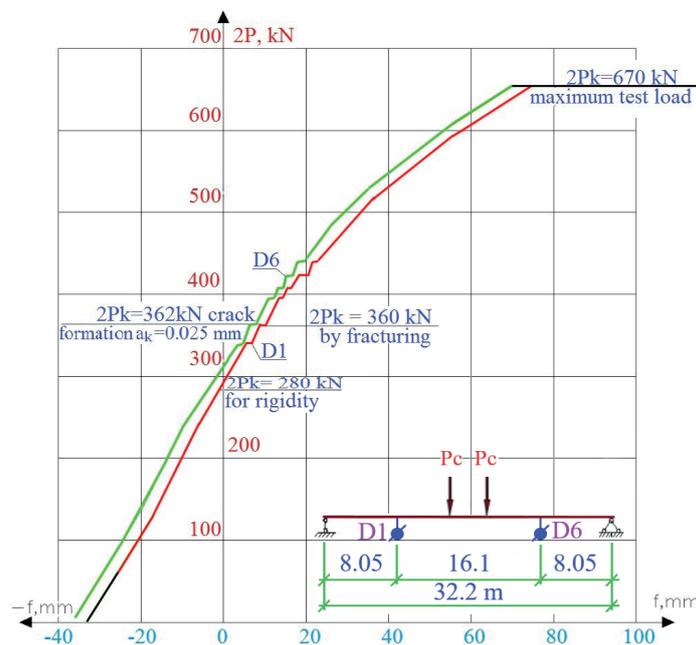
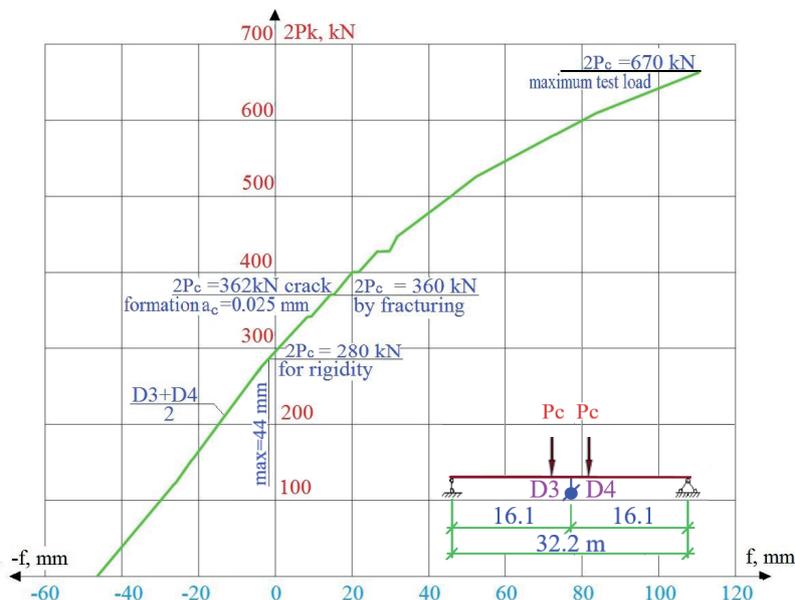
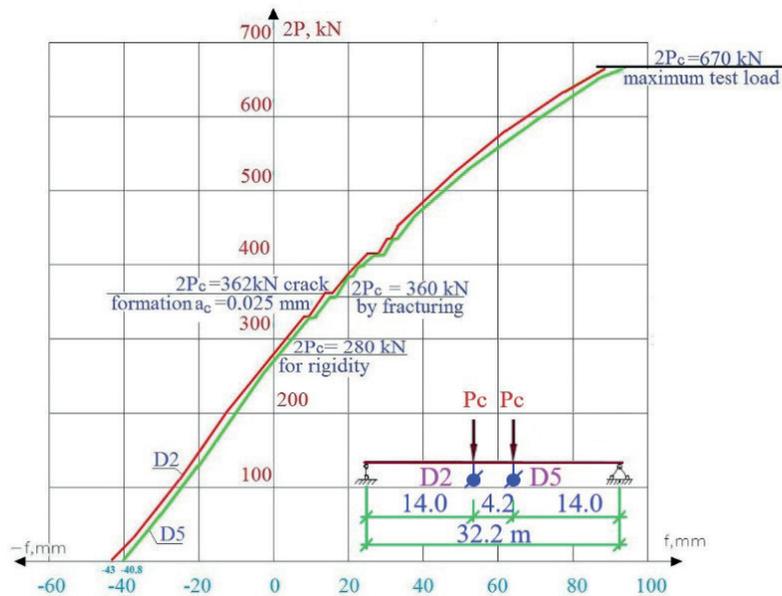
Figure 18 Deflection curves at a distance of 8.05 m from the middle of the span: D1 and D6 - deflectometers

Figure 19 Mid-Span Deflection Graphs: D3 and D4 - deflectometers

Figure 20 Deflection curves at a distance of 2.1 m from the middle of the span: D2 and D5 - deflectometers

Figures 18, 19 and 20 show graphs of deflections during testing of the VTK-33 bridge beam.

At the first stage of testing, the stiffness of the beam was evaluated. With a control load in terms of rigidity equal to $2P_c = 280$ kN, the control deflection of the beam should not exceed a value equal to $f_c = 59.2$ mm. Upon reaching this load, the experimental deflection in the middle of the span of the beam had a value equal to $f_{exp} = 44.0$ mm, which made 74.3% of the control deflection.

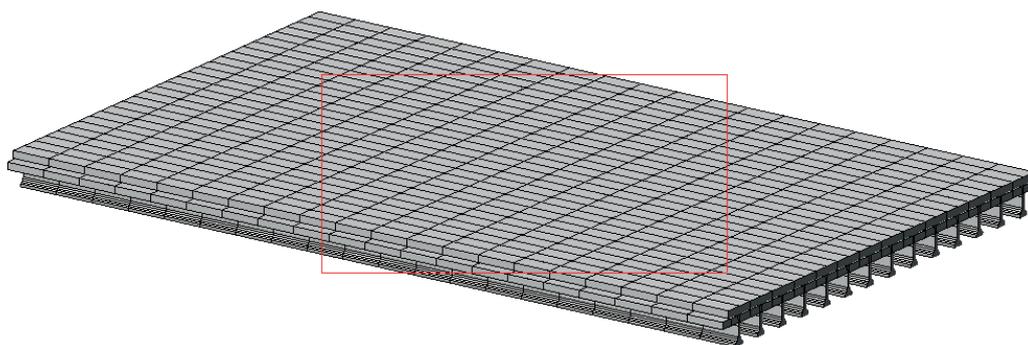
The slab does not go on top of the beams because in the calculation scheme, i.e. in the mathematical model in Lira, all the elements are combined by their centers of gravity (Figure 21). The flanges of the beams are not actually joined together in the computational scheme. This is a conditional simplification of the computational scheme - the joint work of the beams in the transverse direction is ensured by the plate passing through the centers of gravity of the beams. This will have absolutely no effect on the accuracy of the calculation (determination of forces in the beams). The span slab redistributes the load between the beams: it will be affected by the temporary load and the load from the bridge deck.

Figure 21 Spatial model of the bridge span

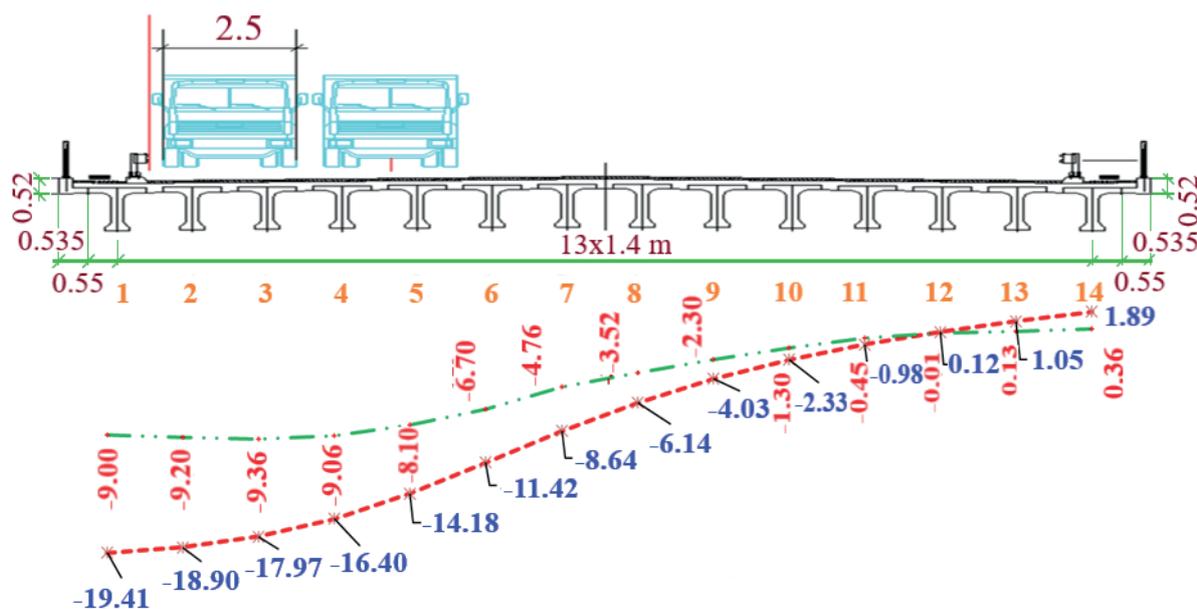
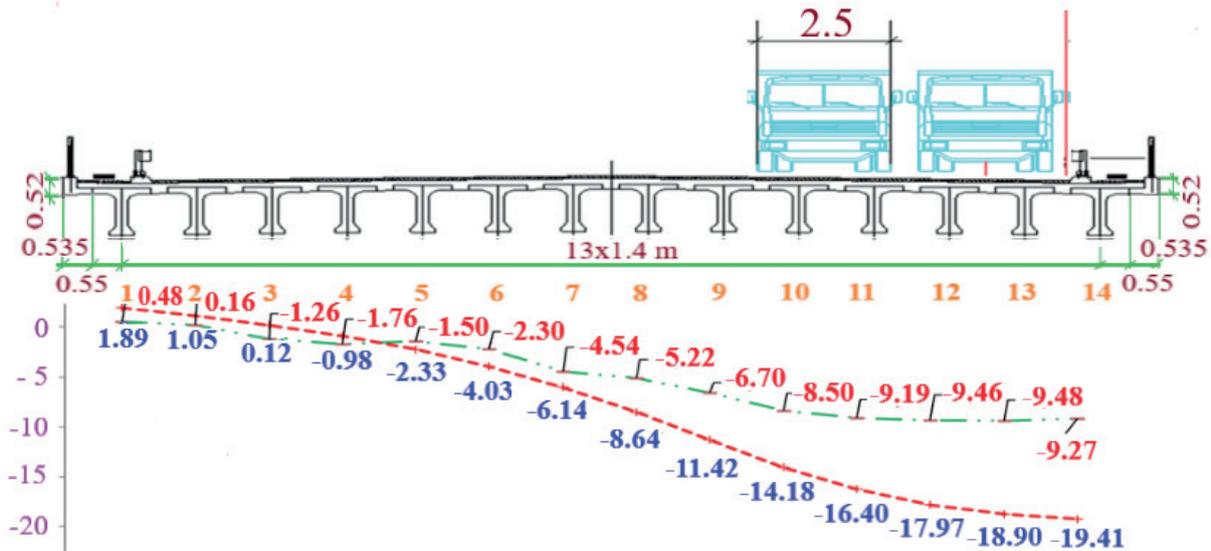
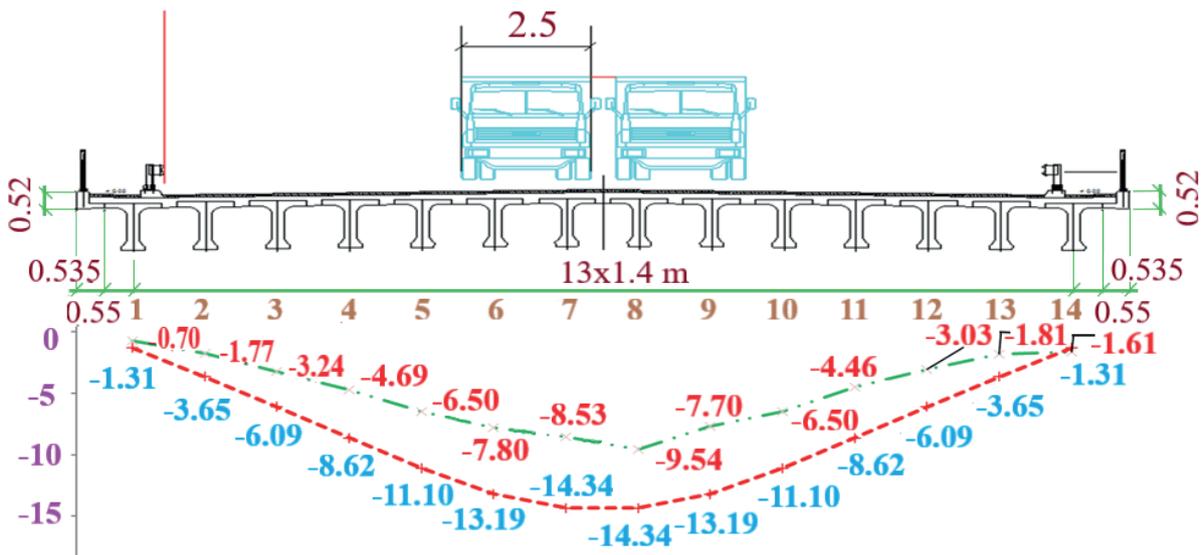
The results of the deflections calculation in the three stages of the span test are shown in Figures 22-24.

Figure 22 Deflections in the beams of the span in the first stage [1]:
 --- maximum deflection according to the test results, - - - design deflection

Figure 23 Deflections in the beams of the span in the second stage [1]:
 --- maximum deflection according to the test results, - - - design deflection

Figure 24 Deflections in the beams of the span in the third stage:
 --- maximum deflection according to the test results, - - - design deflection
