Appendix A

Agency Coordination

Re Early Coordination Review of Proposed Improvements Cherry Capitol
Airport, Traverse City, Michigan

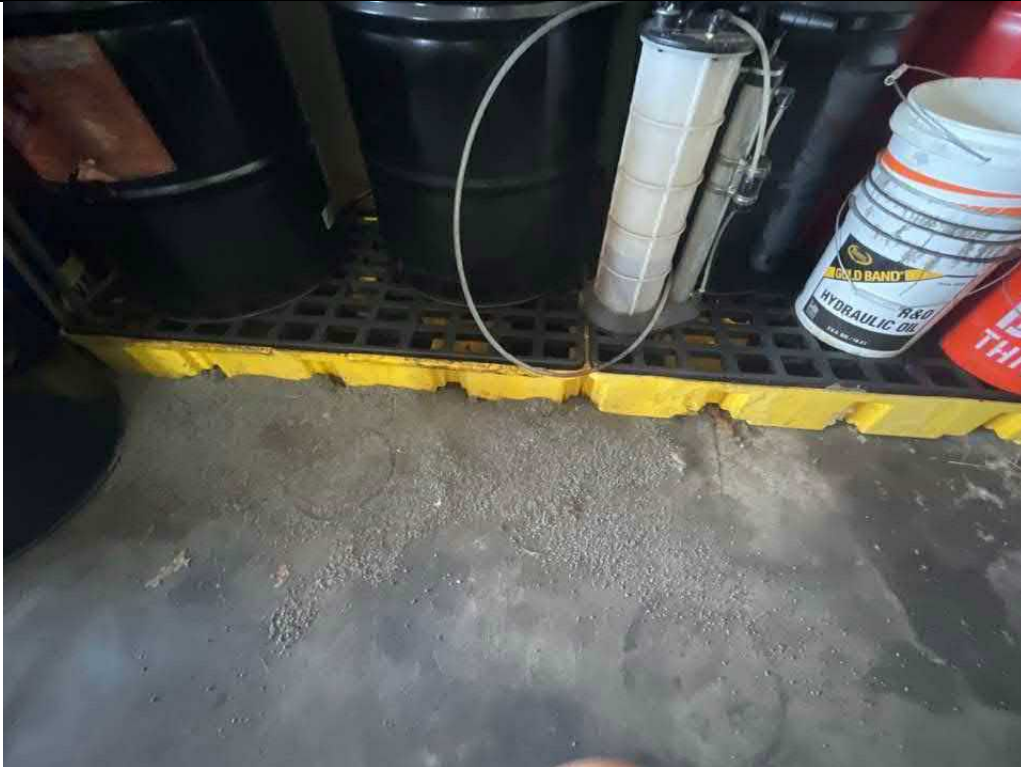
Description	<i>Used Oil containment with de minimus staining on concrete</i>
Viewing Location/Direction	<i>West wall</i>

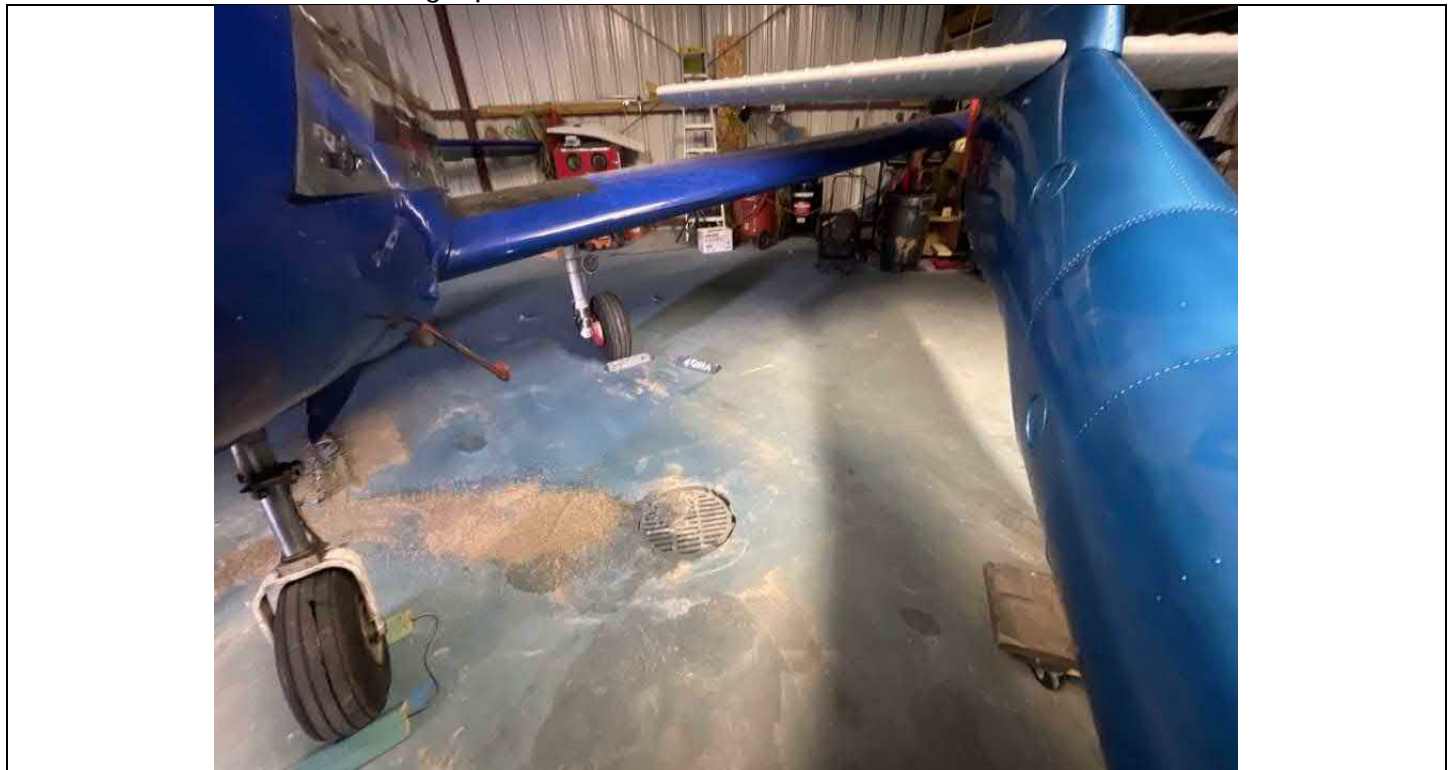
Description	<i>Central floor drain - dry well</i>
Viewing Location/Direction	<i>Facing east</i>

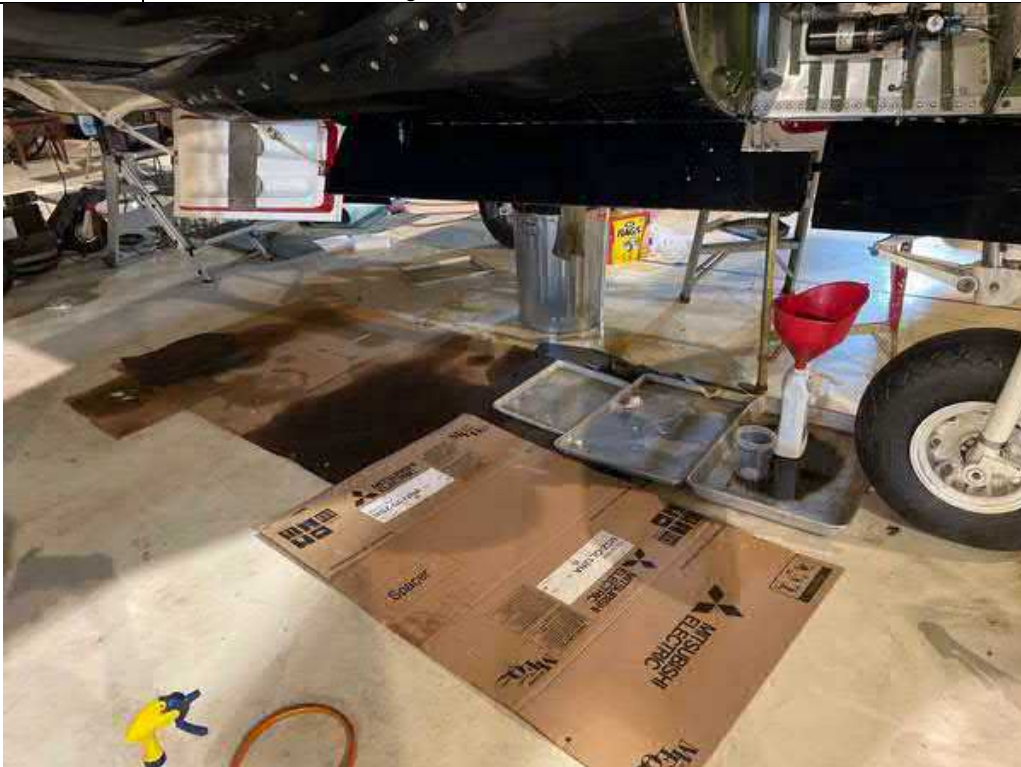
Description	<i>Oil leaking from large old plane in center</i>
Viewing Location/Direction	<i>Center of hangar facing east</i>

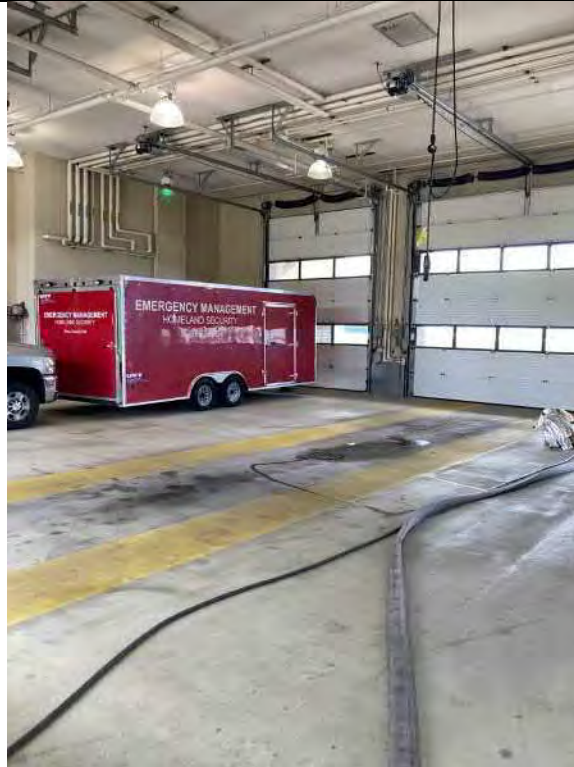
Description	<i>Typical view of garage bay, floor drain in center with staining</i>
Viewing Location/Direction	<i>Looking northwest</i>

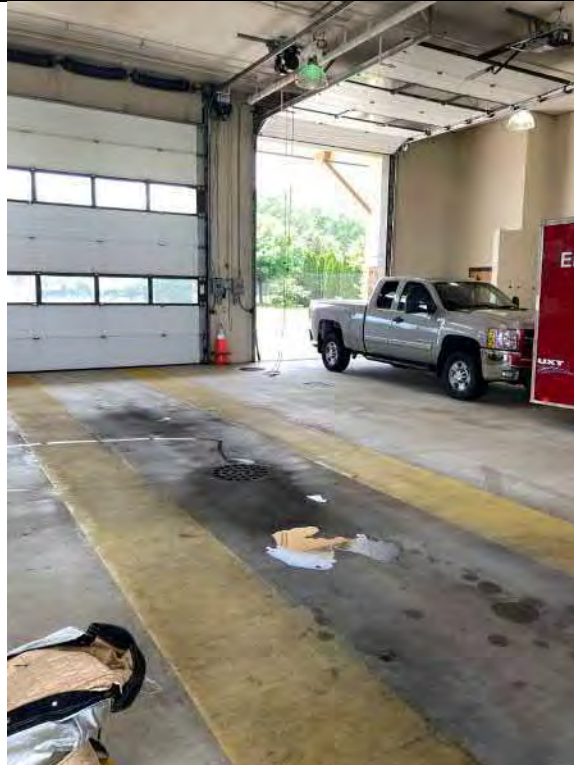
Description	<i>Floor drain with oil-water separator manhole on background</i>
Viewing Location/Direction	<i>Fire fighting building garage, looking southwest</i>

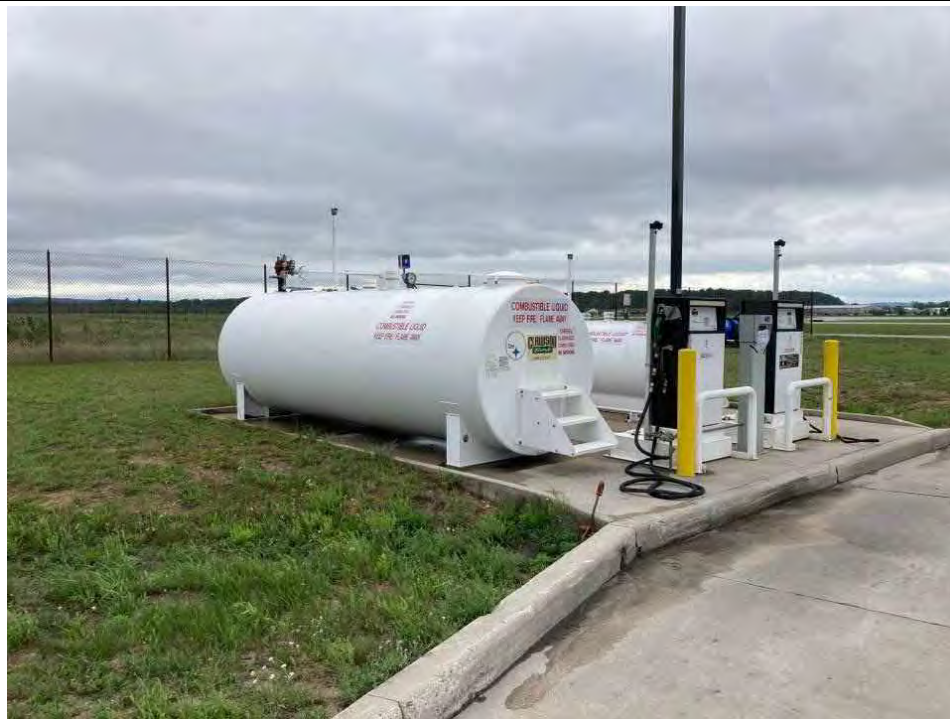
Description	<i>ASTs and drains</i>
Viewing Location/Direction	<i>Looking southwest</i>

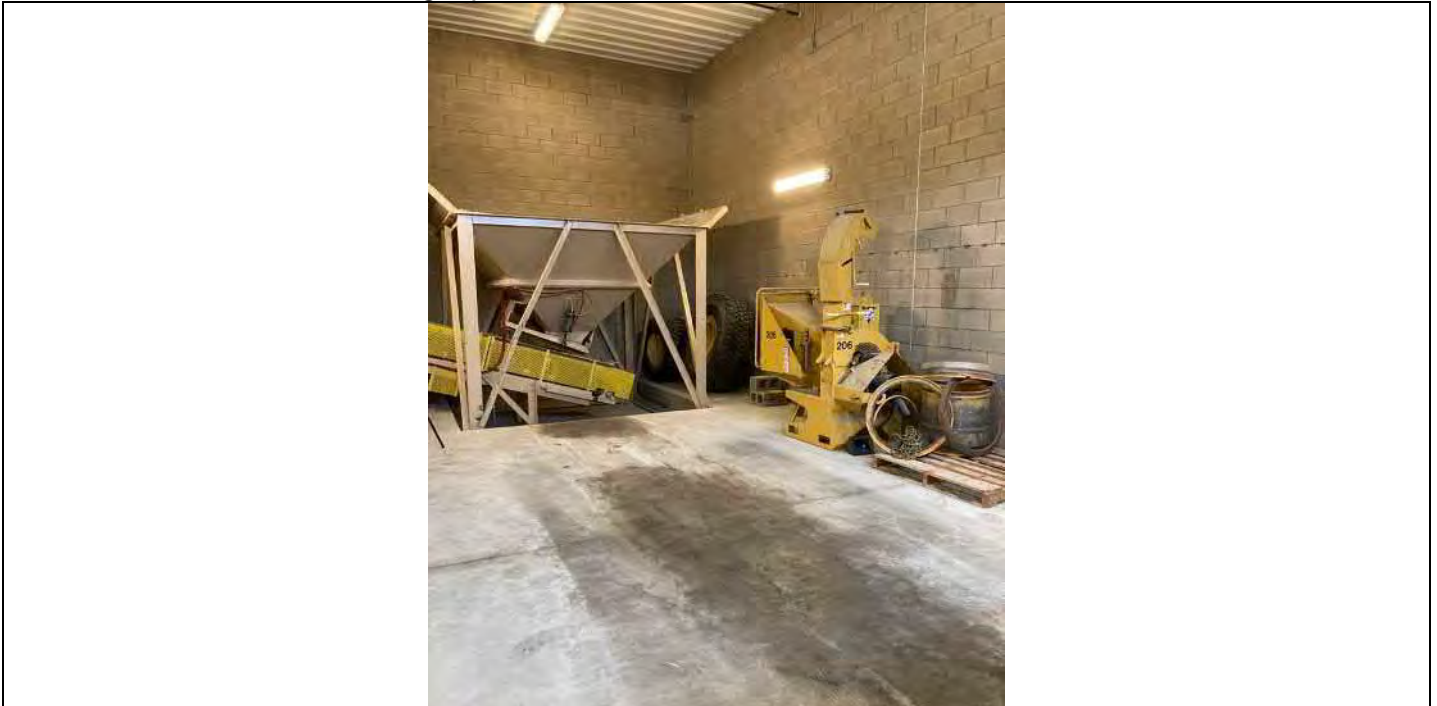
Description	<i>North bay with equipment and floor stain</i>
Viewing Location/Direction	<i>Looking west</i>

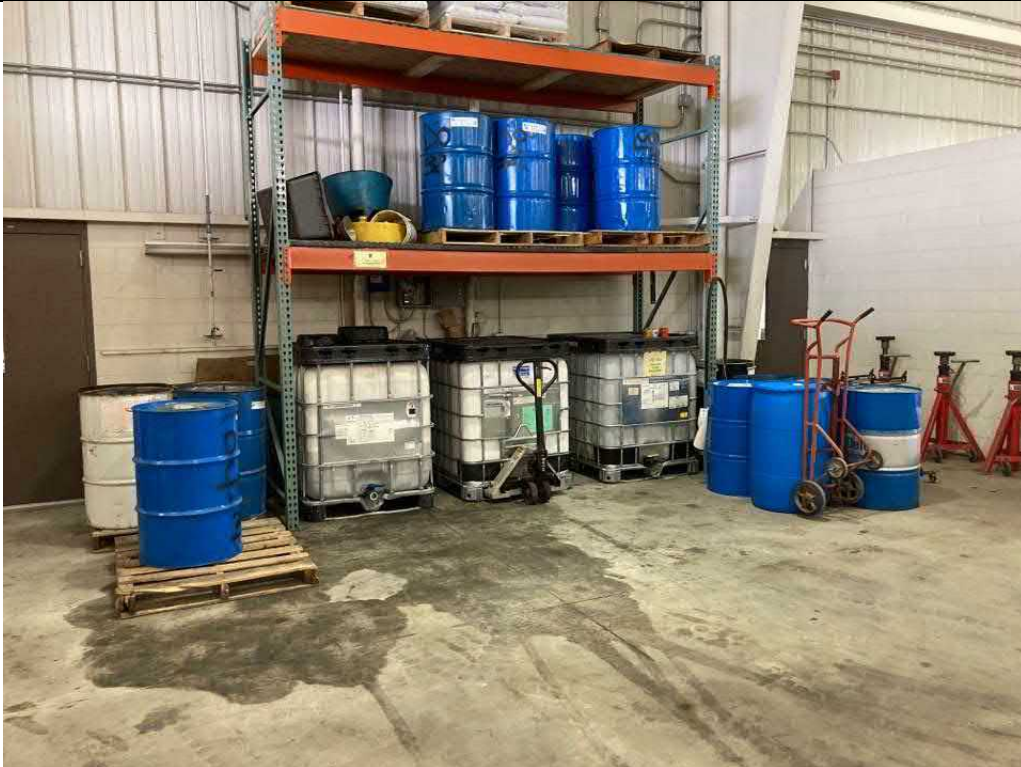
Description	<i>Oil drums, totes, empty drums on left, minor staining on floor</i>
Viewing Location/Direction	<i>Main maintenance area</i>

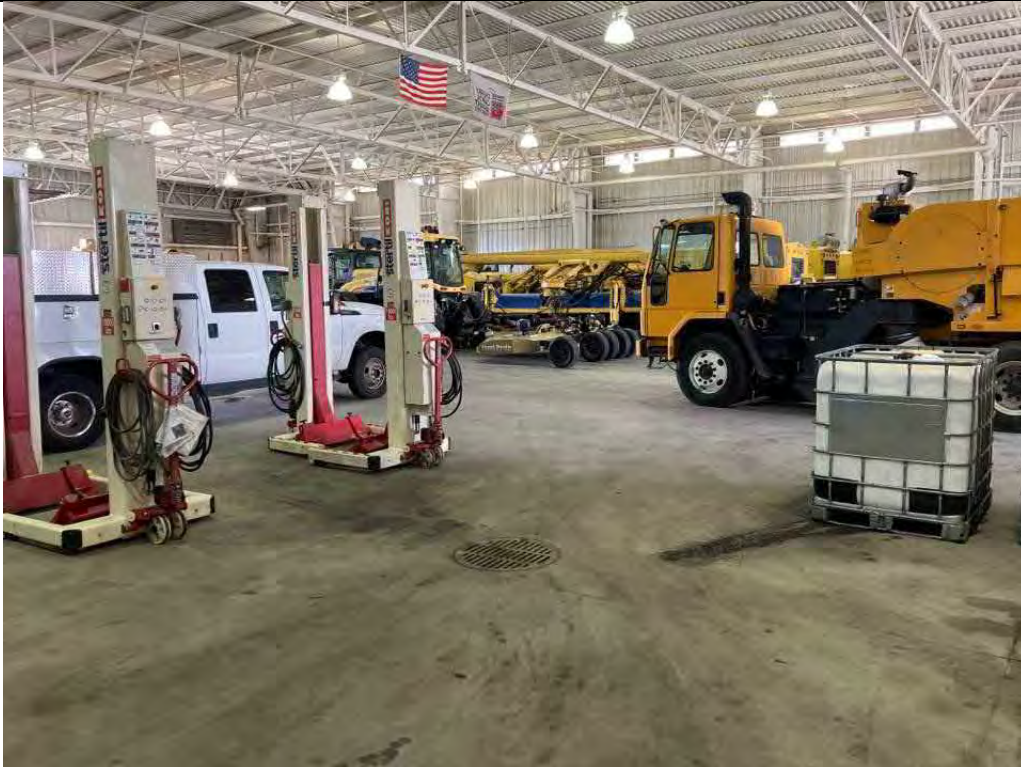
Description	<i>Floor stains in maintenance area near floor drain</i>
Viewing Location/Direction	<i>Main maintenance area in SRE building</i>
