STRUCTURAL STABILITY
RESEARCH COUNCIL

PROCEEDINGS

1995 Theme Conference

*STABILITY PROBLEMS
RELATED TO AGING,
DAMAGED, &
DETERIORATED
STRUCTURES*

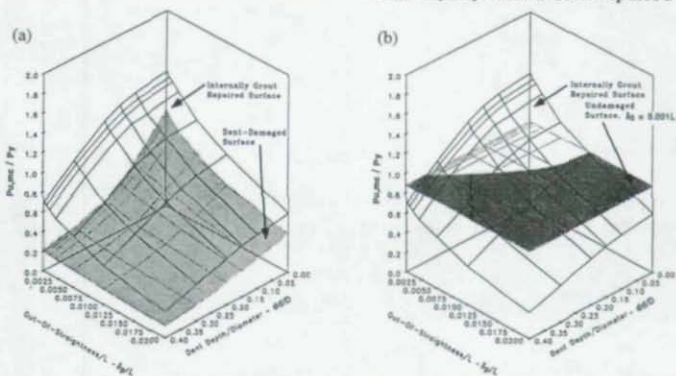
Fig. 13 Comparison of Residual Strength with (a) Repaired, and (b) Non-damaged Strength, $D/t=34.5$

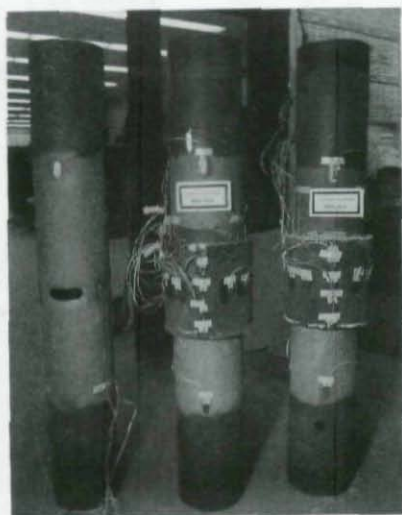
Fig. 20 Corrosion-Damaged Specimen 46-00-95, and Repaired Specimens 46-00-95-C and 46-00-95-E

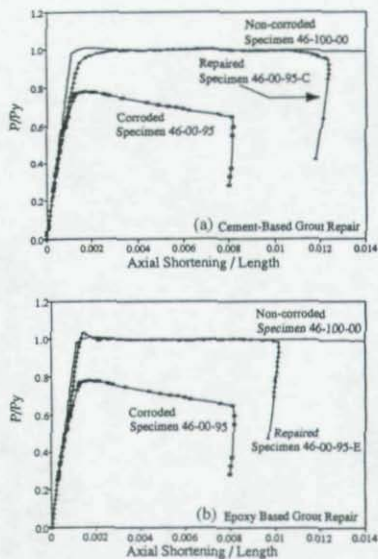
Fig. 21 Axial Load-Shortening Response for (a) Repaired Specimen 46-00-95-C, and (b) Specimen 46-00-95-E

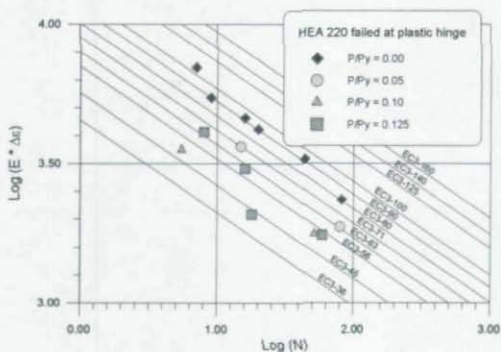
Fig. 3 Effect of axial load on HE220A specimens

Fig. 3 shows the effect of an axial load applied on top of HE220A specimens. Increasing the applied axial load results in a reduction of the fatigue strength of the member, but also in a scattering of the results, although the average slope of the fitting line remains nearly -3.

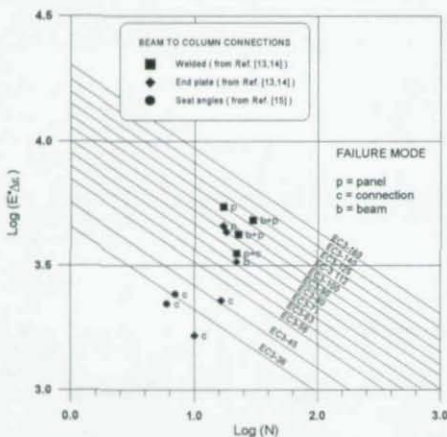
Fig. 7 Fatigue strength of beam to column connections

that the design of connections is critical for a good performance of structures under low cycle fatigue and that, in order to avoid brittle fracture, it should be tried to induce the formation of a plastic hinge in the members, away from the connections. This is of course in good agreement with other results presented in the literature (e.g. [18]).

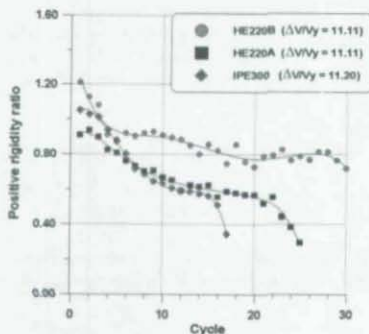
fig. 3 Comparison of typical trends of rigidity ratio for HE220A, HE220B and IPE300 shapes

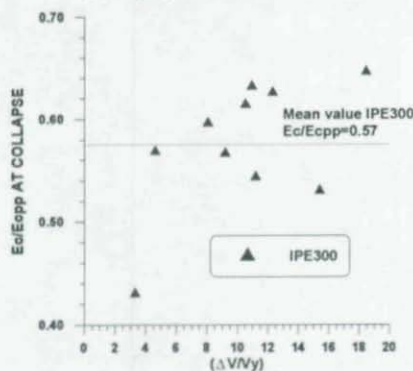
Fig. 13 Values of energy dissipated at last cycle before failure for IPE300 specimens

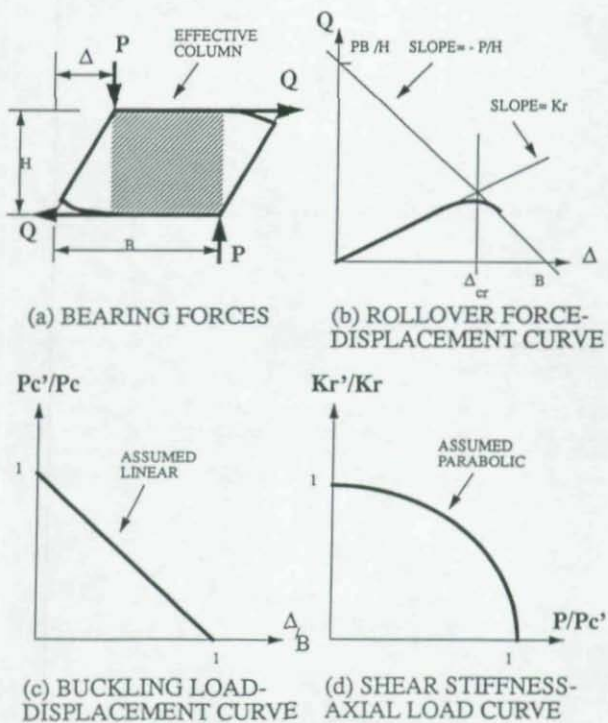
Figure 2 Rollover and buckling limit states for an elastomeric bearing

P_b	=	$\pi^2 T/H^2$
T	=	tilting (bending) stiffness for bearing of unit total height ($E_b I$) (H/T_r)
R	=	shear stiffness for bearing of unit total height $K_r H$
K_r	=	shear stiffness ignoring axial load effects GA/T_r
G	=	shear modulus of rubber
A	=	bonded area of rubber
T_r	=	total thickness of rubber (excludes shims)
H	=	effective height of bearing (includes shims)
E_b	=	bending modulus $E_r (1 + f_b S^2)$
E_r	=	elastic modulus of rubber
f_b	=	bending constant

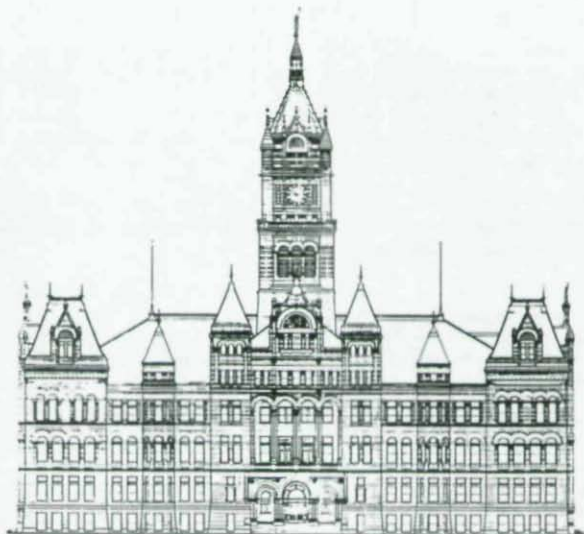
Figure 3 Elevation of City and County Building, Salt Lake City
(from Reference 8)

The seismic vulnerability of the structure, due to its lack of reinforcement, is aggravated by the closeness of the site to the nearby active Wasatch Fault Zone. The building has a record of damage from various earthquakes, the largest occurring in 1934 with a Richter magnitude of about 6.2. Seismic damage to the building includes cracks in the bearing walls and losses of sculptures, roof stones and mechanical equipment from the clock tower.
