49
üçüncü
uluslararası
kerpiç
koruma
sempozyumu

third
international
symposium
on
mudbrick (adobe)
preservation

III. Uluslararası Kerpiç Koruma Sempozyumu
Third International Symposium on Mud Brick (Adobe) Preservation

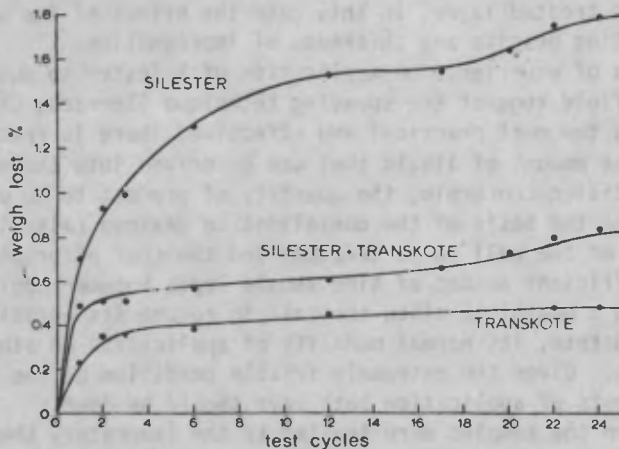
FIGURE 2. Cumulative percent weight loss of treated samples as a function of the number of ageing cycles. (The untreated samples would get out of scale at the second cycle, and are not reported).

The losses of weight as a function of the number of cycles observed in the treated samples are reported in Figure 2. The maximum loss of weight is less than 2 % after 26 cycles for all treated samples. Therefore the protective effectiveness of all the treatments is considerable. However, Transkote appears to limit the destructive effects of water even more than Silester.

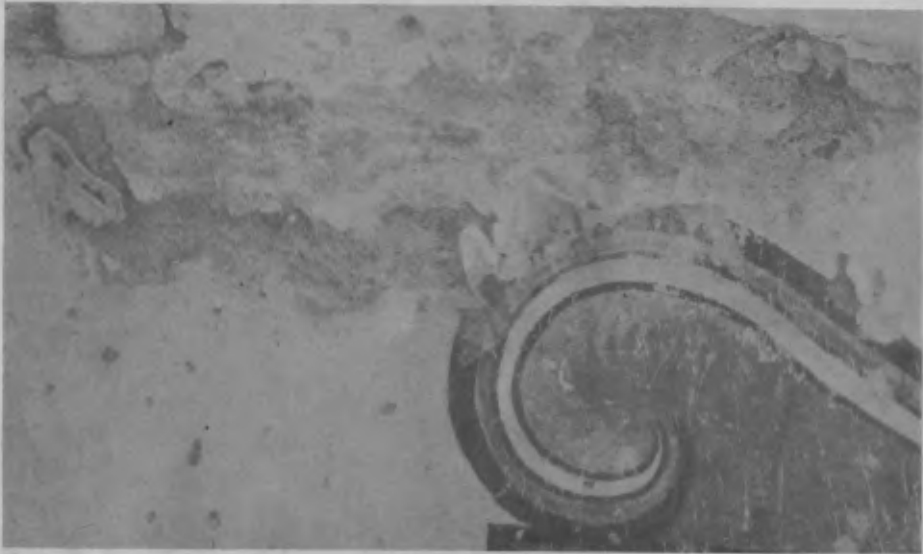
Figure 4: Painted plaster in Sanctuary. Note the paper along the top edge of the painted volute that was used in an attempt to temporarily reattach the paint film to the plaster ground. NPS photograph, 1976.

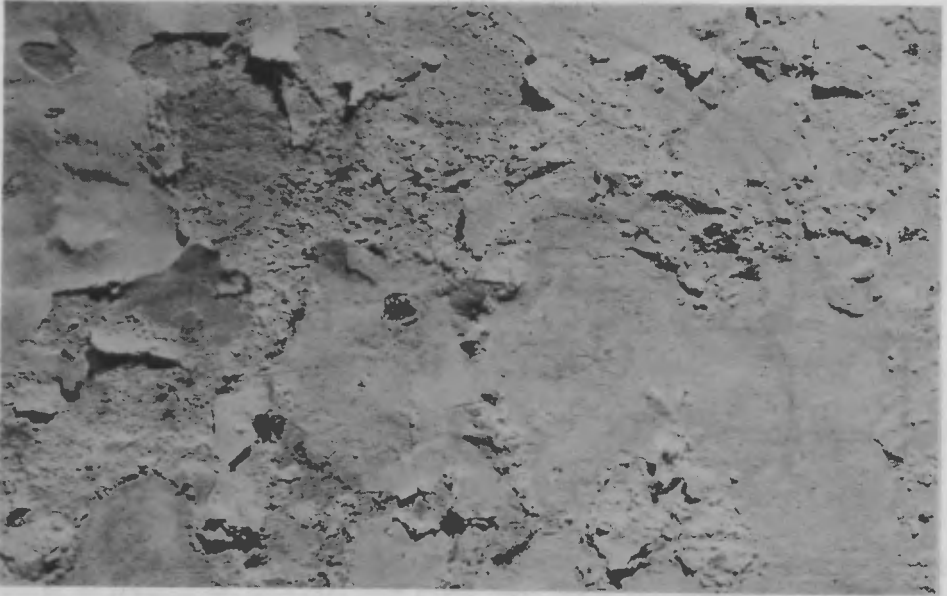
Figure 5: Plaster surface with extensive deterioration by efflorescence forming on the surface and immediately beneath the paint film. NPS photograph, 1979.

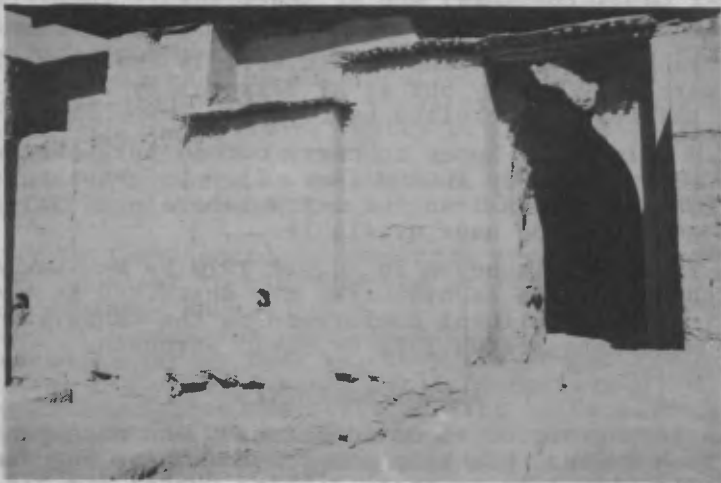
Damage caused by animal scavengers in lower parts of walls
Conservation efforts:

- Note a) replacement of brickwork where original appearance certain
b) protective coating of mudplaster (kaghel)
c) protective roofing using reed and kaghel, extended beyond the limits of the walls by wooden slats.

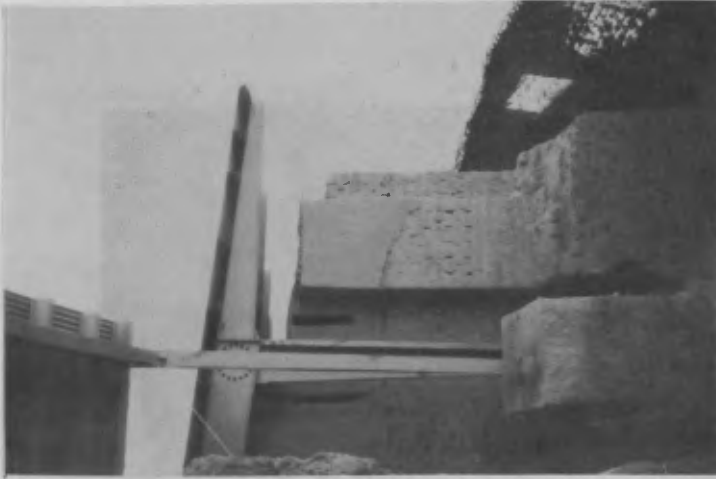
Illustrating a) steel roofs

- b) replacements of brickwork
- c) protective coating of kaghel

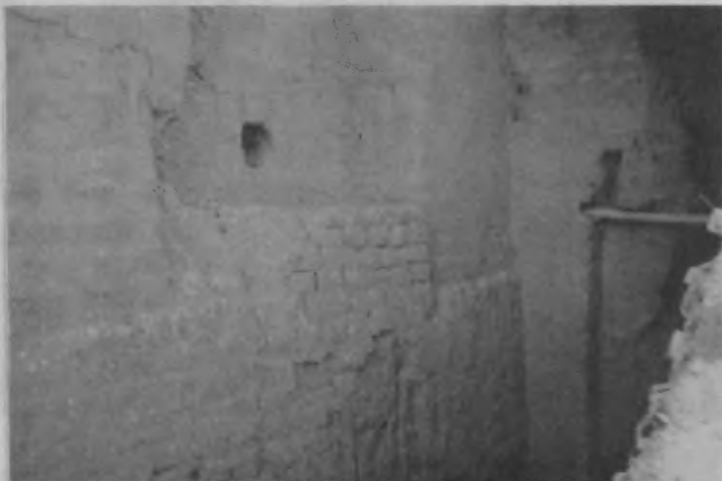
Illustrating problems of decay
Surface spalling on an interior wall.

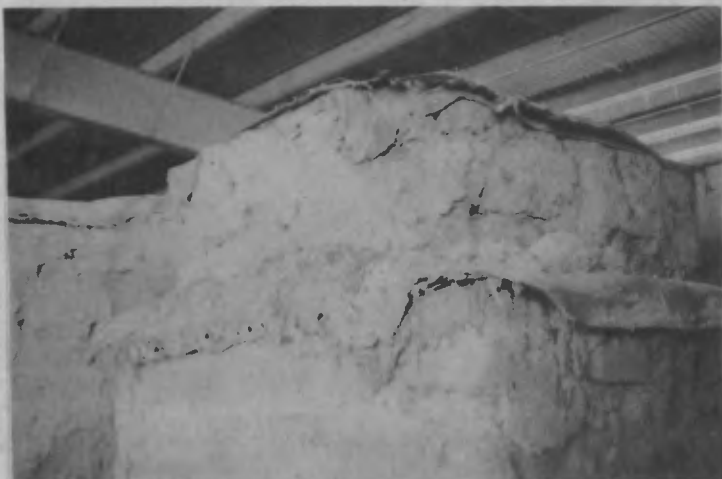
Capping using reed mats and kaghel with a layer of guni between.

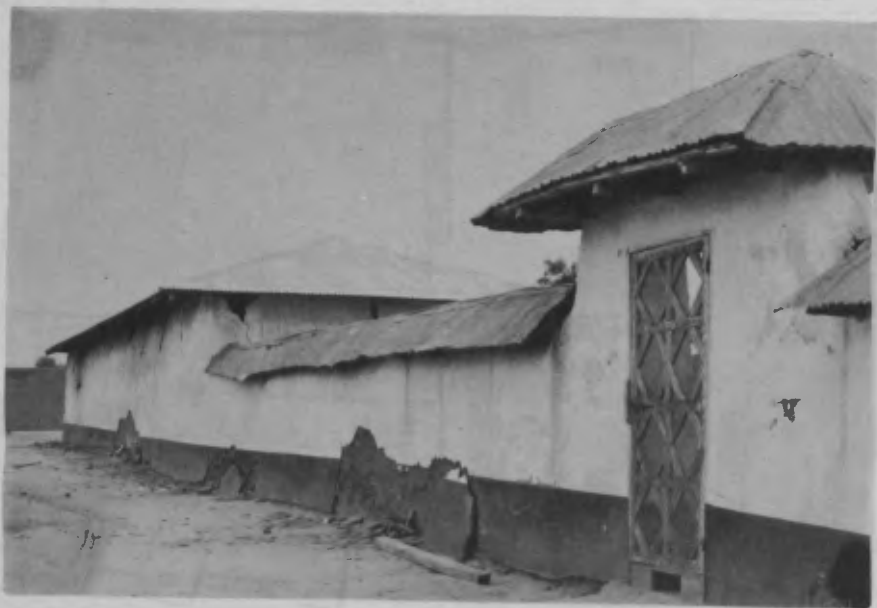
Maison des étrangers. Détachement de l'enduit à la base des murs. Perte du niveau original du sol de la cour.

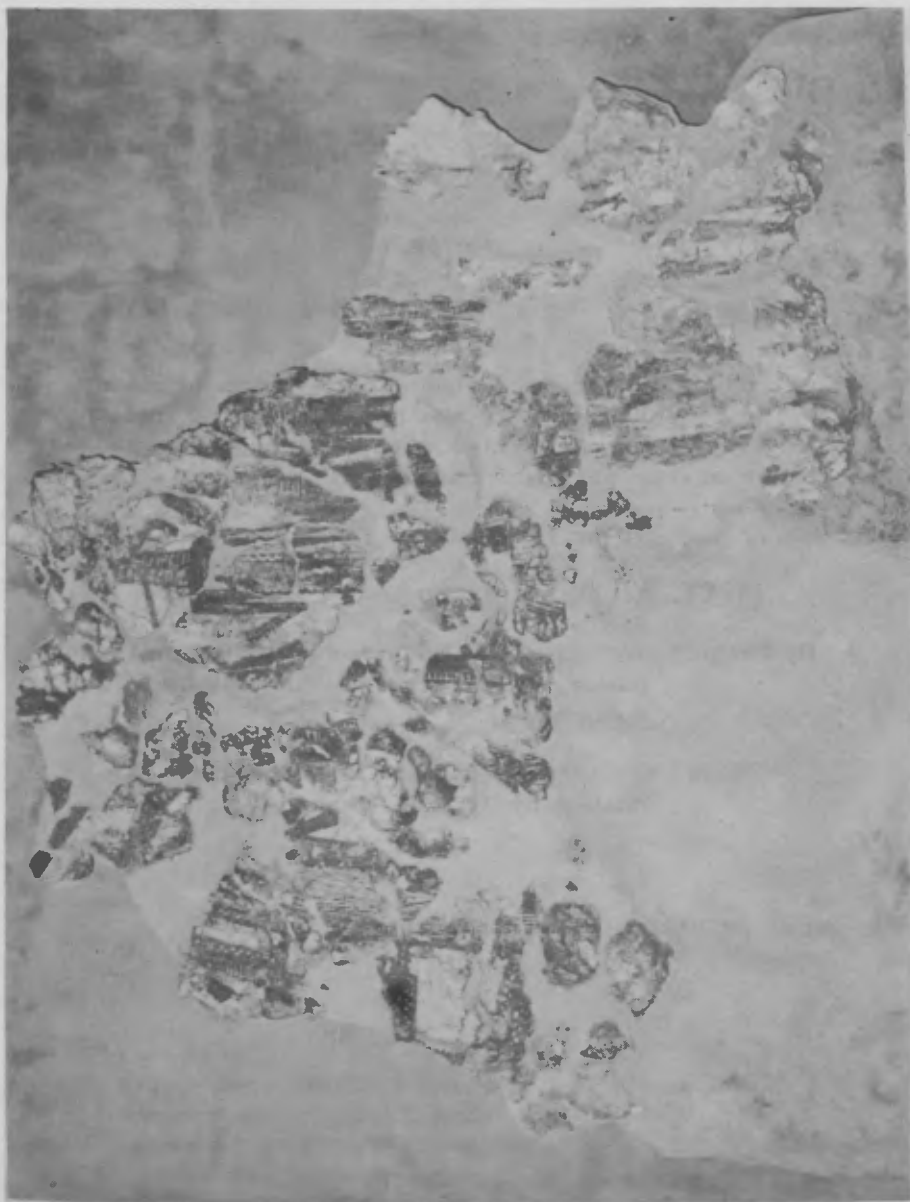
7. The mural painting after treatment. The joins between the five component blocks of the mural painting and the large lacunae have been filled with a stucco composed of a powder of the original mud brick.

Note: joins between the five component blocks

surface of the original mud brick mortar by applying a stucco composed of a 10 percent solution of polyvinyl acetate emulsion and a powder of the original mud brick, retained during the reduction of the pieces. No re-touching was carried out (Photographs 7 and 8).
