PREVENTIVE MEASURES DURING EXCAVATION AND SITE PROTECTION

**PREVENTIVE MEASURES DURING EXCAVATION
AND SITE PROTECTION**

Conference

Ghent, 6 - 8 November 1985

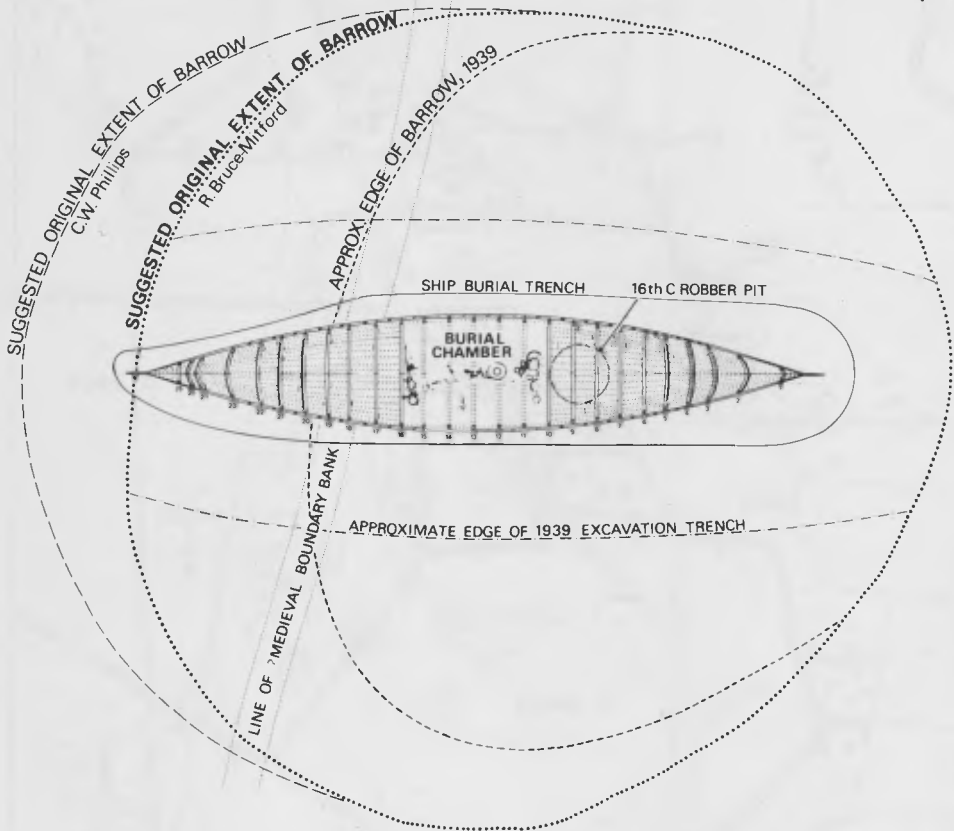
Figure 6. The ship burial in mound 1 (Hooper, after Bruce-Mitford).

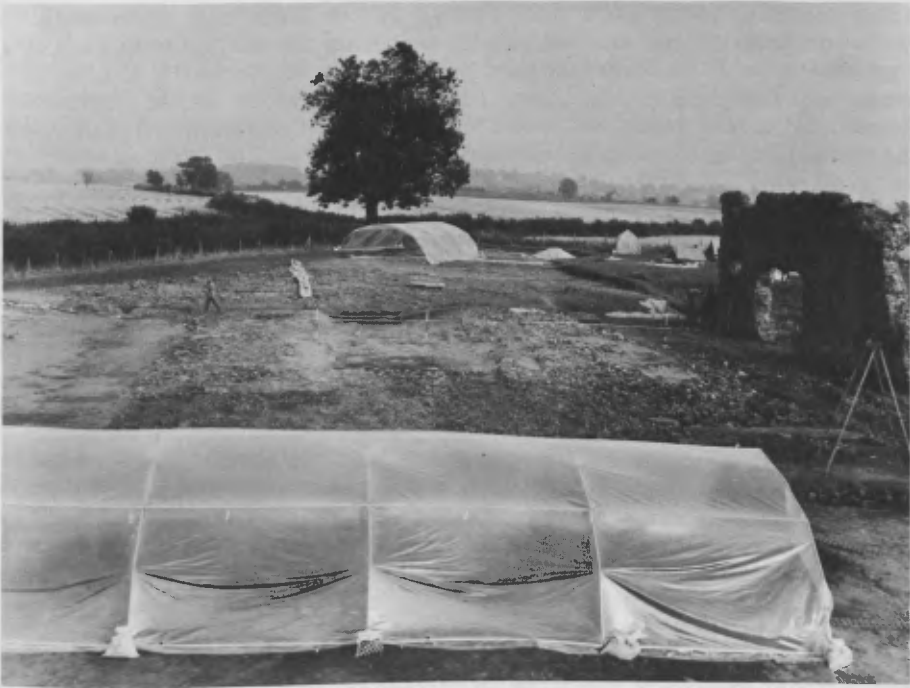
Figure 1. Simple shelter in use at excavation of Baths Basilica, Wroxeter, England. Length of shelter can be extended as required by adding bays.

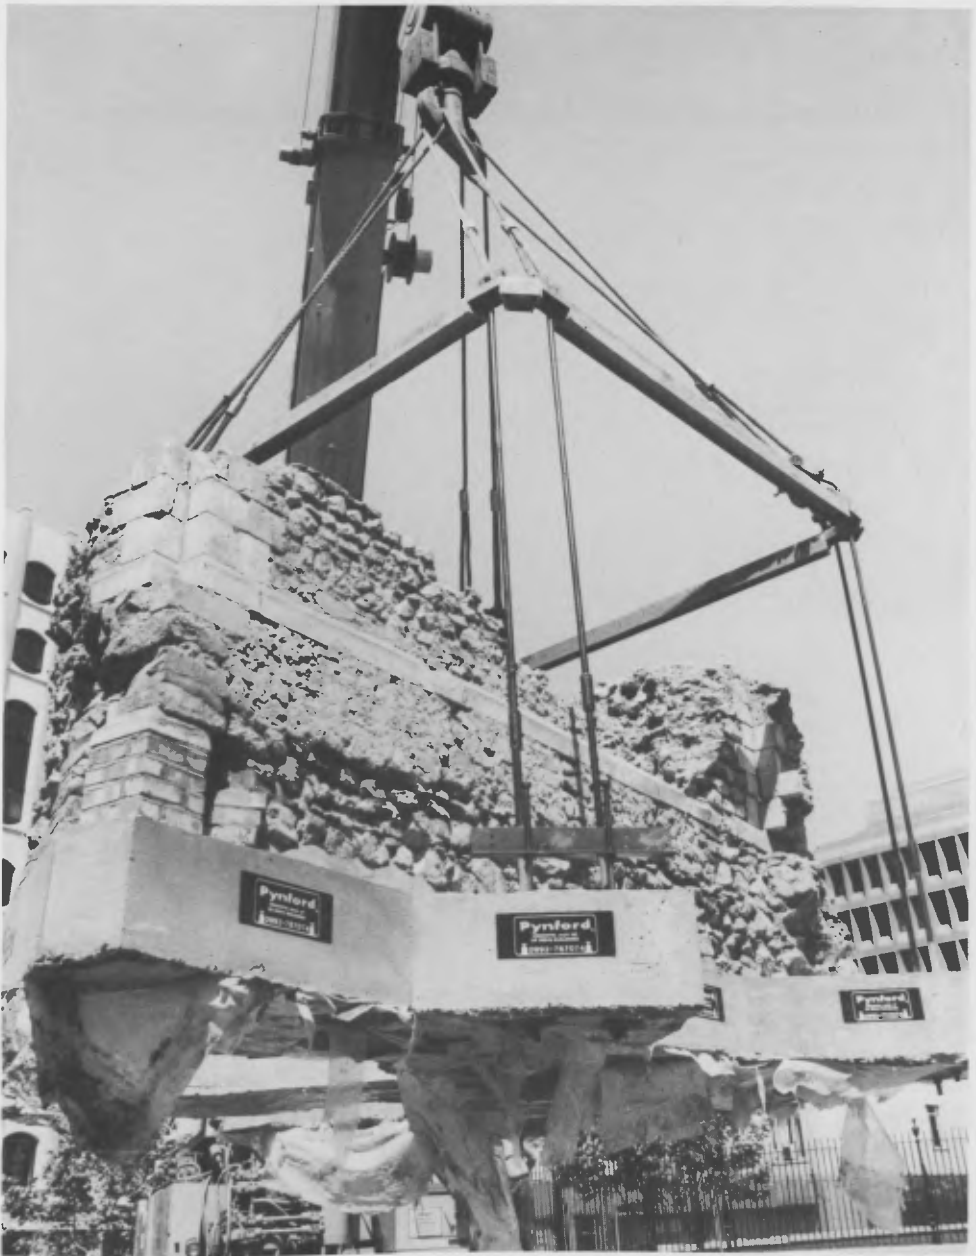
Figure 4. Mitre Street, City of London, 1984: a chapel from the church of Holy Trinity Priory, Aldgate, is lifted by special crane so that building works can commence on site; it was later lifted back into the same position, but slightly lower down. The chapel was underpinned with concrete and lifted in one piece (Museum of London).

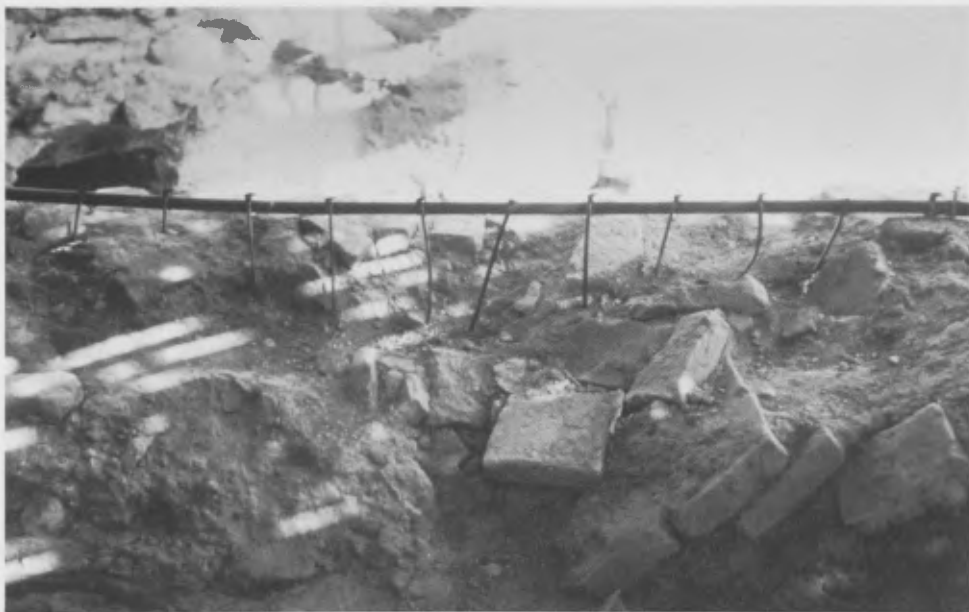
Figure 5. The "drop-by-drop" wetting system enabled the archaeologists to deepen the trench prior to a consolidation intervention, and kept the wall from drying out and running the risk of contraction, crack formation or total collapse. Photo: author.

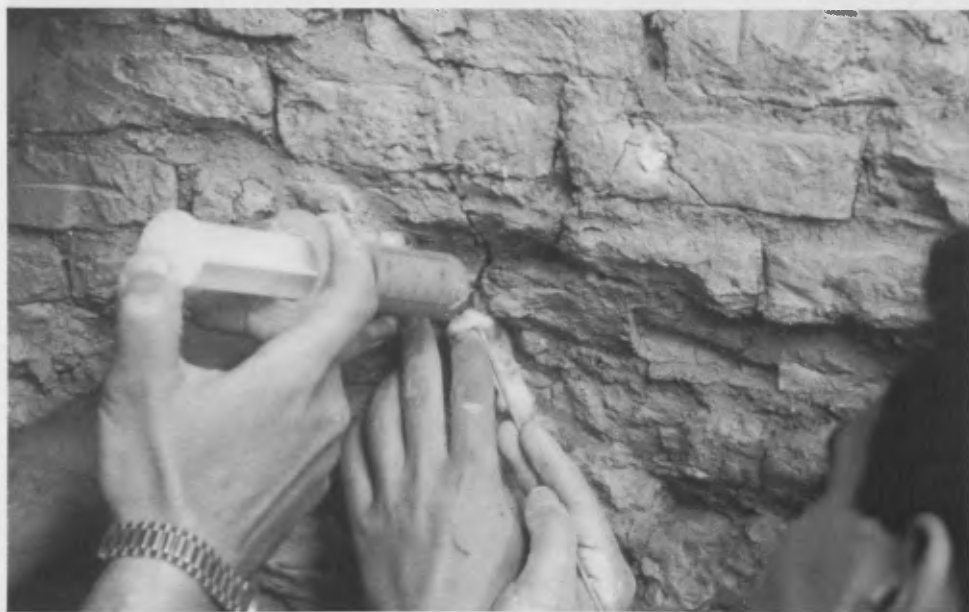
Figure 6. Consolidation with infiltrations of a clay solution combined with 10% hydraulic lime. Photo: author.

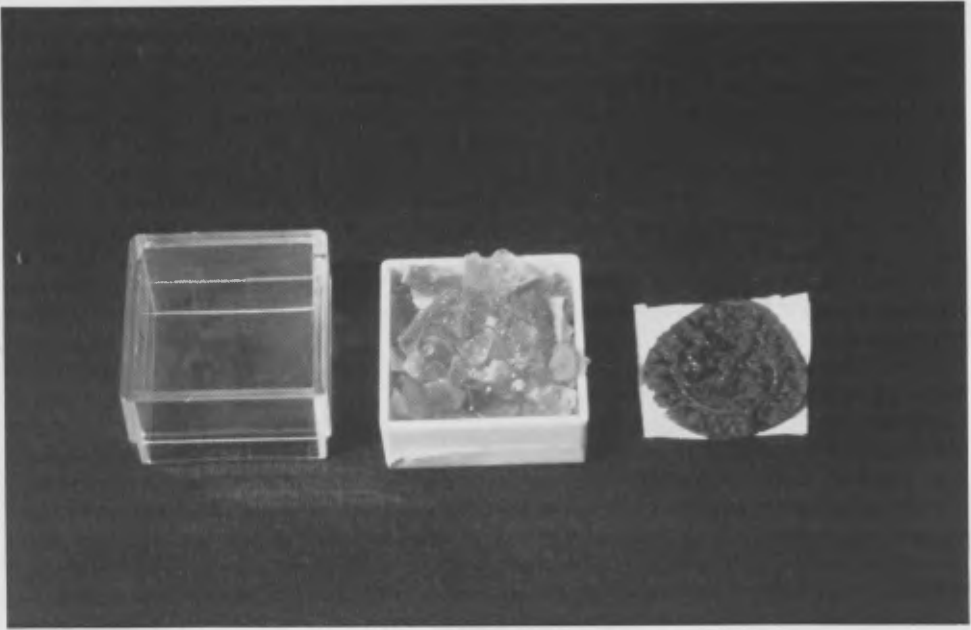
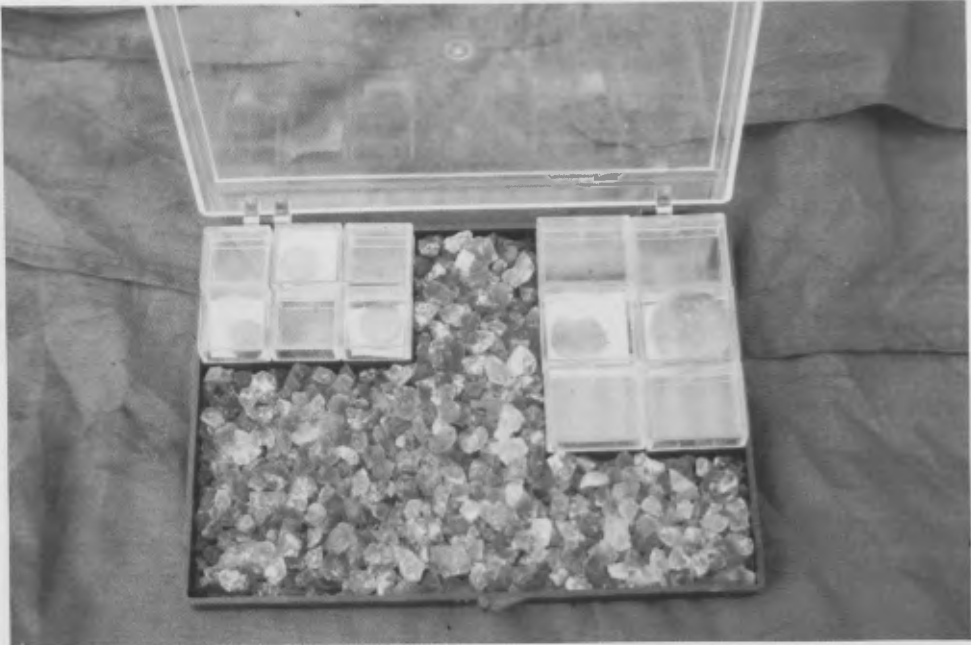
Figures 7-8. Coins were enclosed singly with silica gel inside small containers with transparent closures and glued shut; the small boxes were then placed in similar, but larger, containers, with silica gel and an air-tight seal. Photo: author.

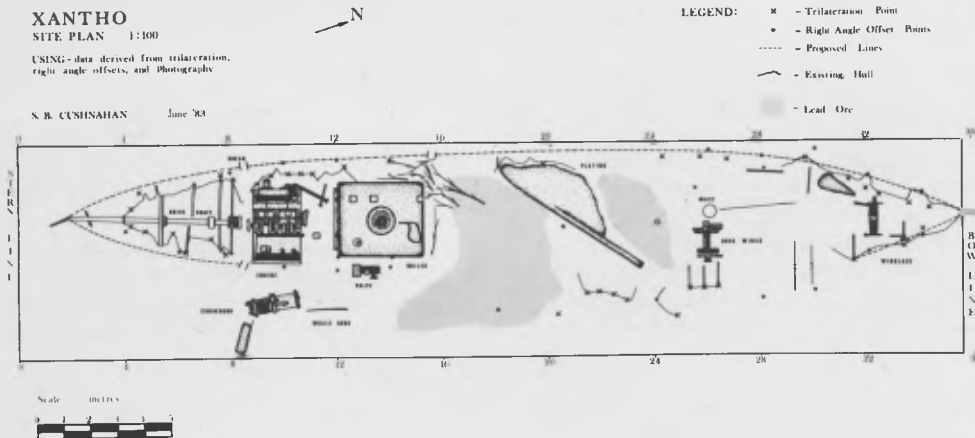
Fig. 2. Plan of the wreck site as examined during the predisturbance survey. The item noted as a condensor was later identified as a steam water heater.

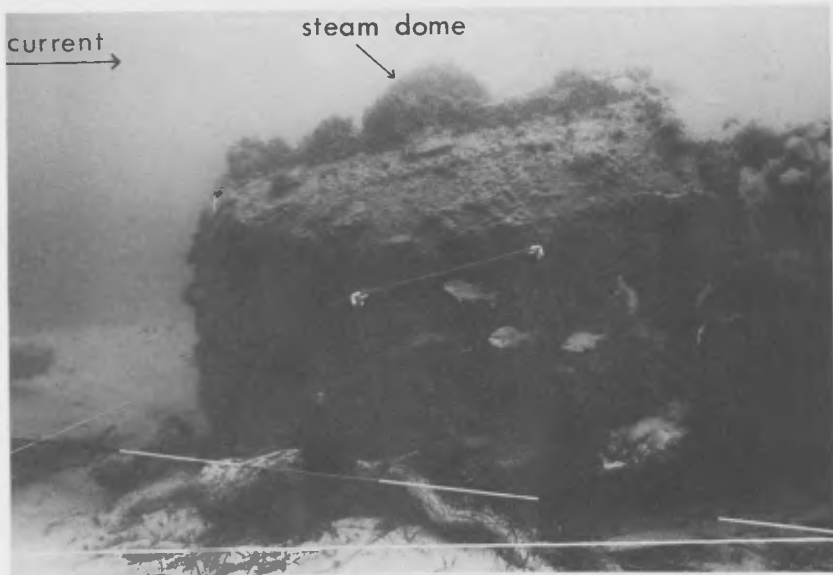
Fig. 3. The *Xantho* boiler as viewed from the port side during the predisturbance survey. The inside measurement of the square grid scale against the boiler is 1.0 metres. Photo: Pat Baker.

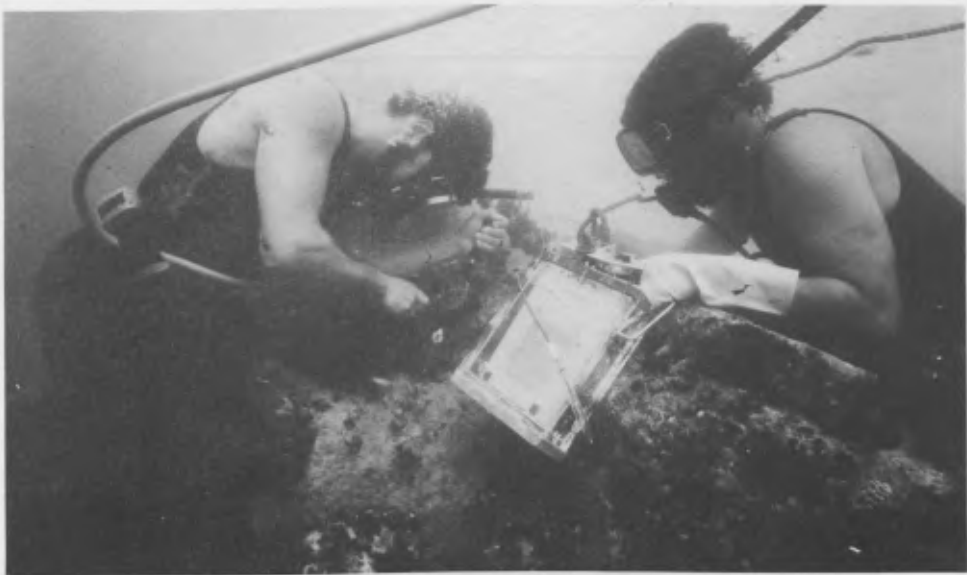
Fig. 4. Drs. MacLeod and North measuring corrosion potentials on the *Xantho* site during the predisturbance survey. The concretion on a piston is being drilled so that the potential measurement on the underlying material can be made. Photo: Mike McCarthy.

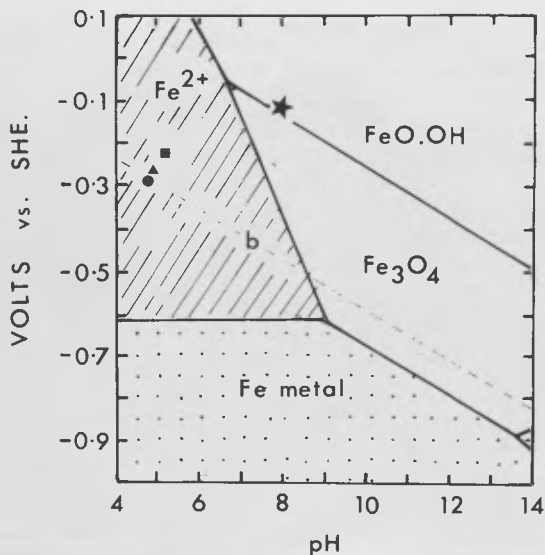
Fig. 5. Pourbaix diagram for iron in equilibrium with a 10^{-6}M Fe^{2+} solution showing on-site corrosion potentials for various parts of the engine. ★Windlass, ■deck winch, ▲mean potential of sixteen objects, ●frame plates, b represents the equilibrium line for water and one atmosphere of hydrogen gas.

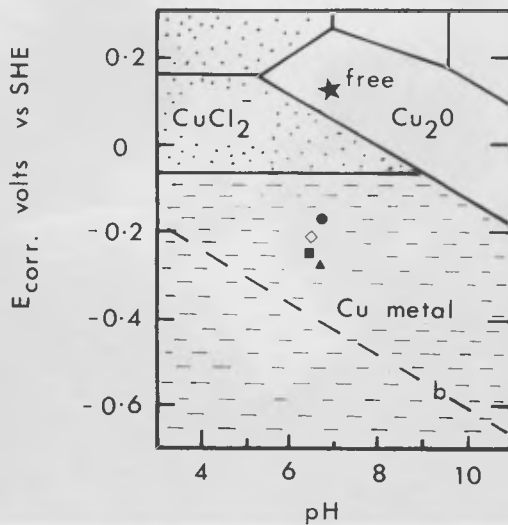
Fig. 6. Pourbaix diagram for copper in sea water in equilibrium with a 10^{-6}M copper solution. The on-site corrosion potentials illustrated are for ★free copper pipe between the boiler and the engine, ●unidentified copper fitting on engine, ◊steam pipe on water heater, ■small copper pipe on engine and ▲for brass steam cocks attached to the engine.

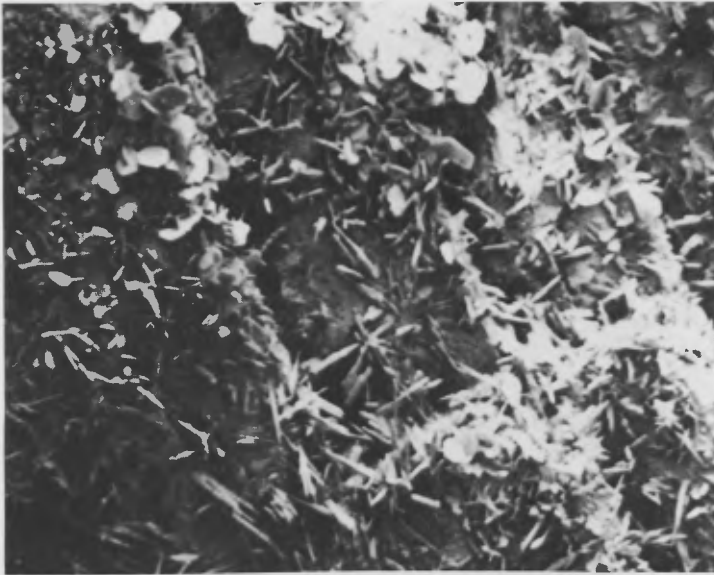
Fig. 7. Scanning electron micrograph of the oxidized galena ore. The spikey crystals are phosgenite ($\text{PbCl}(\text{CO}_3)_{0.5}$) and the plate-like crystals are hydrocerussite, $\text{Pb}_3(\text{OH})_2(\text{CO}_3)_2$ which overly the present galena crystals. Full width of the photograph is $750\mu\text{m}$.

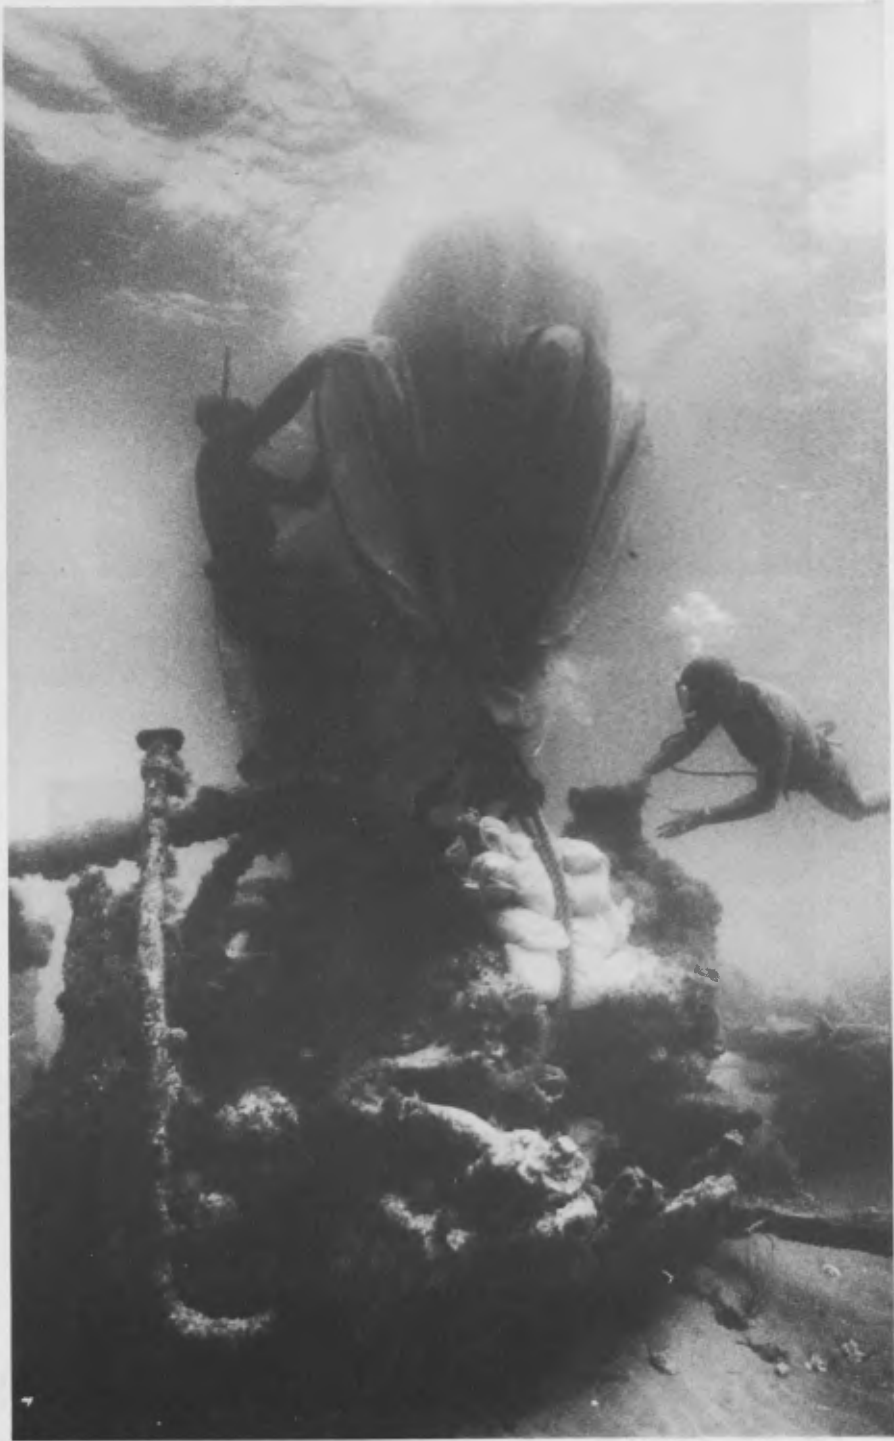
Fig. 9. Raising the *Xantho* engine. Photo: Pat Baker.

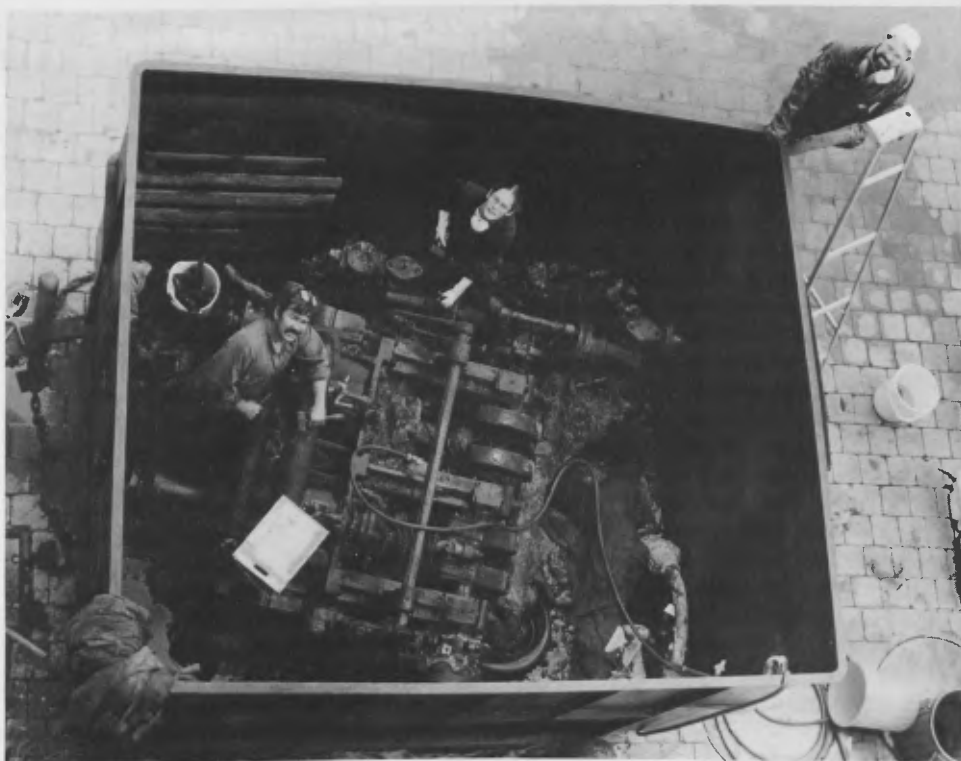
Figure 4. The engine in the process of deconcretion. Photo: Western Mail.

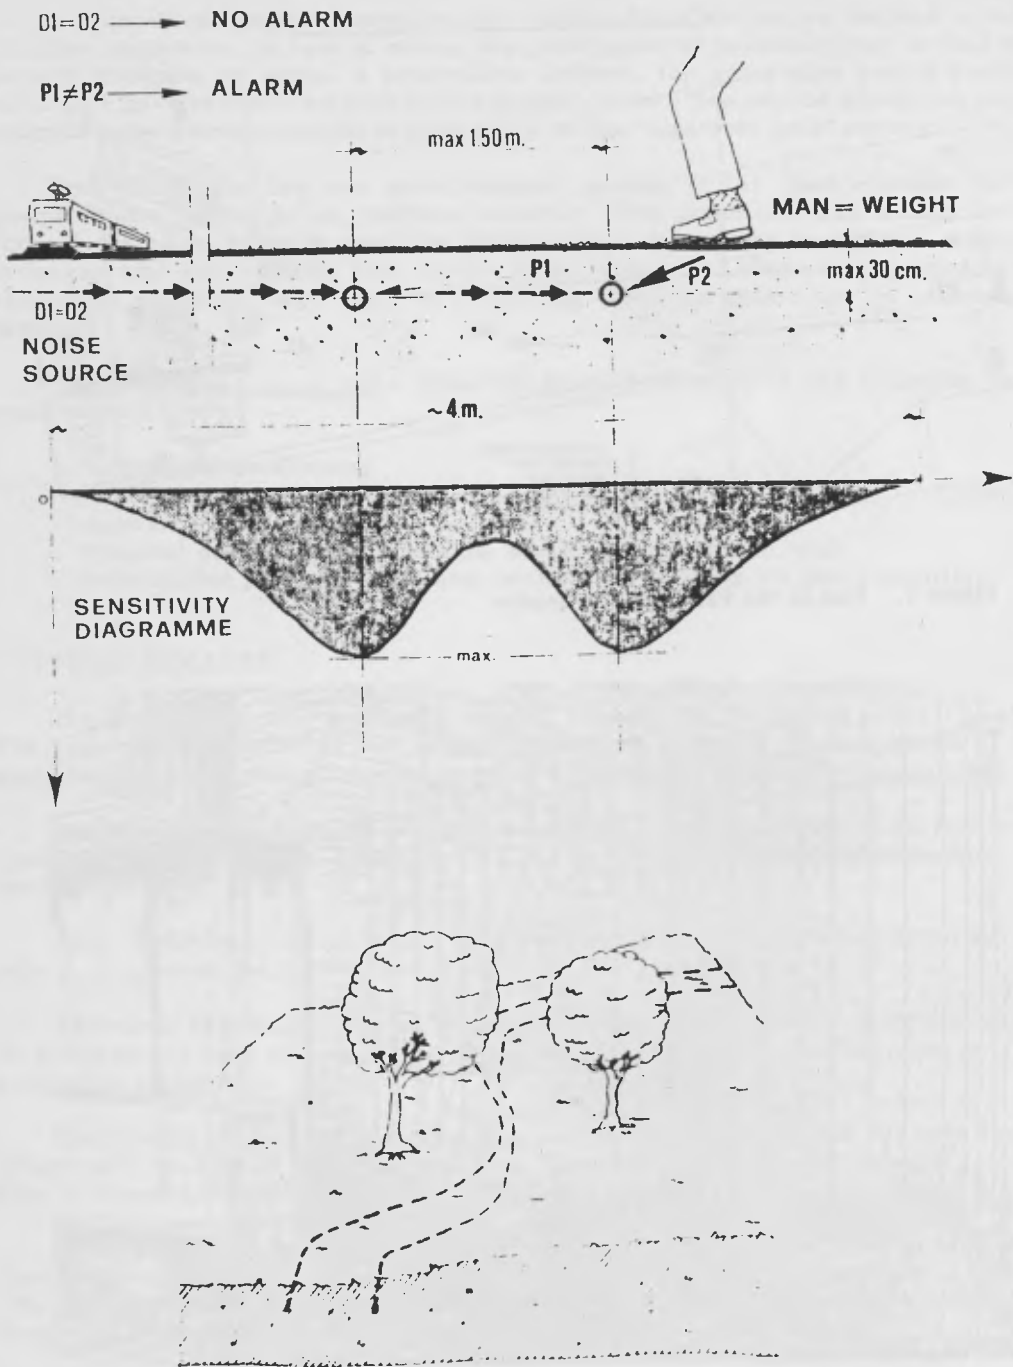
Figure 3. Buried protection schematics.

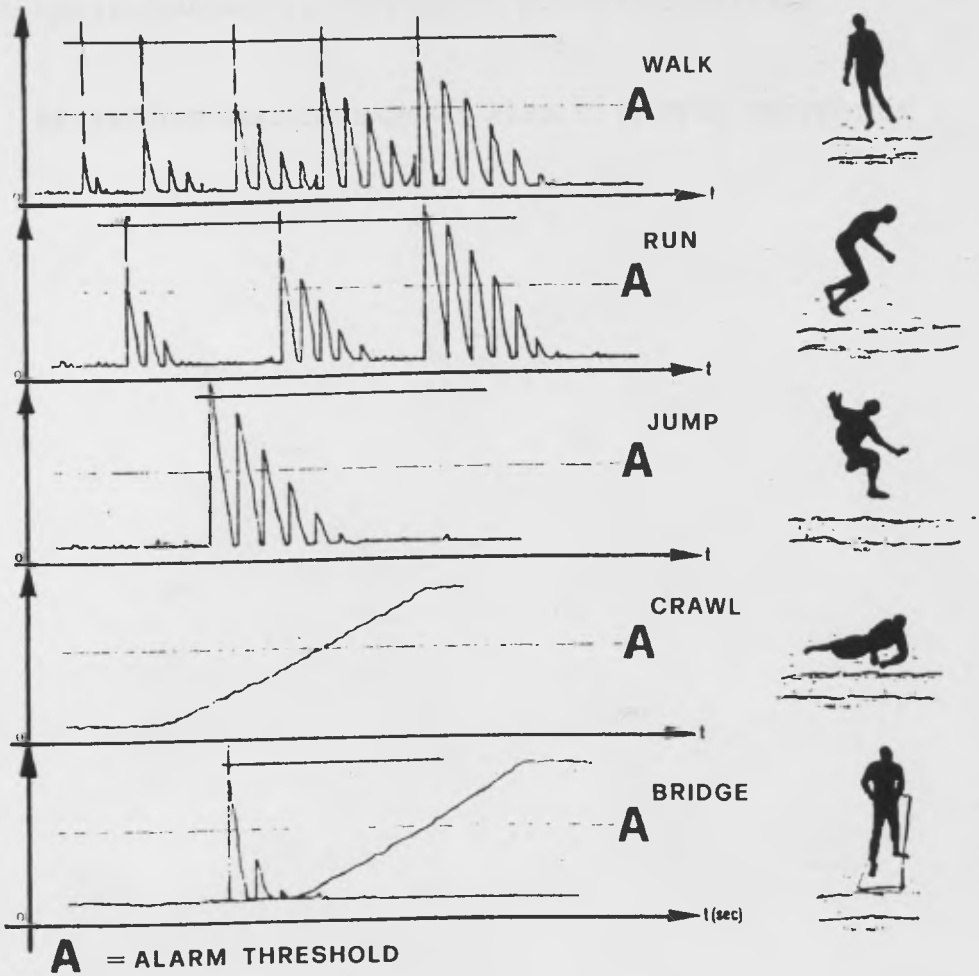
Figure 4. Signals given by penetration attempts.

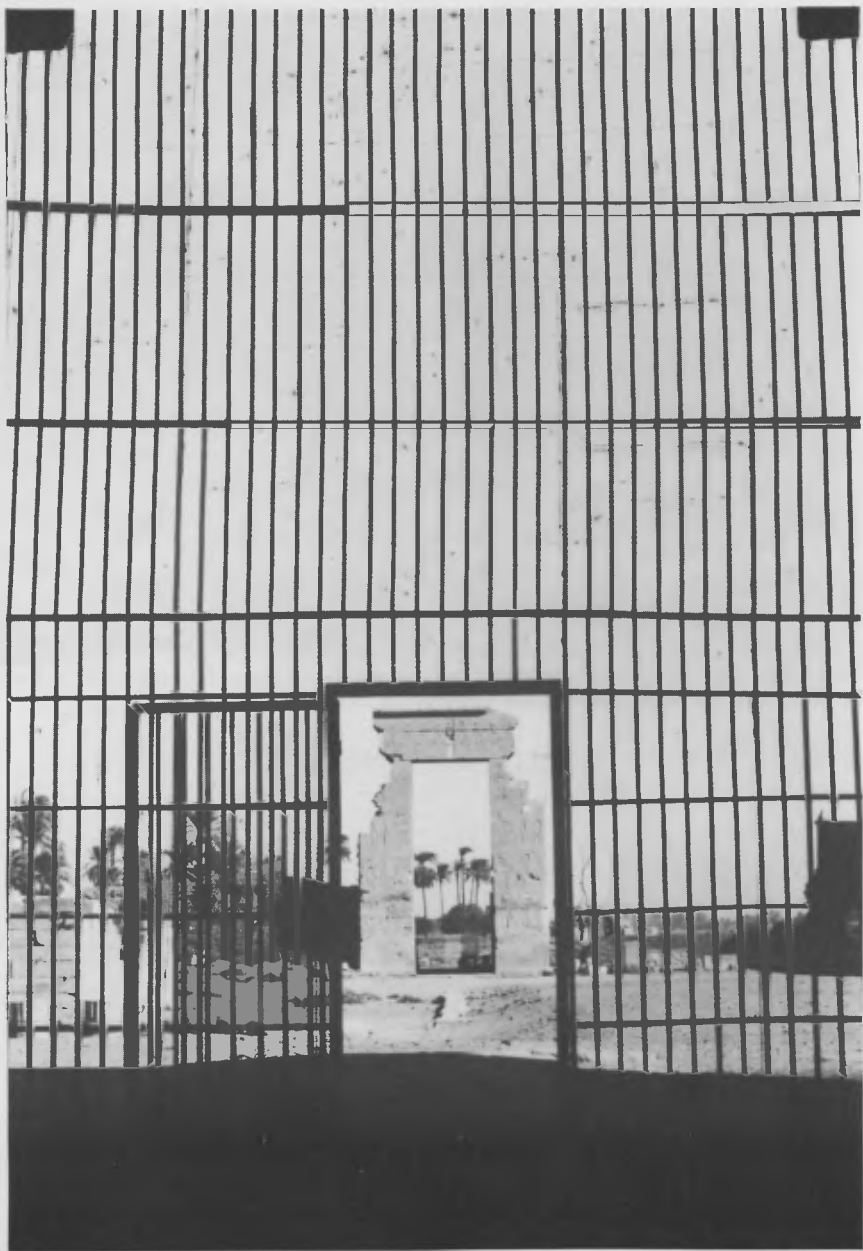
Figure 12. Egypte. Ecran métallique anti-pigeons de l'ensemble d'Hathor à Dendérah. Photo: auteur.

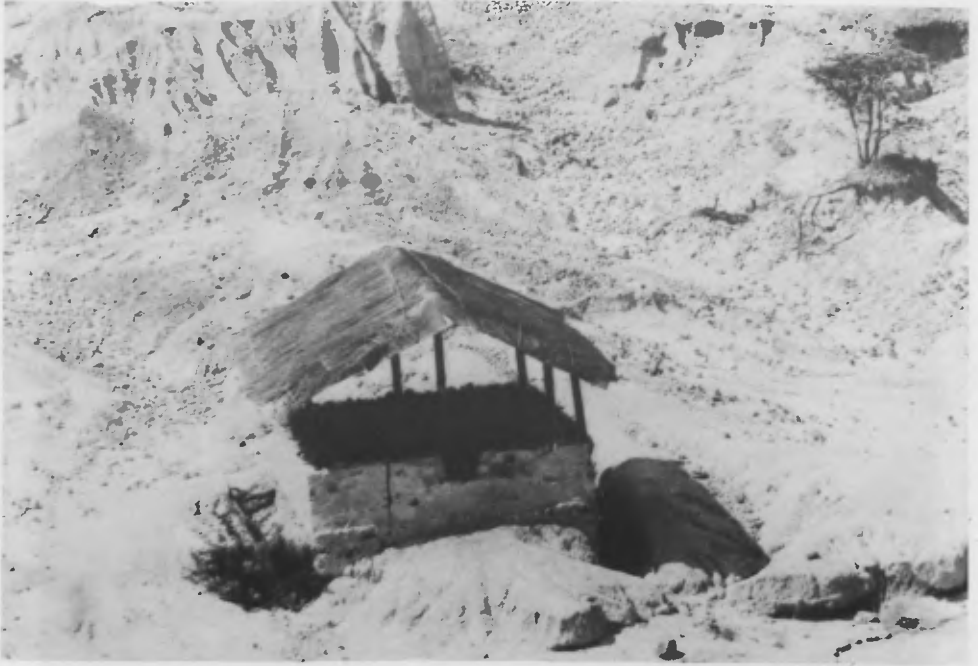
Figure 6. On-the-spot museum - a poorly built shelter that causes decay of fossil fauna, mainly in rainy seasons.

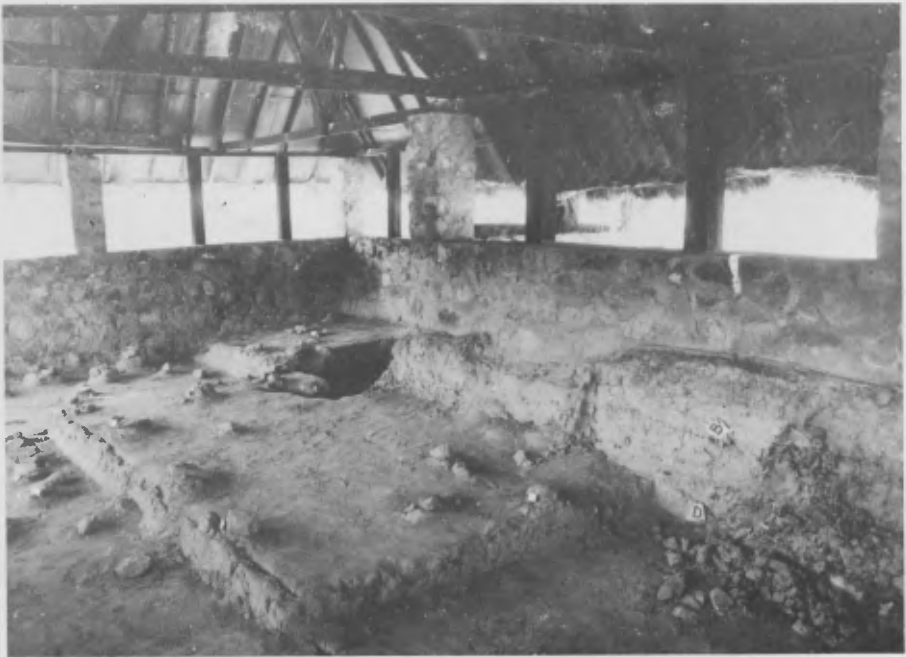
Figure 8. Artifacts displayed in situ in on-the-spot museum; note decay of wall base.

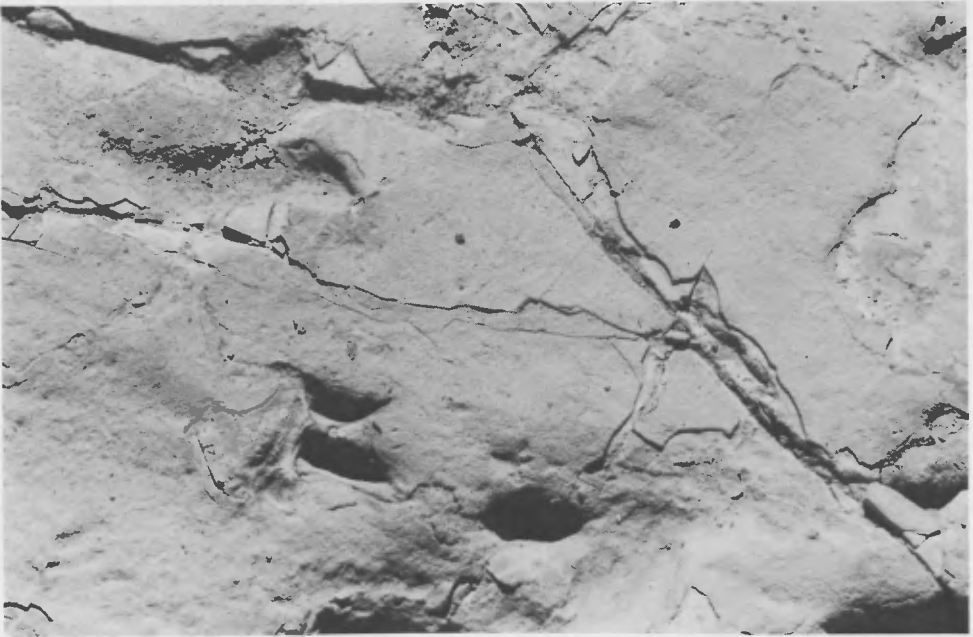
Figure 6. Cracks in the surface and lifting of the thin limonite layer.

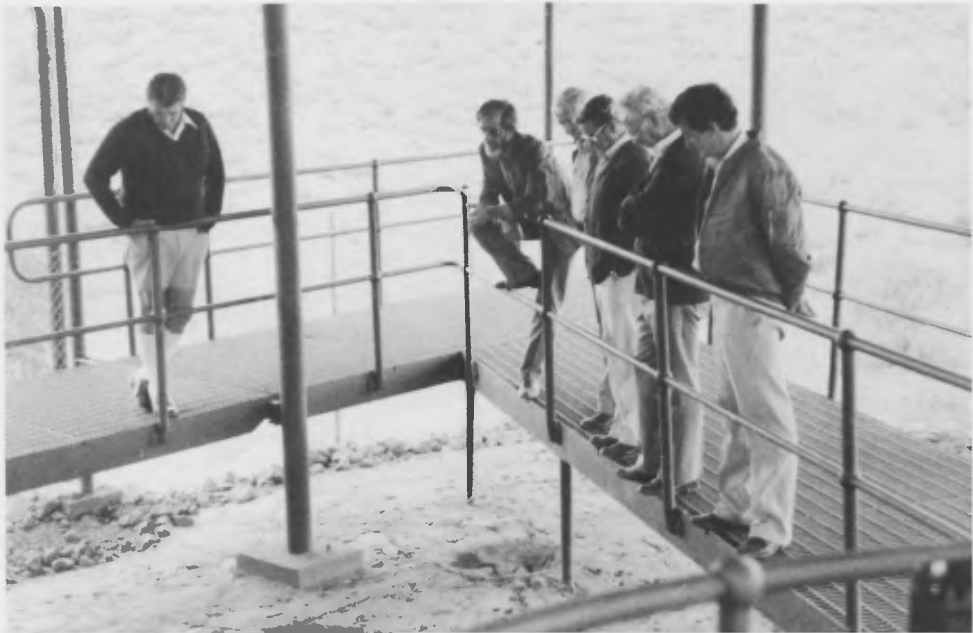
Figure 7. Visitors on the walkway. Note the roof columns and walkway supports embedded in the surface.

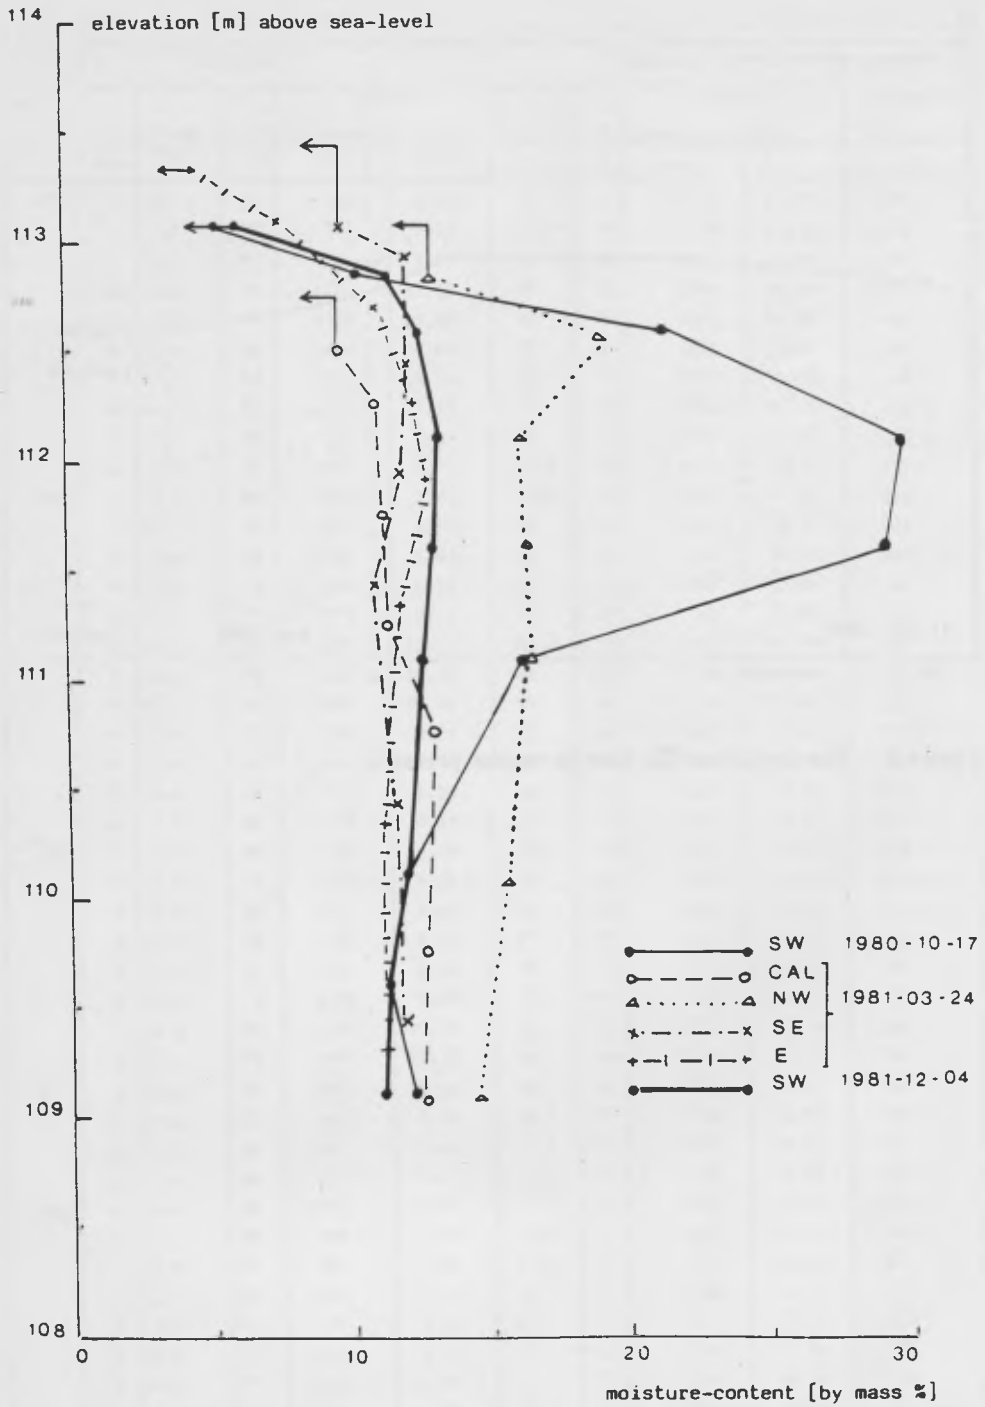
Figure 6. Moisture content of the clay.

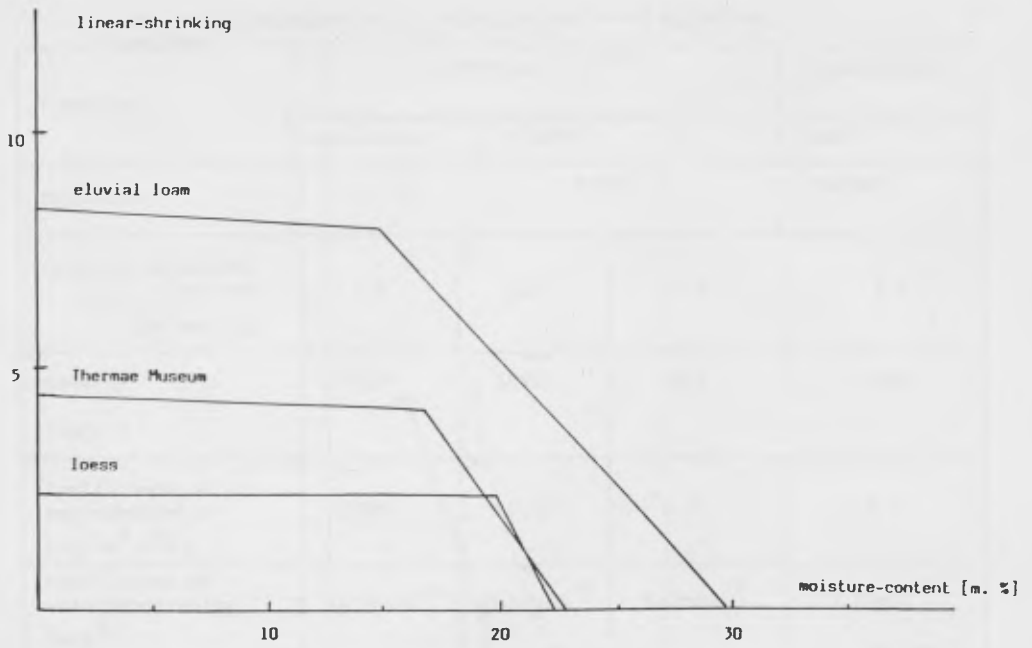
Figure 7. Shrinking curve.

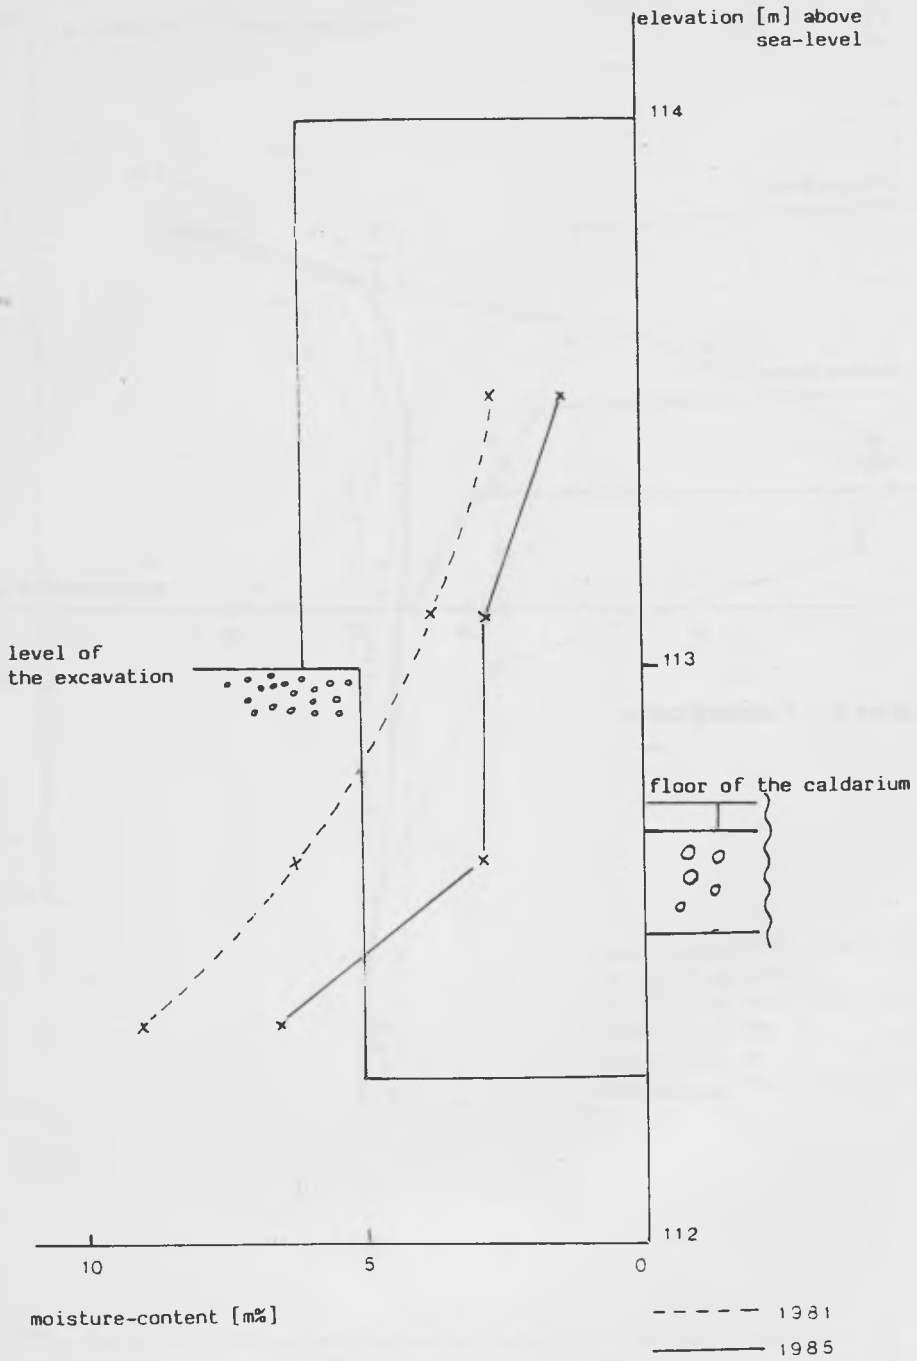
Figure 8. Moisture content of the brickwork.

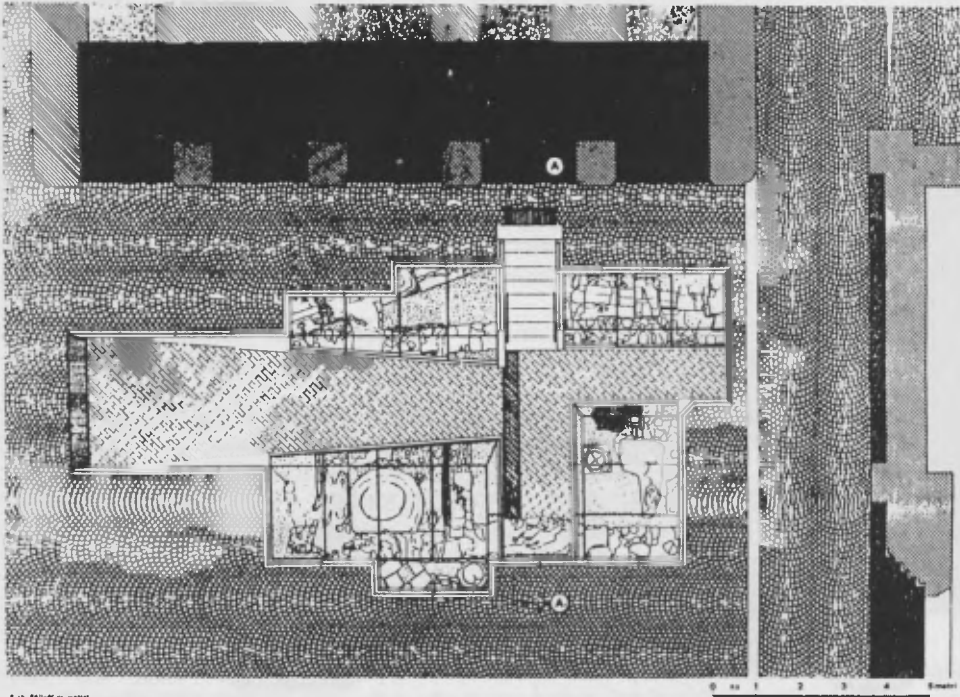
Figure 4. Plan of display area.
