Nine-Element Nonpoint Source Implementation Strategic Plan (NPS-IS plan)

**Pigeon Creek Watershed:
HUC-12 (05040001 01 02)
Approved: April 1, 2019**

Created for:
City of Fairlawn
3300 Fairlawn Service Drive
Fairlawn, OH 44333

Created by:
Environmental Design Group
450 Grant St
Akron, Ohio 44311

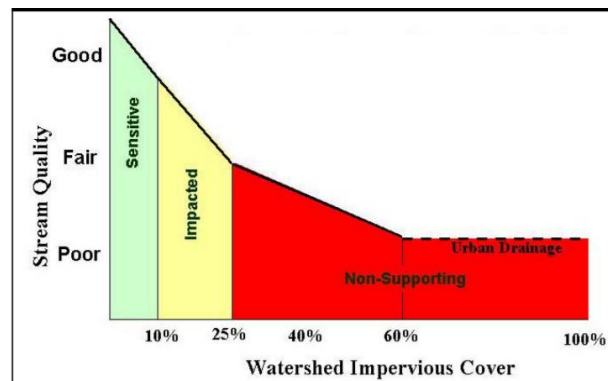
Figure 23: Impervious Cover Model of stream health from Center for Watershed Protection (Schueler, 2003).

Aquatic communities have been demonstrated to show water quality and habitat impairments when their drainage area exceeds 10% impervious cover (Schueler, 2003). Critical Area 1 exceeds this 10% threshold and is within the Impacted range of stream quality, where function begins to decrease but can still be restored. Increasing impervious cover (i.e., hard surfaces such as roads, parking lots, and rooftops) harms water quality. The rate of erosion increases, streams become unstable, and the resulting channel is less able to assimilate nutrients and other pollution. Higher runoff volume increases the amount of pollutants (nutrients, metals, sediment, salts, pesticides, etc.). As water runs over hot pavement and rooftops or sits in detention basins, it becomes heated. When this heated water enters a stream, the higher temperatures reduce dissolved oxygen concentrations that aquatic life need to survive. Increased stormwater runoff leads to higher peak flows, flow variability, and frequency of high flows, causing streambank erosion, channel incision, stream channel

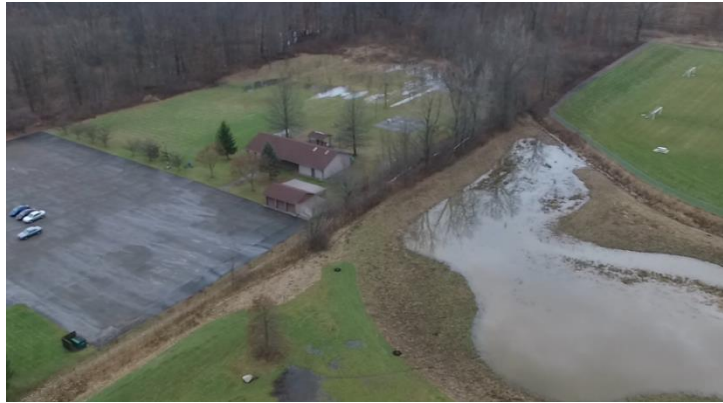
Figure 24: Aerial Image of Fairlawn Park, showing oxbow wetland and adjoining exposed and channelized stream corridor.

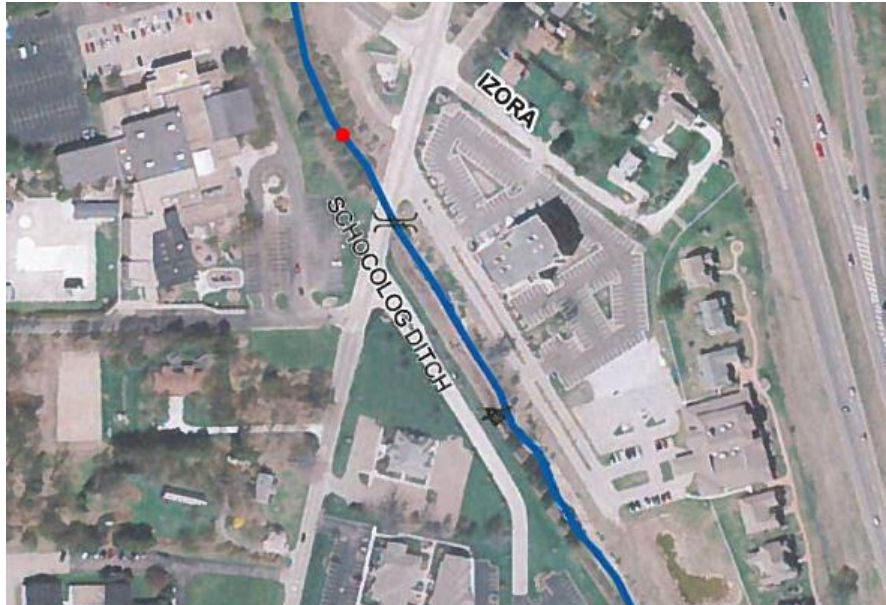
Figure 25: Aerial photo from Wolf Creek Rehabilitation Study, showing channelized and impacted stream downstream of Ohio EPA sampling point.

noted an IBI score of 22 with a narrative rating of Poor, an ICI narrative score of Poor, and a QHEI score of 35 with a narrative rating of Poor. The figure to the right is an aerial image of Schocalog Run from the Wolf Creek Rehabilitation Study, with the approximate Ohio EPA monitoring location shown in red. The stream in this segment is entirely channelized with sparse riparian cover and adjacent medium to high-intensity development.
