A COMPARISON TEST OF UNITED KINGDOM AND UNITED STATES LIGHTWEIGHT RIFLES. TENTH REPORT OF PROJECT NO. TS2-2015

A COMPARISON TEST OF UNITED KINGDOM AND UNITED STATES LIGHTWEIGHT RIFLES.

TENTH REPORT ON PROJECT NO. TS2-2015

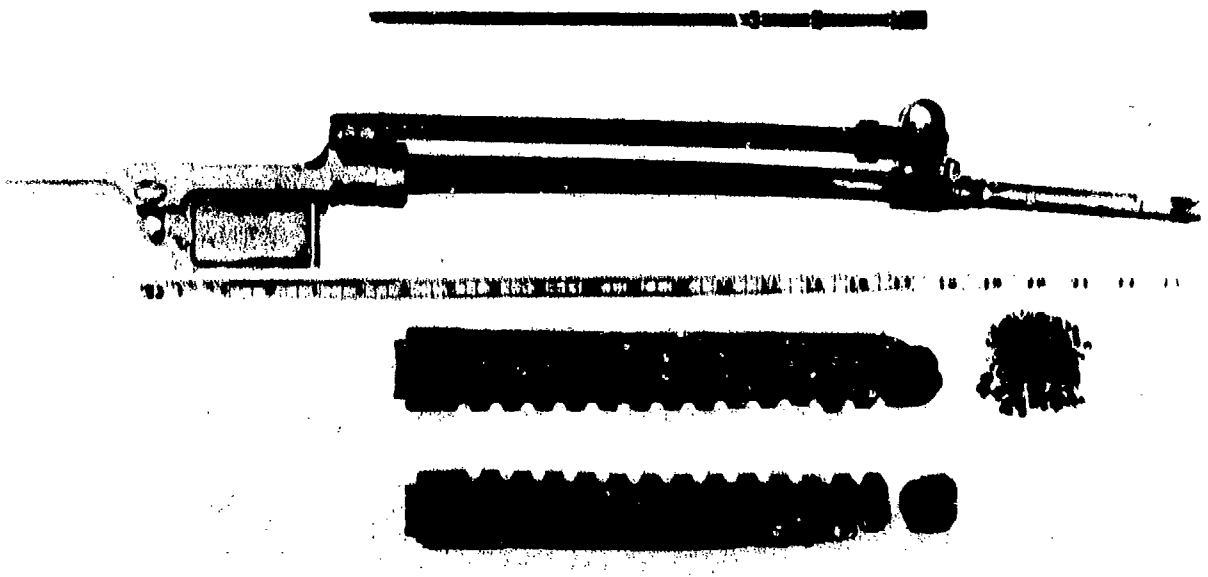
Photograph A61176, attached as Appendix F, shows damage to the handguard, barrel, gas cylinder and piston resulting from this test. The receiver was cracked on the left side at the rear of the cocking handle cut. The front sight fell off during firing. The thumbpiece, screw and lock fell off the bolt stop assembly during the test.

Project No. TS2-2015. Rifle, Lightweight, Caliber .280, FN, No. 7.
Parts damaged in cook-off test.

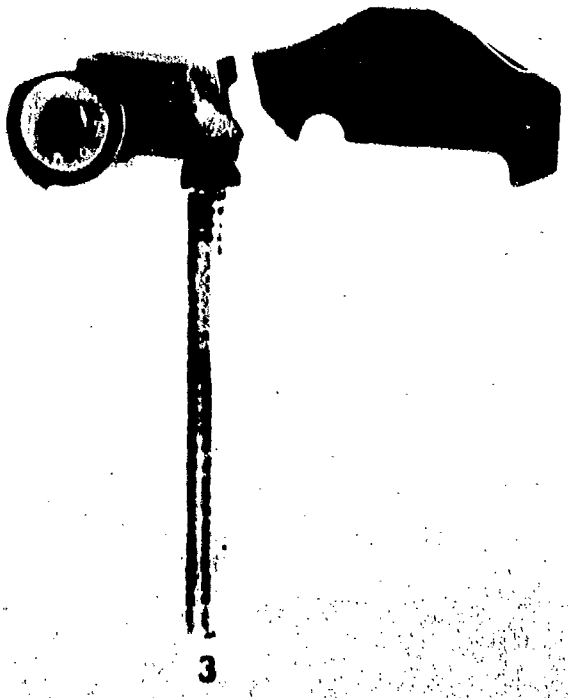
(13) There were few parts failures during the test. Photograph A61177, (Appendix F) shows the broken parts which caused stoppages. Photograph A61178 shows a crack in the receiver of rifle serial number 6. Both rifles fired in the endurance test developed cracks at this point. The cracks did not affect the functioning of the rifles. Failure in the design to include a fillet at the rear of the cocking handle guide caused the receivers to crack at this point.

Project No. TS2-2016. Rifle, Lightweight, Caliber .280, FN. Broken parts. 1. Extractor Spring. 2. Extractor. 3. and 4. Hammers.

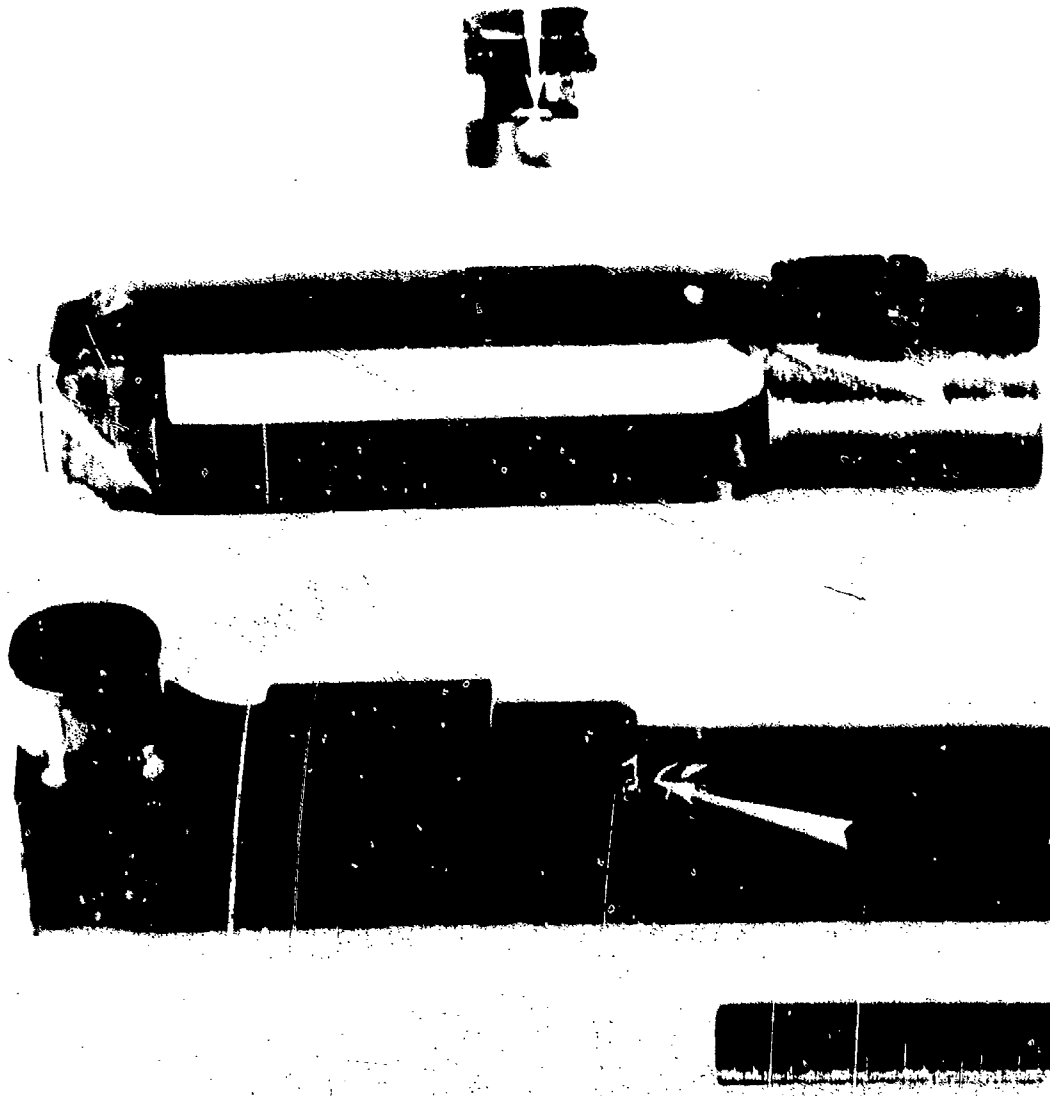
(2) The complicated breech block assembly gave excessive malfunctions and breakages. Photographs numbers A61185, A61187 and A61188, attached as Appendix F show some of the parts which failed in the test. The rearward movement of the recoiling parts was rapid and probably contributed to the breakage of parts. The fired

Project No. T52-2015. Rifle, Lightweight, Caliber .280, XM2. Cracked parts. TOP: Extractor. CENTER: Firing Pin Sleeve. BOTTOM: Piston.

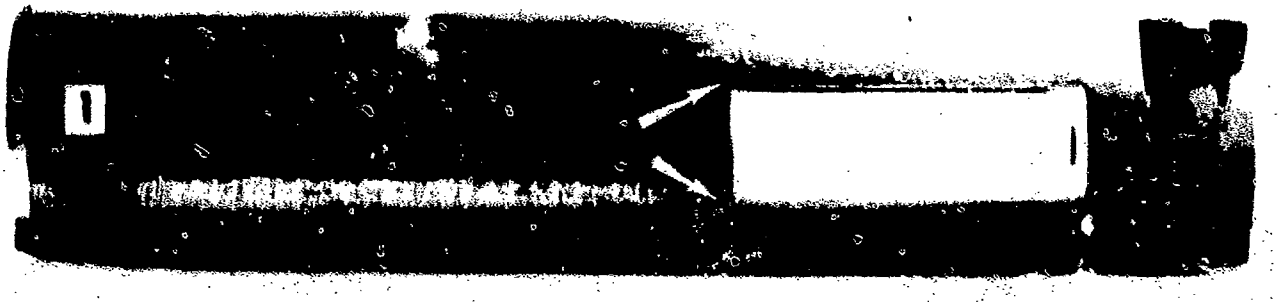
Project No. TS2-2015. Rifle, Lightweight, Caliber .280, [redacted]. Breech block. 1. Side view. 2. Top view. Cracking occurred at points indicated by arrows.

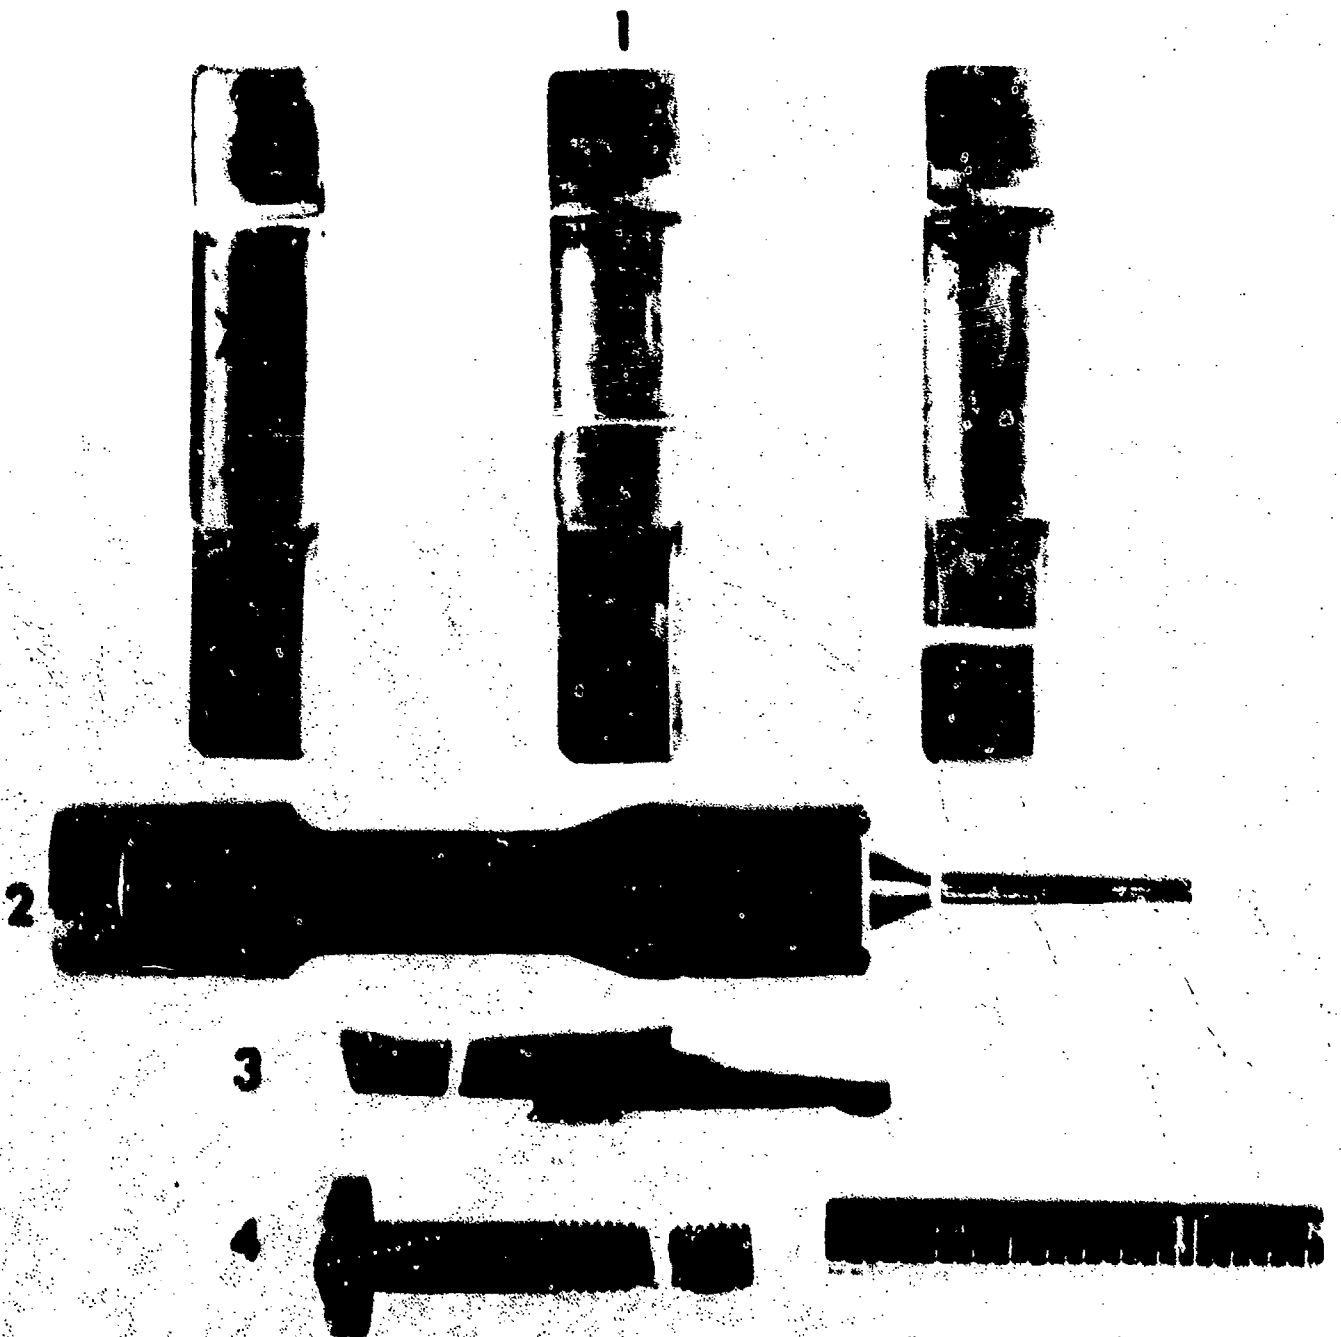
Project No. T52-3015. Rifle, Lightweight, Caliber .280, M52. Broken parts. 1. Locking Lugs. 2. Firing Pin. 3. Gear. 4. Grip Screw.
