THE HISTORY AND PRESERVATION  
OF THE COMMUNITY AUDITORIUM-GYMNASIUM  
Historic Structure Report

**MANZANAR**  
National Historic Site • California

April 1999

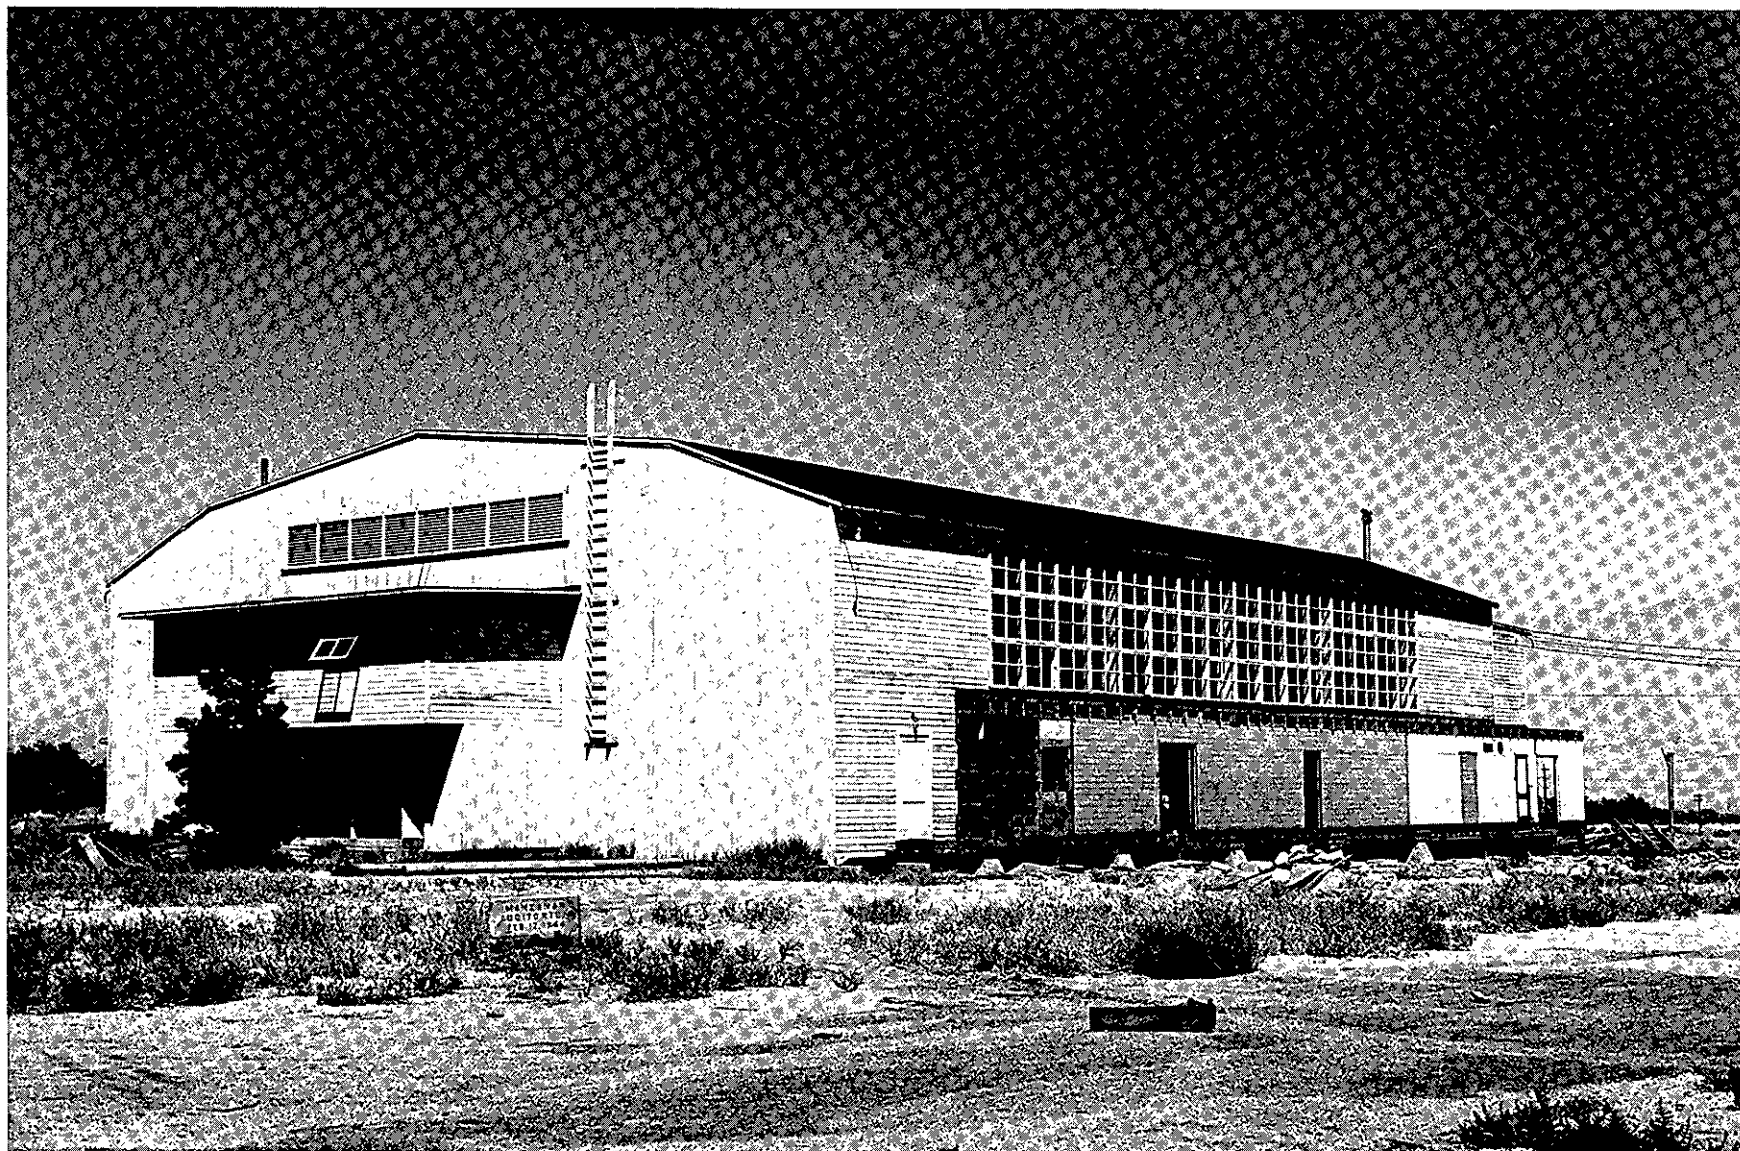
Photo 35. The auditorium was used between 1947 and 1954 by the Veterans of Foreign Wars. This view of the auditorium from the southwest was shortly after the south wing was removed, probably 1954. The VFW moved the south wing structure to Lone Pine and placed it there in an L-shaped configuration. It is still in use by the local VFW chapter and the Lone Pine American Legion Post. The doorways in the second and fourth bays from the west were probably added after 1947. The horizontal board wall finish which was originally within the interior of the south wing and then exposed to the exterior was cedar, typical of the interior wall finish. The exterior siding on the other hand was Douglas Fir. Also exposed by the removal of the south wing and visible in this photo are the concrete footings supporting columns in the main south wall of the auditorium. The cornerstone is in the left center foreground. The pine tree near the west main entrance had substantially increased its height since 1945. Toyo Miyatake Collection, No. 87-G, courtesy Archie A. Miyatake, San Gabriel, California.

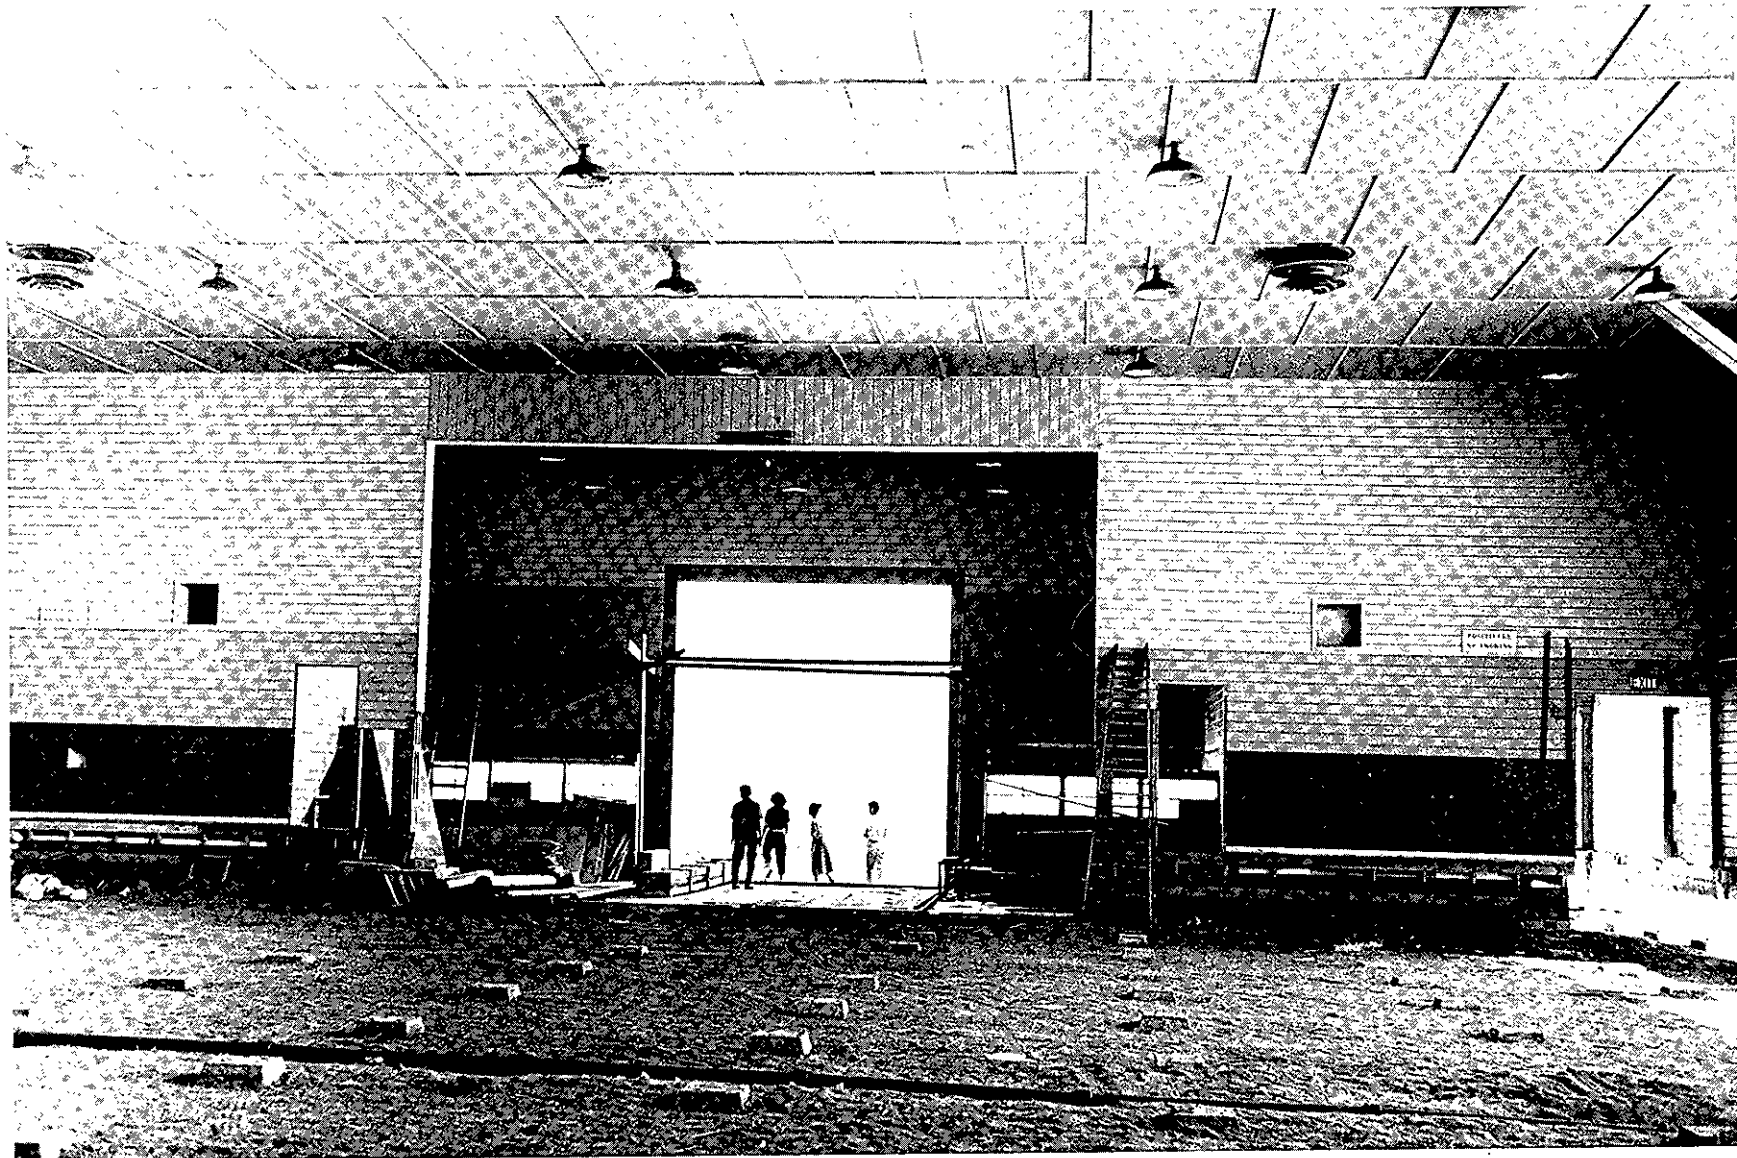
Photo 36. After removal of the south wing by the VFW, Inyo County modified the auditorium building for use as a maintenance facility. This view, probably mid- to late-1954, shows that the stage has been removed and a vehicle access opening constructed in the east exterior wall. The windows that were originally in the space beneath the stage had not yet been removed. The auditorium-gymnasium floor has also been removed. The concrete pads which had provided support for the floor framing were used to fill in spaces between framing and footings at the perimeter of this space before earth fill and a concrete slab were installed. This new floor level is lower than the original floor surface leaving the original floor level and base trim position still visible. Some of the original wood flooring was used on new walls in the former stage space. Toyo Miyatake Collection, No. 87-F, courtesy Archie A. Miyatake, San Gabriel, California.

The main floor of the auditorium is currently a concrete slab that was installed by the county (see historic photo 36) when they adapted the structure as a maintenance garage (ca. 1954). In order to satisfy this new function, major modifications were also made to the auditorium's structure so that it could accommodate heavy equipment.

In addition to the removal of the original stage floor (historic photo 36), its two flanking stair wells were also razed. Paint ghosts of the stairs are visible in basement rooms 118 and 119. In this same historic photograph, the wood gym/auditorium floor has been removed along with flooring at the same elevation in Hall 121. The concrete footings are still in evidence in this photo, but current physical investigation indicates that many of them, if not all, were relocated and stacked with boulders to create a retaining wall for the slab fill around the perimeter of the gymnasium space. The entire gym/auditorium (123), the hall at the southeast corner (121), and a room of undetermined use at the west end of the north wing (106), were all back-filled and a concrete slab poured wall-to-wall.

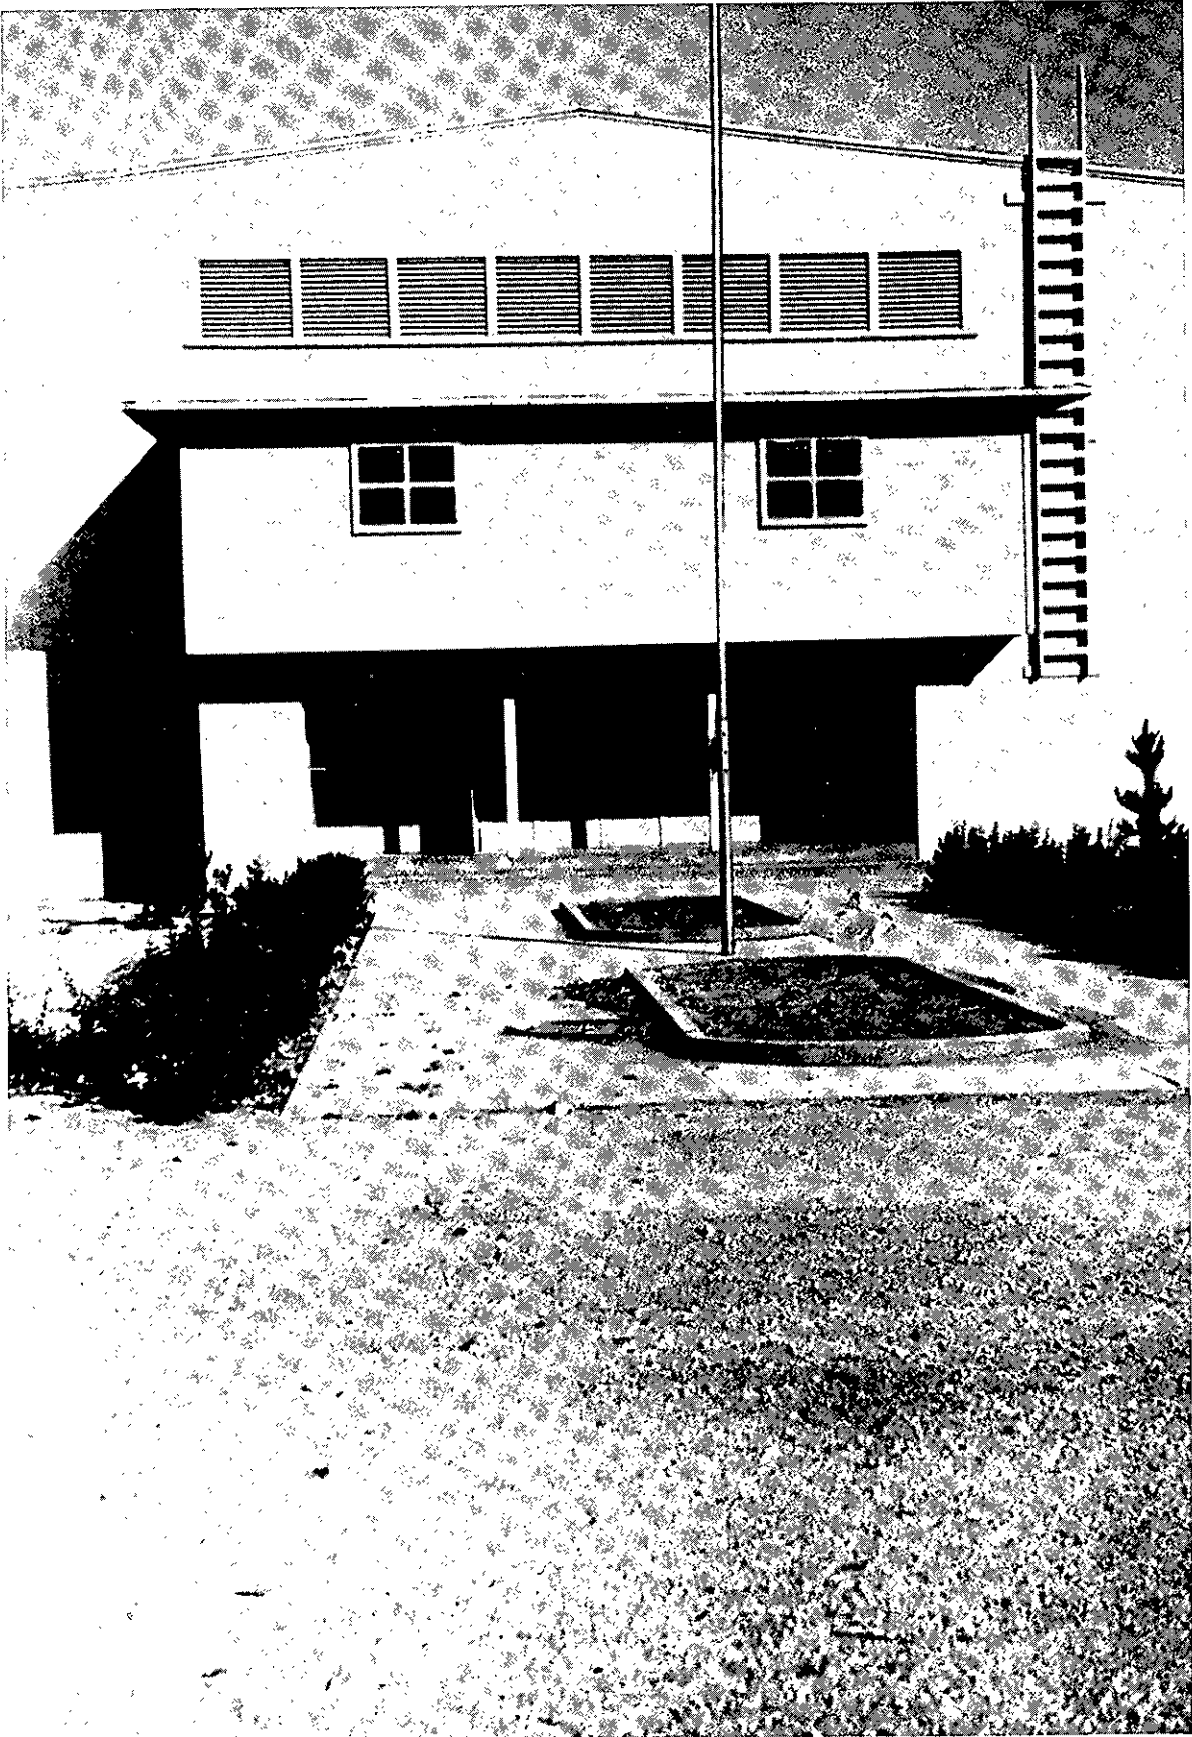
Photo 37. West (main) entrance of the auditorium. This view shows that a small pine tree had been planted on each side of the entrance walks, although they are still small so this photo may have been taken about the time the camp was closed, late 1945, or sometime later. The entryway had also not yet been enclosed. Eastern California Museum Collection, MERR 8.

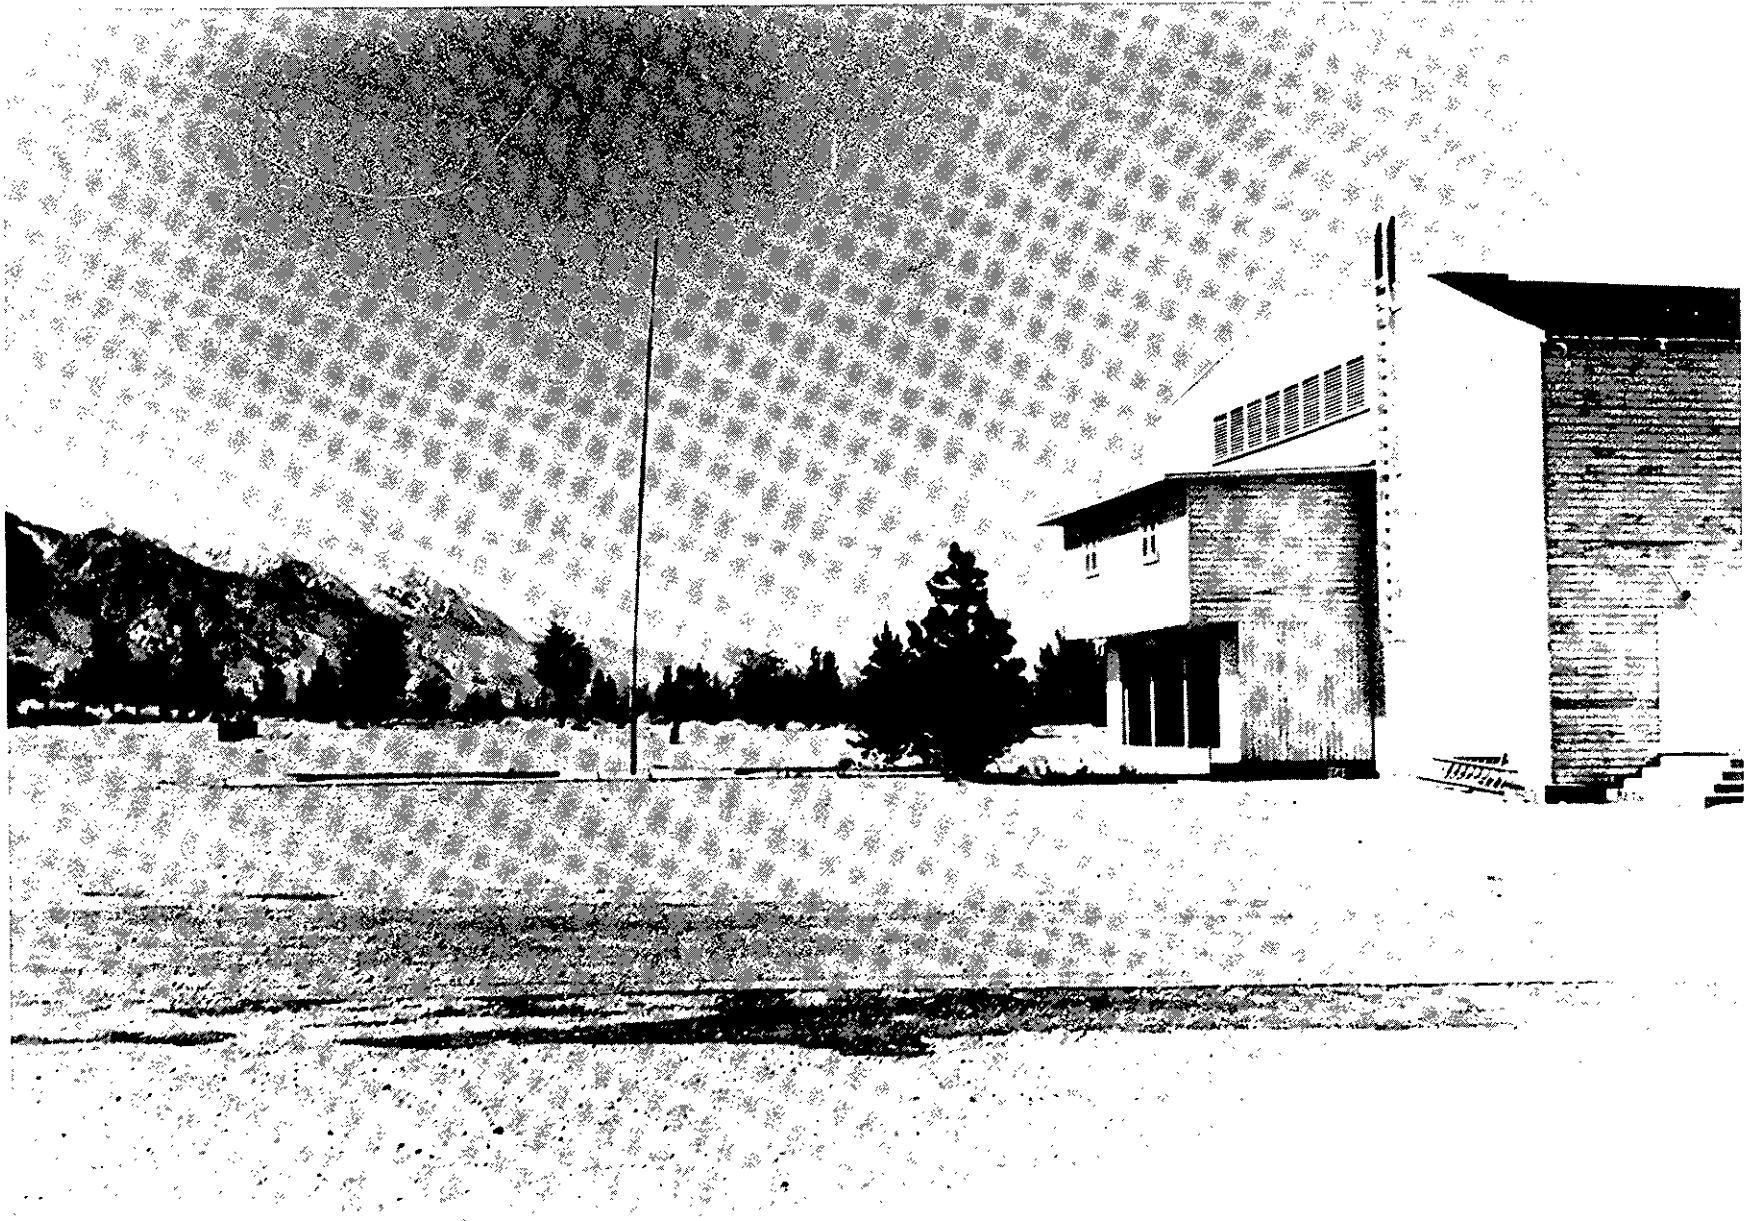
Photo 38. View to the north with the front entrance features and west end of the auditorium-gymnasium building. Barracks Block 13 is just north of the auditorium. The Sierra Nevada mountains are in the background. There are no other buildings visible but the steps at the southwest corner of the building are visible at the extreme right, so this photo was probably taken between 1947 and 1954, most likely in the later part of that period as evidenced by the growth of the two pine trees. The west entrance is unenclosed, indicating that the enclosure was possibly constructed after 1954. Eastern California Museum Collection, NOM 47, 94.80.10a.

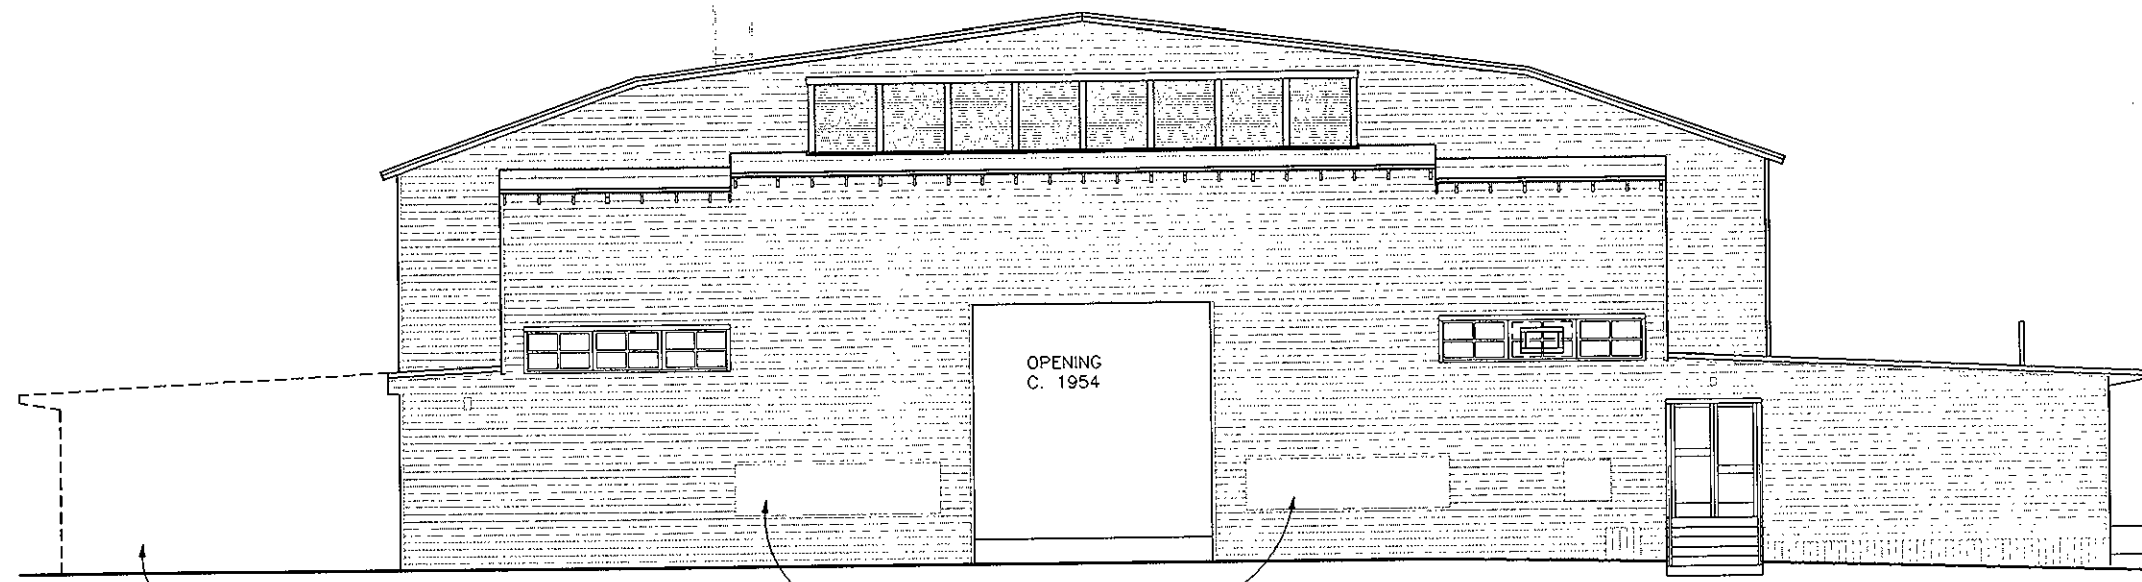
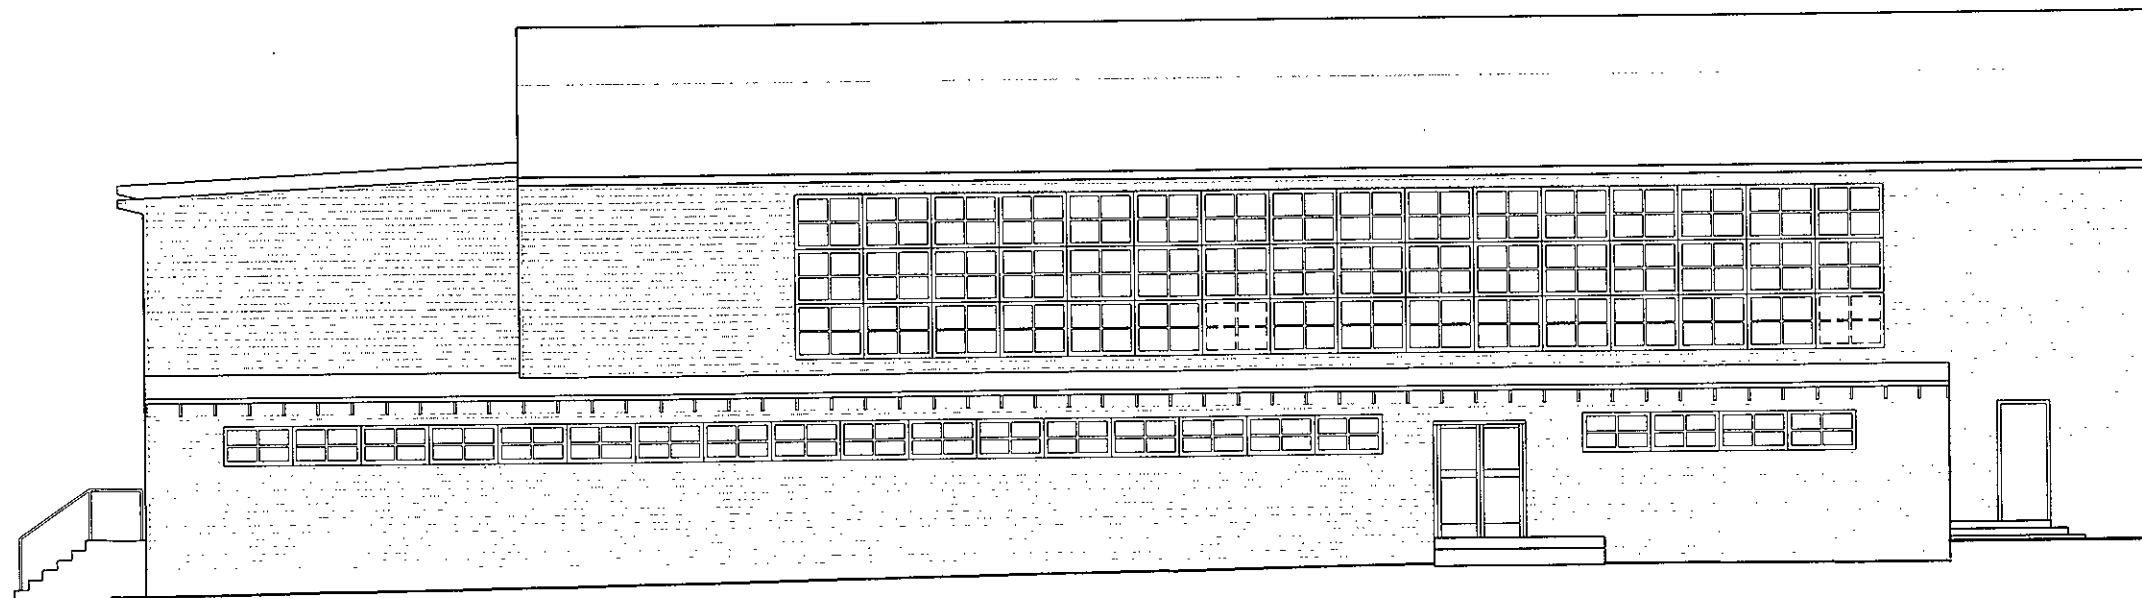
SOUTH WING REMOVED C. 1954

WINDOWS REMOVED, C. 1954

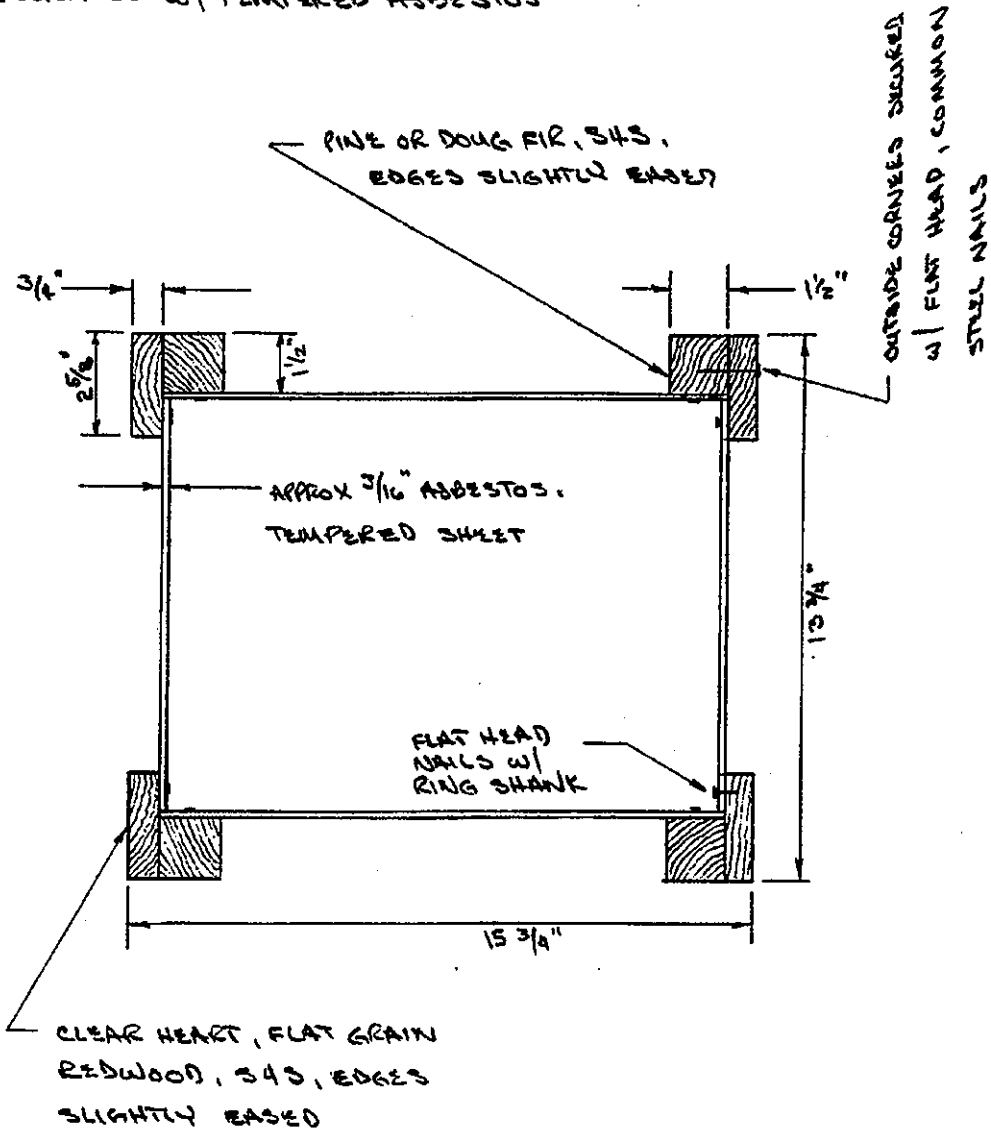
HAN/2 AUDITORIUM  
Room # 205

TYPICAL FURNACE FLUE ENCLOSURE  
INSULATED W/ TEMPERED ASBESTOS

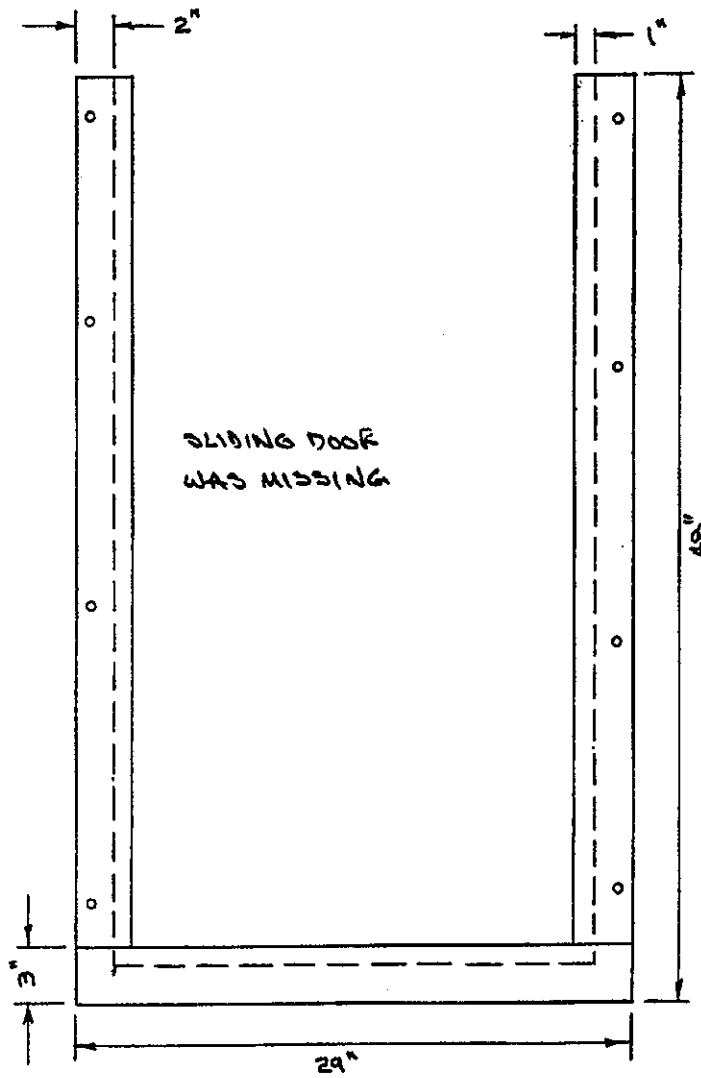
MANZANAR AUDITORIUM  
FURNACE ROOM  
#104, SOUTH ELEVATION

" ORIGINAL SLIDING DOOR UNIT  
MADE OF TEMPERED ASBESTOS "

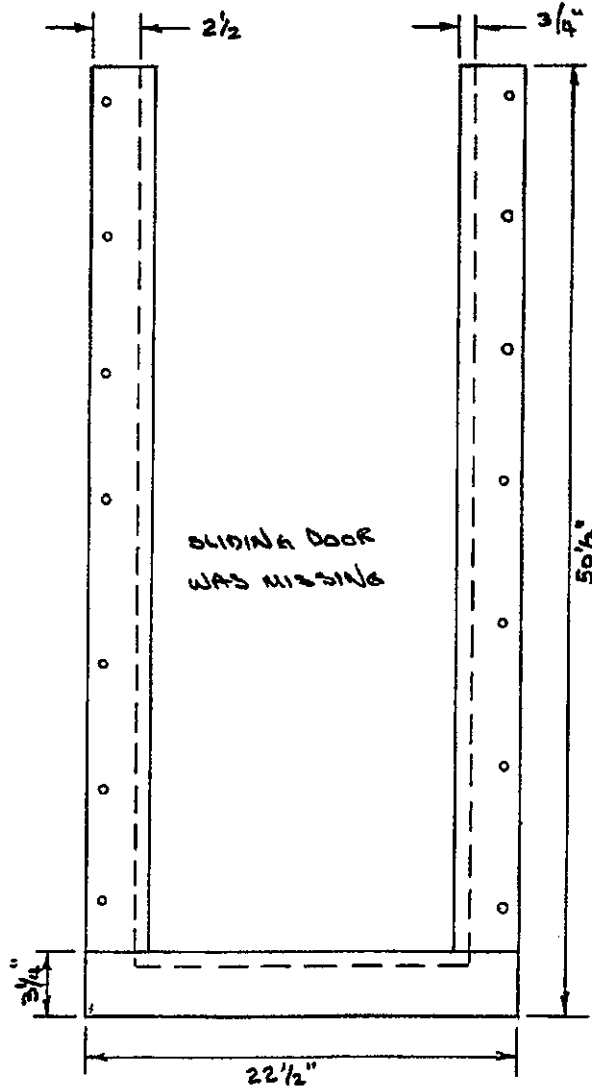
MANZANAR AUDITORIUM  
FURNACE ROOM  
# 104, EAST ELEVATION

ORIGINAL SLIDING DOOR VENT  
MADE OF TEMPERED ASBESTOS

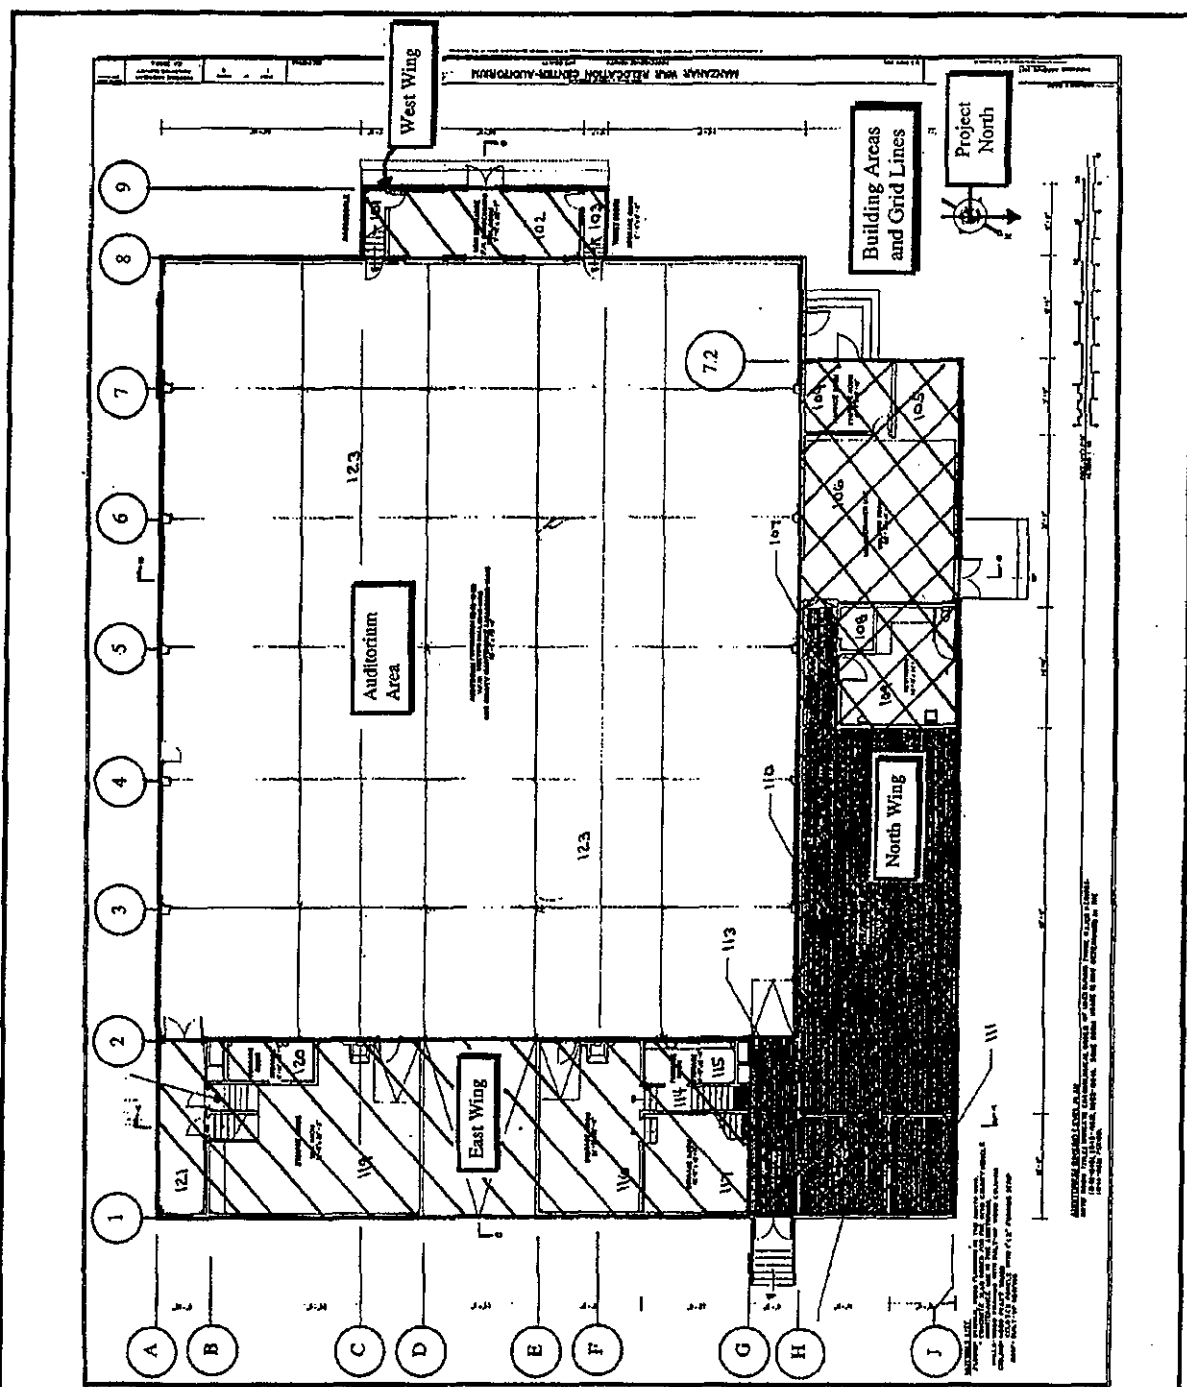
Figure 1 Building Areas

This seismic evaluation was performed on the building as it existed during our site visit in July 1998. Figure 1 contains a ground floor plan with the different building areas labeled. This figure, as well as all others, is from the Historic American Building Survey conducted in 1994 by the National Park Service.

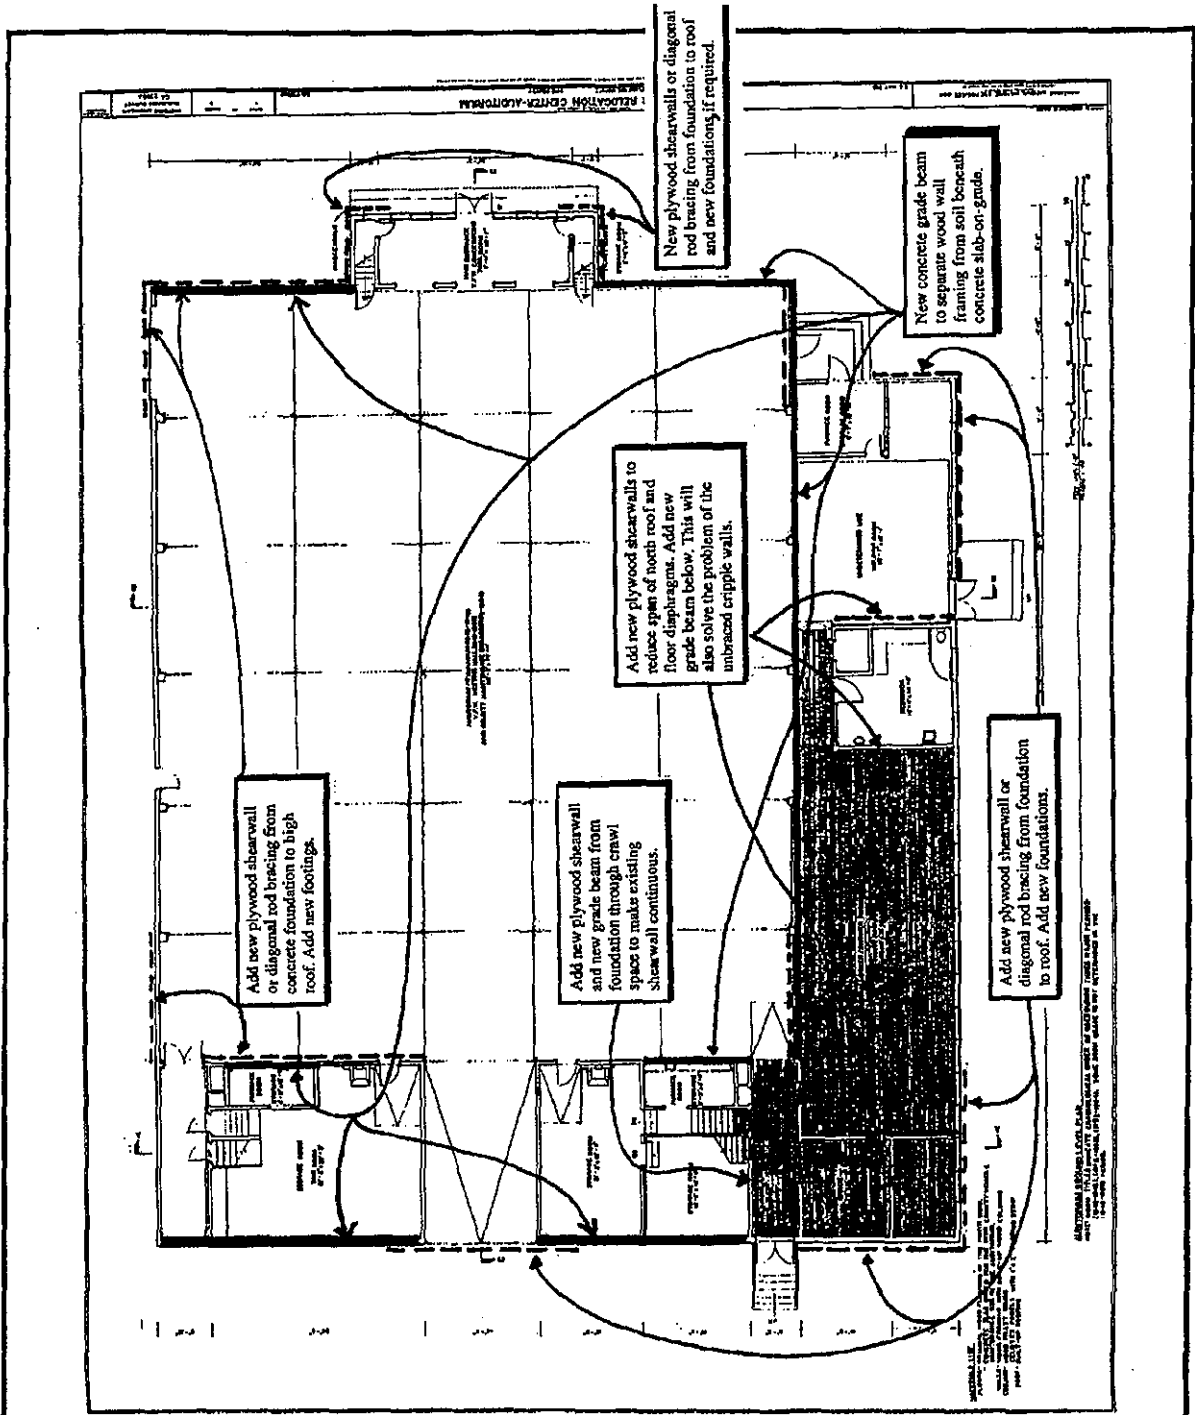
Figure 2 First Floor Plan Added Walls and Grade Beam

The lack of adequate shear walls is a significant problem. The large number of wall openings, both windows and doors, combined with 1x sheathing renders the walls severely overstressed. It is suggested a bay or two on each wall be selected and designed as a new plywood shear wall or new diagonal steel rod braced frame. These must extend from the roof level down to the foundations. These added shear walls and/or bracing would act as the vertical component of the lateral load system for the building; the existing walls should not be combined with the new walls/bracing. Overturning problems are expected at the base of these bays. A new concrete grade beam with new footings or enlarged existing new footings will be required to transfer the lateral shear and overturning forces into the supporting soil. The suggested locations for added shear walls/diagonal braces are shown in Figures 2, 4, 5, 6, and 7.

2. Inadequate Shear Walls - The lack of shear walls is a serious deficiency. The lack of adequate sheathing and the presence of large and numerous door and window openings render the existing walls severely overstressed. Certain portions of the walls should be designed as plywood shear walls or have new steel rod diagonal bracing installed. New concrete grade beams or enlarged footings will be required at the bases of these walls. The suggested locations for these shear walls are shown in Figures 2, 4, 5, 6, and 7, Appendix J.

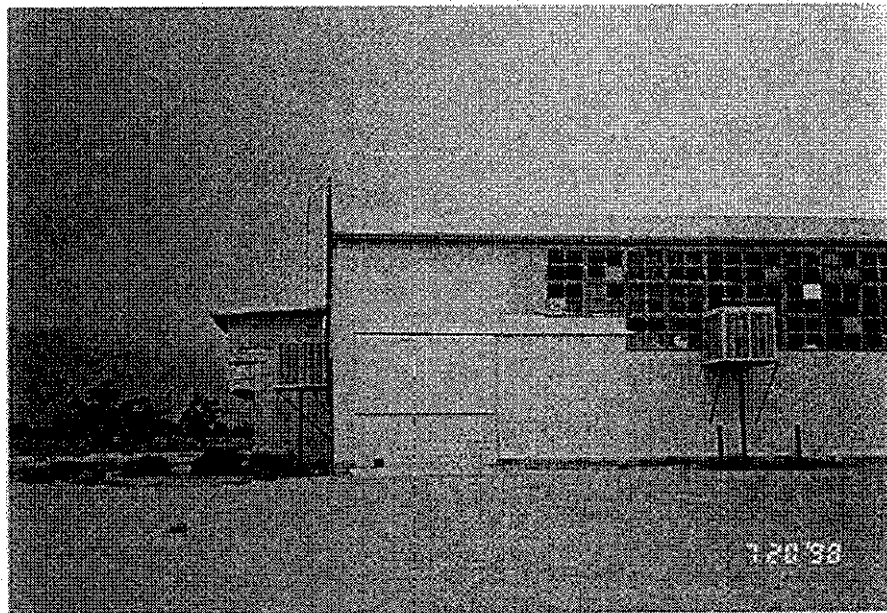
Photo No. 4  
Large Added Door Opening in South Wall

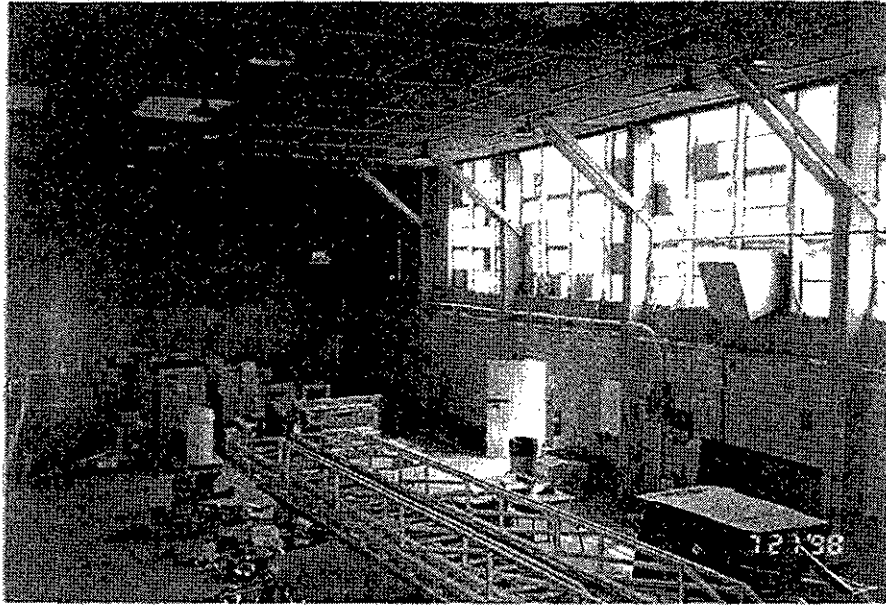
Photo No. 5  
Knee Braces Attached to Wood Columns, South Wall

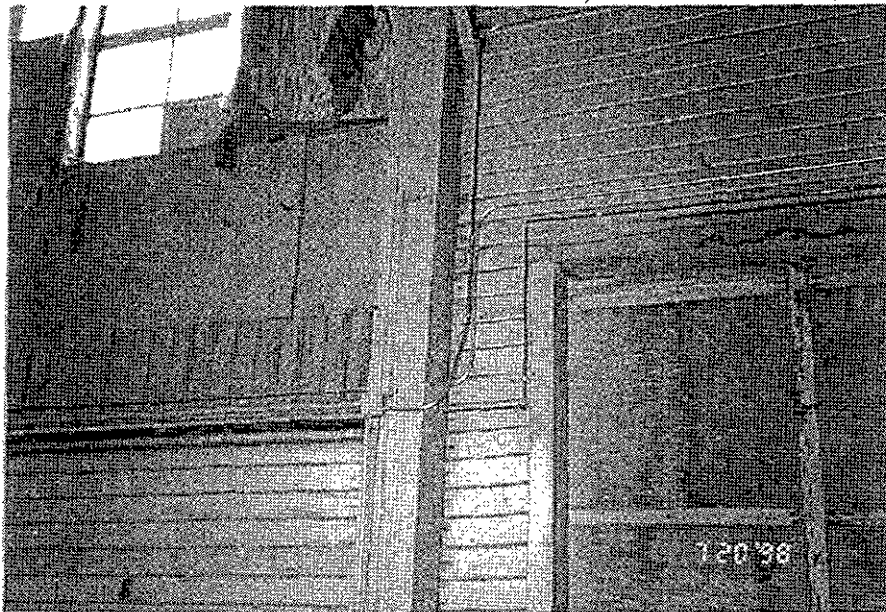
Photo No. 6  
Wall Openings on Grid A at Grid 7

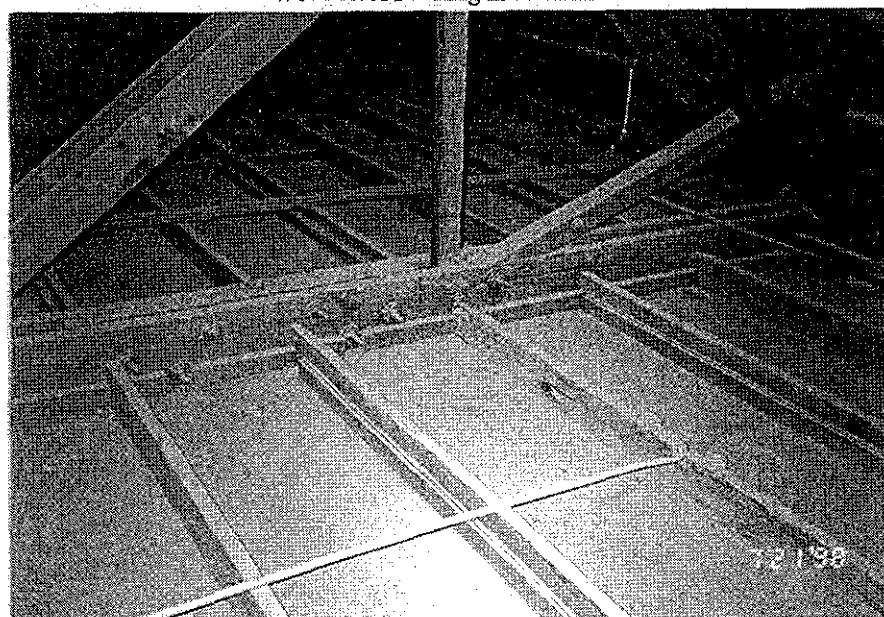
The 2x framing with Celotex panels forming the auditorium ceiling has no horizontal bracing (Photo No. 8). The west end wall, on grid 8, is framed with a joint at the ceiling level (platform framing). The west end wall relies on the ceiling to laterally support the wall, but the ceiling is unable to provide this bracing.

Photo No. 8  
Auditorium Ceiling Framing

Replacing the existing Celotex ceiling with a gypsum board ceiling will improve the bracing but still does not satisfy the building code due to the 80 foot ceiling diaphragm span. Alternatively, 2x wood diagonals can be added in the horizontal plane of the ceiling, or plywood added in alternate bays to the top or bottom of the ceiling joists (Figure 3). This solution can also be designed to act as the primary building diaphragm as discussed in item 4.0.4.

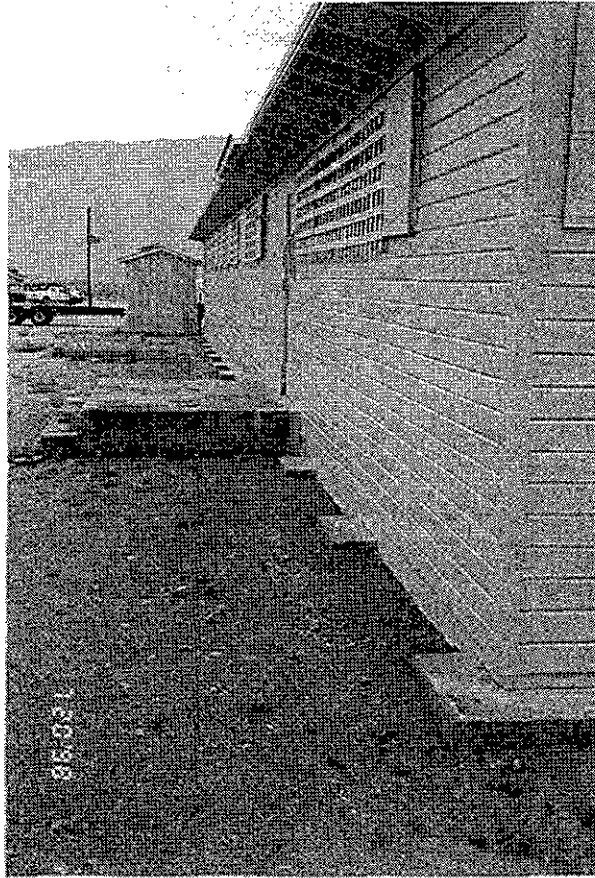
concrete footings (Photo No. 15). The north wing has a perimeter cripple wall which encloses the crawl space (Photo Nos. 15 and 17). The footings supporting the perimeter posts of the north wing are exposed on the exterior (Photo No. 9).

Photo No. 9  
Exposed Footings on North Wall of North Wing

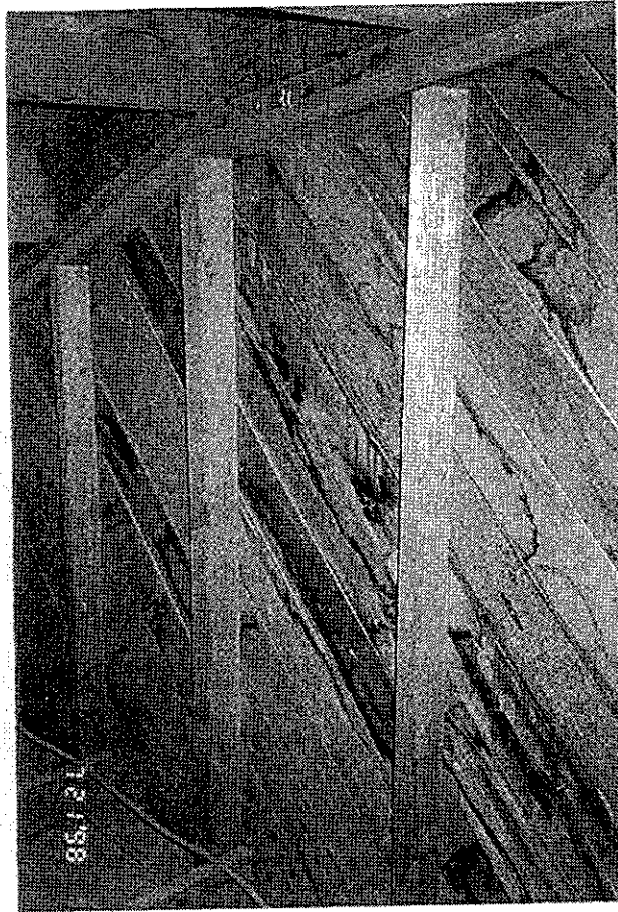
The double 2x top wall plates cannot function as the roof diaphragm chords or as diaphragm drag struts because the plates are not adequately spliced. At the north and south auditorium walls, the top plates are interrupted at each column (Photo No. 19). In addition, the top plates on the east and west auditorium walls are butt spliced at each break in roof slope (Photo No. 10).

Photo No. 10  
Typical exterior Wall Framing Showing Diagonal Wall Sheathing

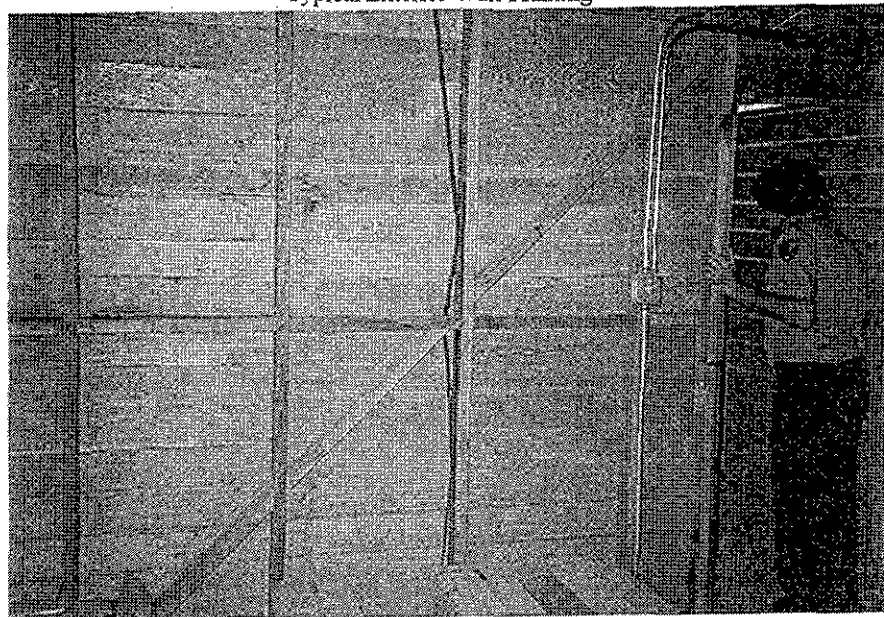
The north, east and west wings have a lateral system consisting of 1x roof and floor sheathed diaphragms spanning to diagonal 1x sheathed walls which act as shear walls. Some diagonal blocking was observed in the interior, horizontally sheathed walls of the east wing (Photo No. 12). These are helpful but have limited strength and stiffness.

Photo No. 12  
Interior Wall with Diagonal Wood Blocking
