THE HISTORY AND PRESERVATION  
OF THE COMMUNITY AUDITORIUM-GYMNASIUM  
Historic Structure Report

**MANZANAR**  
National Historic Site • California

April 1999

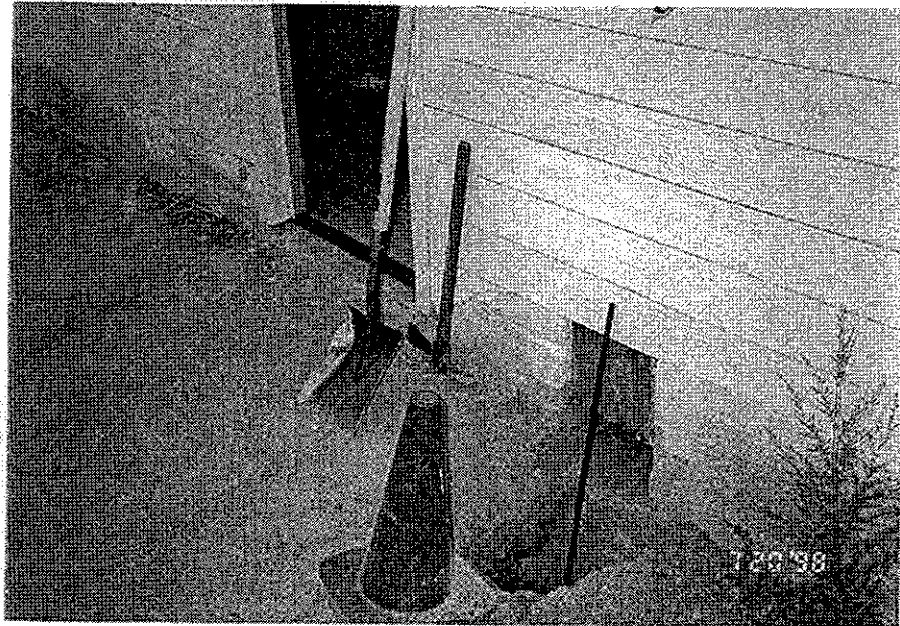
Photo No. 13  
Bottom of South Column at Grids A-4

The decay of the wood columns on the south wall can be repaired. The damaged wood can be removed and replaced by installing a new wood column, or preferably, the concrete support can be raised to avoid wood/soil contact. This is shown in Figure 7. It may also be possible to repair the columns having minor decay with epoxy, but decay will continue unless the wood is separated from soil.

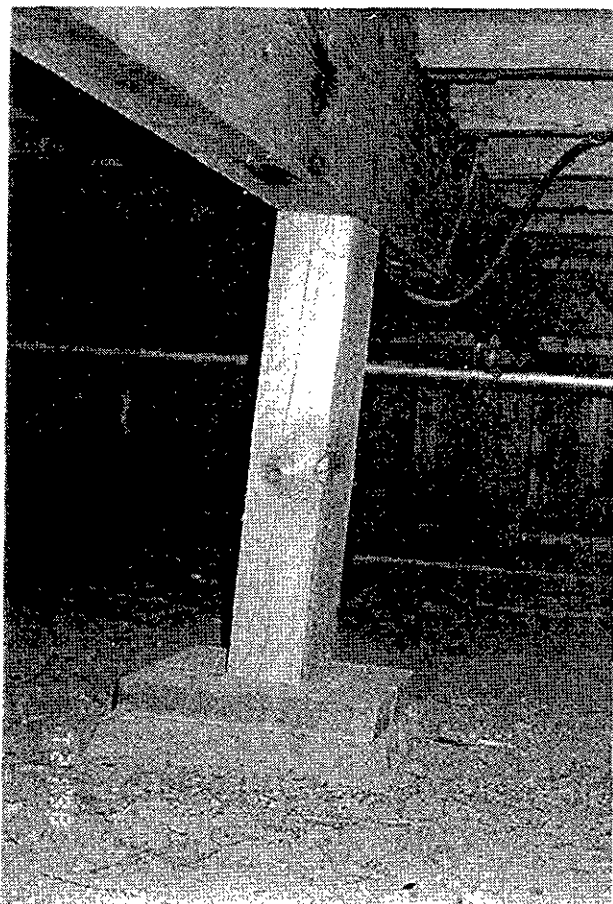
Three, the wood columns do not appear to be connected to their foundation, although this could not be confirmed by visual observation. On the north wing floor framing the floor beams are not connected to the supporting posts, and the posts are not connected to the spread footings (Photo No. 15).

Four, the footing foundations are not interconnected on the north wing (Photo No. 15). Interconnection of footings is necessary to prevent individual footings from moving.

Photo No. 15  
Floor Beam, Post and Footing in Crawl Space of North Wing

- The requirement to interconnect foundation elements should be reviewed by a geotechnical engineer who considers the seismic characteristics of the site and the stability of the surface soils. It is probable this requirement can be removed. If it remains, new steel elements (angles or pipes) could be used by expansion bolting them to the footings. Alternatively a 3 to 4 inch thick concrete slab-on-grade added to the ground in the crawl space should adequately interconnect the existing footings if properly designed and doweled to the footings.

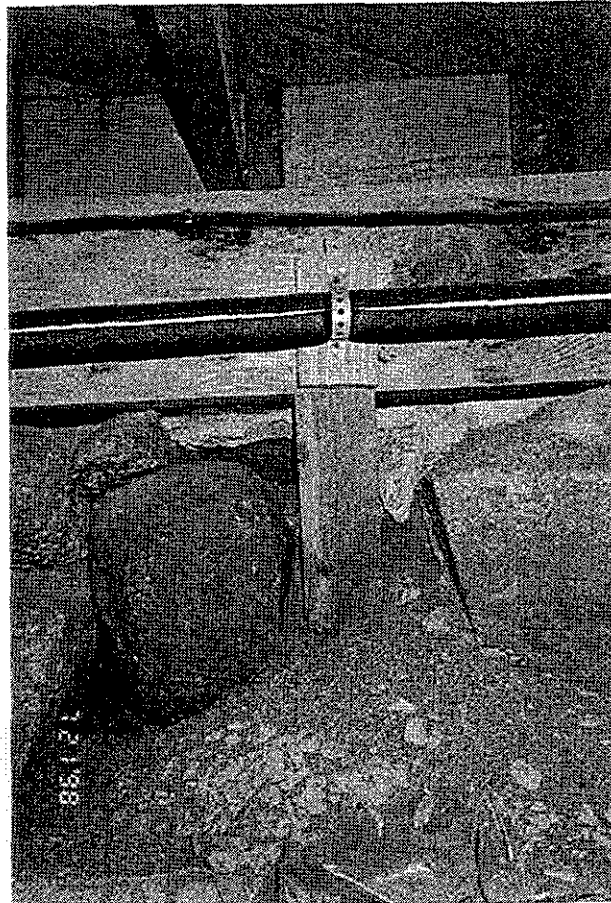
The auditorium north wall is carried on wood beams supported on wood posts set on concrete spread footings (Photo No. 16).

Photo No. 16  
Wood Framing on Grid H in Contact with Soil

The wood below slab-on-grade elevation at the auditorium north, east, and west walls is more difficult to correct. The first step is to confirm this suspected condition by removing selected portions of the interior slab-on-grade down to the footing elevation. If wood is in contact with soil, a new concrete grade beam could be added between footings. These are shown in Figure 2. Alternately, the concrete slab-on-grade could be removed, interior grade lowered to the footing elevation, and a new wood floor over crawl space installed. This solution has the added benefits of being an historically accurate recreation of the original construction and offers opportunities to route electrical, plumbing, and HVAC services under the floor. This solution is expected to be more costly than adding new concrete grade beams.

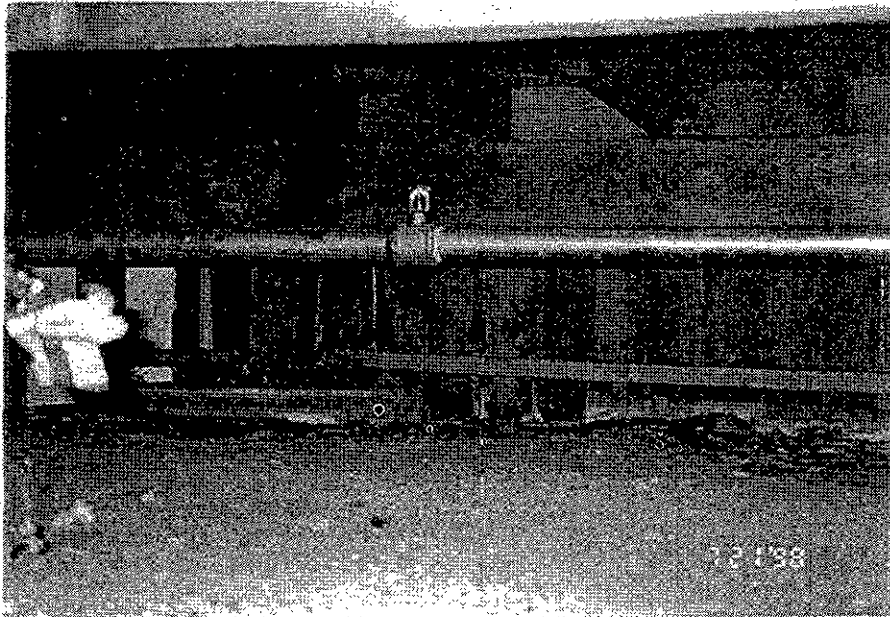
concrete footings (Photo No. 15). The north wing has a perimeter cripple wall which encloses the crawl space (Photo Nos. 15 and 17). The footings supporting the perimeter posts of the north wing are exposed on the exterior (Photo No. 9).

Photo No. 17  
Unbraced Cripple Wall at North Wing

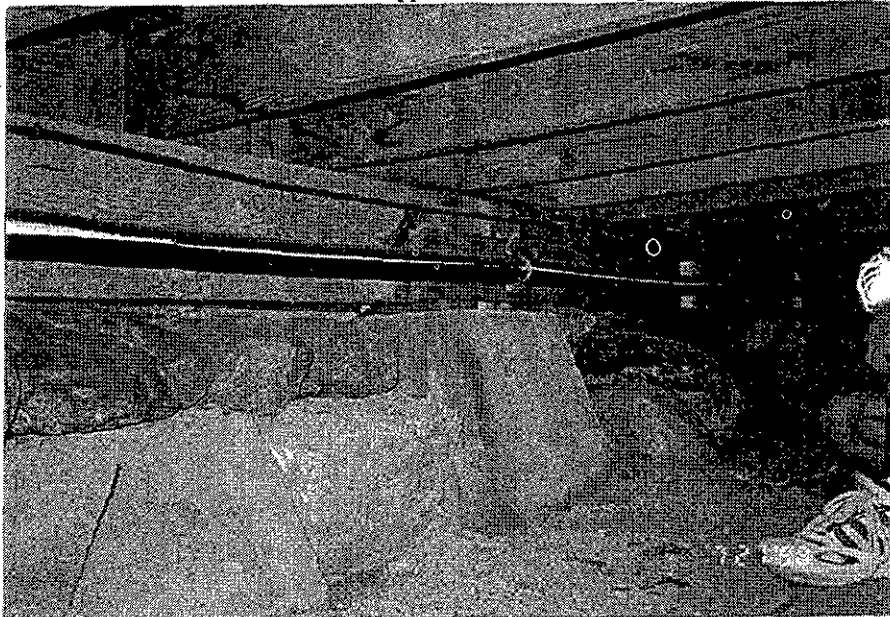
Photo No. 18  
Tapered Footing Supporting Wood Column at Grids H-3

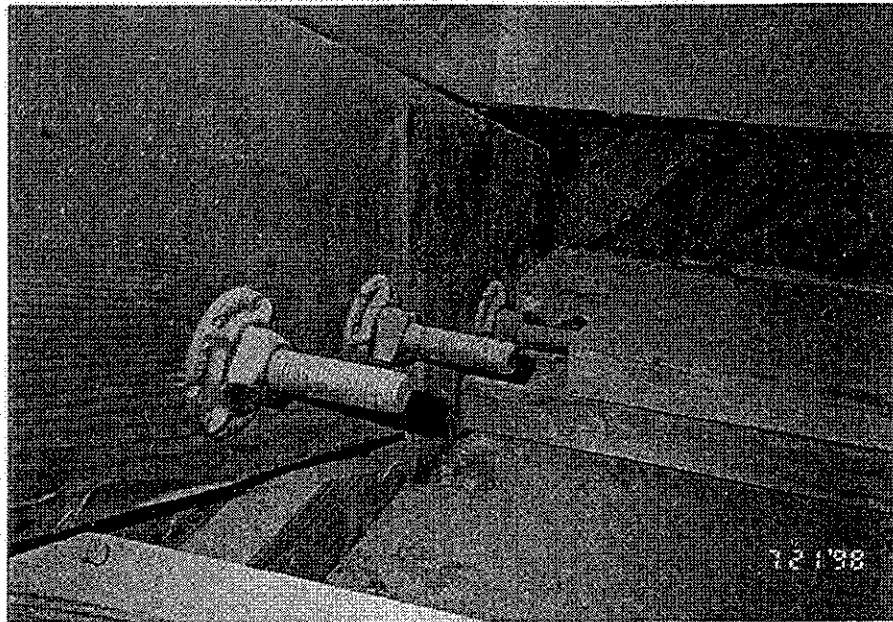
The double 2x top wall plates cannot function as the roof diaphragm chords or as diaphragm drag struts because the plates are not adequately spliced. At the north and south auditorium walls, the top plates are interrupted at each column (Photo No. 19). In addition, the top plates on the east and west auditorium walls are butt spliced at each break in roof slope (Photo No. 10).

Photo No. 19  
Two 2x Top Wall Plate Discontinuous at Truss to Column Connections
