Rotor Tips

JANUARY-FEBRUARY, 1974

Volume VIII No. 1

TECHNICAL SECTION

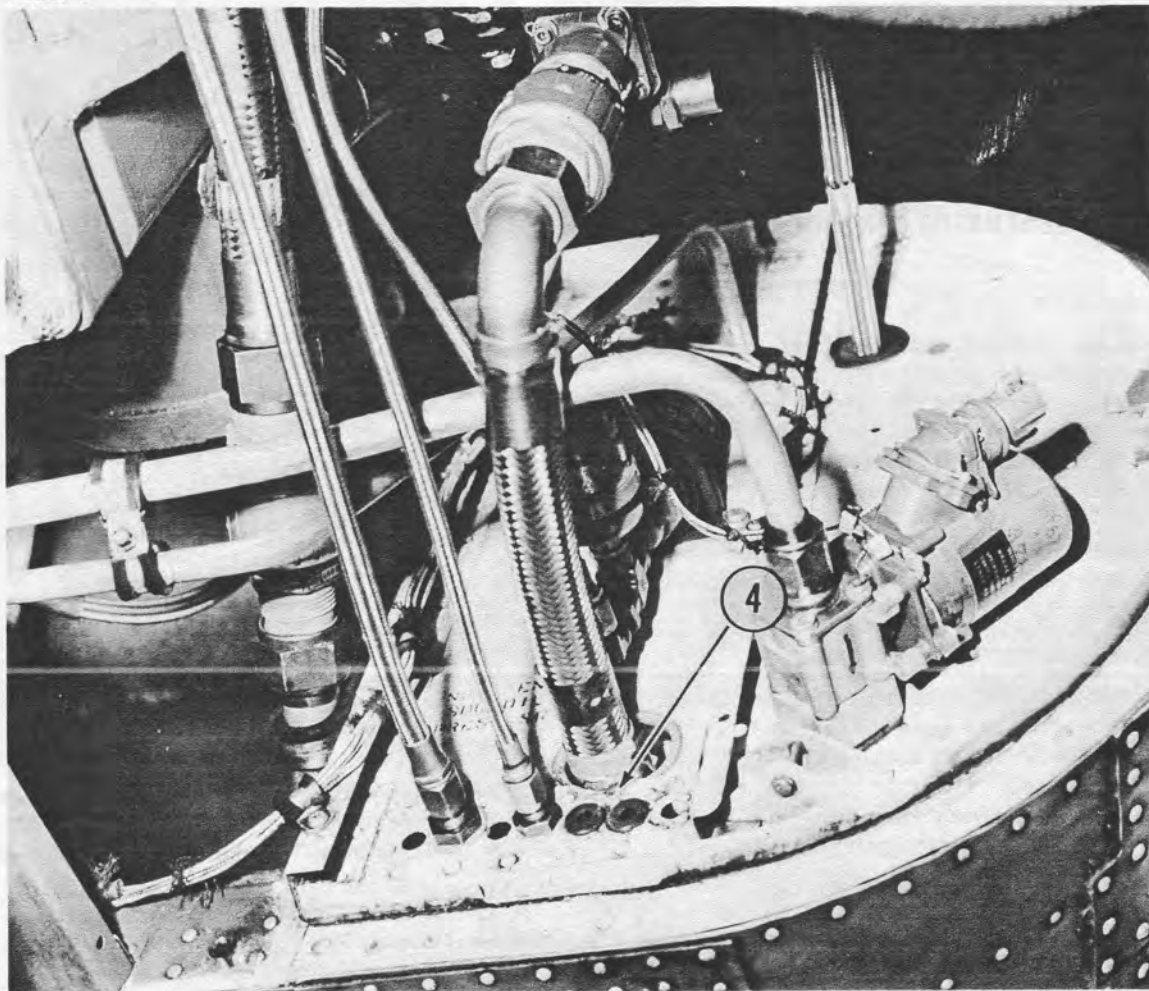
If the longer 20343-1B quick-disconnect (item 2) is used in the inlet line where item 1 belongs, it will force the K678747-17 speed deceiver gearbox oil inlet hose assembly downwards, and cause chafing as it passes through the firewall (see item 4 both photographs). Conversely, if the shorter 20343-1 quick-disconnect (item 1) is used in the outlet line where item 2 belongs, the result will be a stretched and pre-loaded hose assembly.

1. Quick-disconnect, P/N 20343-1
2. Quick-disconnect, P/N 20343-1B
3. Combining gearbox
4. Point of interference-See Photo B

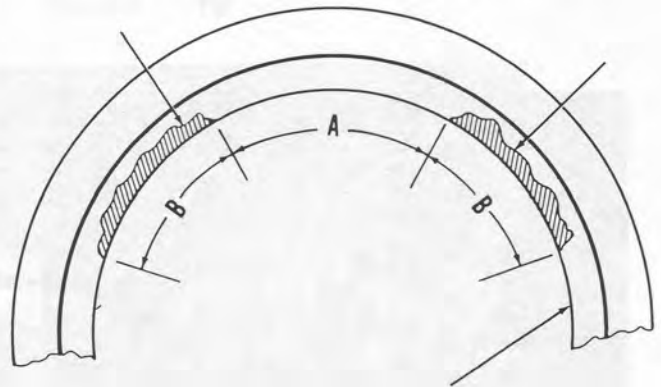
During engine removal/installation, input shaft oil dam seals are exposed to possible damage when mating the speed decriaser and combining gearbox drive splines. Seal replacement procedures require the use of special sockets and tooling, making it necessary to return the gearbox to overhaul for seal replacement. (One input shaft oil dam seal is installed on each side of the forward face of the CGB; see arrow in the photo.)

Oil dam seals (P/N K674853-13) must be replaced when any of the following is discovered:

1. Any missing segment of seal, exceeding 2 inches.
2. Three or more missing segments, which, when added together totals more than 5 inches.
3. Separation between adjacent missing segments (segment A on illustration) is less than shortest adjacent missing segment.

The following inspection criteria is presented to preclude premature gearbox replacement due to damaged seals.
