**OPERATIONAL EFFECTS ON CRASHWORTHY  
SEAT ATTENUATORS**

**Marvin Kent Richards**

**Simula Inc.  
Phoenix, Arizona 85044-5299**

**Final Report for Period September 1987 - November 1989**

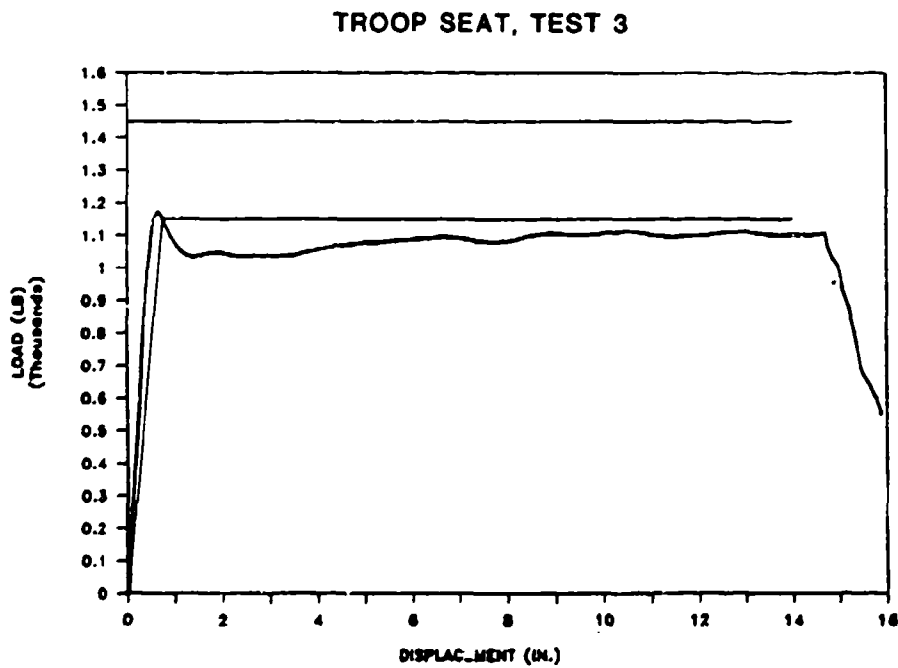
**FIGURE 8. TYPICAL STATIC TEST RESULT - TROOP SEAT, NEW ENERGY ABSORBER.**

An example of a typical static test result for a new troop seat energy absorber is shown in Figure 8. The load peaked out at approximately 1170 lb and then dropped to a relatively steady load around 1070 lb, well below the desired minimum of 1150 lb. This response was similar for all four of the new energy absorbers, which had an average stroking load between 1059 and 1078 lb. Plots for the other three energy absorbers can be found in Appendix B.

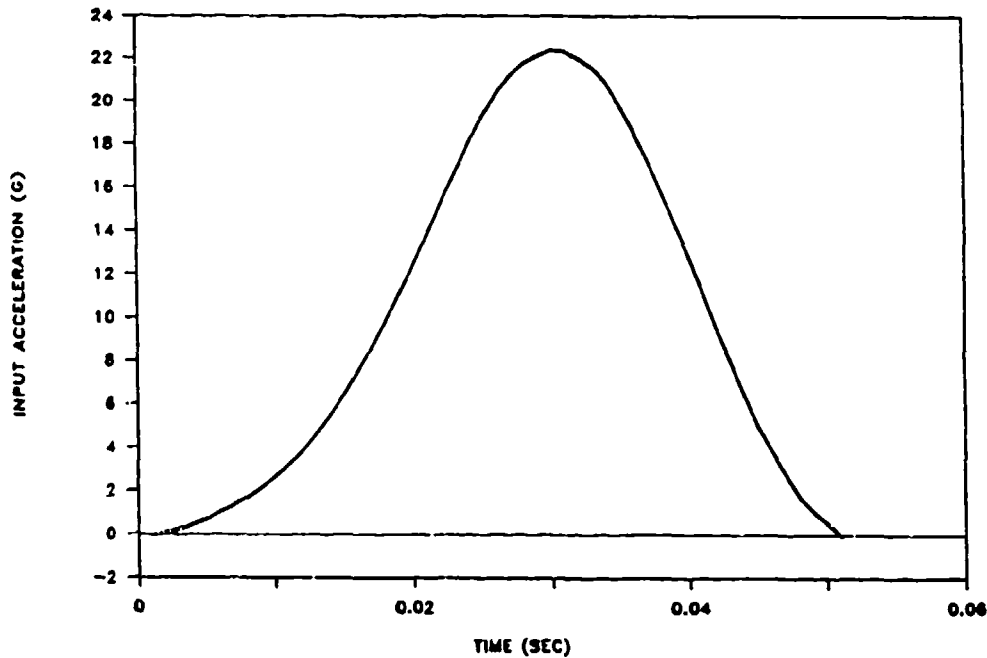
FIGURE 12. TYPICAL TROOP SEAT DYNAMIC TEST INPUT PULSE.

A typical dynamic test input pulse is shown in Figure 12. This pulse has a peak of 22.4 G with an onset rate of approximately 1080 G/sec and total velocity change of 16.5 ft/sec. All energy absorbers were stroked at an average velocity between 8.0 and 11.6 ft/sec.

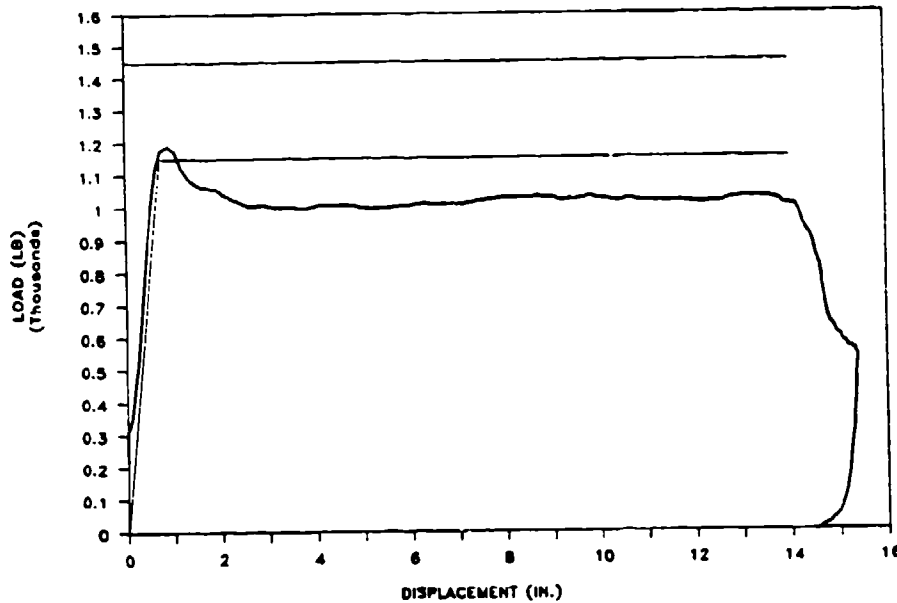
**FIGURE 13. TYPICAL DYNAMIC TEST RESULT - TROOP SEAT, NEW ENERGY ABSORBER.**

An example of a new troop seat energy absorber dynamic test result is shown in Figure 13. Plots for the other five energy absorbers can be found in Appendix B. The load-deflection characteristics were similar to those for the static tests.

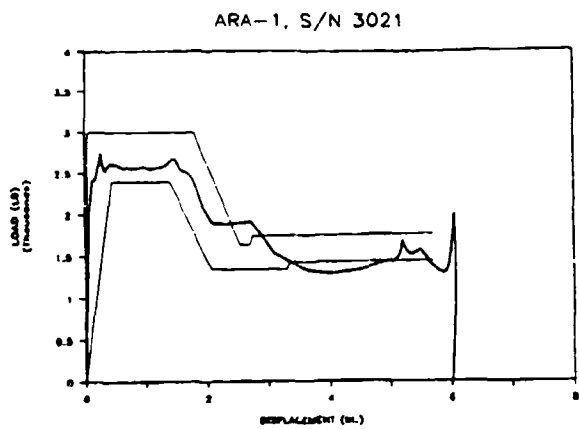
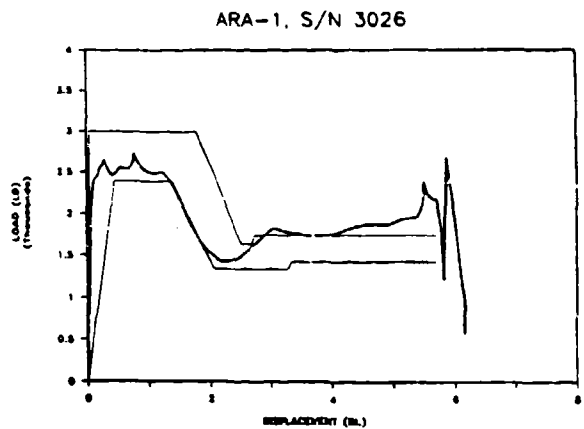
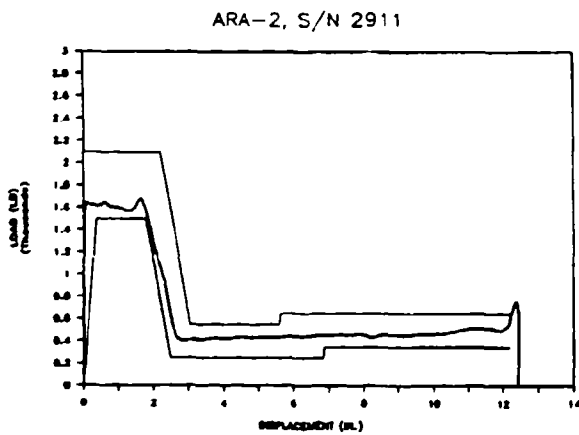
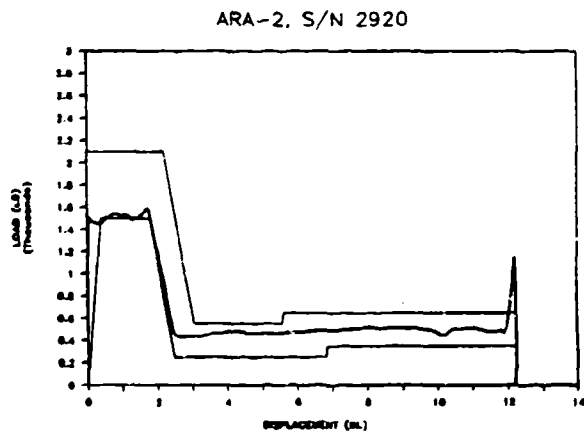
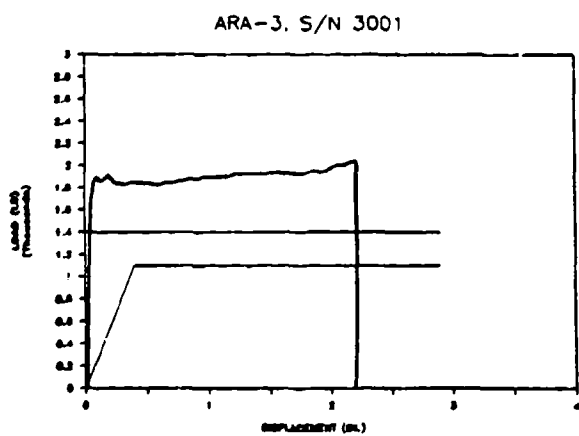
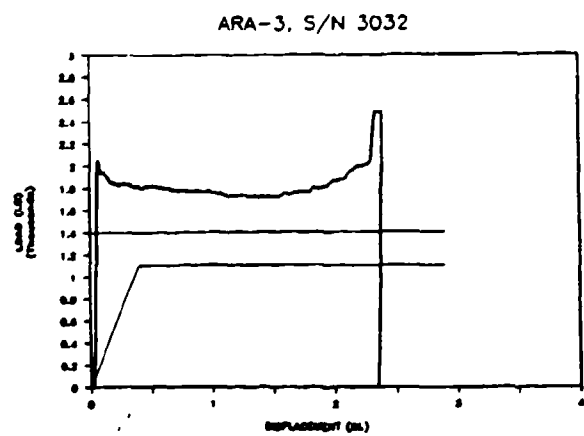
**FIGURE 20. STATIC TEST RESULTS - ARA CREW SEAT, NEW ENERGY ABSORBERS.**

Plots of the static test results for the new ARA energy absorbers are shown in Figure 20. The -1 and -3 energy absorbers did not fall within the specified limits for the entire stroke. The -3 energy absorbers were both high, and one -1 was high and the other low at the end of the stroke. Both -2 energy absorbers met the desired load-deflection characteristics.

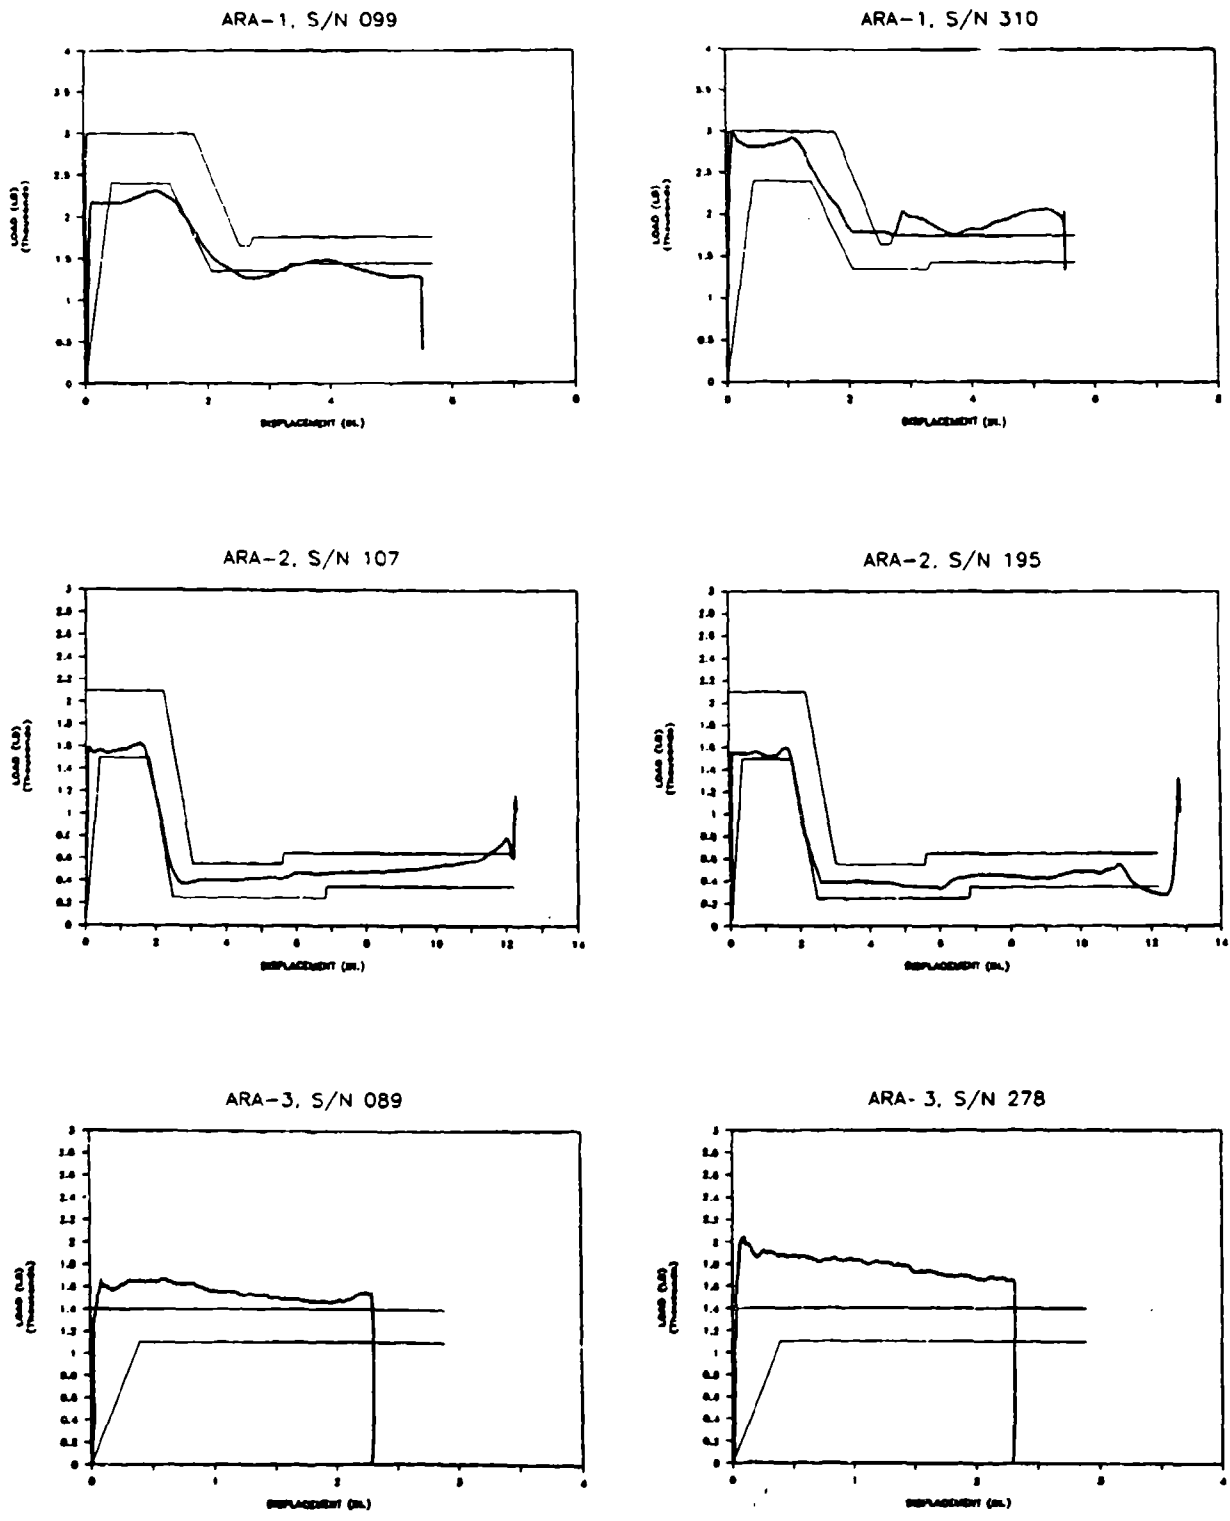
**FIGURE 21. STATIC TEST RESULTS - ARA CREW SEAT, FIELDED ENERGY ABSORBERS.**

Plots of the static test results for the fielded ARA energy absorbers are shown in Figure 21. The load-deflection response of the fielded units was similar to that of the new units in that both -3 energy absorbers were high, and one -1 was high and the other low at the end of stroke. Both -2 energy absorbers met the specified load-deflection requirements.

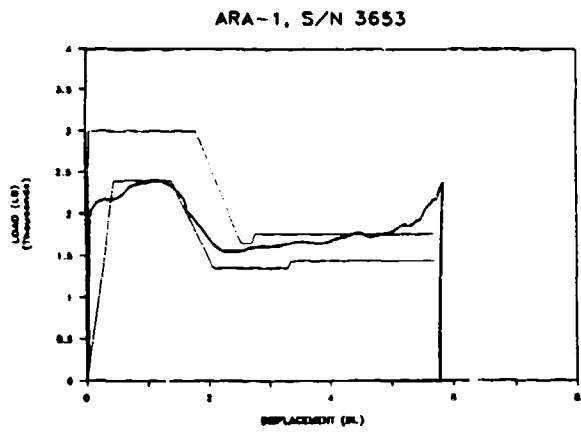
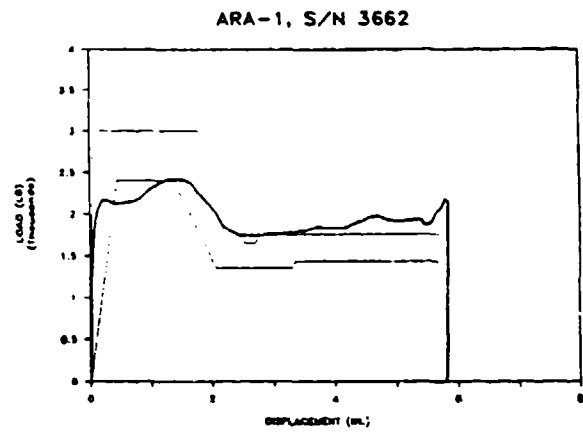
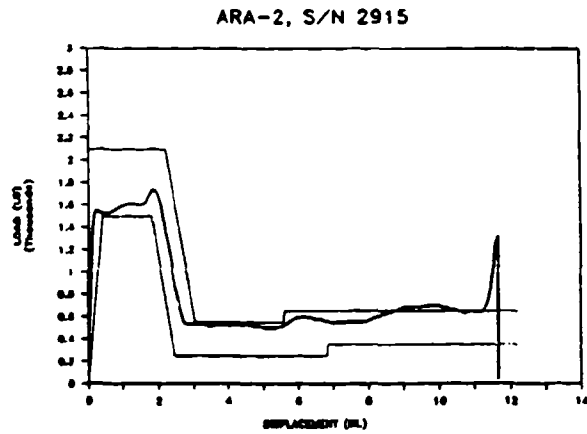
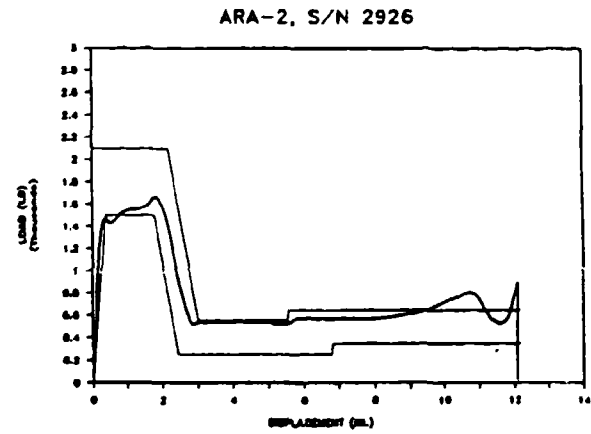
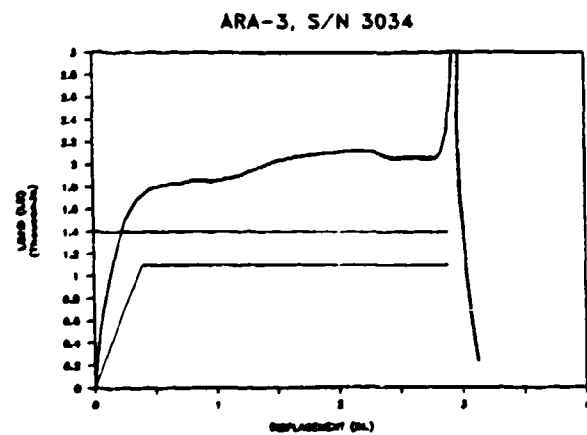
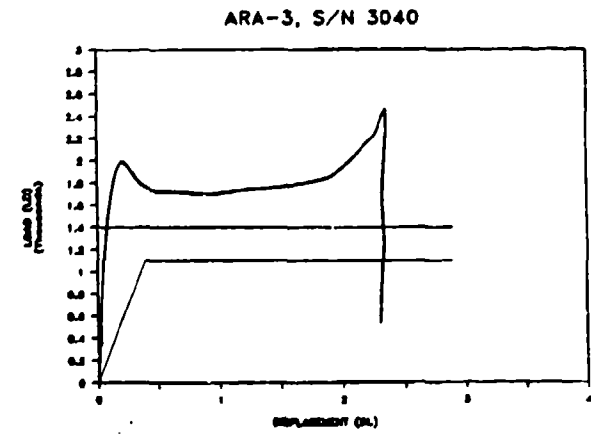
**FIGURE 22. TYPICAL DYNAMIC TEST RESULTS - ARA CREW SEAT, NEW ENERGY ABSORBERS.**

Examples of dynamic test results for the new ARA energy absorbers are shown in Figure 22. The -1 energy absorbers were typically low at the start of the stroke and high at the end of the stroke. The -2 energy absorbers were also typically low at the start of the stroke but usually within the corridor, and then climbed out of the corridor toward the end of the stroke. The -3 energy absorbers were all well above the desired stroking range. Plots for the remaining new energy absorbers can be found in Appendix C.

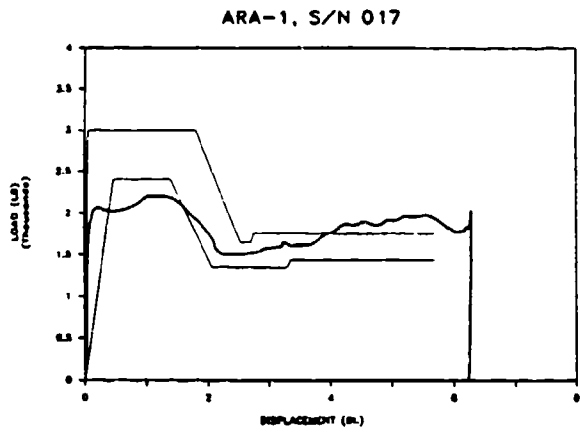
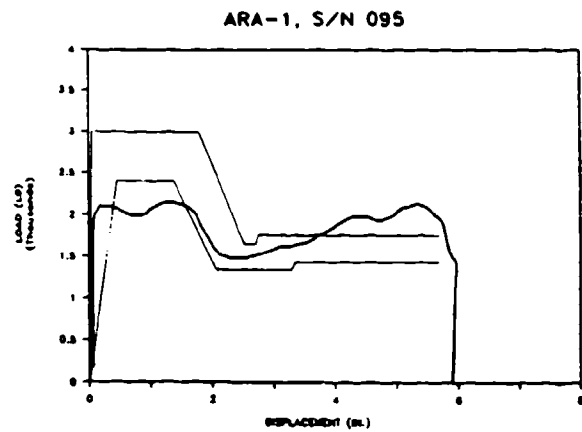
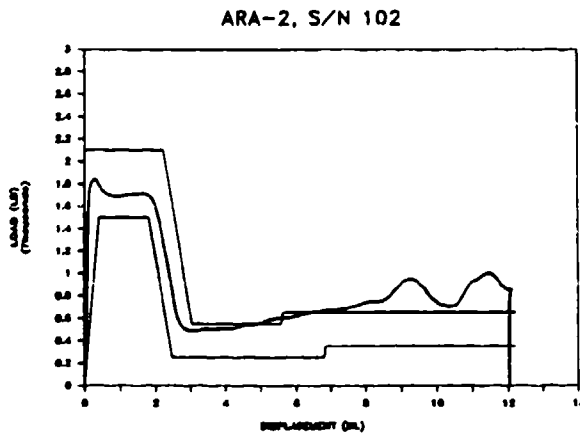
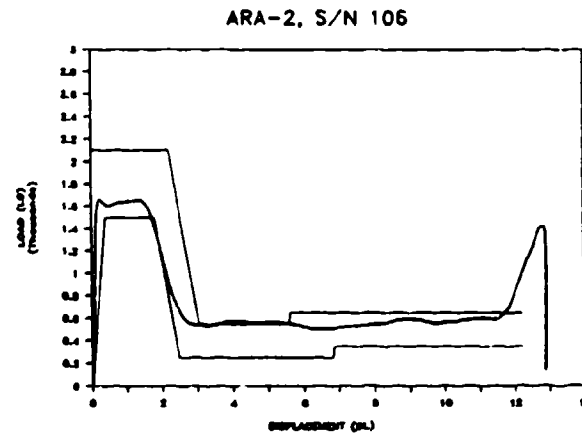
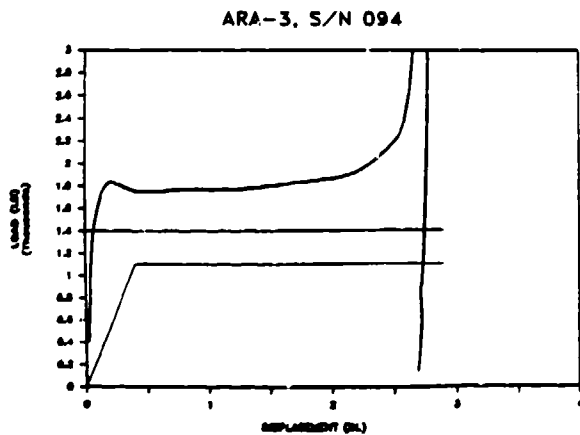
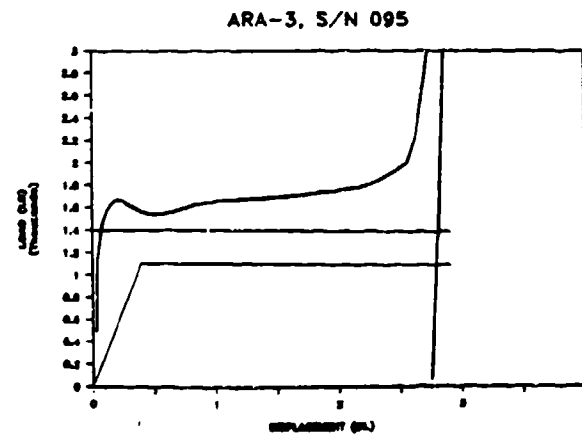
**FIGURE 23. TYPICAL DYNAMIC TEST RESULTS - ARA CREW SEAT, FIELDIED ENERGY ABSORBERS.**

Examples of dynamic test results for the fielded ARA energy absorbers are shown in Figure 23. In general the dynamic response of the fielded energy absorbers was similar to that of the new energy absorbers. Selected worst-case examples are shown in Figure 24. Plots for the remaining fielded energy absorbers can be found in Appendix C.

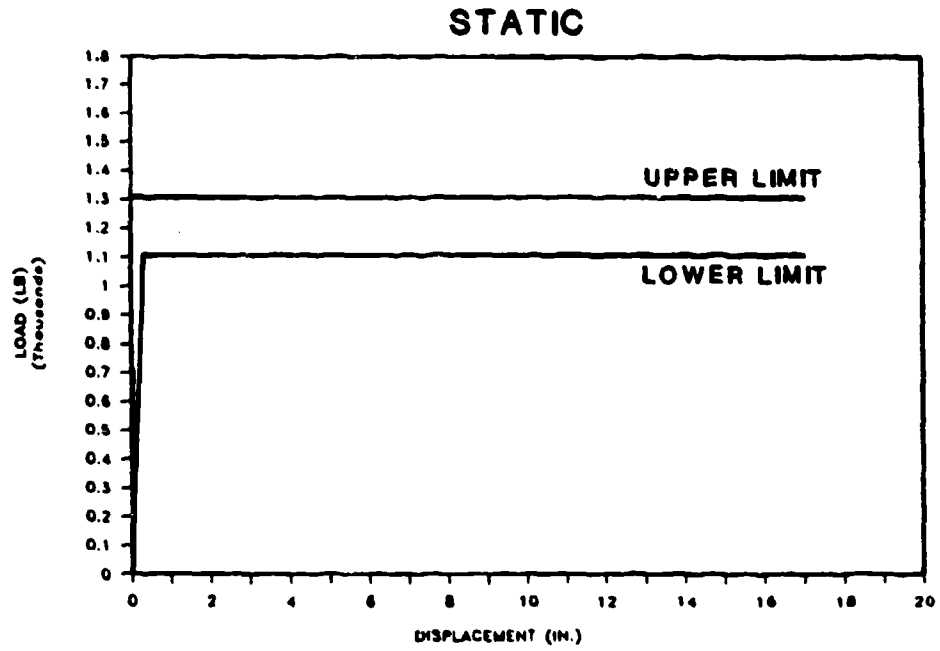
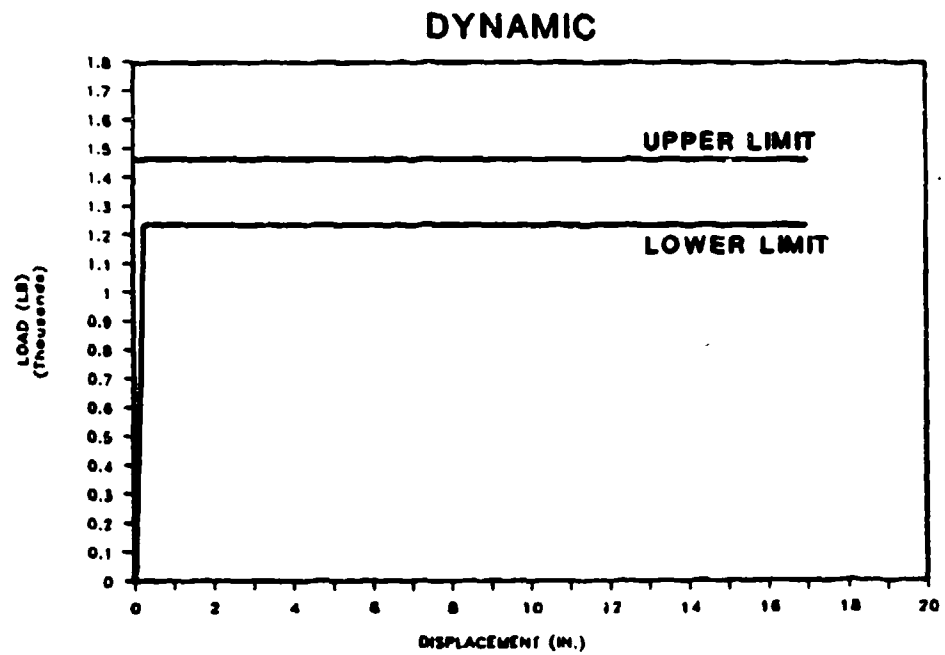
The drawing does not specify the desired dynamic stroking load or the stroke allowed to reach load. According to the static qualification report for this seat (Reference 1), dynamic stroking increased the load by an average of 13 percent, and a stroke of 0.3 in. was required to reach steady state stroking load. This translates to a desired dynamic stroking load of  $1363 \pm 113$  lb. The desired load-deflection corridors are shown in Figure 26.

**FIGURE 26. SIMULA/NORTON ENERGY ABSORBERS  
LOAD-DISPLACEMENT CORRIDORS.**

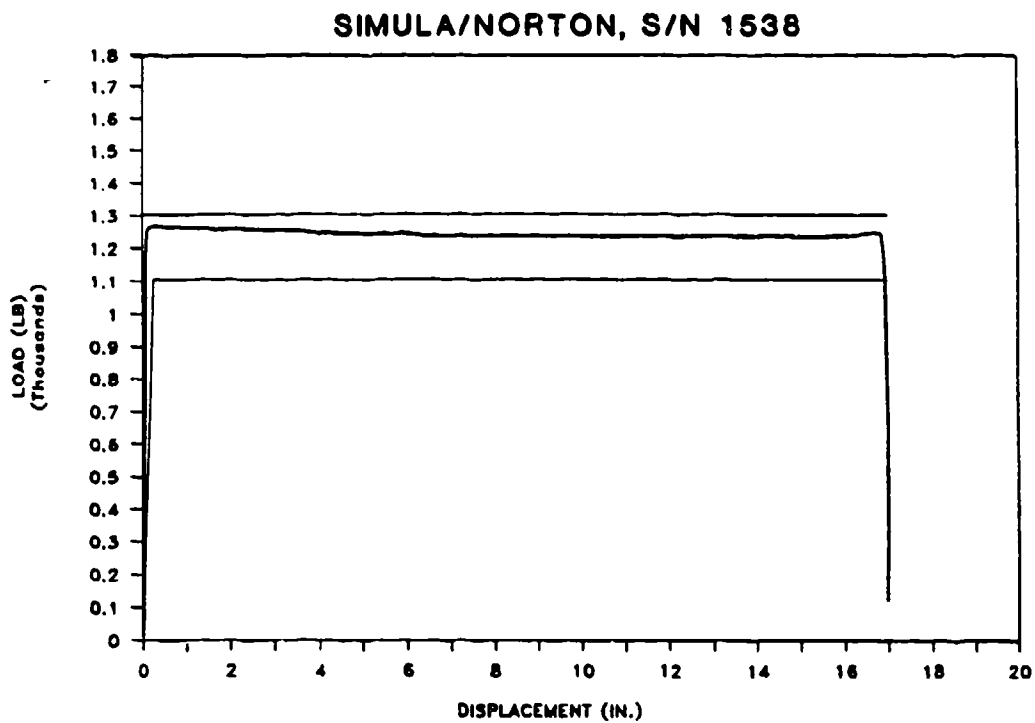
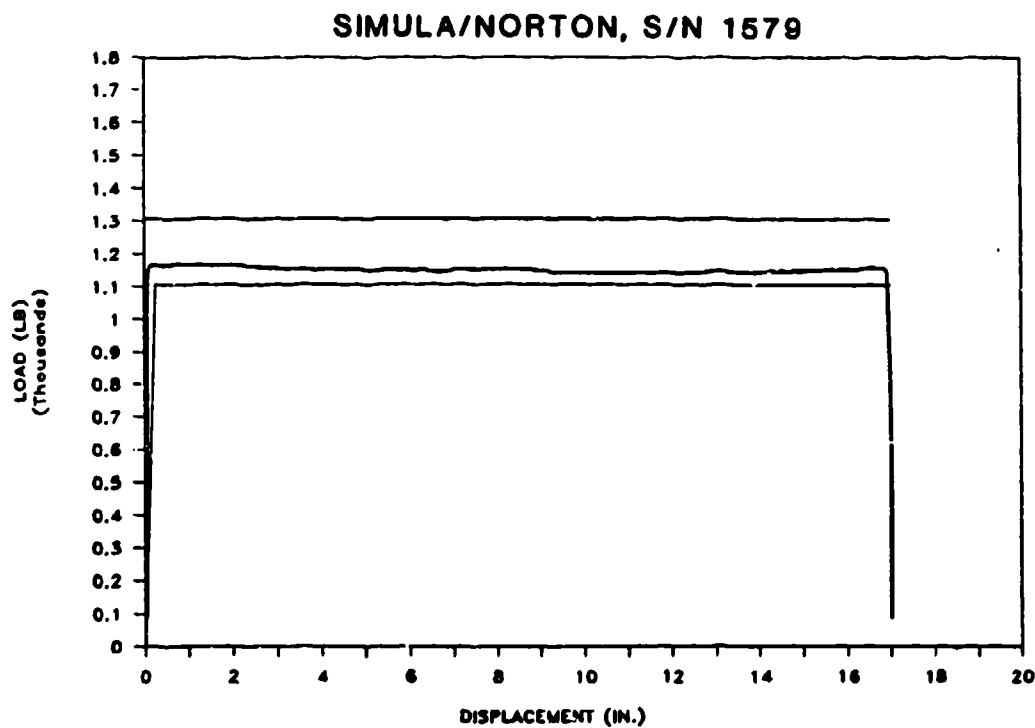
Plots of the static test results for the new Simula/Norton energy absorbers are shown in Figure 27. Both energy absorbers stroked within the desired corridor.

**FIGURE 27. STATIC TEST RESULTS - SIMULA/NORTON CREW SEAT, NEW ENERGY ABSORBERS.**

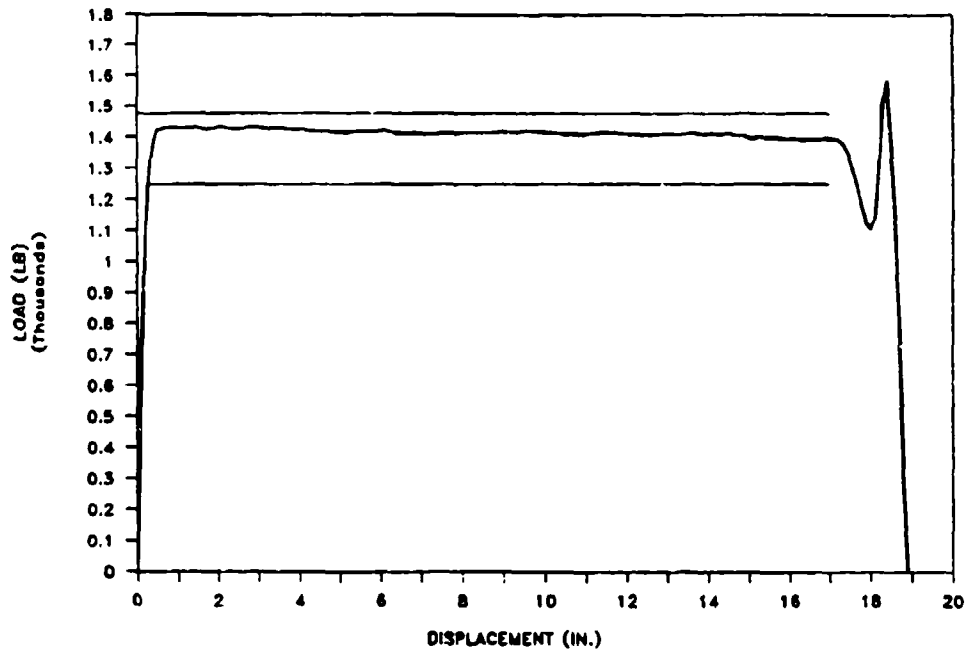
## SIMULA/NORTON, S/N 1537

An example of dynamic test results for a new Simula/Norton energy absorber is shown in Figure 29. All six of the new energy absorbers stroked within the desired corridor. One energy absorber had a small spike outside the corridor at the start of the stroke. Plots of dynamic test results for these energy absorbers can be found in Appendix D.

**FIGURE 29. TYPICAL DYNAMIC TEST RESULT - SIMULA/NORTON CREW SEAT, NEW ENERGY ABSORBER.**

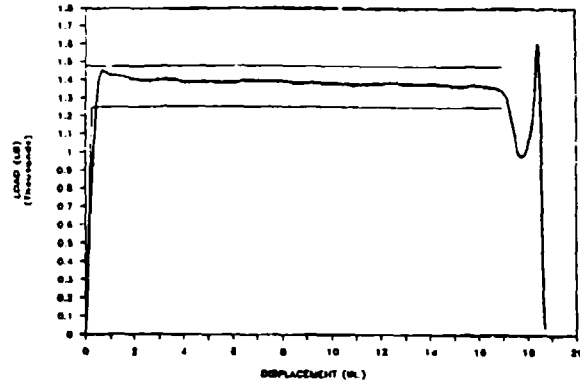
SIMULA/NORTON, S/N 142

b. TYPICAL

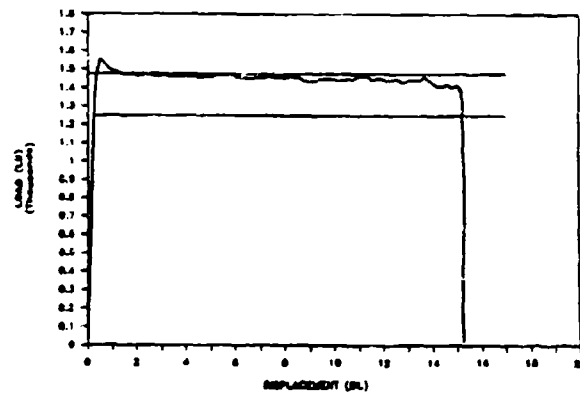
SIMULA/NORTON, S/N 046

Examples of dynamic test results for the fielded Simula/Norton energy absorbers are shown in Figure 30. All of the fielded energy absorbers stroked within the desired limits except S/N 013. Energy absorber S/N 046 had the highest stroke. Note the brief initial spike outside the corridor at the

d. HIGHEST

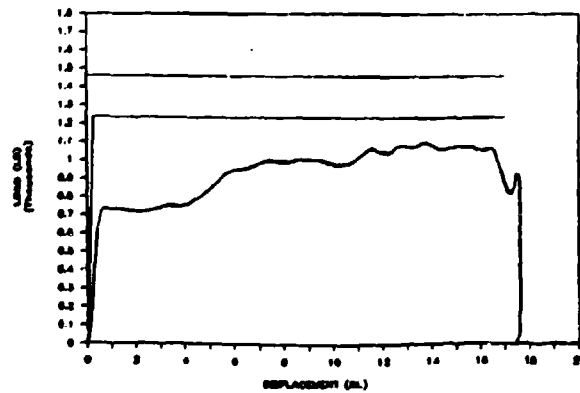
SIMULA/NORTON, S/N 13

e. LOWEST

All of the energy absorbers with corrosion had acceptable load-deflection characteristics and total energy absorption except S/N 013. This energy absorber did have a corrosion patch but it was only in a localized area. S/N 014 had a larger corrosion patch and had acceptable stroking characteristics, indicating that the corrosion was not a factor for stroking performance.

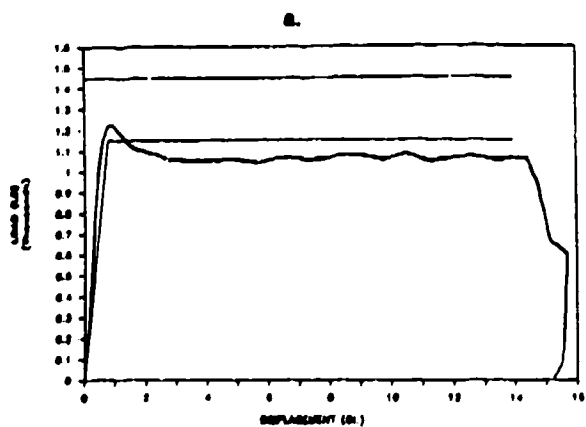
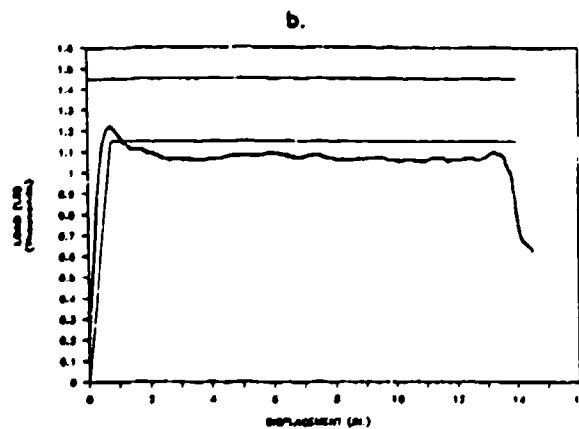
**FIGURE B-26. SIKORSKY TROOP SEAT NEW ENERGY ABSORBERS.**

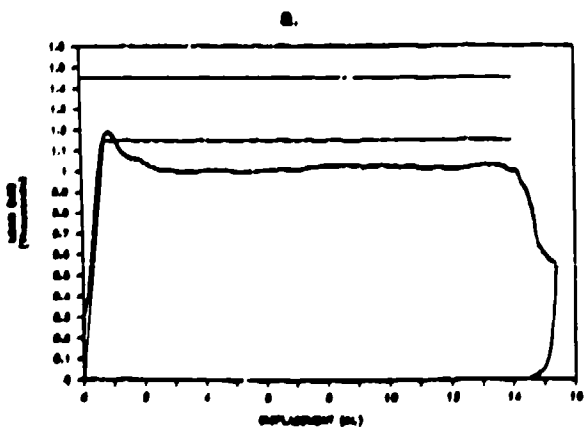
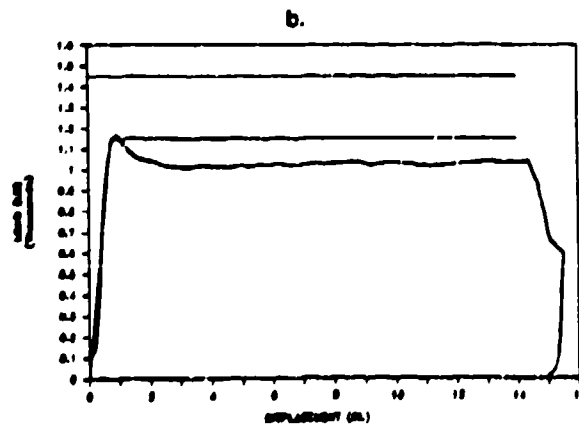
**FIGURE B-27. SIKORSKY TROOP SEAT NEW ENERGY ABSORBERS.**

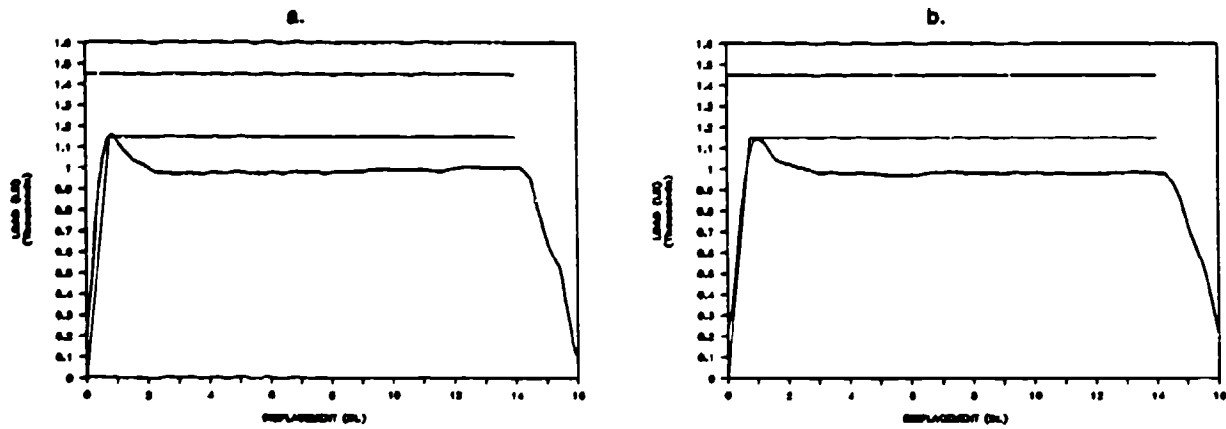
**FIGURE B-28. SIKORSKY TROOP SEAT NEW ENERGY ABSORBERS.**

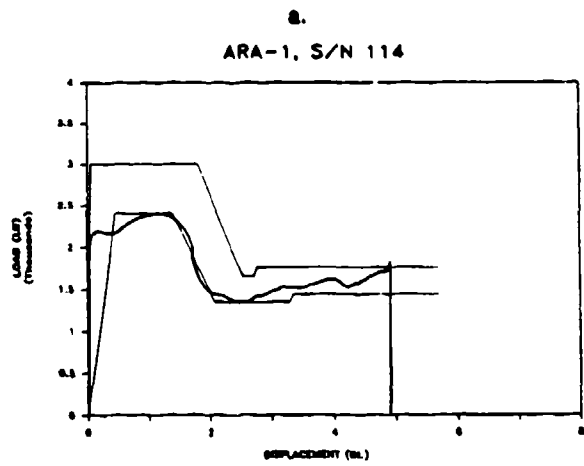
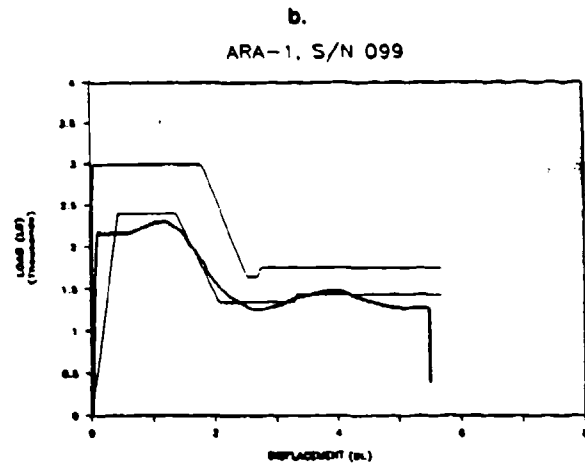
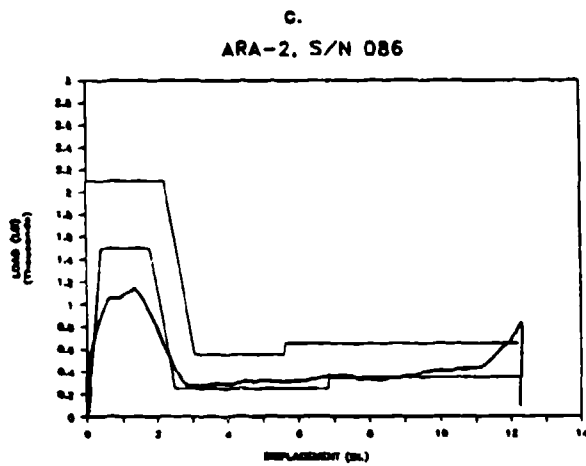
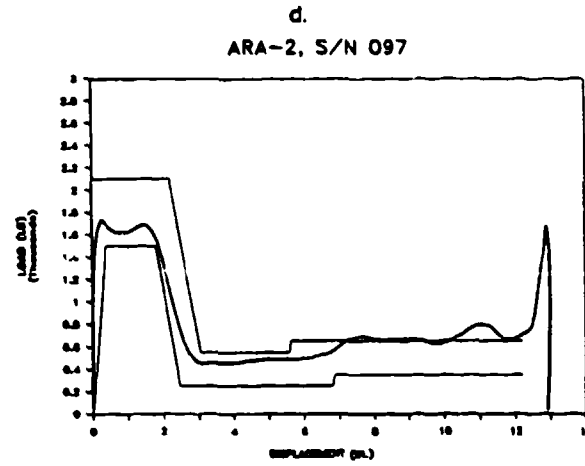
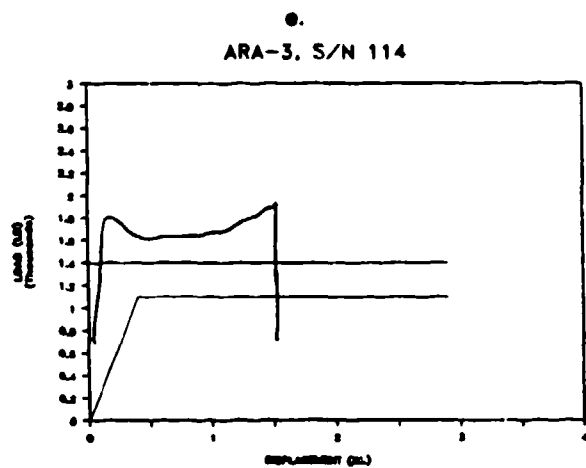
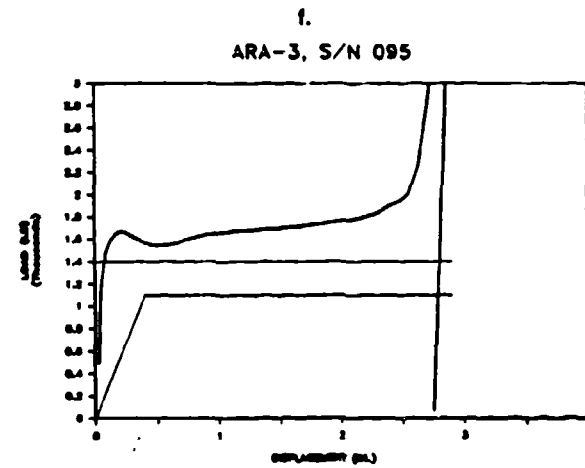
FIGURE C-2. ARA SEAT S/N \*, AIRCRAFT T/N 81-23597.

\*Name placard missing.

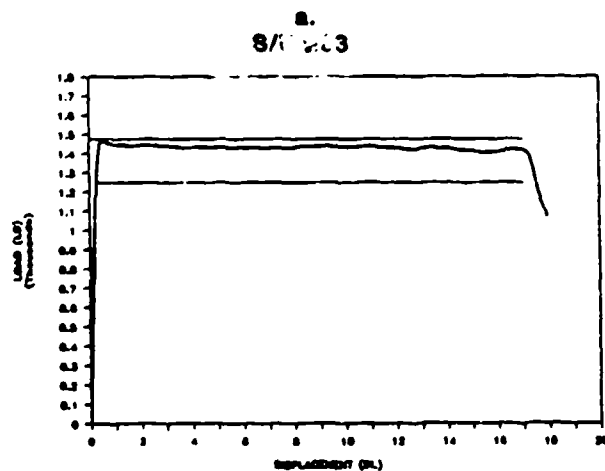
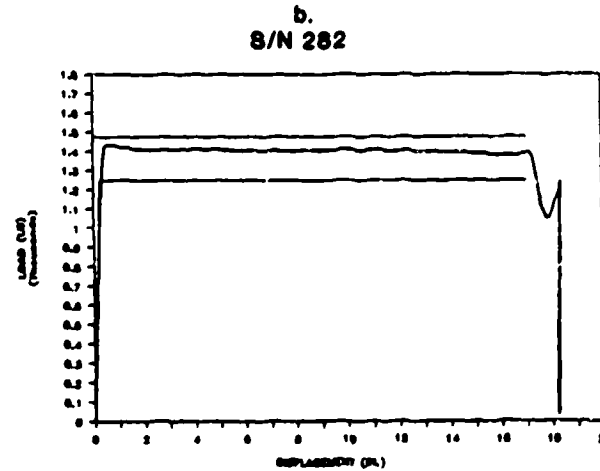
FIGURE D-8. SIMULA/NORTON SEAT S/N \*, AIRCRAFT T/N 78-22990.

\*Name placard missing.
