PHASE I INSPECTION REPORT  
NATIONAL DAM INSPECTION PROGRAM

Latrobe Reservoir

16 May 1978 (visual inspection)

PHASE I INSPECTION REPORT  
NATIONAL DAM INSPECTION PROGRAM  
LATROBE RESERVOIR  
NDI# PA-479, PENNDR# 65-66

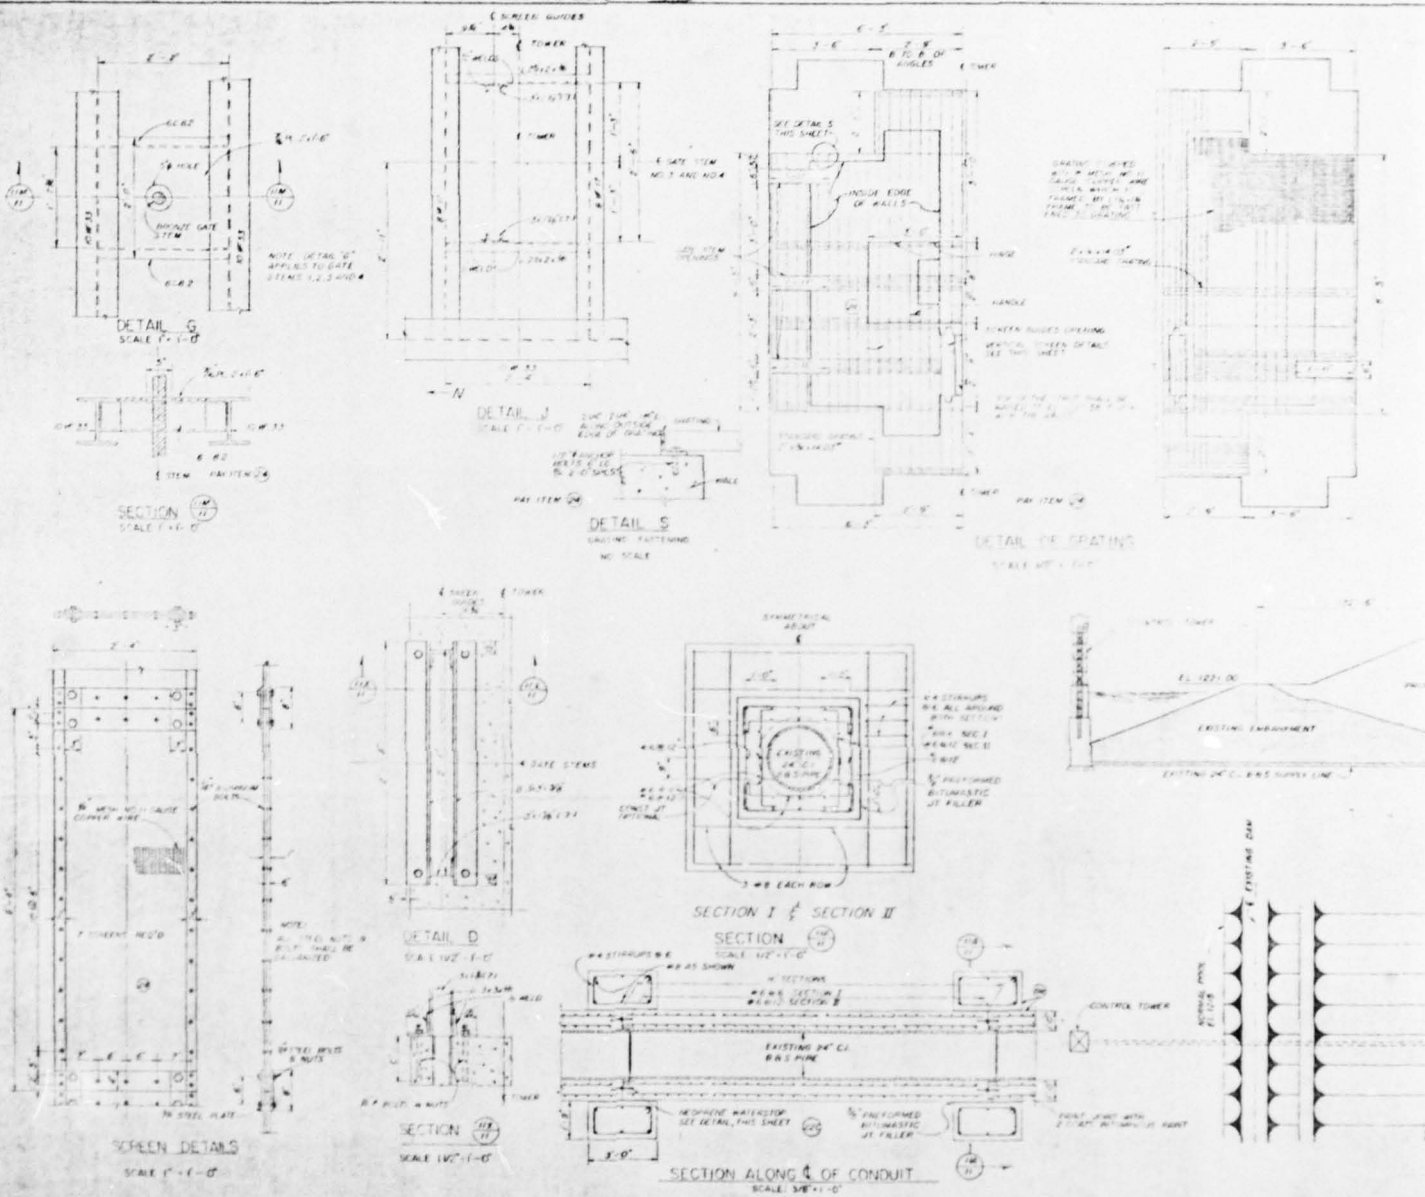
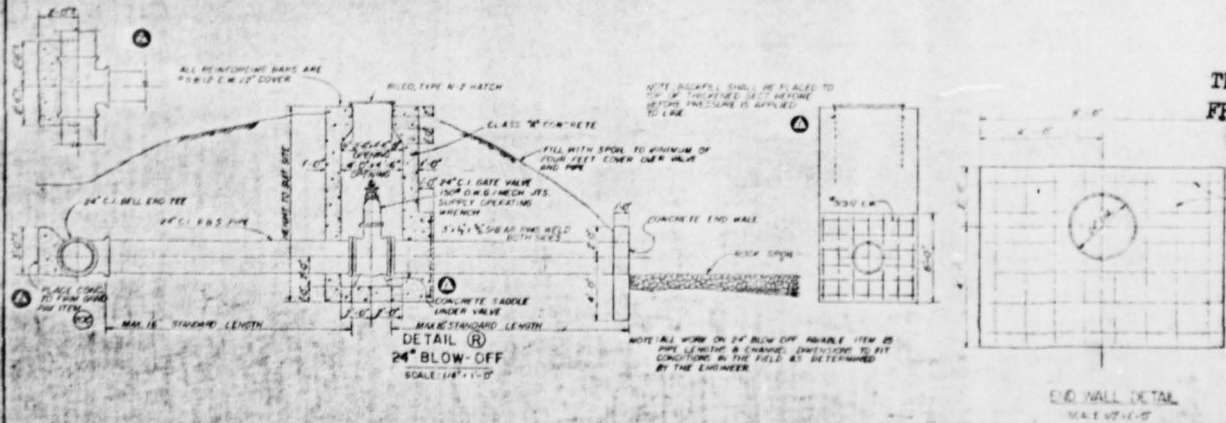
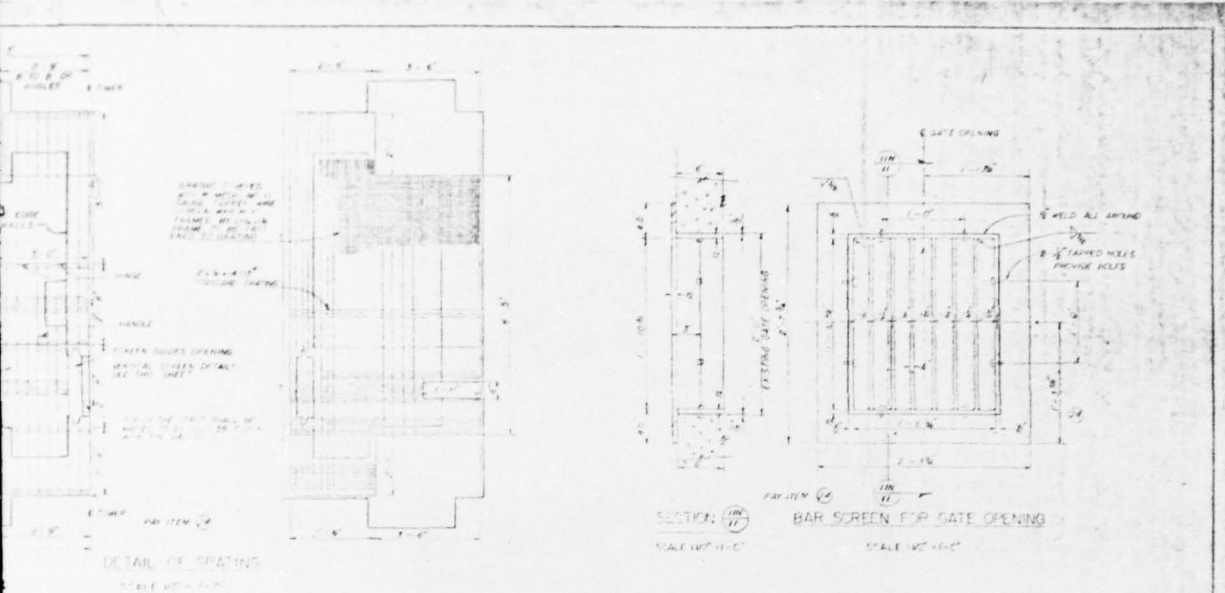
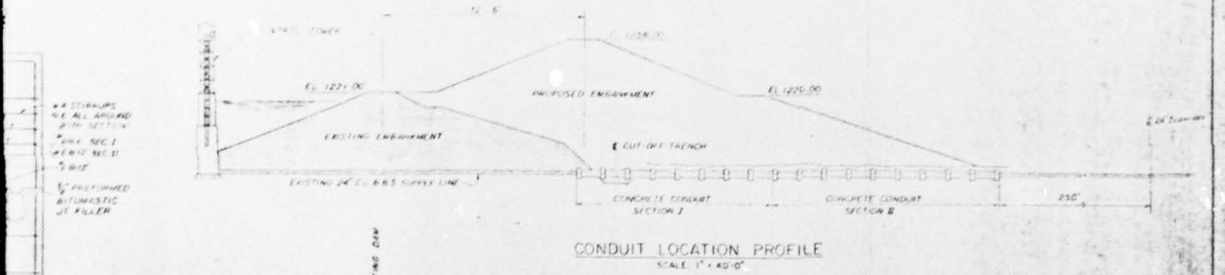
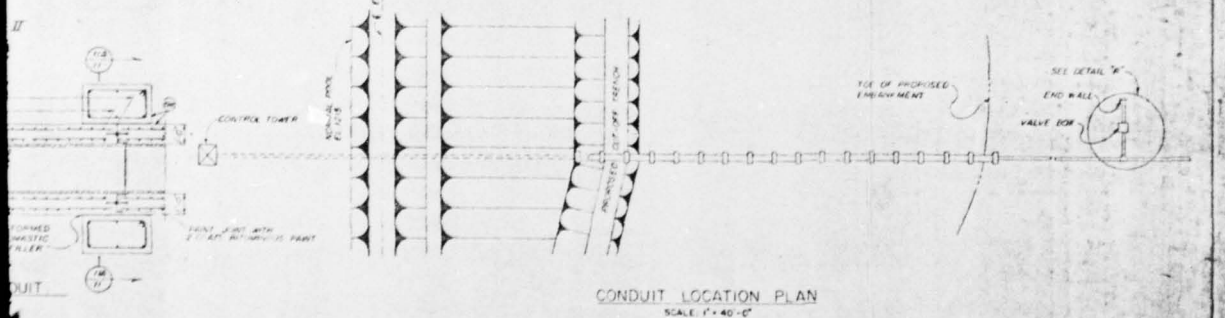
FIGURE 5 2

c) Gate House. The original gate house was modified in 1958 in order to raise the structure and permit the drawing of water through four gates located at different elevations within the reservoir. The gates discharge water directly into the 24-inch supply line. Details of the modifications of the gate house are shown on Figure 5.
