# 9710 W Outer Dr

## Existing Condition Photos

# 9730 W Outer Dr

# Detailed Scope of Work

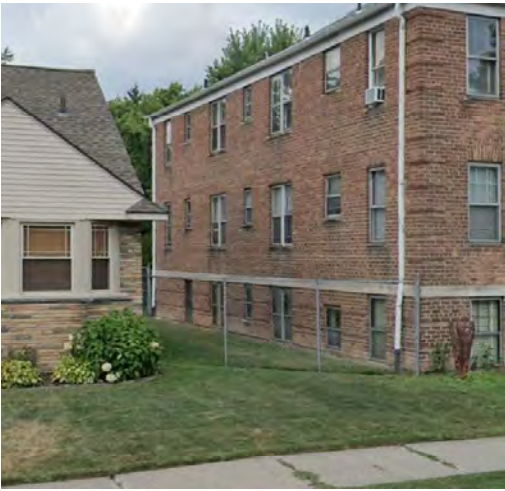
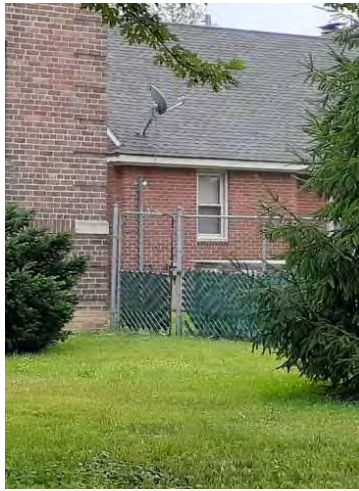
### Existing Fence

- Short runs of chain link fence go beyond the property line

10. Install new security fence at perimeter of parking lot and ramp with pedestrian swing gate and remote operated vehicular gates; existing sections of fence on-site to remain

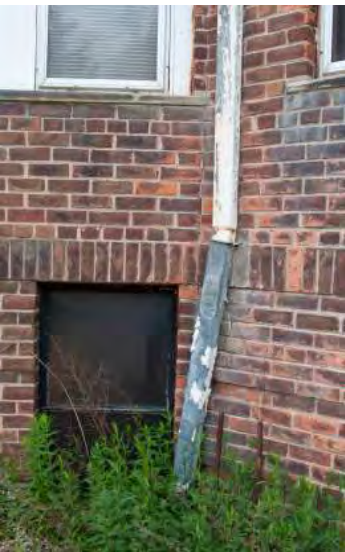
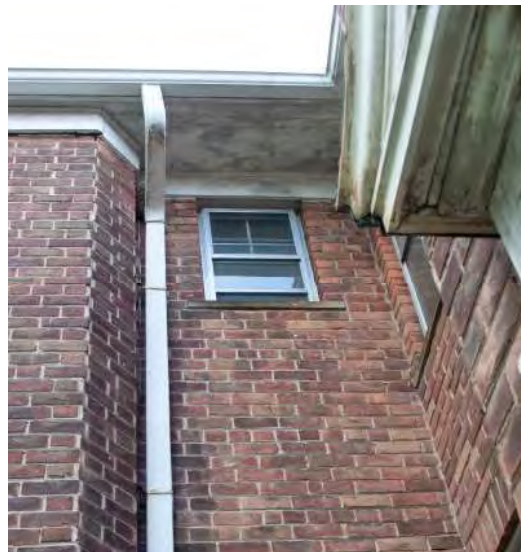
### Existing Downspouts

- Downspouts are in good condition and are tied into the City sewer; Paint is flaking off.
- Gutters need painting

8. Repair existing historic woodwork at front entries of 9710 & 9730
9. Scrape and paint all exterior doors, wood features, and gutters; paint and install new 8"x8" brick vents per res. unit in brick facades (avoid front facade) where brick vent is not already existing

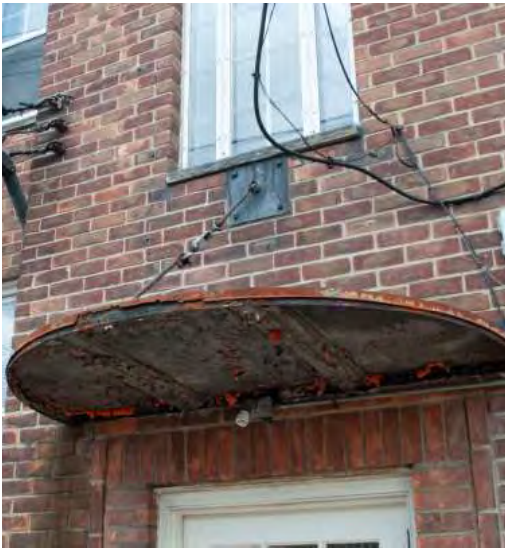
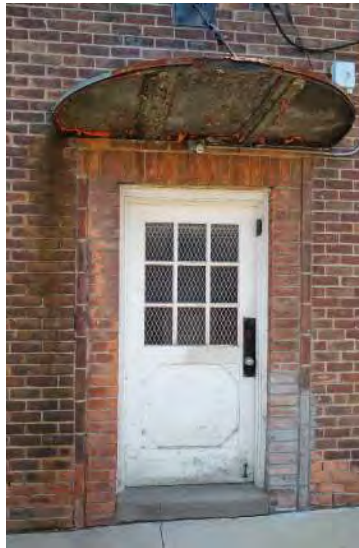
### Existing Canopy

- Existing tie back canopy is corroded and in need of repair/reconstruction
- Brick is discolored/damaged around door and canopy due to improper drainage

4. Install new accessible ramp and railing at 9730 new accessible entry
5. Replace existing 9710 steel & wood canopy in kind, and install similar new canopy at new 9730 accessible entry; install downspout at both canopies for water mitigation

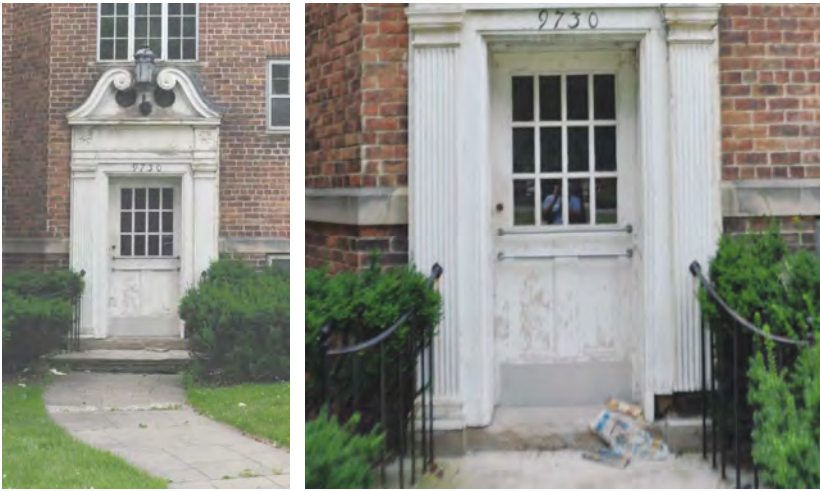
### Existing 9730 Front Landing

- Existing landing is damaged and hazardous

6. At 9730 front entry, remove & replace existing concrete landing in kind & restore historic light fixture
7. Replace all other light fixtures at entrances with new; install new exterior sconce at new accessible entry; remove building-mounted security lights; install new security lighting at parking lot & ramp

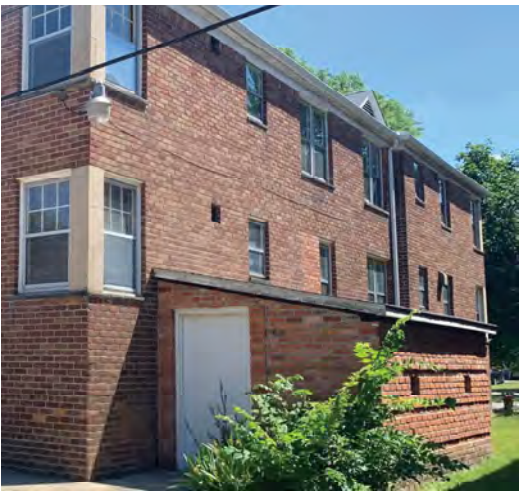
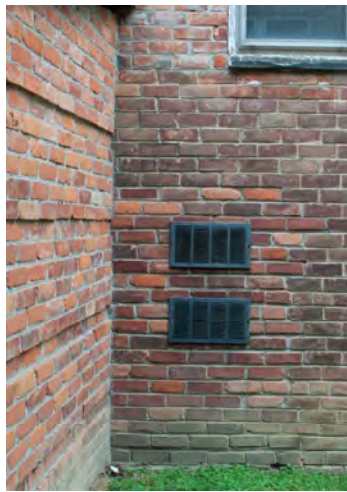
### Existing Vents in Masonry

- Existing vents in masonry are located in the kitchens in 9710
- Existing vents in masonry are also located at the mechanical room in 9710

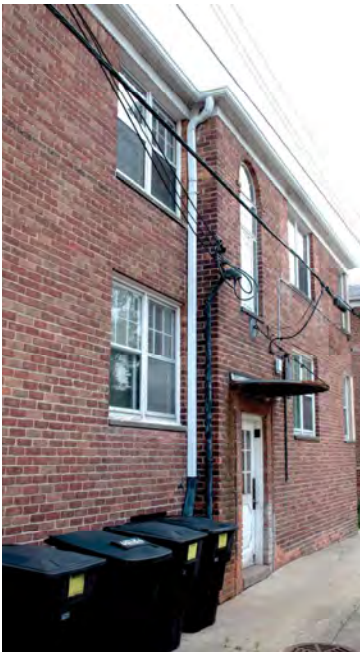
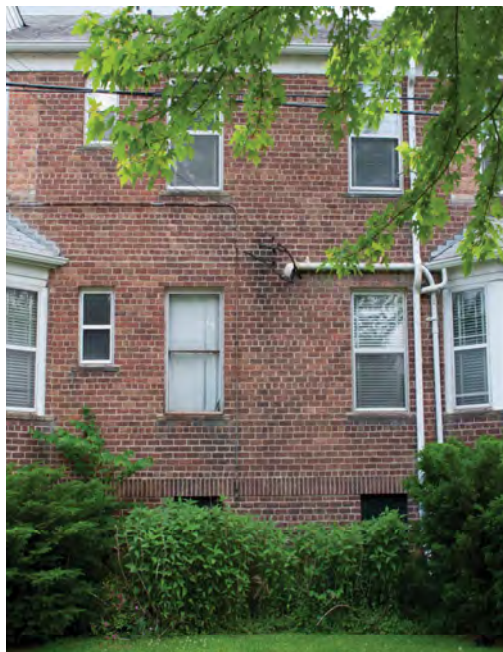
### Existing Conduit

- Conduit is building-mounted at the back of both buildings

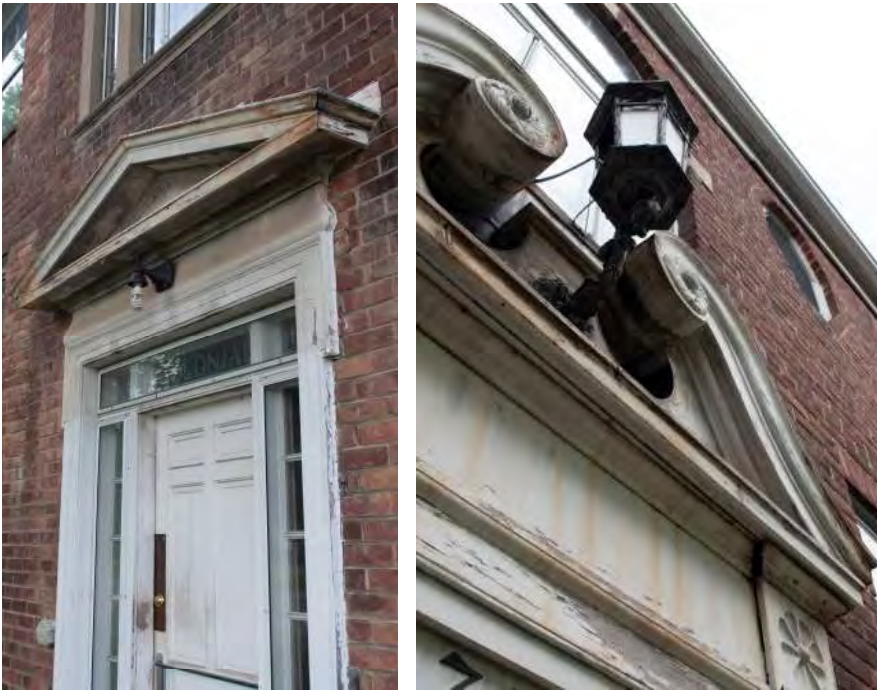
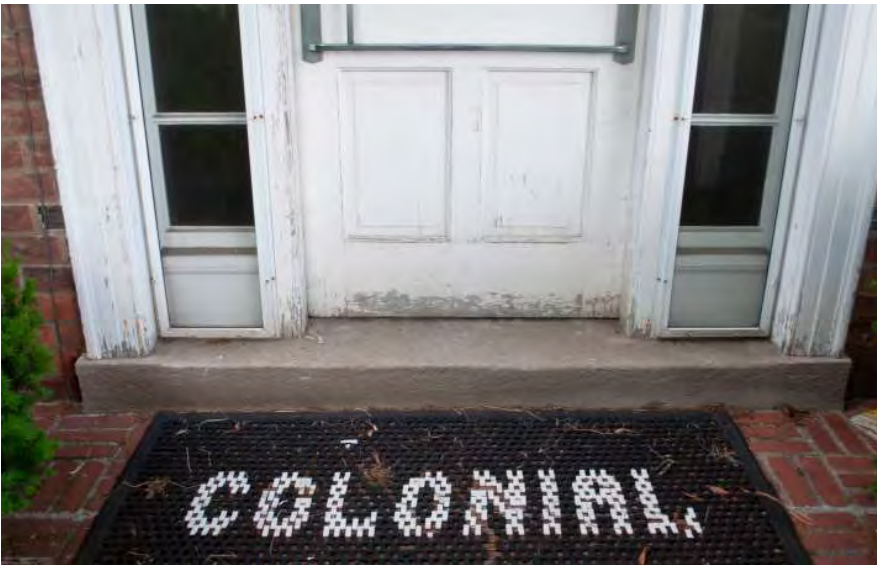
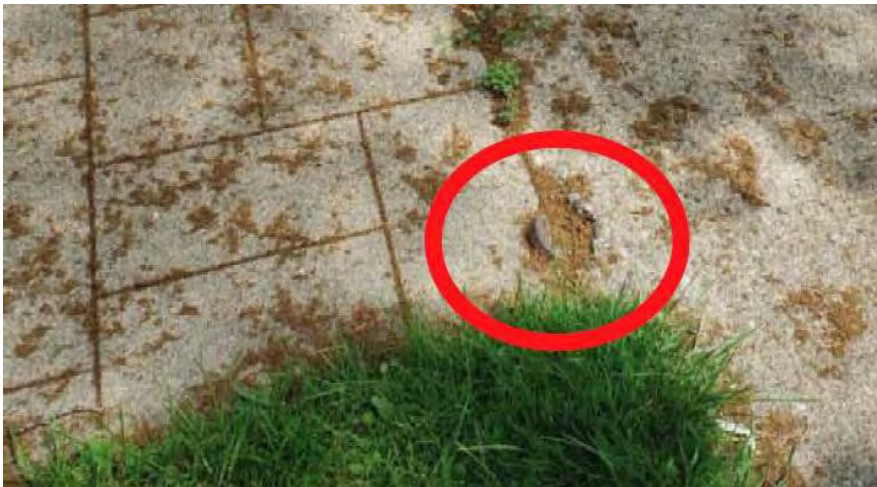
## Historic Woodwork & Fixture

- Existing historic woodwork at front entries of both buildings shows deterioration and is in need of repair/reconstruction and new paint to match existing
- Existing historic light is in fair condition, flaking paint and rust should be removed and fixture restored

- An existing utility cap is protruding up above the pavement where the front entry path meets the sidewalk and is a potential tripping hazard

13. Repair pathway and sidewalk near 9730 front entry; remedy utility cap trip hazard at 9710 front entry
14. Regrade site to slope away from buildings where necessary; remove existing landscaping in order to regrade and replace with similar

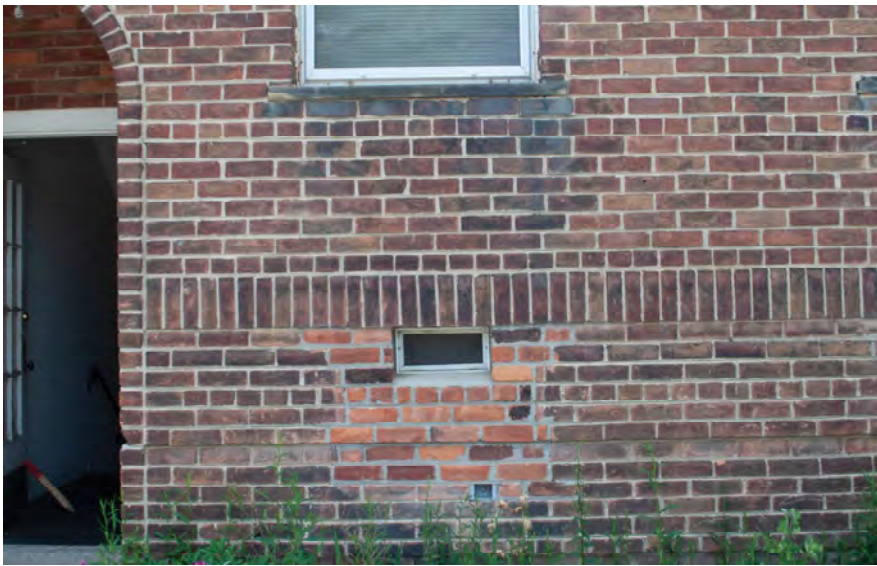
### Sill & Brick Discoloration

- Existing stone sills and masonry below are discolored and possibly water damaged
- Existing small windows in utility rooms appear to be added after original construction. The color of these bricks suggests that they were used in conjunction with the addition of the gas shed, and attempt to match the 'cleaned' color of the original bricks.

1. Restore the existing masonry (brick), utilizing repointing, tuckpointing, and cleaning as necessary
2. Replace the existing leaky (non-historic) asphalt shingle roof in kind

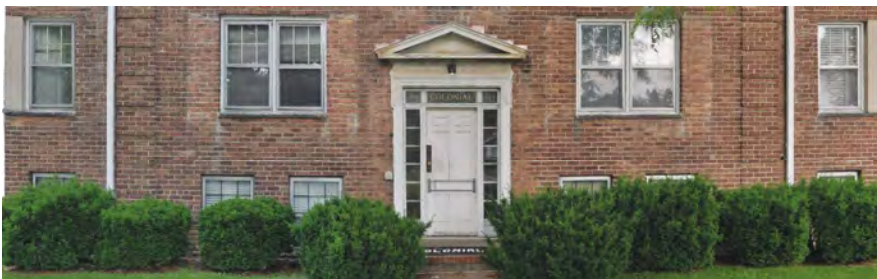
### Existing Landscaping

- Existing shrubs line the front facades of both buildings as well as a section of the back facade of 9730, some being dead/dying
- Two coniferous trees and several deciduous trees dot the site at the perimeter of the parking lot and parking lot islands and line the street frontage
- An ornamental tree is adjacent to the 9730 front entry

17. Restore any disturbed areas with lawn; remove (2) trees to accommodate ramp, install parking lot & site deciduous trees (Red Sunset Maple, Autumn Brilliance Serviceberry, American Hophornbeam); other new plantings (crosshatch) include shrubs (Annabelle Hydrangea, Kelseyi Dwarf Dogwood, Dense Yew, Hicks Yew) and perennials (Happy Returns Daylily, Pardon Me Daylily, Russian Sage)

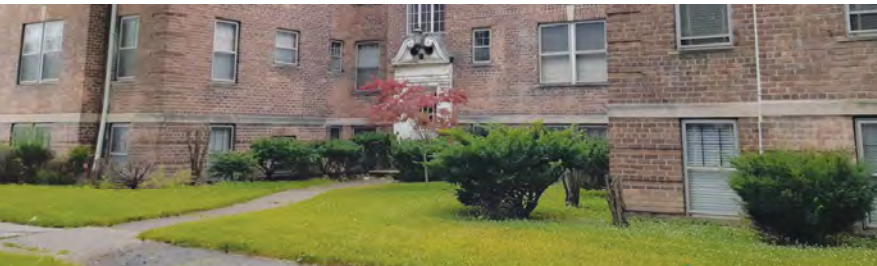
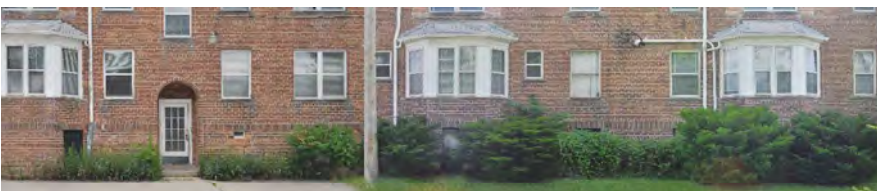
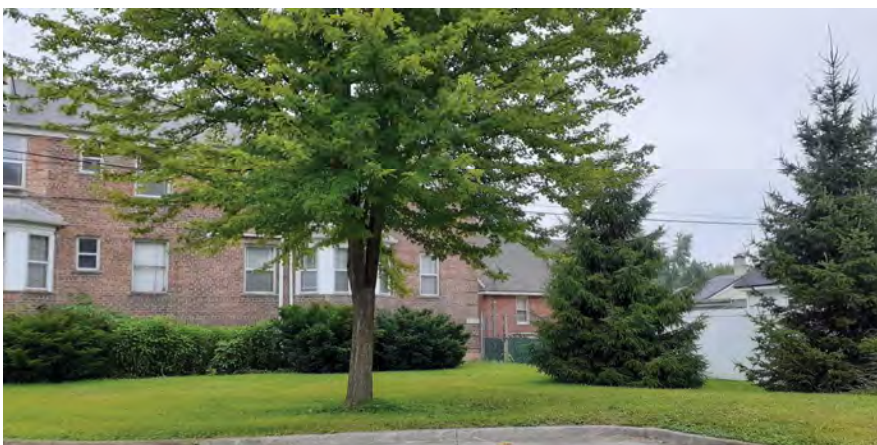
# Existing Conditions Detail Photos

- Existing parking layout has two-directional one-way parking, and only accommodates 33 parking spaces. New residential unit count is 35.
- Existing path between buildings is only 2'-0" wide.
- Existing path and sidewalk near the front of 9730 W Outer Dr front entry is missing a section and heaving.

11. Remove & replace narrow gray concrete pathway between buildings with accessible path (5'-0"W)
12. Re-stripe (to 90 degree spaces & (2) accessible spaces) and reconfigure curbs at existing parking lot to match unit count; remove and replace concrete as needed at parking lot to properly grade

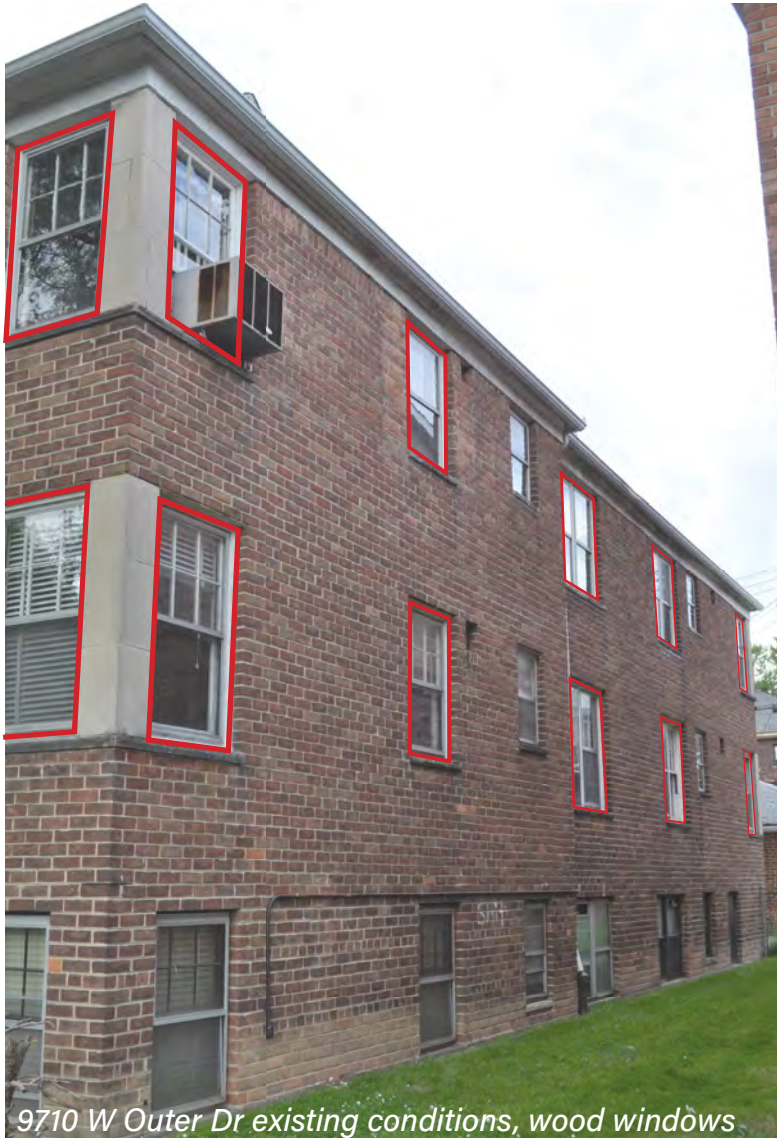
9710 W Outer Dr existing conditions, wood windows

9710 W Outer Dr Wood Windows

- Some exterior sills are split, allowing water to enter the building envelope
- The majority of sills are fissured, causing dry rot and material breakdown

- The operability of the windows ranges from inconsistent to very difficult
- They use a tape balance system that is not readily replaced without potential damage to the master frame

- The jamb liner/weatherstrip is in poor conditions and is not a product that is available for replacement
- All windows require re-glazing with new glazing compound, and existing material is unable to be removed without damage to the sashes and breaking the glass

- The glazing compound is falling out and breaking down on all sashes
- The paint is peeling
- The caulking is failing and falling out
- The storm windows are in poor condition with many broken track guides and failing corner joinery, allowing water to get trapped on the exterior sills, and dry rot and decay in 30-40% of the openings

- A true restoration process is not able to be implemented for these windows. Painting and Glazing Repair can be done; however, this approach does not address the described window issues.

3. Replace the existing deteriorated wood and steel windows with double hung thermally-broken aluminum windows and install thermally-broken windows at new openings for new Level 00 units

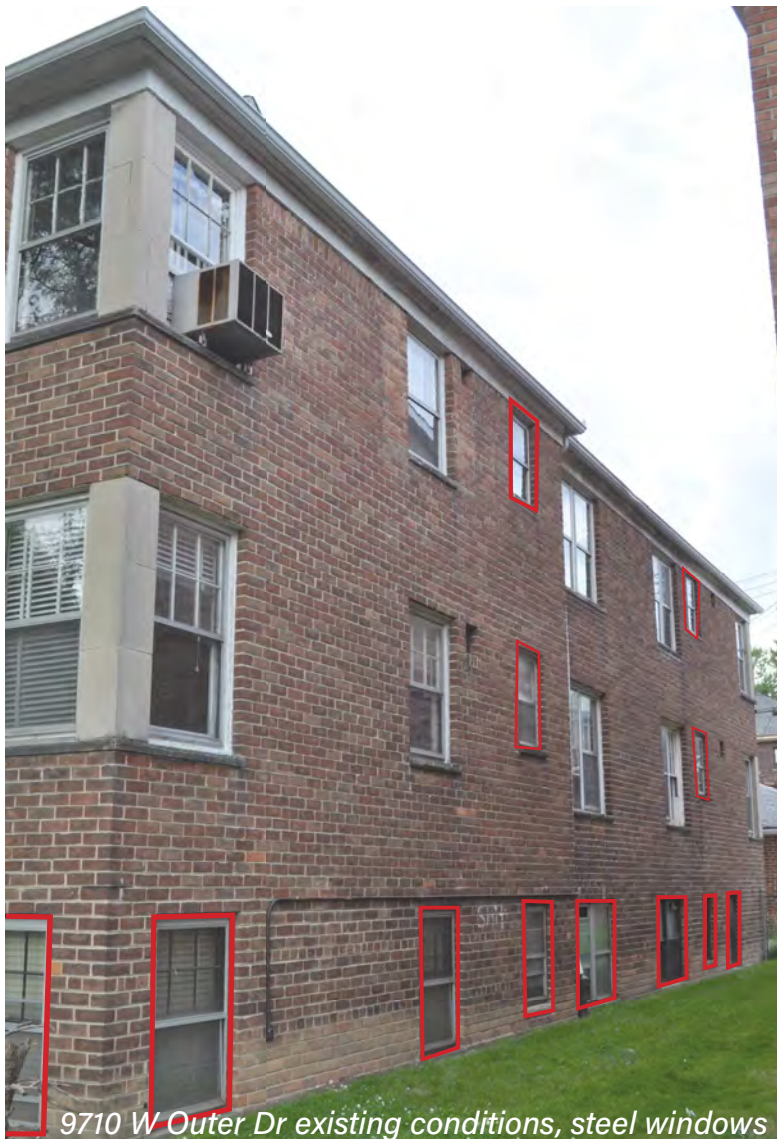
9710 W Outer Dr existing conditions, steel windows

9710 & 9730 W Outer Dr Steel Windows  
Steel construction set in wood framed, masonry opening with stone sills, *highlighted in red*; include all bathroom, Level 00, & 9730 windows.

- The exterior perimeter caulking is failing and coming loose from the masonry
- The locks are bent/broken in over 80% of all windows
- The weather stripping is rusted and the tape balancers are typically bent, crimped, or torn, making the operation and sash movement stiff and resistant

- There isn't a tight seal at the points of weatherstripping between the sash and master frame causing air infiltration and condensation, which has caused corrosion on the interior painted surfaces

- The exterior paint is worn, peeling, and/or allowing rust and corrosion to bleed thru to the surface
- The butt joint tubular steel framing has mild-to-heavy corrosion at the exterior sill, the sash, and frame joinery

- The storm windows have many broken track guides and failing corner joinery, trapping water on the exterior sill creating rust and corrosion
- The glazing compound is falling out and failing on all sashes

- These windows do not lend themselves to restoration, as the components are in poor condition and no replacement parts are available, and leaving the sashes in place will not resolved the poor operation issue

- All existing window components to be removed and disposed of; abatement may be required. Wood blocking to be set in the in the jamb cavity.
- Repair fixed decorative windows in the common area stairs wells only.
- New windows to be set directly in the masonry openings and anchored to the wood blocking. Prior to this installation all voids would be insulated.
- Interior plaster returns to be repaired.
- Perimeter caulking to be applied on the interior and exterior, and windows to be cleaned and adjusted.

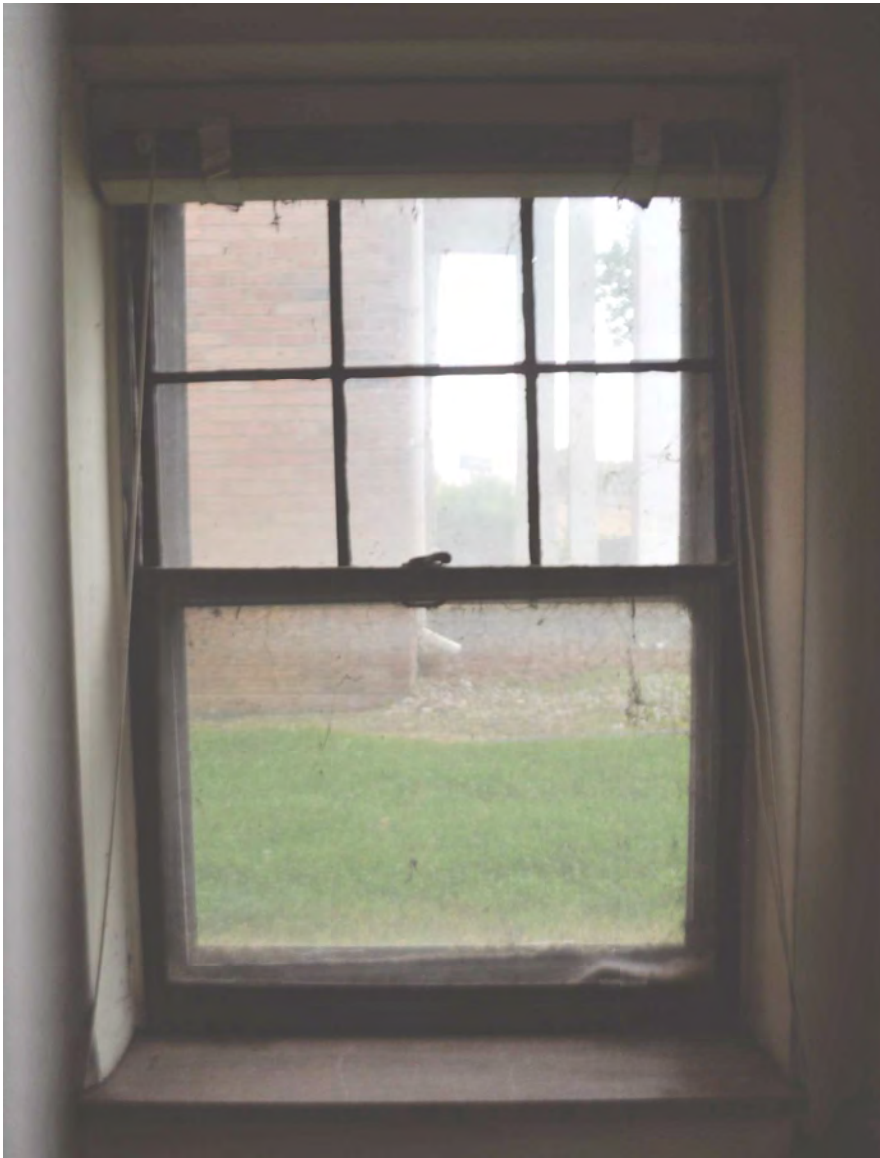
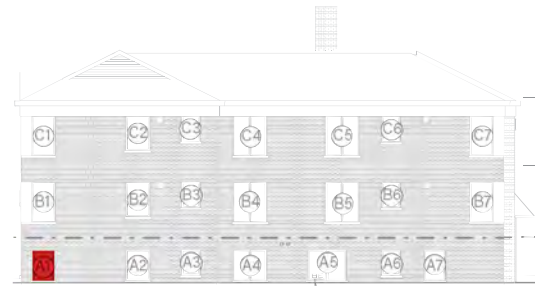
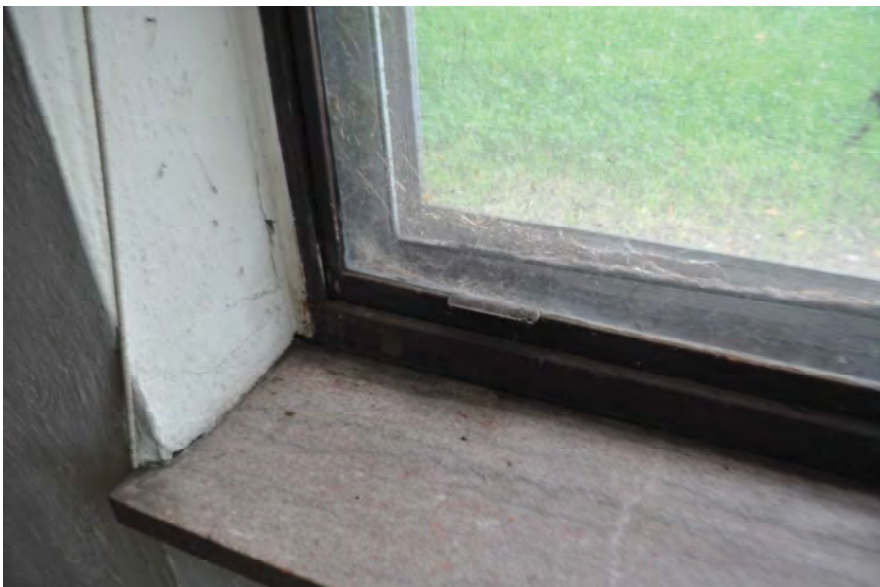
### Window A1, Type D1

- Note: Extent of exterior deterioration, dry rot, and loss of operability is not fully apparent in interior photos. Replacement parts for existing windows are unavailable, making restoration of thermal and operable functionality impossible, and long-term maintenance infeasible. Recommendation is for replacement, for quality of life of future tenants and for feasibility of long-term maintenance.
- See Window Assessment (Blackberry) in appendix for further detail and information, including further notes on deterioration beyond repair
- See Appendix for Window Schedule & Measurements

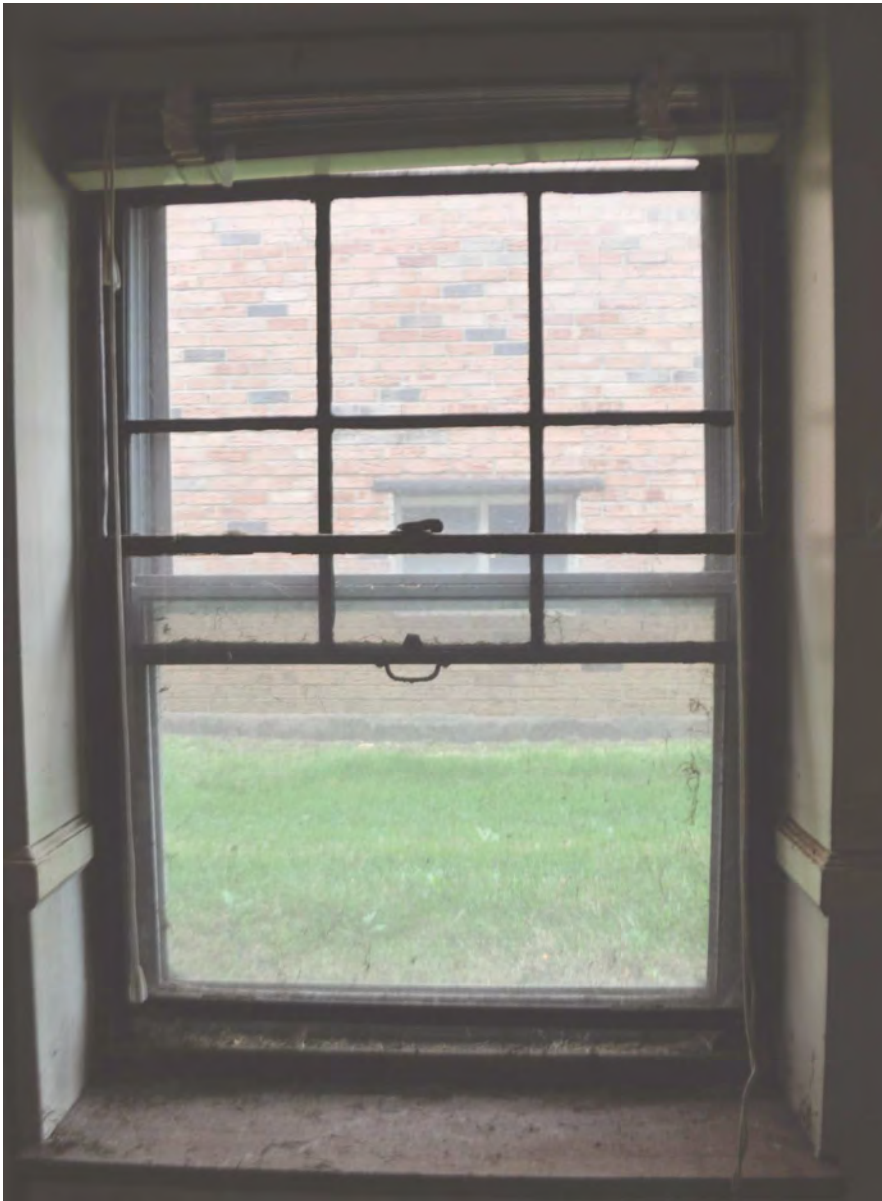
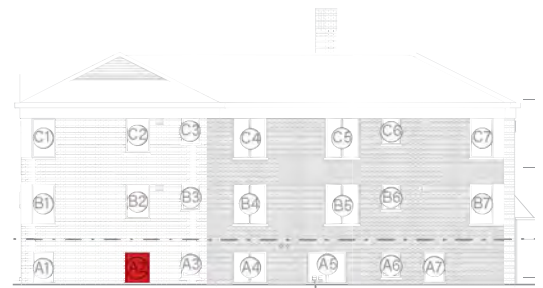
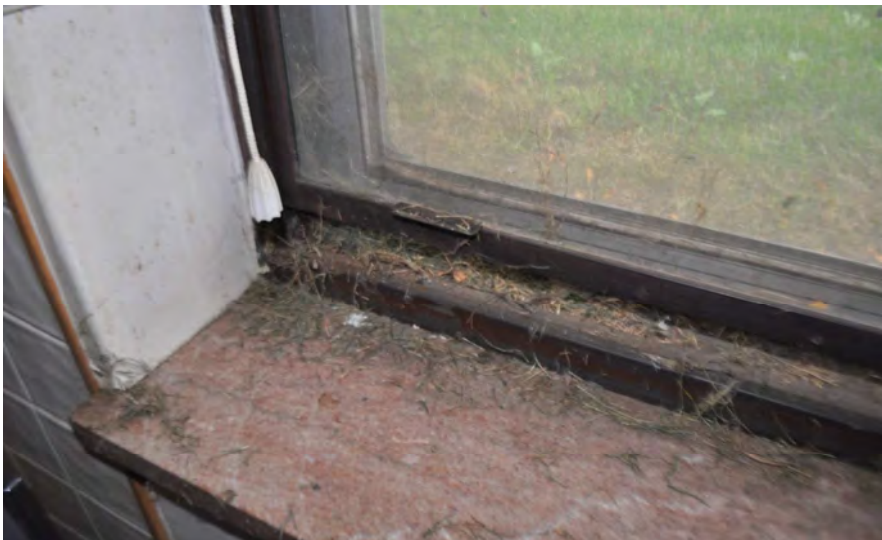
### Window A2, Type F1

- Note: Extent of exterior deterioration, dry rot, and loss of operability is not fully apparent in interior photos. Replacement parts for existing windows are unavailable, making restoration of thermal and operable functionality impossible, and long-term maintenance infeasible. Recommendation is for replacement, for quality of life of future tenants and for feasibility of long-term maintenance.
- See Window Assessment (Blackberry) in appendix for further detail and information, including further notes on deterioration beyond repair
- See Appendix for Window Schedule & Measurements

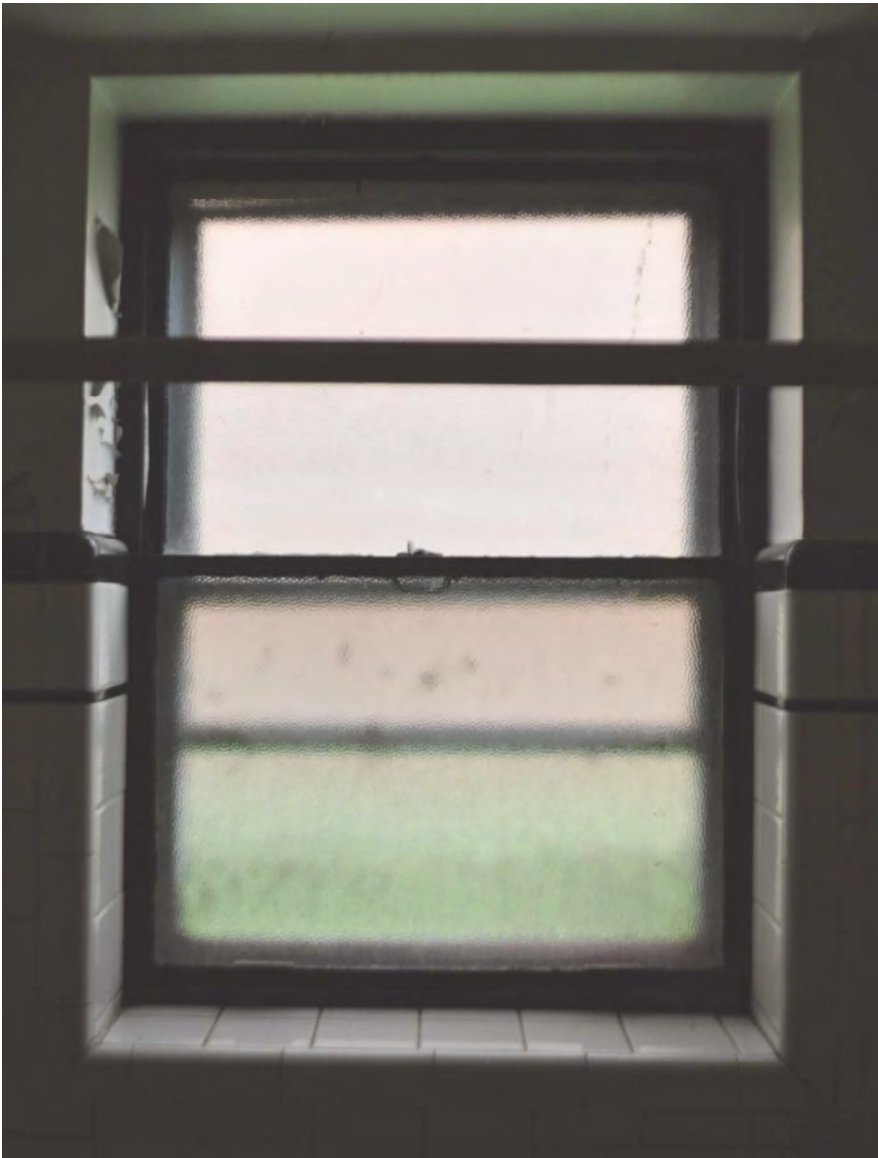
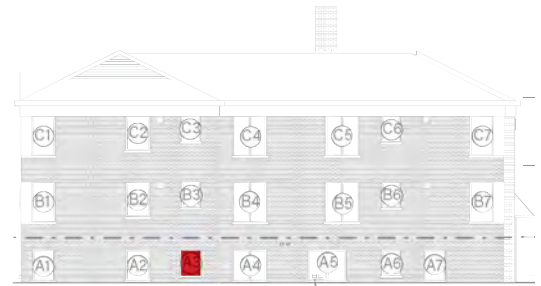
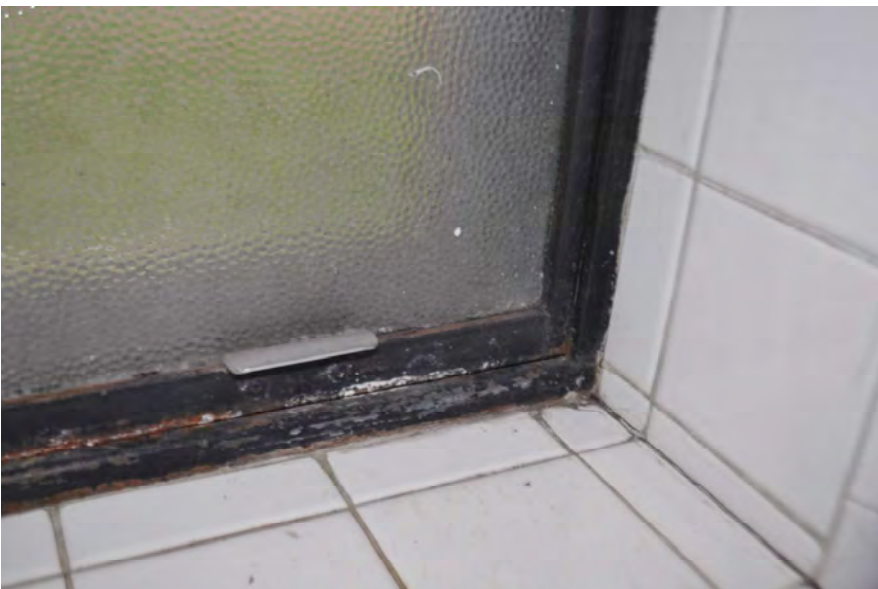
### Window A3, Type G1

- Note: Extent of exterior deterioration, dry rot, and loss of operability is not fully apparent in interior photos. Replacement parts for existing windows are unavailable, making restoration of thermal and operable functionality impossible, and long-term maintenance infeasible. Recommendation is for replacement, for quality of life of future tenants and for feasibility of long-term maintenance.
- See Window Assessment (Blackberry) in appendix for further detail and information, including further notes on deterioration beyond repair
- See Appendix for Window Schedule & Measurements

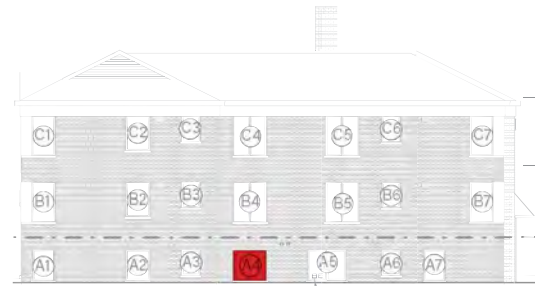
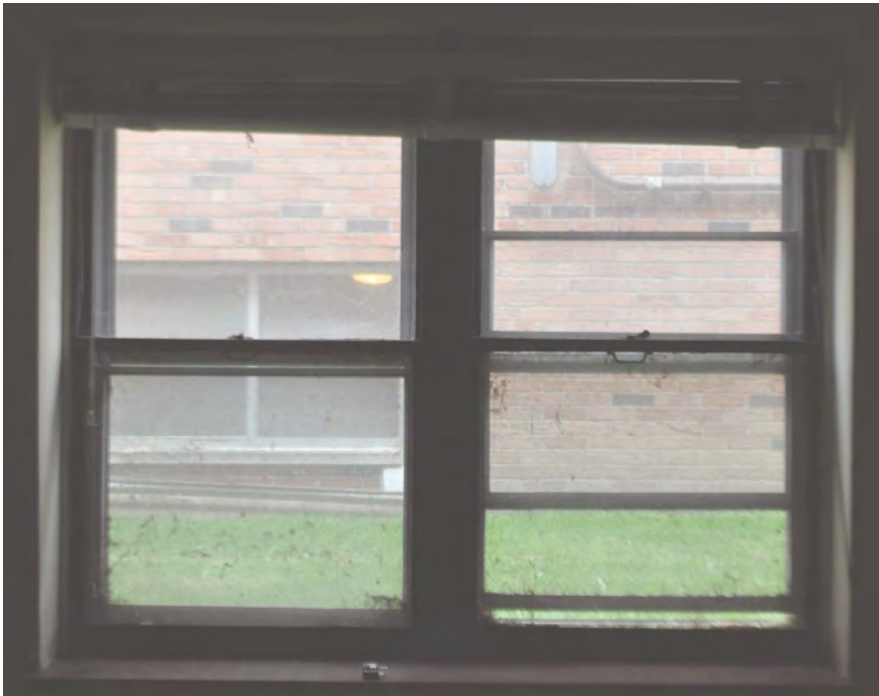
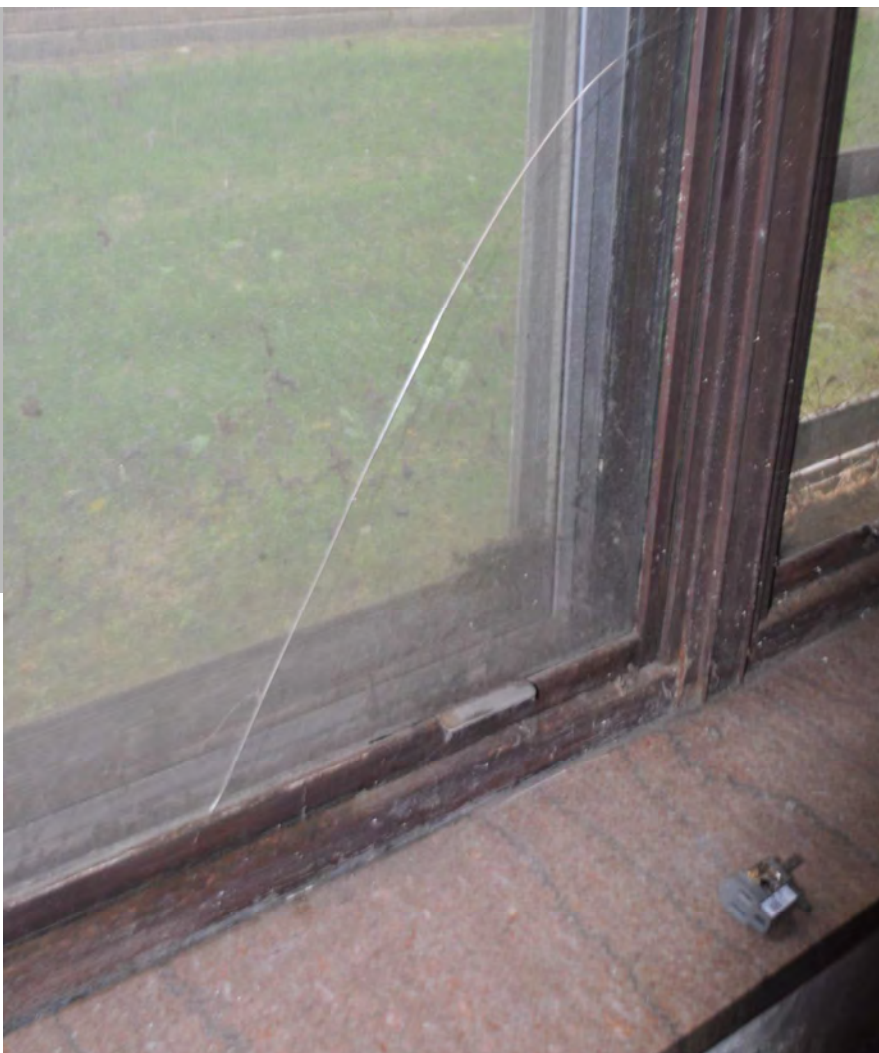
### Window A4, Type L1

- Broken Glass
- Note: Extent of exterior deterioration, dry rot, and loss of operability is not fully apparent in interior photos. Replacement parts for existing windows are unavailable, making restoration of thermal and operable functionality impossible, and long-term maintenance infeasible. Recommendation is for replacement, for quality of life of future tenants and for feasibility of long-term maintenance.
- See Window Assessment (Blackberry) in appendix for further detail and information, including further notes on deterioration beyond repair
- See Appendix for Window Schedule & Measurements

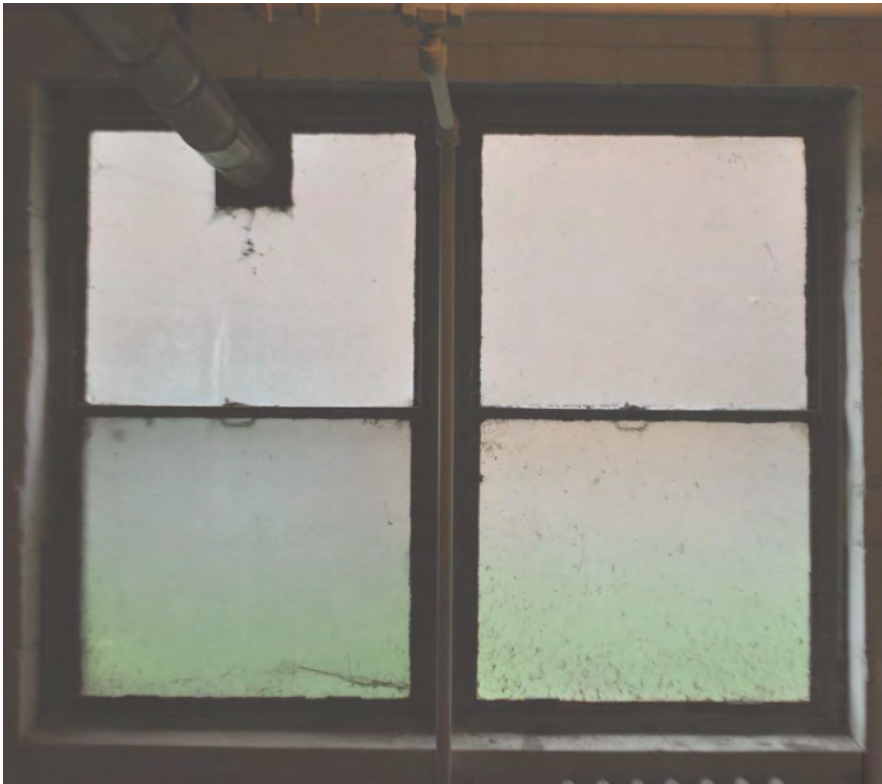
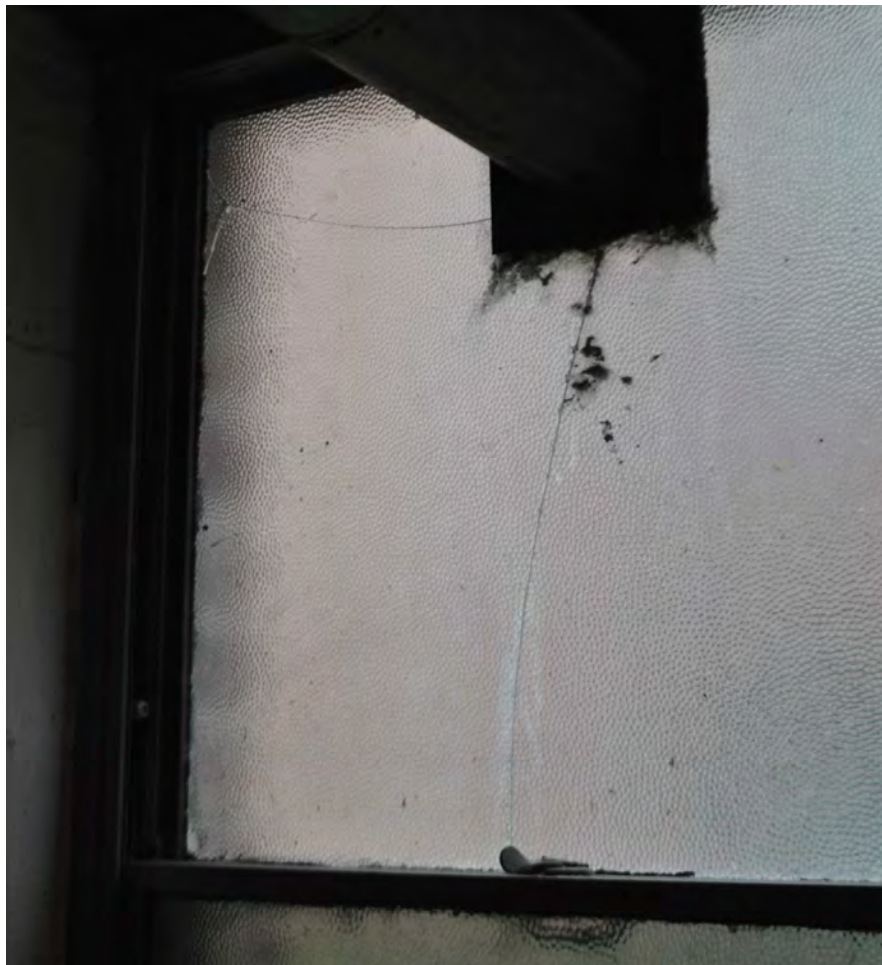
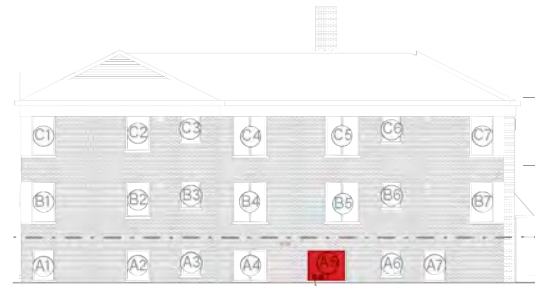
### Window A5, Type H1

- Broken Glass
- Note: Extent of exterior deterioration, dry rot, and loss of operability is not fully apparent in interior photos. Replacement parts for existing windows are unavailable, making restoration of thermal and operable functionality impossible, and long-term maintenance infeasible. Recommendation is for replacement, for quality of life of future tenants and for feasibility of long-term maintenance.
- See Window Assessment (Blackberry) in appendix for further detail and information, including further notes on deterioration beyond repair
- See Appendix for Window Schedule & Measurements

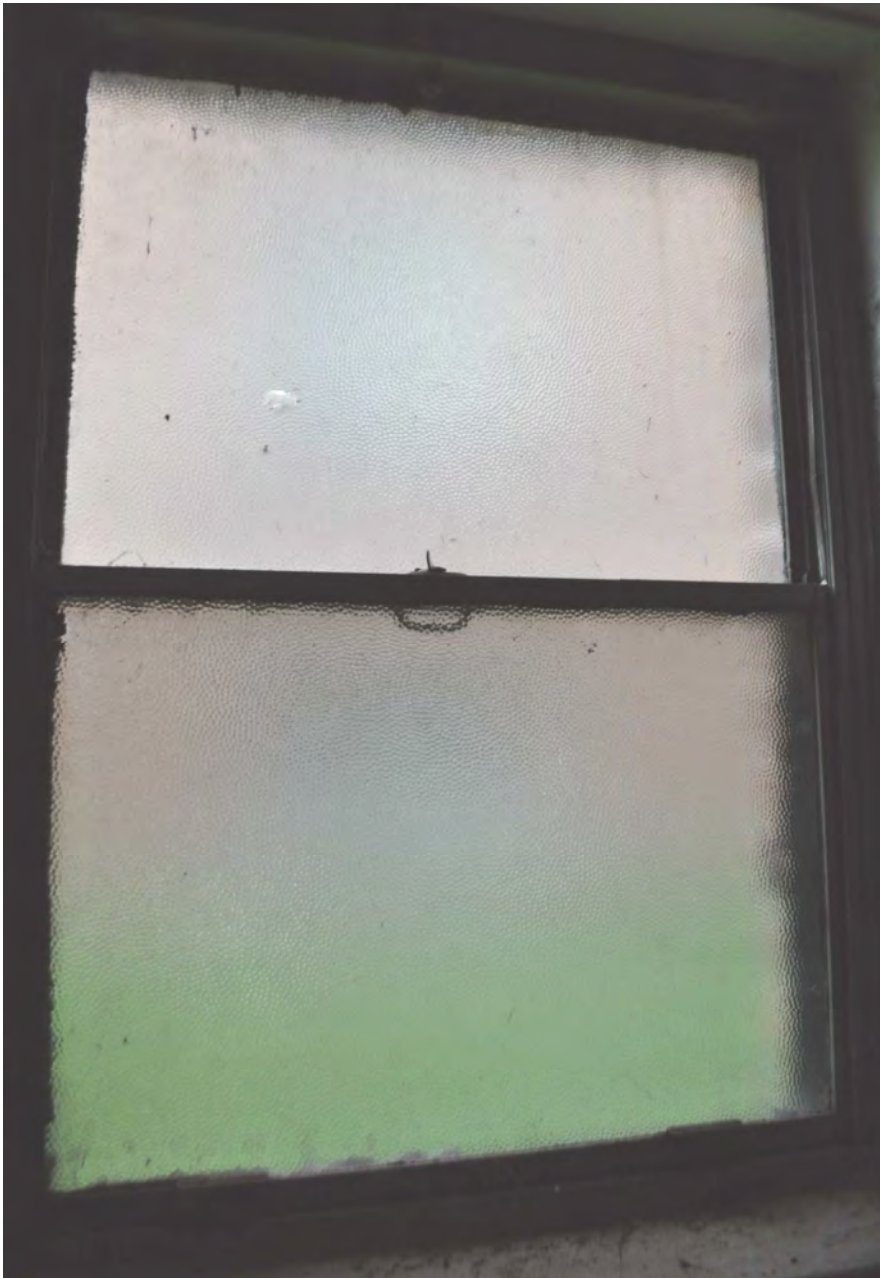
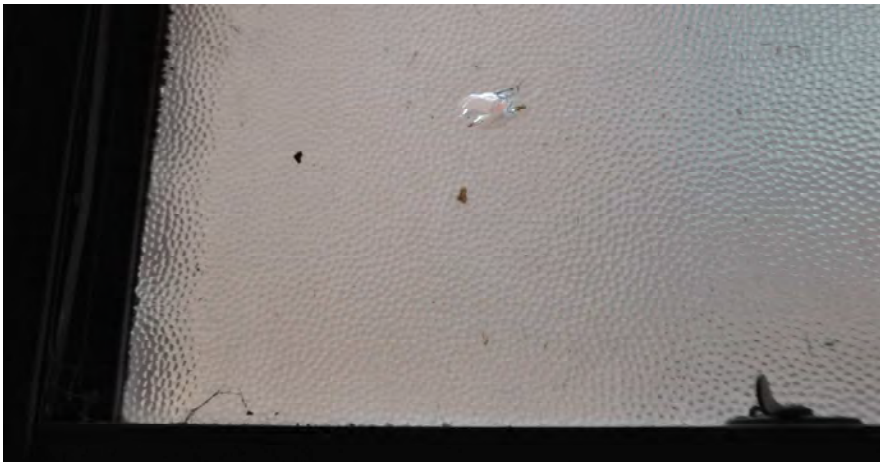
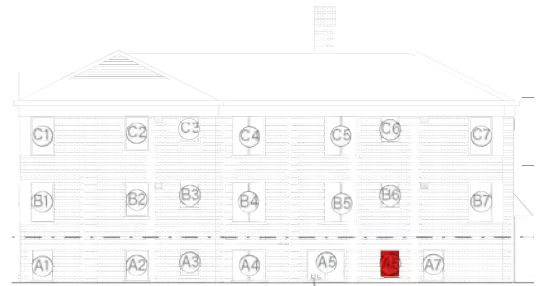
### Window A6, Type G1

- Broken Glass
- Note: Extent of exterior deterioration, dry rot, and loss of operability is not fully apparent in interior photos. Replacement parts for existing windows are unavailable, making restoration of thermal and operable functionality impossible, and long-term maintenance infeasible. Recommendation is for replacement, for quality of life of future tenants and for feasibility of long-term maintenance.
- See Window Assessment (Blackberry) in appendix for further detail and information, including further notes on deterioration beyond repair
- See Appendix for Window Schedule & Measurements

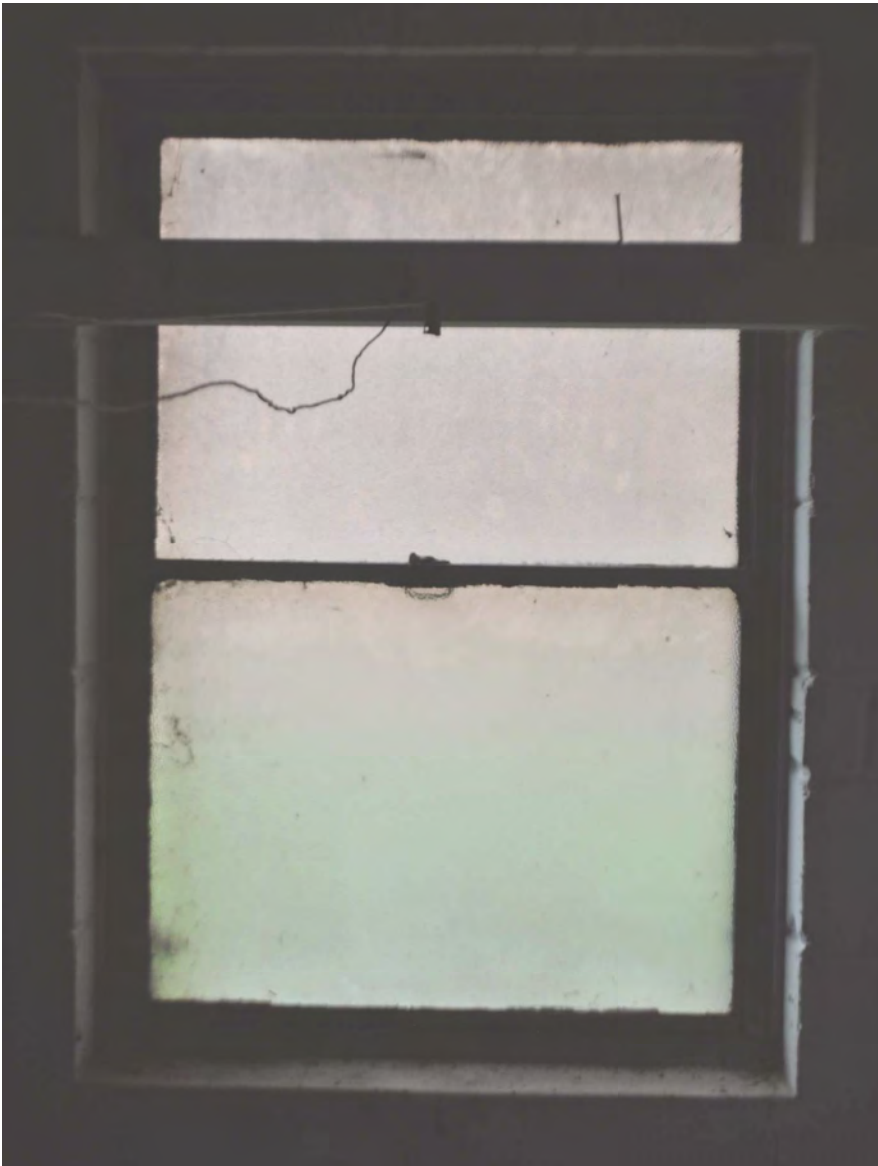
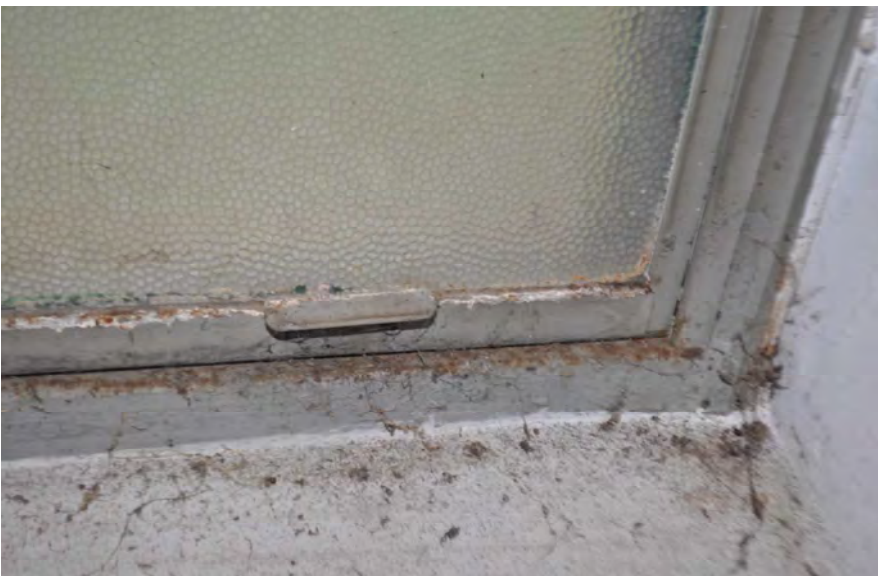
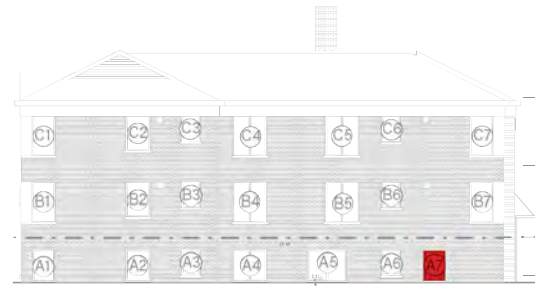
### Window A7, Type D2

- Note: Extent of exterior deterioration, dry rot, and loss of operability is not fully apparent in interior photos. Replacement parts for existing windows are unavailable, making restoration of thermal and operable functionality impossible, and long-term maintenance infeasible. Recommendation is for replacement, for quality of life of future tenants and for feasibility of long-term maintenance.
- See Window Assessment (Blackberry) in appendix for further detail and information, including further notes on deterioration beyond repair
- See Appendix for Window Schedule & Measurements
