# 9710 W Outer Dr

## Existing Condition Photos

# 9730 W Outer Dr

# Detailed Scope of Work

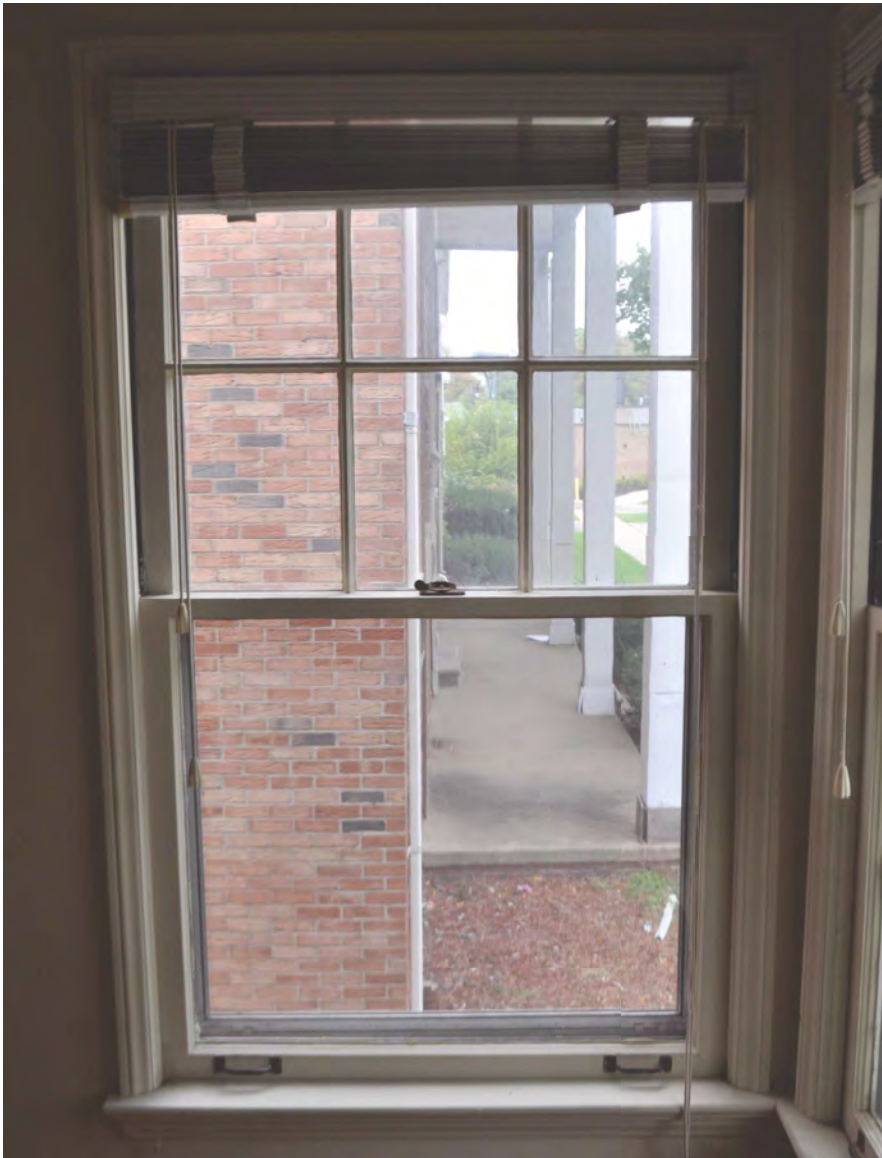
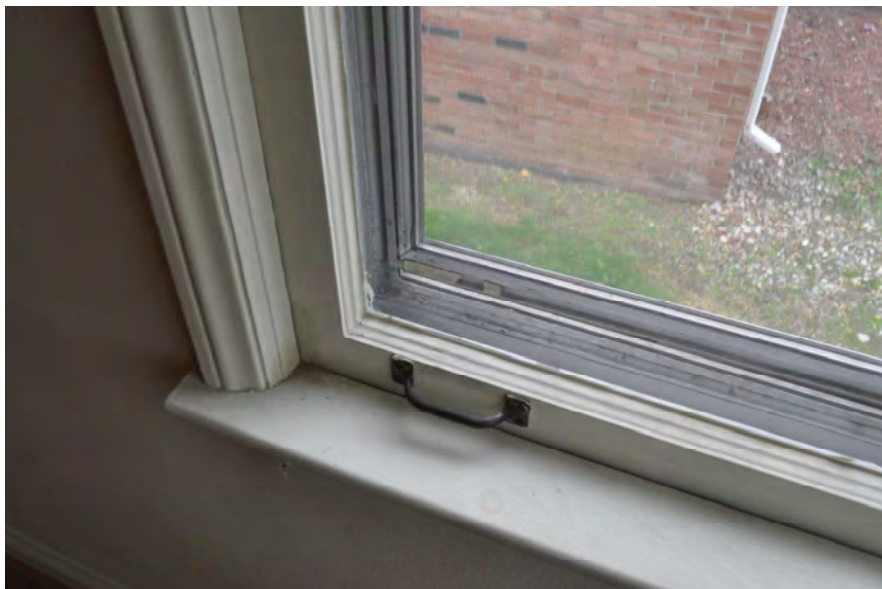
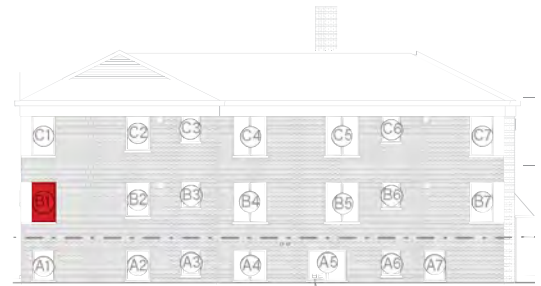
### Window B1, Type A1

- Note: Extent of exterior deterioration, dry rot, and loss of operability is not fully apparent in interior photos. Replacement parts for existing windows are unavailable, making restoration of thermal and operable functionality impossible, and long-term maintenance infeasible. Recommendation is for replacement, for quality of life of future tenants and for feasibility of long-term maintenance.
- See Window Assessment (Blackberry) in appendix for further detail and information, including further notes on deterioration beyond repair
- See Appendix for Window Schedule & Measurements

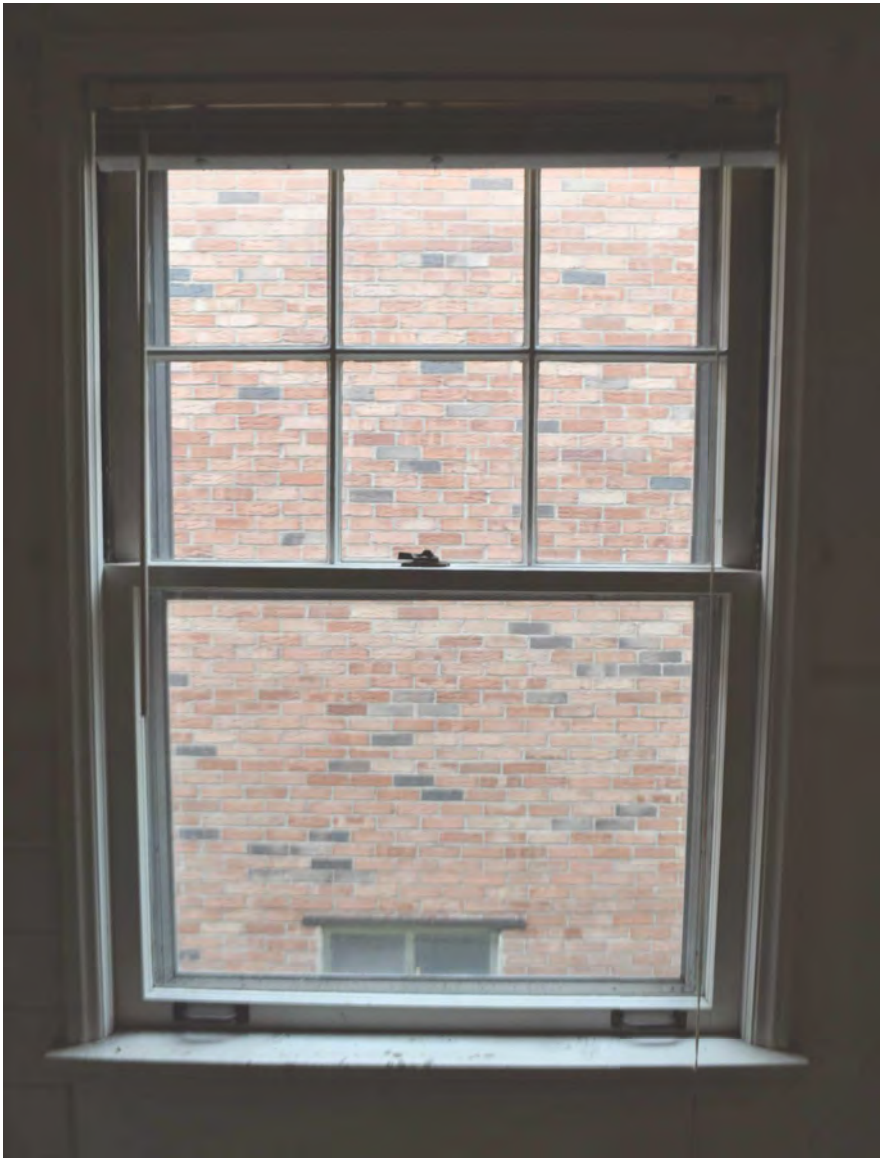
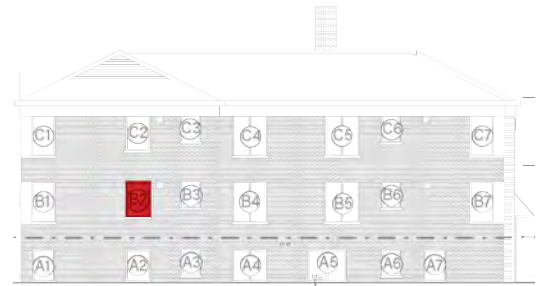
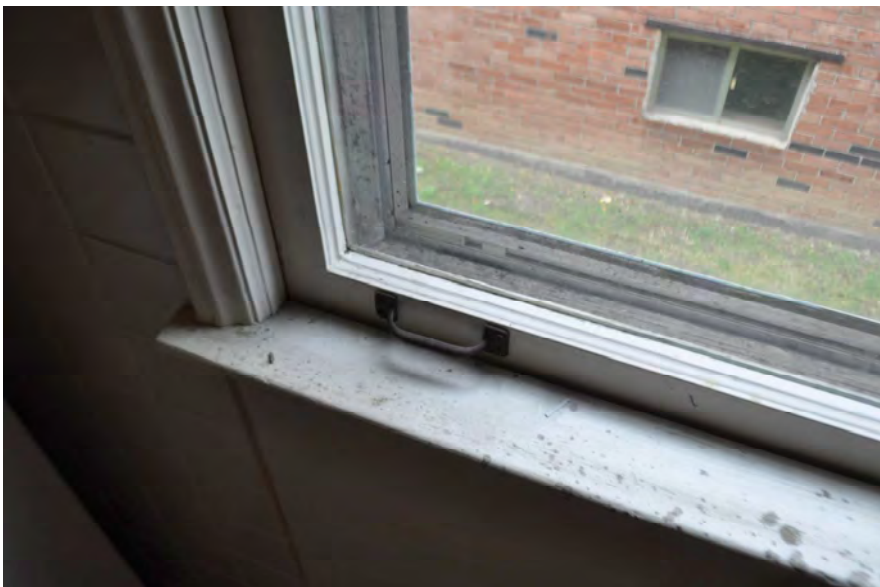
### Window B2, Type E1

- Note: Extent of exterior deterioration, dry rot, and loss of operability is not fully apparent in interior photos. Replacement parts for existing windows are unavailable, making restoration of thermal and operable functionality impossible, and long-term maintenance infeasible. Recommendation is for replacement, for quality of life of future tenants and for feasibility of long-term maintenance.
- See Window Assessment (Blackberry) in appendix for further detail and information, including further notes on deterioration beyond repair
- See Appendix for Window Schedule & Measurements

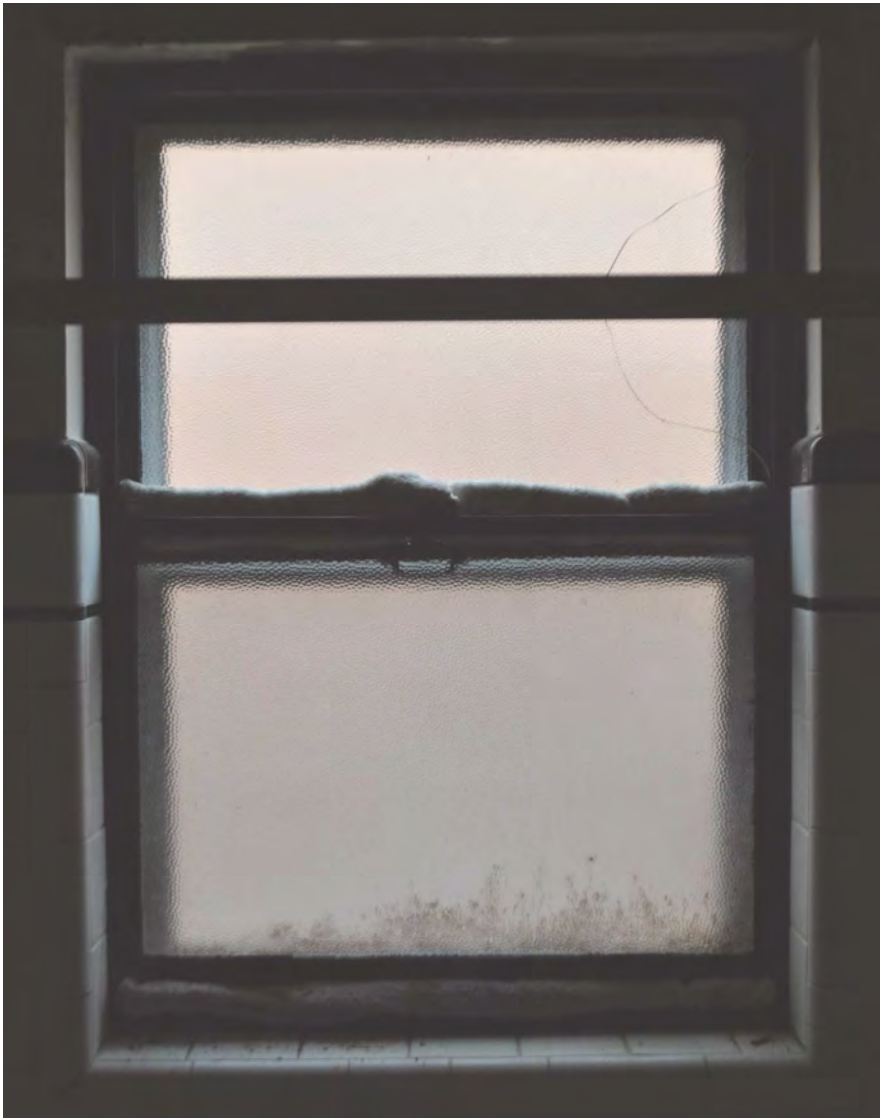
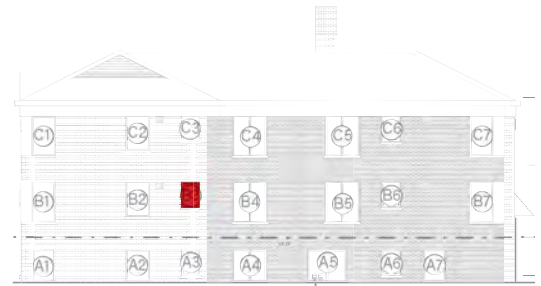
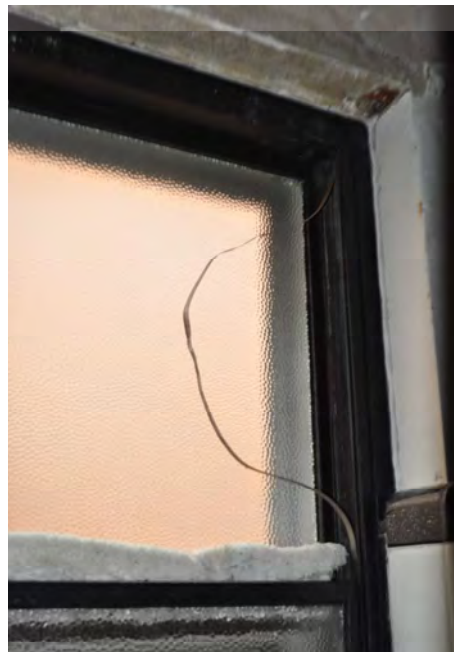
### Window B3, Type G1

- Broken Balance
- Note: Extent of exterior deterioration, dry rot, and loss of operability is not fully apparent in interior photos. Replacement parts for existing windows are unavailable, making restoration of thermal and operable functionality impossible, and long-term maintenance infeasible. Recommendation is for replacement, for quality of life of future tenants and for feasibility of long-term maintenance.
- See Window Assessment (Blackberry) in appendix for further detail and information, including further notes on deterioration beyond repair
- See Appendix for Window Schedule & Measurements

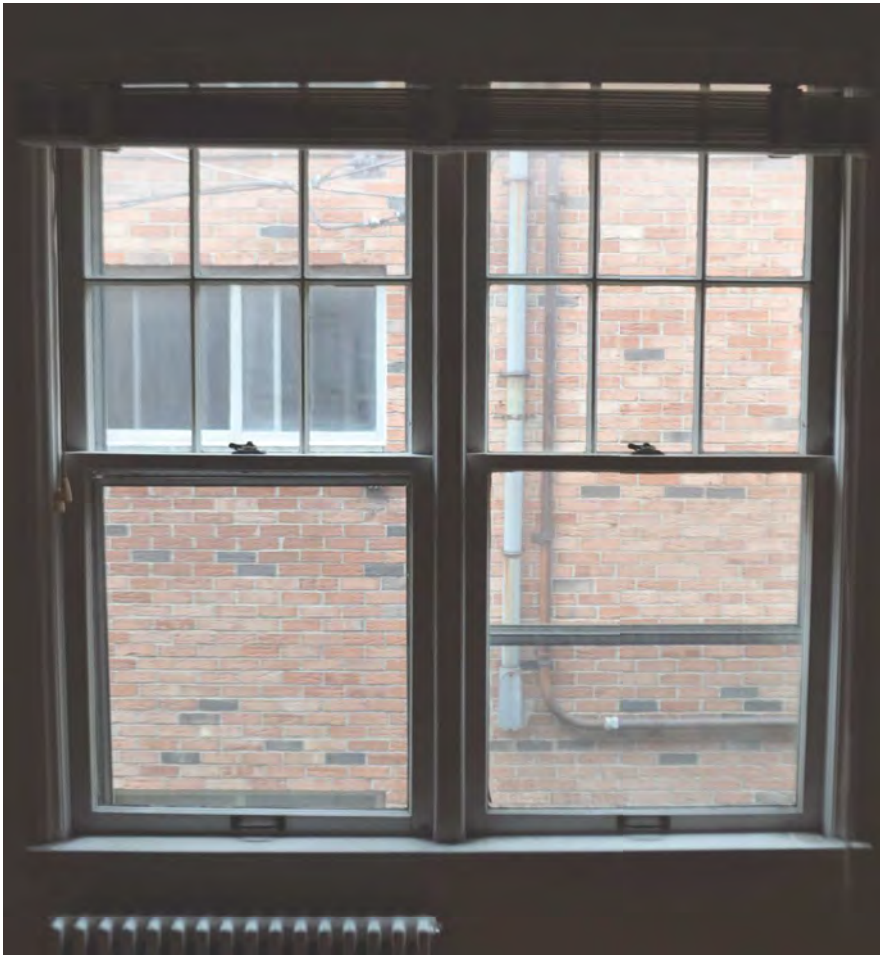
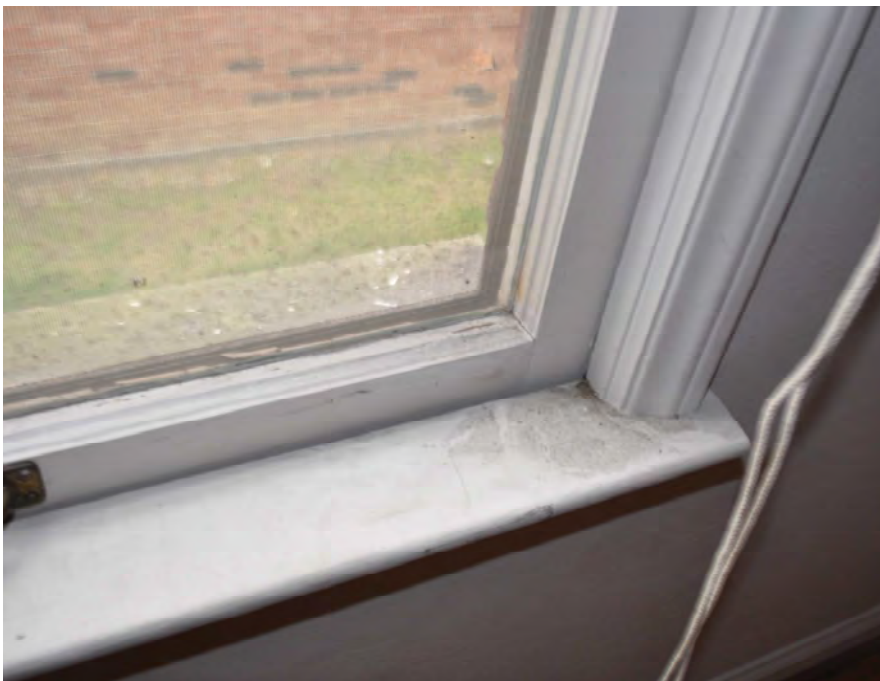
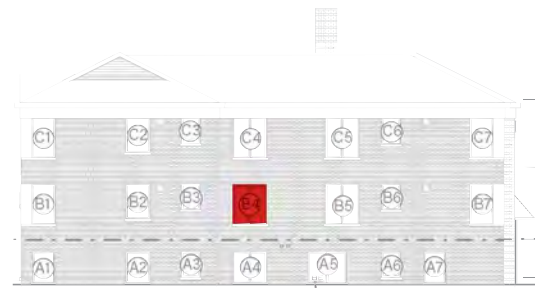
### Window B4, Type K1

- Note: Extent of exterior deterioration, dry rot, and loss of operability is not fully apparent in interior photos. Replacement parts for existing windows are unavailable, making restoration of thermal and operable functionality impossible, and long-term maintenance infeasible. Recommendation is for replacement, for quality of life of future tenants and for feasibility of long-term maintenance.
- See Window Assessment (Blackberry) in appendix for further detail and information, including further notes on deterioration beyond repair
- See Appendix for Window Schedule & Measurements

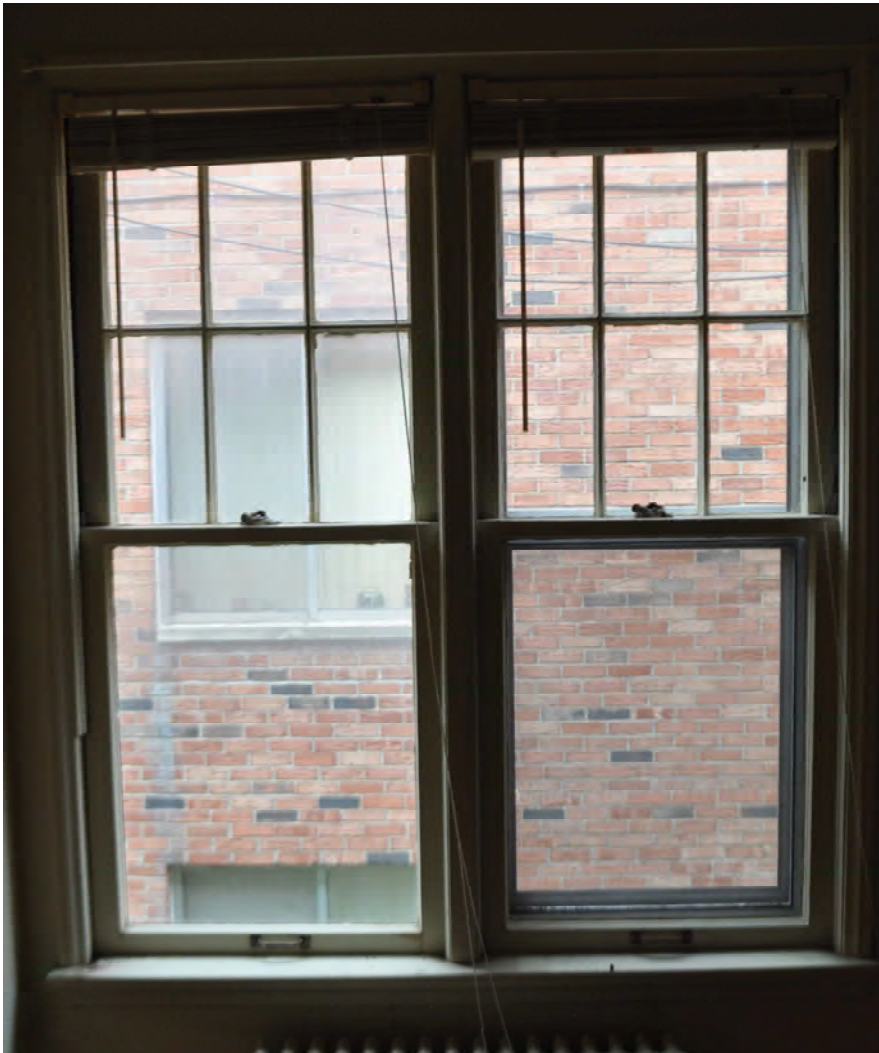
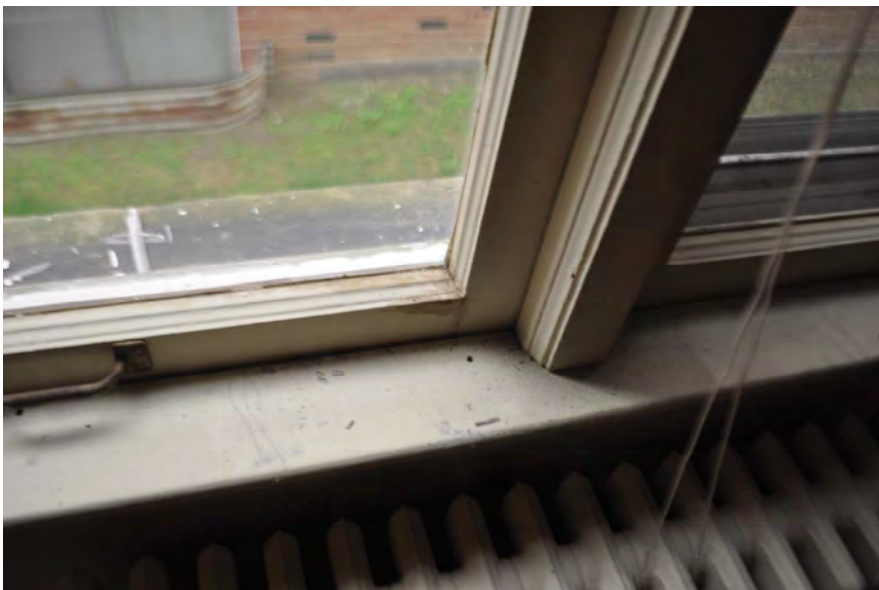
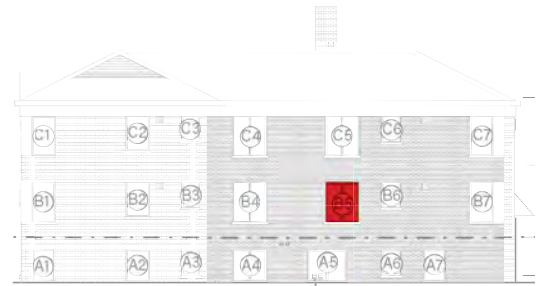
### Window B5, Type K1

- Note: Extent of exterior deterioration, dry rot, and loss of operability is not fully apparent in interior photos. Replacement parts for existing windows are unavailable, making restoration of thermal and operable functionality impossible, and long-term maintenance infeasible. Recommendation is for replacement, for quality of life of future tenants and for feasibility of long-term maintenance.
- See Window Assessment (Blackberry) in appendix for further detail and information, including further notes on deterioration beyond repair
- See Appendix for Window Schedule & Measurements

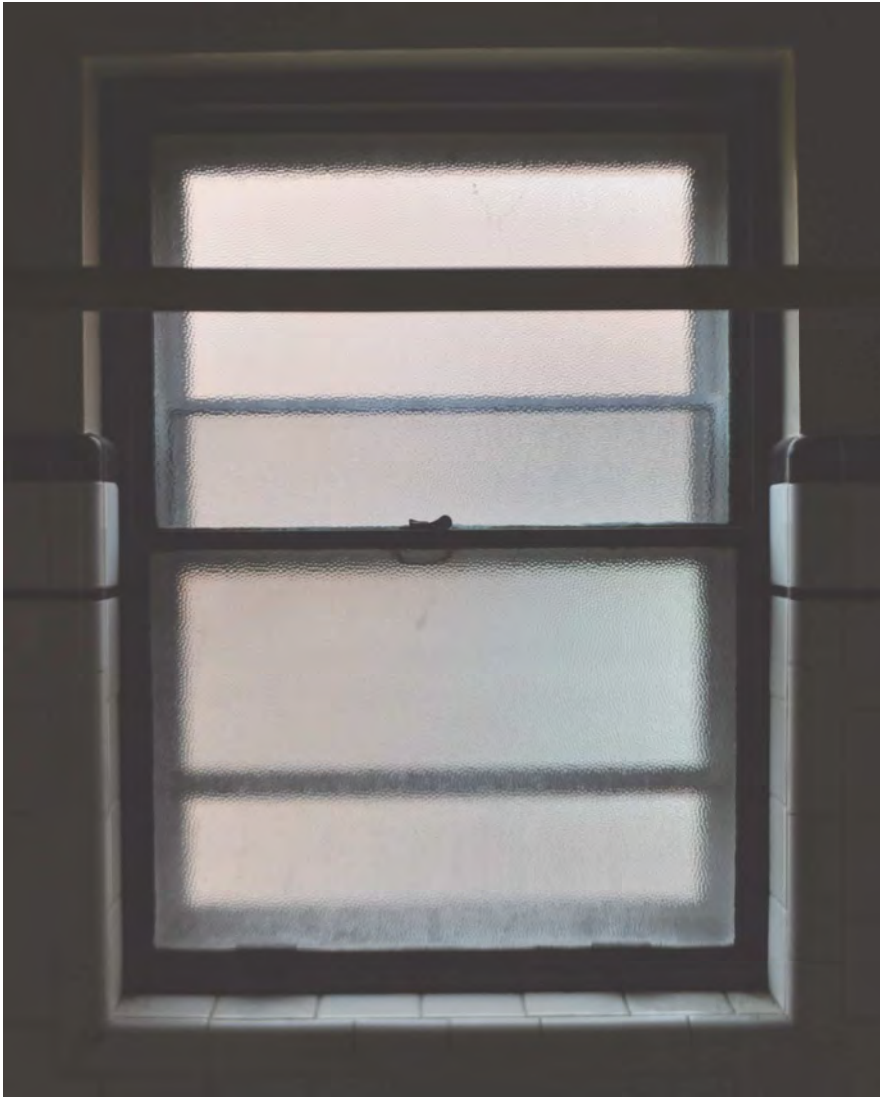
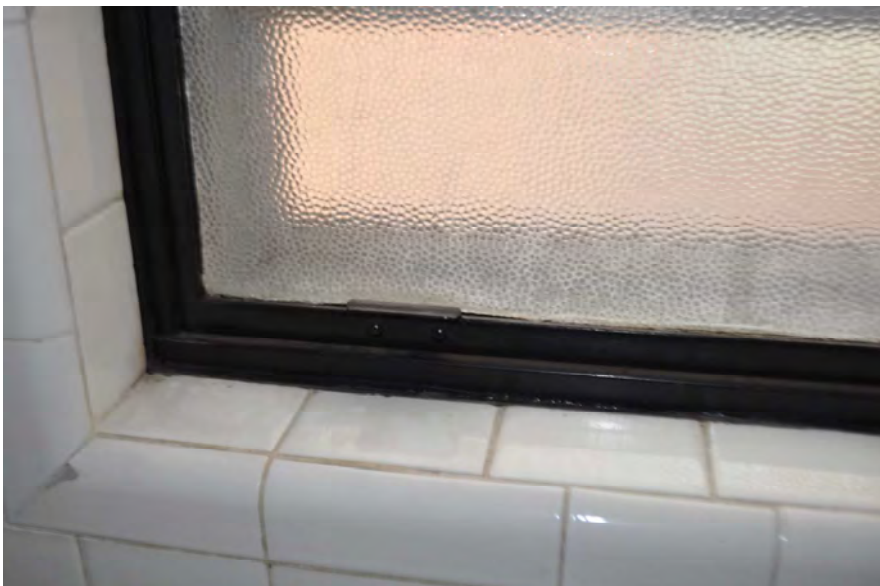
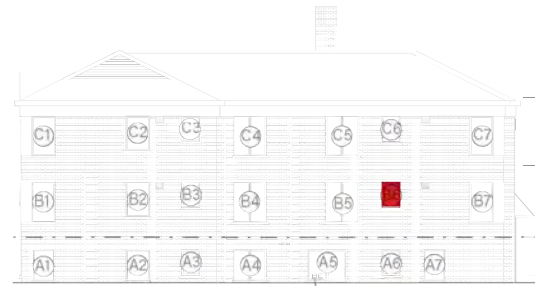
### Window B6, Type G1

- Note: Extent of exterior deterioration, dry rot, and loss of operability is not fully apparent in interior photos. Replacement parts for existing windows are unavailable, making restoration of thermal and operable functionality impossible, and long-term maintenance infeasible. Recommendation is for replacement, for quality of life of future tenants and for feasibility of long-term maintenance.
- See Window Assessment (Blackberry) in appendix for further detail and information, including further notes on deterioration beyond repair
- See Appendix for Window Schedule & Measurements

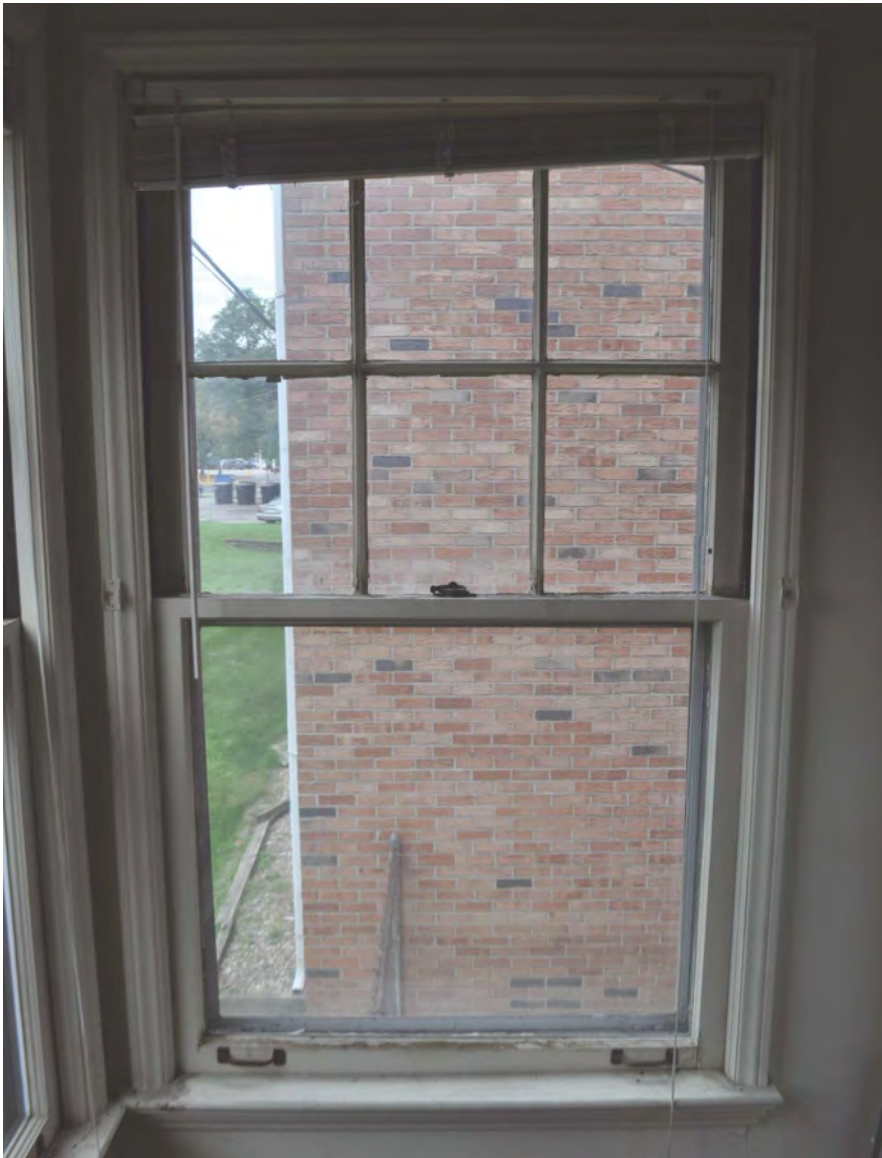
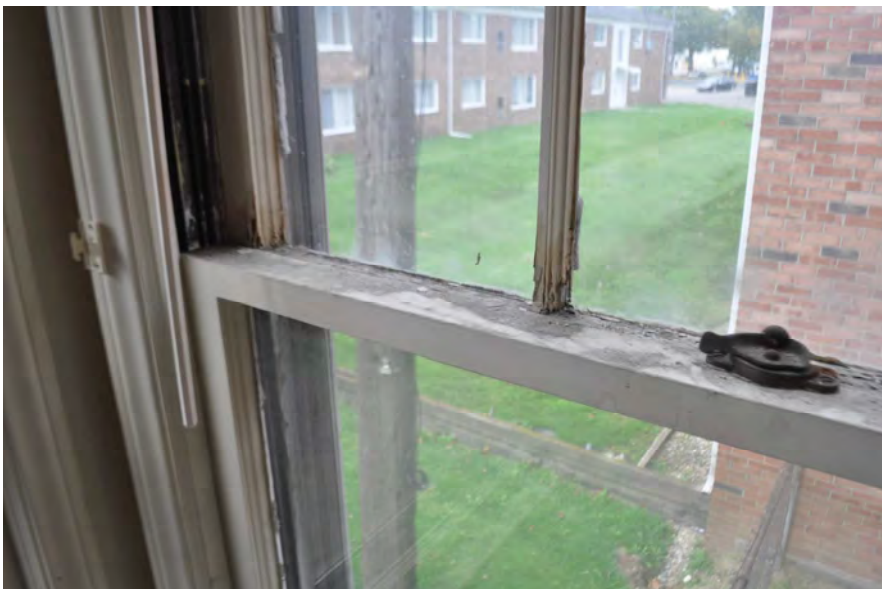
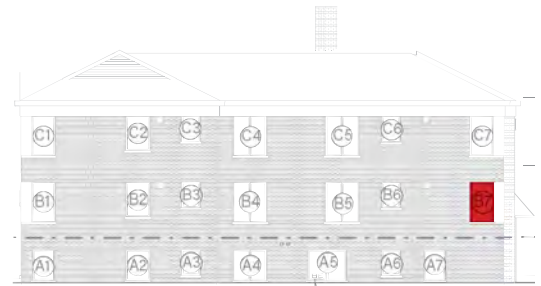
### Window B7, Type A1

- Badly Rotted
- Note: Extent of exterior deterioration, dry rot, and loss of operability is not fully apparent in interior photos. Replacement parts for existing windows are unavailable, making restoration of thermal and operable functionality impossible, and long-term maintenance infeasible. Recommendation is for replacement, for quality of life of future tenants and for feasibility of long-term maintenance.
- See Window Assessment (Blackberry) in appendix for further detail and information, including further notes on deterioration beyond repair
- See Appendix for Window Schedule & Measurements

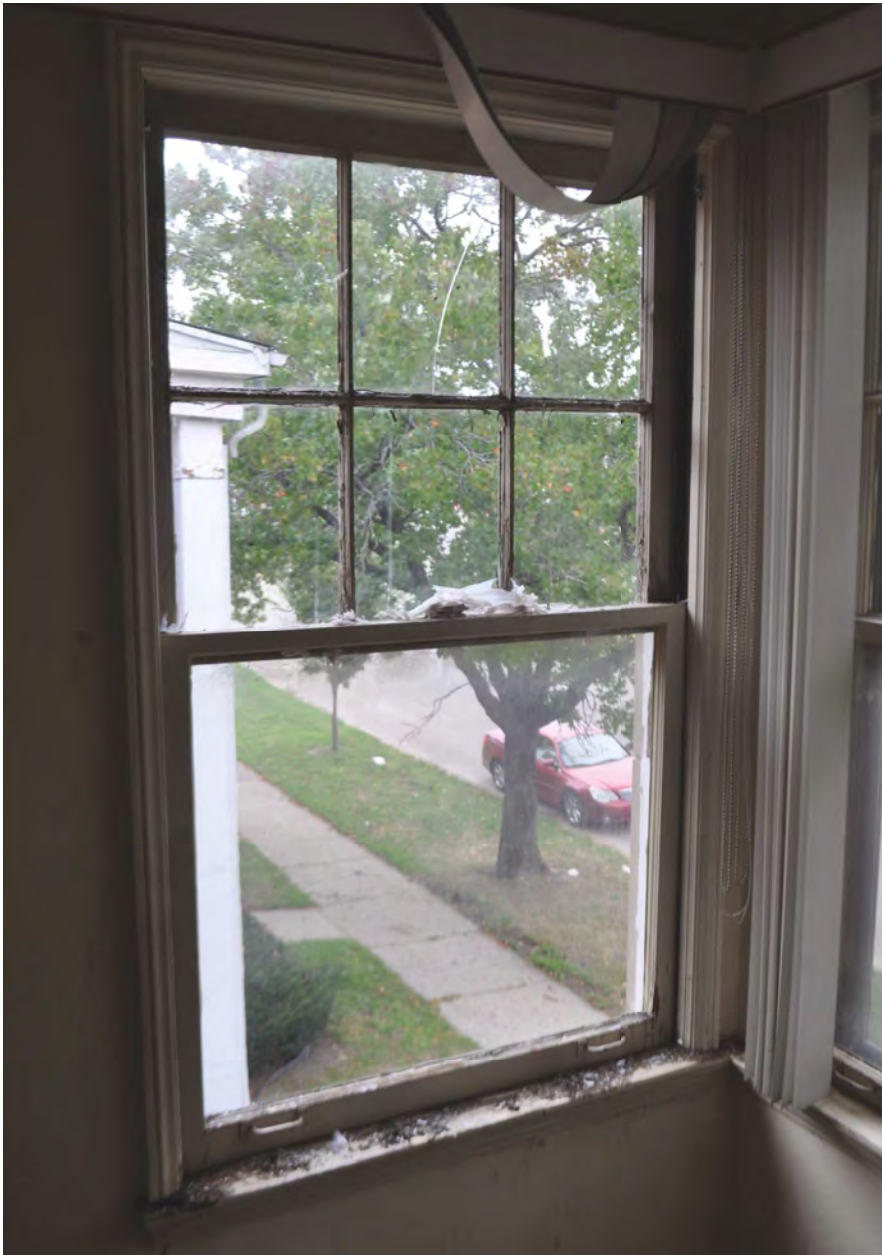
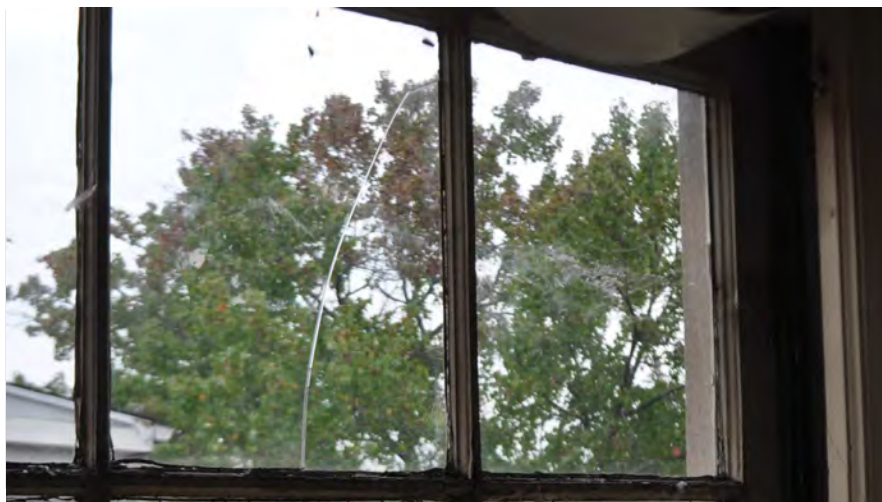
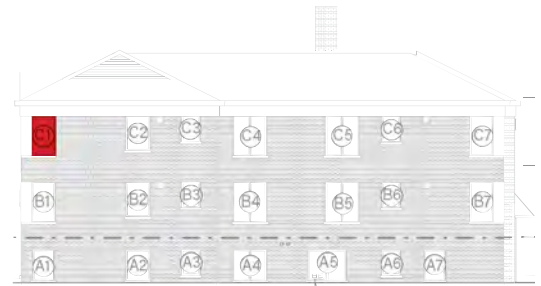
### Window C1, Type A1

- Broken Glass
- Note: Extent of exterior deterioration, dry rot, and loss of operability is not fully apparent in interior photos. Replacement parts for existing windows are unavailable, making restoration of thermal and operable functionality impossible, and long-term maintenance infeasible. Recommendation is for replacement, for quality of life of future tenants and for feasibility of long-term maintenance.
- See Window Assessment (Blackberry) in appendix for further detail and information, including further notes on deterioration beyond repair
- See Appendix for Window Schedule & Measurements

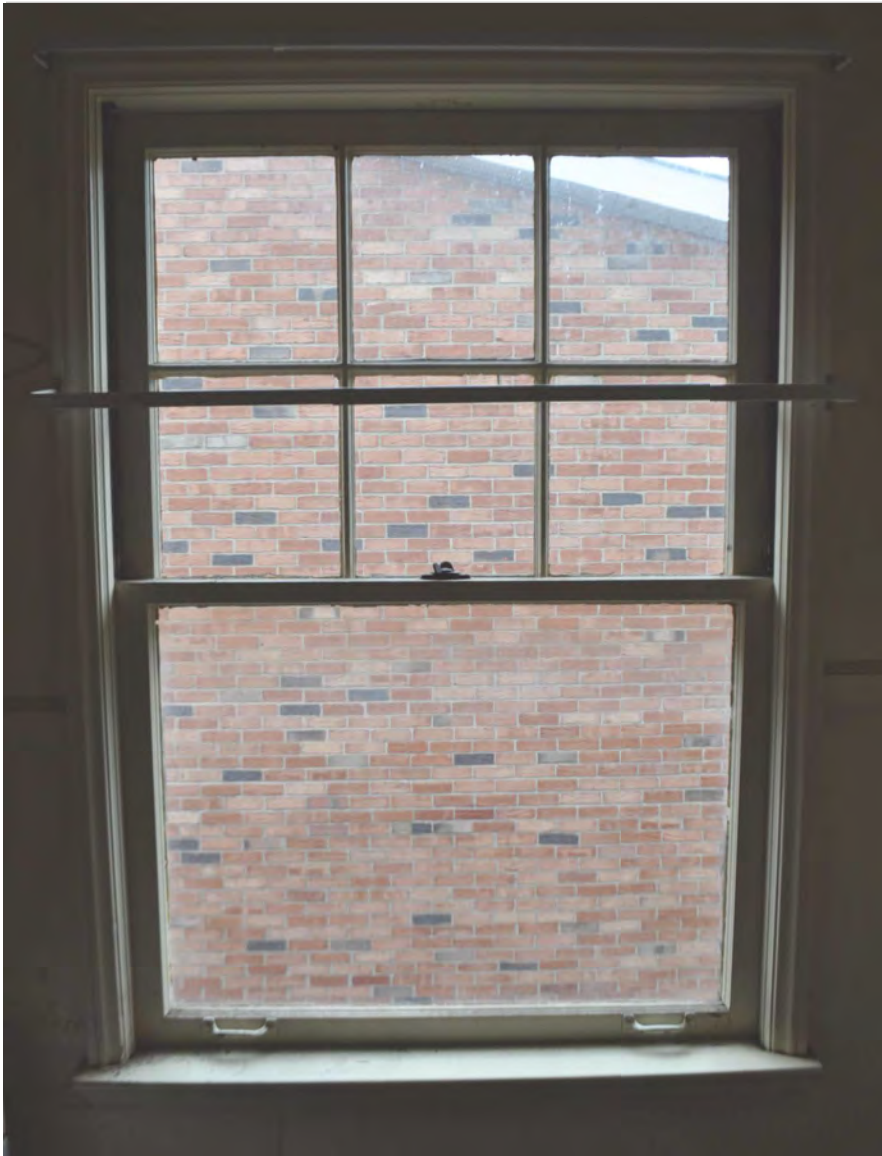
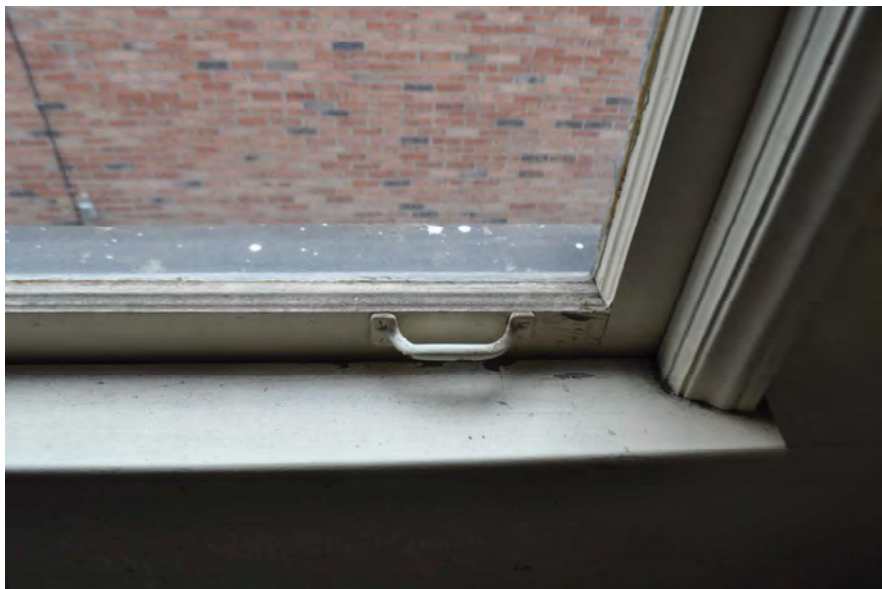
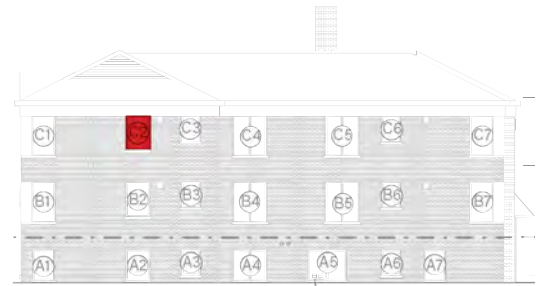
### Window C2, Type E1

- Note: Extent of exterior deterioration, dry rot, and loss of operability is not fully apparent in interior photos. Replacement parts for existing windows are unavailable, making restoration of thermal and operable functionality impossible, and long-term maintenance infeasible. Recommendation is for replacement, for quality of life of future tenants and for feasibility of long-term maintenance.
- See Window Assessment (Blackberry) in appendix for further detail and information, including further notes on deterioration beyond repair
- See Appendix for Window Schedule & Measurements

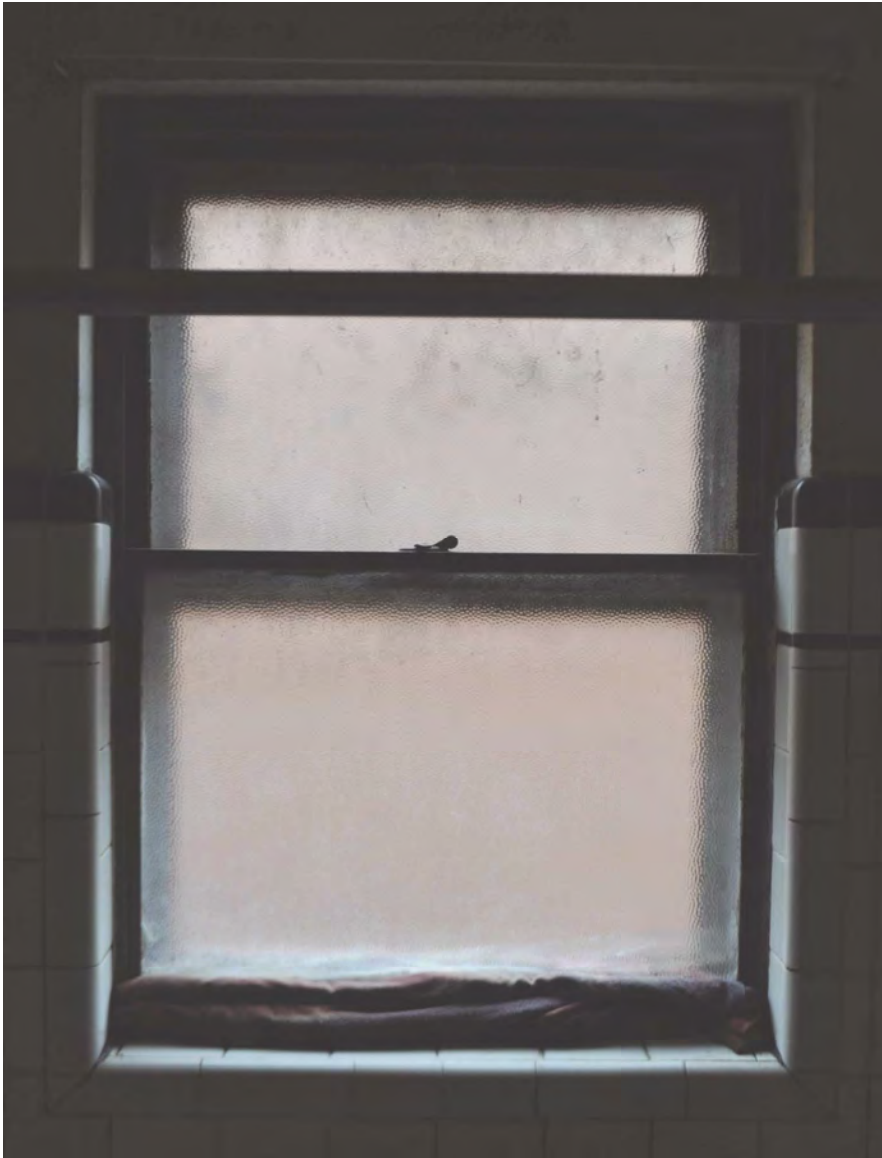
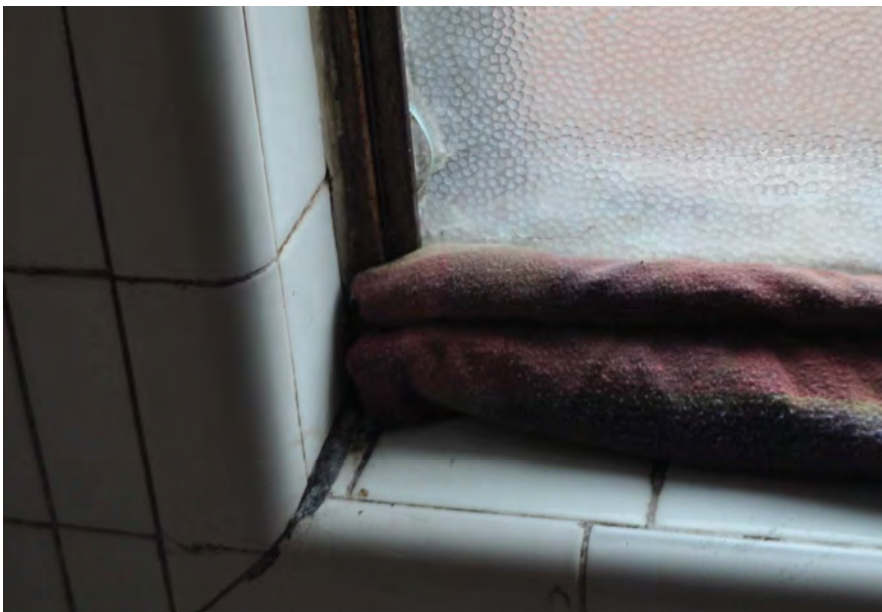
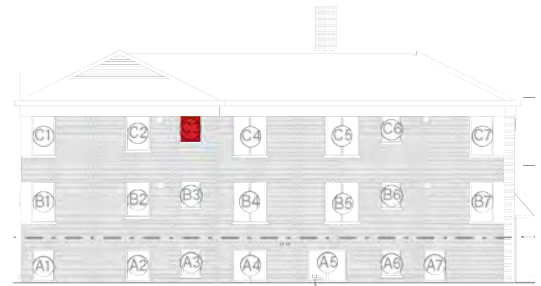
### Window C3, Type G1

- Broken Glass
- Note: Extent of exterior deterioration, dry rot, and loss of operability is not fully apparent in interior photos. Replacement parts for existing windows are unavailable, making restoration of thermal and operable functionality impossible, and long-term maintenance infeasible. Recommendation is for replacement, for quality of life of future tenants and for feasibility of long-term maintenance.
- See Window Assessment (Blackberry) in appendix for further detail and information, including further notes on deterioration beyond repair
- See Appendix for Window Schedule & Measurements

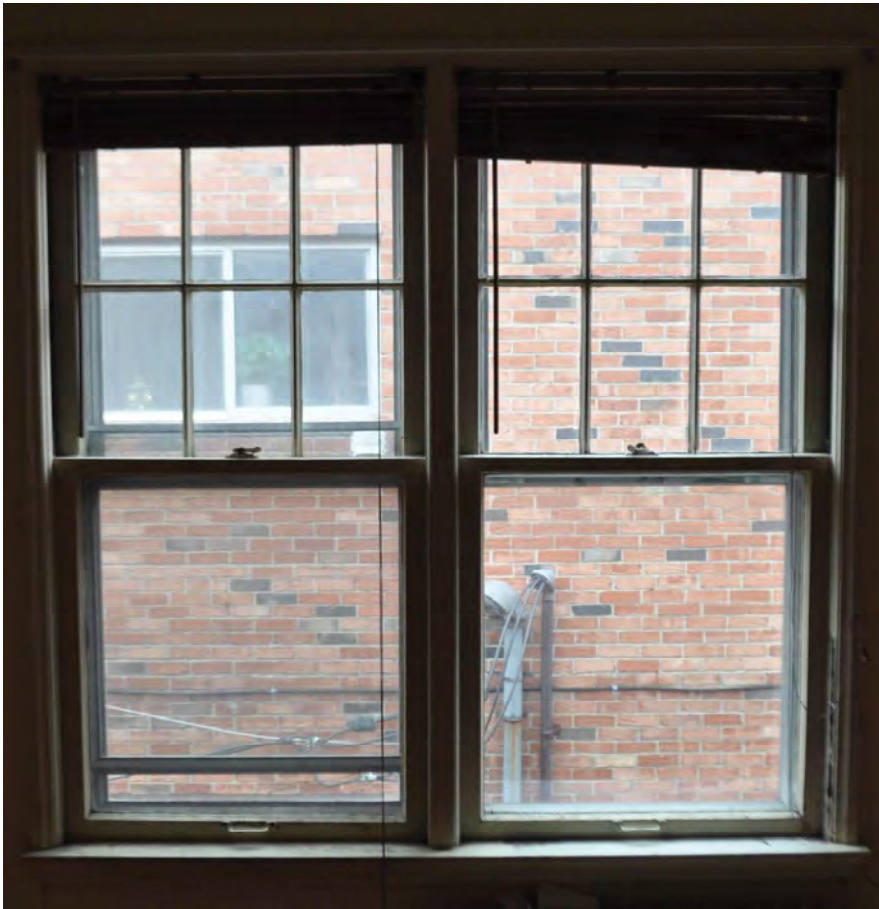
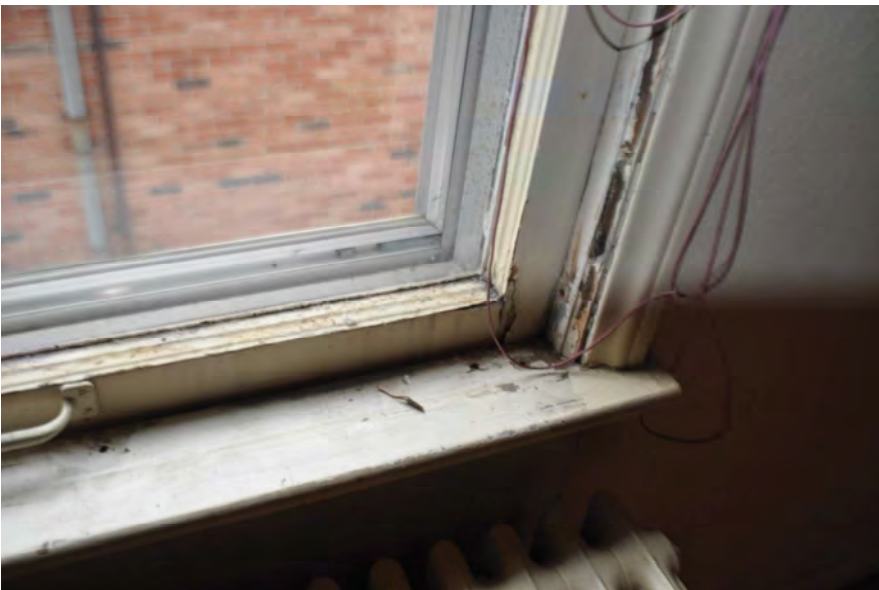
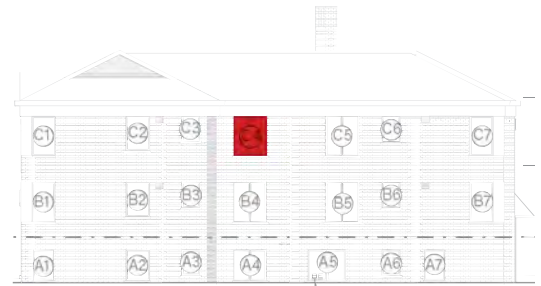
### Window C4, Type K1

- Note: Extent of exterior deterioration, dry rot, and loss of operability is not fully apparent in interior photos. Replacement parts for existing windows are unavailable, making restoration of thermal and operable functionality impossible, and long-term maintenance infeasible. Recommendation is for replacement, for quality of life of future tenants and for feasibility of long-term maintenance.
- See Window Assessment (Blackberry) in appendix for further detail and information, including further notes on deterioration beyond repair
- See Appendix for Window Schedule & Measurements

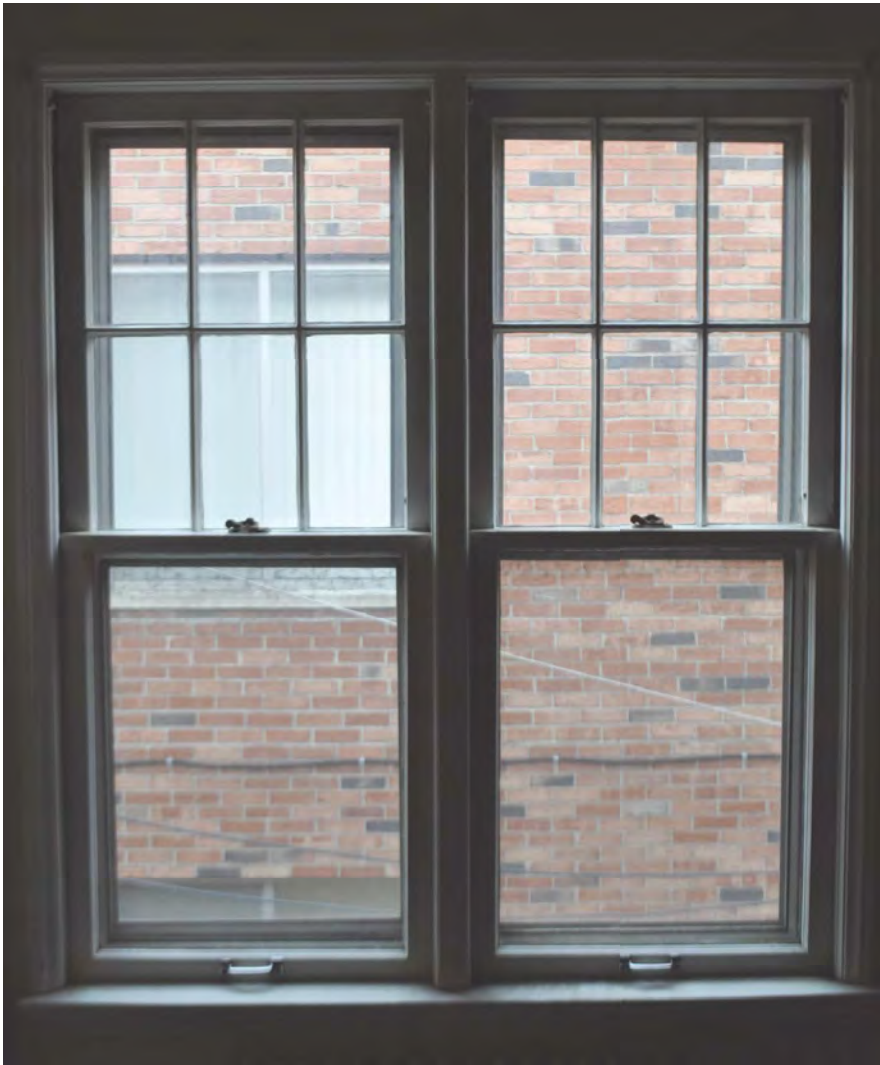
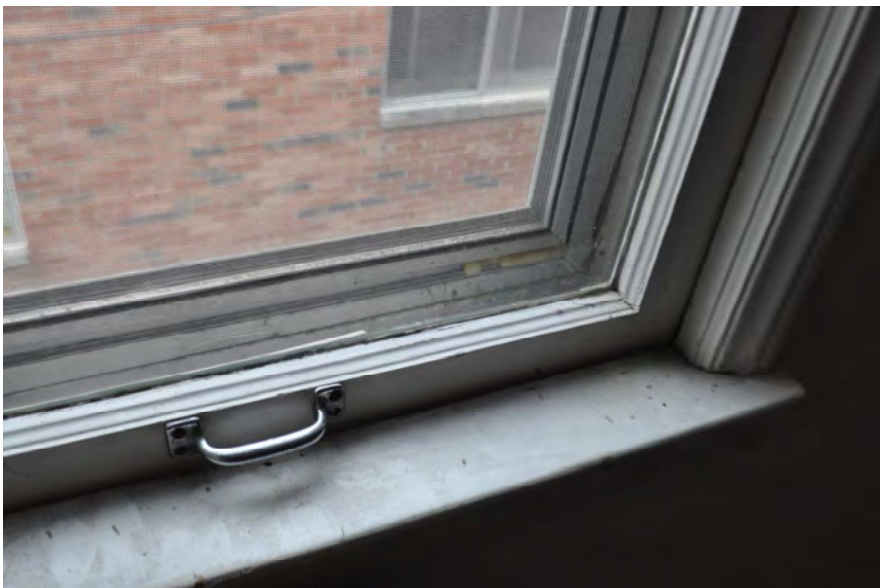
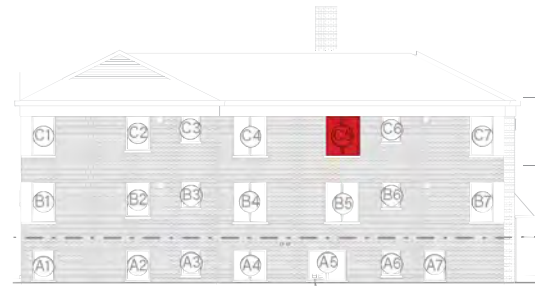
### Window C5, Type K1

- Note: Extent of exterior deterioration, dry rot, and loss of operability is not fully apparent in interior photos. Replacement parts for existing windows are unavailable, making restoration of thermal and operable functionality impossible, and long-term maintenance infeasible. Recommendation is for replacement, for quality of life of future tenants and for feasibility of long-term maintenance.
- See Window Assessment (Blackberry) in appendix for further detail and information, including further notes on deterioration beyond repair
- See Appendix for Window Schedule & Measurements
