# 9710 W Outer Dr

## Existing Condition Photos

# 9730 W Outer Dr

# Detailed Scope of Work

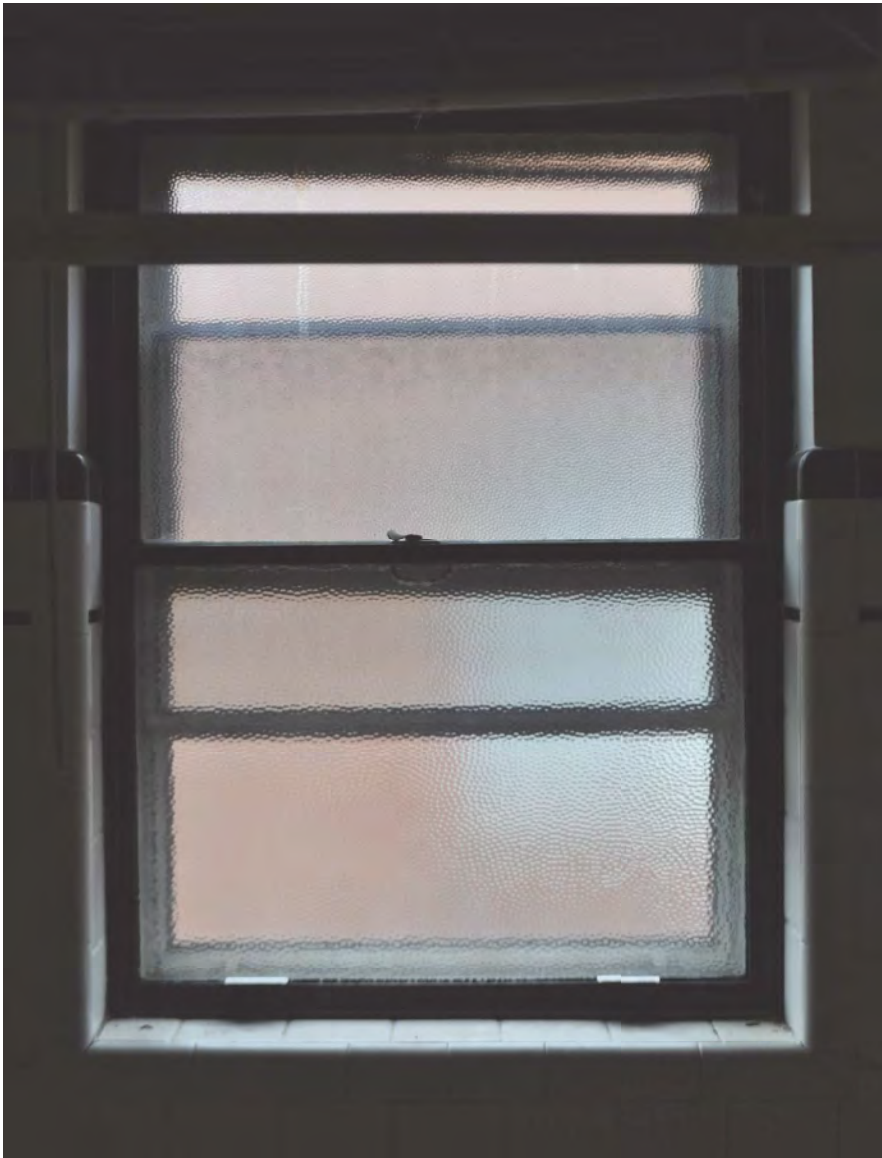
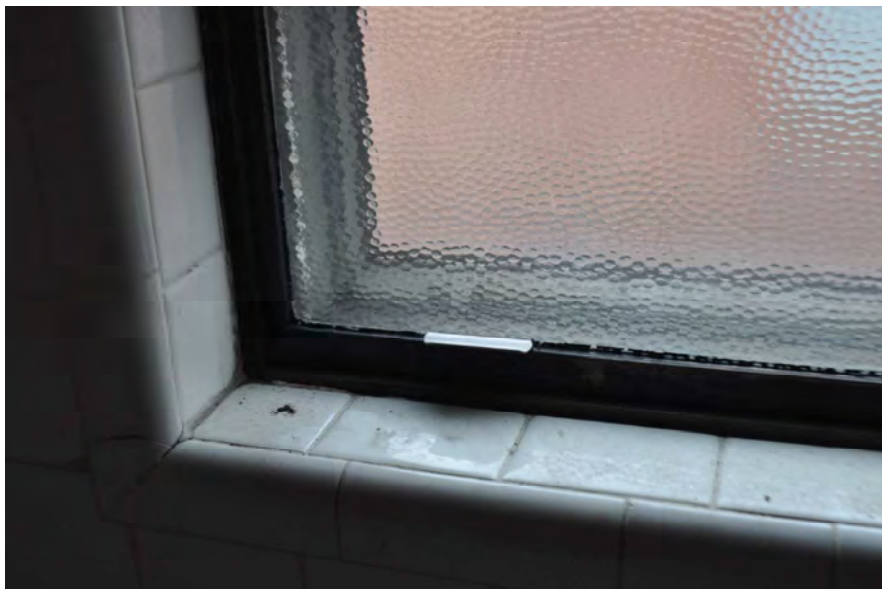
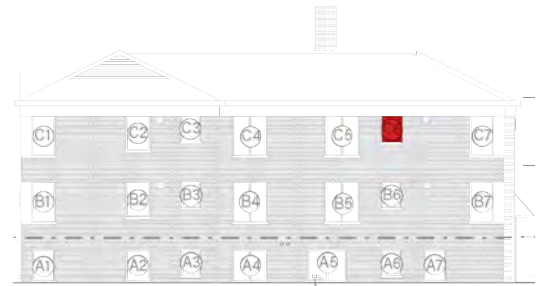
### Window C6, Type G1

- Note: Extent of exterior deterioration, dry rot, and loss of operability is not fully apparent in interior photos. Replacement parts for existing windows are unavailable, making restoration of thermal and operable functionality impossible, and long-term maintenance infeasible. Recommendation is for replacement, for quality of life of future tenants and for feasibility of long-term maintenance.
- See Window Assessment (Blackberry) in appendix for further detail and information, including further notes on deterioration beyond repair
- See Appendix for Window Schedule & Measurements

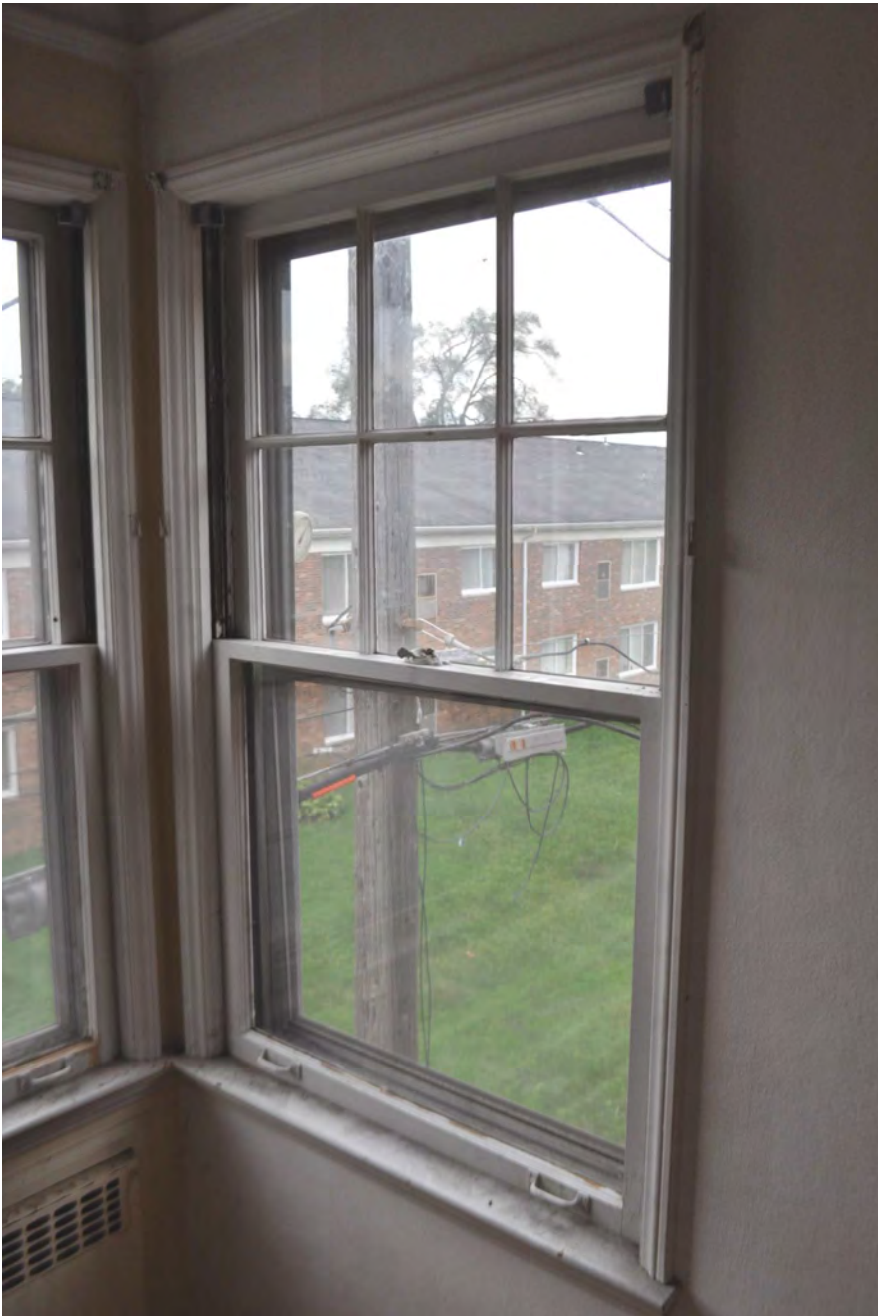
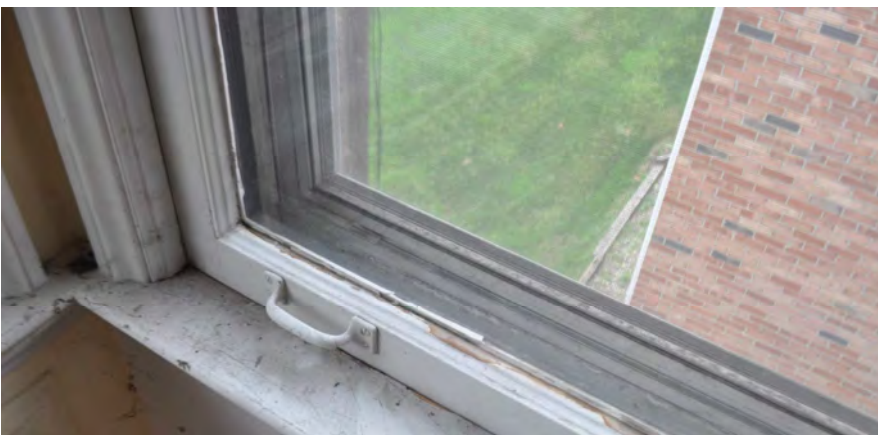
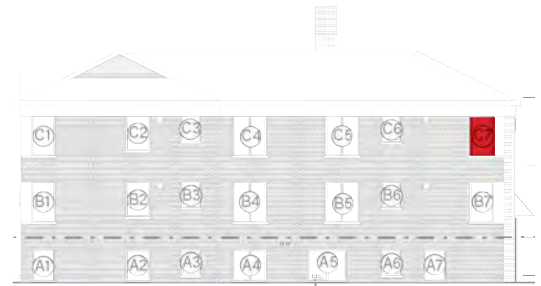
### Window C7, Type A1

- Note: Extent of exterior deterioration, dry rot, and loss of operability is not fully apparent in interior photos. Replacement parts for existing windows are unavailable, making restoration of thermal and operable functionality impossible, and long-term maintenance infeasible. Recommendation is for replacement, for quality of life of future tenants and for feasibility of long-term maintenance.
- See Window Assessment (Blackberry) in appendix for further detail and information, including further notes on deterioration beyond repair
- See Appendix for Window Schedule & Measurements

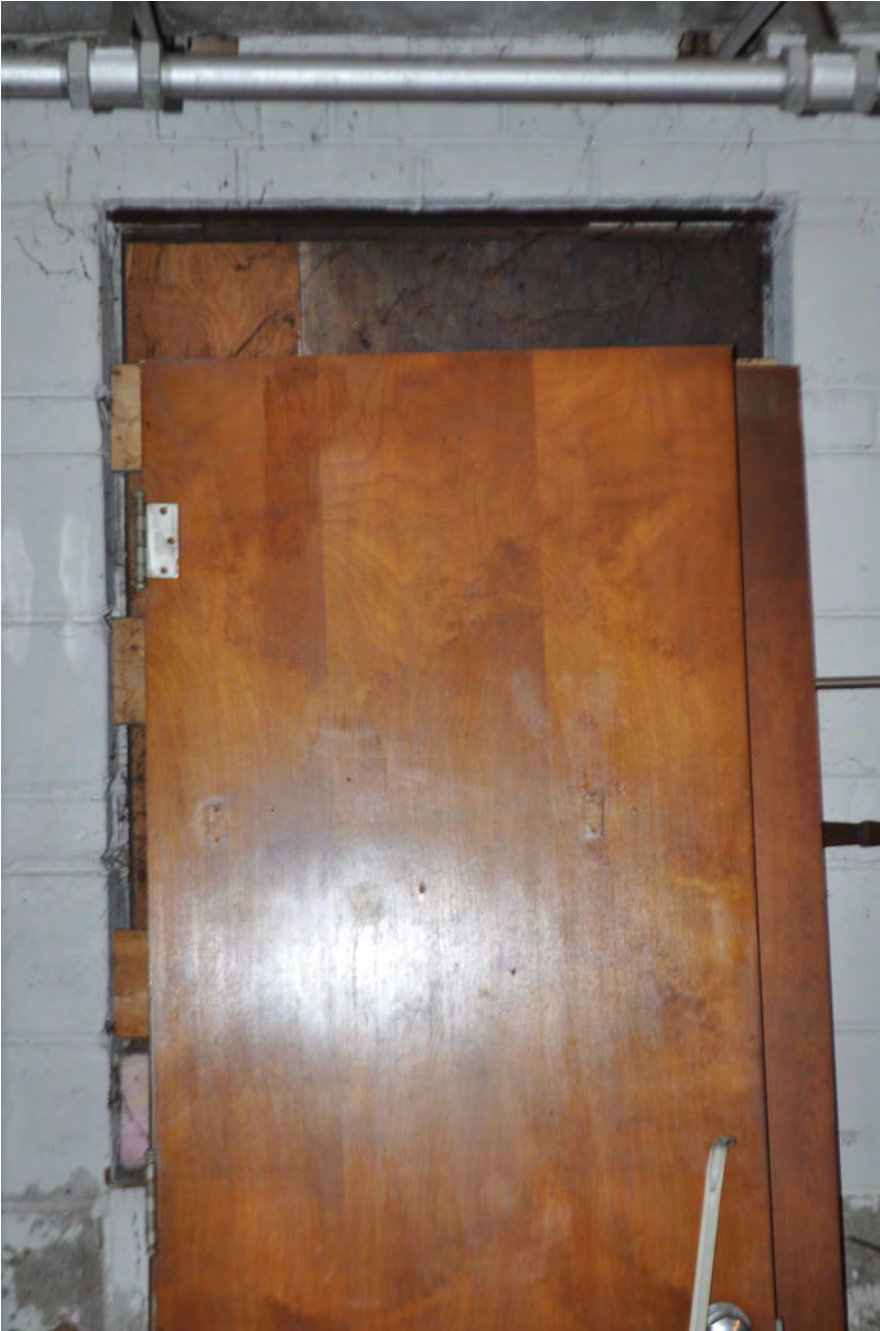
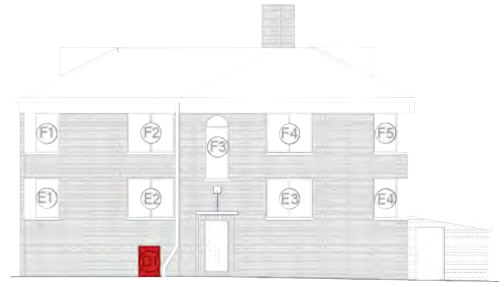
### Window D1, Type D1

- Note: Extent of exterior deterioration, dry rot, and loss of operability is not fully apparent in interior photos. Replacement parts for existing windows are unavailable, making restoration of thermal and operable functionality impossible, and long-term maintenance infeasible. Recommendation is for replacement, for quality of life of future tenants and for feasibility of long-term maintenance.
- See Window Assessment (Blackberry) in appendix for further detail and information, including further notes on deterioration beyond repair
- See Appendix for Window Schedule & Measurements

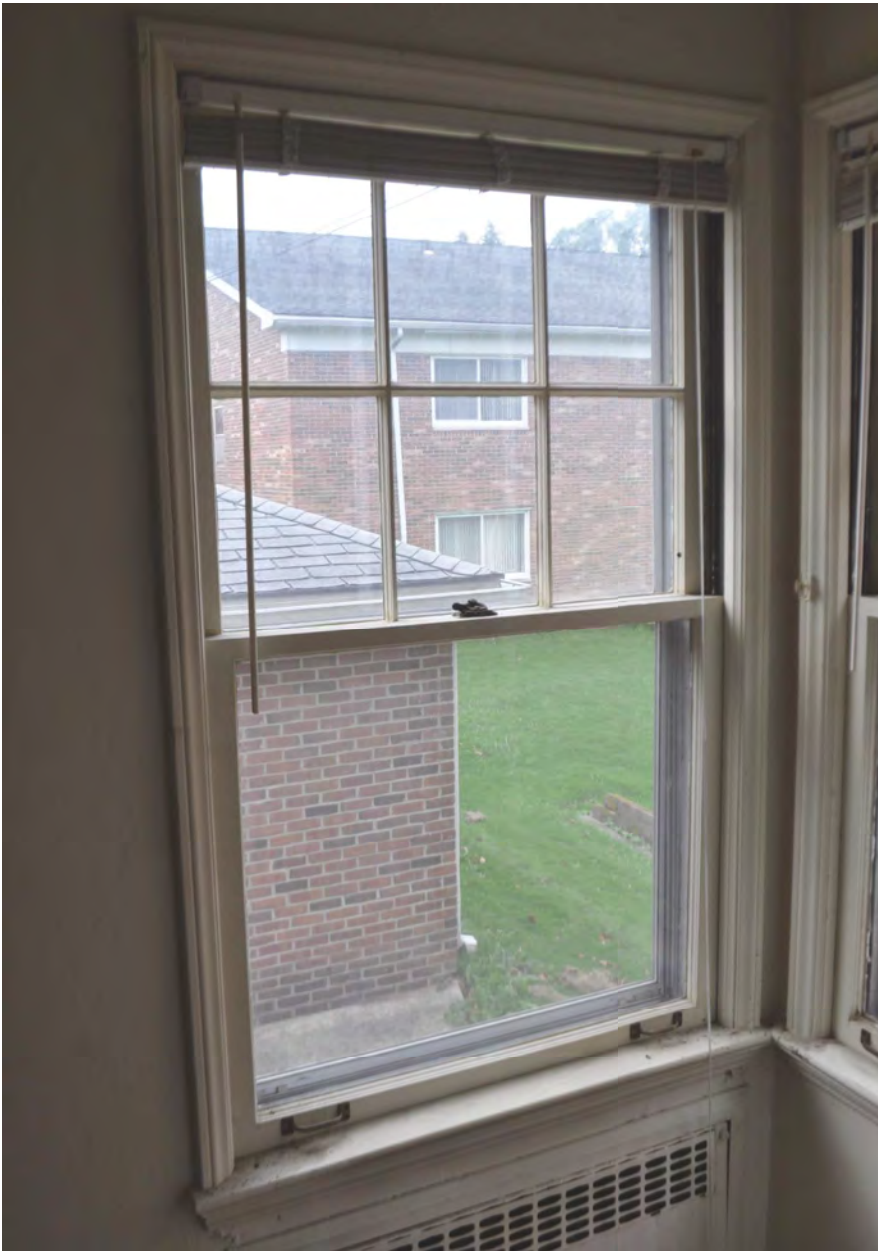
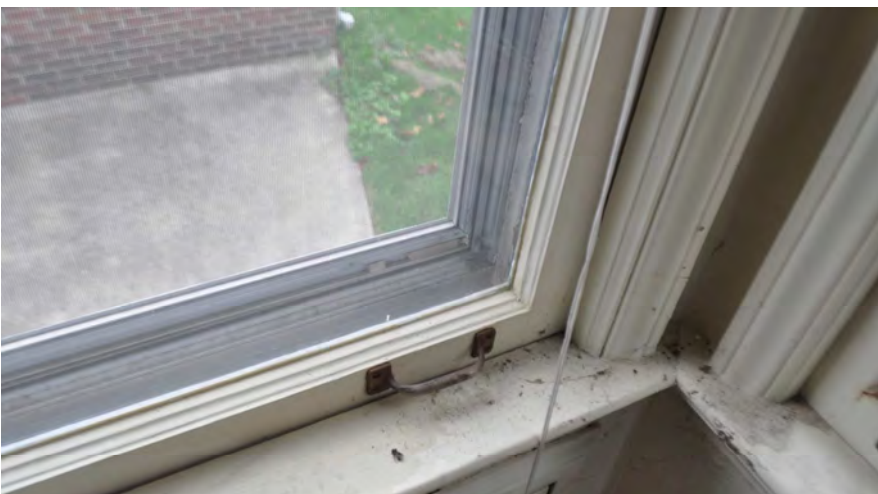
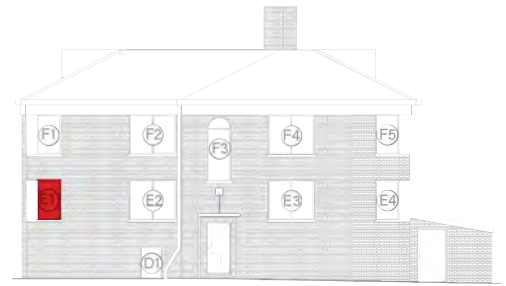
### Window E1, Type A1

- Note: Extent of exterior deterioration, dry rot, and loss of operability is not fully apparent in interior photos. Replacement parts for existing windows are unavailable, making restoration of thermal and operable functionality impossible, and long-term maintenance infeasible. Recommendation is for replacement, for quality of life of future tenants and for feasibility of long-term maintenance.
- See Window Assessment (Blackberry) in appendix for further detail and information, including further notes on deterioration beyond repair
- See Appendix for Window Schedule & Measurements

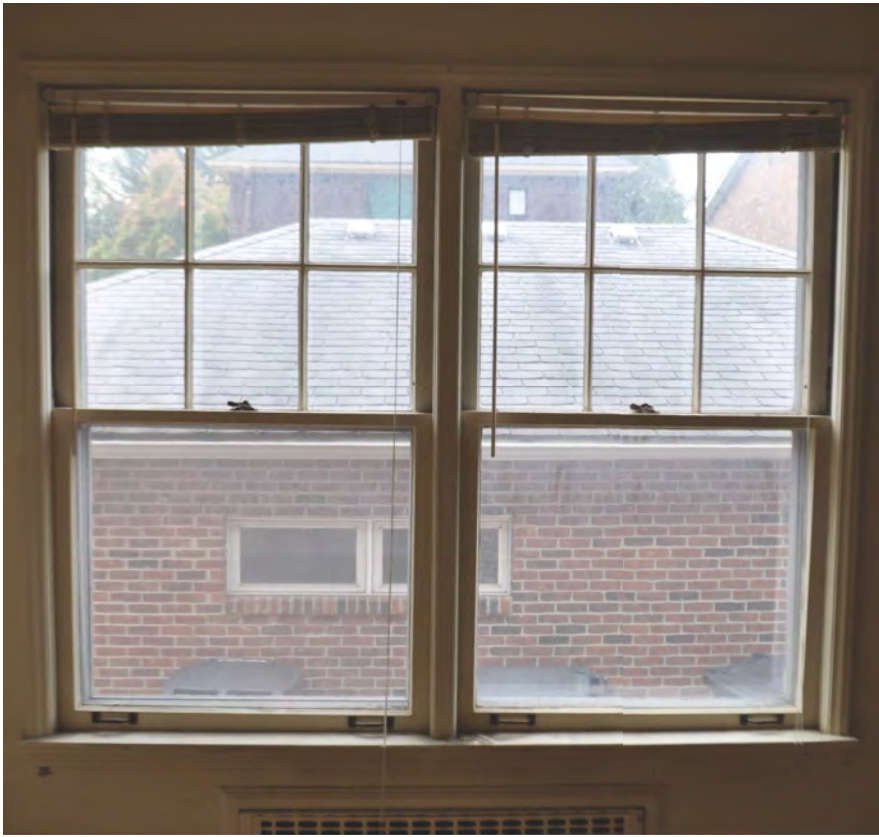
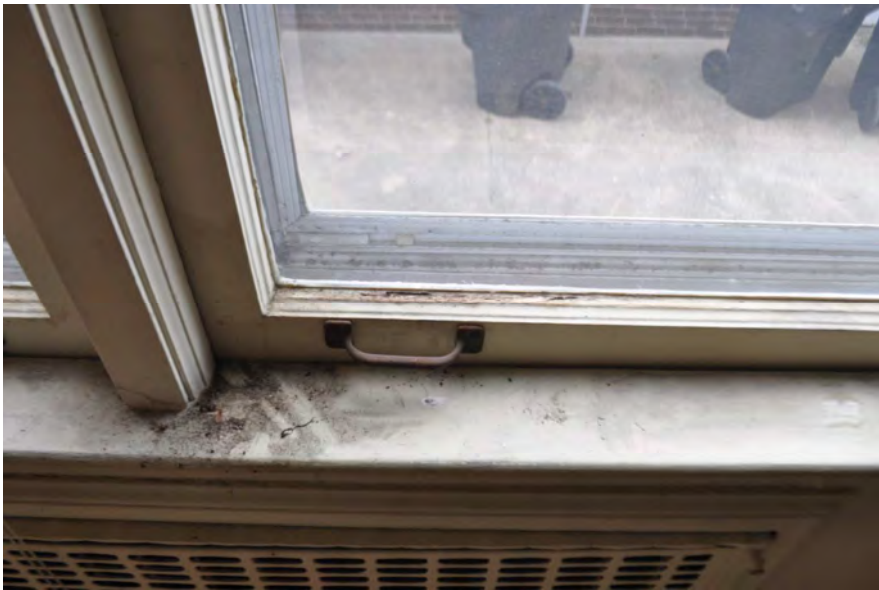
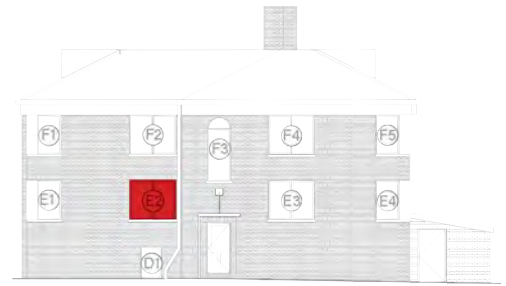
### Window E2, Type B1

- Note: Extent of exterior deterioration, dry rot, and loss of operability is not fully apparent in interior photos. Replacement parts for existing windows are unavailable, making restoration of thermal and operable functionality impossible, and long-term maintenance infeasible. Recommendation is for replacement, for quality of life of future tenants and for feasibility of long-term maintenance.
- See Window Assessment (Blackberry) in appendix for further detail and information, including further notes on deterioration beyond repair
- See Appendix for Window Schedule & Measurements

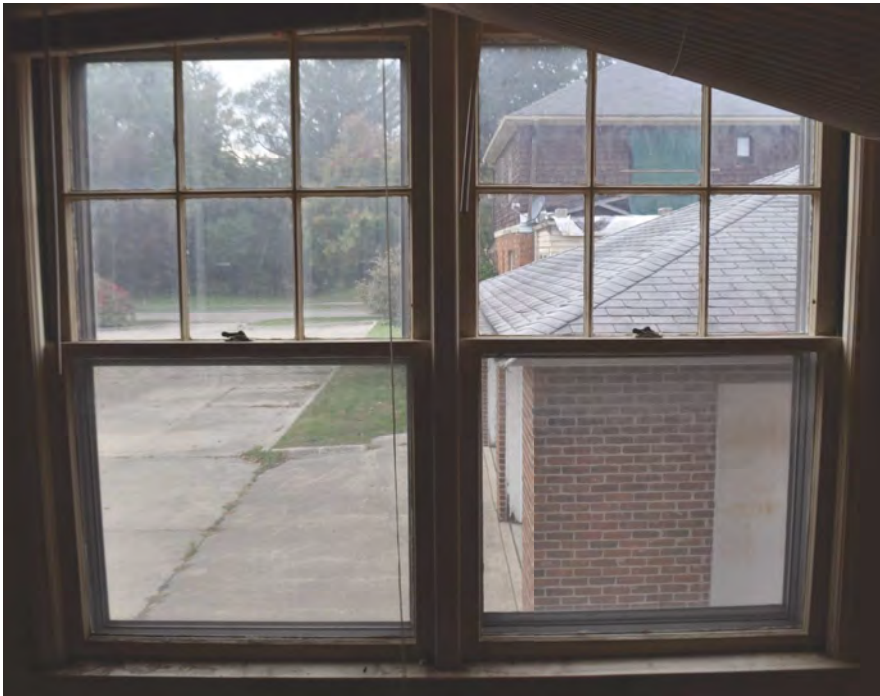
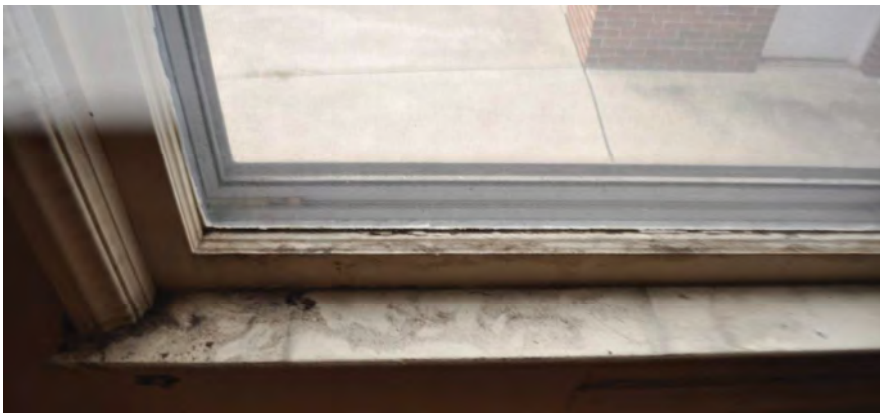
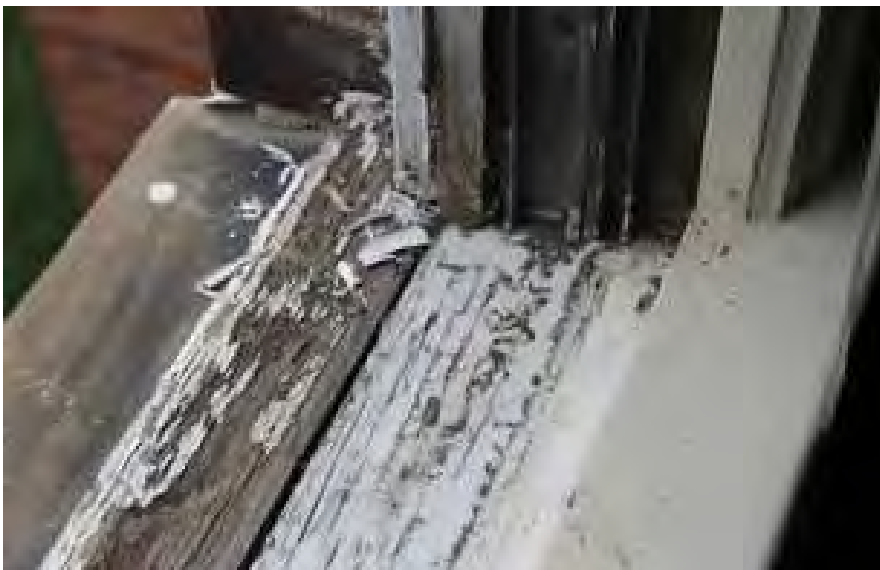
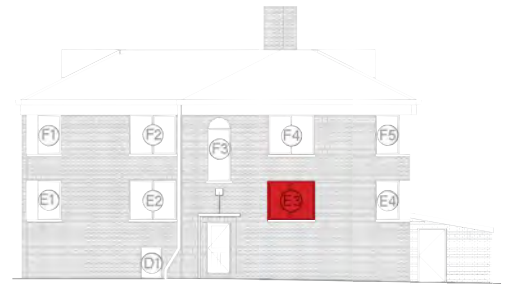
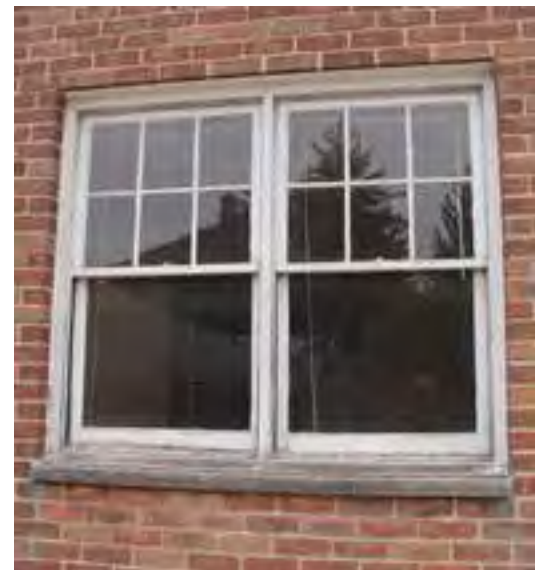
### Window E3, Type B1

- Exterior Split Sill
- Note: Extent of exterior deterioration, dry rot, and loss of operability is not fully apparent in interior photos. Replacement parts for existing windows are unavailable, making restoration of thermal and operable functionality impossible, and long-term maintenance infeasible. Recommendation is for replacement, for quality of life of future tenants and for feasibility of long-term maintenance.
- See Window Assessment (Blackberry) in appendix for further detail and information, including further notes on deterioration beyond repair
- See Appendix for Window Schedule & Measurements

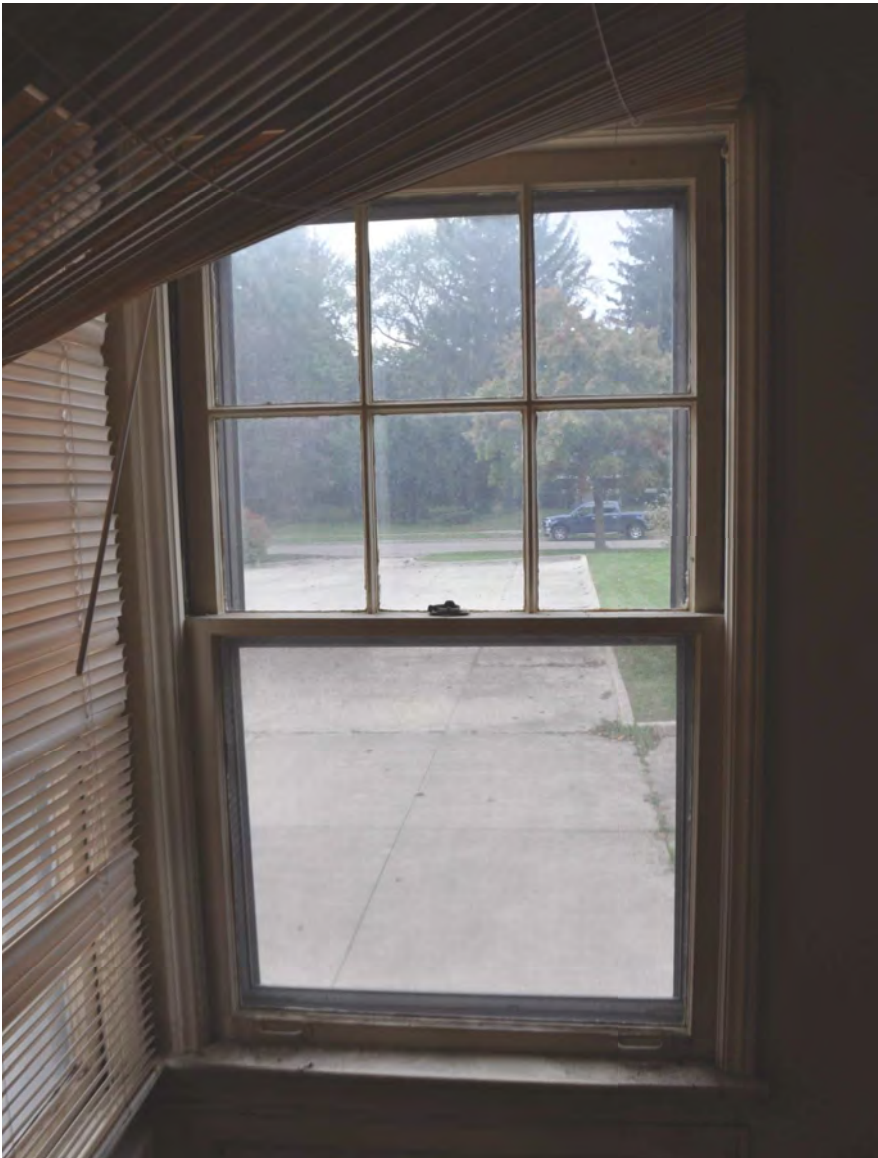
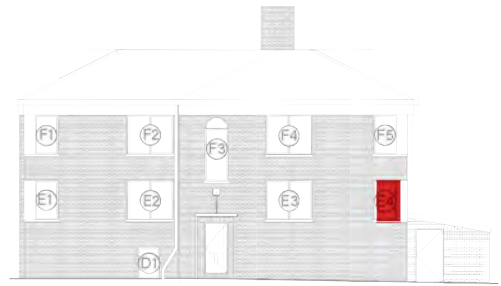
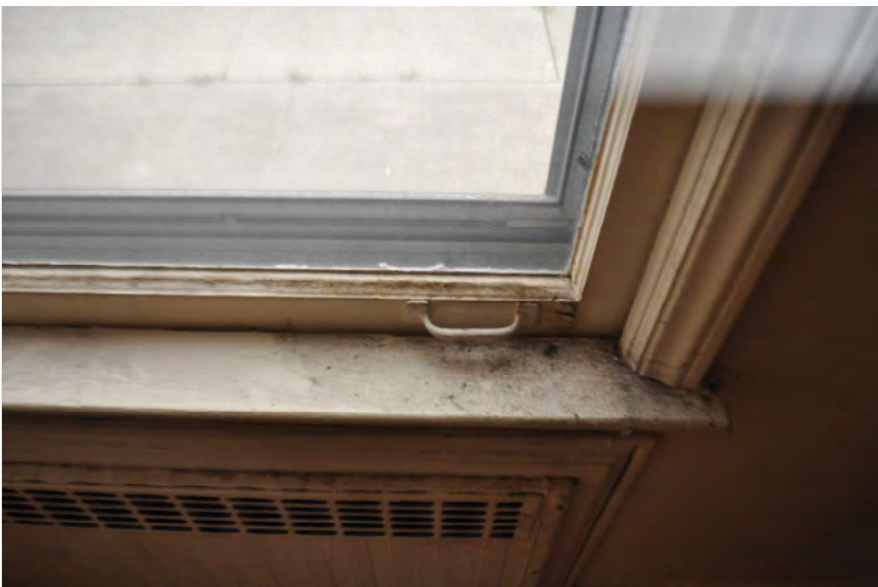
### Window E4, Type A1

- Note: Extent of exterior deterioration, dry rot, and loss of operability is not fully apparent in interior photos. Replacement parts for existing windows are unavailable, making restoration of thermal and operable functionality impossible, and long-term maintenance infeasible. Recommendation is for replacement, for quality of life of future tenants and for feasibility of long-term maintenance.
- See Window Assessment (Blackberry) in appendix for further detail and information, including further notes on deterioration beyond repair
- See Appendix for Window Schedule & Measurements

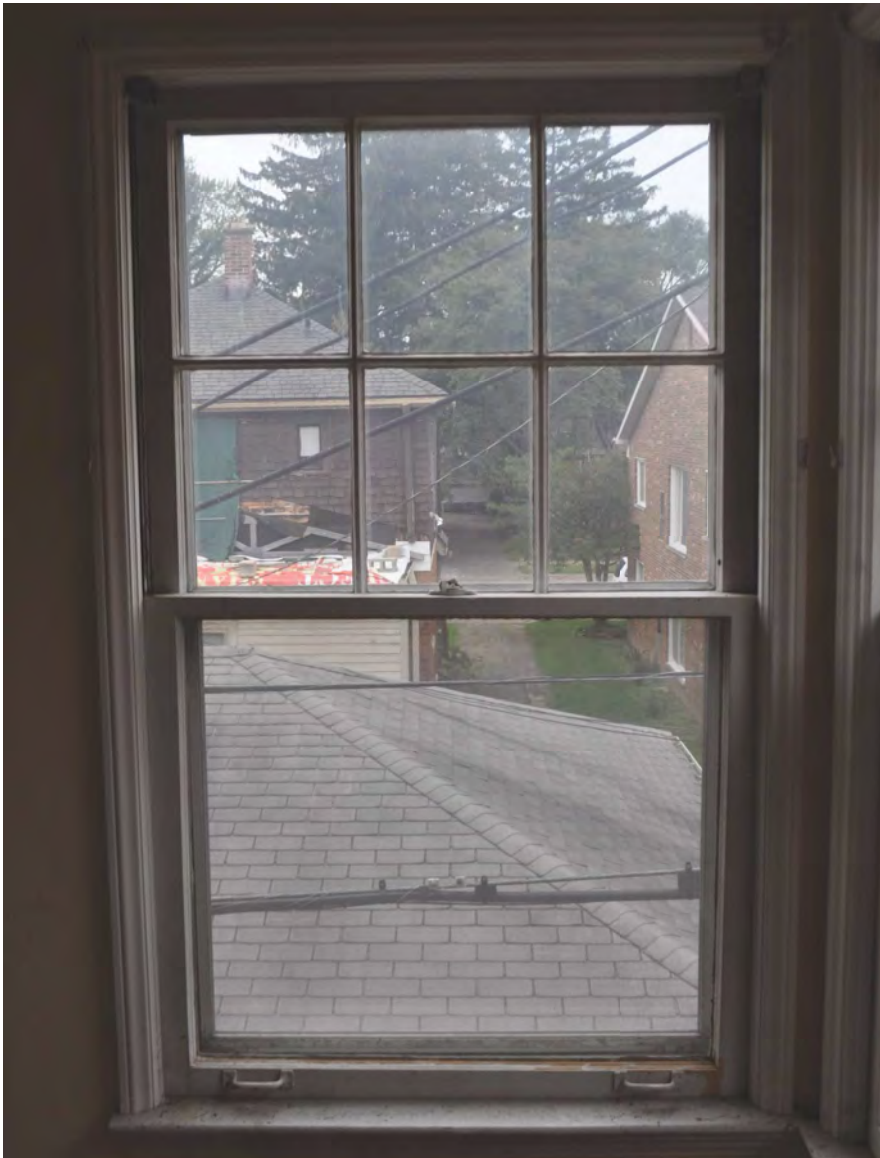
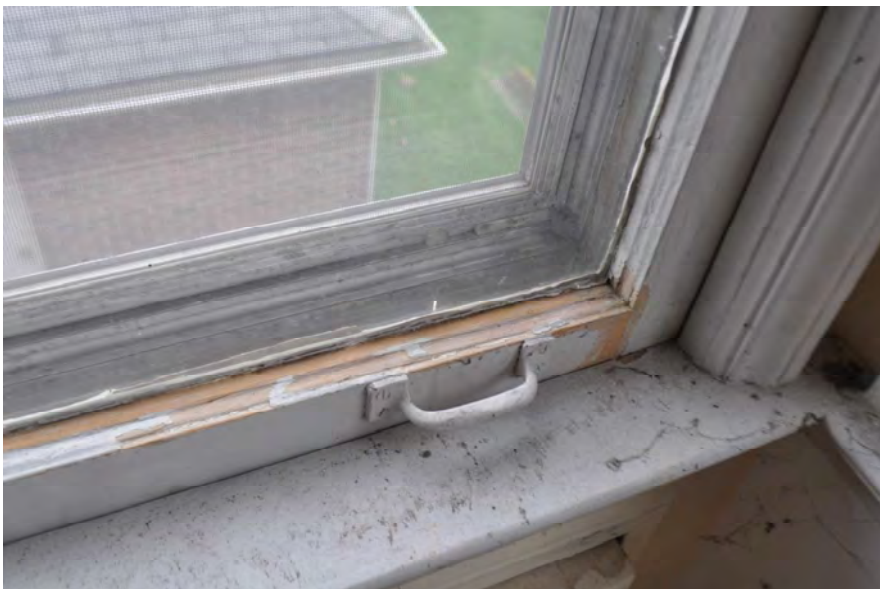
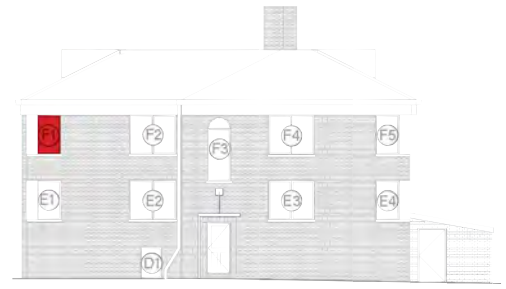
### Window F1, Type A1

- Note: Extent of exterior deterioration, dry rot, and loss of operability is not fully apparent in interior photos. Replacement parts for existing windows are unavailable, making restoration of thermal and operable functionality impossible, and long-term maintenance infeasible. Recommendation is for replacement, for quality of life of future tenants and for feasibility of long-term maintenance.
- See Window Assessment (Blackberry) in appendix for further detail and information, including further notes on deterioration beyond repair
- See Appendix for Window Schedule & Measurements

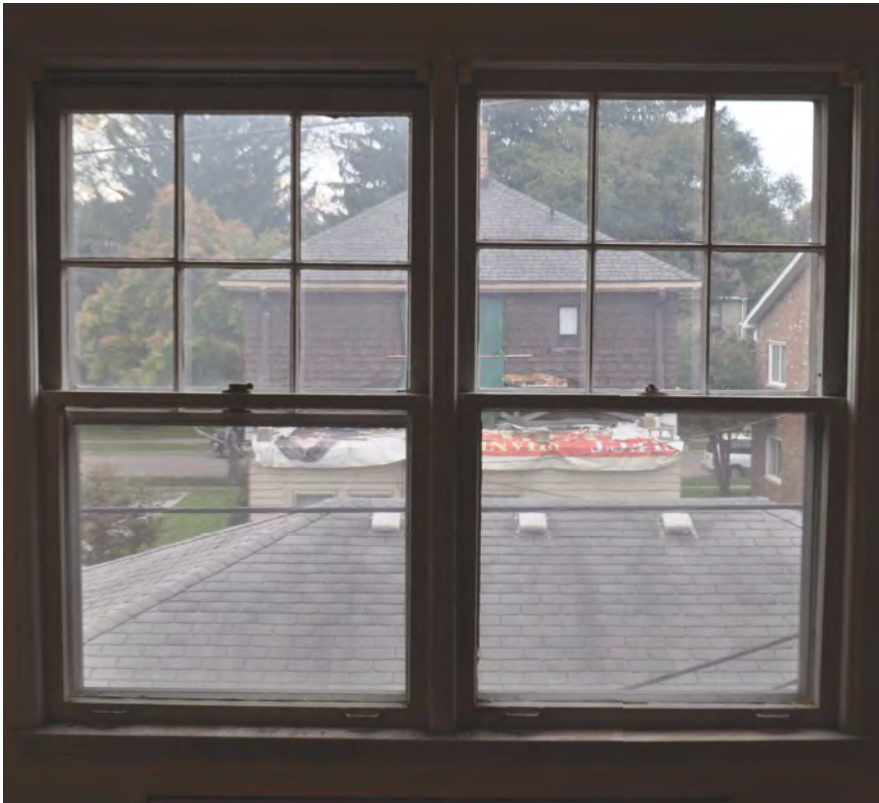
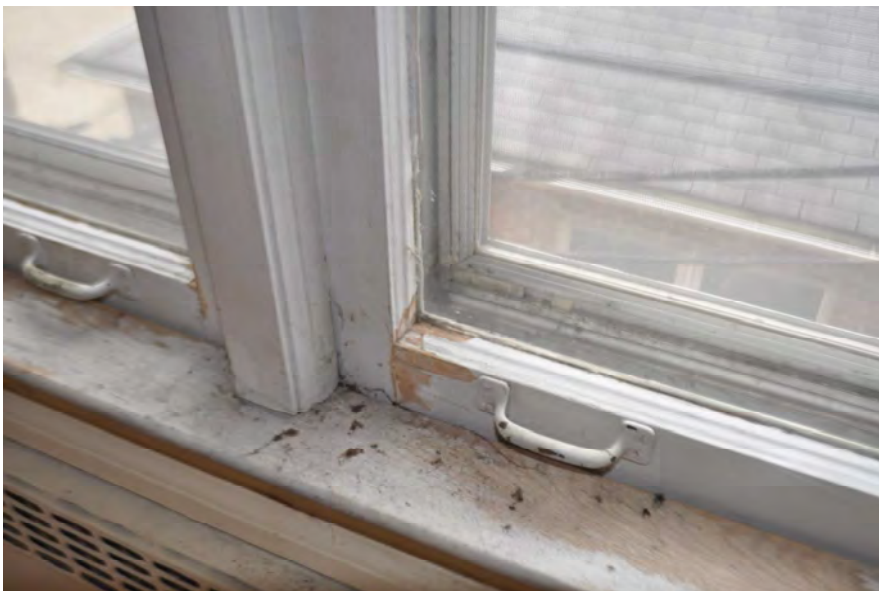
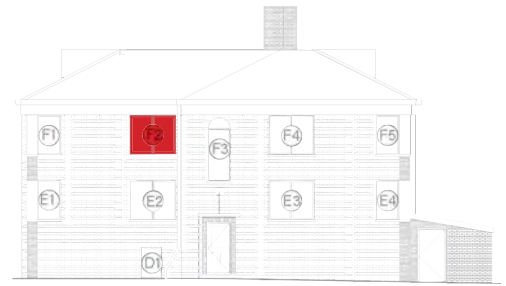
### Window F2, Type B1

- Note: Extent of exterior deterioration, dry rot, and loss of operability is not fully apparent in interior photos. Replacement parts for existing windows are unavailable, making restoration of thermal and operable functionality impossible, and long-term maintenance infeasible. Recommendation is for replacement, for quality of life of future tenants and for feasibility of long-term maintenance.
- See Window Assessment (Blackberry) in appendix for further detail and information, including further notes on deterioration beyond repair
- See Appendix for Window Schedule & Measurements

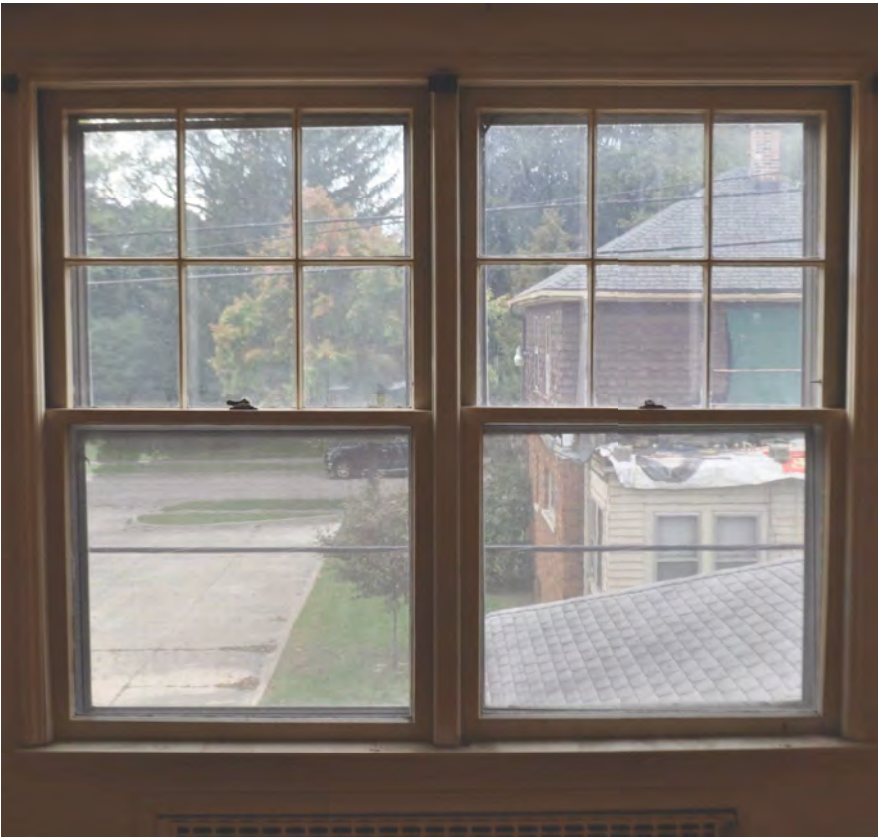
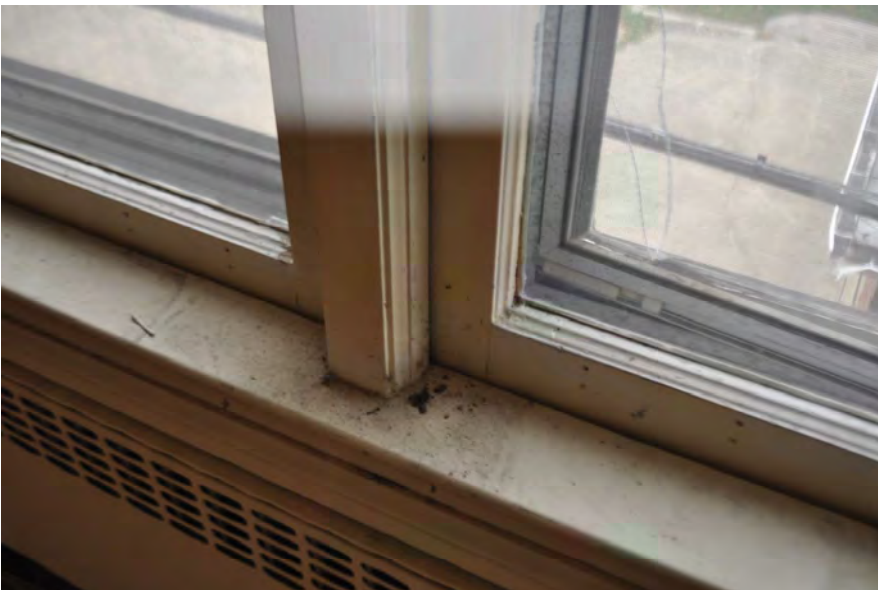
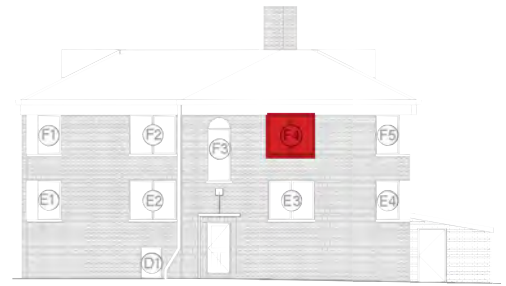
### Window F4, Type B1

- Note: Extent of exterior deterioration, dry rot, and loss of operability is not fully apparent in interior photos. Replacement parts for existing windows are unavailable, making restoration of thermal and operable functionality impossible, and long-term maintenance infeasible. Recommendation is for replacement, for quality of life of future tenants and for feasibility of long-term maintenance.
- See Window Assessment (Blackberry) in appendix for further detail and information, including further notes on deterioration beyond repair
- See Appendix for Window Schedule & Measurements

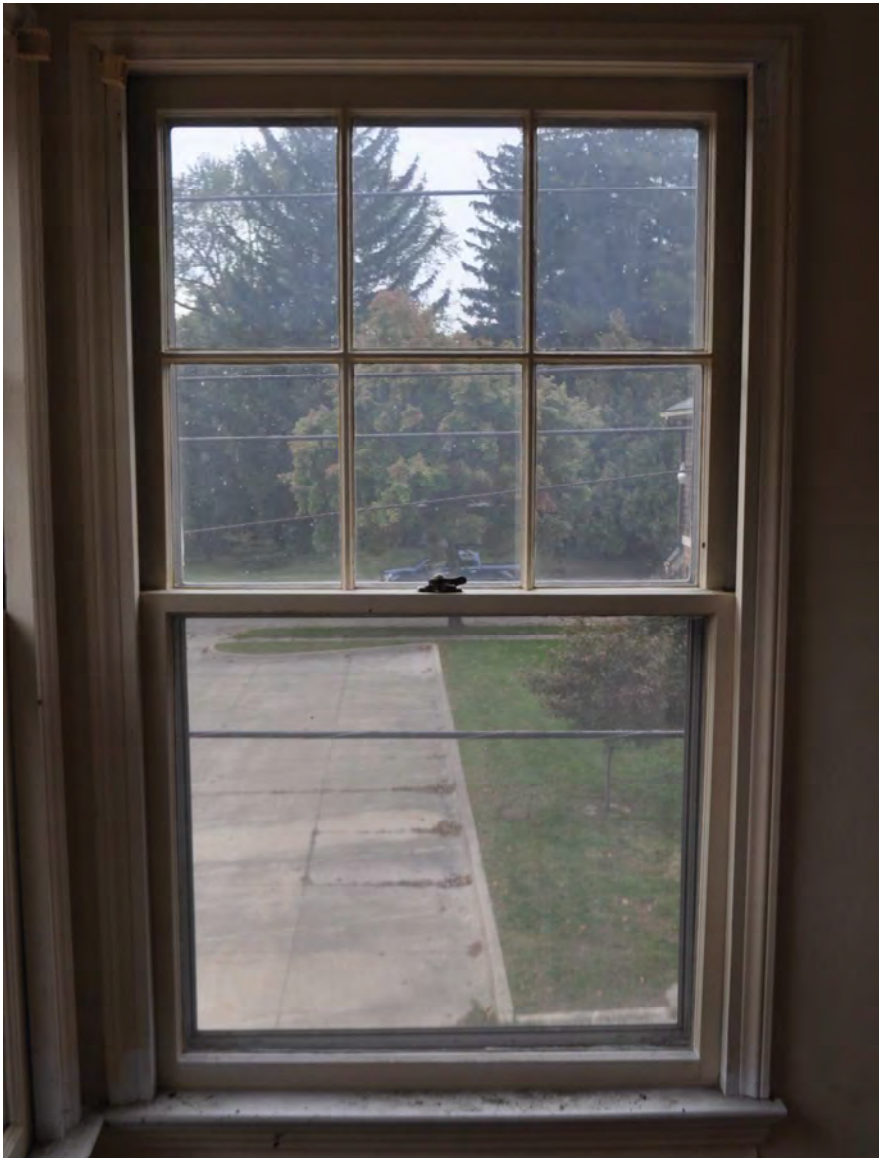
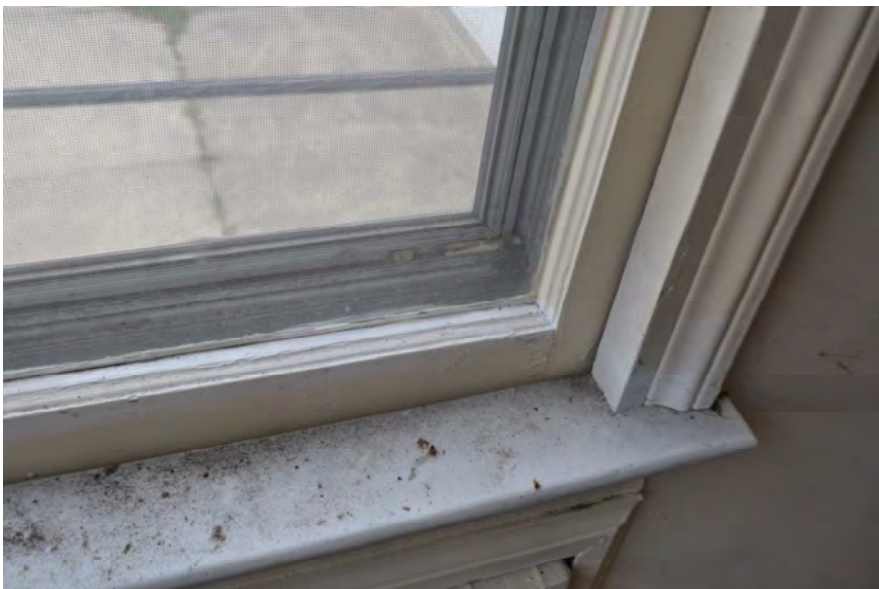
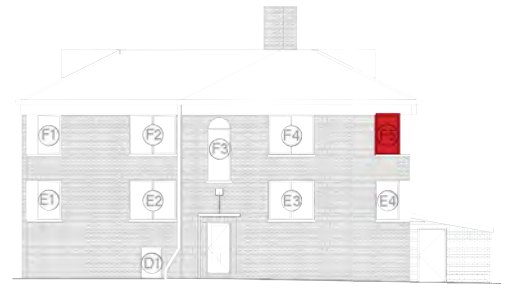
### Window F5, Type A1

- Note: Extent of exterior deterioration, dry rot, and loss of operability is not fully apparent in interior photos. Replacement parts for existing windows are unavailable, making restoration of thermal and operable functionality impossible, and long-term maintenance infeasible. Recommendation is for replacement, for quality of life of future tenants and for feasibility of long-term maintenance.
- See Window Assessment (Blackberry) in appendix for further detail and information, including further notes on deterioration beyond repair
- See Appendix for Window Schedule & Measurements

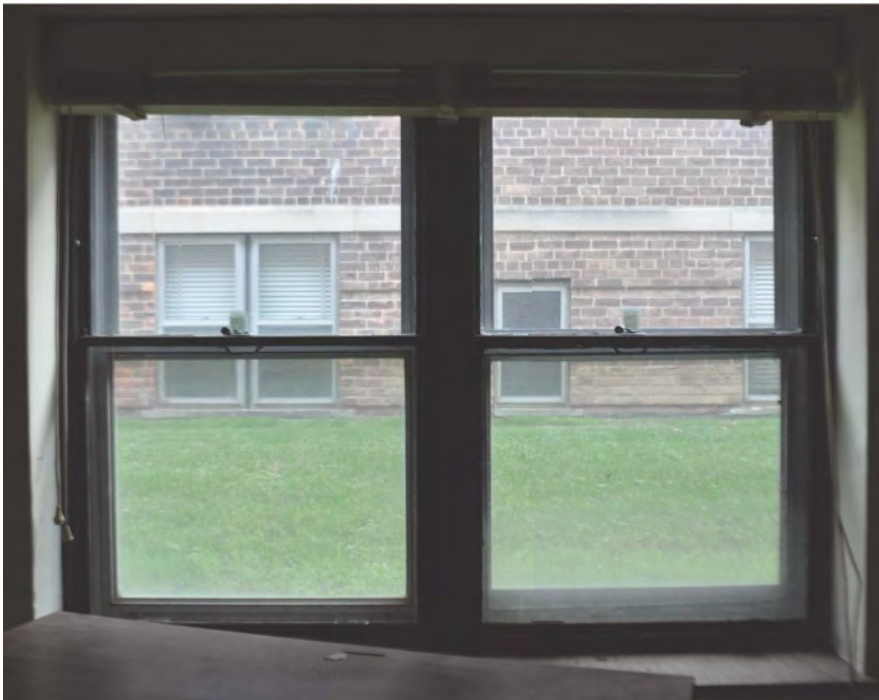
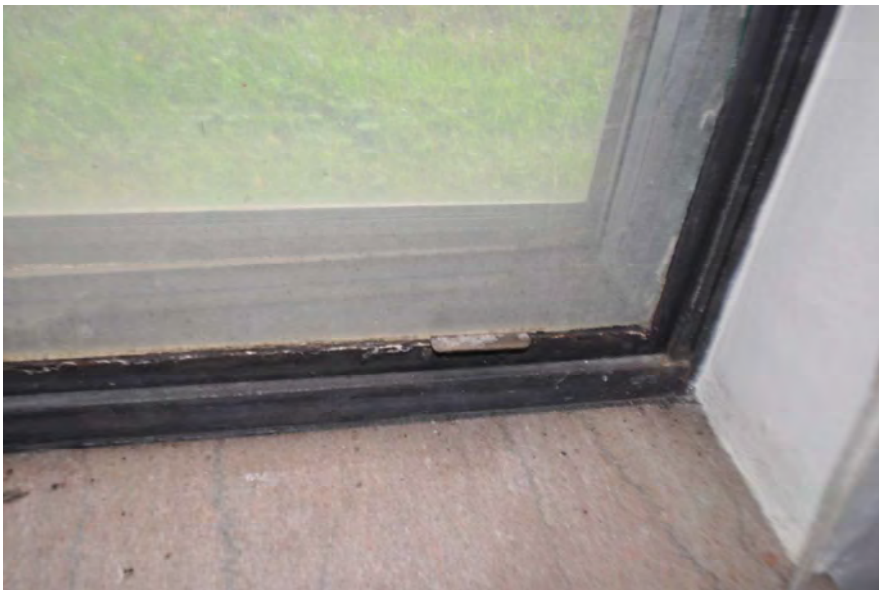
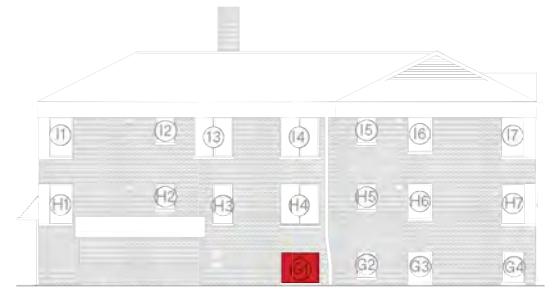
### Window G1, Type H1

- Note: Extent of exterior deterioration, dry rot, and loss of operability is not fully apparent in interior photos. Replacement parts for existing windows are unavailable, making restoration of thermal and operable functionality impossible, and long-term maintenance infeasible. Recommendation is for replacement, for quality of life of future tenants and for feasibility of long-term maintenance.
- See Window Assessment (Blackberry) in appendix for further detail and information, including further notes on deterioration beyond repair
- See Appendix for Window Schedule & Measurements

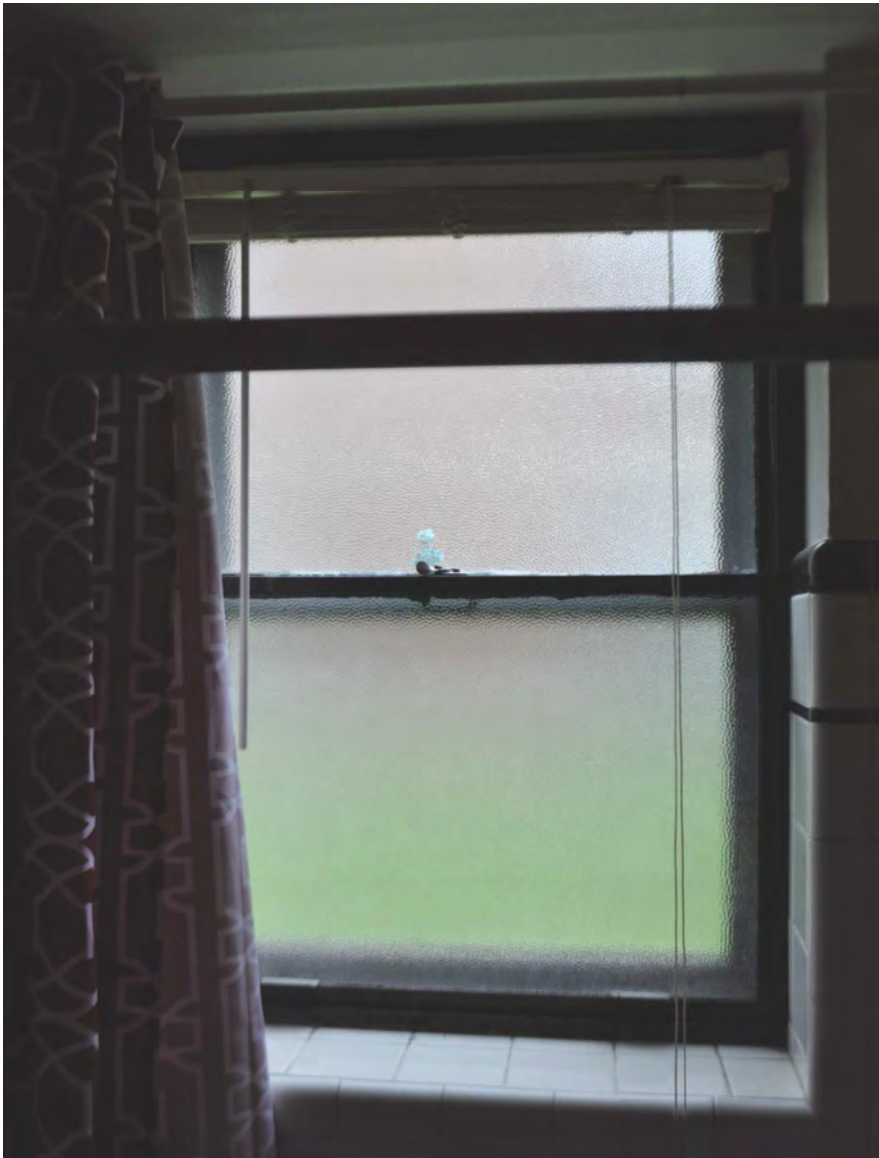
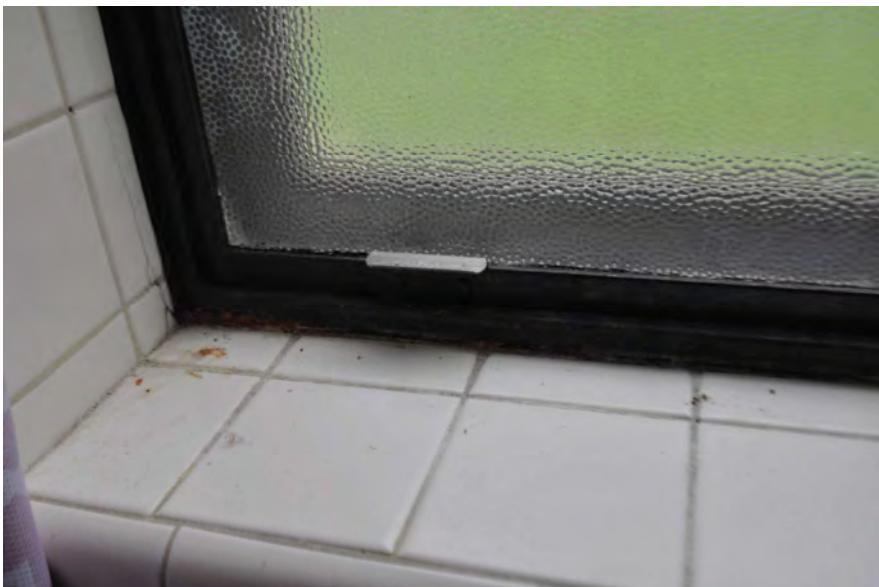
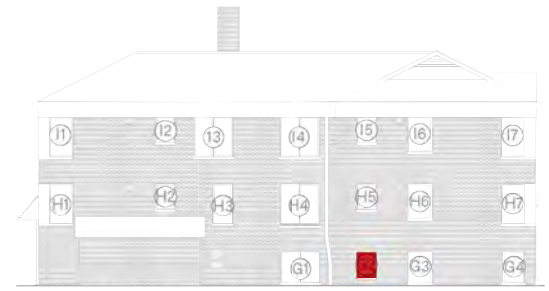
### Window G2, Type G1

- Note: Extent of exterior deterioration, dry rot, and loss of operability is not fully apparent in interior photos. Replacement parts for existing windows are unavailable, making restoration of thermal and operable functionality impossible, and long-term maintenance infeasible. Recommendation is for replacement, for quality of life of future tenants and for feasibility of long-term maintenance.
- See Window Assessment (Blackberry) in appendix for further detail and information, including further notes on deterioration beyond repair
- See Appendix for Window Schedule & Measurements
