# 9710 W Outer Dr

## Existing Condition Photos

# 9730 W Outer Dr

# Detailed Scope of Work

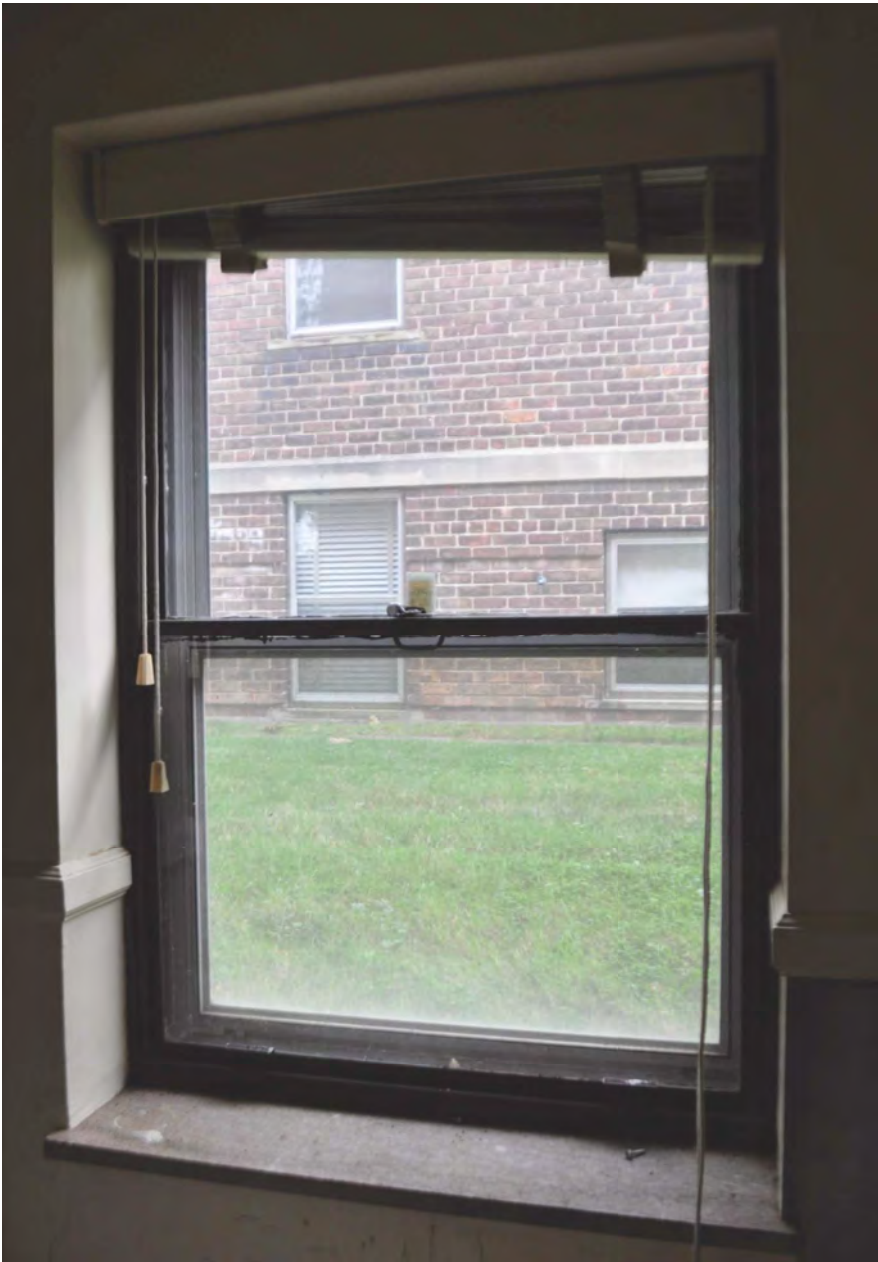
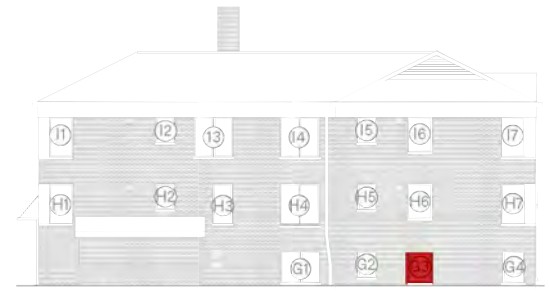
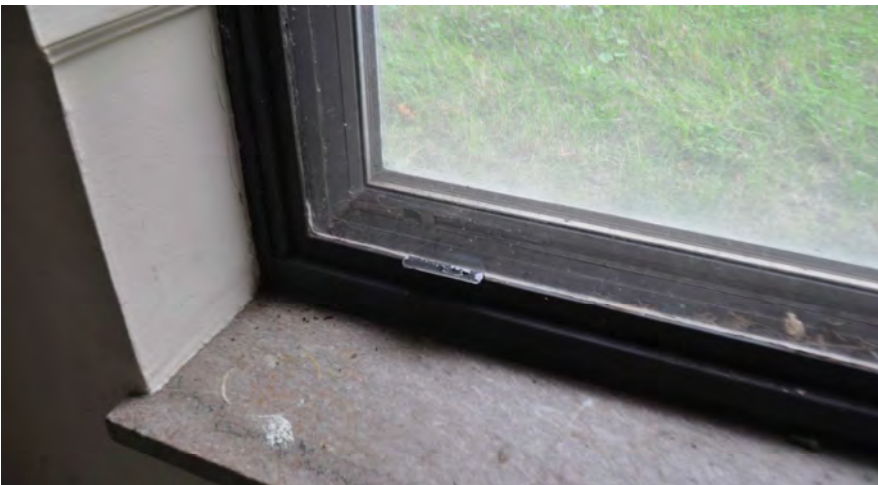
### Window G3, Type F2

- Note: Extent of exterior deterioration, dry rot, and loss of operability is not fully apparent in interior photos. Replacement parts for existing windows are unavailable, making restoration of thermal and operable functionality impossible, and long-term maintenance infeasible. Recommendation is for replacement, for quality of life of future tenants and for feasibility of long-term maintenance.
- See Window Assessment (Blackberry) in appendix for further detail and information, including further notes on deterioration beyond repair
- See Appendix for Window Schedule & Measurements

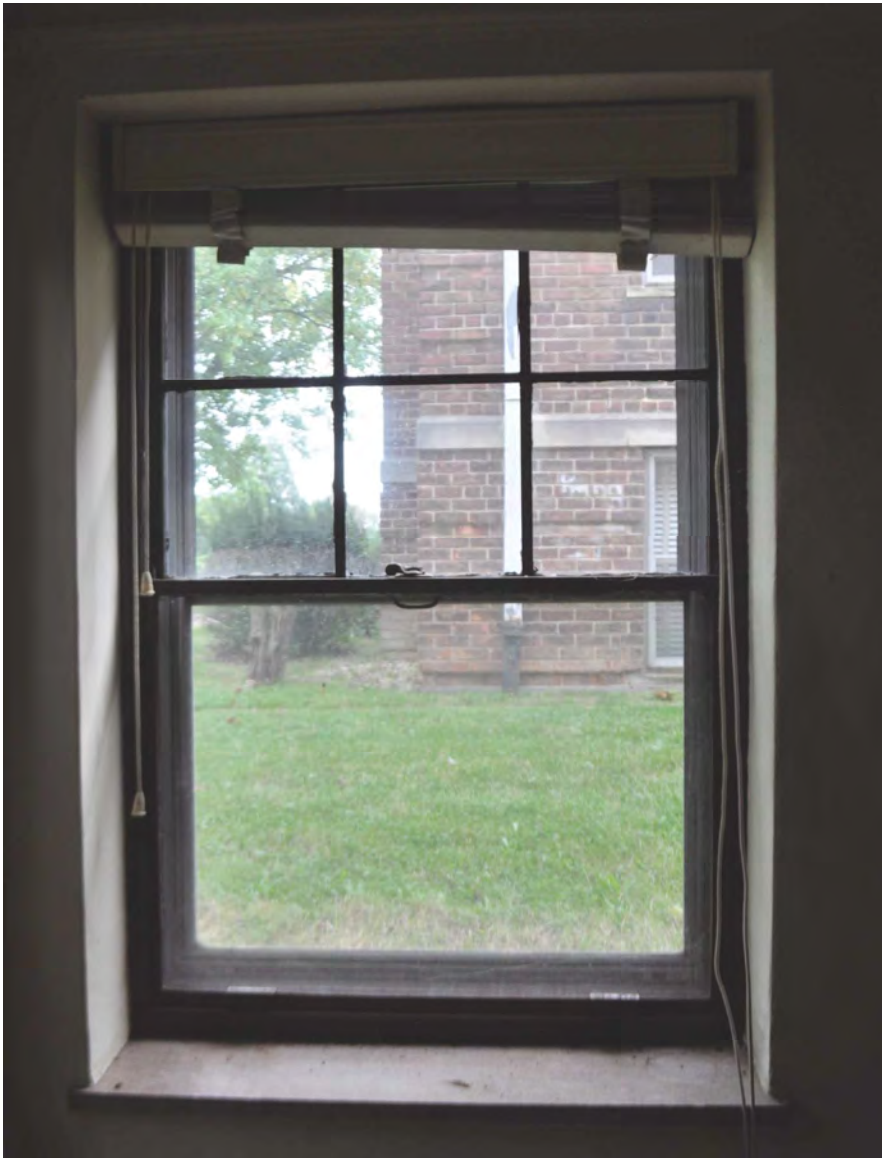
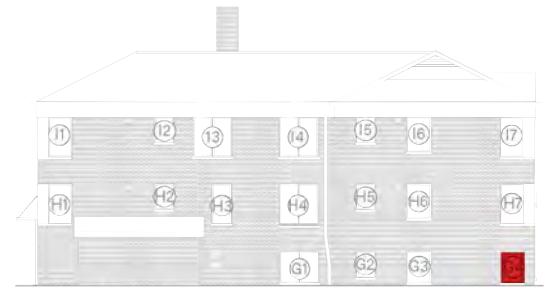
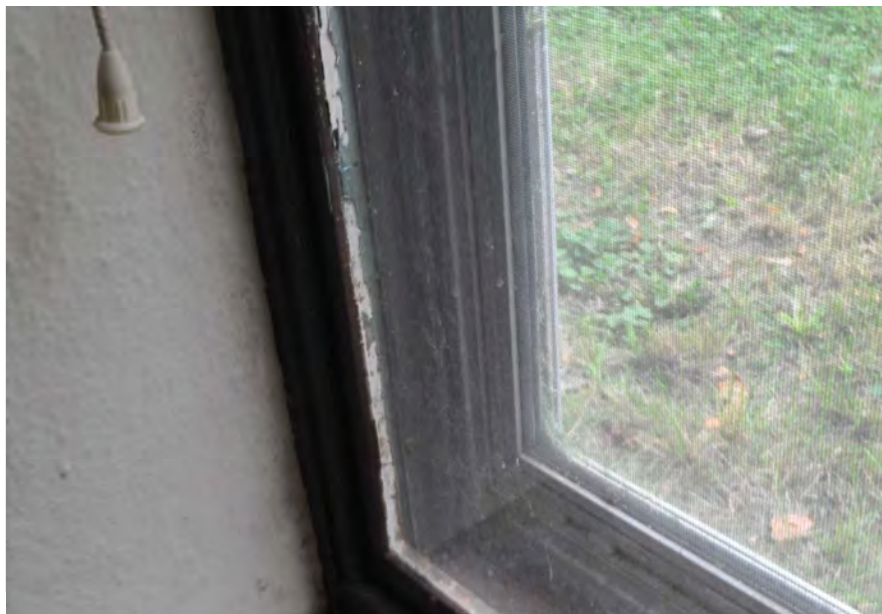
### Window G4, Type D1

- Note: Extent of exterior deterioration, dry rot, and loss of operability is not fully apparent in interior photos. Replacement parts for existing windows are unavailable, making restoration of thermal and operable functionality impossible, and long-term maintenance infeasible. Recommendation is for replacement, for quality of life of future tenants and for feasibility of long-term maintenance.
- See Window Assessment (Blackberry) in appendix for further detail and information, including further notes on deterioration beyond repair
- See Appendix for Window Schedule & Measurements

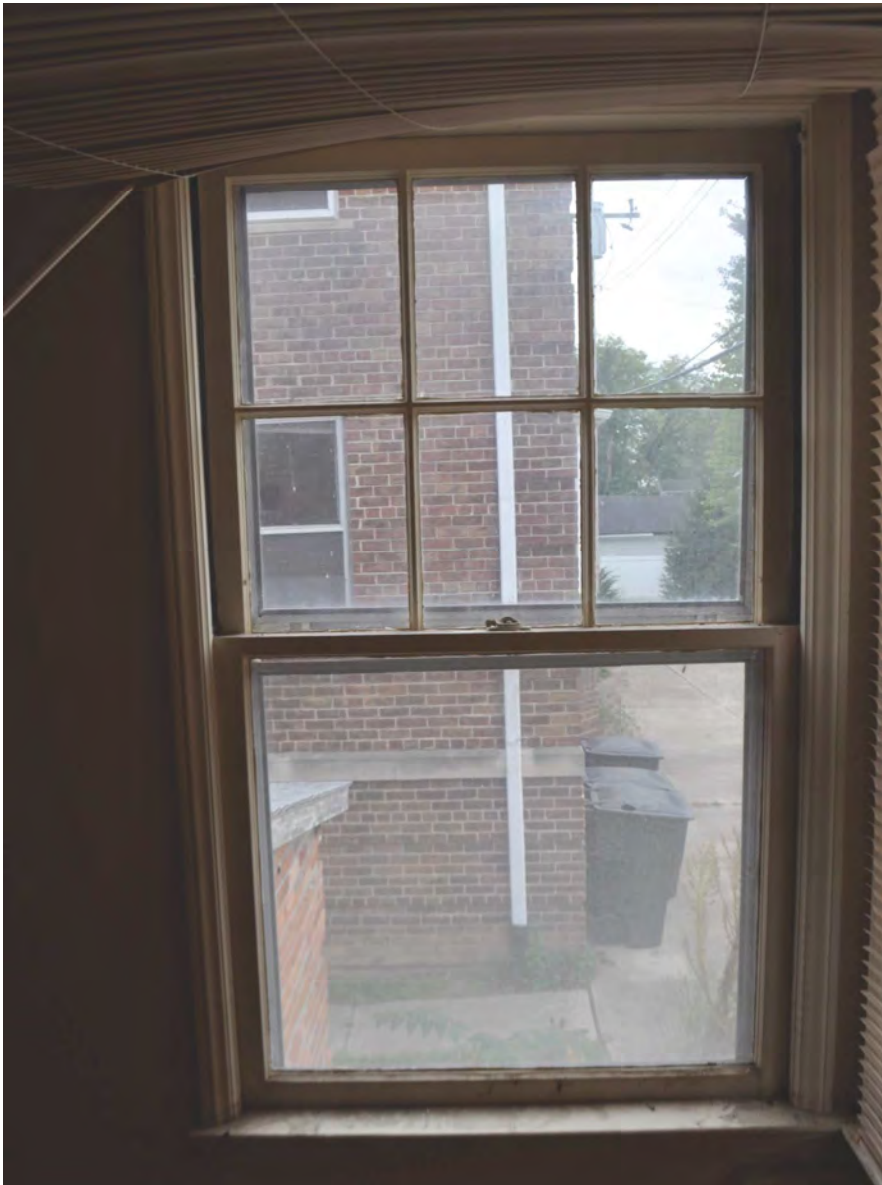
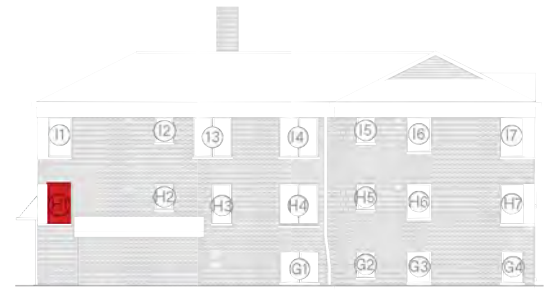
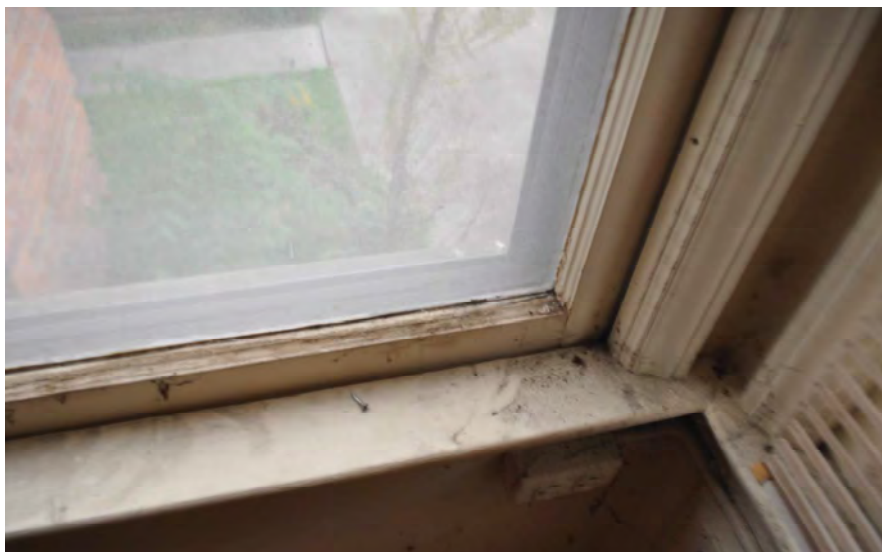
### Window H1, Type A1

- Note: Extent of exterior deterioration, dry rot, and loss of operability is not fully apparent in interior photos. Replacement parts for existing windows are unavailable, making restoration of thermal and operable functionality impossible, and long-term maintenance infeasible. Recommendation is for replacement, for quality of life of future tenants and for feasibility of long-term maintenance.
- See Window Assessment (Blackberry) in appendix for further detail and information, including further notes on deterioration beyond repair
- See Appendix for Window Schedule & Measurements

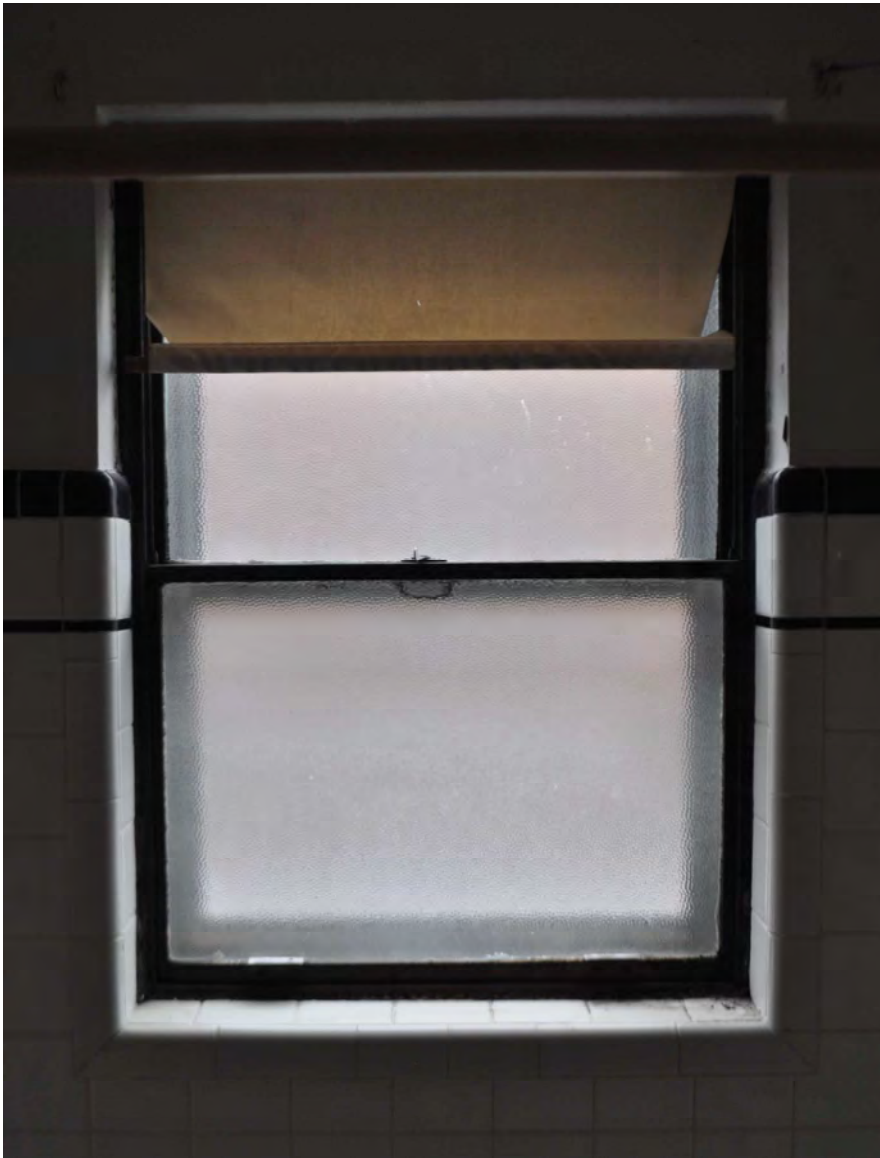
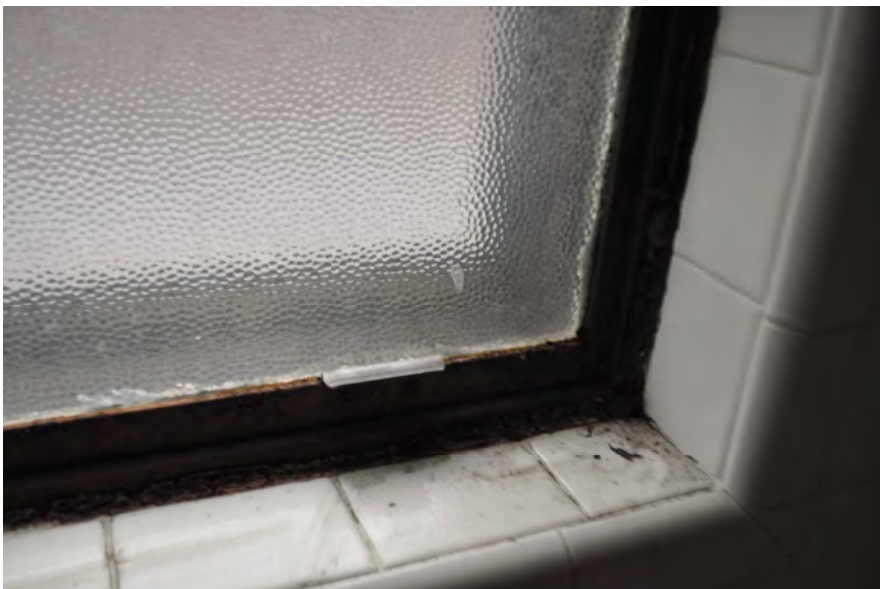
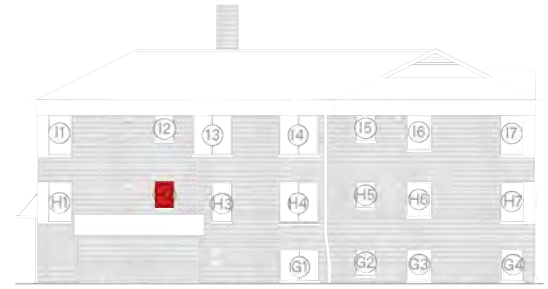
### Window H2, Type G1

- Note: Extent of exterior deterioration, dry rot, and loss of operability is not fully apparent in interior photos. Replacement parts for existing windows are unavailable, making restoration of thermal and operable functionality impossible, and long-term maintenance infeasible. Recommendation is for replacement, for quality of life of future tenants and for feasibility of long-term maintenance.
- See Window Assessment (Blackberry) in appendix for further detail and information, including further notes on deterioration beyond repair
- See Appendix for Window Schedule & Measurements

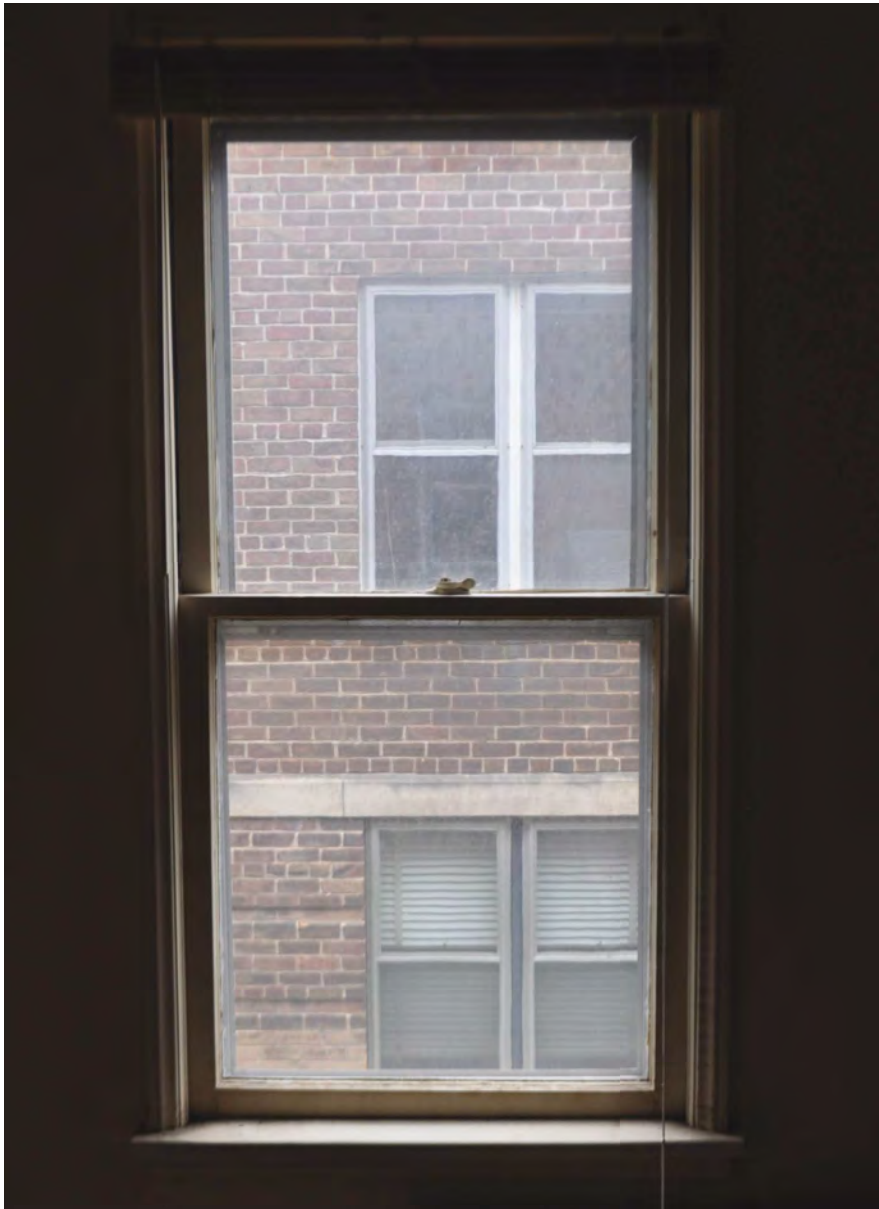
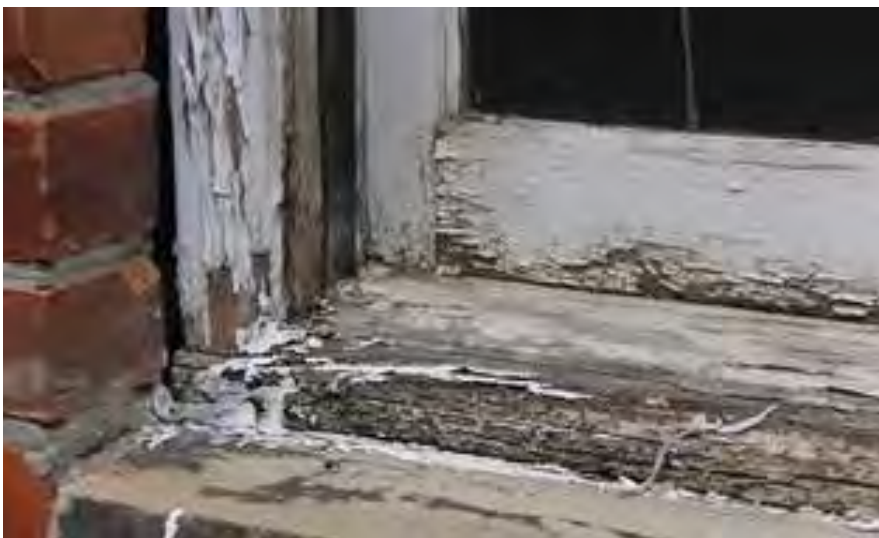
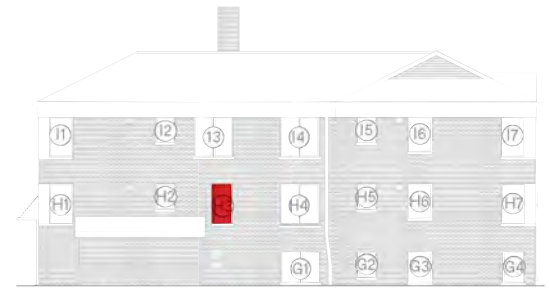
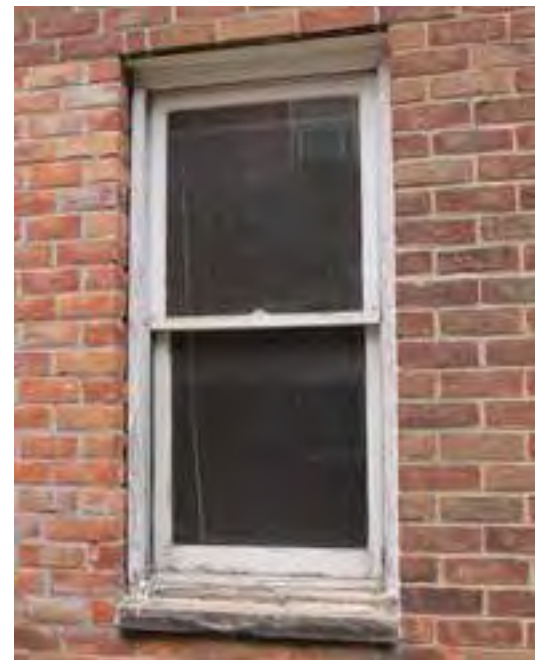
### Window H3, Type J1

- Exterior Rotted Sill
- Note: Extent of exterior deterioration, dry rot, and loss of operability is not fully apparent in interior photos. Replacement parts for existing windows are unavailable, making restoration of thermal and operable functionality impossible, and long-term maintenance infeasible. Recommendation is for replacement, for quality of life of future tenants and for feasibility of long-term maintenance.
- See Window Assessment (Blackberry) in appendix for further detail and information, including further notes on deterioration beyond repair
- See Appendix for Window Schedule & Measurements

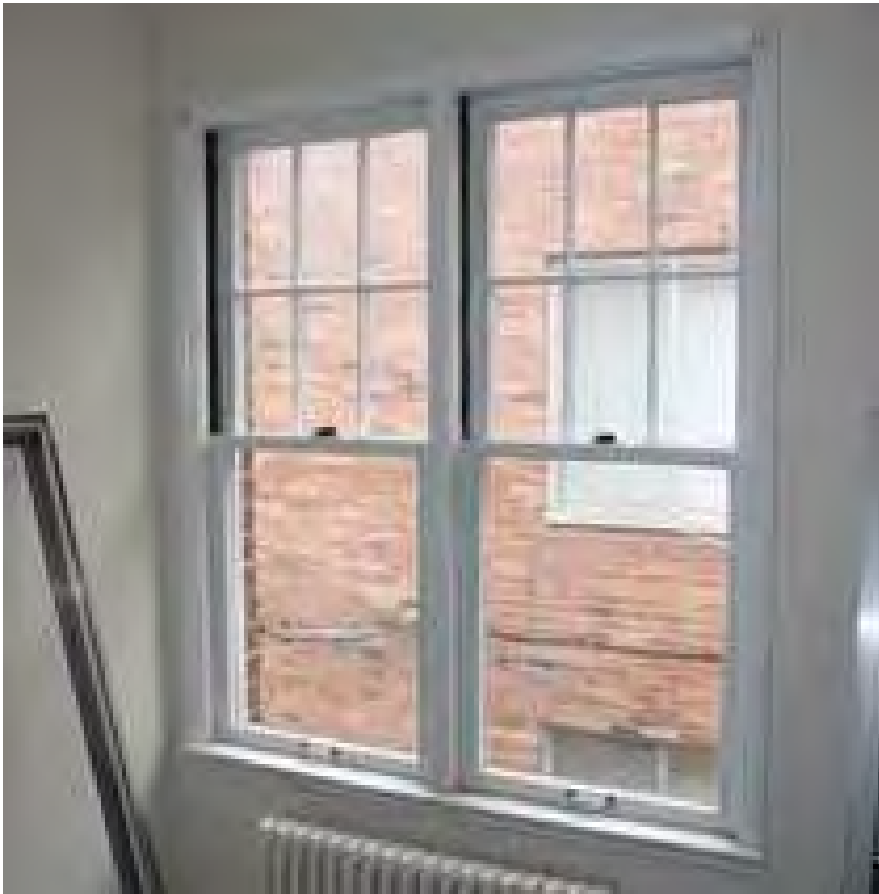
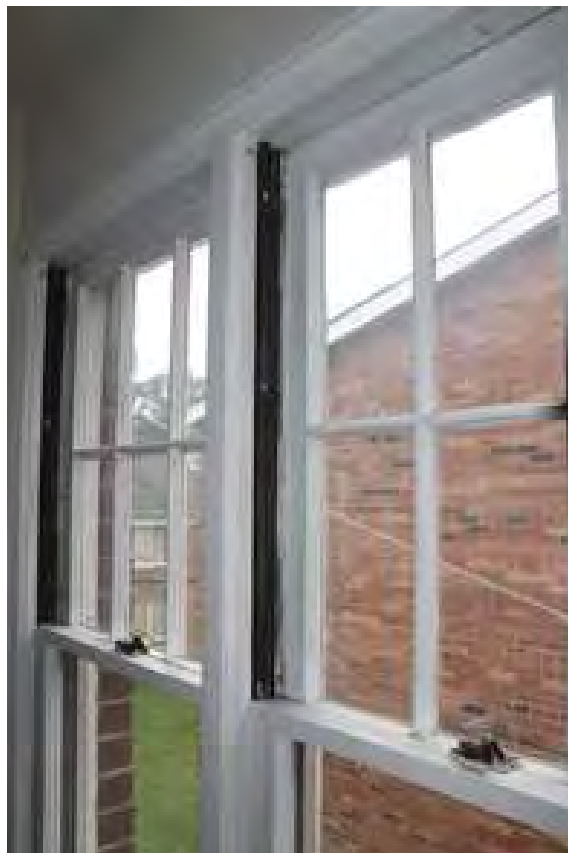
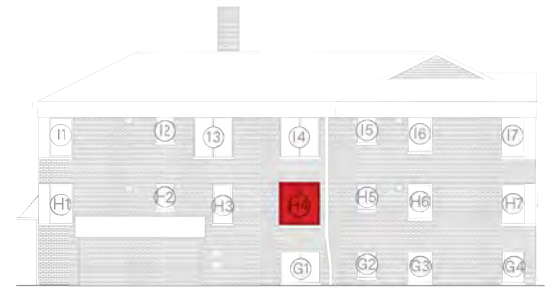
### Window H4, Type I1

- Note: Extent of exterior deterioration, dry rot, and loss of operability is not fully apparent in interior photos. Replacement parts for existing windows are unavailable, making restoration of thermal and operable functionality impossible, and long-term maintenance infeasible. Recommendation is for replacement, for quality of life of future tenants and for feasibility of long-term maintenance.
- See Window Assessment (Blackberry) in appendix for further detail and information, including further notes on deterioration beyond repair
- See Appendix for Window Schedule & Measurements

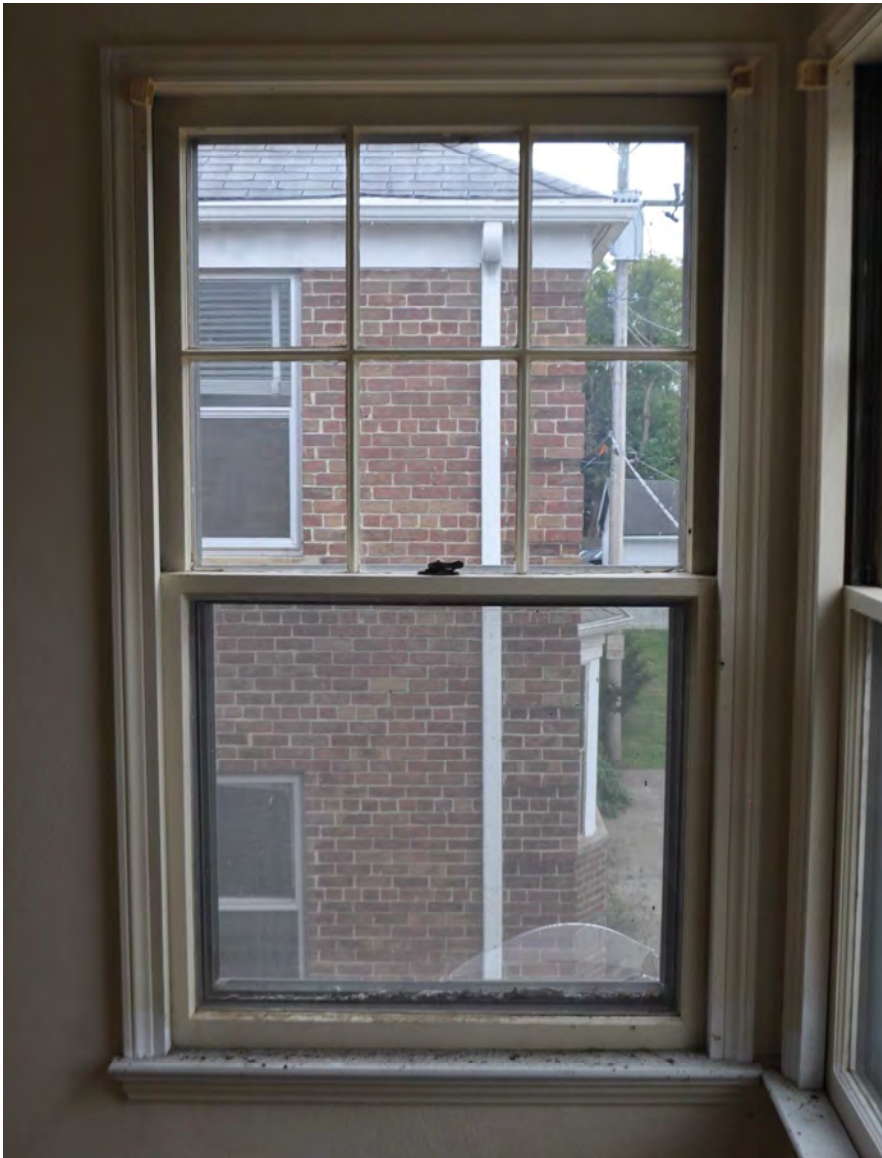
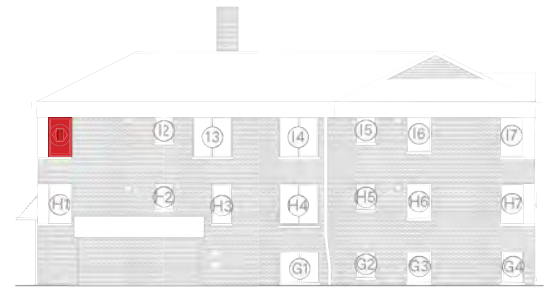
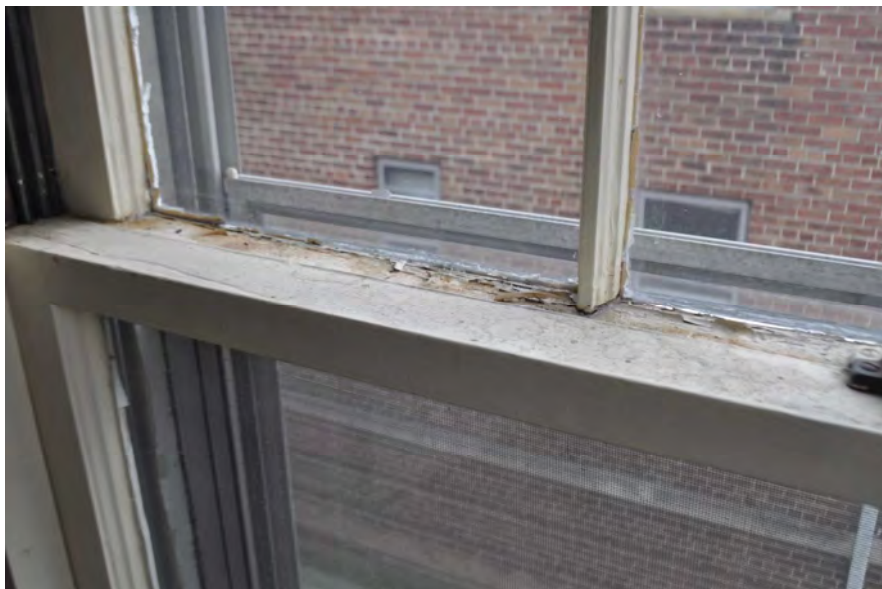
### Window I1, Type A1

- Note: Extent of exterior deterioration, dry rot, and loss of operability is not fully apparent in interior photos. Replacement parts for existing windows are unavailable, making restoration of thermal and operable functionality impossible, and long-term maintenance infeasible. Recommendation is for replacement, for quality of life of future tenants and for feasibility of long-term maintenance.
- See Window Assessment (Blackberry) in appendix for further detail and information, including further notes on deterioration beyond repair
- See Appendix for Window Schedule & Measurements

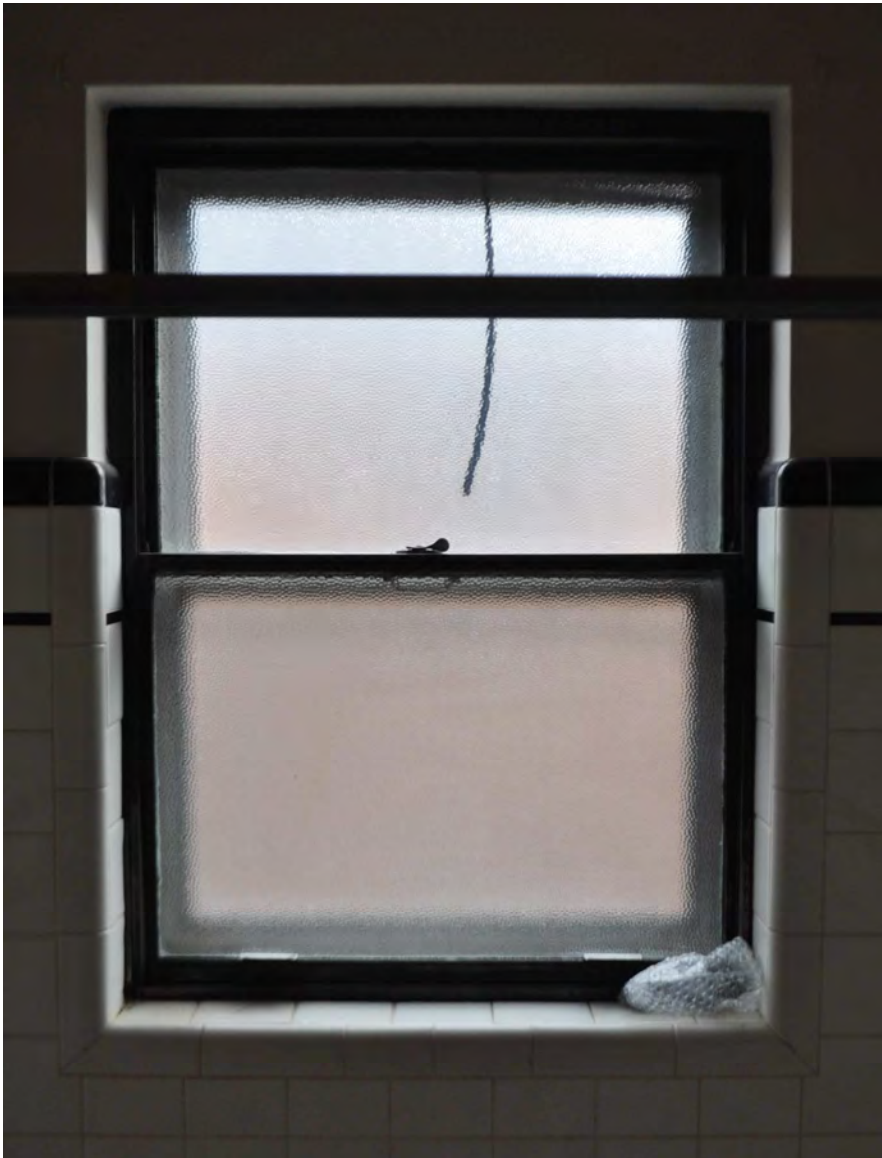
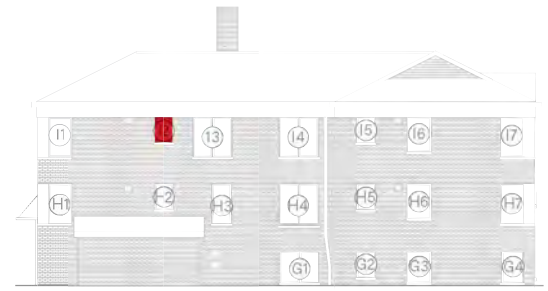
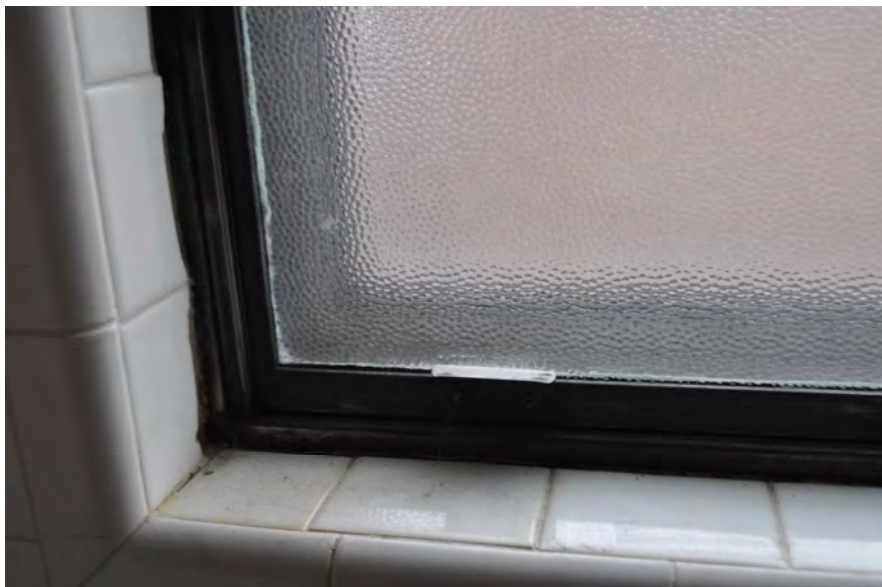
### Window I2, Type G1

- Note: Extent of exterior deterioration, dry rot, and loss of operability is not fully apparent in interior photos. Replacement parts for existing windows are unavailable, making restoration of thermal and operable functionality impossible, and long-term maintenance infeasible. Recommendation is for replacement, for quality of life of future tenants and for feasibility of long-term maintenance.
- See Window Assessment (Blackberry) in appendix for further detail and information, including further notes on deterioration beyond repair
- See Appendix for Window Schedule & Measurements

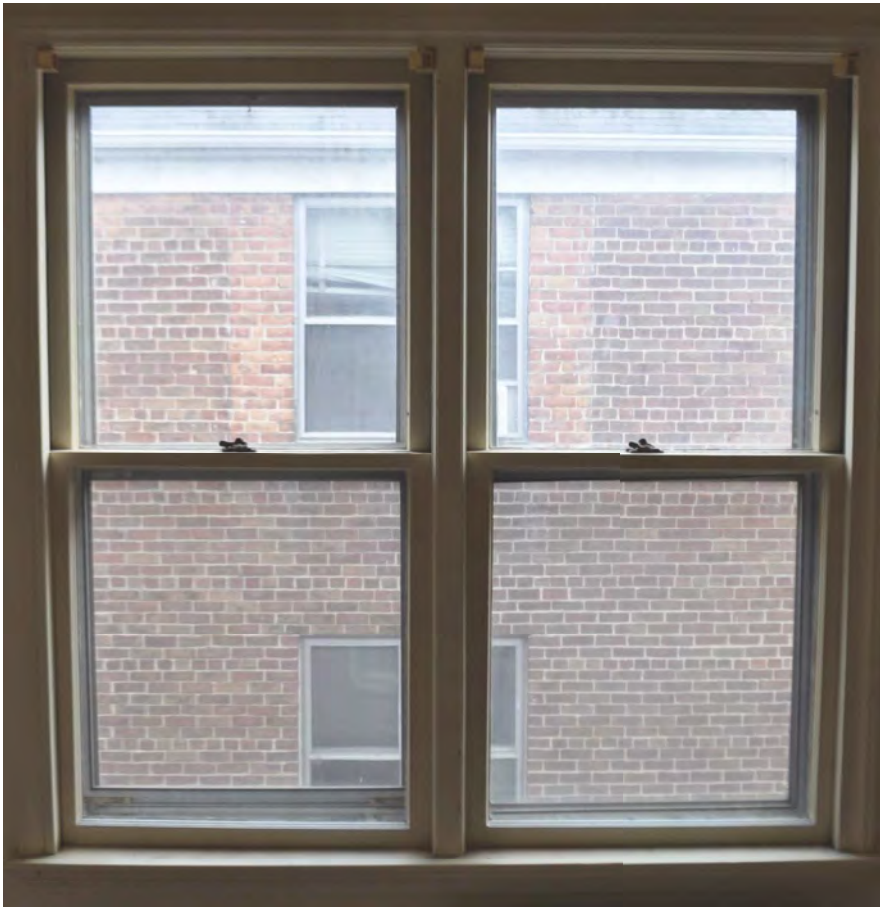
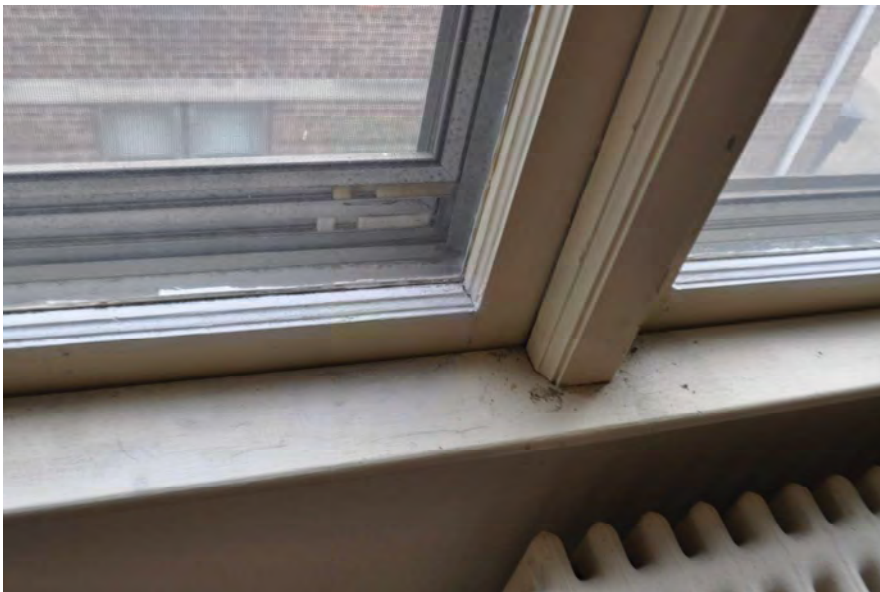
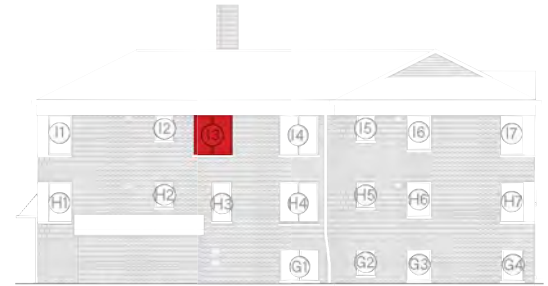
### Window I3, Type I1

- Note: Extent of exterior deterioration, dry rot, and loss of operability is not fully apparent in interior photos. Replacement parts for existing windows are unavailable, making restoration of thermal and operable functionality impossible, and long-term maintenance infeasible. Recommendation is for replacement, for quality of life of future tenants and for feasibility of long-term maintenance.
- See Window Assessment (Blackberry) in appendix for further detail and information, including further notes on deterioration beyond repair
- See Appendix for Window Schedule & Measurements

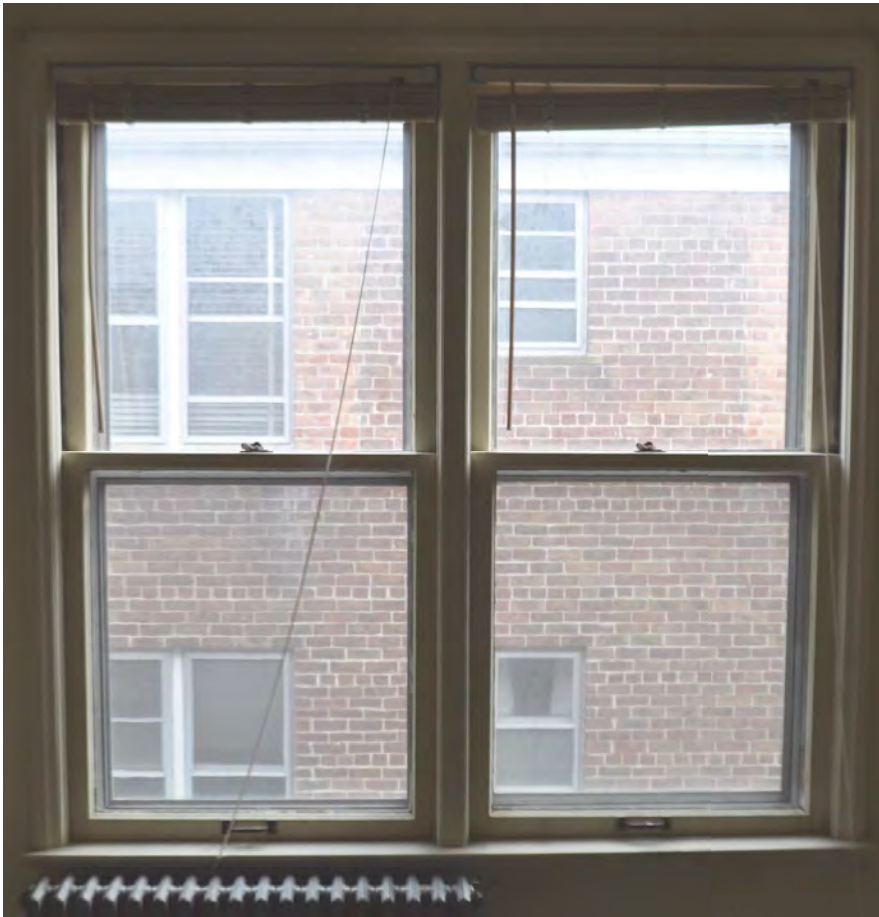
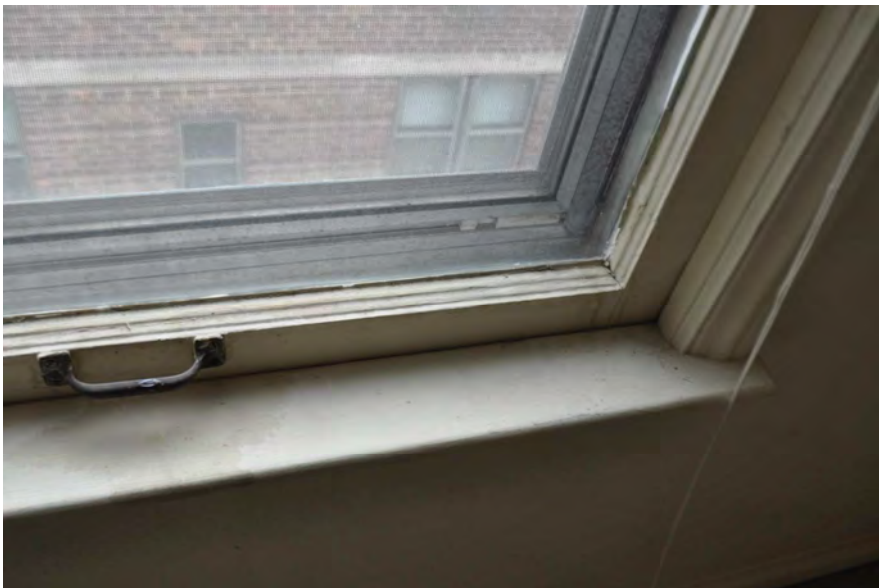
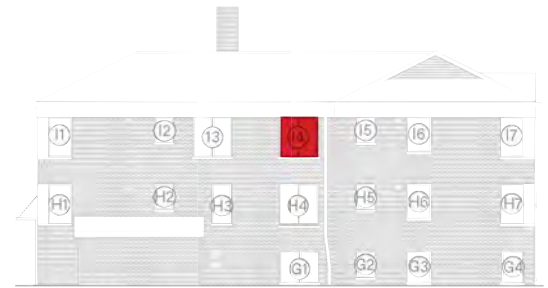
### Window I4, Type I1

- Note: Extent of exterior deterioration, dry rot, and loss of operability is not fully apparent in interior photos. Replacement parts for existing windows are unavailable, making restoration of thermal and operable functionality impossible, and long-term maintenance infeasible. Recommendation is for replacement, for quality of life of future tenants and for feasibility of long-term maintenance.
- See Window Assessment (Blackberry) in appendix for further detail and information, including further notes on deterioration beyond repair
- See Appendix for Window Schedule & Measurements

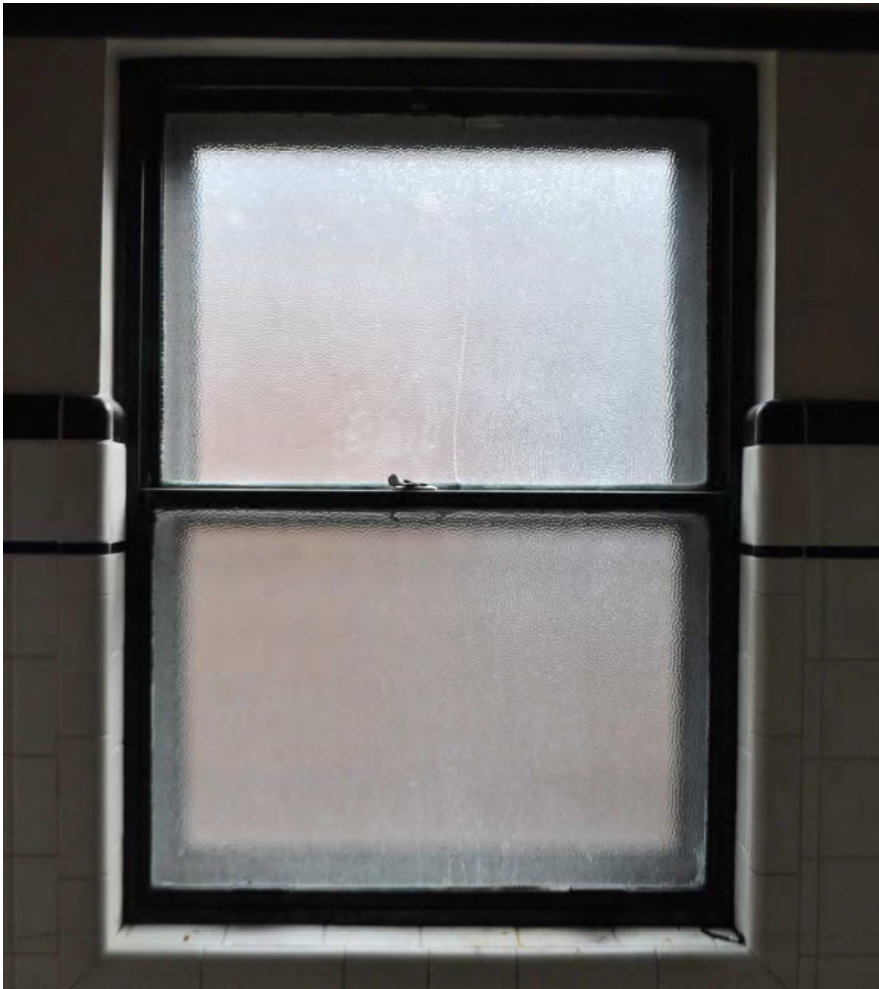
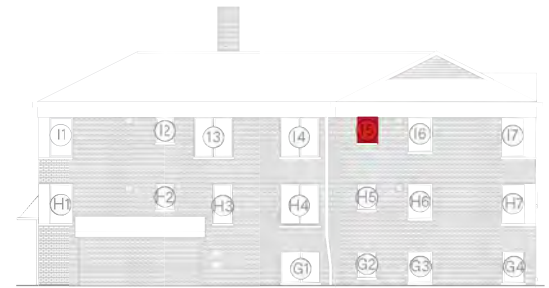
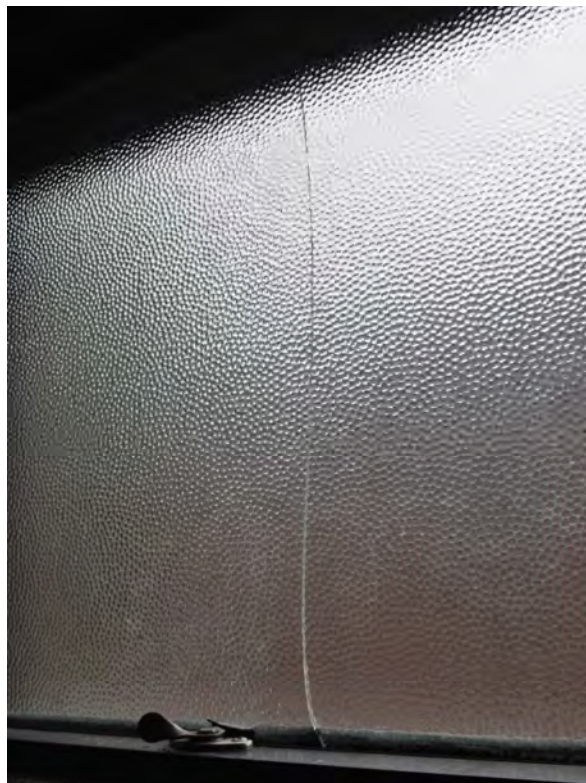
### Window I5, Type G1

- Broken Glass
- Note: Extent of exterior deterioration, dry rot, and loss of operability is not fully apparent in interior photos. Replacement parts for existing windows are unavailable, making restoration of thermal and operable functionality impossible, and long-term maintenance infeasible. Recommendation is for replacement, for quality of life of future tenants and for feasibility of long-term maintenance.
- See Window Assessment (Blackberry) in appendix for further detail and information, including further notes on deterioration beyond repair
- See Appendix for Window Schedule & Measurements

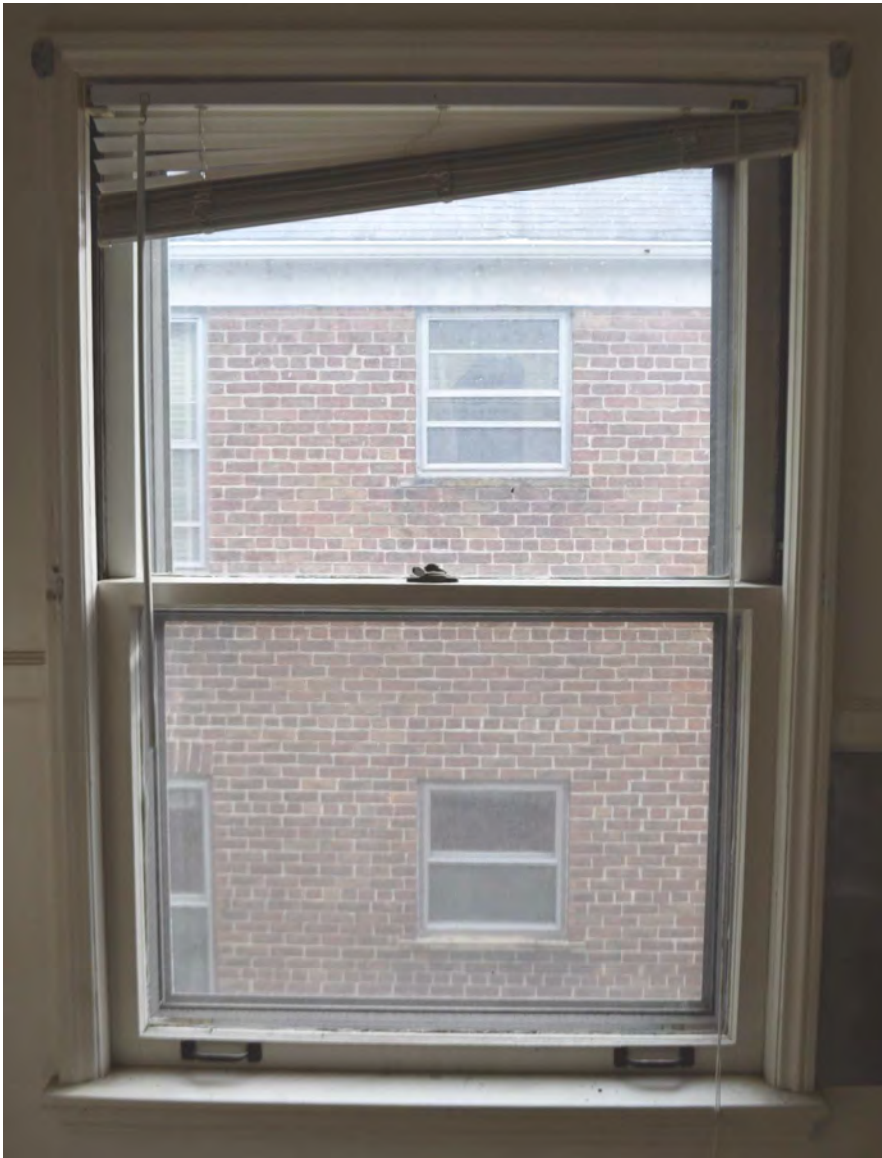
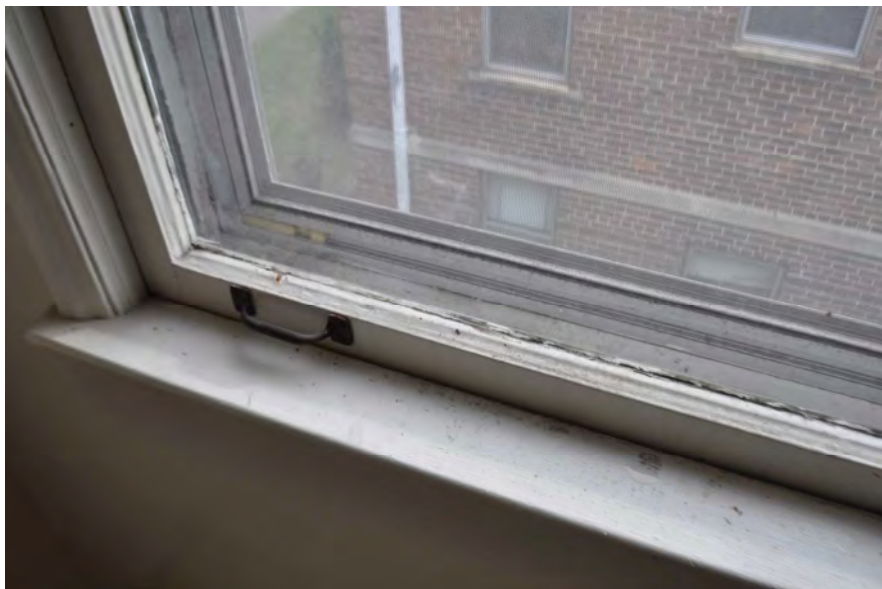
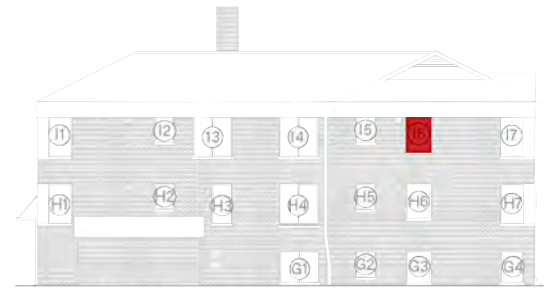
### Window I6, Type E2

- Note: Extent of exterior deterioration, dry rot, and loss of operability is not fully apparent in interior photos. Replacement parts for existing windows are unavailable, making restoration of thermal and operable functionality impossible, and long-term maintenance infeasible. Recommendation is for replacement, for quality of life of future tenants and for feasibility of long-term maintenance.
- See Window Assessment (Blackberry) in appendix for further detail and information, including further notes on deterioration beyond repair
- See Appendix for Window Schedule & Measurements
