# 9710 W Outer Dr

## Existing Condition Photos

# 9730 W Outer Dr

# Detailed Scope of Work

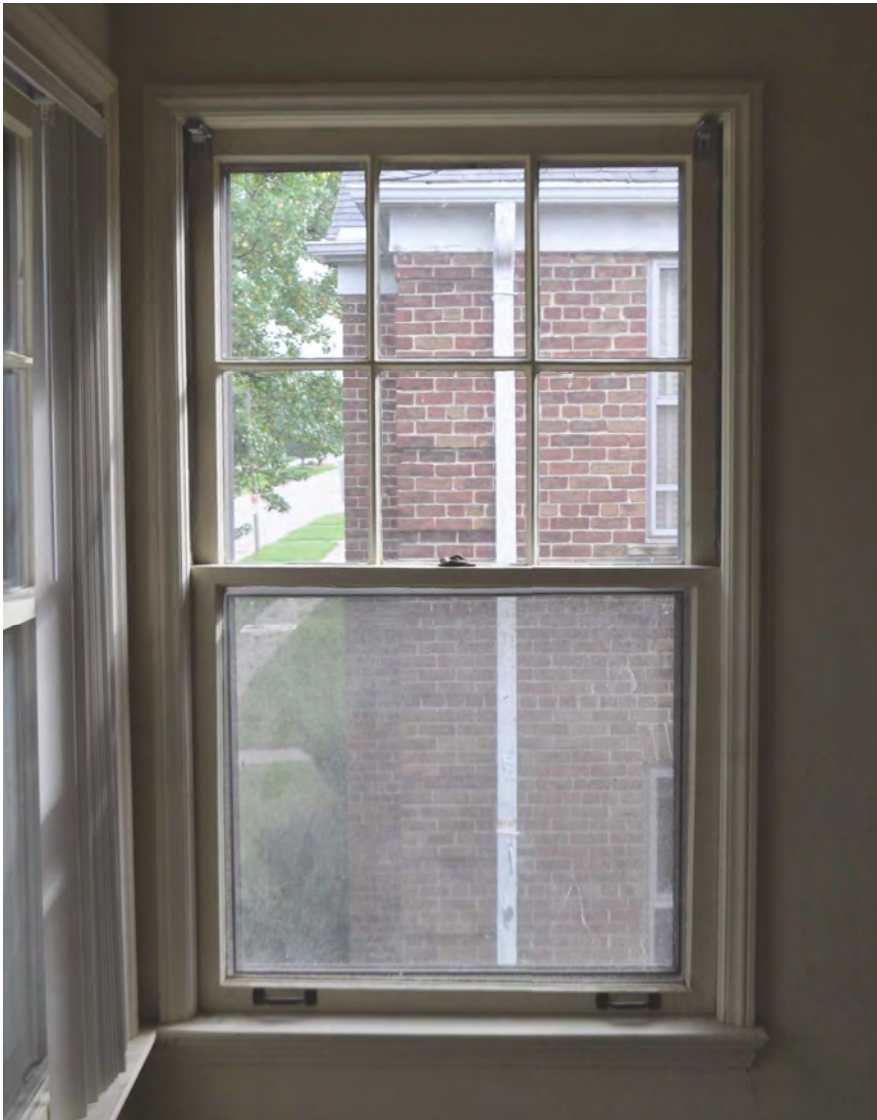
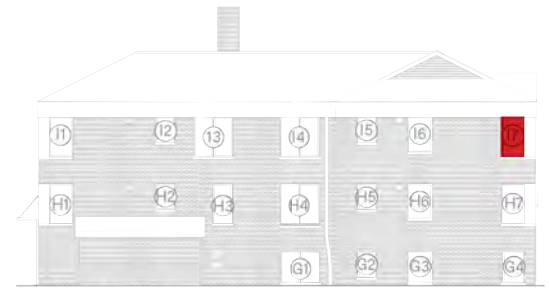
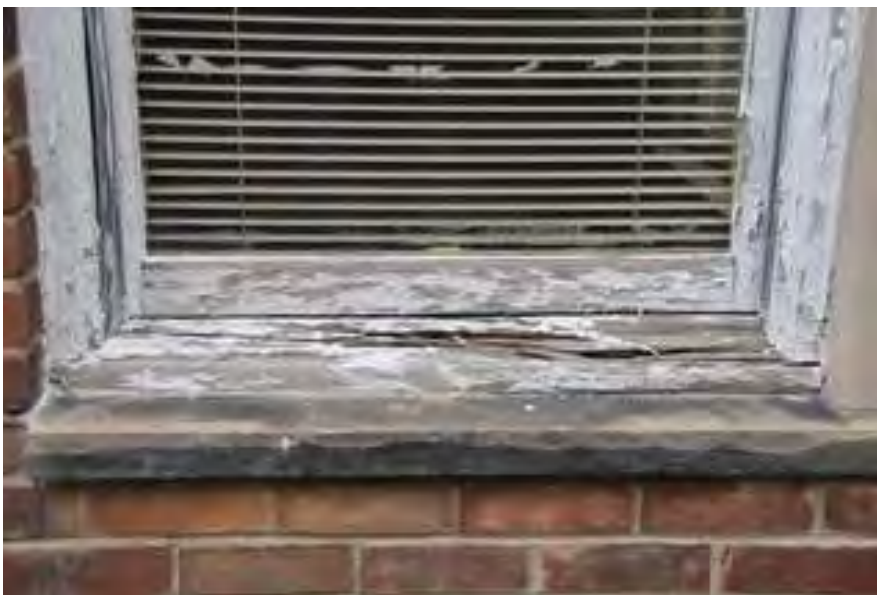
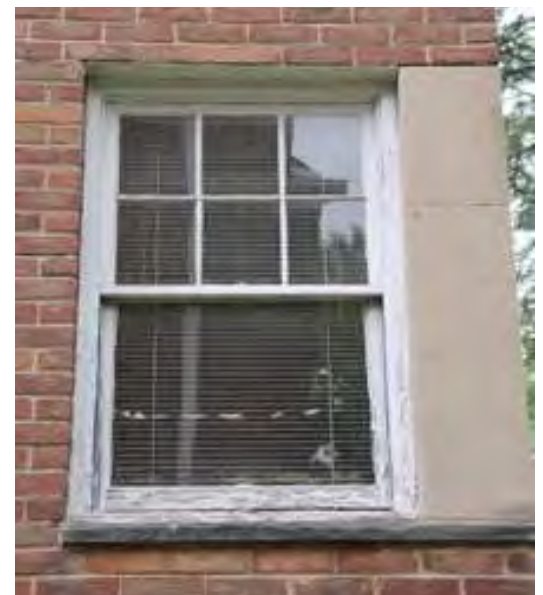
### Window 17, Type A1

- Note: Extent of exterior deterioration, dry rot, and loss of operability is not fully apparent in interior photos. Replacement parts for existing windows are unavailable, making restoration of thermal and operable functionality impossible, and long-term maintenance infeasible. Recommendation is for replacement, for quality of life of future tenants and for feasibility of long-term maintenance.
- See Window Assessment (Blackberry) in appendix for further detail and information, including further notes on deterioration beyond repair
- See Appendix for Window Schedule & Measurements

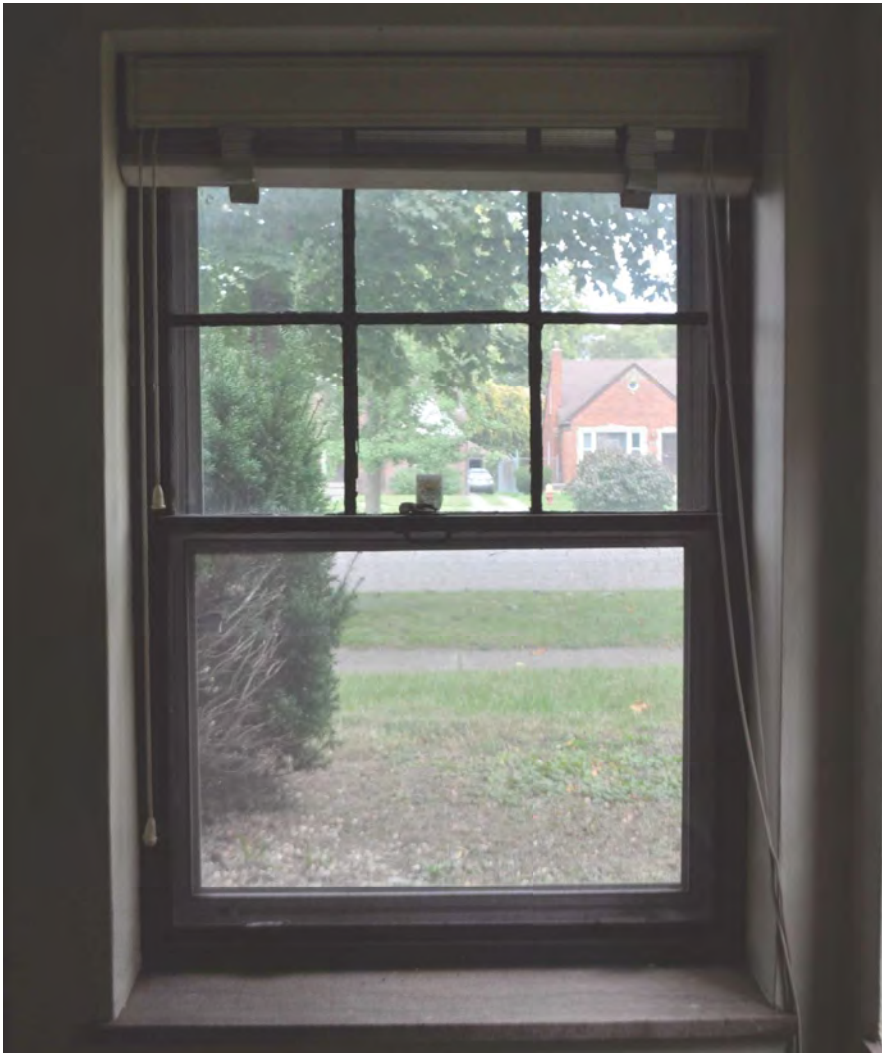
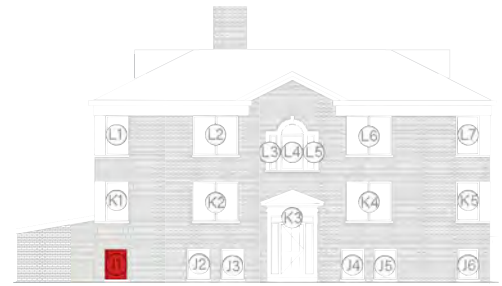
### Window J1, Type D1

- Note: Extent of exterior deterioration, dry rot, and loss of operability is not fully apparent in interior photos. Replacement parts for existing windows are unavailable, making restoration of thermal and operable functionality impossible, and long-term maintenance infeasible. Recommendation is for replacement, for quality of life of future tenants and for feasibility of long-term maintenance.
- See Window Assessment (Blackberry) in appendix for further detail and information, including further notes on deterioration beyond repair
- See Appendix for Window Schedule & Measurements

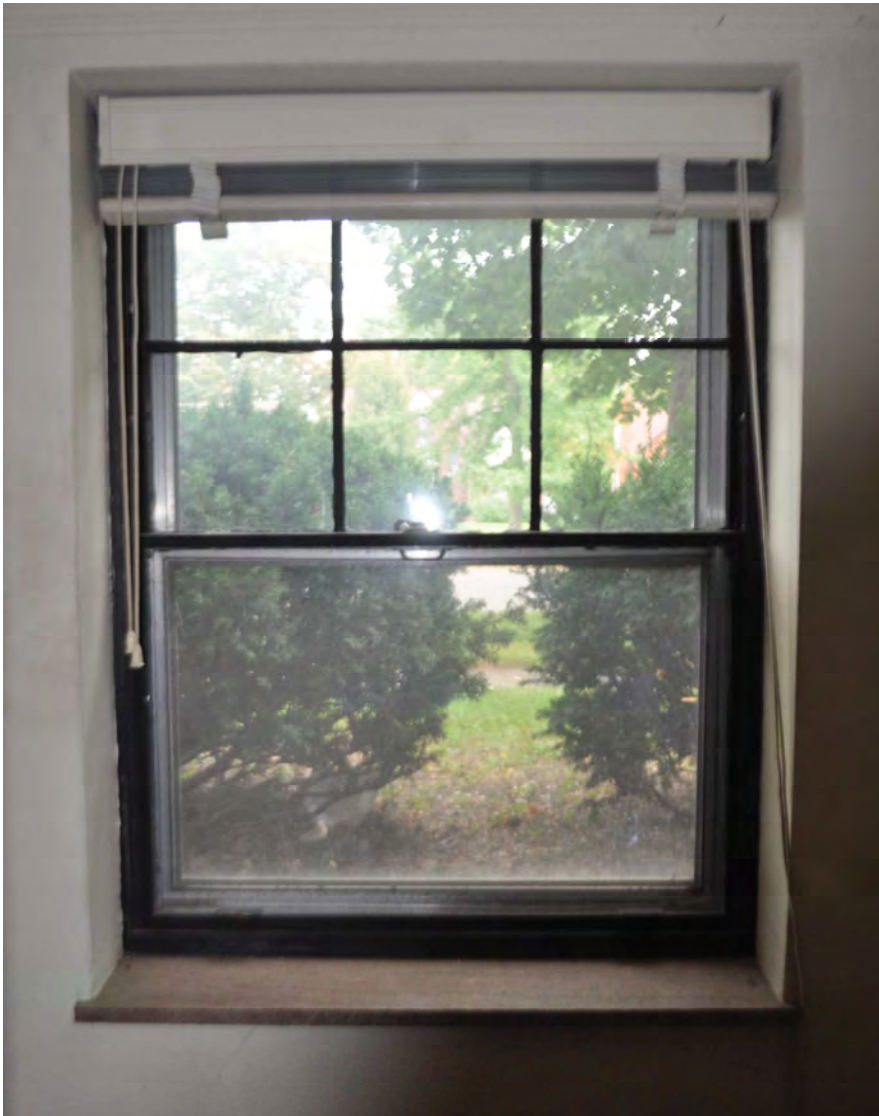
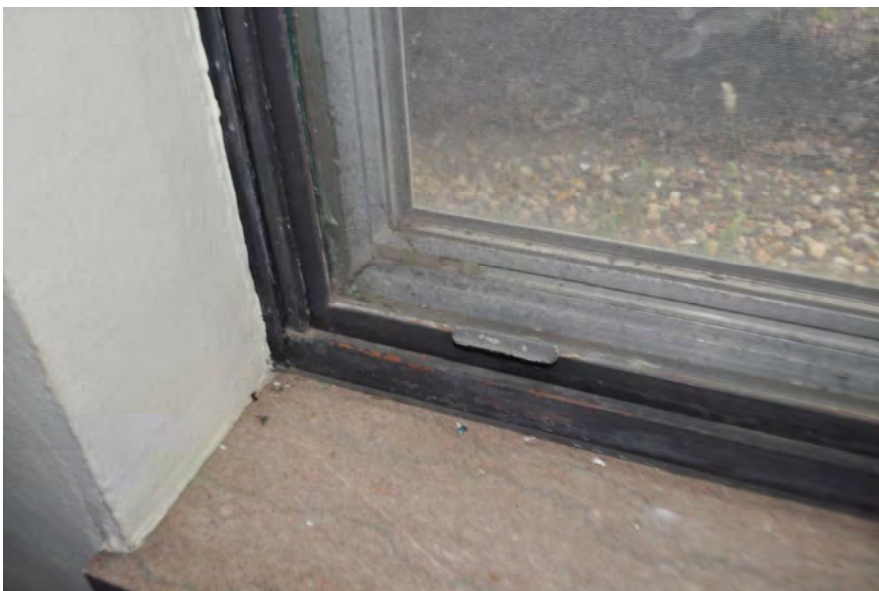
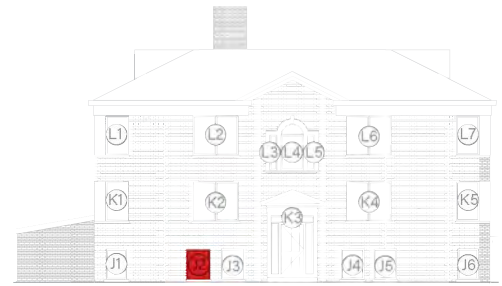
### Window J2, Type C1

- Note: Extent of exterior deterioration, dry rot, and loss of operability is not fully apparent in interior photos. Replacement parts for existing windows are unavailable, making restoration of thermal and operable functionality impossible, and long-term maintenance infeasible. Recommendation is for replacement, for quality of life of future tenants and for feasibility of long-term maintenance.
- See Window Assessment (Blackberry) in appendix for further detail and information, including further notes on deterioration beyond repair
- See Appendix for Window Schedule & Measurements

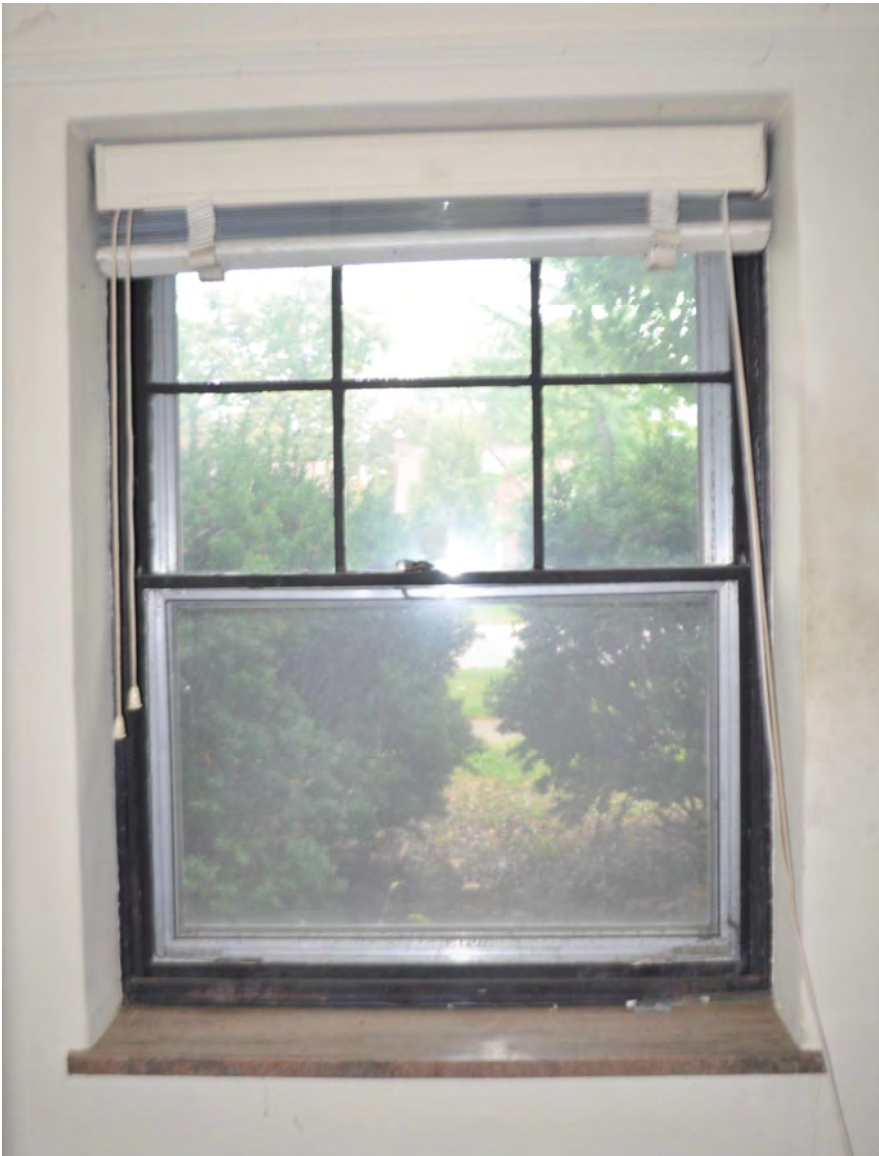
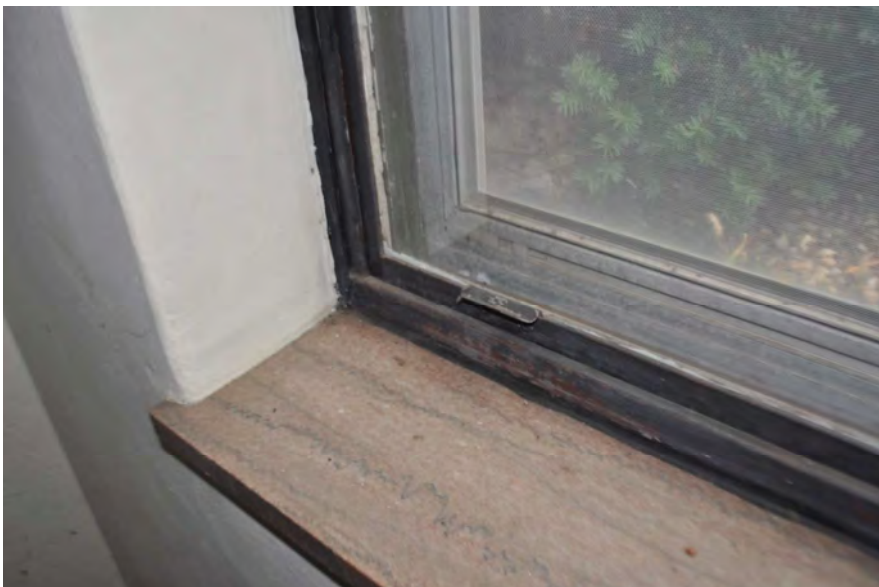
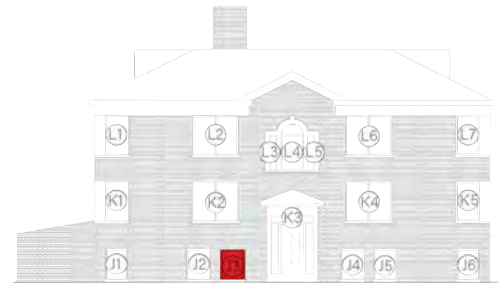
### Window J3, Type C1

- Note: Extent of exterior deterioration, dry rot, and loss of operability is not fully apparent in interior photos. Replacement parts for existing windows are unavailable, making restoration of thermal and operable functionality impossible, and long-term maintenance infeasible. Recommendation is for replacement, for quality of life of future tenants and for feasibility of long-term maintenance.
- See Window Assessment (Blackberry) in appendix for further detail and information, including further notes on deterioration beyond repair
- See Appendix for Window Schedule & Measurements

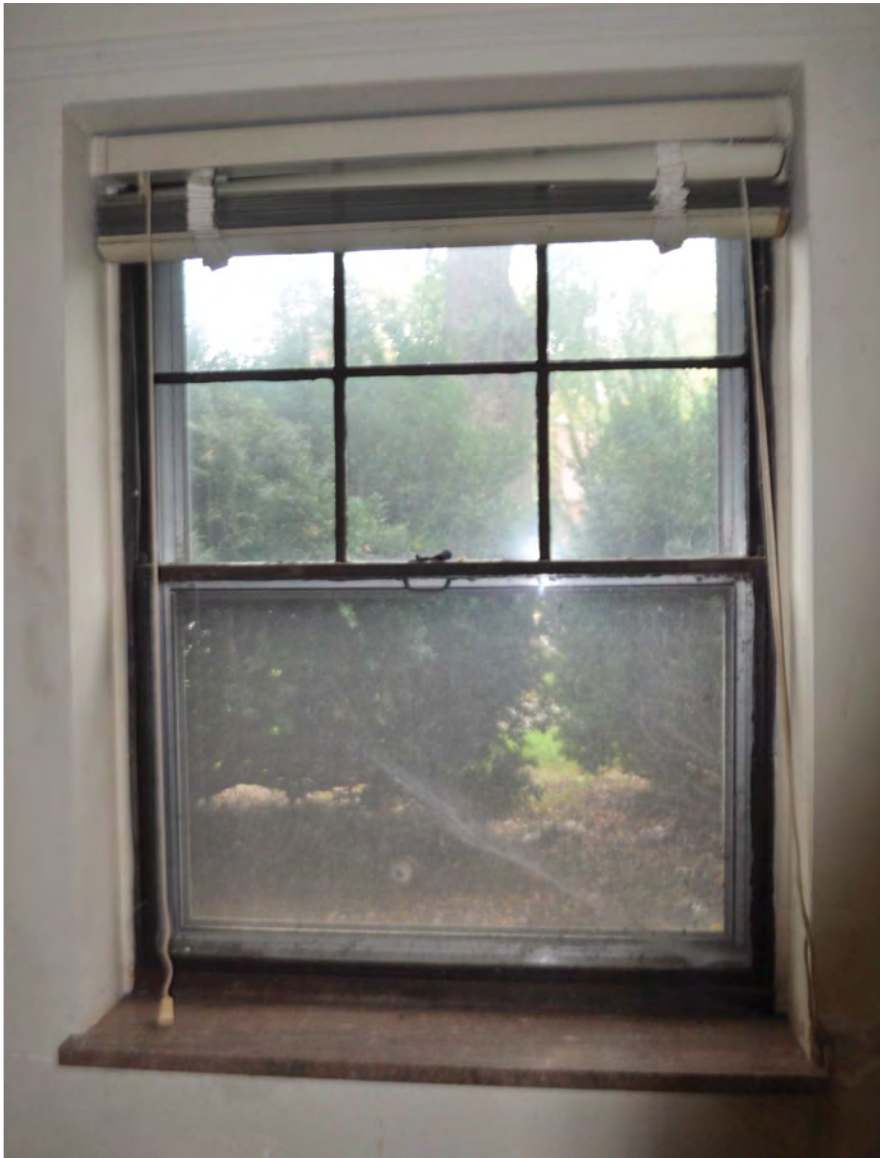
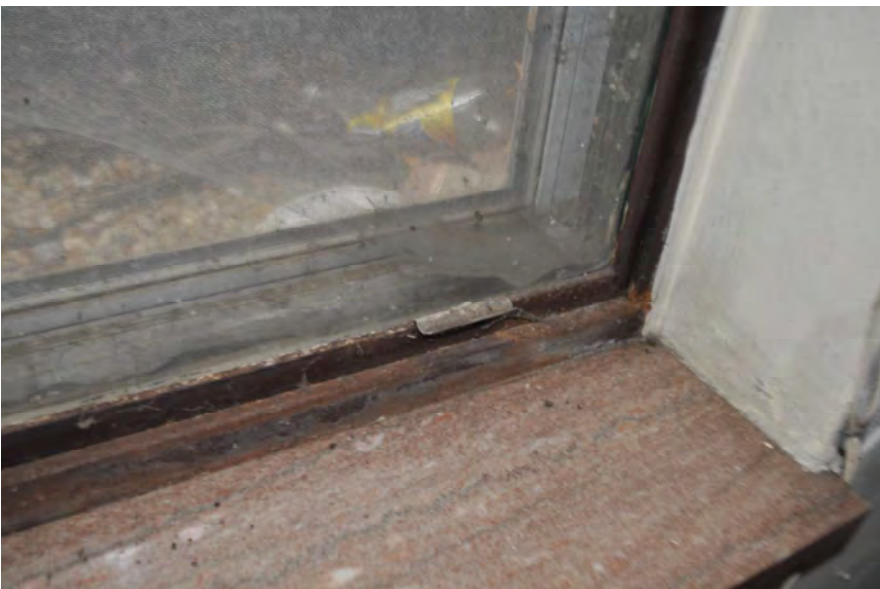
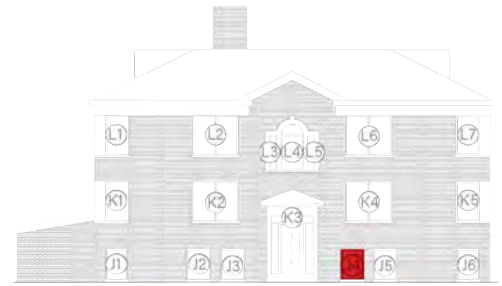
### Window J4, Type C1

- Badly Rotted
- Note: Extent of exterior deterioration, dry rot, and loss of operability is not fully apparent in interior photos. Replacement parts for existing windows are unavailable, making restoration of thermal and operable functionality impossible, and long-term maintenance infeasible. Recommendation is for replacement, for quality of life of future tenants and for feasibility of long-term maintenance.
- See Window Assessment (Blackberry) in appendix for further detail and information, including further notes on deterioration beyond repair
- See Appendix for Window Schedule & Measurements

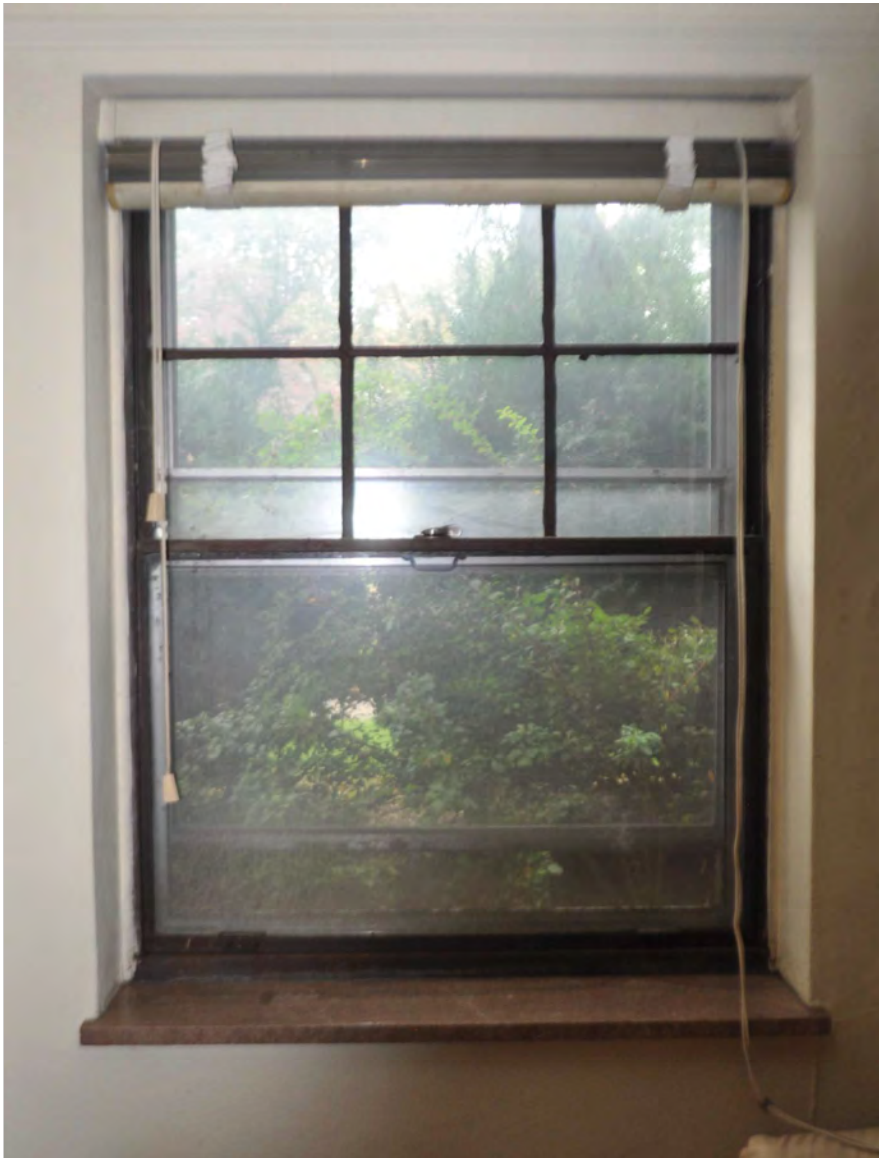
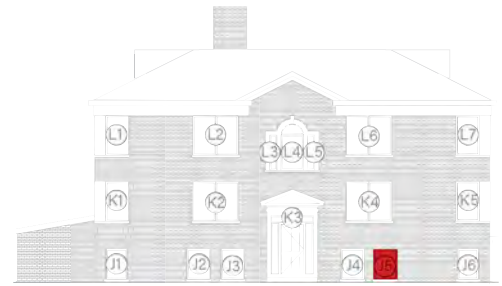
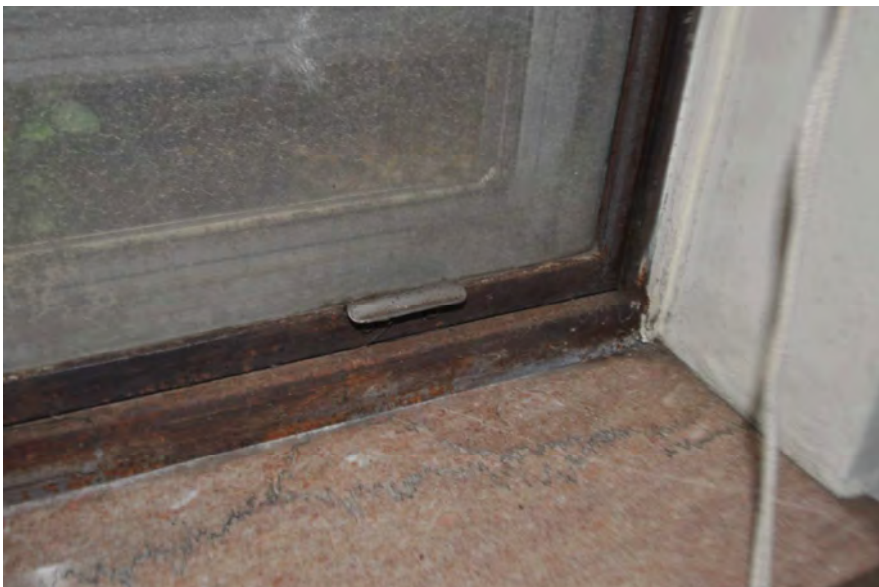
### Window J5, Type C1

- Badly Rotted
- Note: Extent of exterior deterioration, dry rot, and loss of operability is not fully apparent in interior photos. Replacement parts for existing windows are unavailable, making restoration of thermal and operable functionality impossible, and long-term maintenance infeasible. Recommendation is for replacement, for quality of life of future tenants and for feasibility of long-term maintenance.
- See Window Assessment (Blackberry) in appendix for further detail and information, including further notes on deterioration beyond repair
- See Appendix for Window Schedule & Measurements

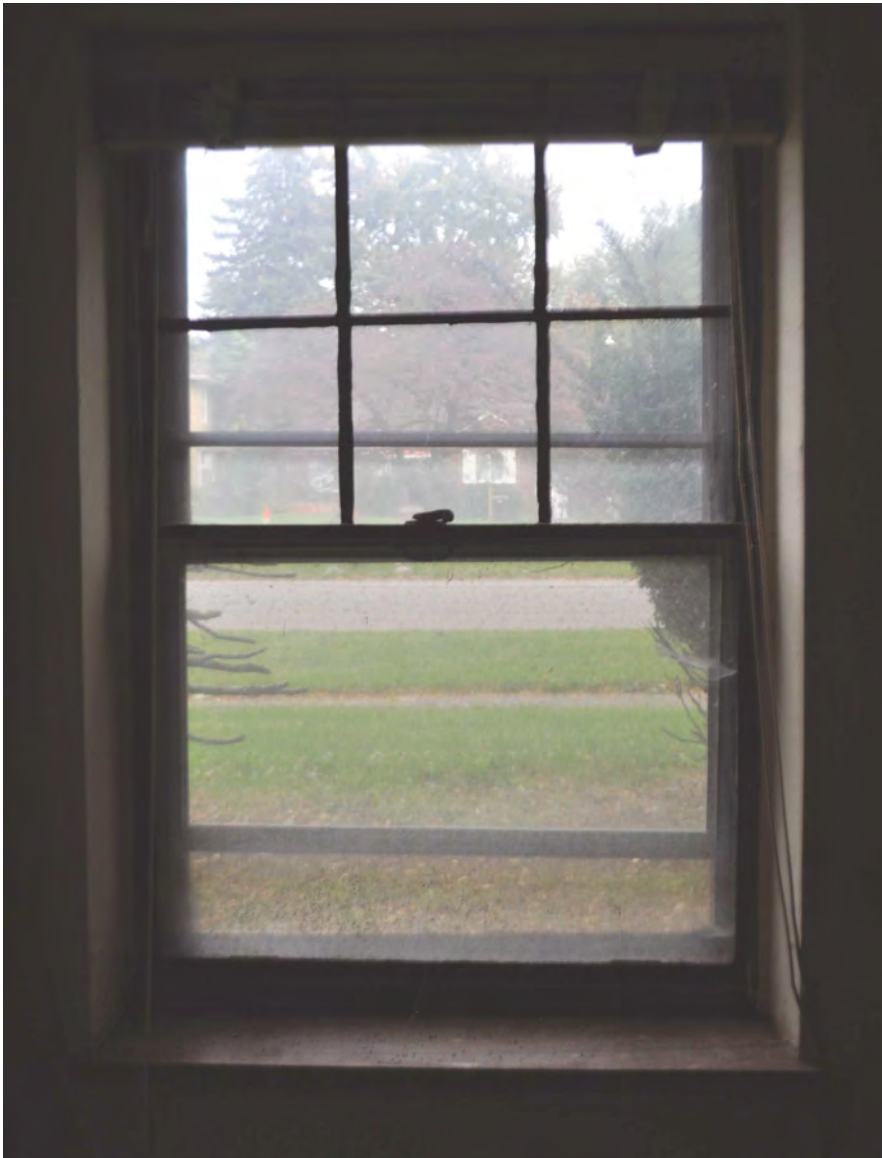
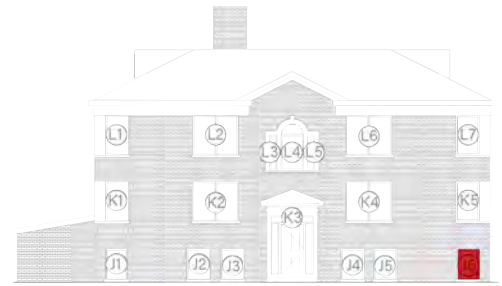
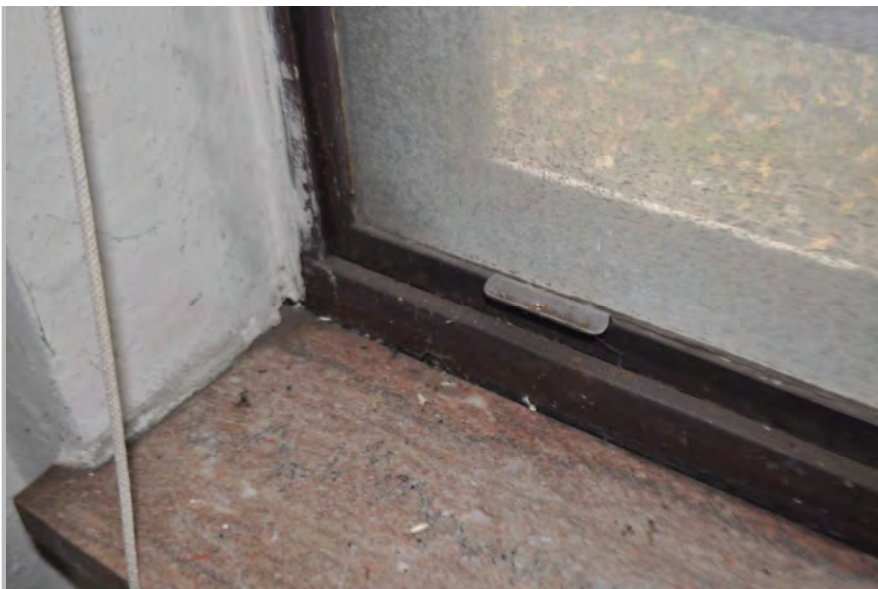
### Window J6, Type D1

- Note: Extent of exterior deterioration, dry rot, and loss of operability is not fully apparent in interior photos. Replacement parts for existing windows are unavailable, making restoration of thermal and operable functionality impossible, and long-term maintenance infeasible. Recommendation is for replacement, for quality of life of future tenants and for feasibility of long-term maintenance.
- See Window Assessment (Blackberry) in appendix for further detail and information, including further notes on deterioration beyond repair
- See Appendix for Window Schedule & Measurements

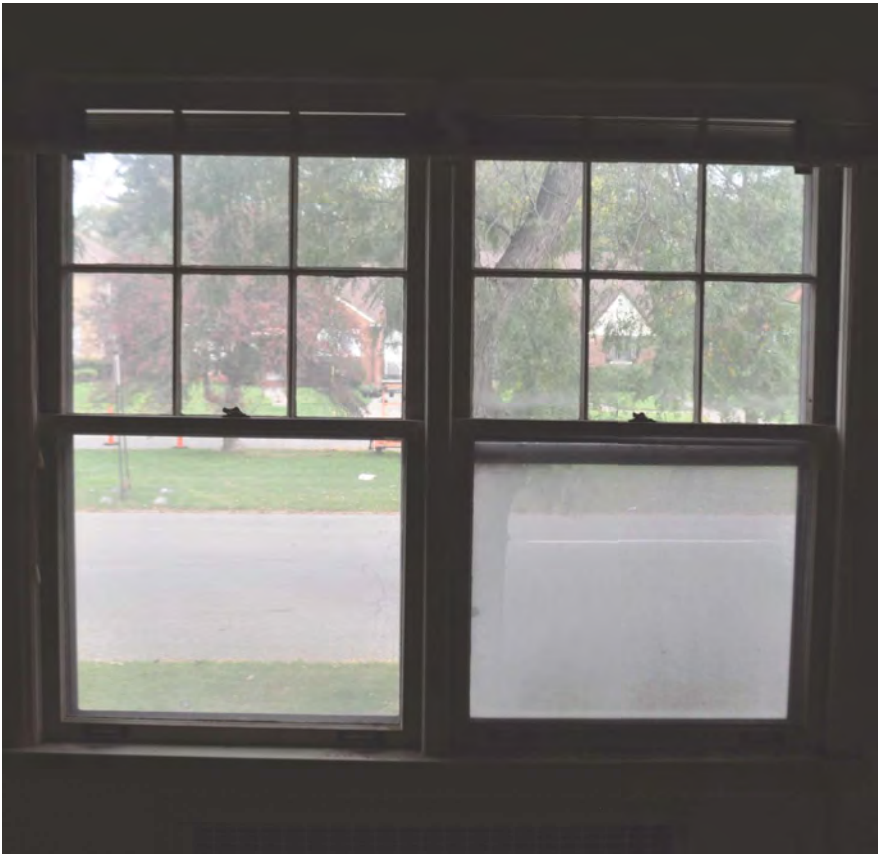
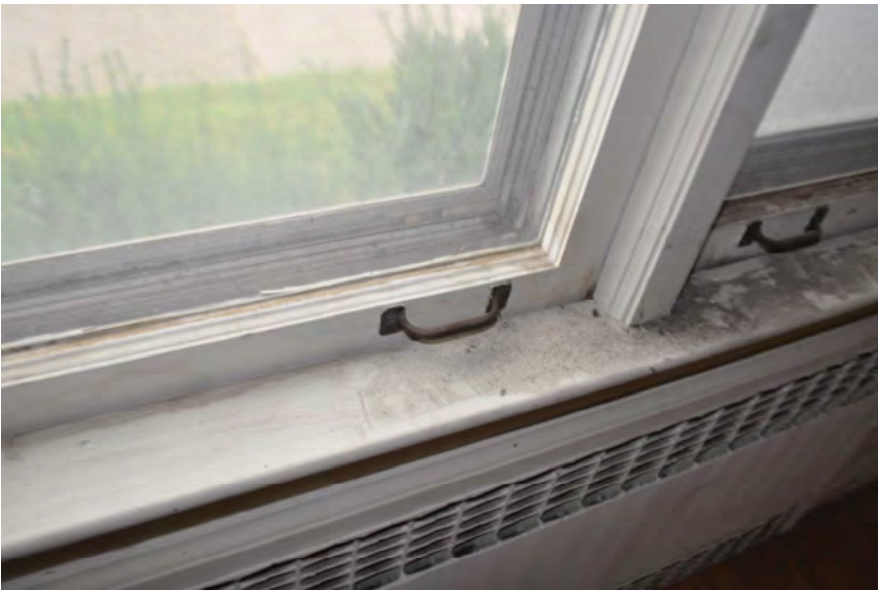
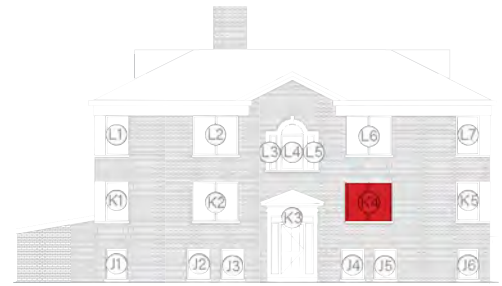
### Window K4, Type B1

- Note: Extent of exterior deterioration, dry rot, and loss of operability is not fully apparent in interior photos. Replacement parts for existing windows are unavailable, making restoration of thermal and operable functionality impossible, and long-term maintenance infeasible. Recommendation is for replacement, for quality of life of future tenants and for feasibility of long-term maintenance.
- See Window Assessment (Blackberry) in appendix for further detail and information, including further notes on deterioration beyond repair
- See Appendix for Window Schedule & Measurements

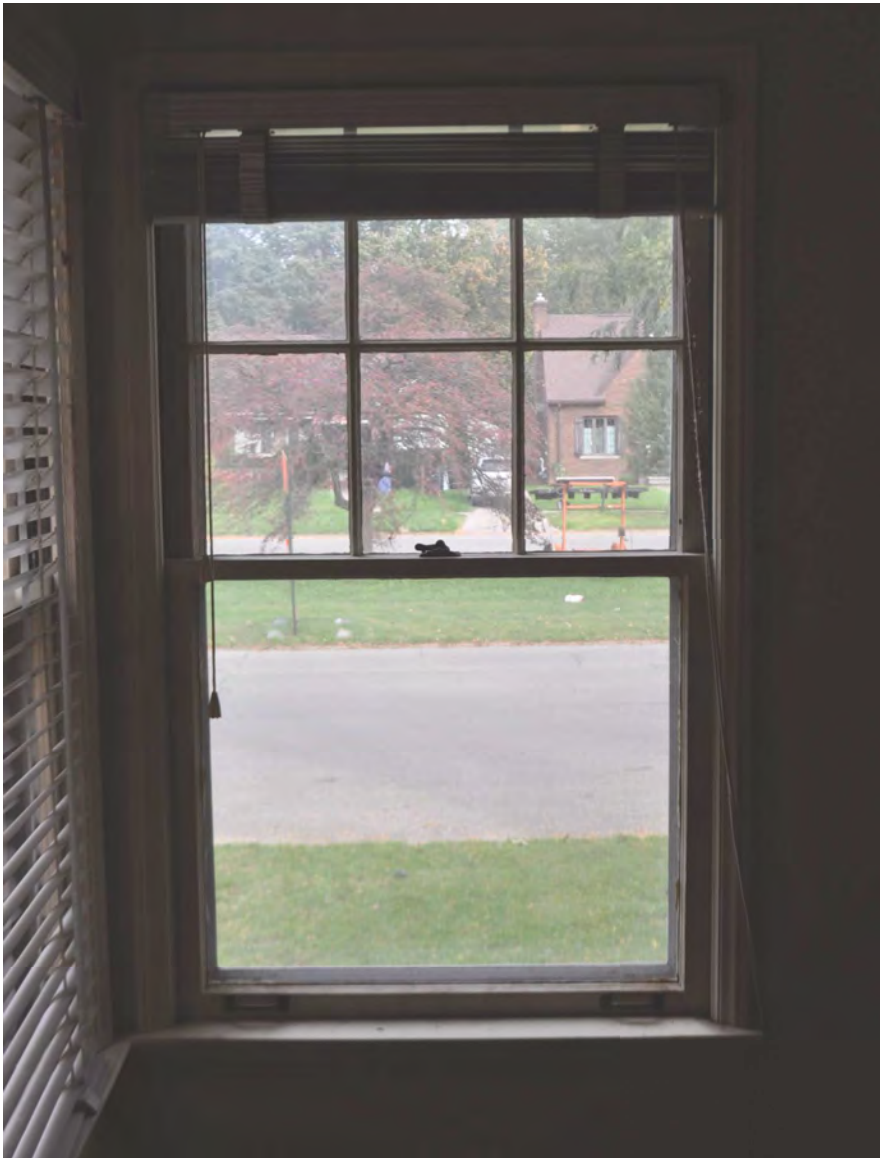
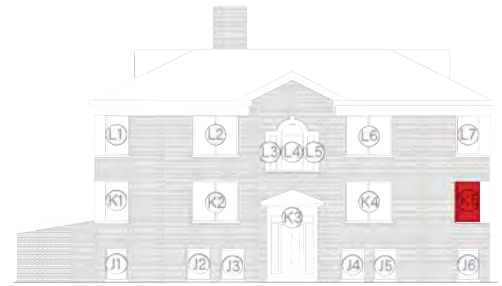
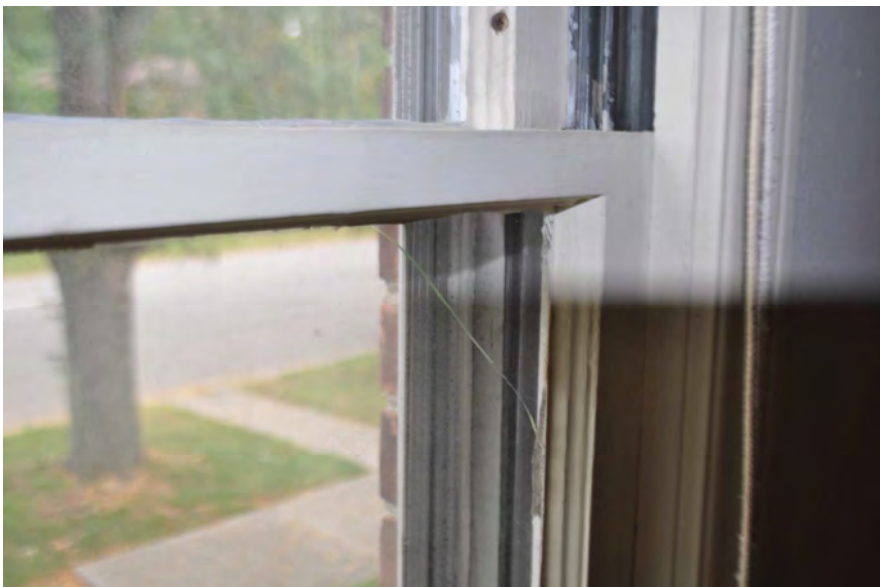
### Window K5, Type A1

- Broken Glass
- Note: Extent of exterior deterioration, dry rot, and loss of operability is not fully apparent in interior photos. Replacement parts for existing windows are unavailable, making restoration of thermal and operable functionality impossible, and long-term maintenance infeasible. Recommendation is for replacement, for quality of life of future tenants and for feasibility of long-term maintenance.
- See Window Assessment (Blackberry) in appendix for further detail and information, including further notes on deterioration beyond repair
- See Appendix for Window Schedule & Measurements

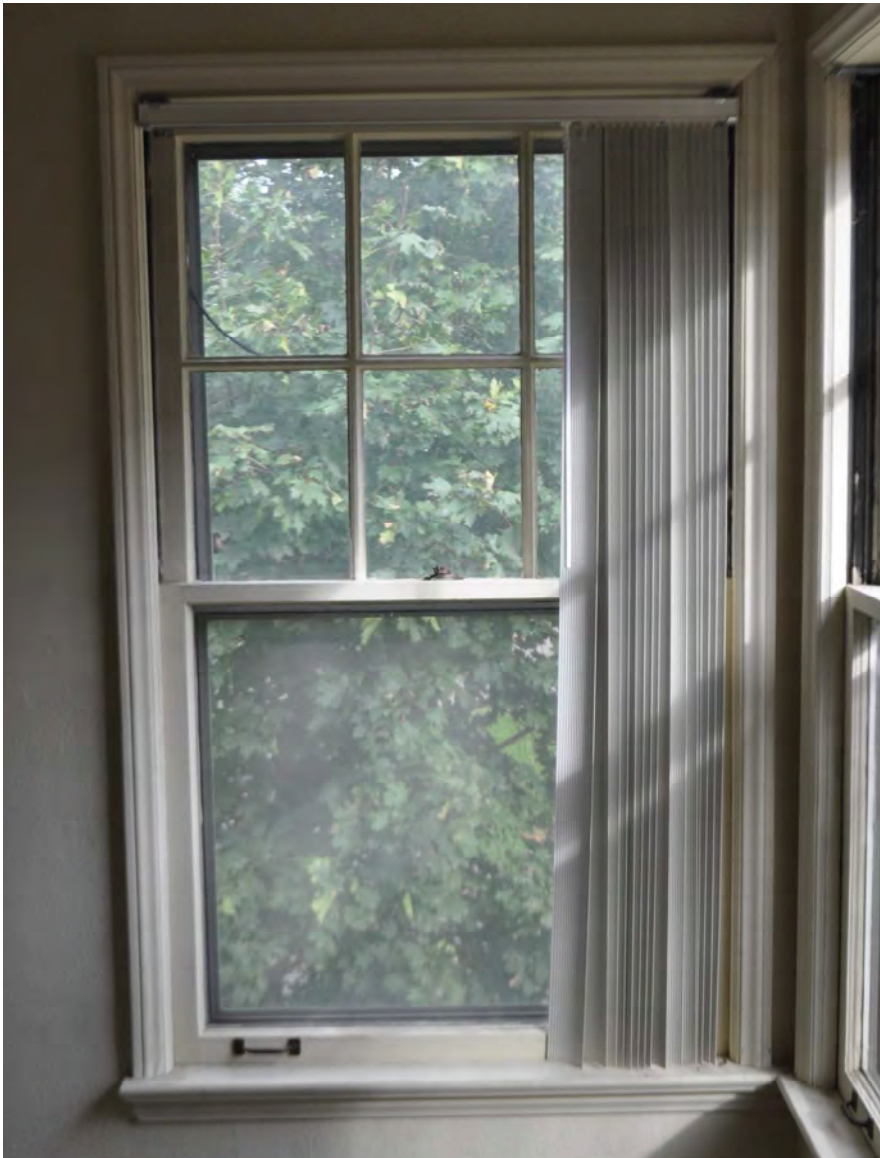
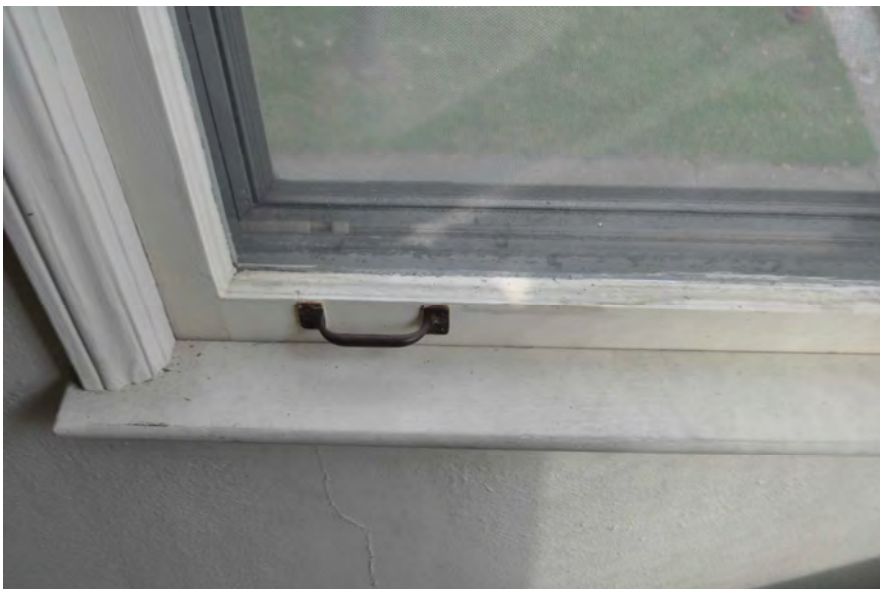
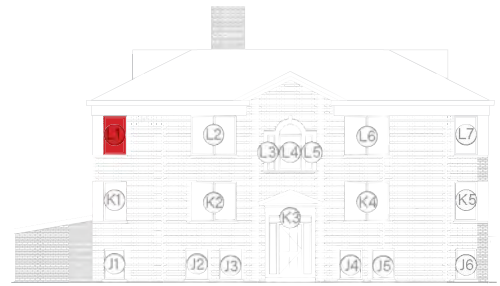
### Window L1, Type A1

- Note: Extent of exterior deterioration, dry rot, and loss of operability is not fully apparent in interior photos. Replacement parts for existing windows are unavailable, making restoration of thermal and operable functionality impossible, and long-term maintenance infeasible. Recommendation is for replacement, for quality of life of future tenants and for feasibility of long-term maintenance.
- See Window Assessment (Blackberry) in appendix for further detail and information, including further notes on deterioration beyond repair
- See Appendix for Window Schedule & Measurements

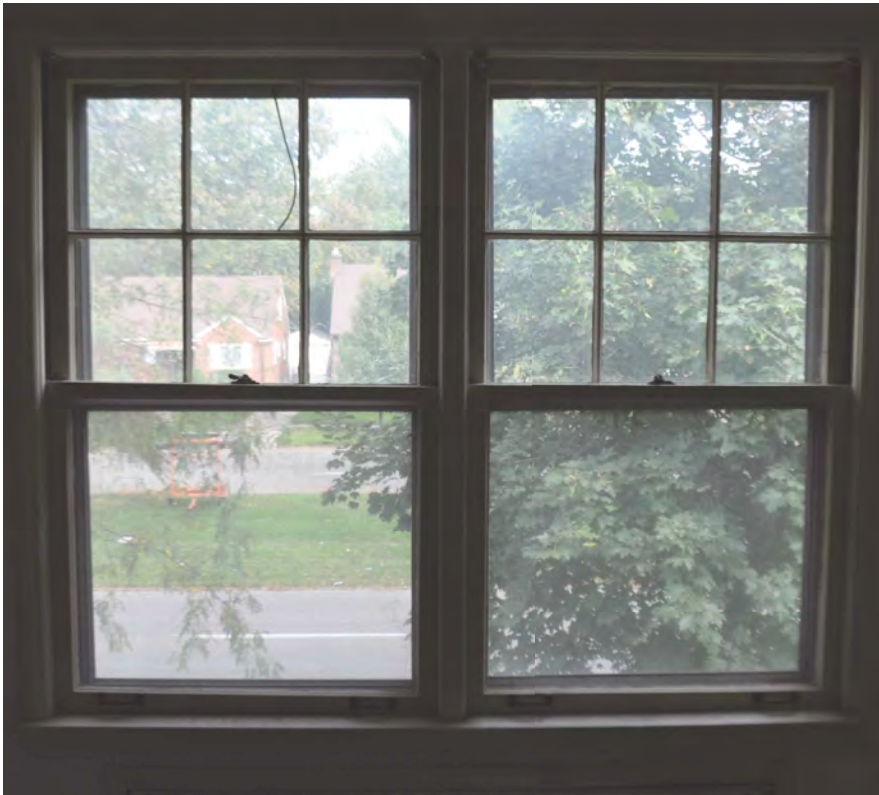
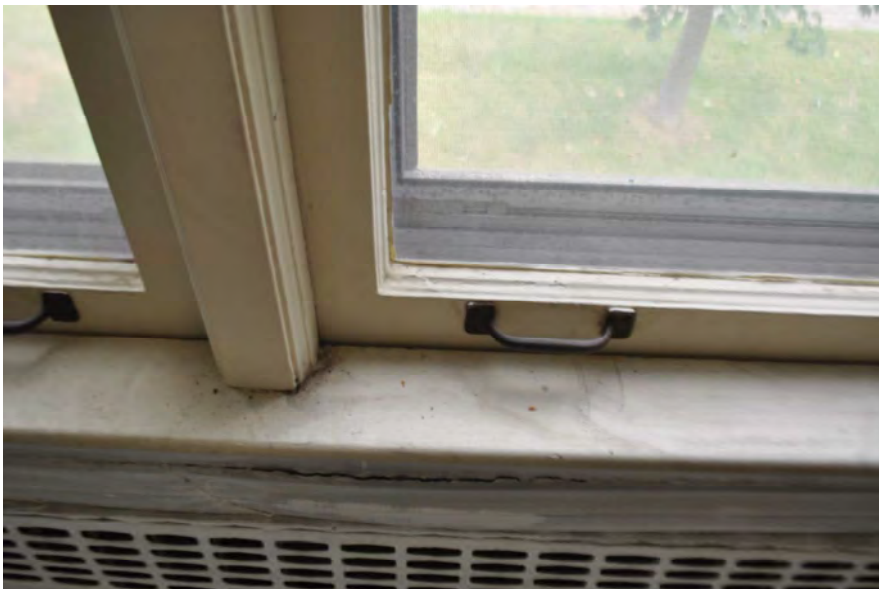
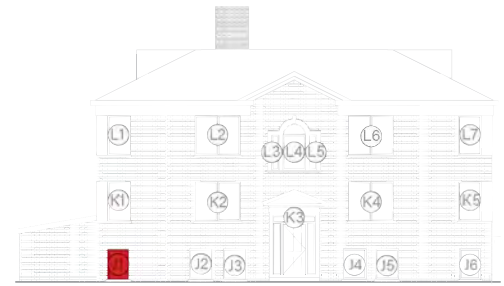
### Window L2, Type B1

- Note: Extent of exterior deterioration, dry rot, and loss of operability is not fully apparent in interior photos. Replacement parts for existing windows are unavailable, making restoration of thermal and operable functionality impossible, and long-term maintenance infeasible. Recommendation is for replacement, for quality of life of future tenants and for feasibility of long-term maintenance.
- See Window Assessment (Blackberry) in appendix for further detail and information, including further notes on deterioration beyond repair
- See Appendix for Window Schedule & Measurements

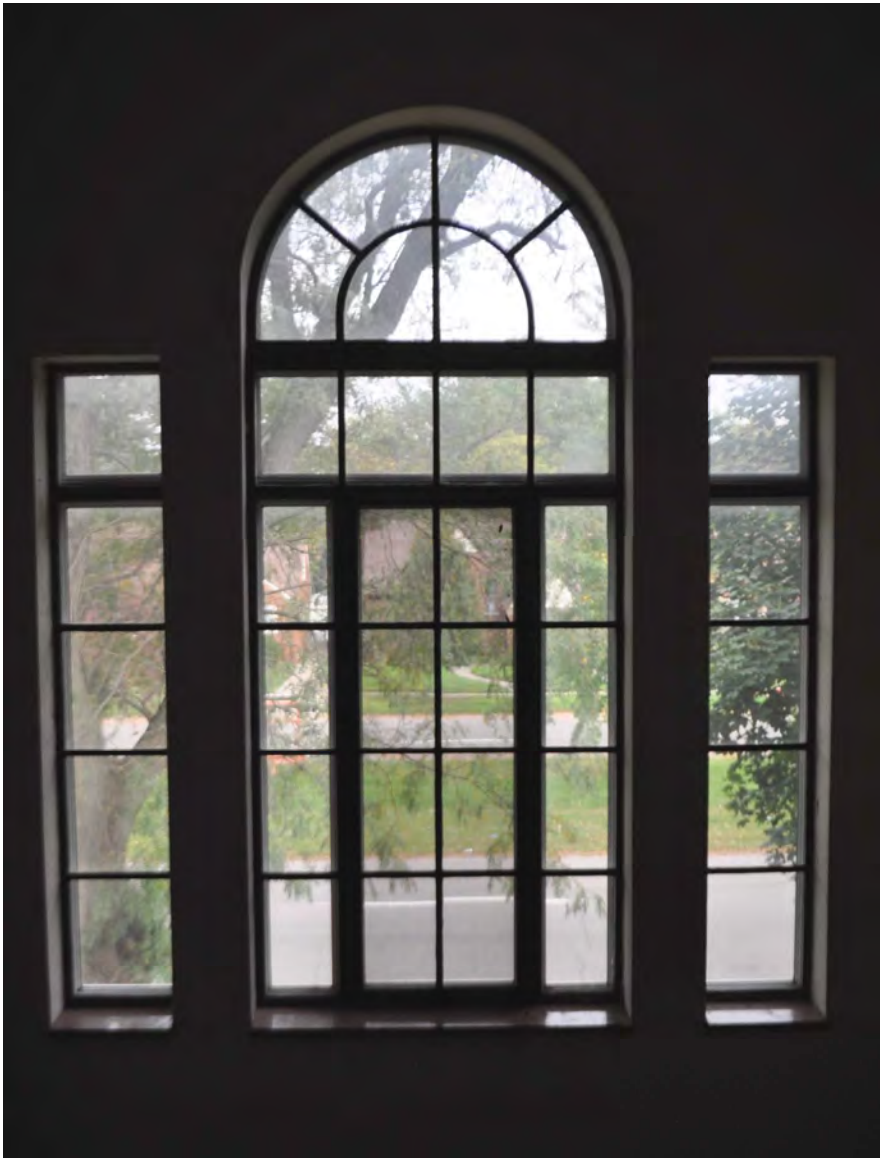
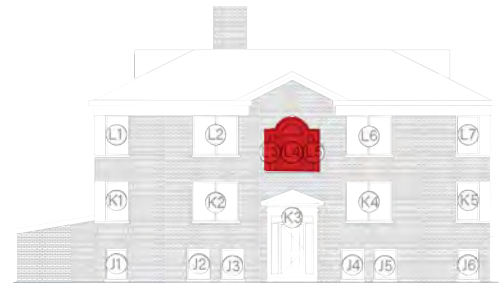
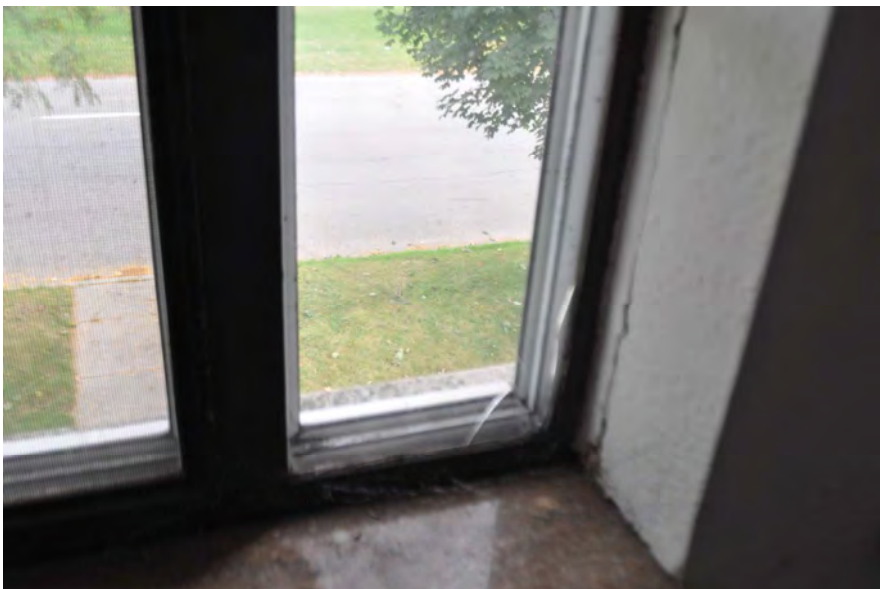
Window L3, Type S3

- Existing Fixed Window at Common Area Stairwell to be repaired
- See Appendix for Window Schedule & Measurements
- See Window Assessment & Survey by Blackberry in appendices for further details and information

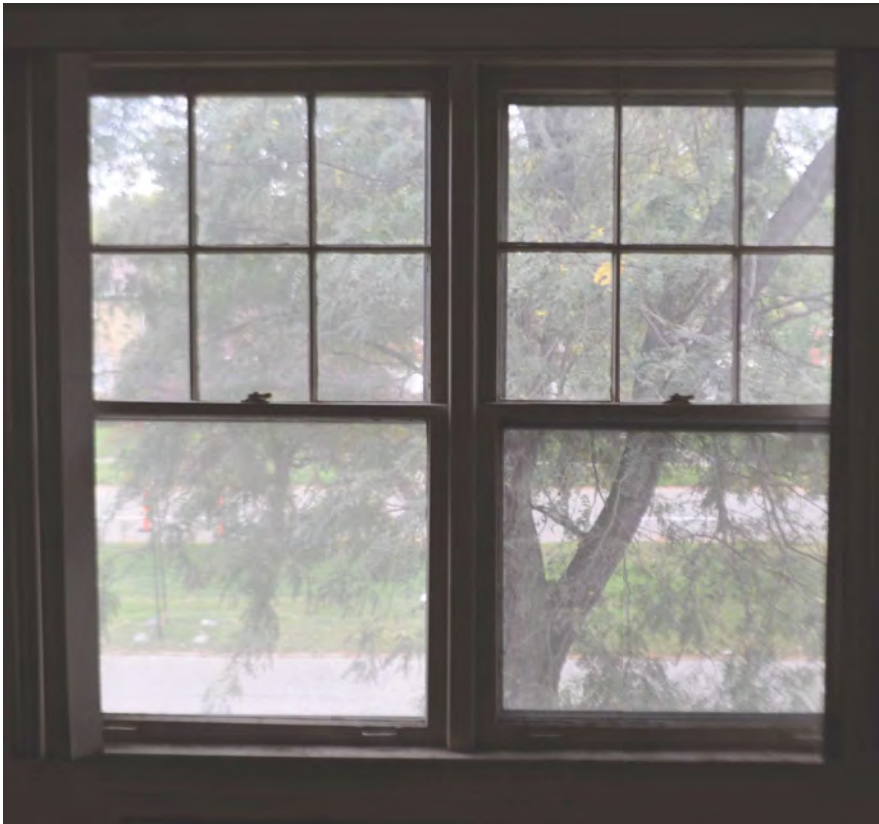
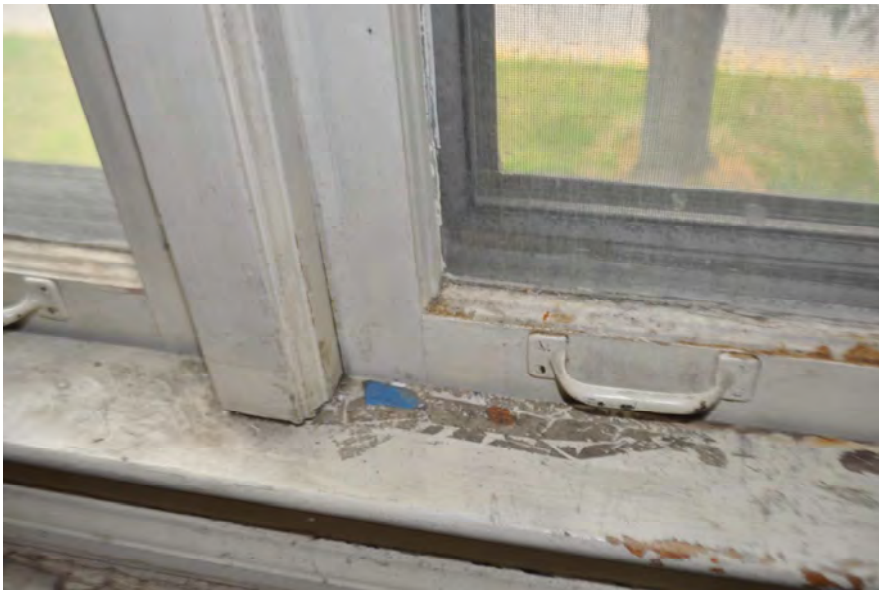
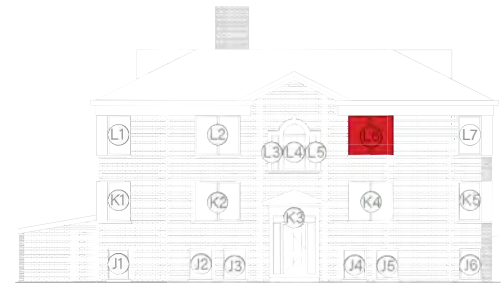
### Window L6, Type B1

- Note: Extent of exterior deterioration, dry rot, and loss of operability is not fully apparent in interior photos. Replacement parts for existing windows are unavailable, making restoration of thermal and operable functionality impossible, and long-term maintenance infeasible. Recommendation is for replacement, for quality of life of future tenants and for feasibility of long-term maintenance.
- See Window Assessment (Blackberry) in appendix for further detail and information, including further notes on deterioration beyond repair
- See Appendix for Window Schedule & Measurements
