# 9710 W Outer Dr

## Existing Condition Photos

# 9730 W Outer Dr

# Detailed Scope of Work

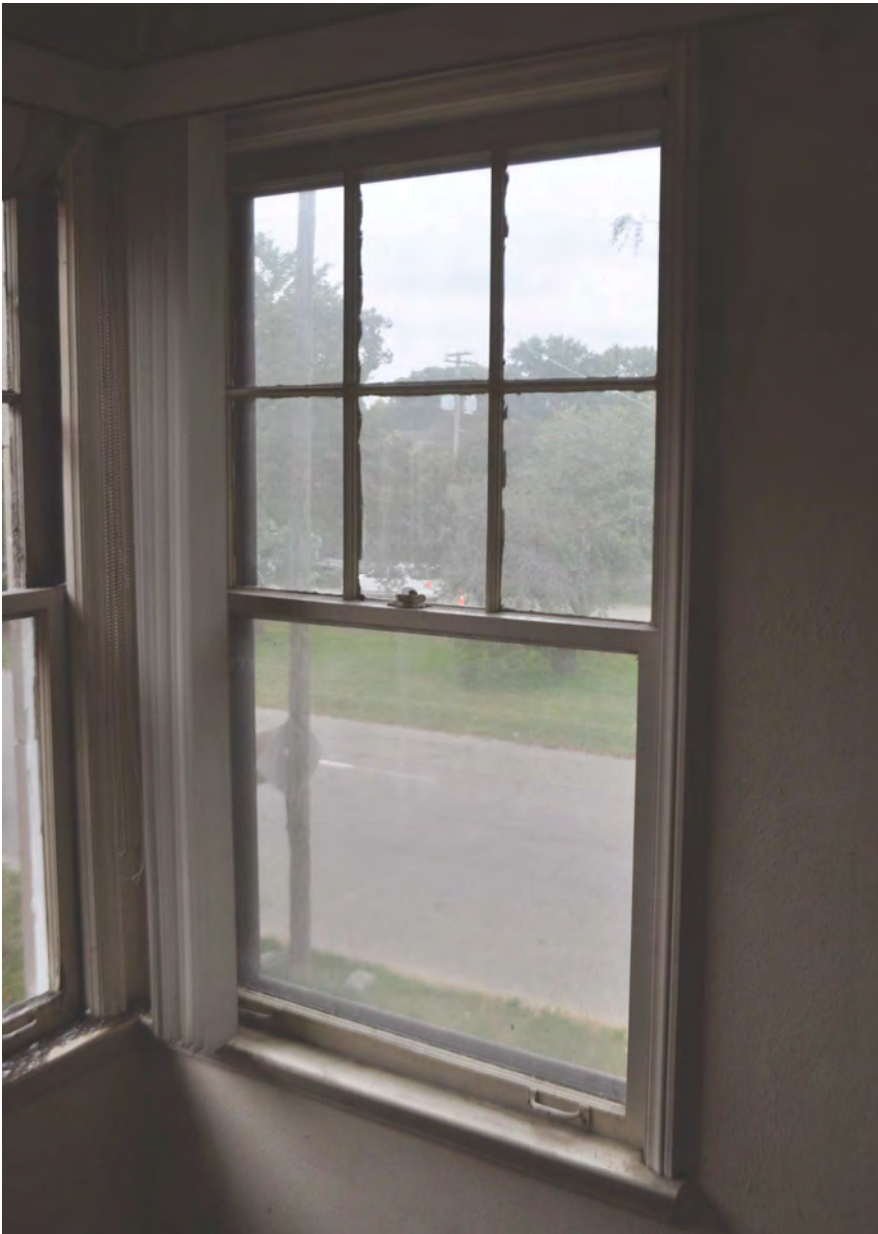
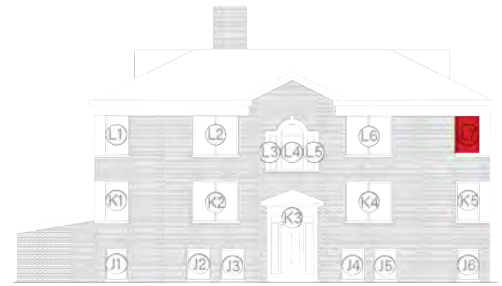
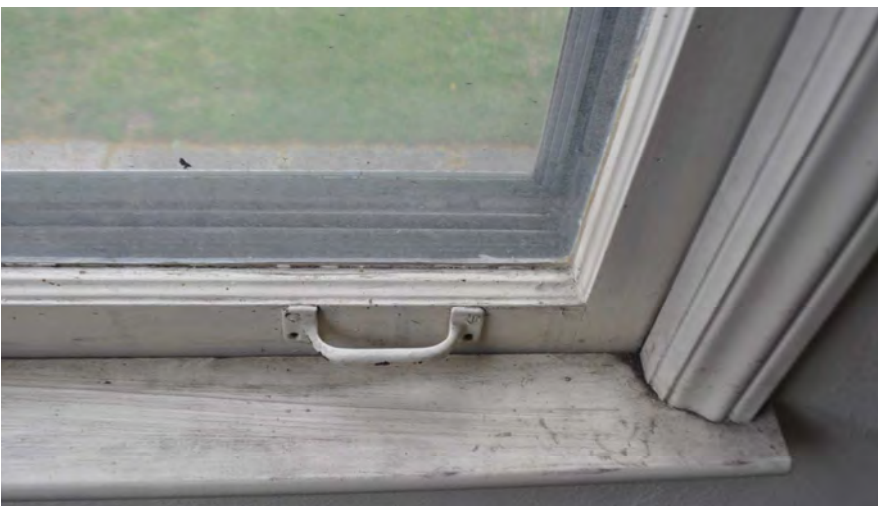
### Window L7, Type A1

- Note: Extent of exterior deterioration, dry rot, and loss of operability is not fully apparent in interior photos. Replacement parts for existing windows are unavailable, making restoration of thermal and operable functionality impossible, and long-term maintenance infeasible. Recommendation is for replacement, for quality of life of future tenants and for feasibility of long-term maintenance.
- See Window Assessment (Blackberry) in appendix for further detail and information, including further notes on deterioration beyond repair
- See Appendix for Window Schedule & Measurements

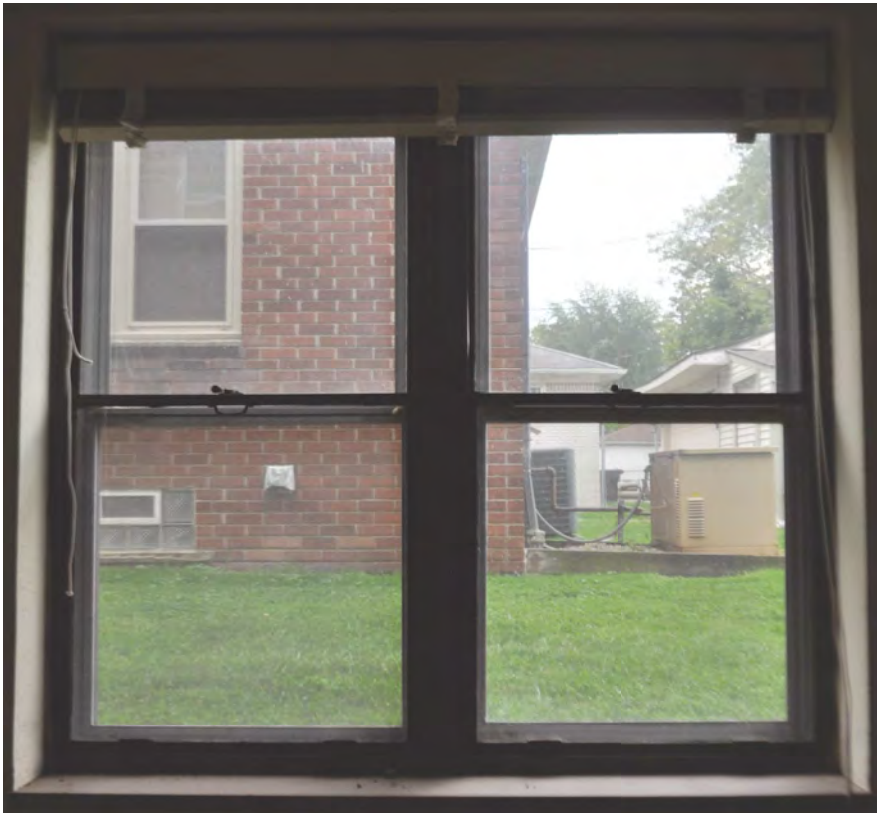
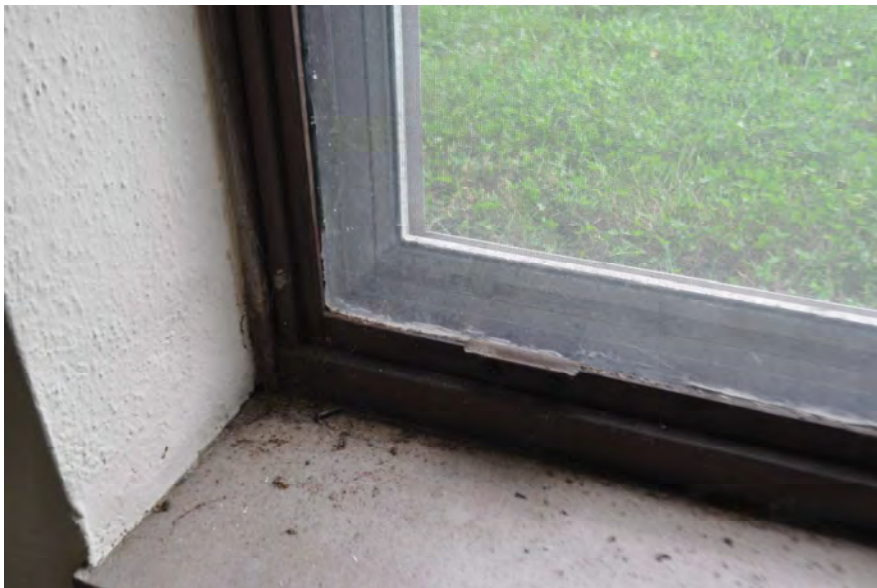
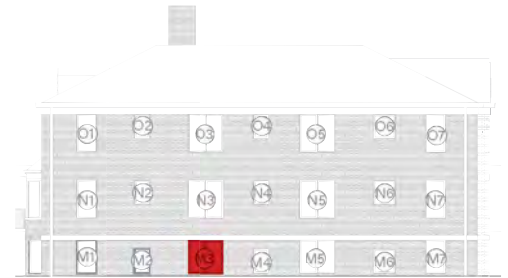
### Window M3, Type Y1

- Badly Corroded
- Note: Extent of exterior deterioration, corrosion, and loss of operability is not fully apparent in interior photos. Replacement parts for existing windows are unavailable, making restoration of thermal and operable functionality impossible, and long-term maintenance infeasible. Recommendation is for replacement, for quality of life of future tenants and for feasibility of long-term maintenance.
- See Window Assessment (Blackberry) in appendix for further detail and information, including further notes on deterioration beyond repair
- See Appendix for Window Schedule & Measurements

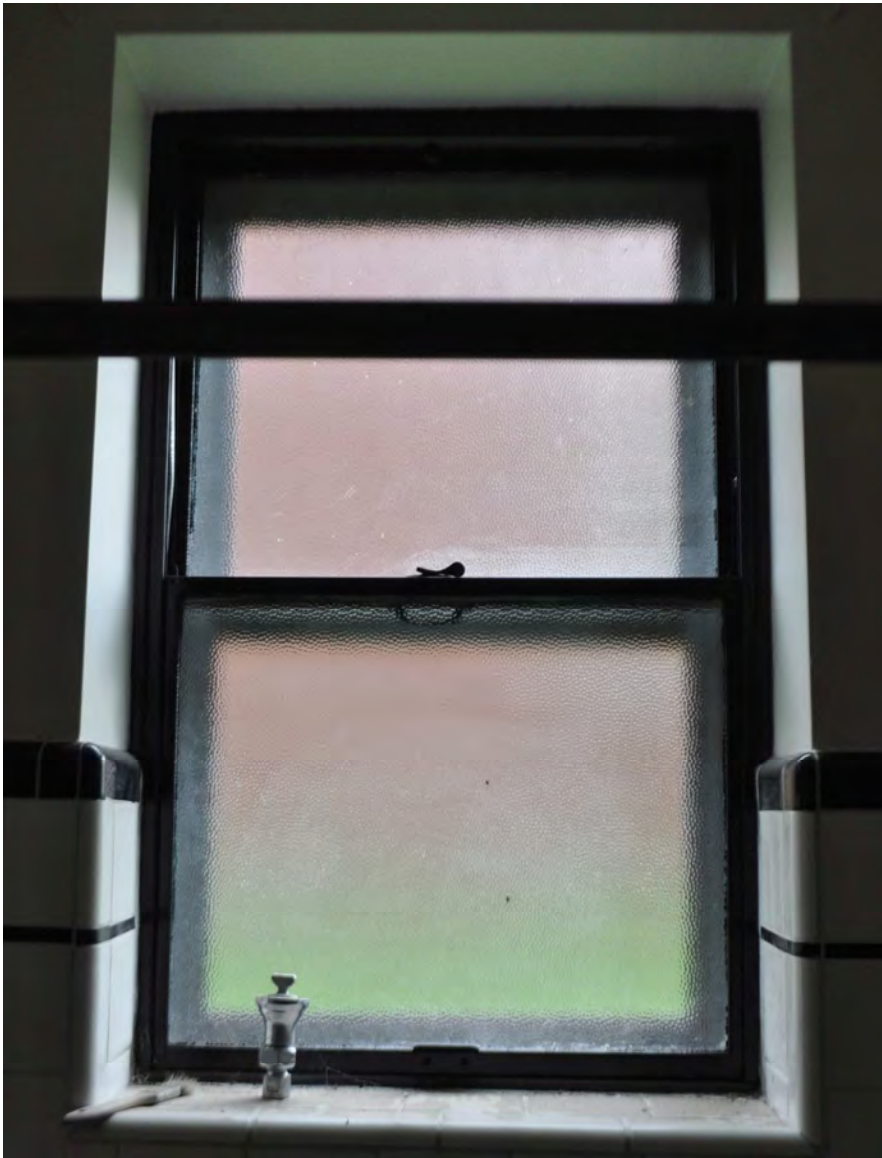
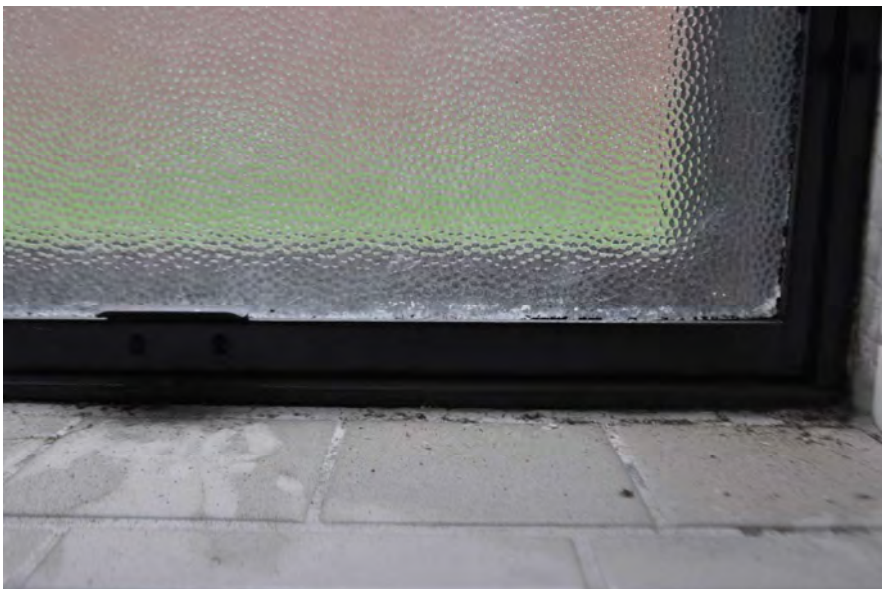
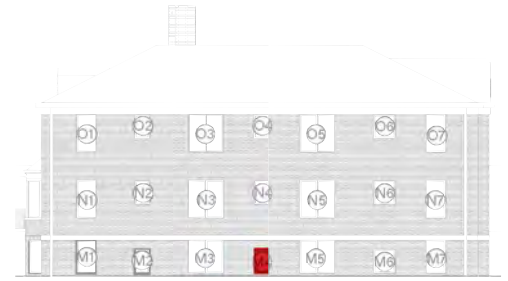
### Window M4, Type U2

- Badly Corroded
- Note: Extent of exterior deterioration, corrosion, and loss of operability is not fully apparent in interior photos. Replacement parts for existing windows are unavailable, making restoration of thermal and operable functionality impossible, and long-term maintenance infeasible. Recommendation is for replacement, for quality of life of future tenants and for feasibility of long-term maintenance.
- See Window Assessment (Blackberry) in appendix for further detail and information, including further notes on deterioration beyond repair
- See Appendix for Window Schedule & Measurements

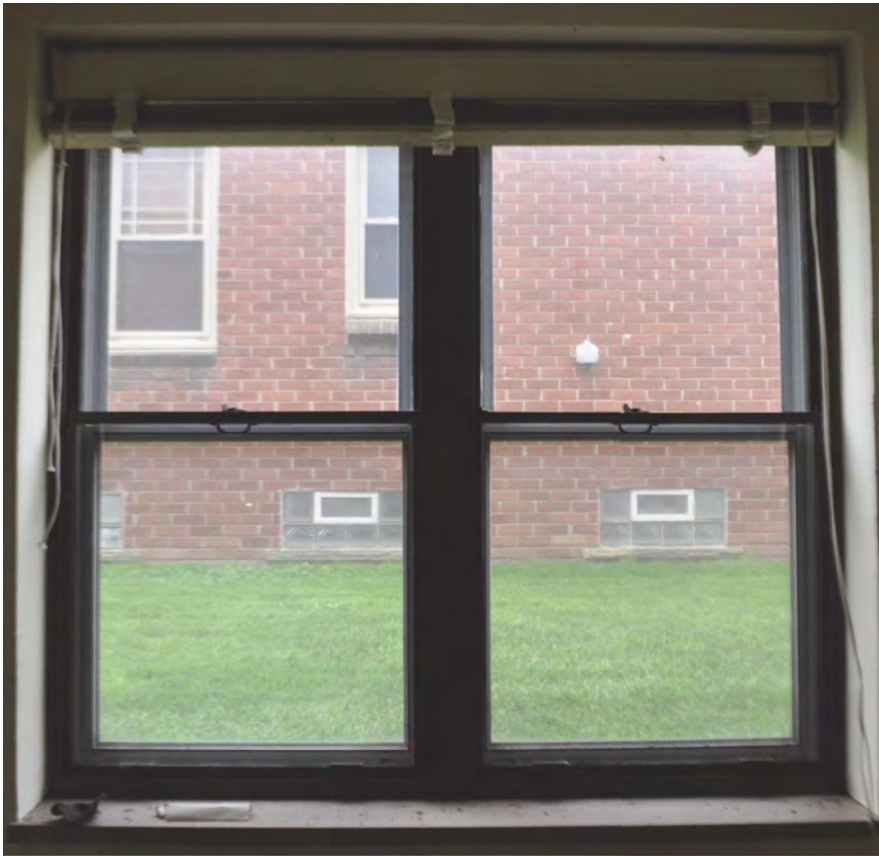
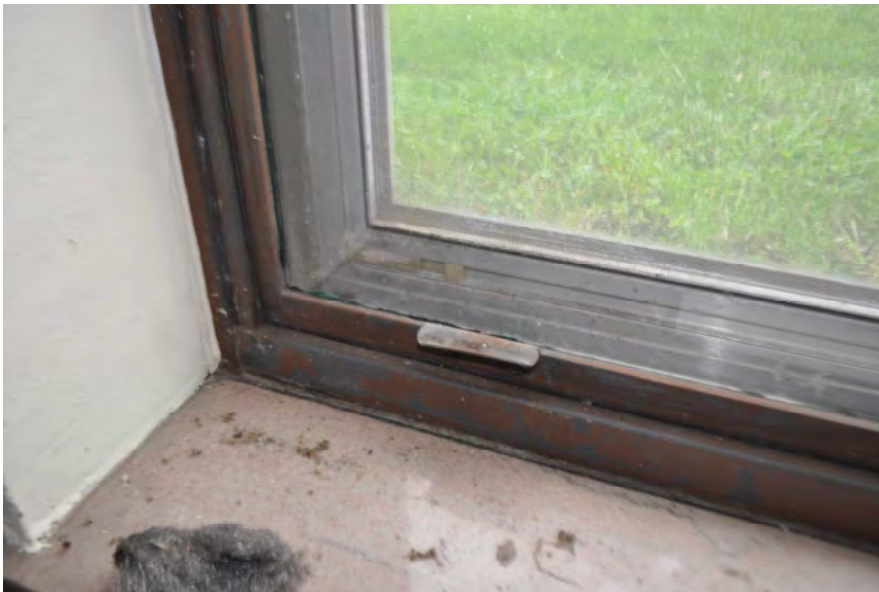
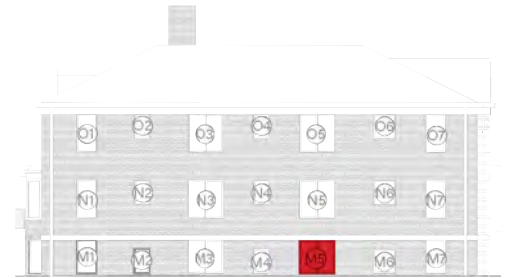
### Window M5, Type Y1

- Badly Corroded
- Note: Extent of exterior deterioration, corrosion, and loss of operability is not fully apparent in interior photos. Replacement parts for existing windows are unavailable, making restoration of thermal and operable functionality impossible, and long-term maintenance infeasible. Recommendation is for replacement, for quality of life of future tenants and for feasibility of long-term maintenance.
- See Window Assessment (Blackberry) in appendix for further detail and information, including further notes on deterioration beyond repair
- See Appendix for Window Schedule & Measurements

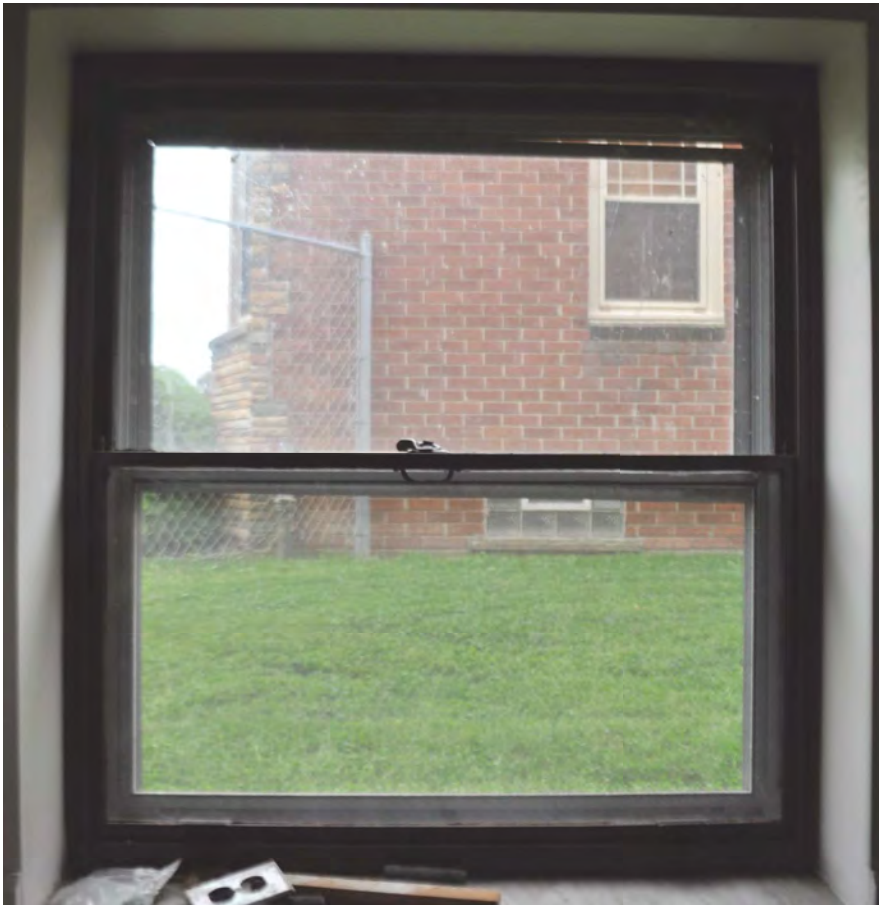
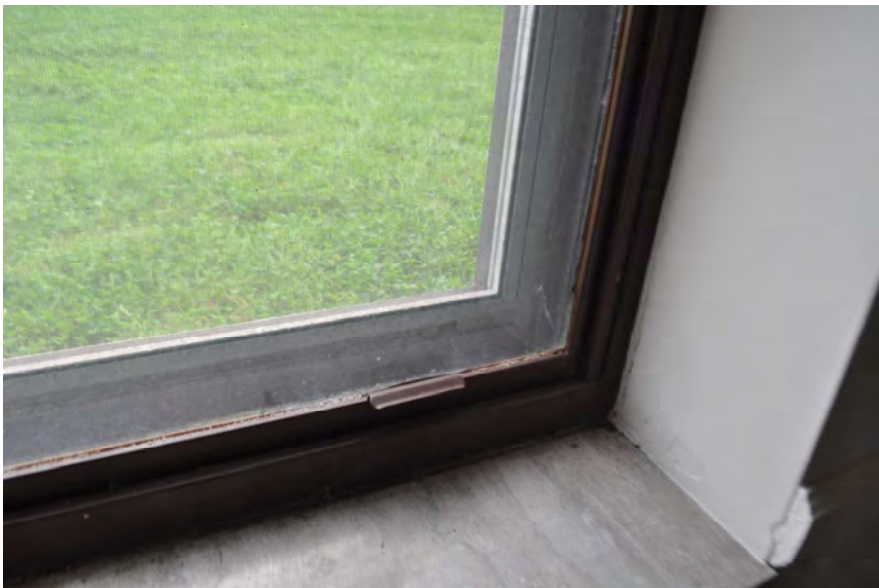
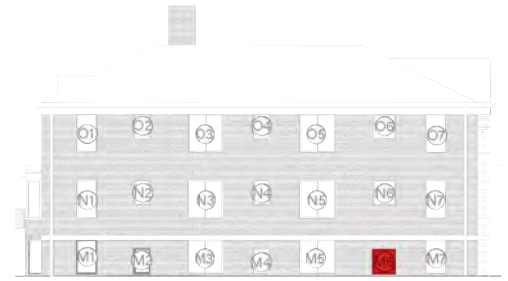
### Window M6, Type T2

- Badly Corroded
- Note: Extent of exterior deterioration, corrosion, and loss of operability is not fully apparent in interior photos. Replacement parts for existing windows are unavailable, making restoration of thermal and operable functionality impossible, and long-term maintenance infeasible. Recommendation is for replacement, for quality of life of future tenants and for feasibility of long-term maintenance.
- See Window Assessment (Blackberry) in appendix for further detail and information, including further notes on deterioration beyond repair
- See Appendix for Window Schedule & Measurements

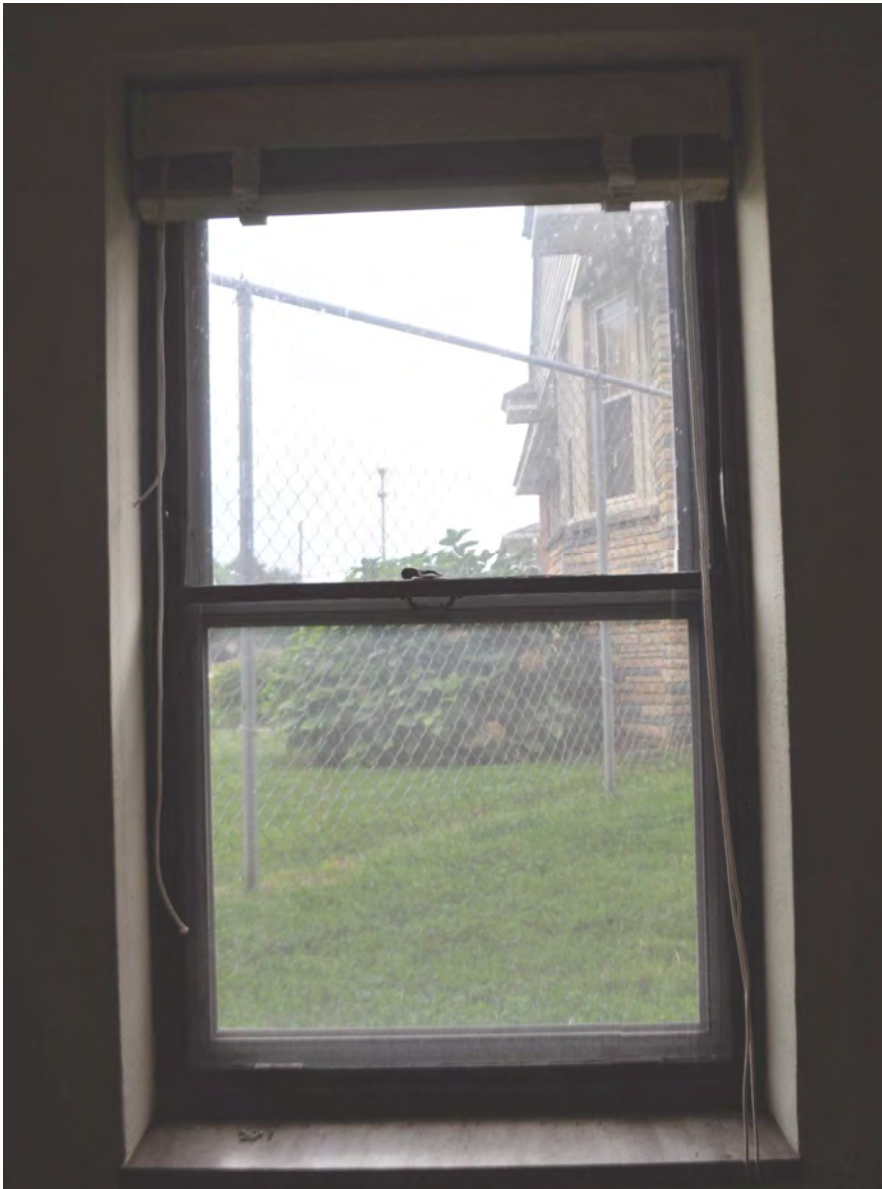
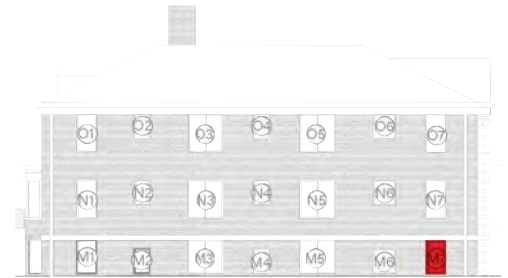
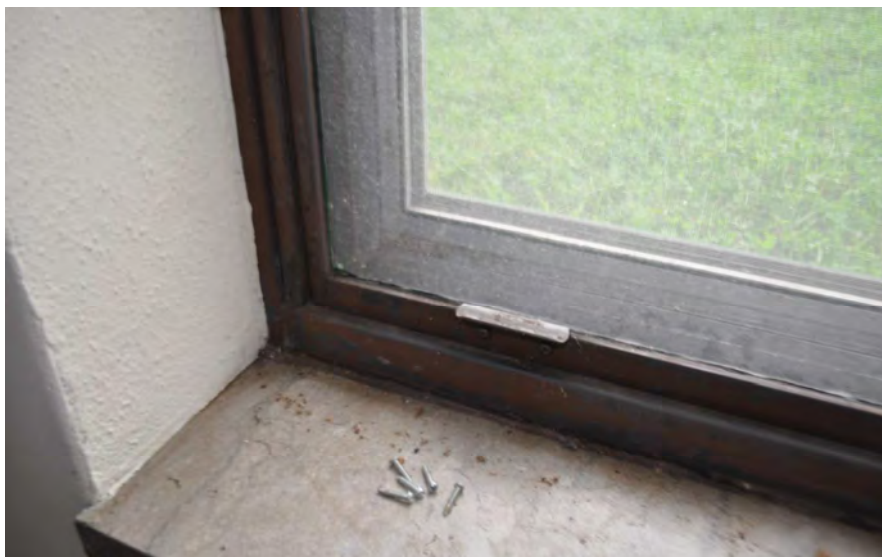
### Window M7, Type M2

- Badly Corroded
- Note: Extent of exterior deterioration, corrosion, and loss of operability is not fully apparent in interior photos. Replacement parts for existing windows are unavailable, making restoration of thermal and operable functionality impossible, and long-term maintenance infeasible. Recommendation is for replacement, for quality of life of future tenants and for feasibility of long-term maintenance.
- See Window Assessment (Blackberry) in appendix for further detail and information, including further notes on deterioration beyond repair
- See Appendix for Window Schedule & Measurements

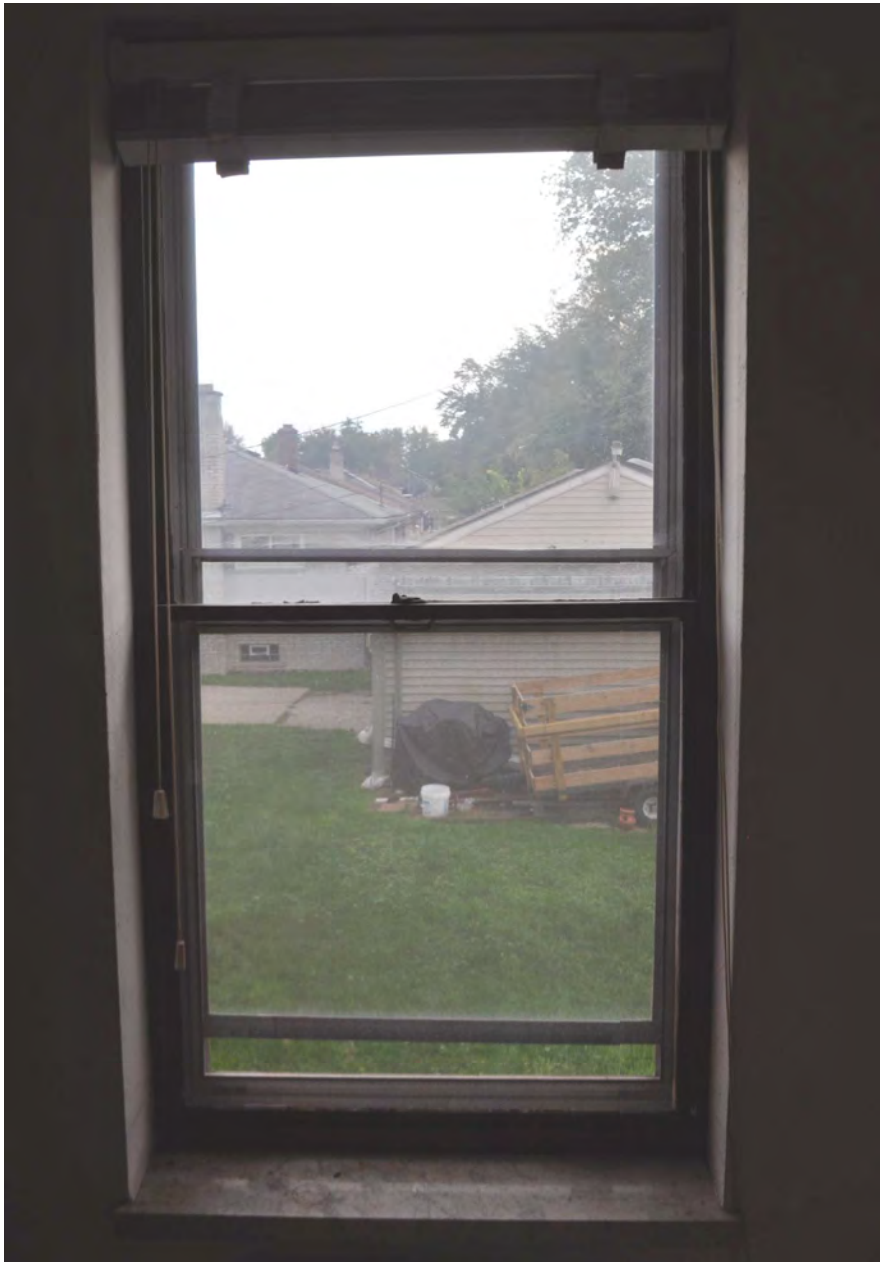
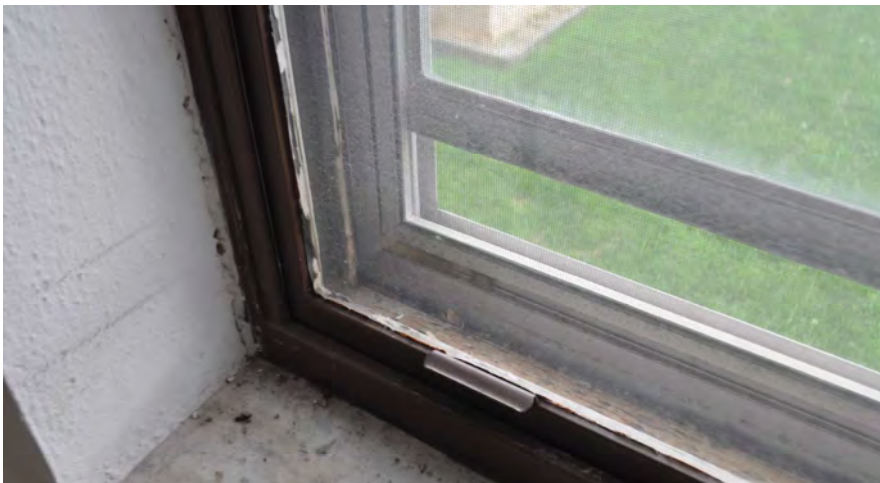
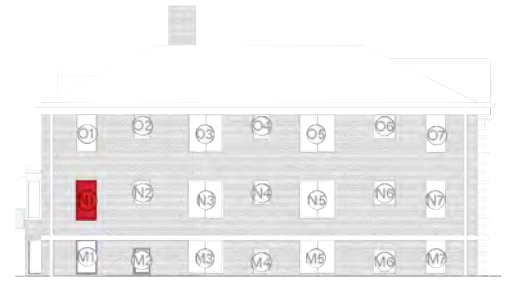
### Window N1, Type N2

- Note: Extent of exterior deterioration, corrosion, and loss of operability is not fully apparent in interior photos. Replacement parts for existing windows are unavailable, making restoration of thermal and operable functionality impossible, and long-term maintenance infeasible. Recommendation is for replacement, for quality of life of future tenants and for feasibility of long-term maintenance.
- See Window Assessment (Blackberry) in appendix for further detail and information, including further notes on deterioration beyond repair
- See Appendix for Window Schedule & Measurements

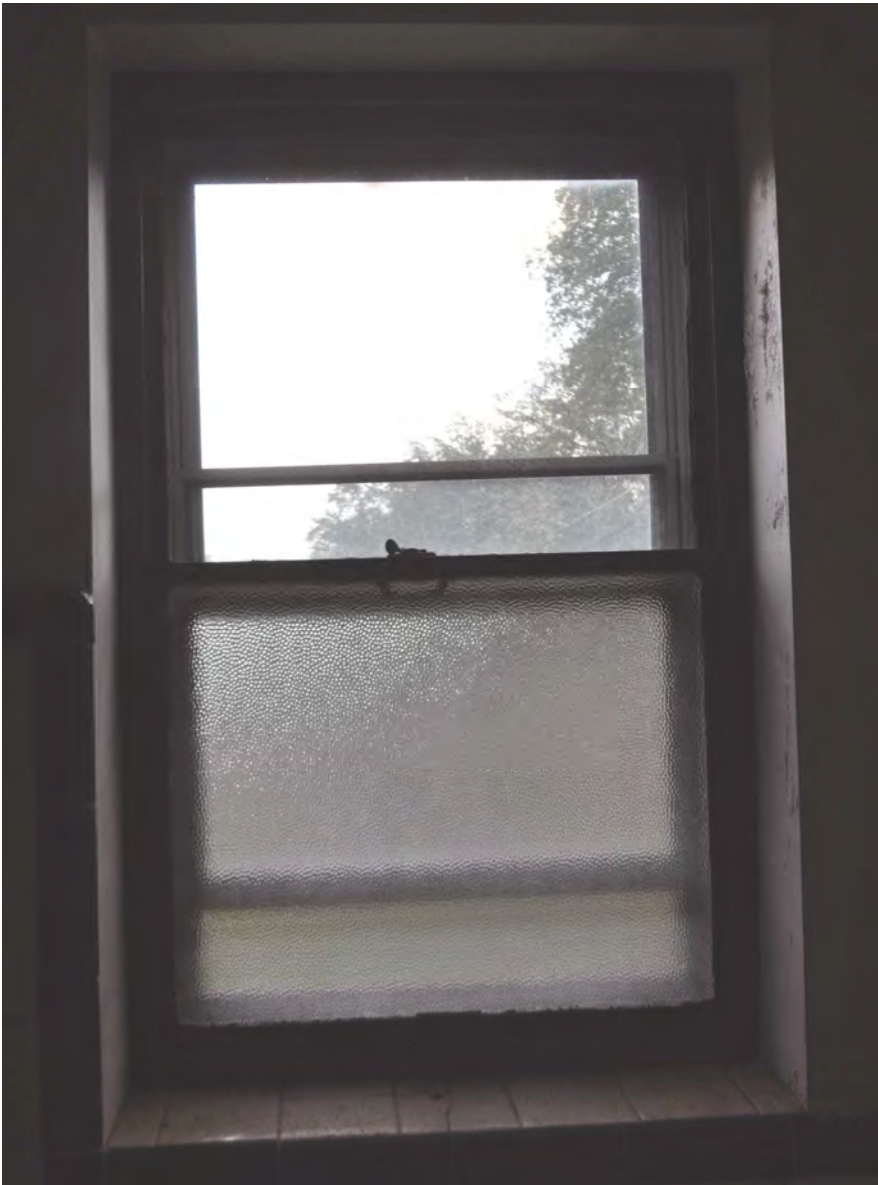
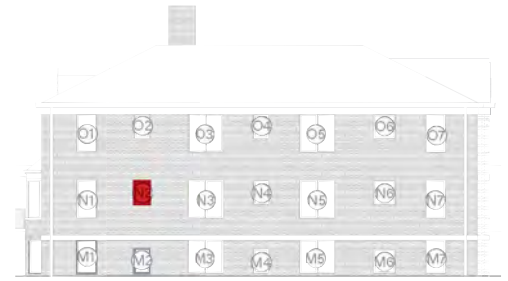
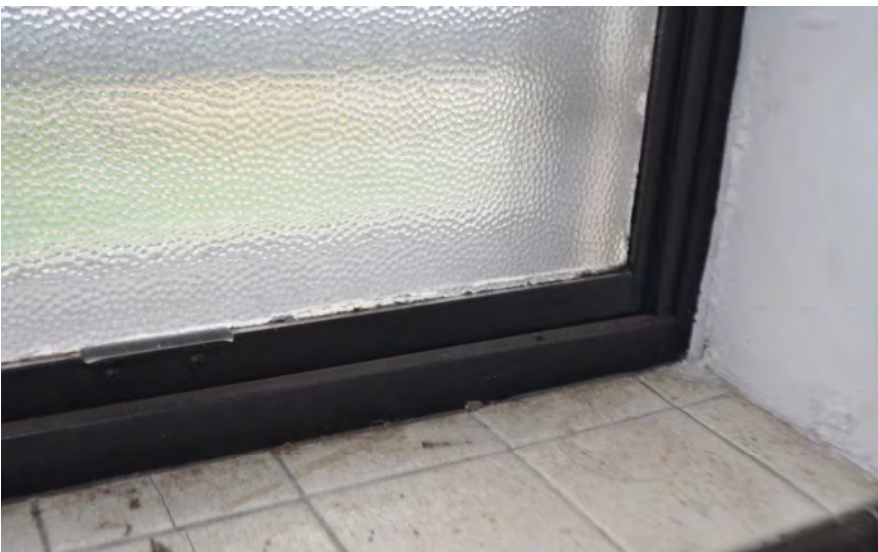
### Window N2, Type U2

- Note: Extent of exterior deterioration, corrosion, and loss of operability is not fully apparent in interior photos. Replacement parts for existing windows are unavailable, making restoration of thermal and operable functionality impossible, and long-term maintenance infeasible. Recommendation is for replacement, for quality of life of future tenants and for feasibility of long-term maintenance.
- See Window Assessment (Blackberry) in appendix for further detail and information, including further notes on deterioration beyond repair
- See Appendix for Window Schedule & Measurements

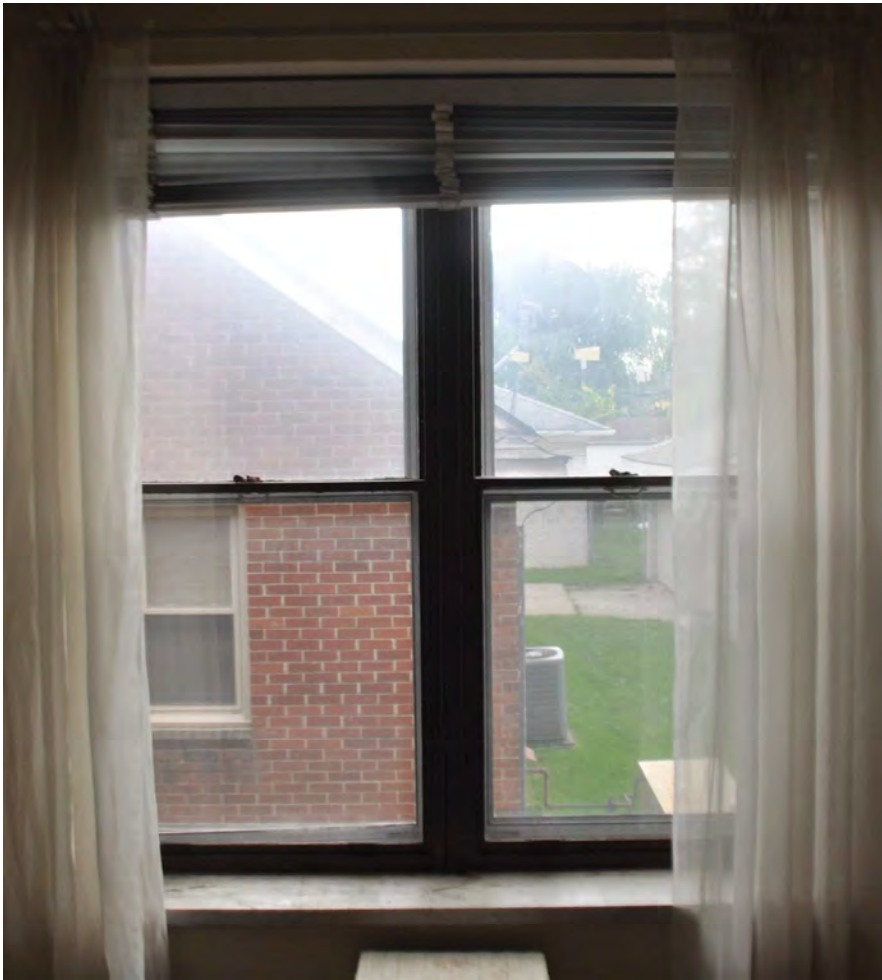
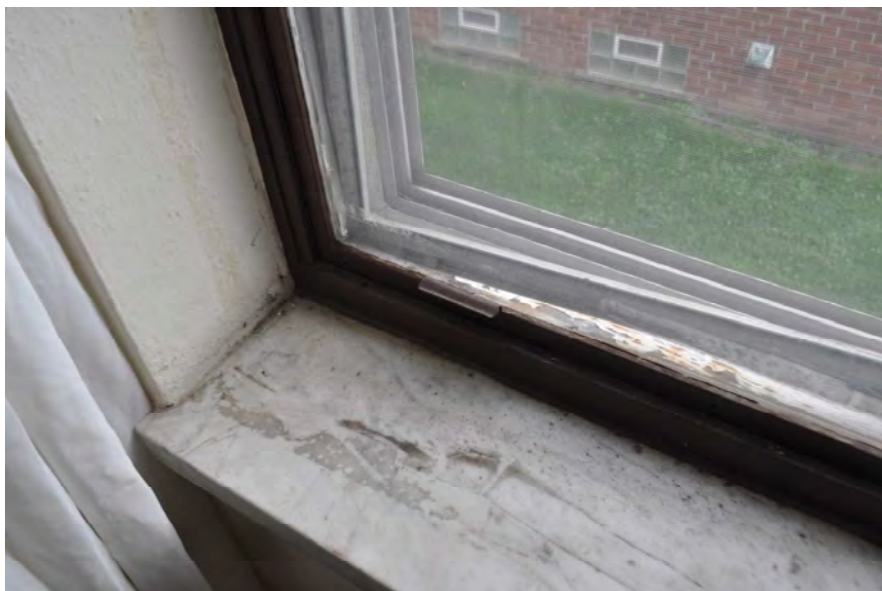
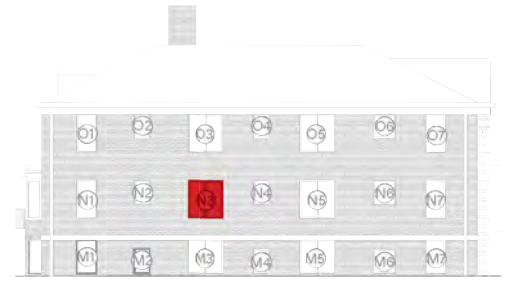
### Window N3, Type Z1

- Note: Extent of exterior deterioration, corrosion, and loss of operability is not fully apparent in interior photos. Replacement parts for existing windows are unavailable, making restoration of thermal and operable functionality impossible, and long-term maintenance infeasible. Recommendation is for replacement, for quality of life of future tenants and for feasibility of long-term maintenance.
- See Window Assessment (Blackberry) in appendix for further detail and information, including further notes on deterioration beyond repair
- See Appendix for Window Schedule & Measurements

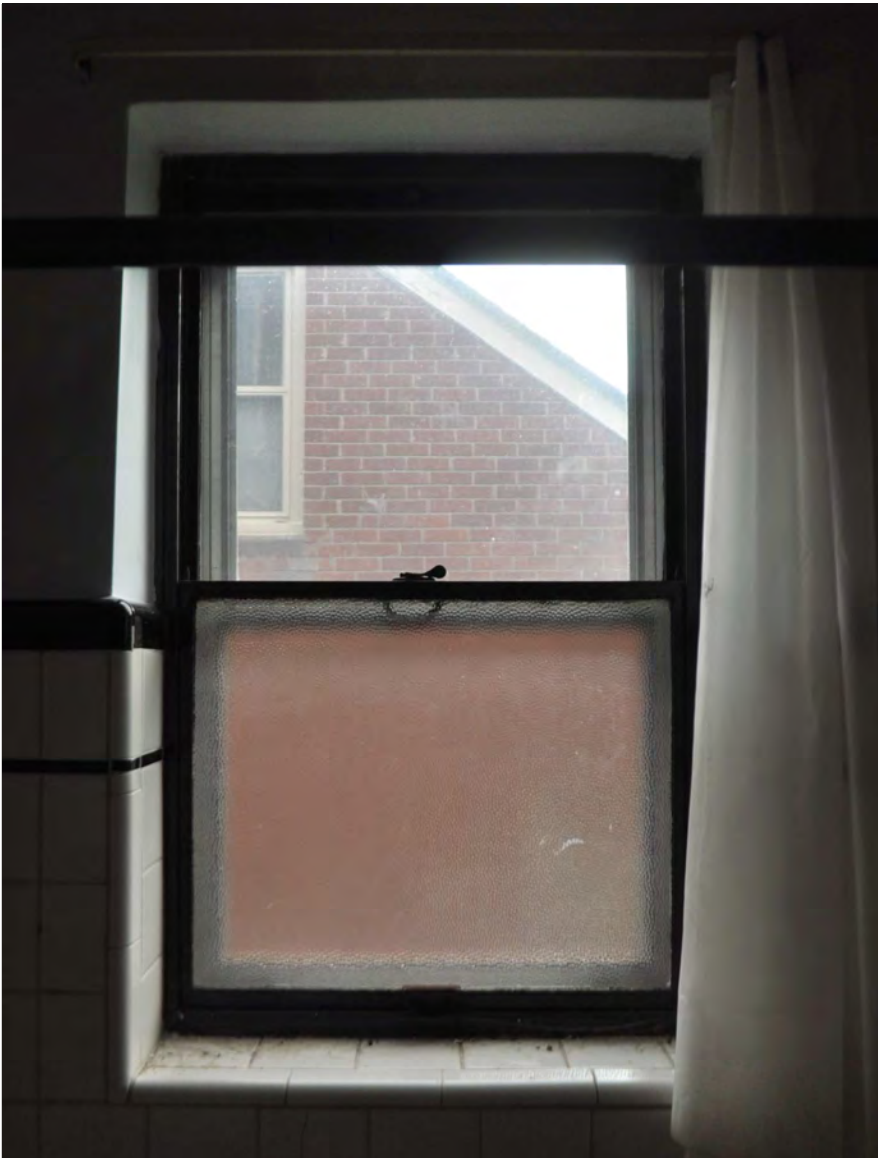
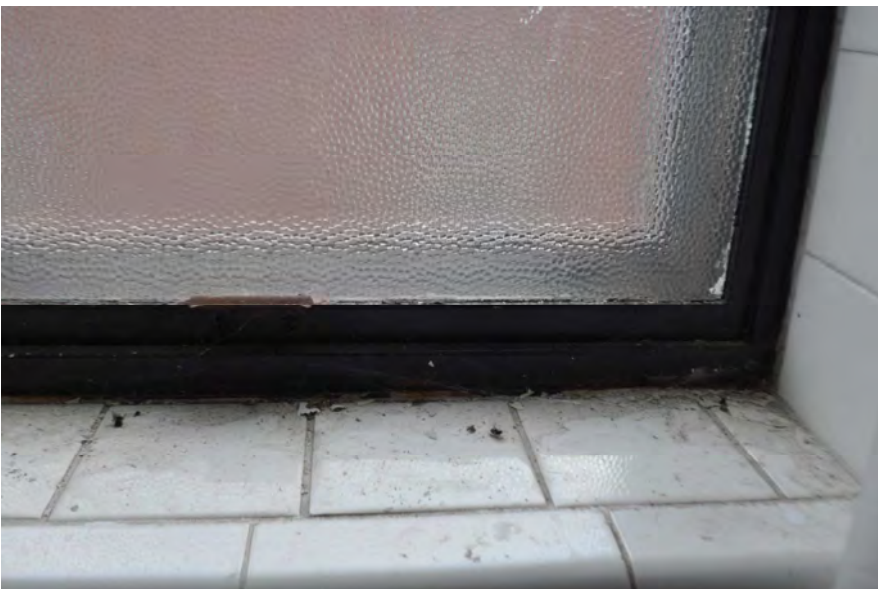
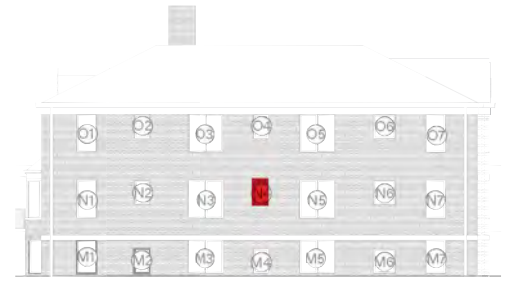
### Window N4, Type U2

- Note: Extent of exterior deterioration, corrosion, and loss of operability is not fully apparent in interior photos. Replacement parts for existing windows are unavailable, making restoration of thermal and operable functionality impossible, and long-term maintenance infeasible. Recommendation is for replacement, for quality of life of future tenants and for feasibility of long-term maintenance.
- See Window Assessment (Blackberry) in appendix for further detail and information, including further notes on deterioration beyond repair
- See Appendix for Window Schedule & Measurements

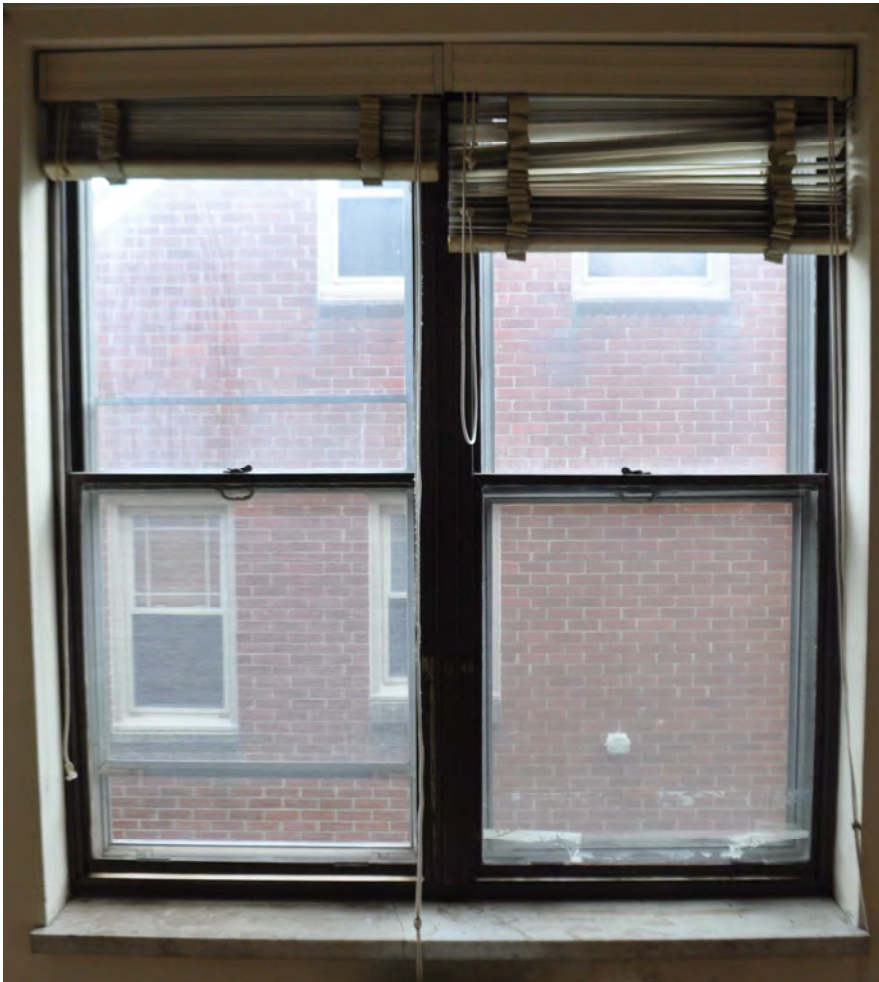
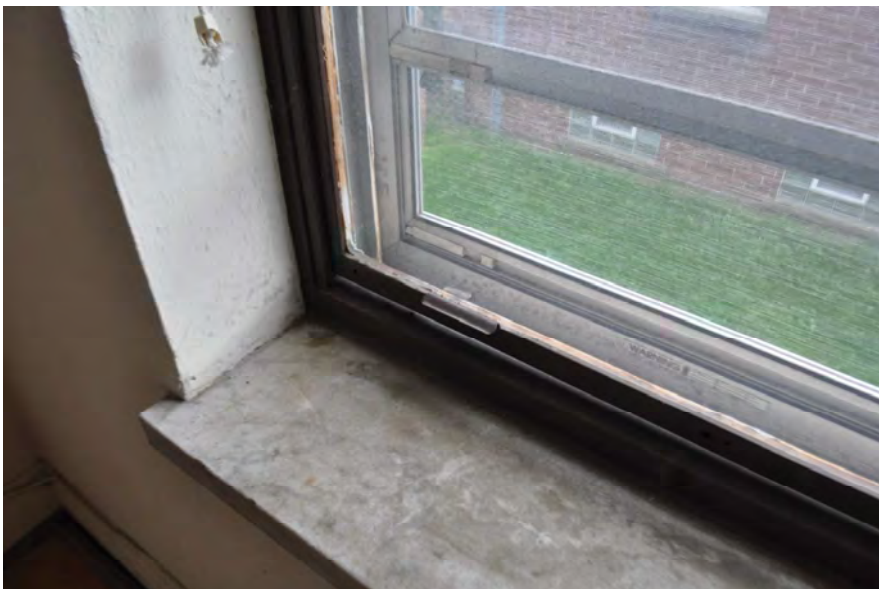
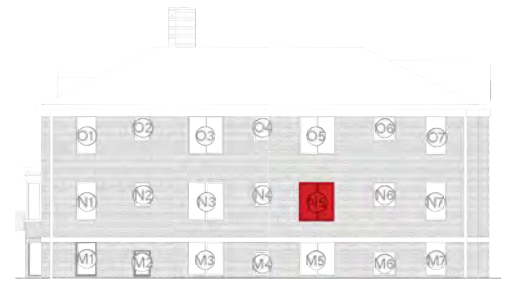
### Window N5, Type Z1

- Note: Extent of exterior deterioration, corrosion, and loss of operability is not fully apparent in interior photos. Replacement parts for existing windows are unavailable, making restoration of thermal and operable functionality impossible, and long-term maintenance infeasible. Recommendation is for replacement, for quality of life of future tenants and for feasibility of long-term maintenance.
- See Window Assessment (Blackberry) in appendix for further detail and information, including further notes on deterioration beyond repair
- See Appendix for Window Schedule & Measurements

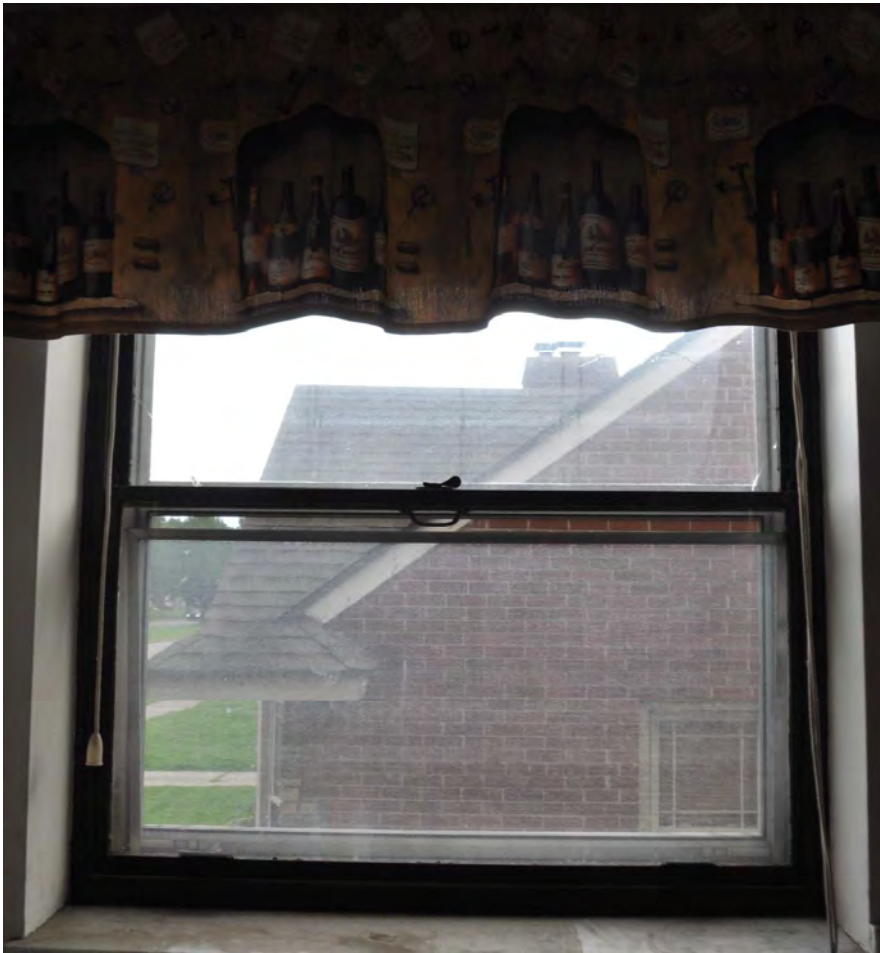
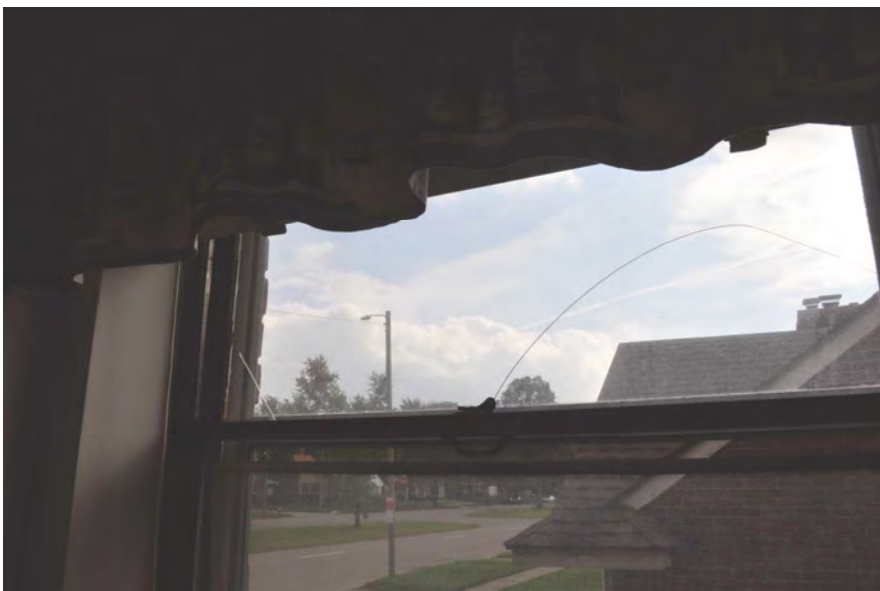
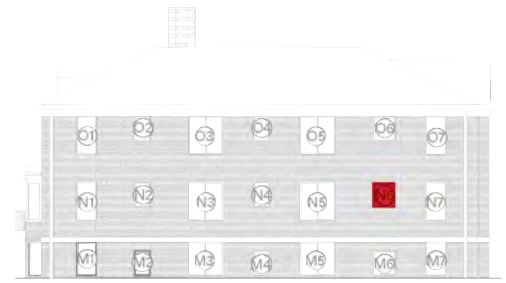
### Window N6, Type T2

- Broken Glass
- Note: Extent of exterior deterioration, corrosion, and loss of operability is not fully apparent in interior photos. Replacement parts for existing windows are unavailable, making restoration of thermal and operable functionality impossible, and long-term maintenance infeasible. Recommendation is for replacement, for quality of life of future tenants and for feasibility of long-term maintenance.
- See Window Assessment (Blackberry) in appendix for further detail and information, including further notes on deterioration beyond repair
- See Appendix for Window Schedule & Measurements

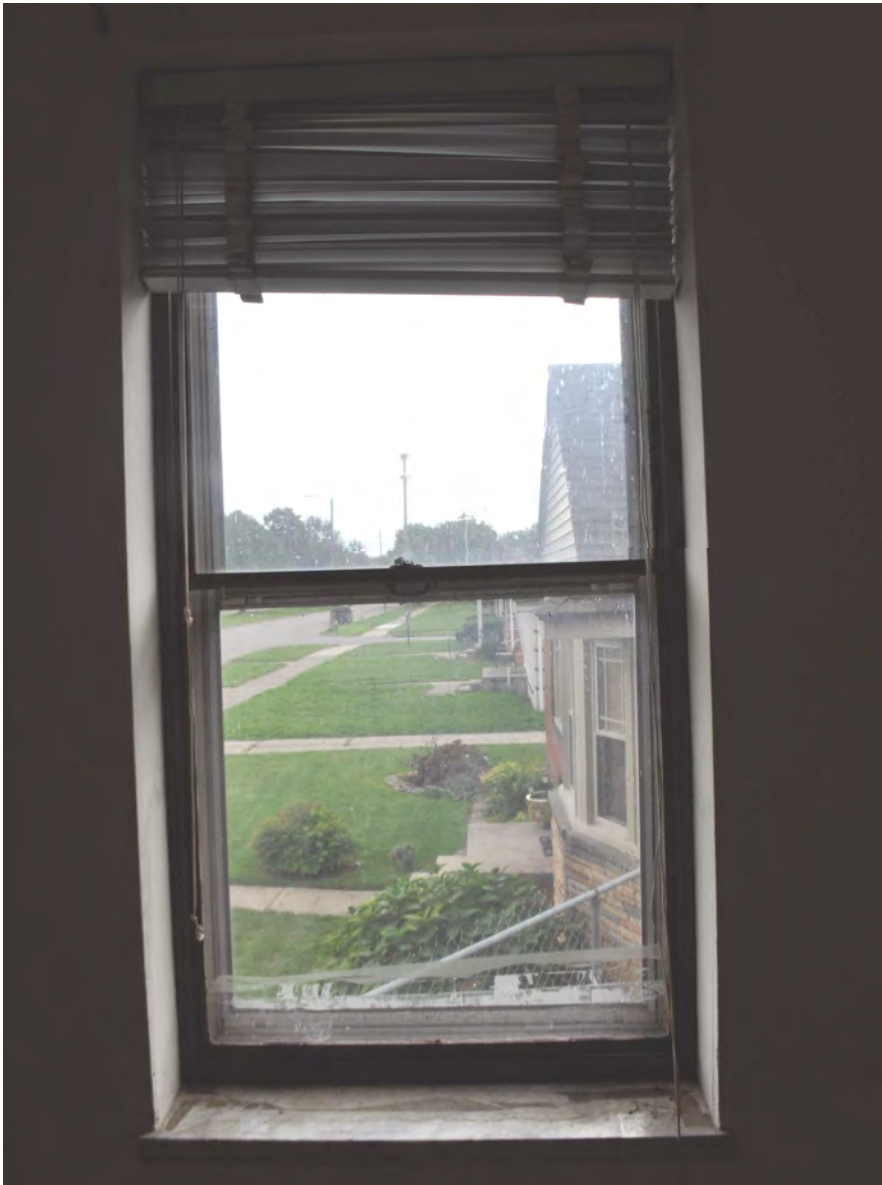
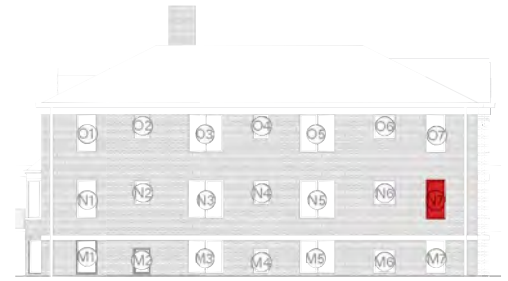
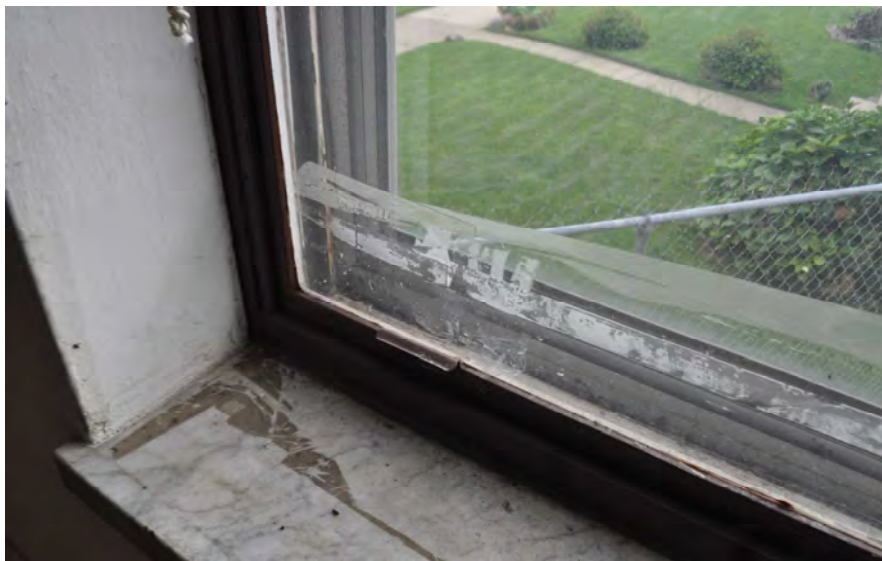
### Window N7, Type N2

- Note: Extent of exterior deterioration, corrosion, and loss of operability is not fully apparent in interior photos. Replacement parts for existing windows are unavailable, making restoration of thermal and operable functionality impossible, and long-term maintenance infeasible. Recommendation is for replacement, for quality of life of future tenants and for feasibility of long-term maintenance.
- See Window Assessment (Blackberry) in appendix for further detail and information, including further notes on deterioration beyond repair
- See Appendix for Window Schedule & Measurements
