# 9710 W Outer Dr

## Existing Condition Photos

# 9730 W Outer Dr

# Detailed Scope of Work

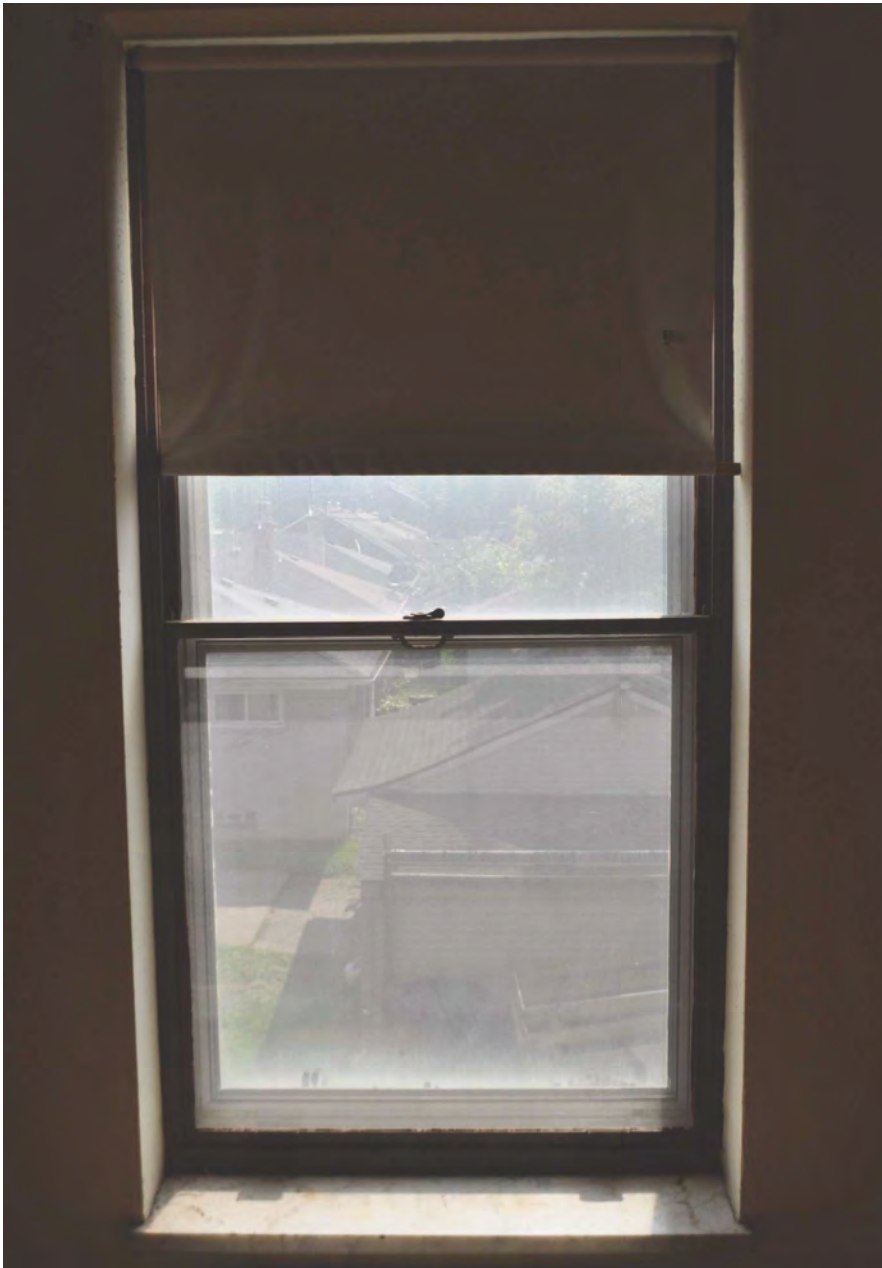
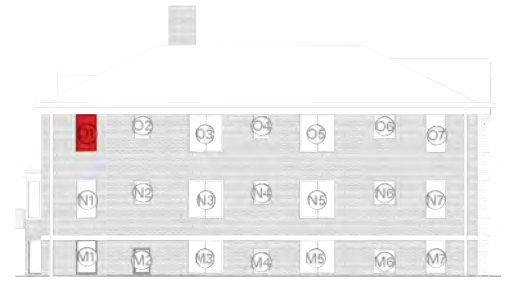
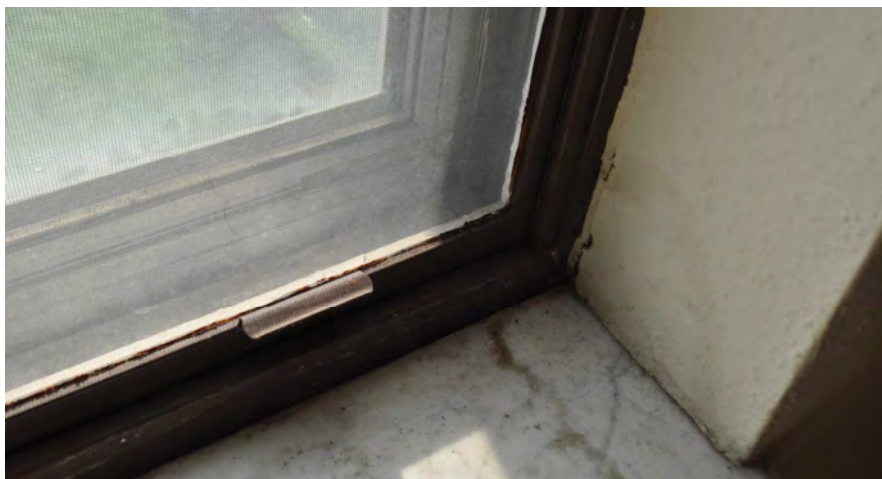
### Window O1, Type N2

- Note: Extent of exterior deterioration, corrosion, and loss of operability is not fully apparent in interior photos. Replacement parts for existing windows are unavailable, making restoration of thermal and operable functionality impossible, and long-term maintenance infeasible. Recommendation is for replacement, for quality of life of future tenants and for feasibility of long-term maintenance.
- See Window Assessment (Blackberry) in appendix for further detail and information, including further notes on deterioration beyond repair
- See Appendix for Window Schedule & Measurements

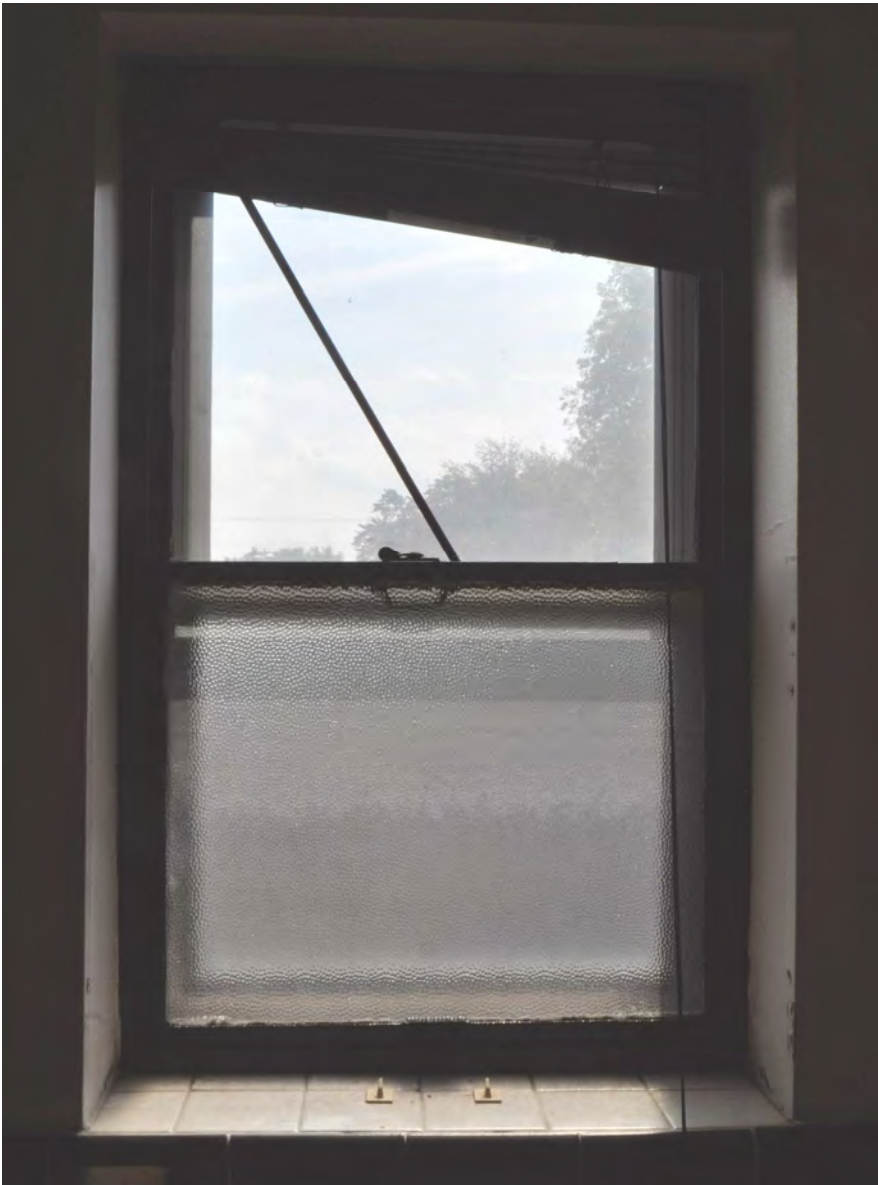
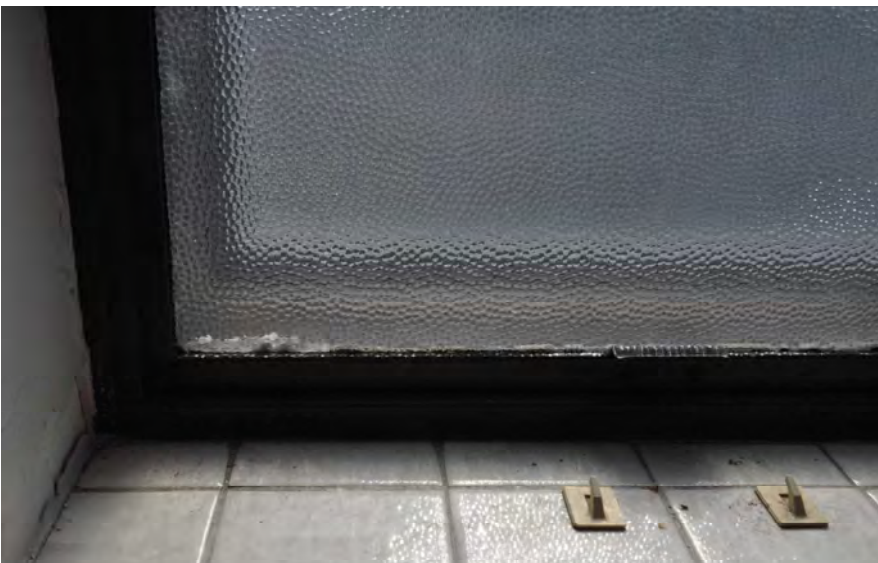
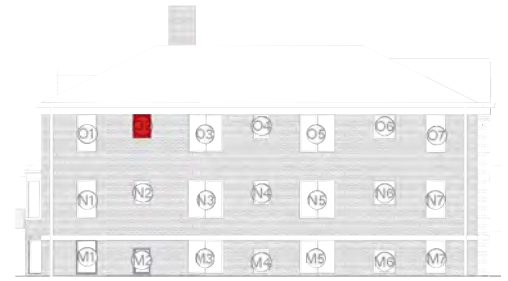
### Window O2, Type U2

- Note: Extent of exterior deterioration, corrosion, and loss of operability is not fully apparent in interior photos. Replacement parts for existing windows are unavailable, making restoration of thermal and operable functionality impossible, and long-term maintenance infeasible. Recommendation is for replacement, for quality of life of future tenants and for feasibility of long-term maintenance.
- See Window Assessment (Blackberry) in appendix for further detail and information, including further notes on deterioration beyond repair
- See Appendix for Window Schedule & Measurements

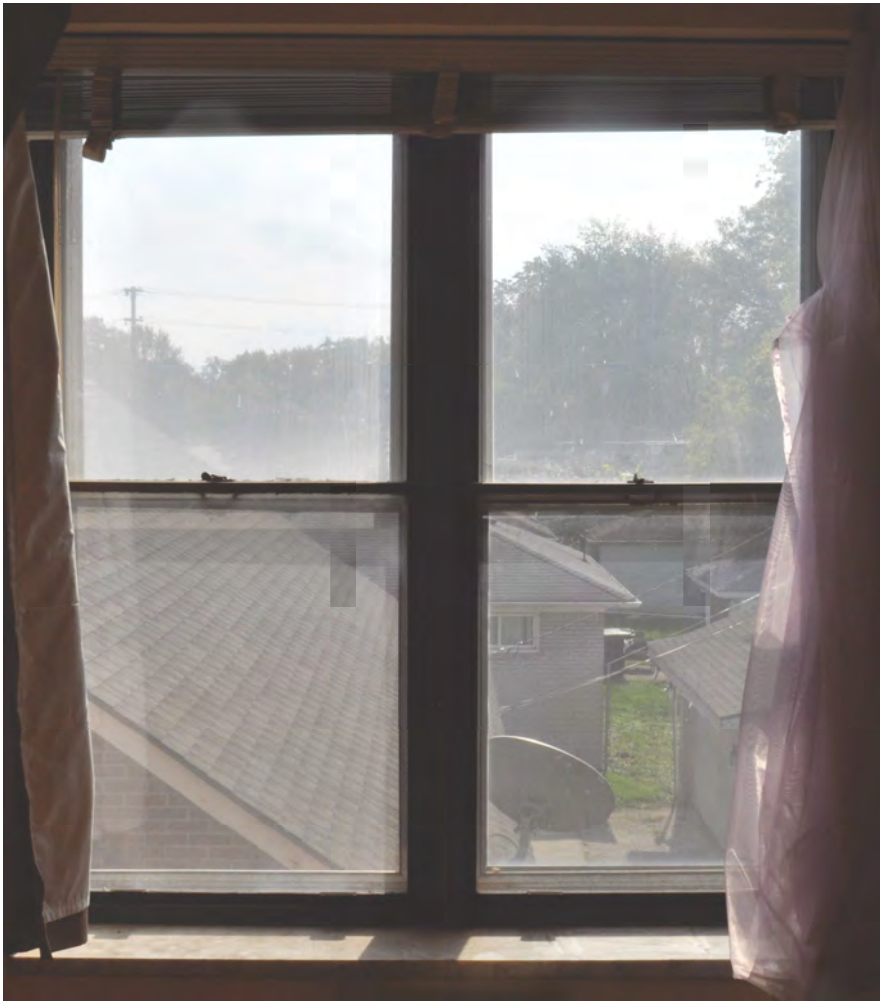
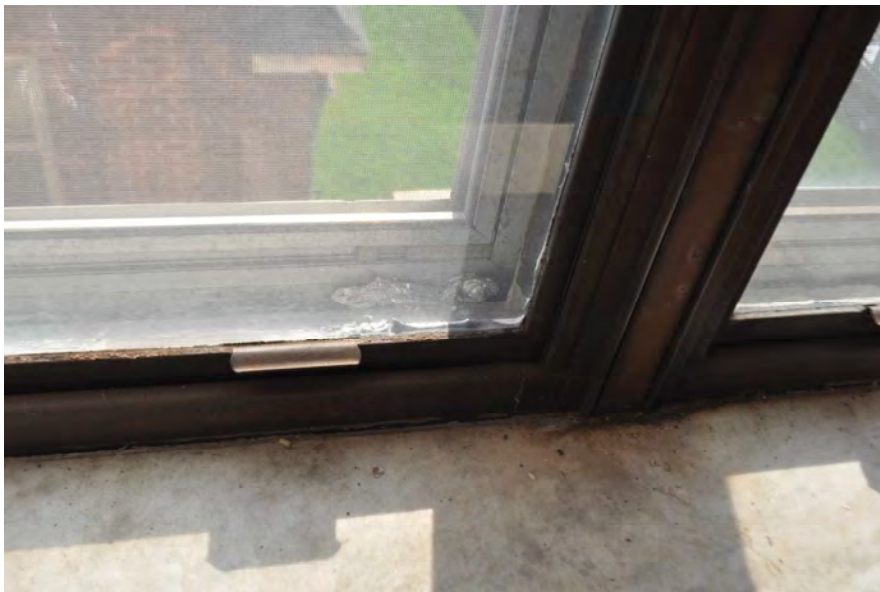
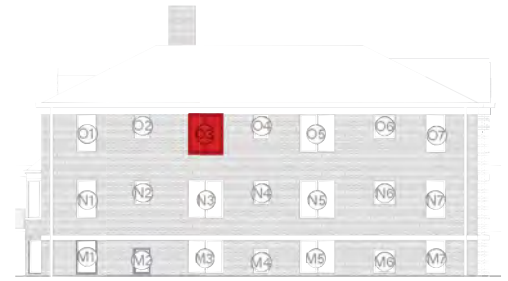
### Window O3, Type Z1

- Note: Extent of exterior deterioration, corrosion, and loss of operability is not fully apparent in interior photos. Replacement parts for existing windows are unavailable, making restoration of thermal and operable functionality impossible, and long-term maintenance infeasible. Recommendation is for replacement, for quality of life of future tenants and for feasibility of long-term maintenance.
- See Window Assessment (Blackberry) in appendix for further detail and information, including further notes on deterioration beyond repair
- See Appendix for Window Schedule & Measurements

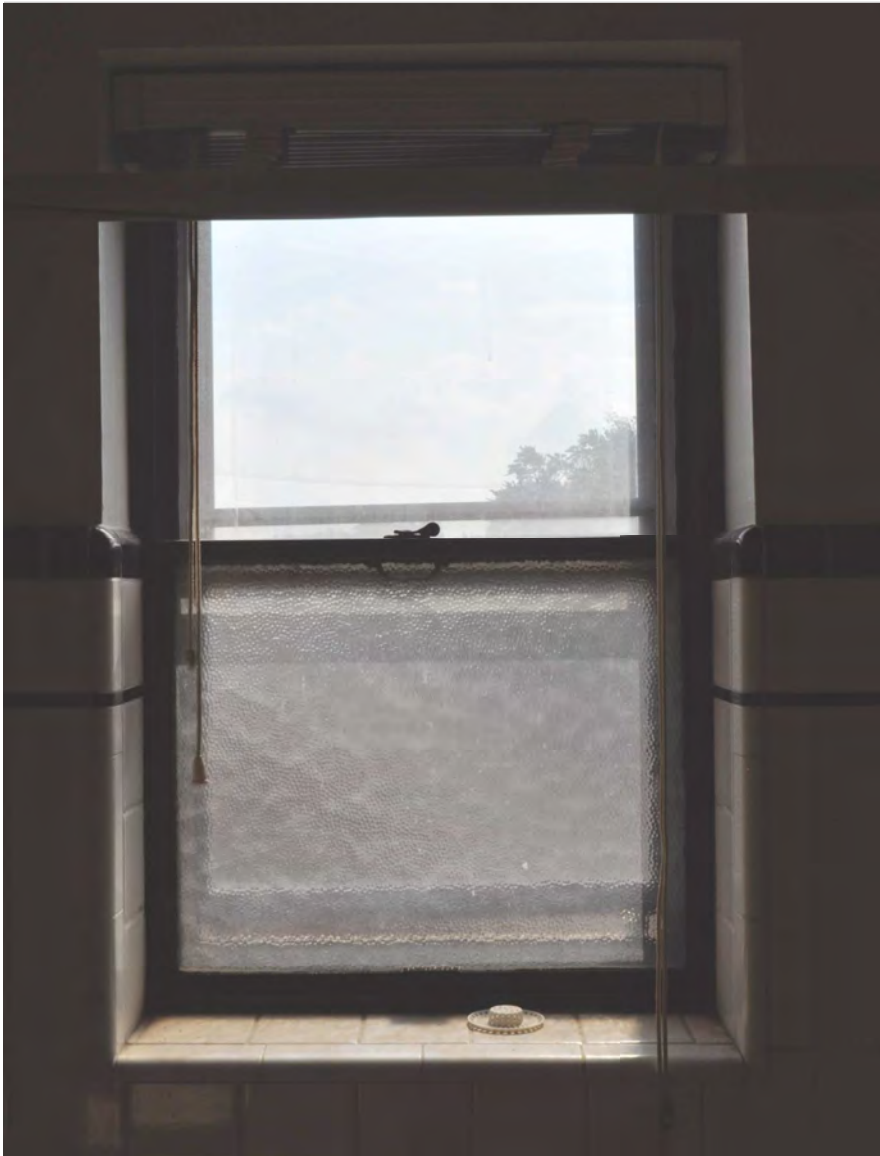
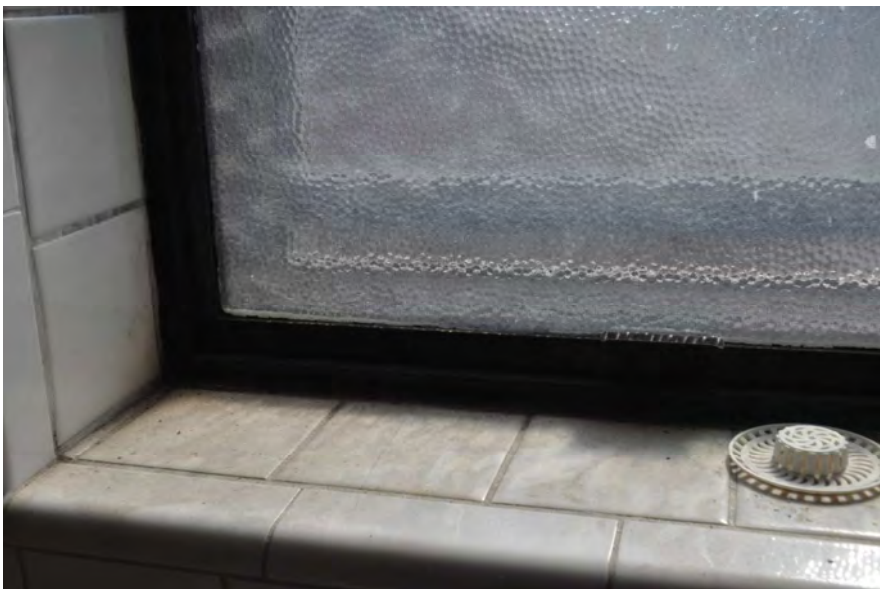
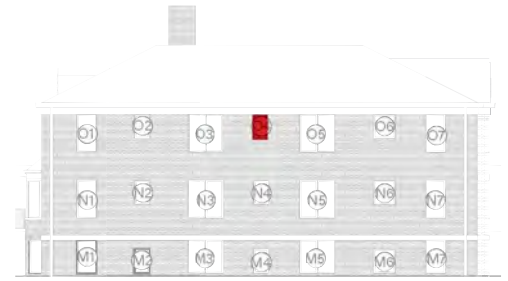
### Window O4, Type U2

- Note: Extent of exterior deterioration, corrosion, and loss of operability is not fully apparent in interior photos. Replacement parts for existing windows are unavailable, making restoration of thermal and operable functionality impossible, and long-term maintenance infeasible. Recommendation is for replacement, for quality of life of future tenants and for feasibility of long-term maintenance.
- See Window Assessment (Blackberry) in appendix for further detail and information, including further notes on deterioration beyond repair
- See Appendix for Window Schedule & Measurements

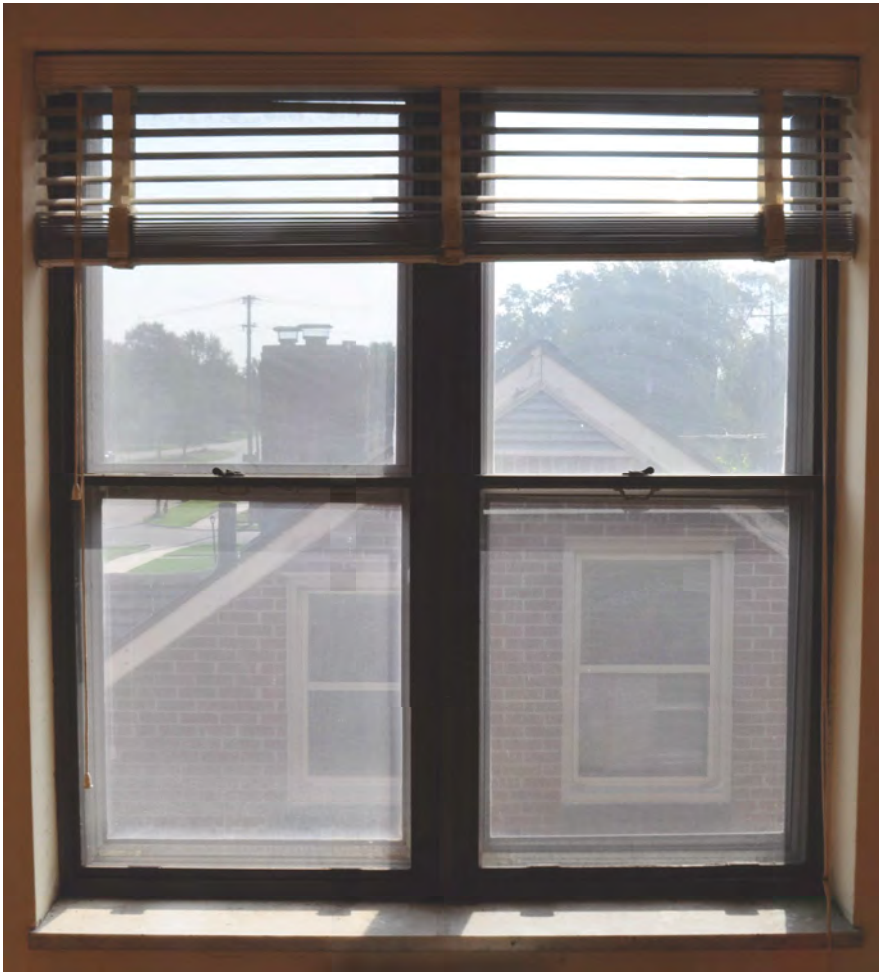
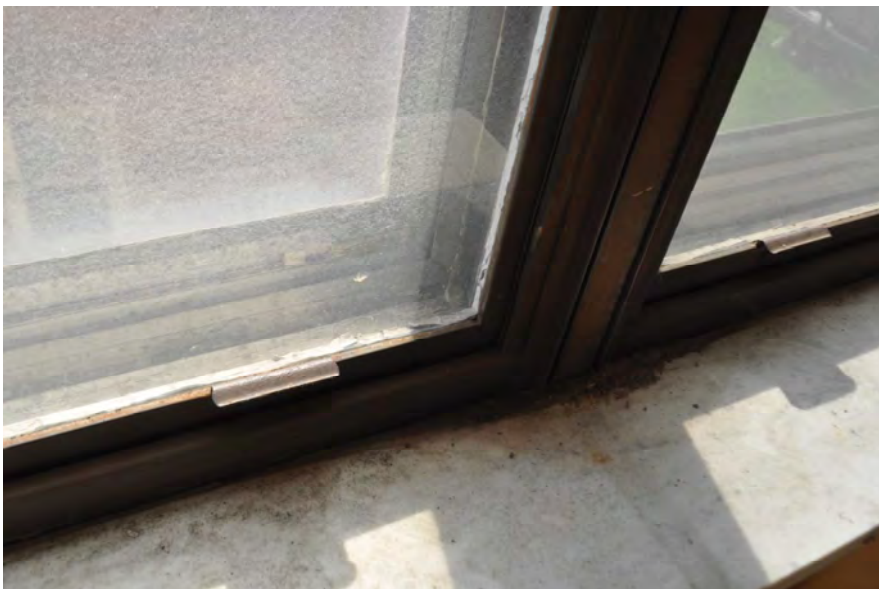
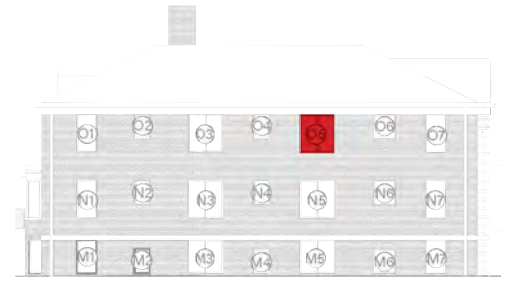
### Window O5, Type Z1

- Note: Extent of exterior deterioration, corrosion, and loss of operability is not fully apparent in interior photos. Replacement parts for existing windows are unavailable, making restoration of thermal and operable functionality impossible, and long-term maintenance infeasible. Recommendation is for replacement, for quality of life of future tenants and for feasibility of long-term maintenance.
- See Window Assessment (Blackberry) in appendix for further detail and information, including further notes on deterioration beyond repair
- See Appendix for Window Schedule & Measurements

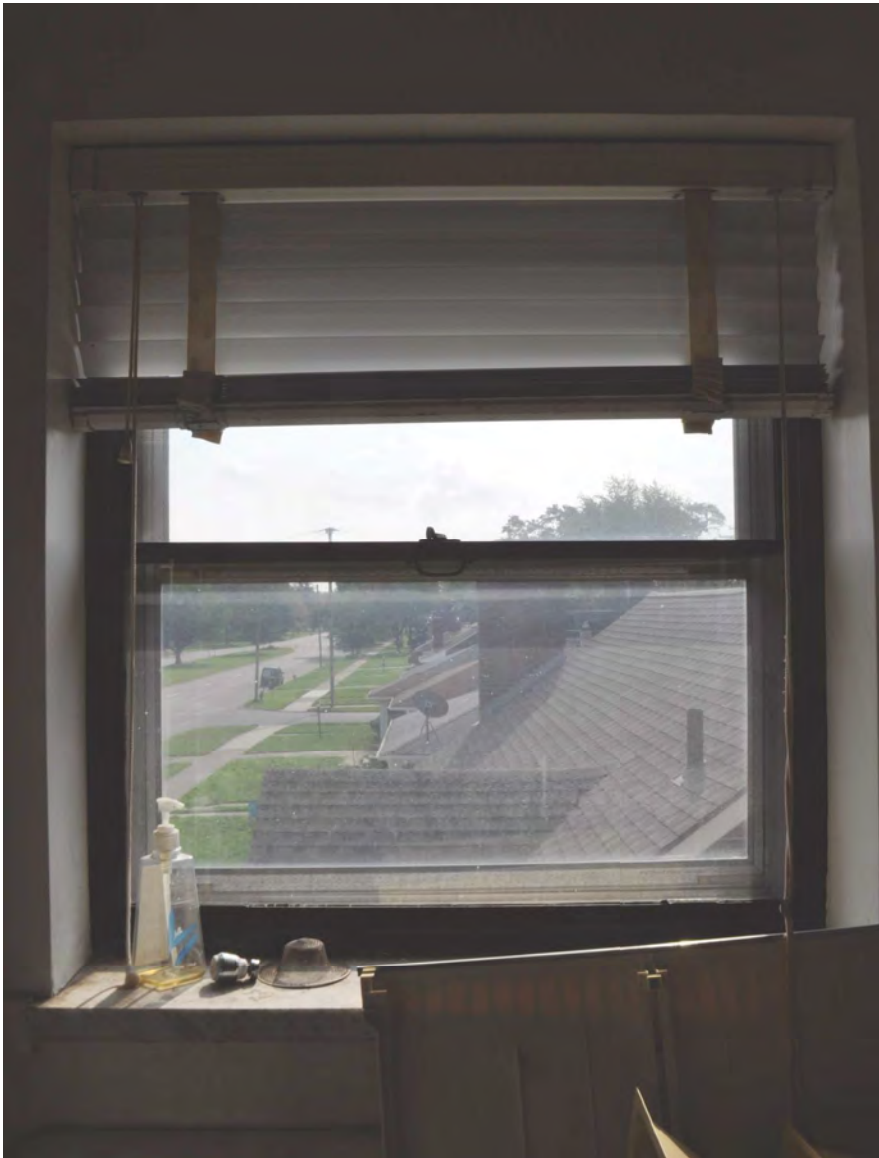
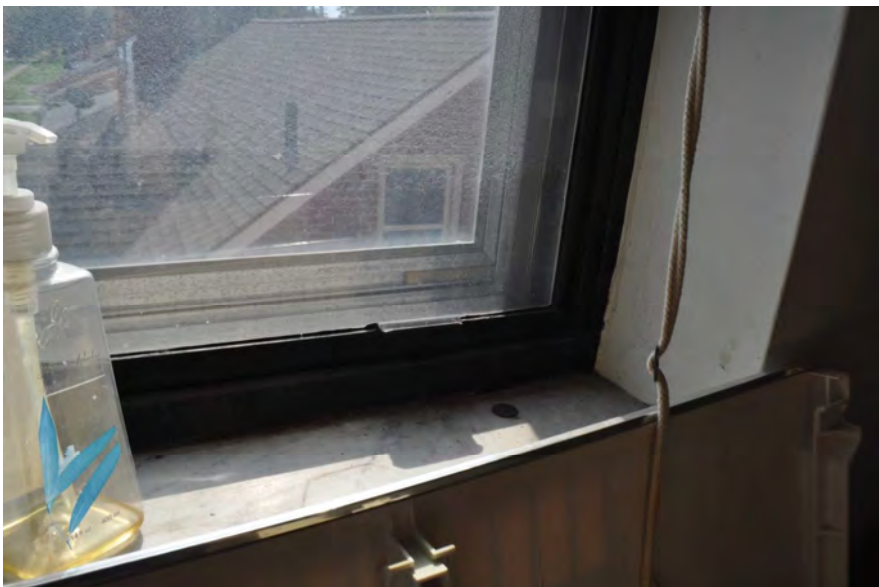
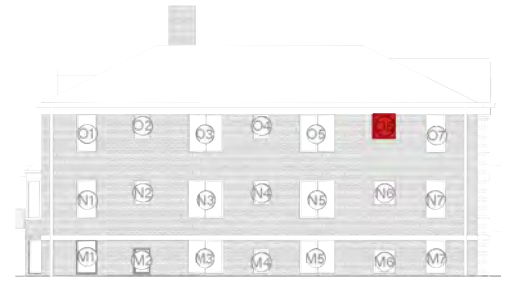
### Window O6, Type T2

- Note: Extent of exterior deterioration, corrosion, and loss of operability is not fully apparent in interior photos. Replacement parts for existing windows are unavailable, making restoration of thermal and operable functionality impossible, and long-term maintenance infeasible. Recommendation is for replacement, for quality of life of future tenants and for feasibility of long-term maintenance.
- See Window Assessment (Blackberry) in appendix for further detail and information, including further notes on deterioration beyond repair
- See Appendix for Window Schedule & Measurements

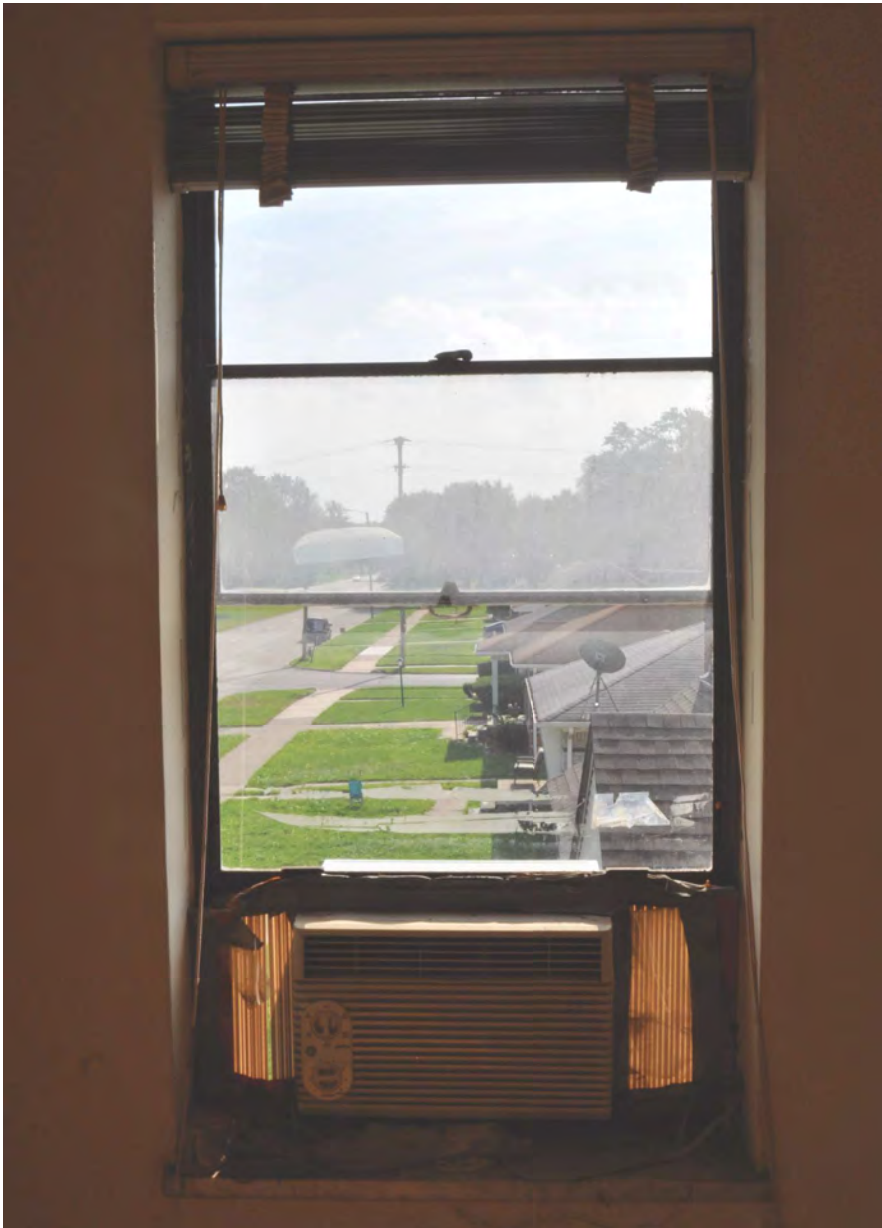
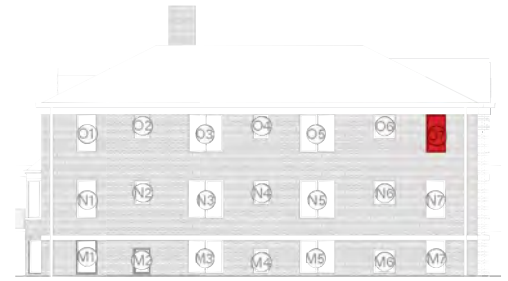
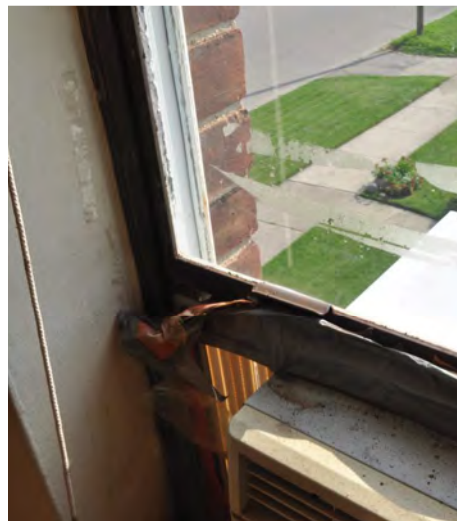
### Window O7, Type N2

- Badly Corroded
- Note: Extent of exterior deterioration, corrosion, and loss of operability is not fully apparent in interior photos. Replacement parts for existing windows are unavailable, making restoration of thermal and operable functionality impossible, and long-term maintenance infeasible. Recommendation is for replacement, for quality of life of future tenants and for feasibility of long-term maintenance.
- See Window Assessment (Blackberry) in appendix for further detail and information, including further notes on deterioration beyond repair
- See Appendix for Window Schedule & Measurements

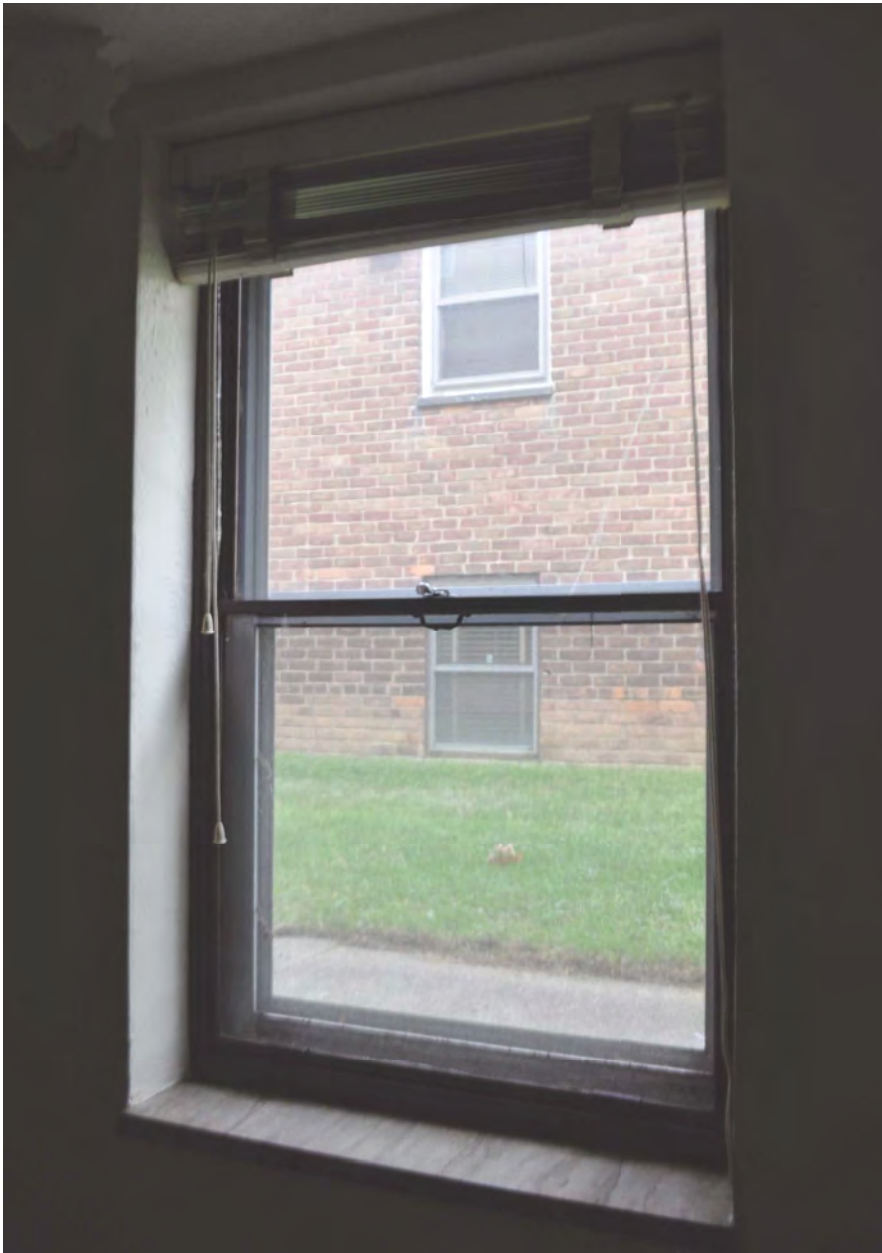
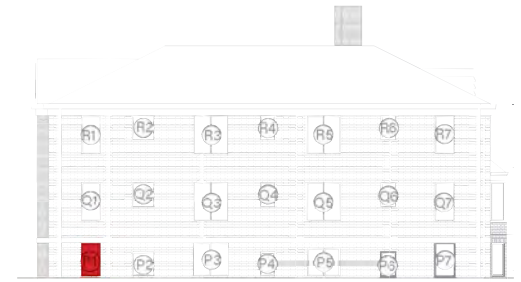
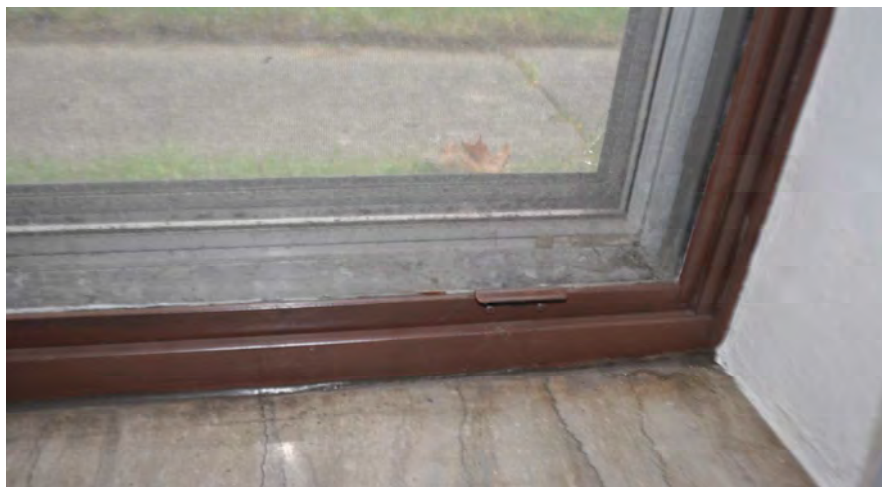
### Window P1, Type M2

- Badly Corroded
- Note: Extent of exterior deterioration, corrosion, and loss of operability is not fully apparent in interior photos. Replacement parts for existing windows are unavailable, making restoration of thermal and operable functionality impossible, and long-term maintenance infeasible. Recommendation is for replacement, for quality of life of future tenants and for feasibility of long-term maintenance.
- See Window Assessment (Blackberry) in appendix for further detail and information, including further notes on deterioration beyond repair
- See Appendix for Window Schedule & Measurements

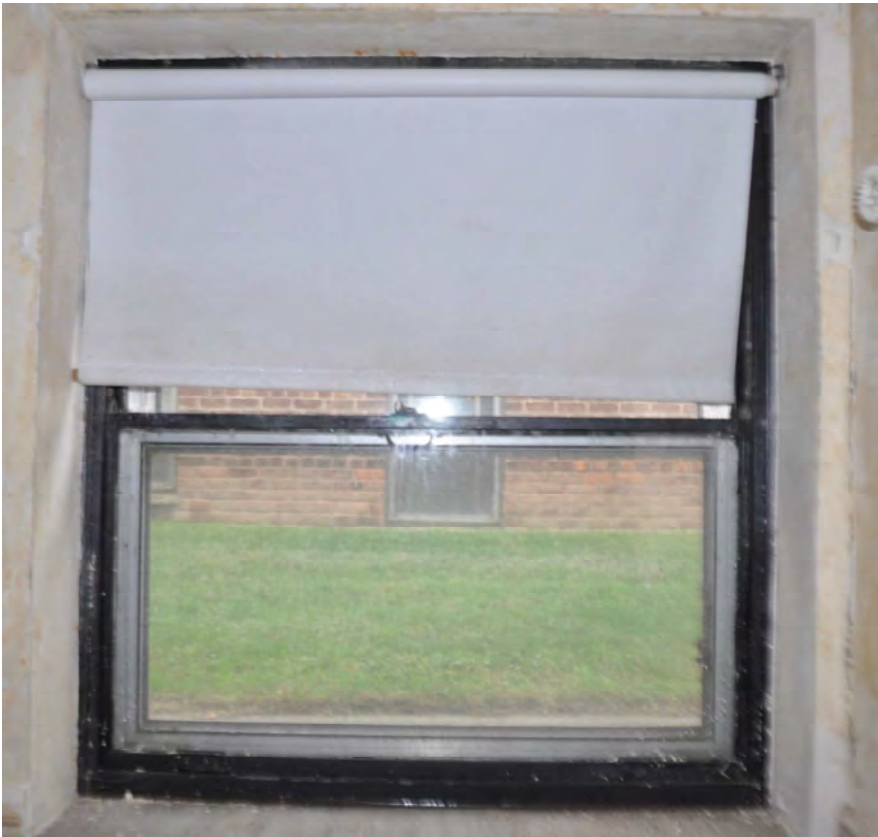
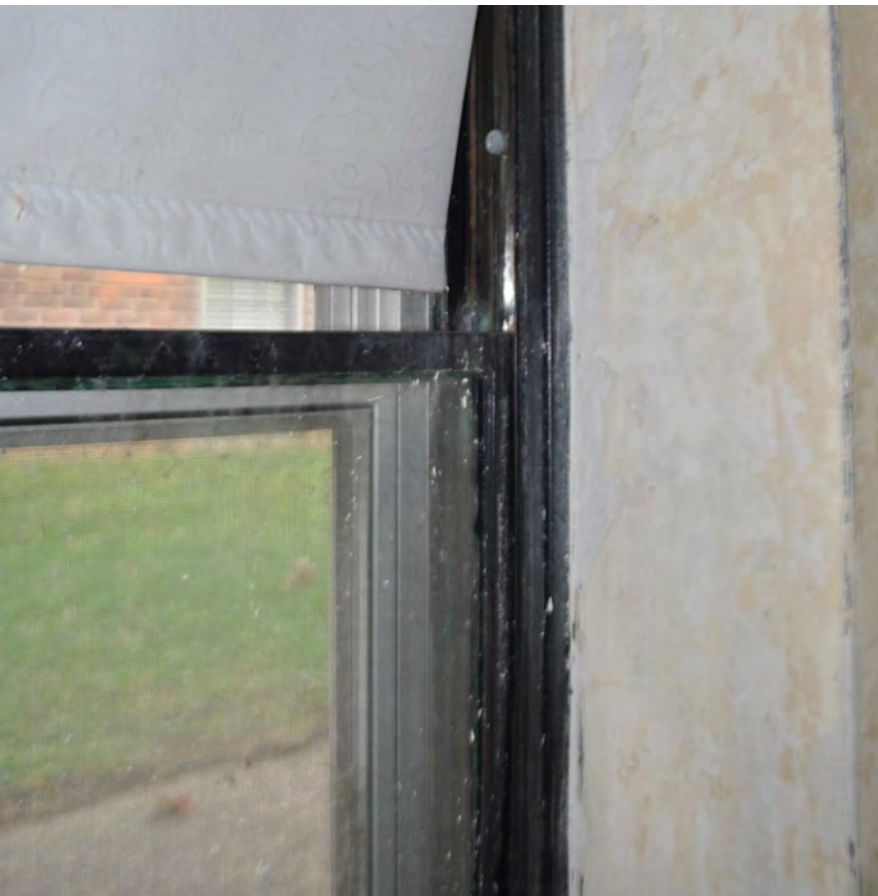
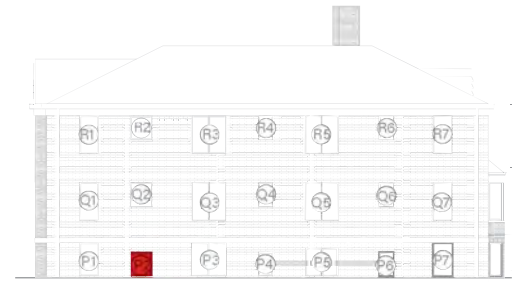
### Window P2, Type T2

- Badly Corroded
- Note: Extent of exterior deterioration, corrosion, and loss of operability is not fully apparent in interior photos. Replacement parts for existing windows are unavailable, making restoration of thermal and operable functionality impossible, and long-term maintenance infeasible. Recommendation is for replacement, for quality of life of future tenants and for feasibility of long-term maintenance.
- See Window Assessment (Blackberry) in appendix for further detail and information, including further notes on deterioration beyond repair
- See Appendix for Window Schedule & Measurements

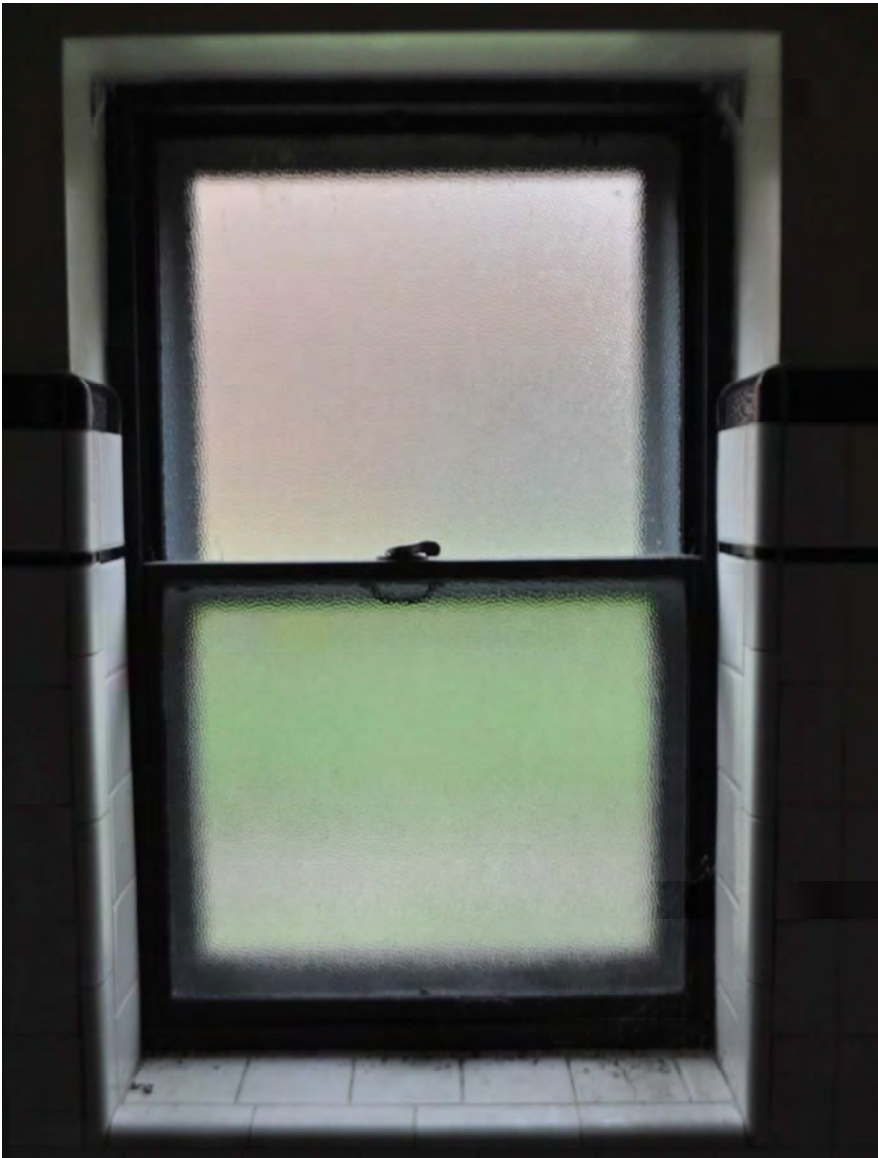
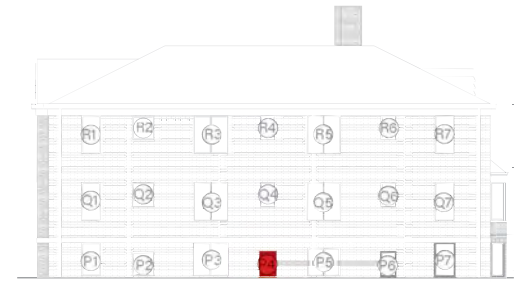
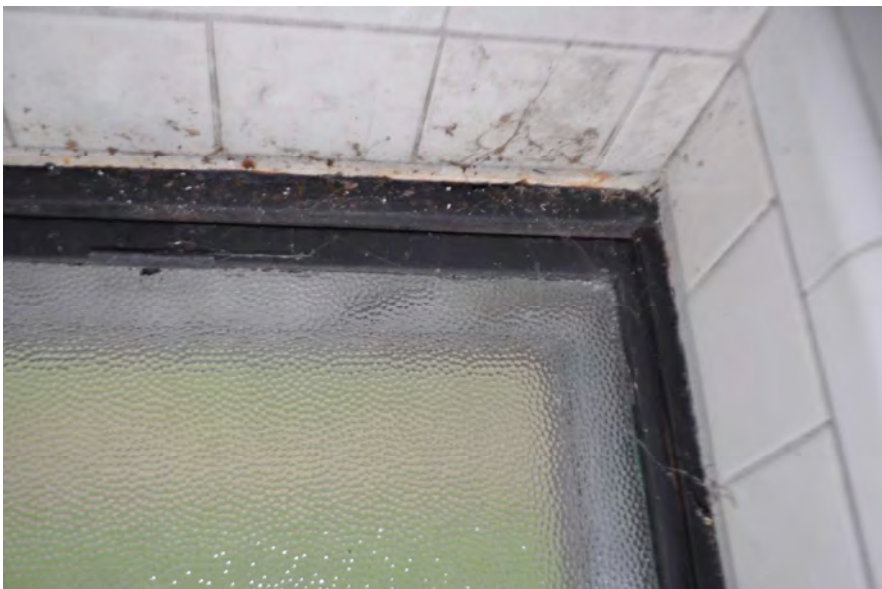
### Window P4, Type U2

- Badly Corroded
- Note: Extent of exterior deterioration, corrosion, and loss of operability is not fully apparent in interior photos. Replacement parts for existing windows are unavailable, making restoration of thermal and operable functionality impossible, and long-term maintenance infeasible. Recommendation is for replacement, for quality of life of future tenants and for feasibility of long-term maintenance.
- See Window Assessment (Blackberry) in appendix for further detail and information, including further notes on deterioration beyond repair
- See Appendix for Window Schedule & Measurements

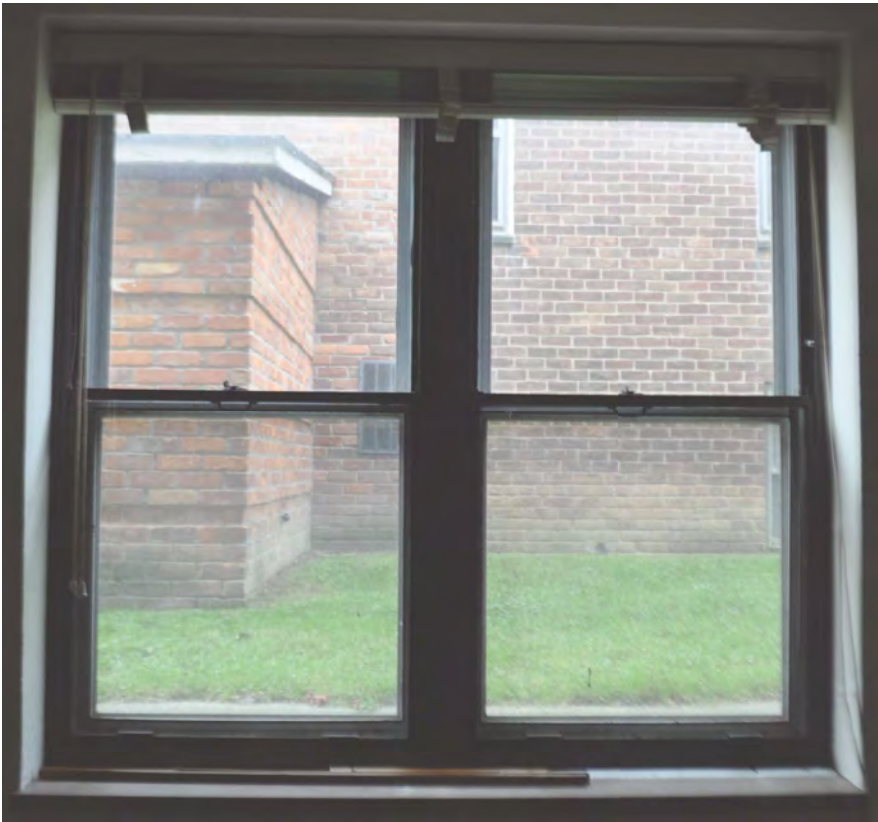
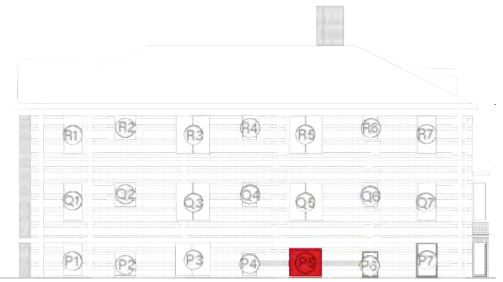
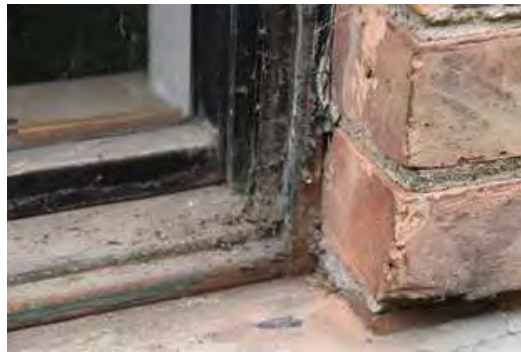
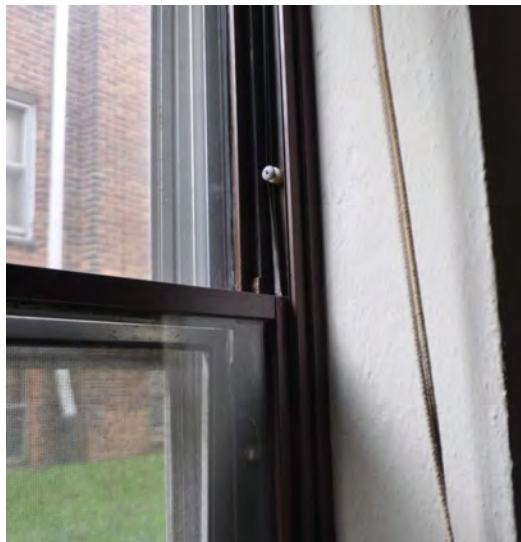
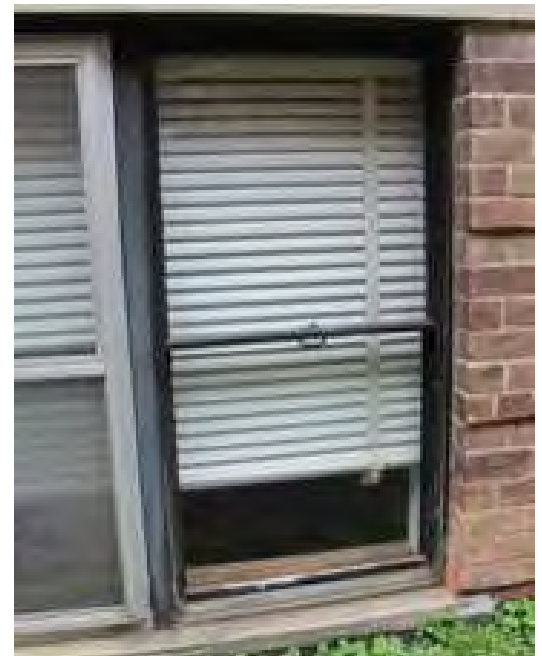
### Window P5, Type Y1

- Badly Corroded
- Note: Extent of exterior deterioration, corrosion, and loss of operability is not fully apparent in interior photos. Replacement parts for existing windows are unavailable, making restoration of thermal and operable functionality impossible, and long-term maintenance infeasible. Recommendation is for replacement, for quality of life of future tenants and for feasibility of long-term maintenance.
- See Window Assessment (Blackberry) in appendix for further detail and information, including further notes on deterioration beyond repair
- See Appendix for Window Schedule & Measurements

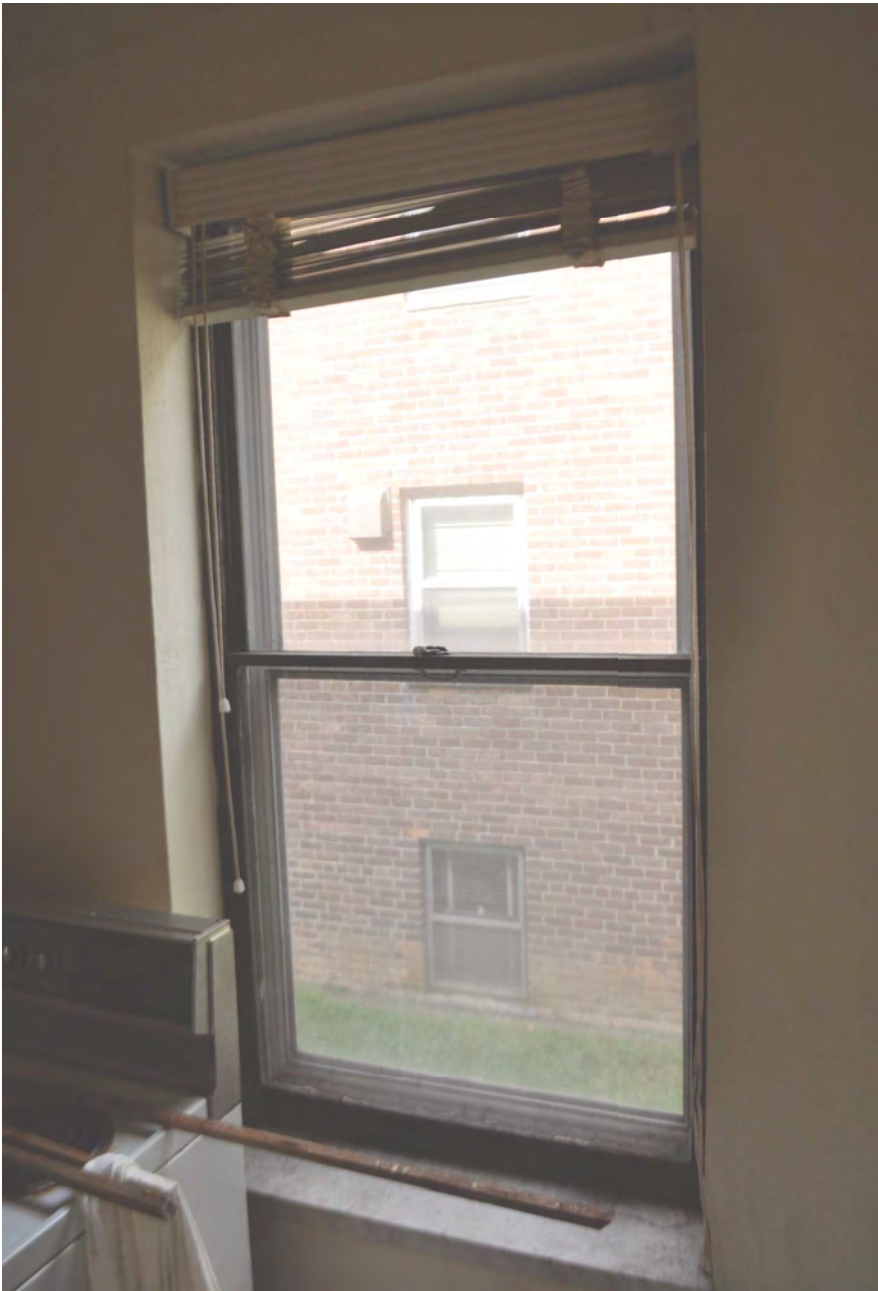
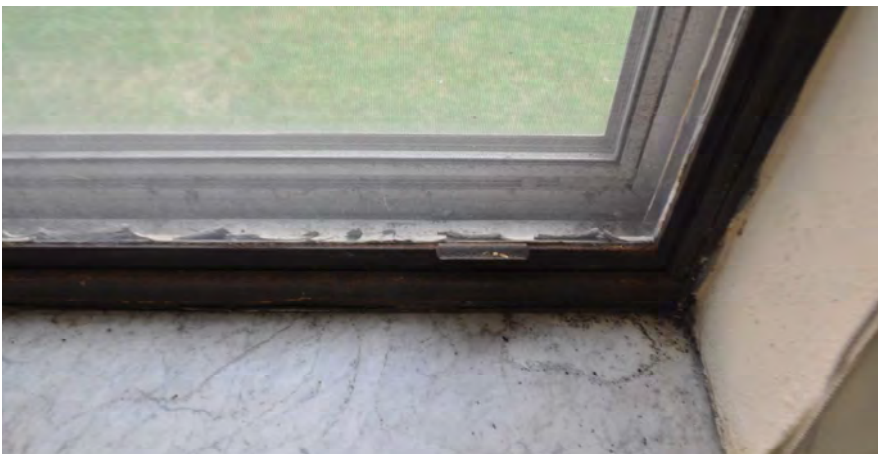
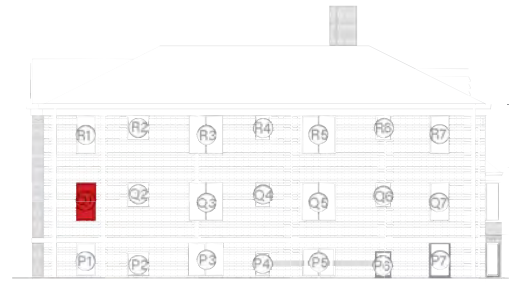
### Window Q1, Type N2

- Badly Corroded
- Note: Extent of exterior deterioration, corrosion, and loss of operability is not fully apparent in interior photos. Replacement parts for existing windows are unavailable, making restoration of thermal and operable functionality impossible, and long-term maintenance infeasible. Recommendation is for replacement, for quality of life of future tenants and for feasibility of long-term maintenance.
- See Window Assessment (Blackberry) in appendix for further detail and information, including further notes on deterioration beyond repair
- See Appendix for Window Schedule & Measurements
