# 9710 W Outer Dr

## Existing Condition Photos

# 9730 W Outer Dr

# Detailed Scope of Work

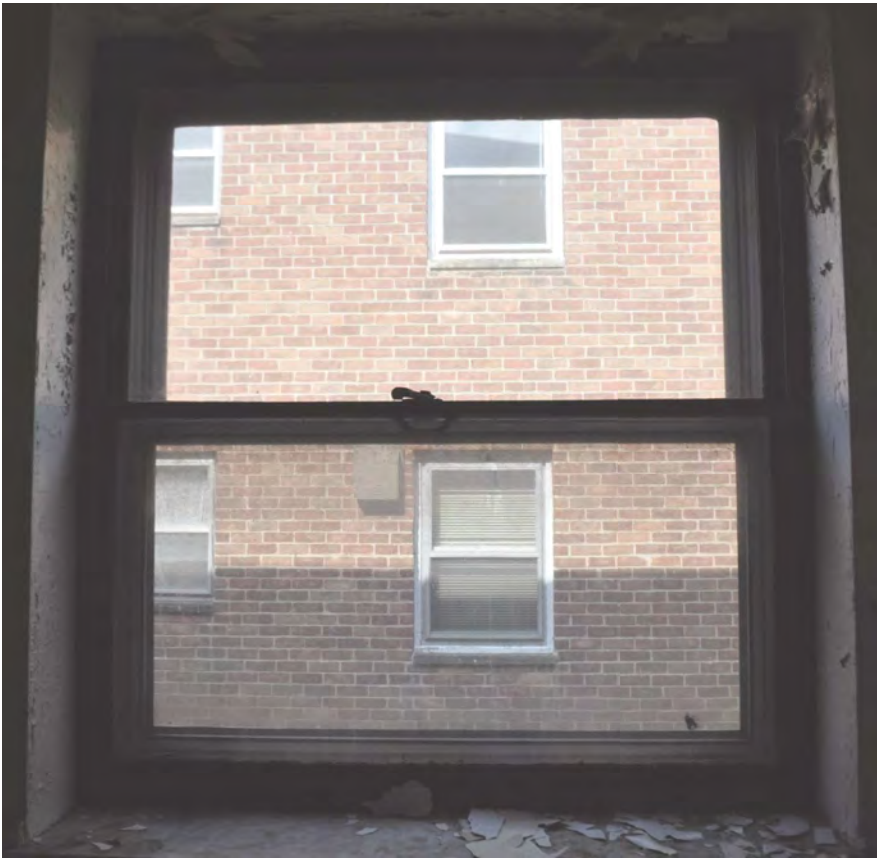
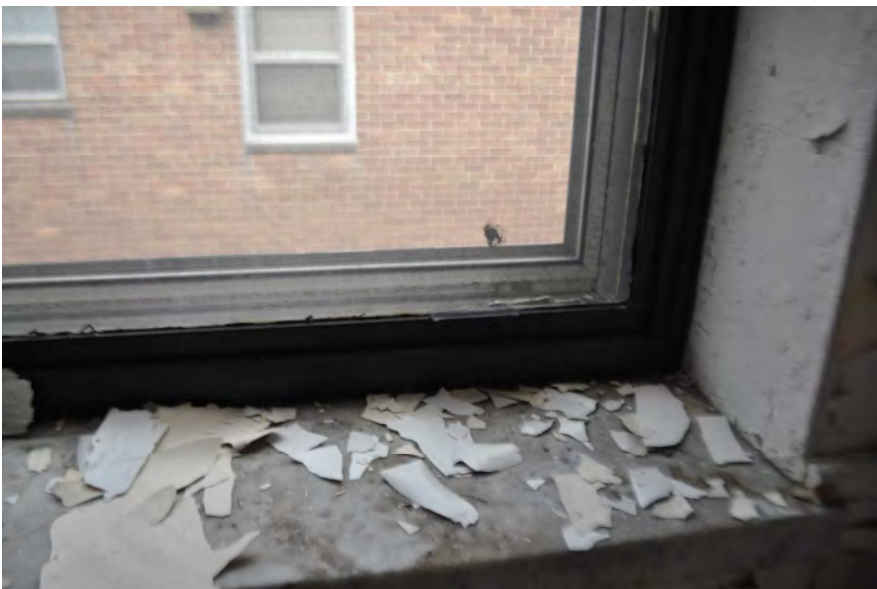
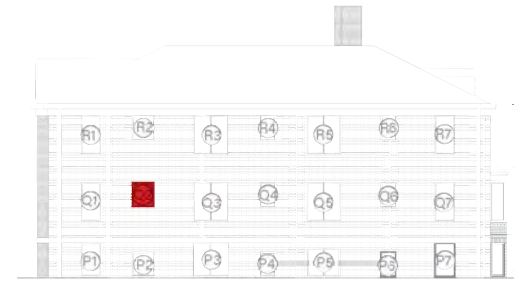
### Window Q2, Type T2

- Note: Extent of exterior deterioration, corrosion, and loss of operability is not fully apparent in interior photos. Replacement parts for existing windows are unavailable, making restoration of thermal and operable functionality impossible, and long-term maintenance infeasible. Recommendation is for replacement, for quality of life of future tenants and for feasibility of long-term maintenance.
- See Window Assessment (Blackberry) in appendix for further detail and information, including further notes on deterioration beyond repair
- See Appendix for Window Schedule & Measurements

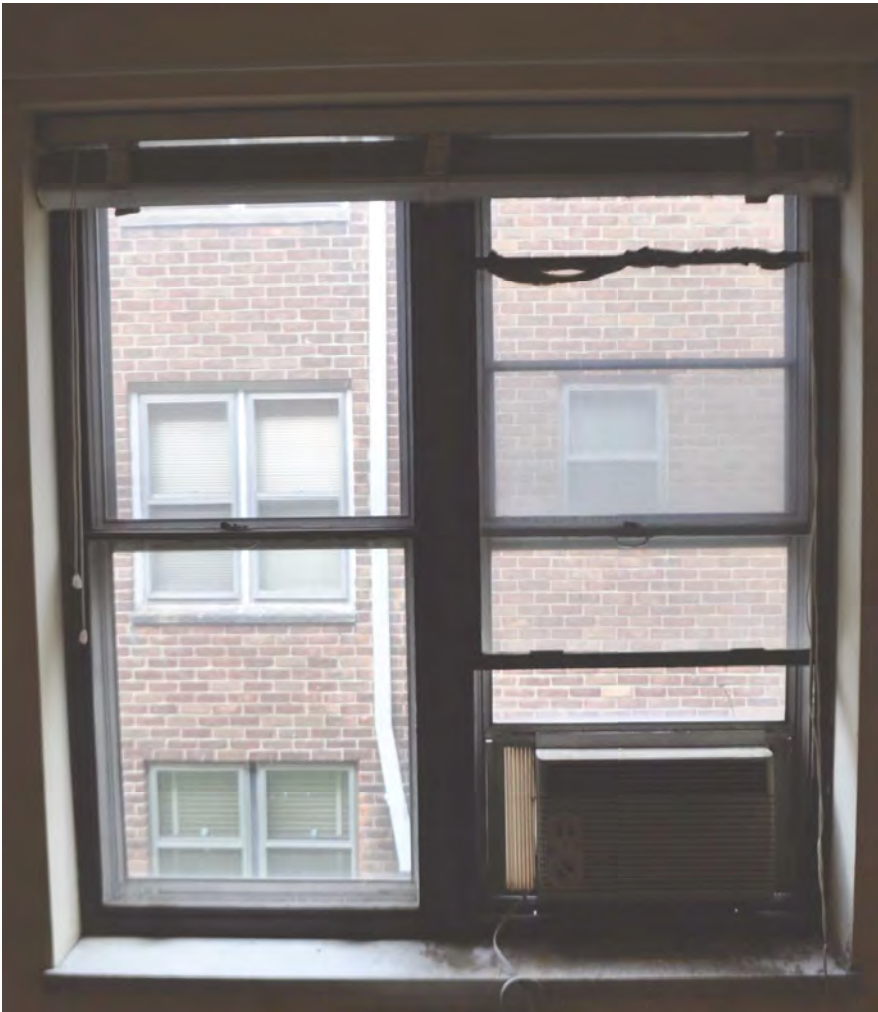
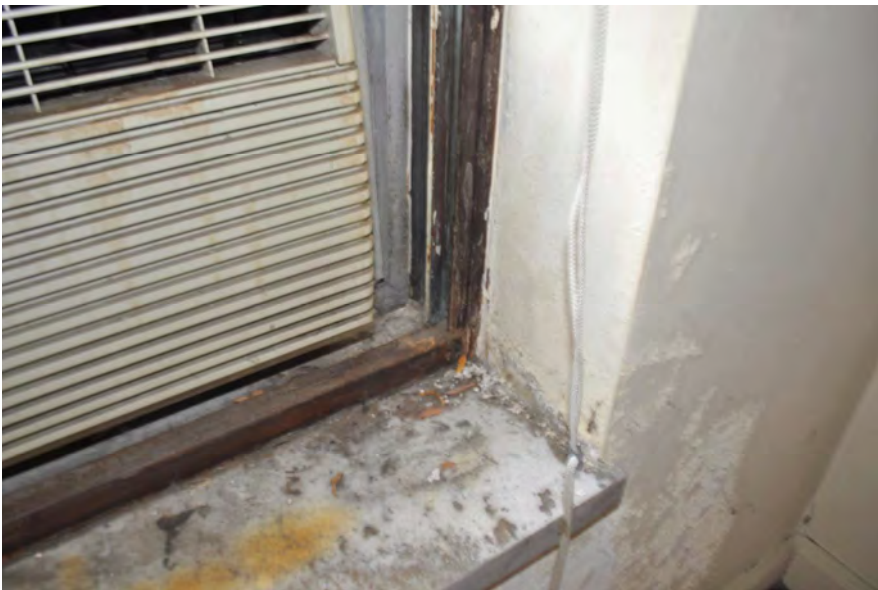
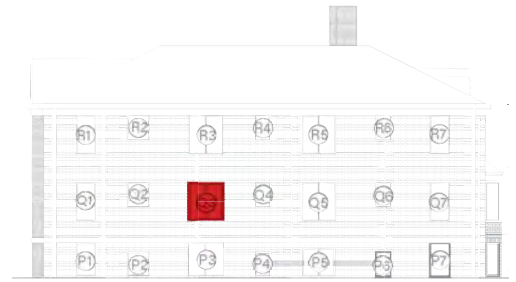
### Window Q3, Type Z1

- Badly Corroded
- Note: Extent of exterior deterioration, corrosion, and loss of operability is not fully apparent in interior photos. Replacement parts for existing windows are unavailable, making restoration of thermal and operable functionality impossible, and long-term maintenance infeasible. Recommendation is for replacement, for quality of life of future tenants and for feasibility of long-term maintenance.
- See Window Assessment (Blackberry) in appendix for further detail and information, including further notes on deterioration beyond repair
- See Appendix for Window Schedule & Measurements

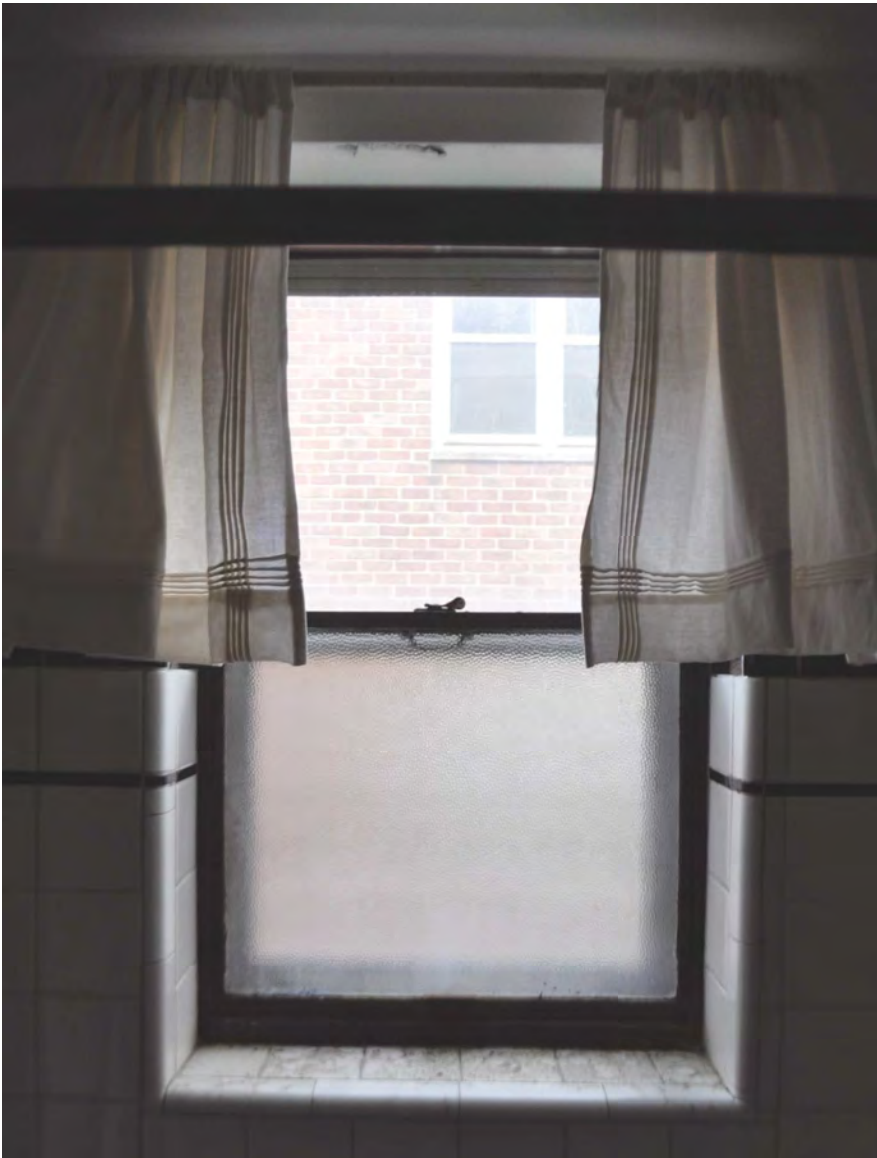
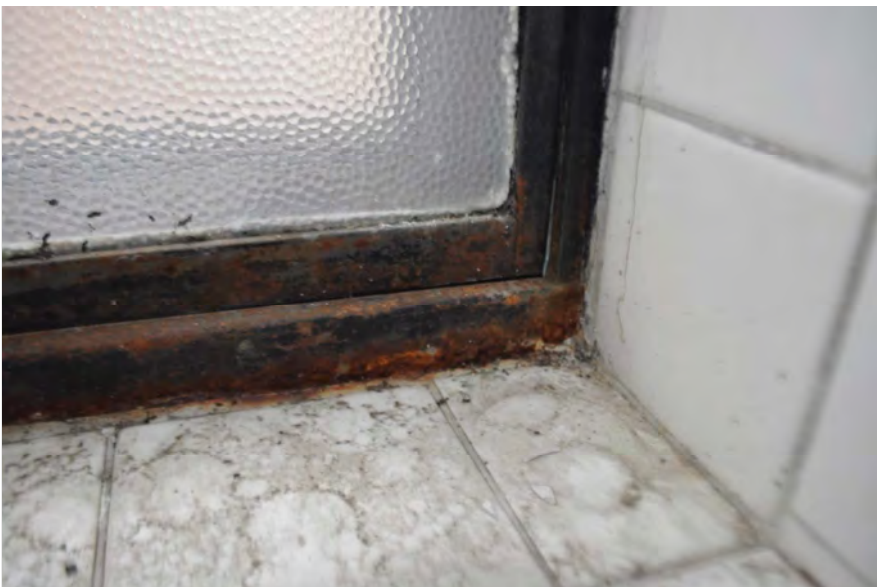
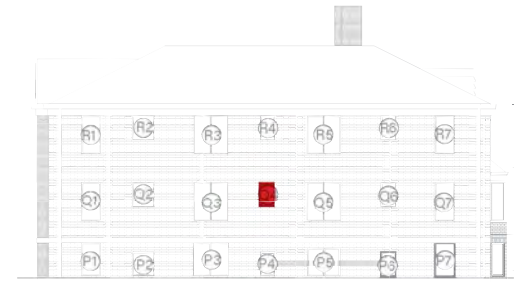
### Window Q4, Type U2

- Badly Corroded
- Note: Extent of exterior deterioration, corrosion, and loss of operability is not fully apparent in interior photos. Replacement parts for existing windows are unavailable, making restoration of thermal and operable functionality impossible, and long-term maintenance infeasible. Recommendation is for replacement, for quality of life of future tenants and for feasibility of long-term maintenance.
- See Window Assessment (Blackberry) in appendix for further detail and information, including further notes on deterioration beyond repair
- See Appendix for Window Schedule & Measurements

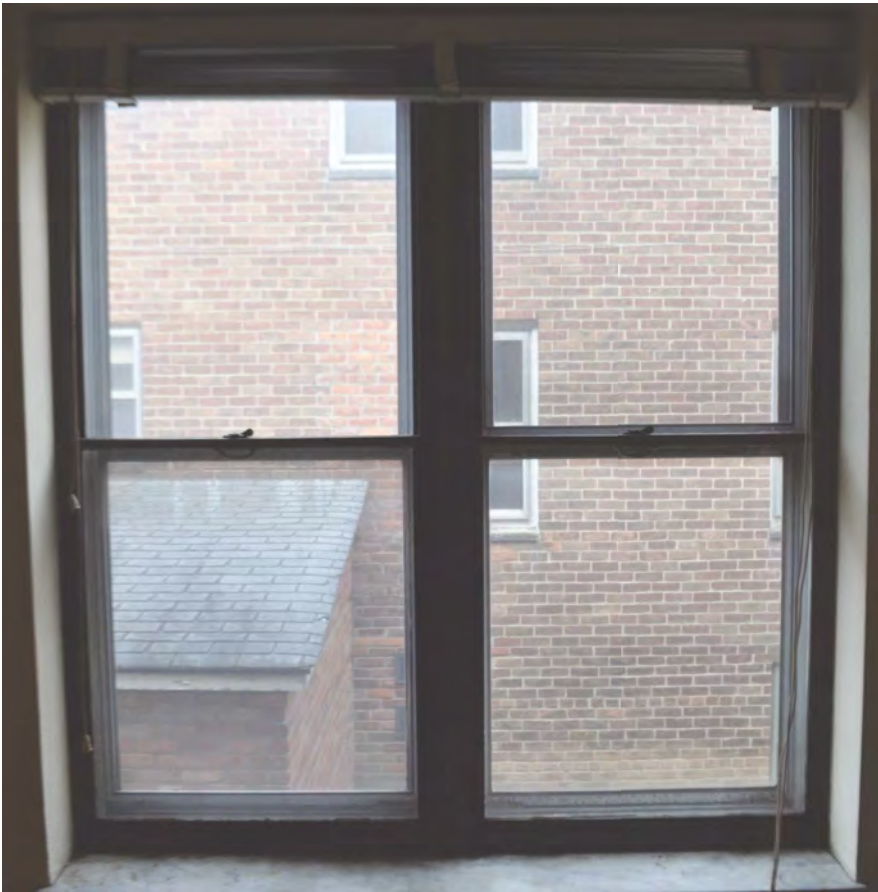
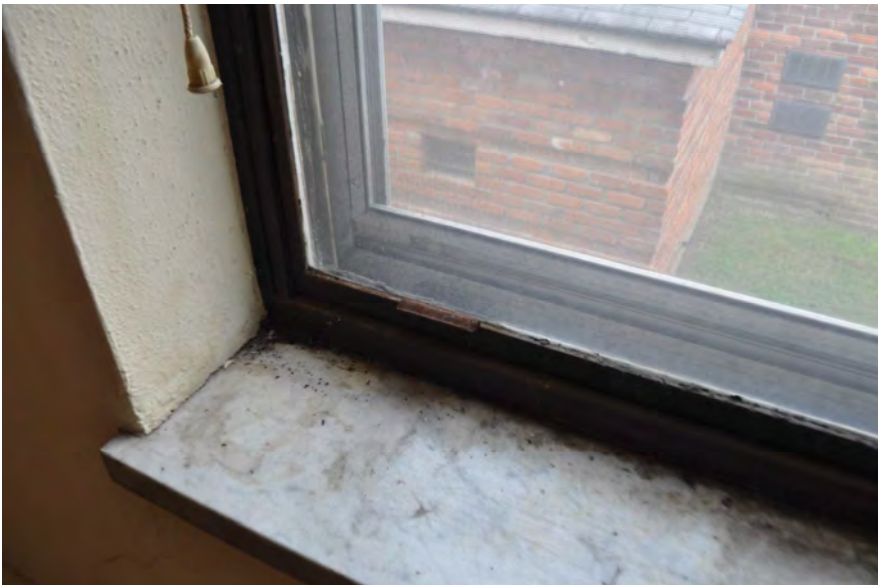
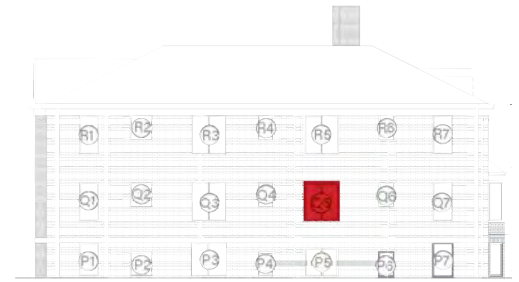
### Window Q5, Type Z1

- Note: Extent of exterior deterioration, corrosion, and loss of operability is not fully apparent in interior photos. Replacement parts for existing windows are unavailable, making restoration of thermal and operable functionality impossible, and long-term maintenance infeasible. Recommendation is for replacement, for quality of life of future tenants and for feasibility of long-term maintenance.
- See Window Assessment (Blackberry) in appendix for further detail and information, including further notes on deterioration beyond repair
- See Appendix for Window Schedule & Measurements

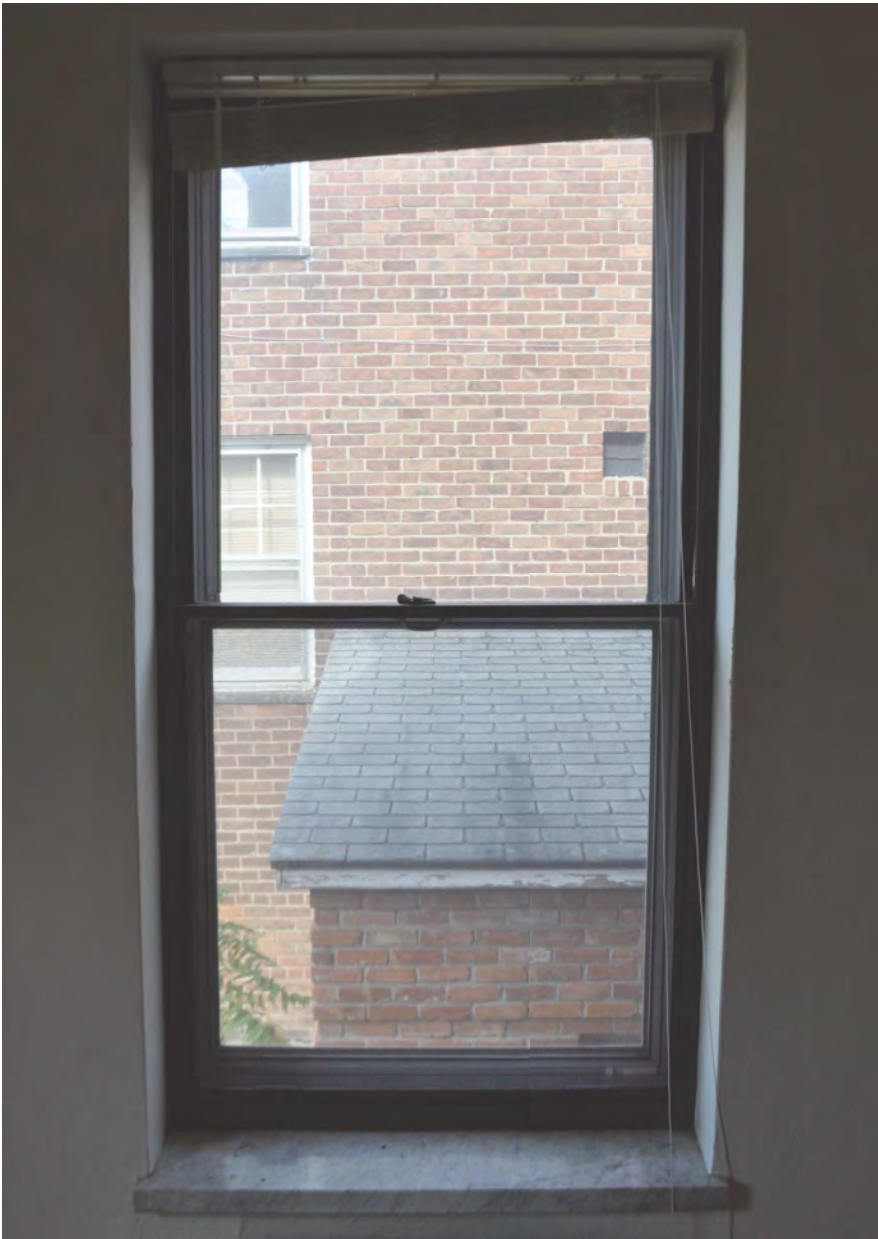
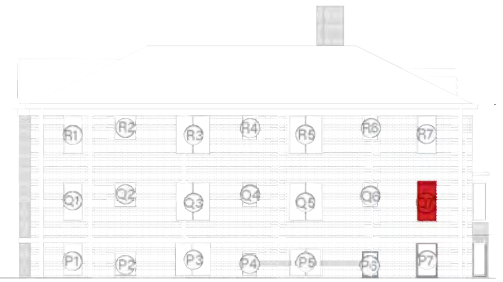
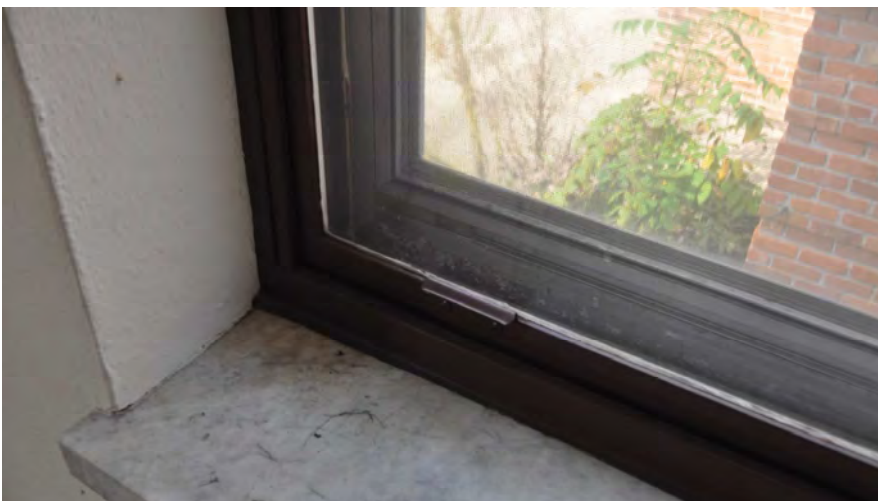
### Window Q7, Type N2

- Note: Extent of exterior deterioration, corrosion, and loss of operability is not fully apparent in interior photos. Replacement parts for existing windows are unavailable, making restoration of thermal and operable functionality impossible, and long-term maintenance infeasible. Recommendation is for replacement, for quality of life of future tenants and for feasibility of long-term maintenance.
- See Window Assessment (Blackberry) in appendix for further detail and information, including further notes on deterioration beyond repair
- See Appendix for Window Schedule & Measurements

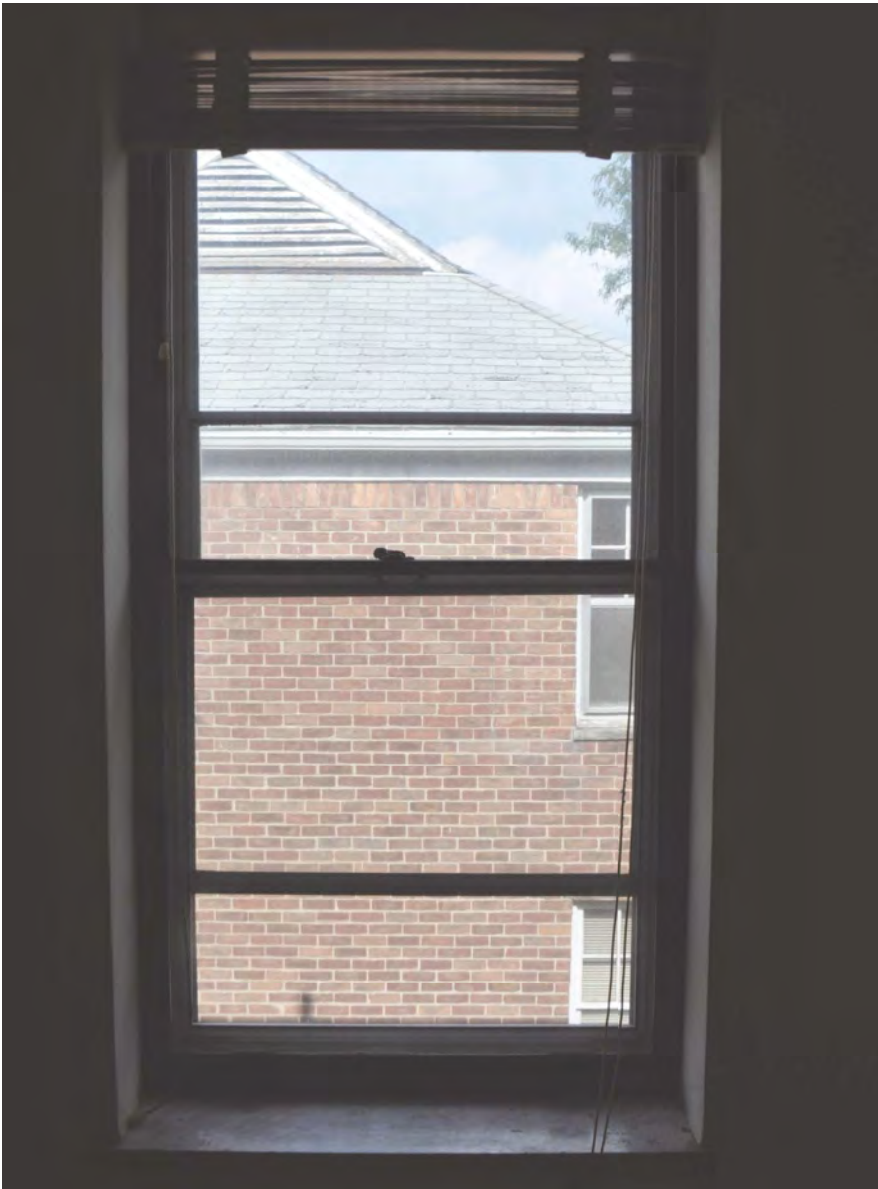
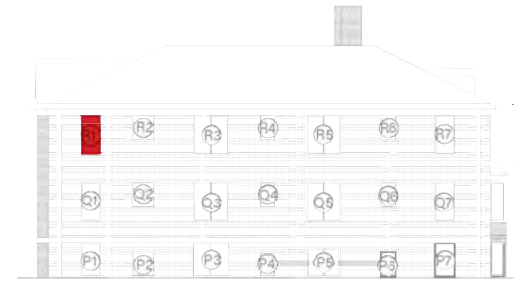
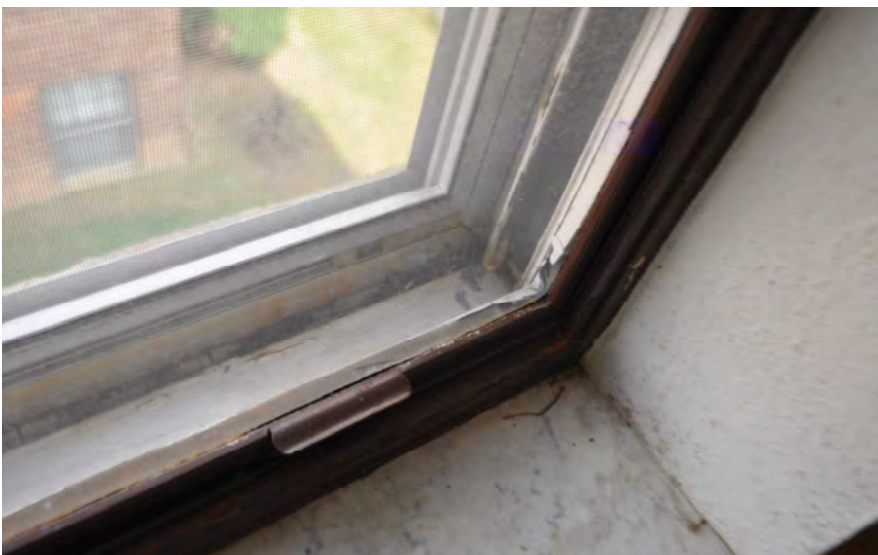
### Window R1, Type N2

- Note: Extent of exterior deterioration, corrosion, and loss of operability is not fully apparent in interior photos. Replacement parts for existing windows are unavailable, making restoration of thermal and operable functionality impossible, and long-term maintenance infeasible. Recommendation is for replacement, for quality of life of future tenants and for feasibility of long-term maintenance.
- See Window Assessment (Blackberry) in appendix for further detail and information, including further notes on deterioration beyond repair
- See Appendix for Window Schedule & Measurements

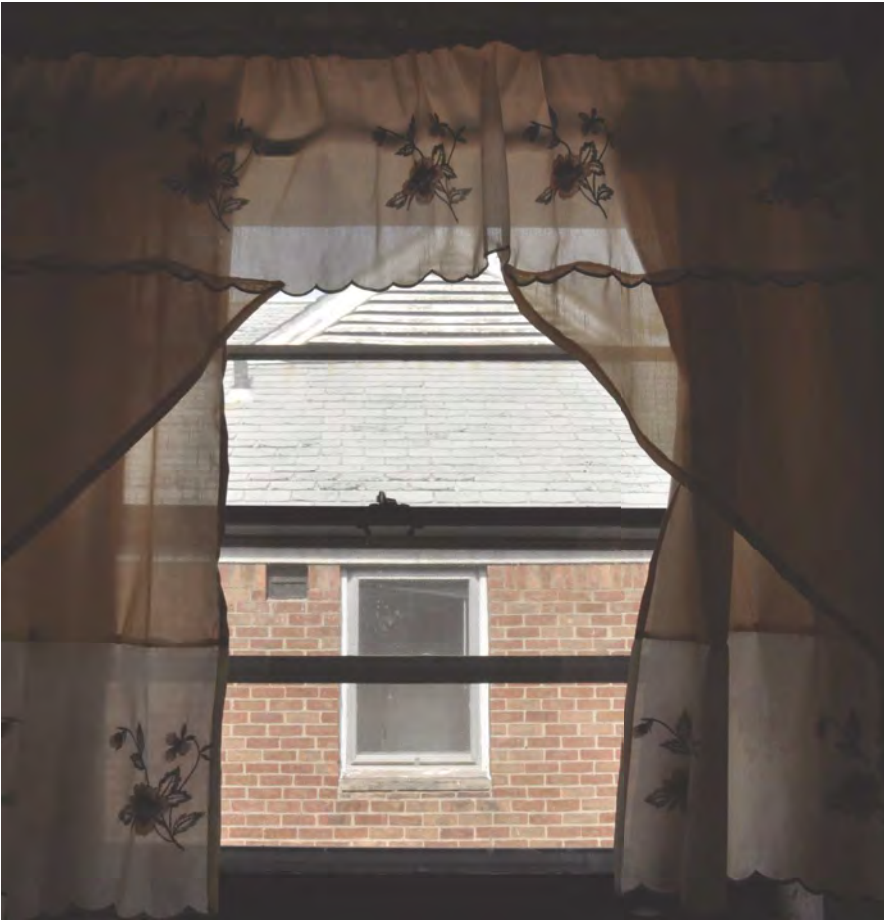
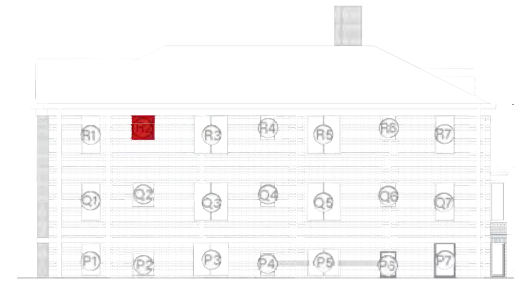
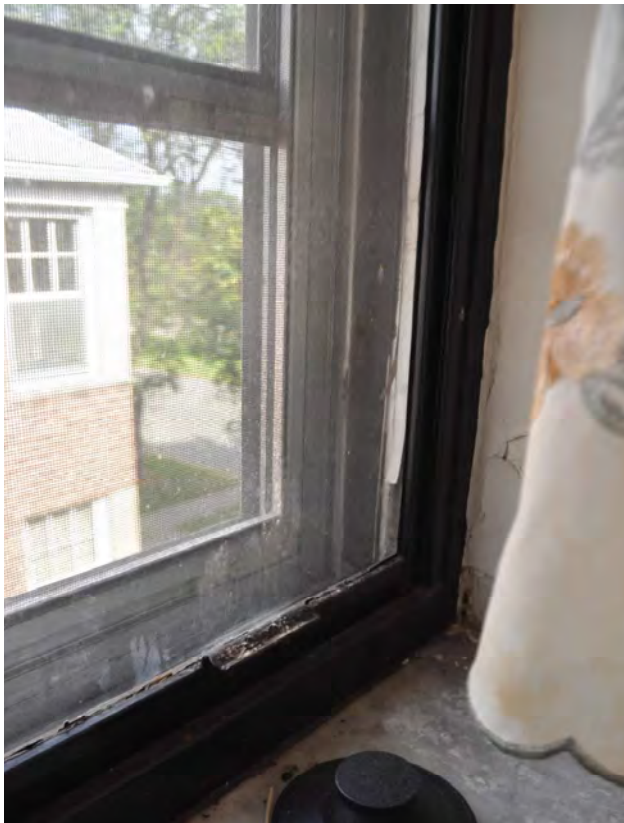
### Window R2, Type T2

- Note: Extent of exterior deterioration, corrosion, and loss of operability is not fully apparent in interior photos. Replacement parts for existing windows are unavailable, making restoration of thermal and operable functionality impossible, and long-term maintenance infeasible. Recommendation is for replacement, for quality of life of future tenants and for feasibility of long-term maintenance.
- See Window Assessment (Blackberry) in appendix for further detail and information, including further notes on deterioration beyond repair
- See Appendix for Window Schedule & Measurements

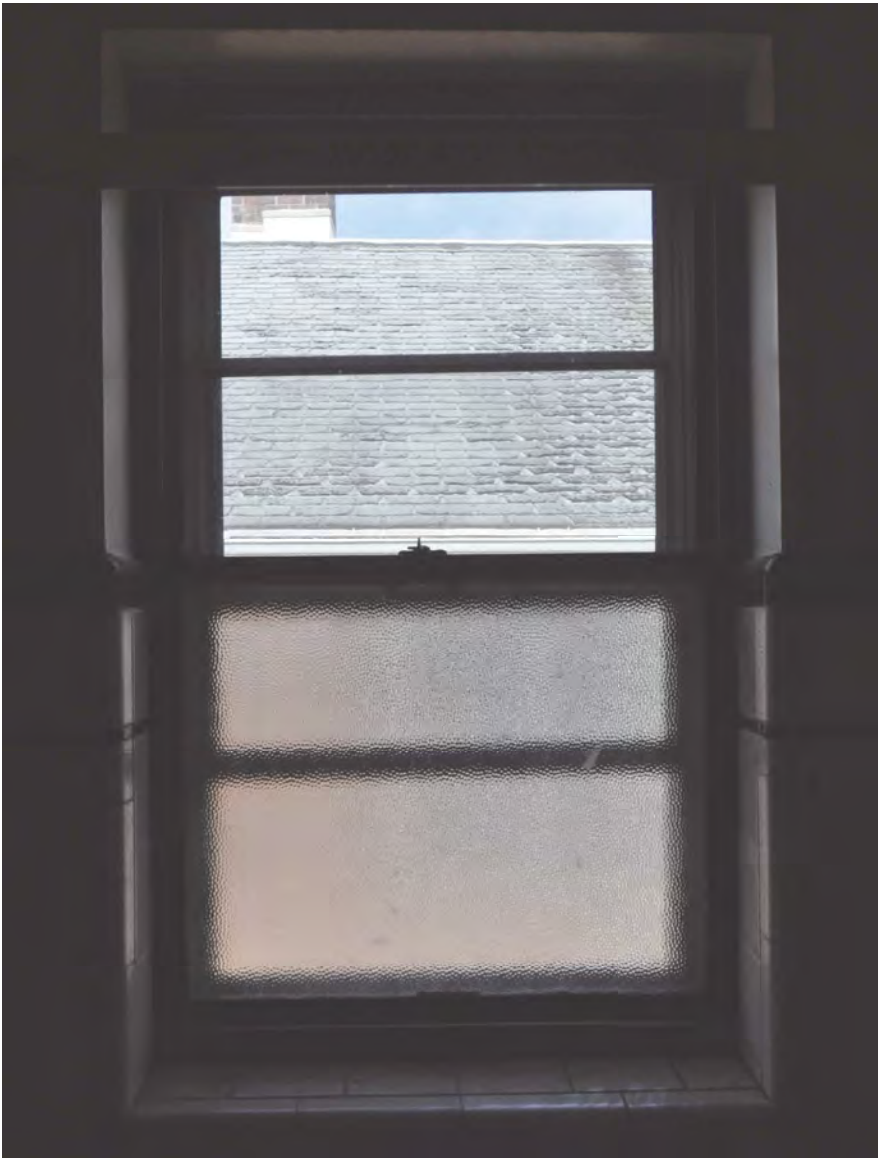
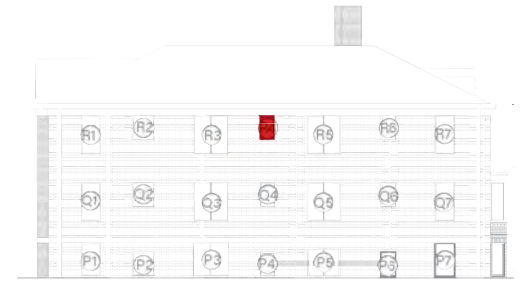
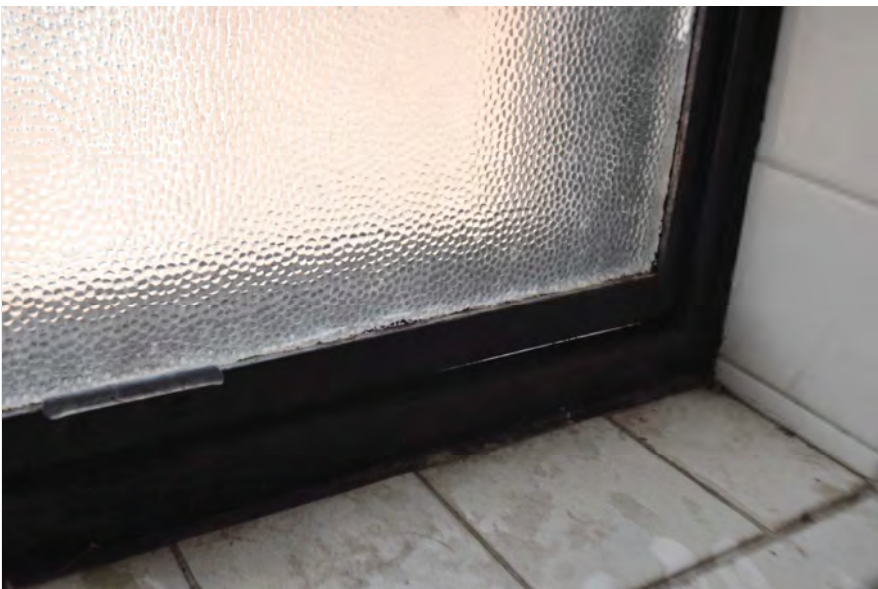
### Window R4, Type U2

- Note: Extent of exterior deterioration, corrosion, and loss of operability is not fully apparent in interior photos. Replacement parts for existing windows are unavailable, making restoration of thermal and operable functionality impossible, and long-term maintenance infeasible. Recommendation is for replacement, for quality of life of future tenants and for feasibility of long-term maintenance.
- See Window Assessment (Blackberry) in appendix for further detail and information, including further notes on deterioration beyond repair
- See Appendix for Window Schedule & Measurements

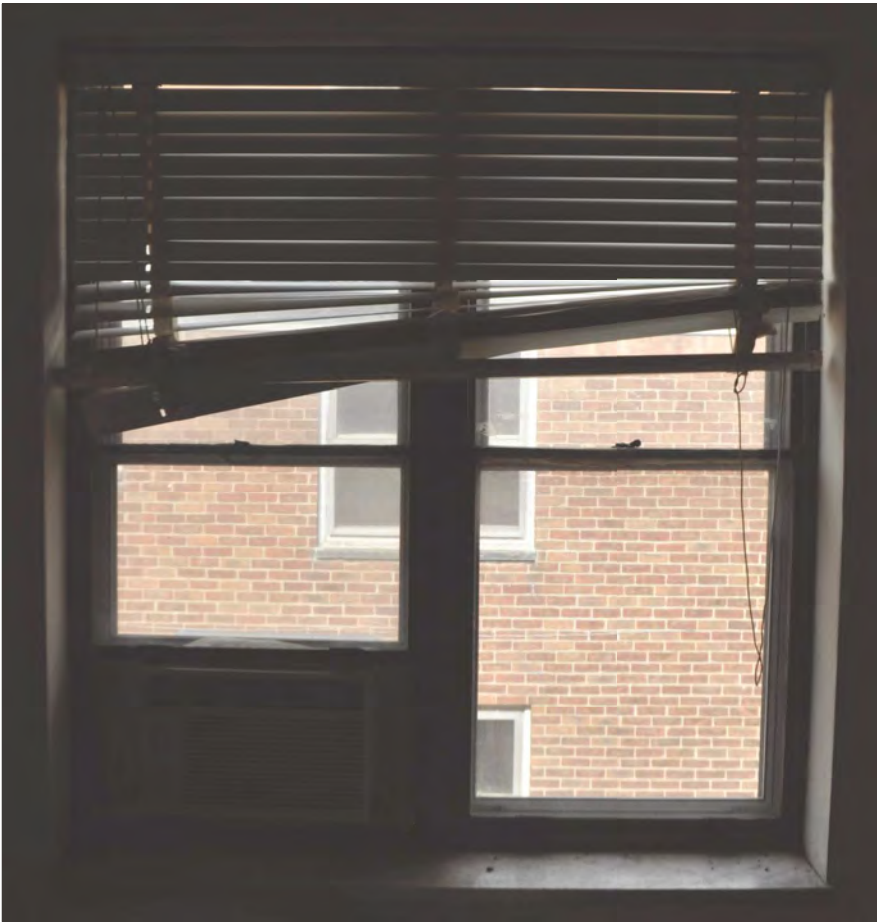
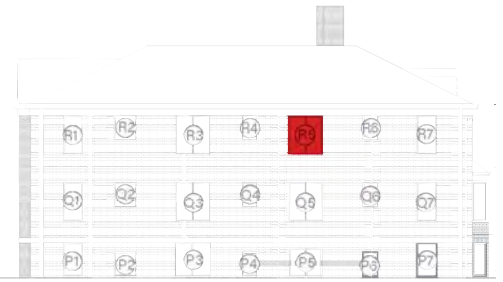
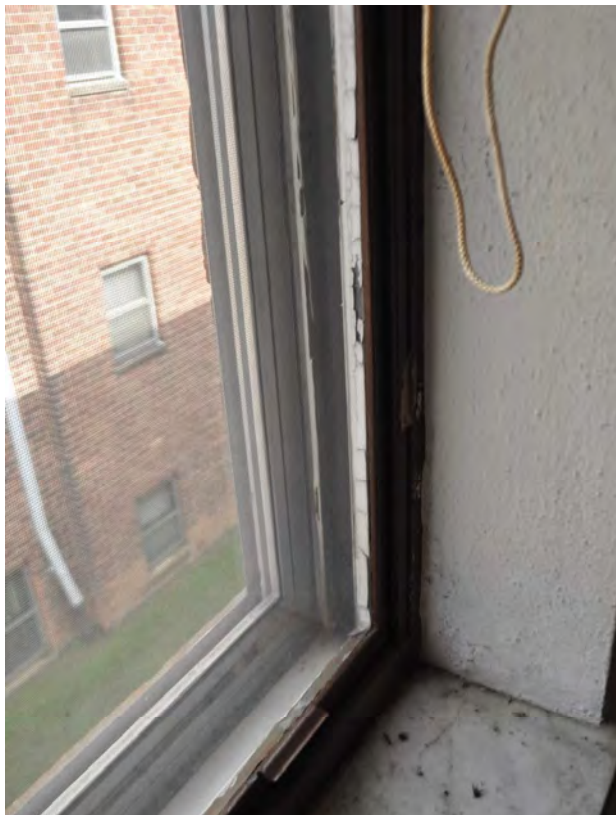
### Window R5, Type Z1

- Note: Extent of exterior deterioration, corrosion, and loss of operability is not fully apparent in interior photos. Replacement parts for existing windows are unavailable, making restoration of thermal and operable functionality impossible, and long-term maintenance infeasible. Recommendation is for replacement, for quality of life of future tenants and for feasibility of long-term maintenance.
- See Window Assessment (Blackberry) in appendix for further detail and information, including further notes on deterioration beyond repair
- See Appendix for Window Schedule & Measurements

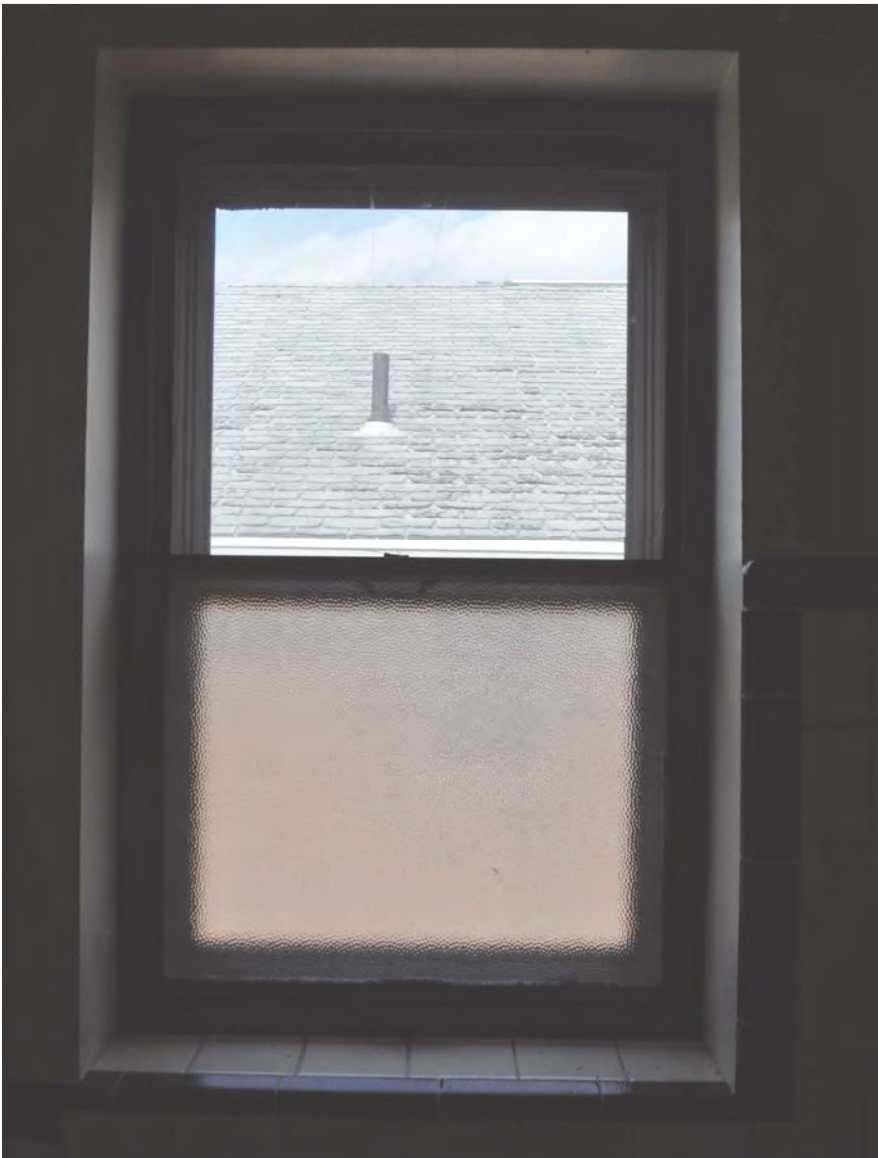
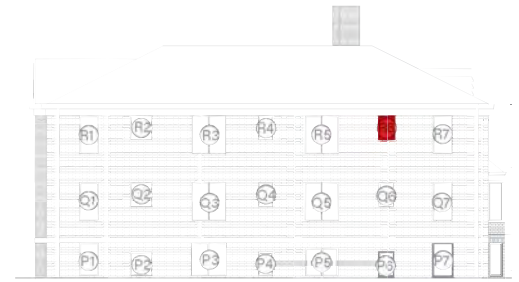
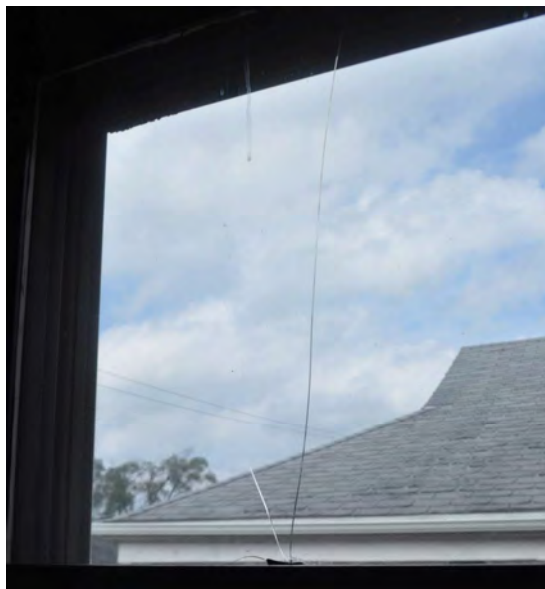
### Window R6, Type U2

- Broken Glass
- Note: Extent of exterior deterioration, corrosion, and loss of operability is not fully apparent in interior photos. Replacement parts for existing windows are unavailable, making restoration of thermal and operable functionality impossible, and long-term maintenance infeasible. Recommendation is for replacement, for quality of life of future tenants and for feasibility of long-term maintenance.
- See Window Assessment (Blackberry) in appendix for further detail and information, including further notes on deterioration beyond repair
- See Appendix for Window Schedule & Measurements

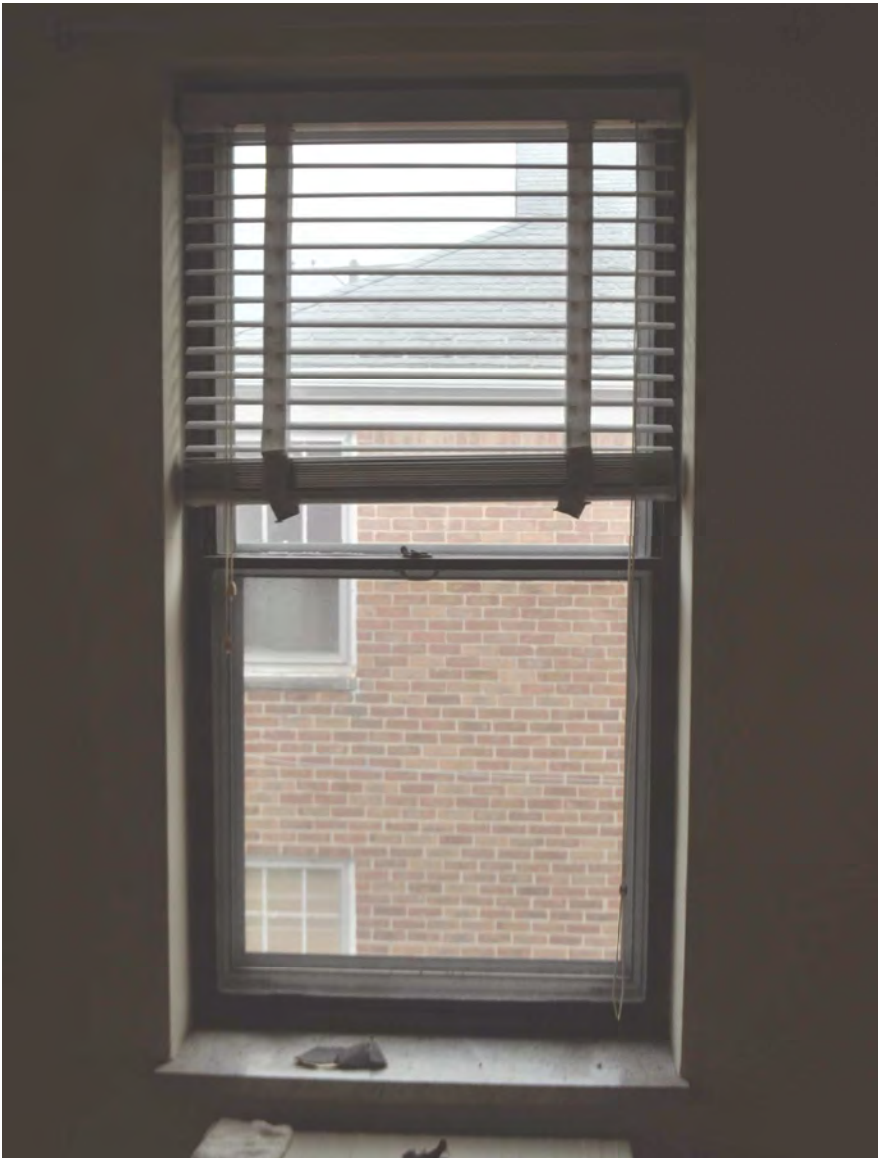
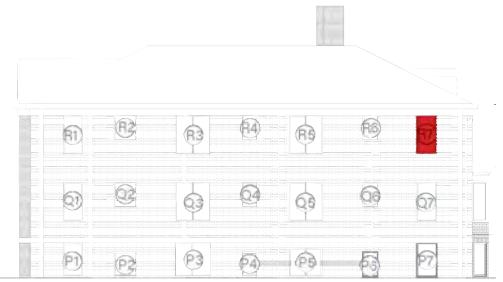
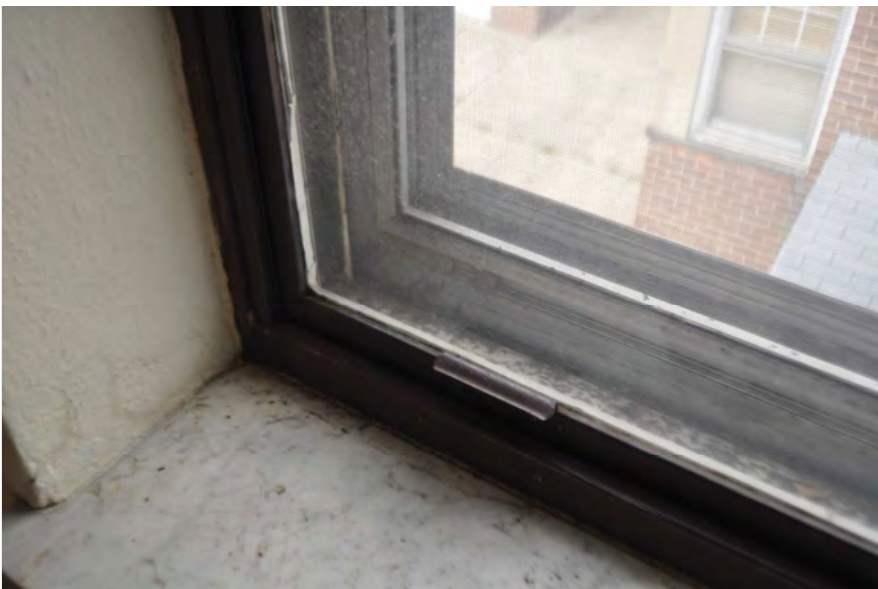
### Window R7, Type N2

- Note: Extent of exterior deterioration, corrosion, and loss of operability is not fully apparent in interior photos. Replacement parts for existing windows are unavailable, making restoration of thermal and operable functionality impossible, and long-term maintenance infeasible. Recommendation is for replacement, for quality of life of future tenants and for feasibility of long-term maintenance.
- See Window Assessment (Blackberry) in appendix for further detail and information, including further notes on deterioration beyond repair
- See Appendix for Window Schedule & Measurements

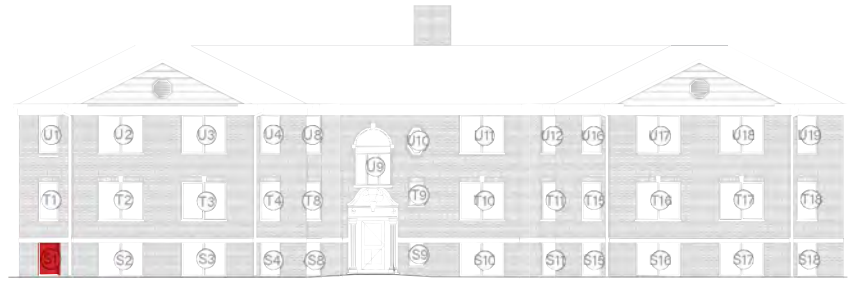
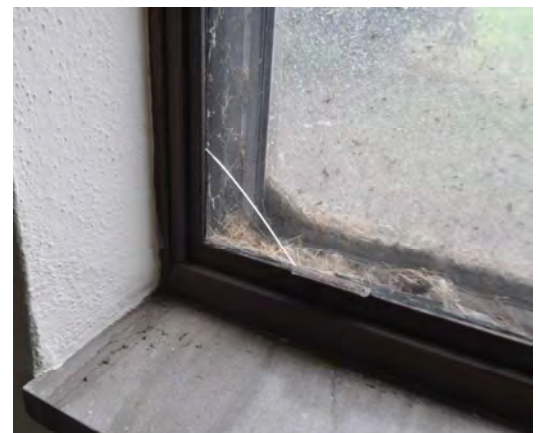
### Window S1, Type M1

- Badly Corroded
- Broken Glass
- Note: Extent of exterior deterioration, corrosion, and loss of operability is not fully apparent in interior photos. Replacement parts for existing windows are unavailable, making restoration of thermal and operable functionality impossible, and long-term maintenance infeasible. Recommendation is for replacement, for quality of life of future tenants and for feasibility of long-term maintenance.
- See Window Assessment (Blackberry) in appendix for further detail and information, including further notes on deterioration beyond repair
- See Appendix for Window Schedule & Measurements

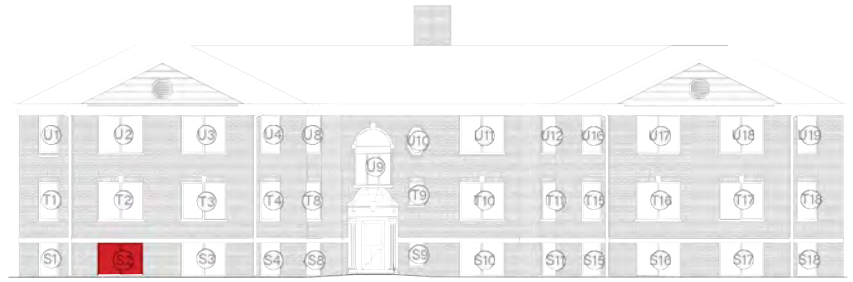
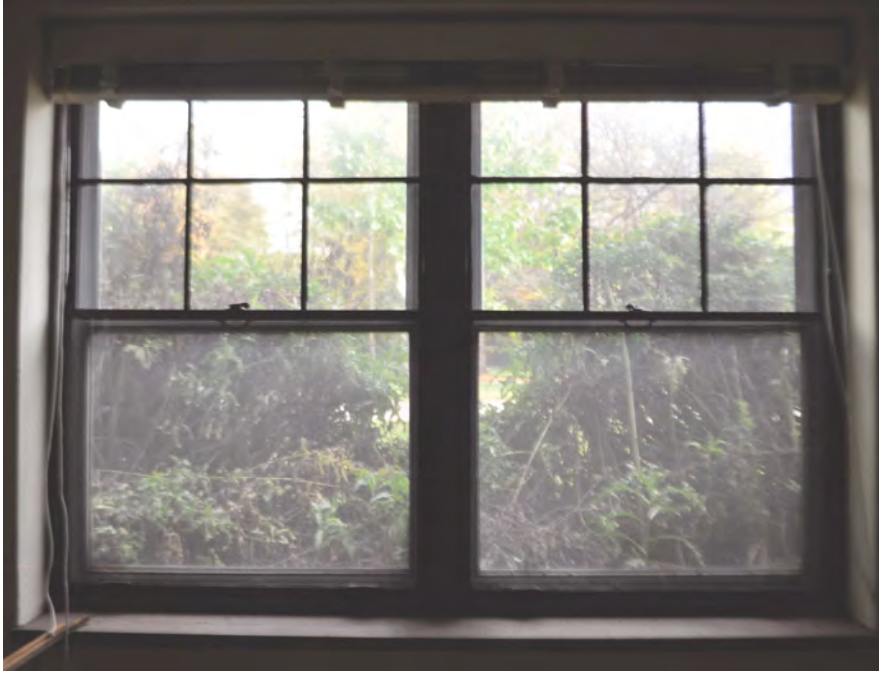
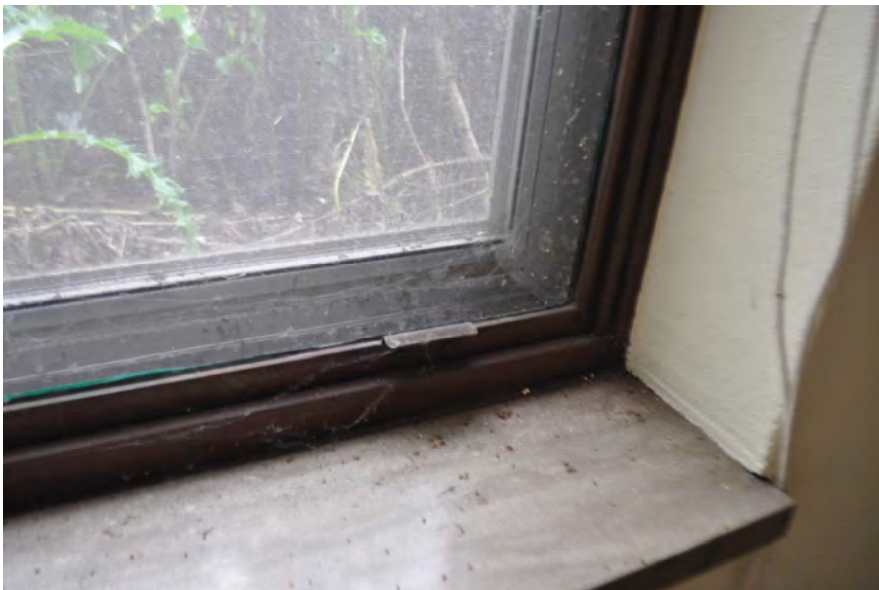
### Window S2, Type O1

- Badly Corroded
- Note: Extent of exterior deterioration, corrosion, and loss of operability is not fully apparent in interior photos. Replacement parts for existing windows are unavailable, making restoration of thermal and operable functionality impossible, and long-term maintenance infeasible. Recommendation is for replacement, for quality of life of future tenants and for feasibility of long-term maintenance.
- See Window Assessment (Blackberry) in appendix for further detail and information, including further notes on deterioration beyond repair
- See Appendix for Window Schedule & Measurements

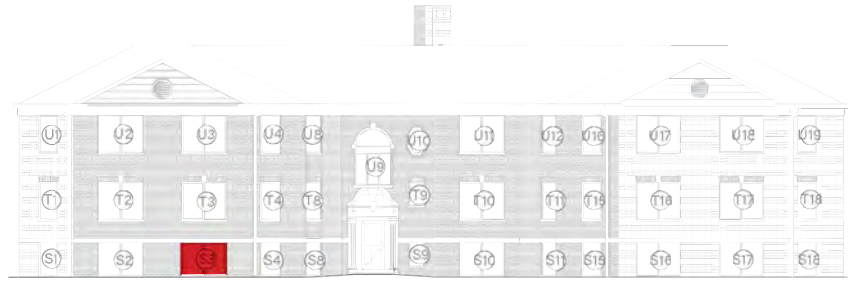
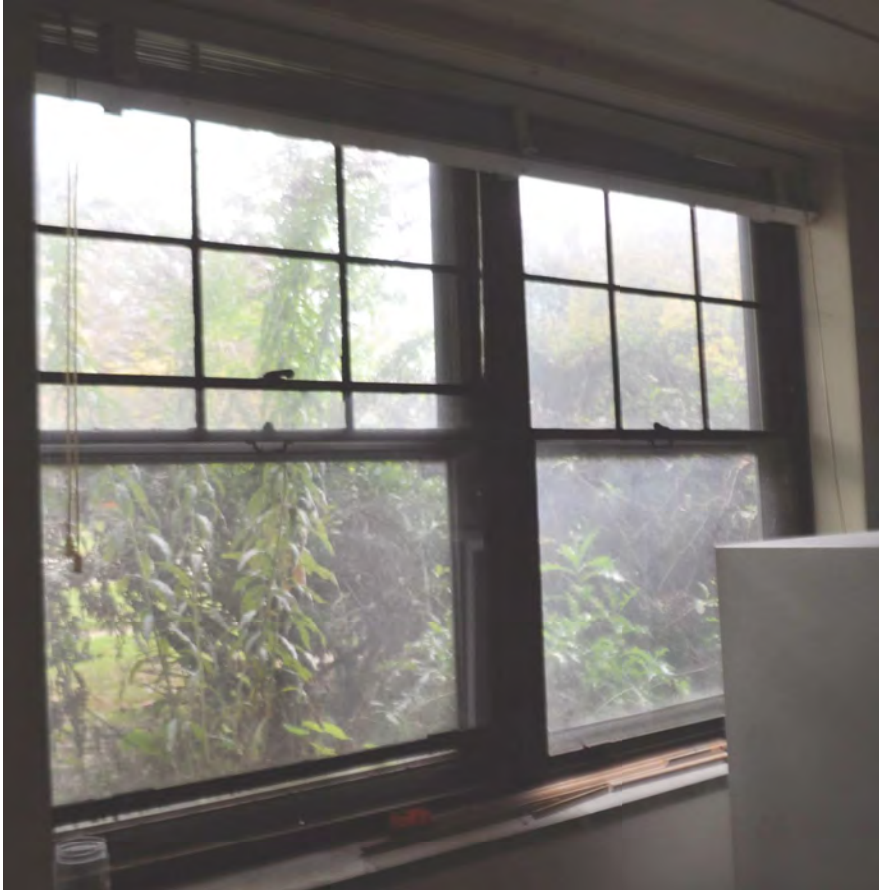
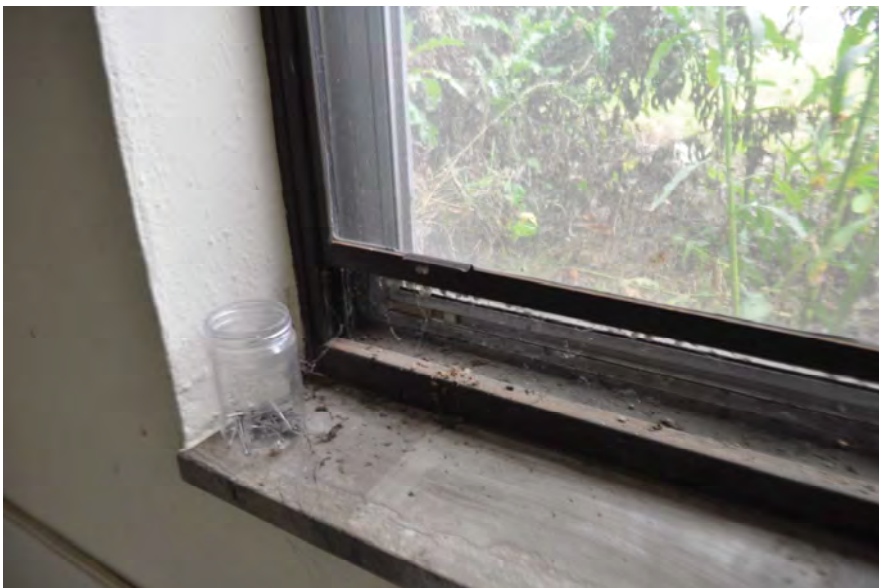
### Window S3, Type O1

- Badly Corroded
- Note: Extent of exterior deterioration, corrosion, and loss of operability is not fully apparent in interior photos. Replacement parts for existing windows are unavailable, making restoration of thermal and operable functionality impossible, and long-term maintenance infeasible. Recommendation is for replacement, for quality of life of future tenants and for feasibility of long-term maintenance.
- See Window Assessment (Blackberry) in appendix for further detail and information, including further notes on deterioration beyond repair
- See Appendix for Window Schedule & Measurements
