# 9710 W Outer Dr

## Existing Condition Photos

# 9730 W Outer Dr

# Detailed Scope of Work

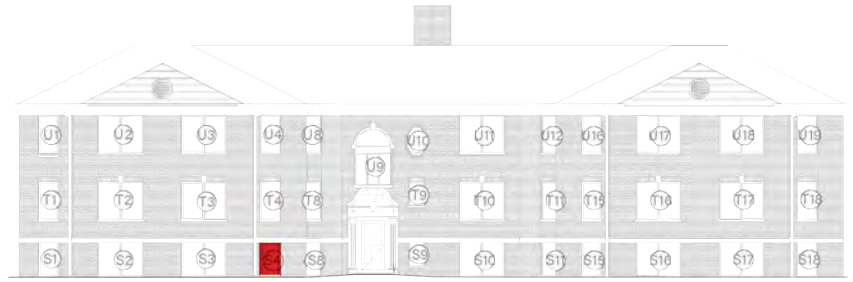
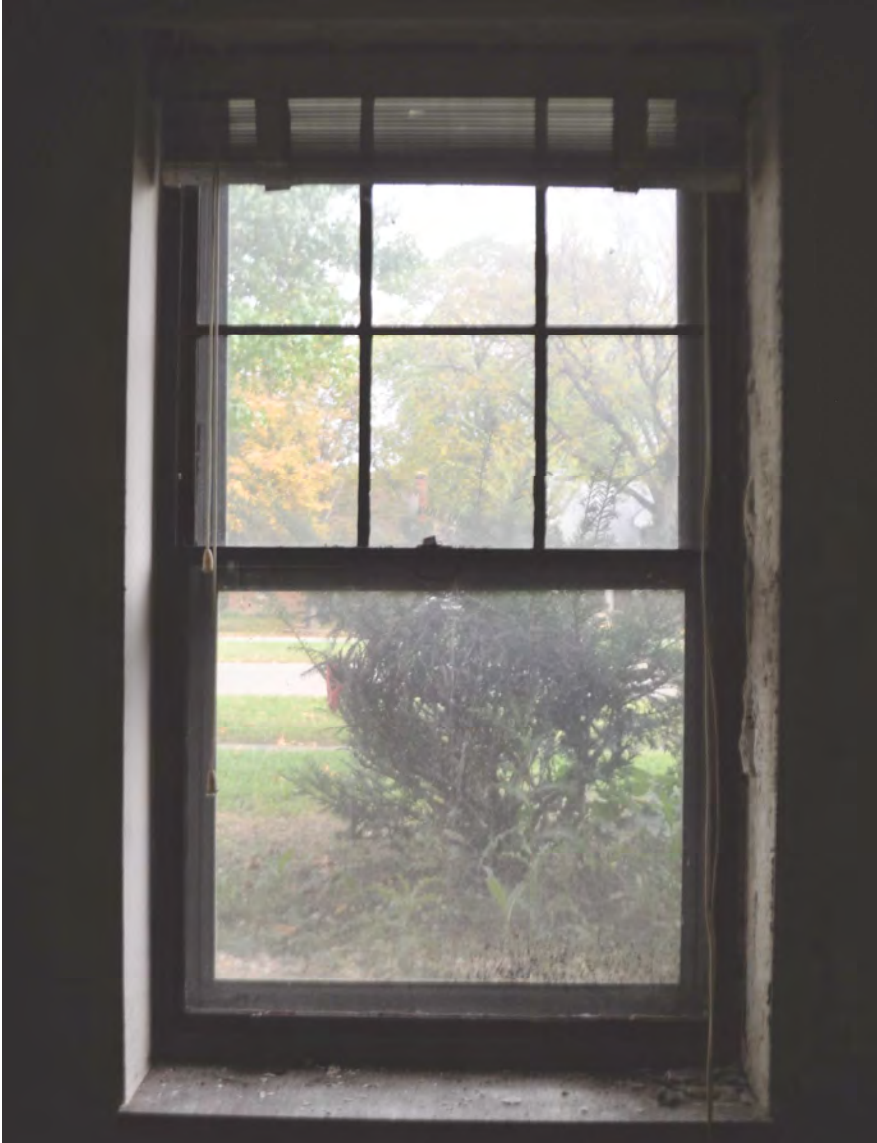
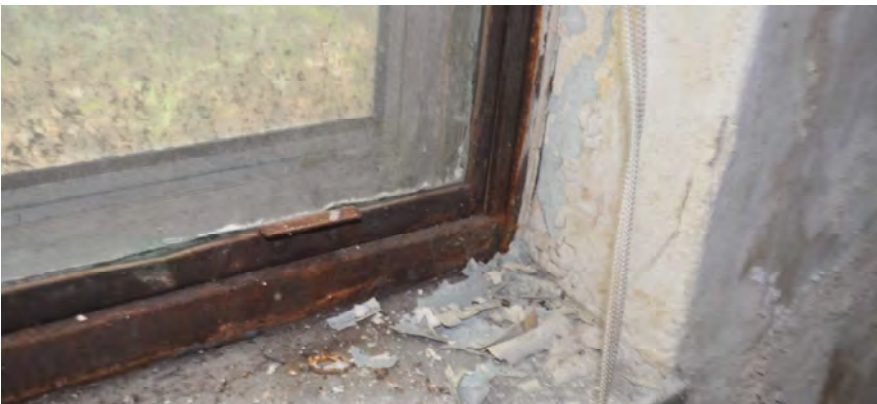
### Window S4, Type M1

- Badly Corroded
- Water Infiltration
- Note: Extent of exterior deterioration, corrosion, and loss of operability is not fully apparent in interior photos. Replacement parts for existing windows are unavailable, making restoration of thermal and operable functionality impossible, and long-term maintenance infeasible. Recommendation is for replacement, for quality of life of future tenants and for feasibility of long-term maintenance.
- See Window Assessment (Blackberry) in appendix for further detail and information, including further notes on deterioration beyond repair
- See Appendix for Window Schedule & Measurements

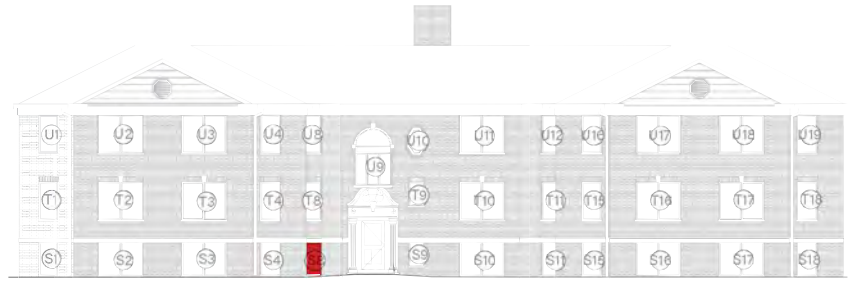
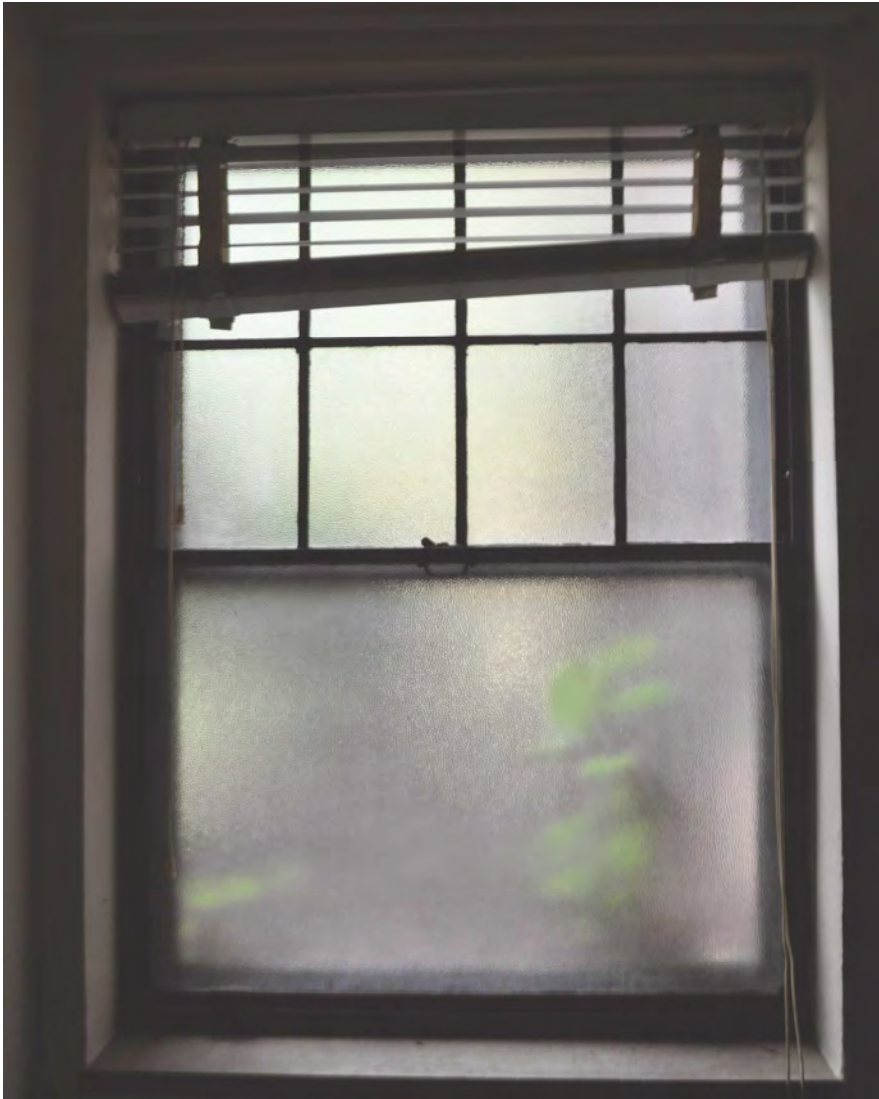
### Window S8, Type Q1

- Badly Corroded
- Note: Extent of exterior deterioration, corrosion, and loss of operability is not fully apparent in interior photos. Replacement parts for existing windows are unavailable, making restoration of thermal and operable functionality impossible, and long-term maintenance infeasible. Recommendation is for replacement, for quality of life of future tenants and for feasibility of long-term maintenance.
- See Window Assessment (Blackberry) in appendix for further detail and information, including further notes on deterioration beyond repair
- See Appendix for Window Schedule & Measurements

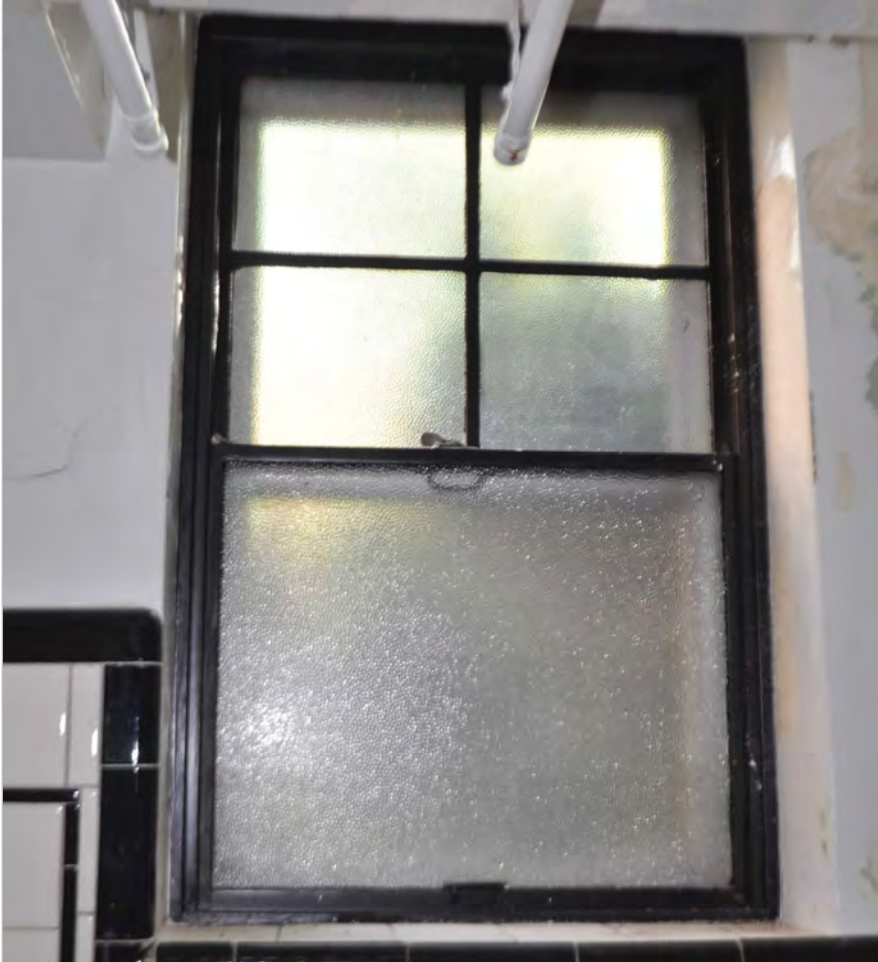
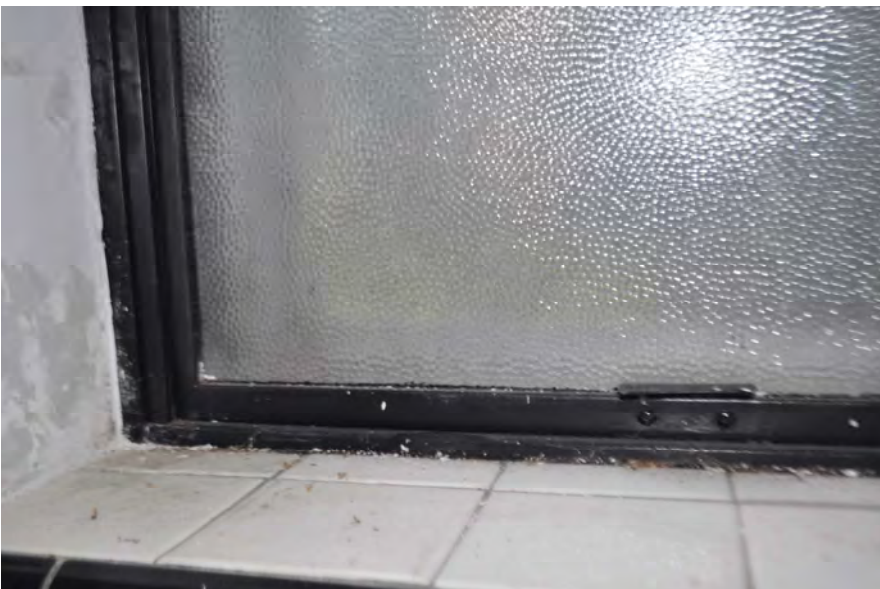
### Window S9, Type U1

- Badly Corroded
- Note: Extent of exterior deterioration, corrosion, and loss of operability is not fully apparent in interior photos. Replacement parts for existing windows are unavailable, making restoration of thermal and operable functionality impossible, and long-term maintenance infeasible. Recommendation is for replacement, for quality of life of future tenants and for feasibility of long-term maintenance.
- See Window Assessment (Blackberry) in appendix for further detail and information, including further notes on deterioration beyond repair
- See Appendix for Window Schedule & Measurements

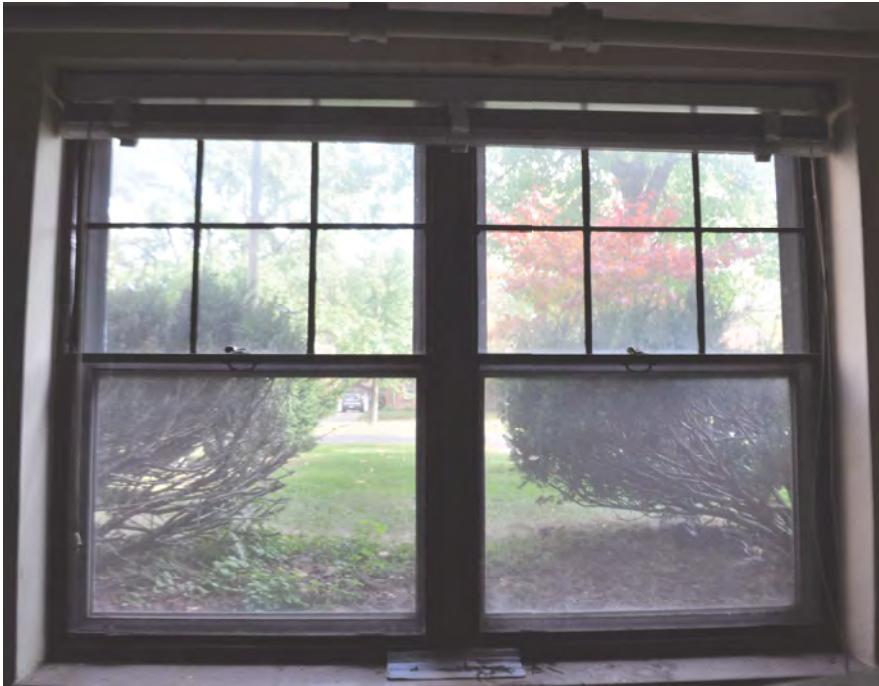
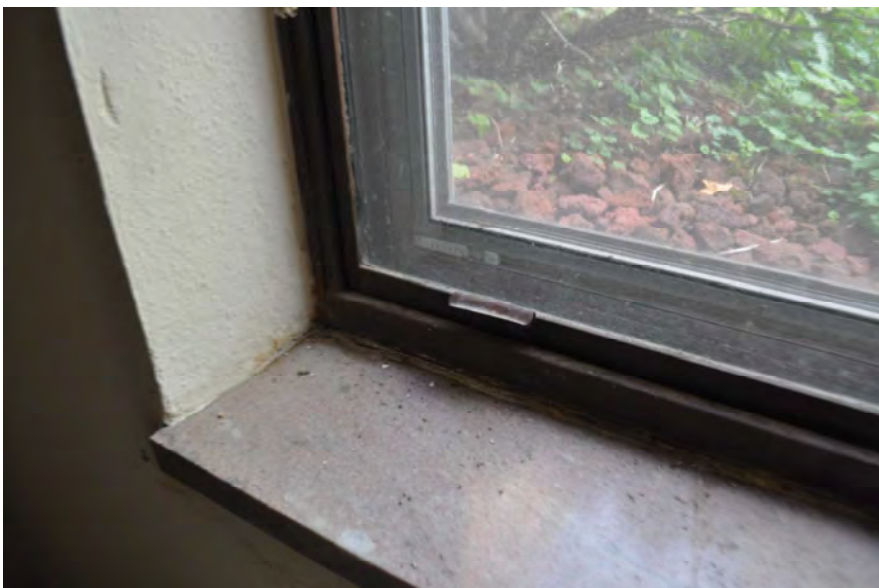
### Window S10, Type O1

- Badly Corroded
- Note: Extent of exterior deterioration, corrosion, and loss of operability is not fully apparent in interior photos. Replacement parts for existing windows are unavailable, making restoration of thermal and operable functionality impossible, and long-term maintenance infeasible. Recommendation is for replacement, for quality of life of future tenants and for feasibility of long-term maintenance.
- See Window Assessment (Blackberry) in appendix for further detail and information, including further notes on deterioration beyond repair
- See Appendix for Window Schedule & Measurements

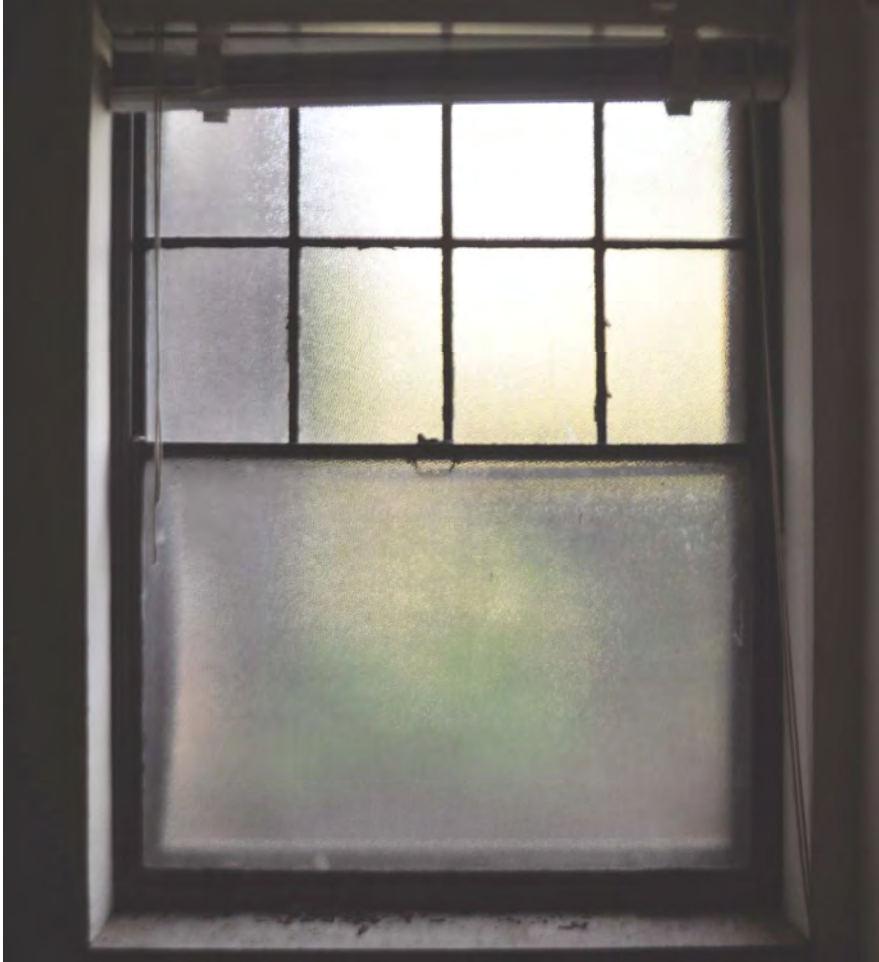
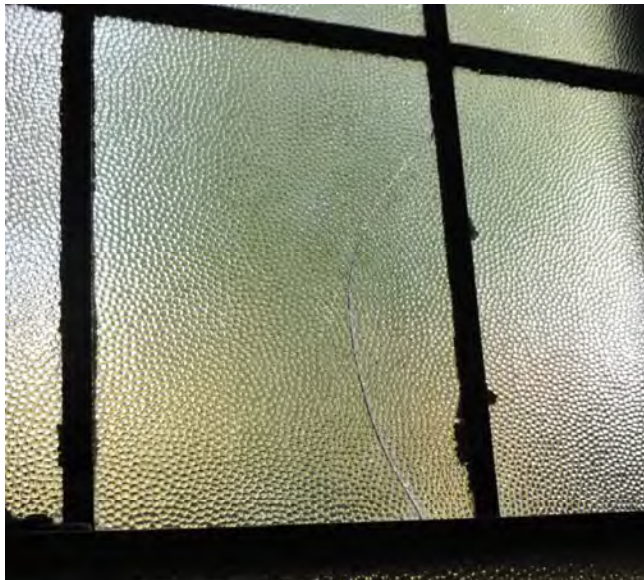
### Window S11, Type O1

- Badly Corroded
- Broken Glass
- Note: Extent of exterior deterioration, corrosion, and loss of operability is not fully apparent in interior photos. Replacement parts for existing windows are unavailable, making restoration of thermal and operable functionality impossible, and long-term maintenance infeasible. Recommendation is for replacement, for quality of life of future tenants and for feasibility of long-term maintenance.
- See Window Assessment (Blackberry) in appendix for further detail and information, including further notes on deterioration beyond repair
- See Appendix for Window Schedule & Measurements

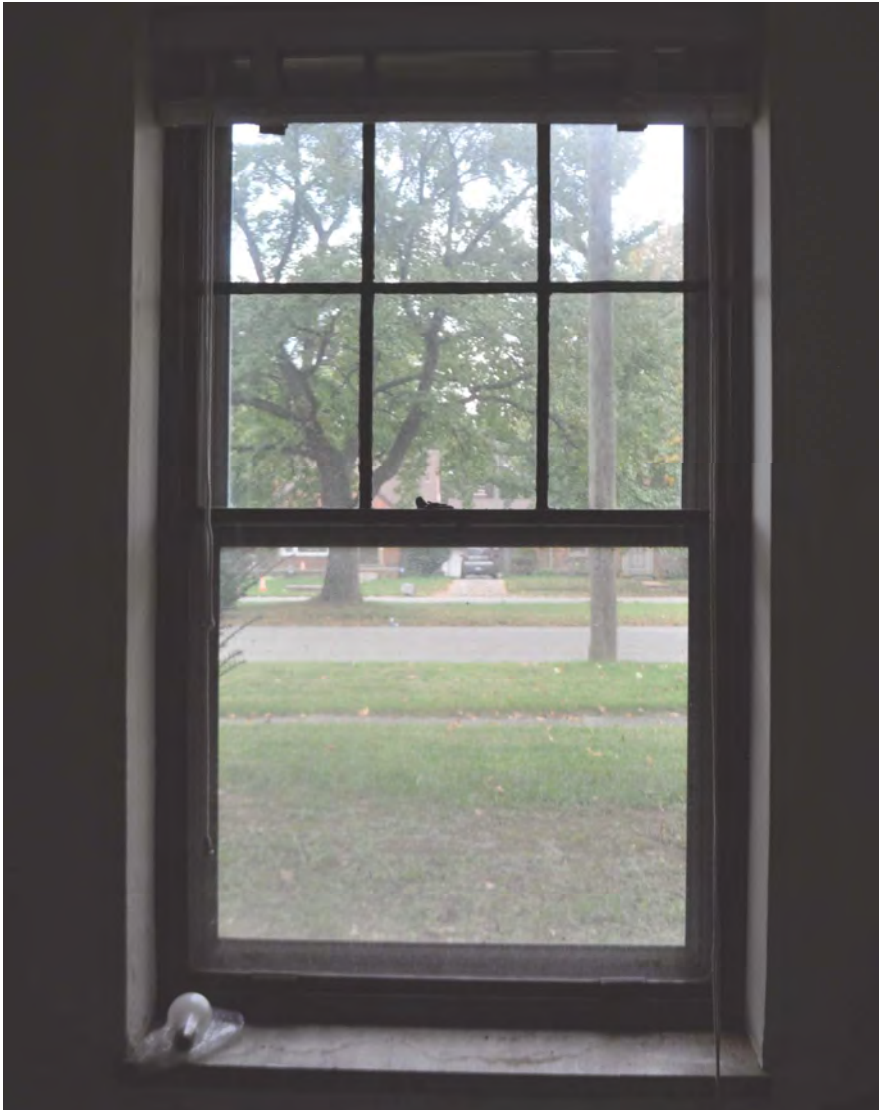
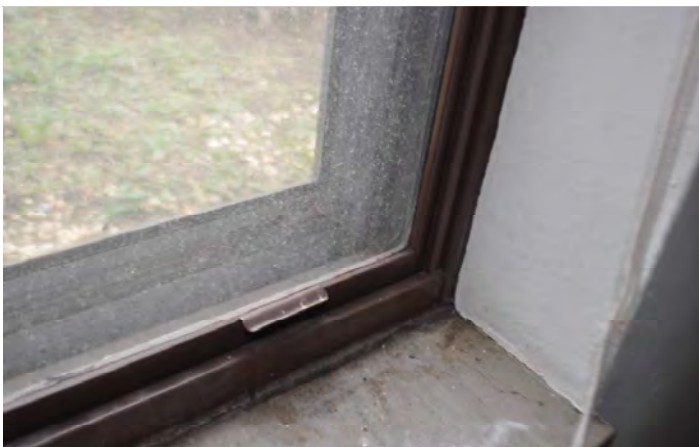
### Window S15, Type M1

- Badly Corroded
- Note: Extent of exterior deterioration, corrosion, and loss of operability is not fully apparent in interior photos. Replacement parts for existing windows are unavailable, making restoration of thermal and operable functionality impossible, and long-term maintenance infeasible. Recommendation is for replacement, for quality of life of future tenants and for feasibility of long-term maintenance.
- See Window Assessment (Blackberry) in appendix for further detail and information, including further notes on deterioration beyond repair
- See Appendix for Window Schedule & Measurements

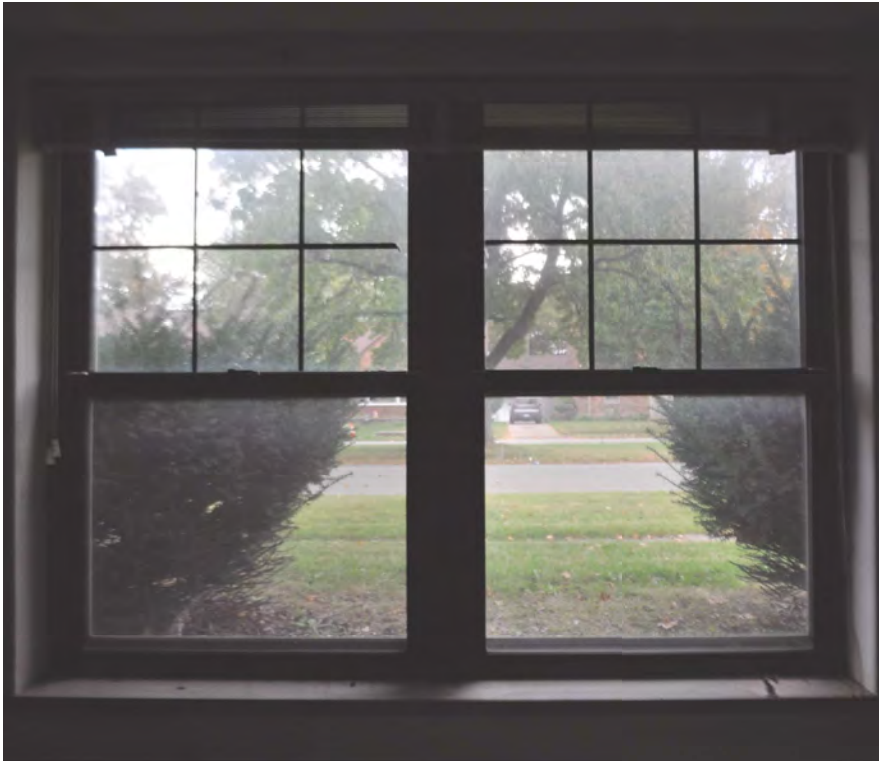
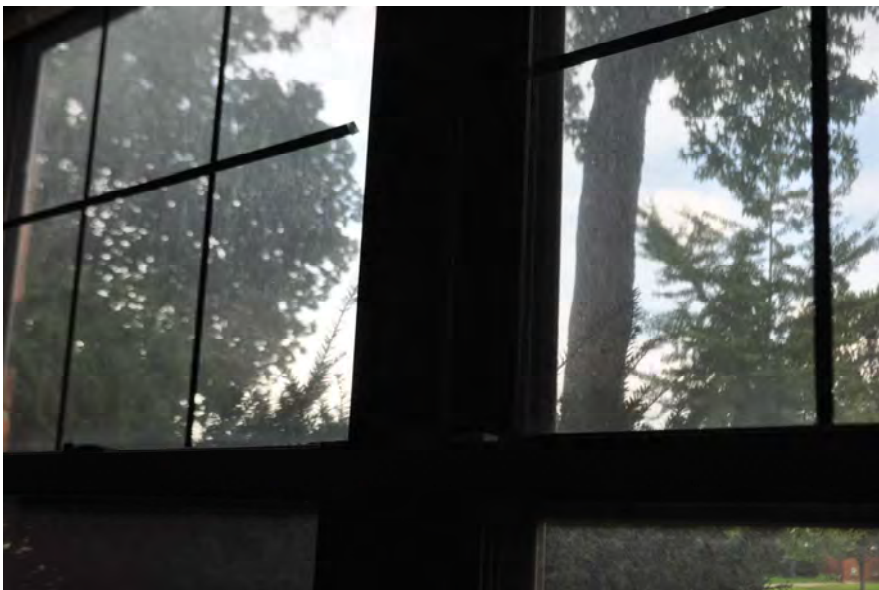
### Window S16, TypeO1

- Badly Corroded
- Replacement window, not historic
- Note: Extent of exterior deterioration, corrosion, and loss of operability is not fully apparent in interior photos. Replacement parts for existing windows are unavailable, making restoration of thermal and operable functionality impossible, and long-term maintenance infeasible. Recommendation is for replacement, for quality of life of future tenants and for feasibility of long-term maintenance.
- See Window Assessment (Blackberry) in appendix for further detail and information, including further notes on deterioration beyond repair
- See Appendix for Window Schedule & Measurements

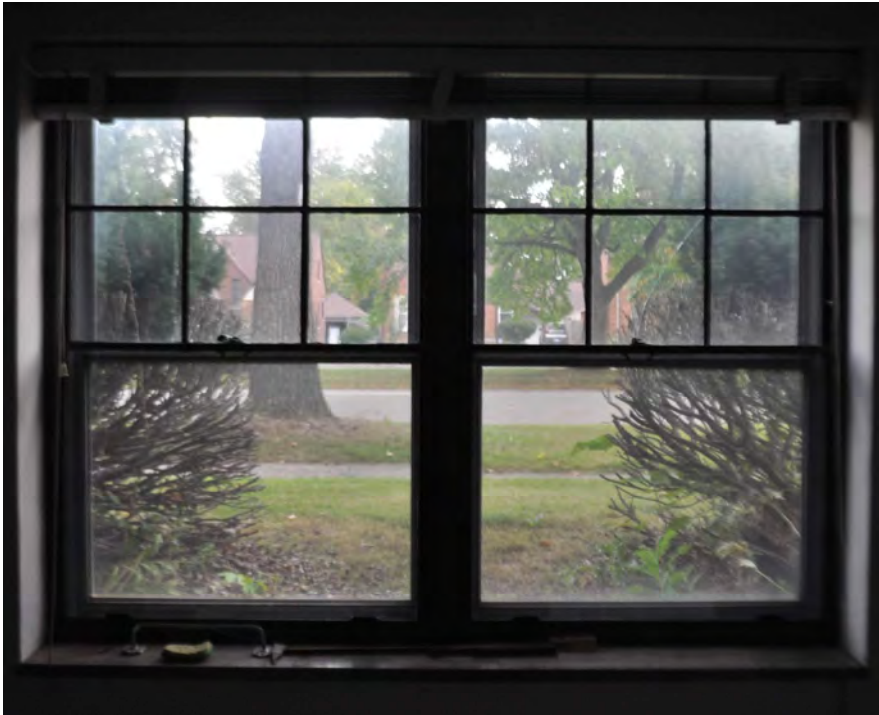
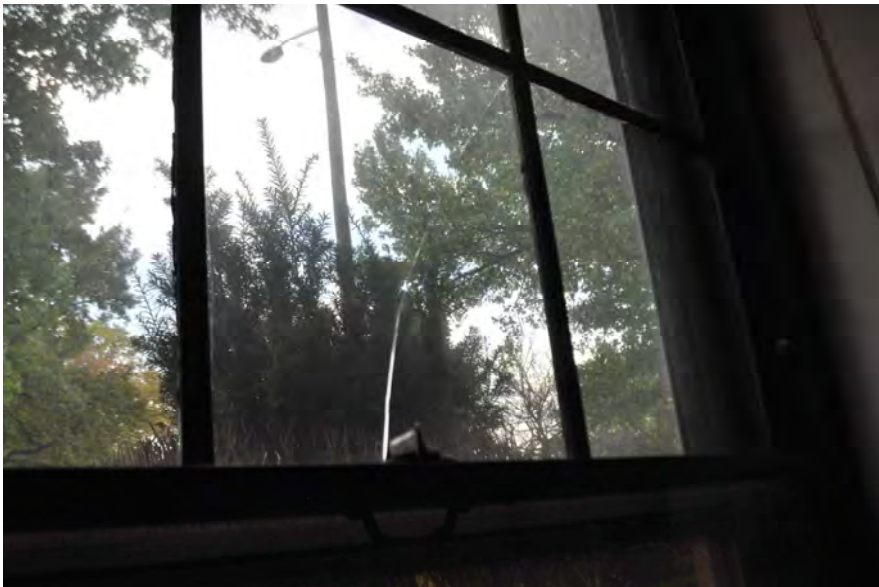
### Window S17, Type O1

- Badly Corroded
- Broken Glass
- Note: Extent of exterior deterioration, corrosion, and loss of operability is not fully apparent in interior photos. Replacement parts for existing windows are unavailable, making restoration of thermal and operable functionality impossible, and long-term maintenance infeasible. Recommendation is for replacement, for quality of life of future tenants and for feasibility of long-term maintenance.
- See Window Assessment (Blackberry) in appendix for further detail and information, including further notes on deterioration beyond repair
- See Appendix for Window Schedule & Measurements

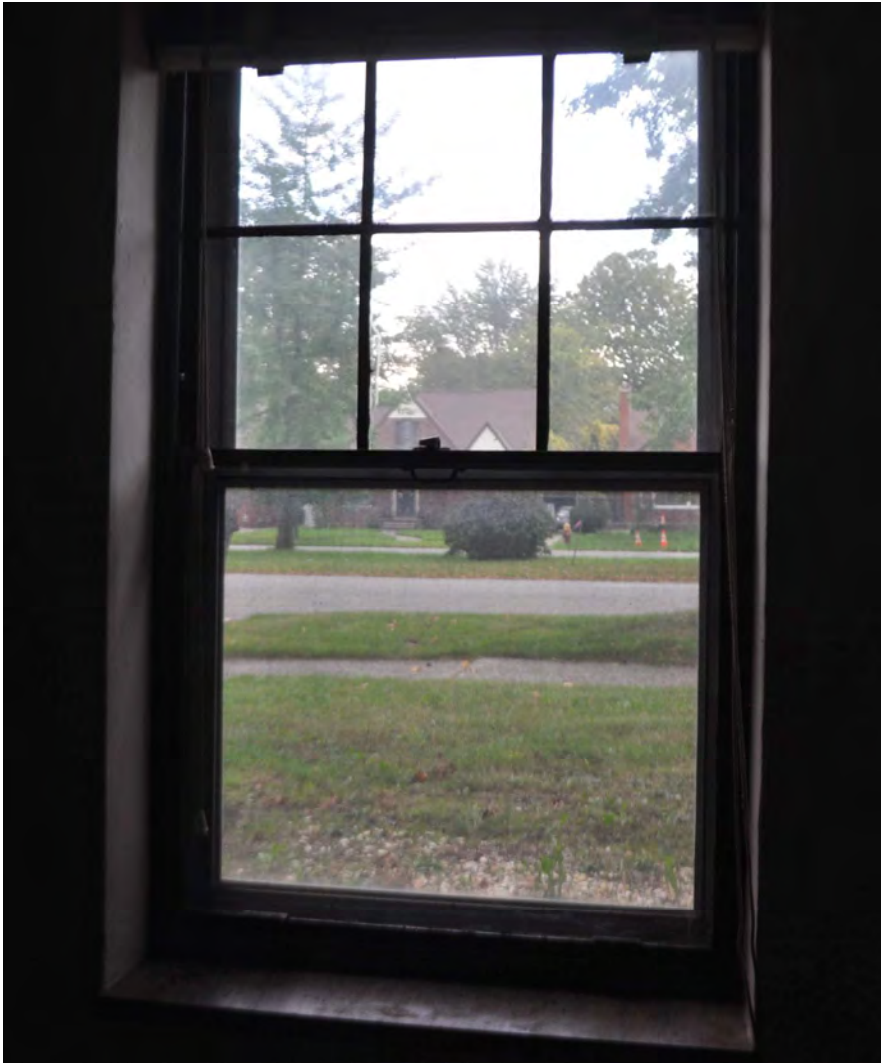
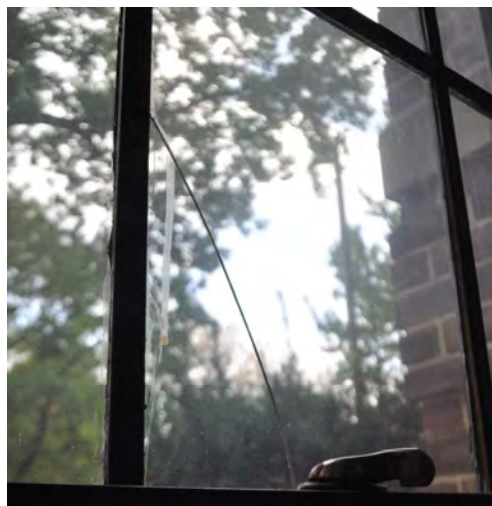
### Window S18, Type M1

- Badly Corroded
- Broken Glass
- Note: Extent of exterior deterioration, corrosion, and loss of operability is not fully apparent in interior photos. Replacement parts for existing windows are unavailable, making restoration of thermal and operable functionality impossible, and long-term maintenance infeasible. Recommendation is for replacement, for quality of life of future tenants and for feasibility of long-term maintenance.
- See Window Assessment (Blackberry) in appendix for further detail and information, including further notes on deterioration beyond repair
- See Appendix for Window Schedule & Measurements

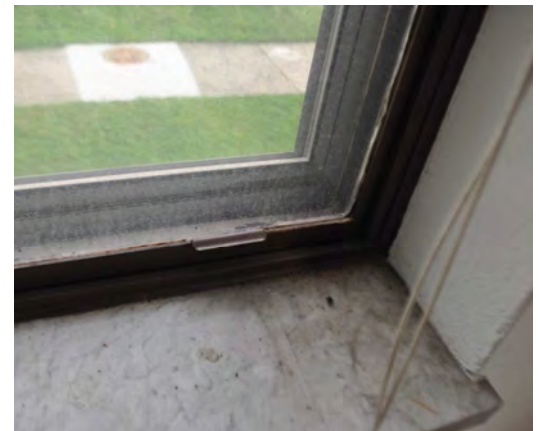
### Window T1, Type N1

- Note: Extent of exterior deterioration, corrosion, and loss of operability is not fully apparent in interior photos. Replacement parts for existing windows are unavailable, making restoration of thermal and operable functionality impossible, and long-term maintenance infeasible. Recommendation is for replacement, for quality of life of future tenants and for feasibility of long-term maintenance.
- See Window Assessment (Blackberry) in appendix for further detail and information, including further notes on deterioration beyond repair
- See Appendix for Window Schedule & Measurements

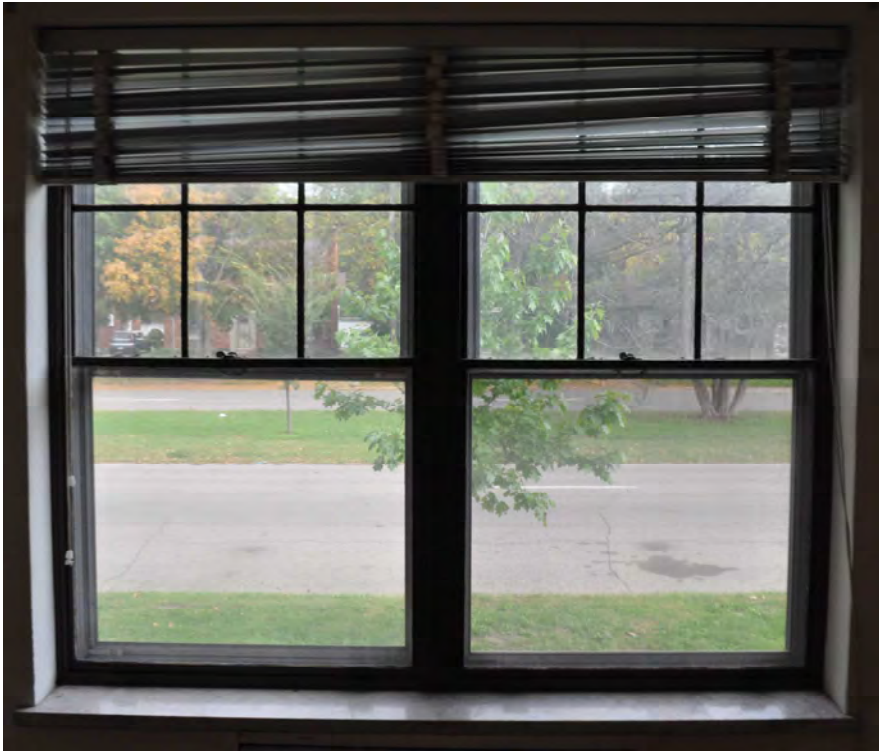
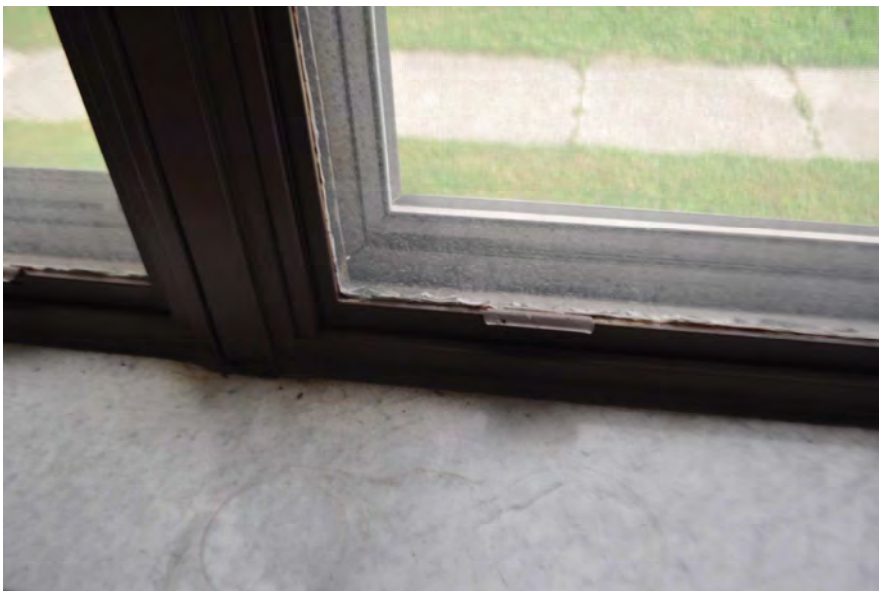
### Window T2, Type P1

- Note: Extent of exterior deterioration, corrosion, and loss of operability is not fully apparent in interior photos. Replacement parts for existing windows are unavailable, making restoration of thermal and operable functionality impossible, and long-term maintenance infeasible. Recommendation is for replacement, for quality of life of future tenants and for feasibility of long-term maintenance.
- See Window Assessment (Blackberry) in appendix for further detail and information, including further notes on deterioration beyond repair
- See Appendix for Window Schedule & Measurements

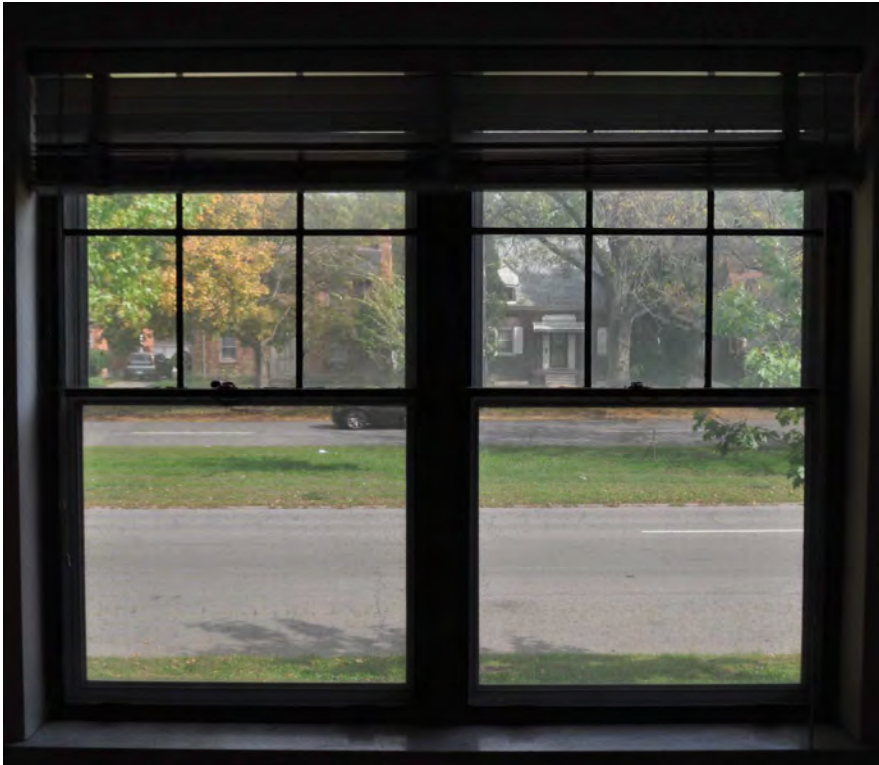
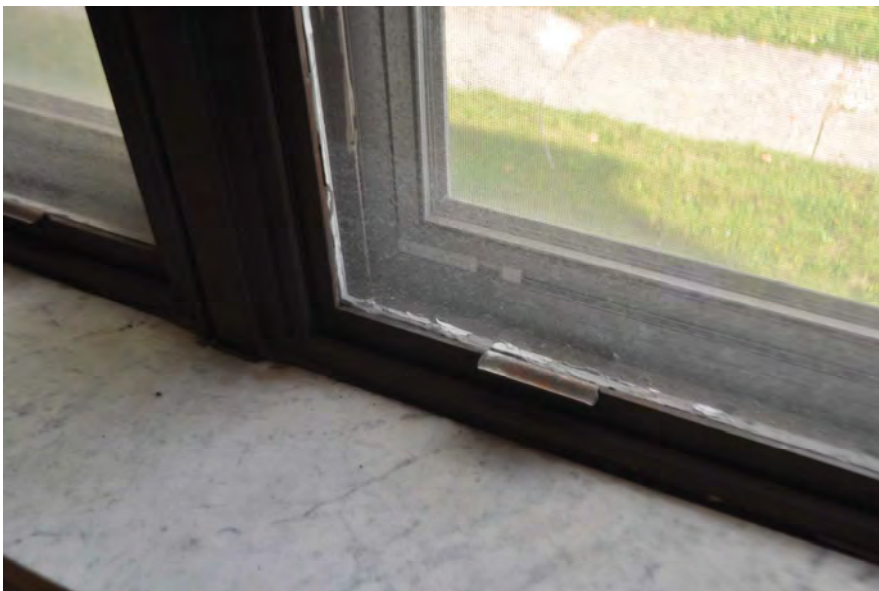
### Window T3, Type P1

- Note: Extent of exterior deterioration, corrosion, and loss of operability is not fully apparent in interior photos. Replacement parts for existing windows are unavailable, making restoration of thermal and operable functionality impossible, and long-term maintenance infeasible. Recommendation is for replacement, for quality of life of future tenants and for feasibility of long-term maintenance.
- See Window Assessment (Blackberry) in appendix for further detail and information, including further notes on deterioration beyond repair
- See Appendix for Window Schedule & Measurements

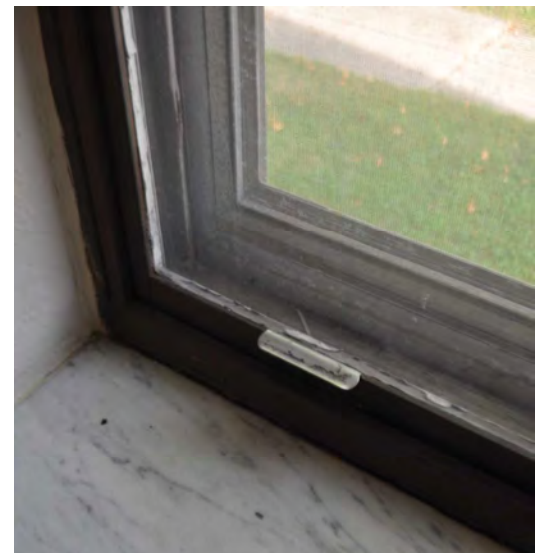
### Window T4, Type N1

- Note: Extent of exterior deterioration, corrosion, and loss of operability is not fully apparent in interior photos. Replacement parts for existing windows are unavailable, making restoration of thermal and operable functionality impossible, and long-term maintenance infeasible. Recommendation is for replacement, for quality of life of future tenants and for feasibility of long-term maintenance.
- See Window Assessment (Blackberry) in appendix for further detail and information, including further notes on deterioration beyond repair
- See Appendix for Window Schedule & Measurements

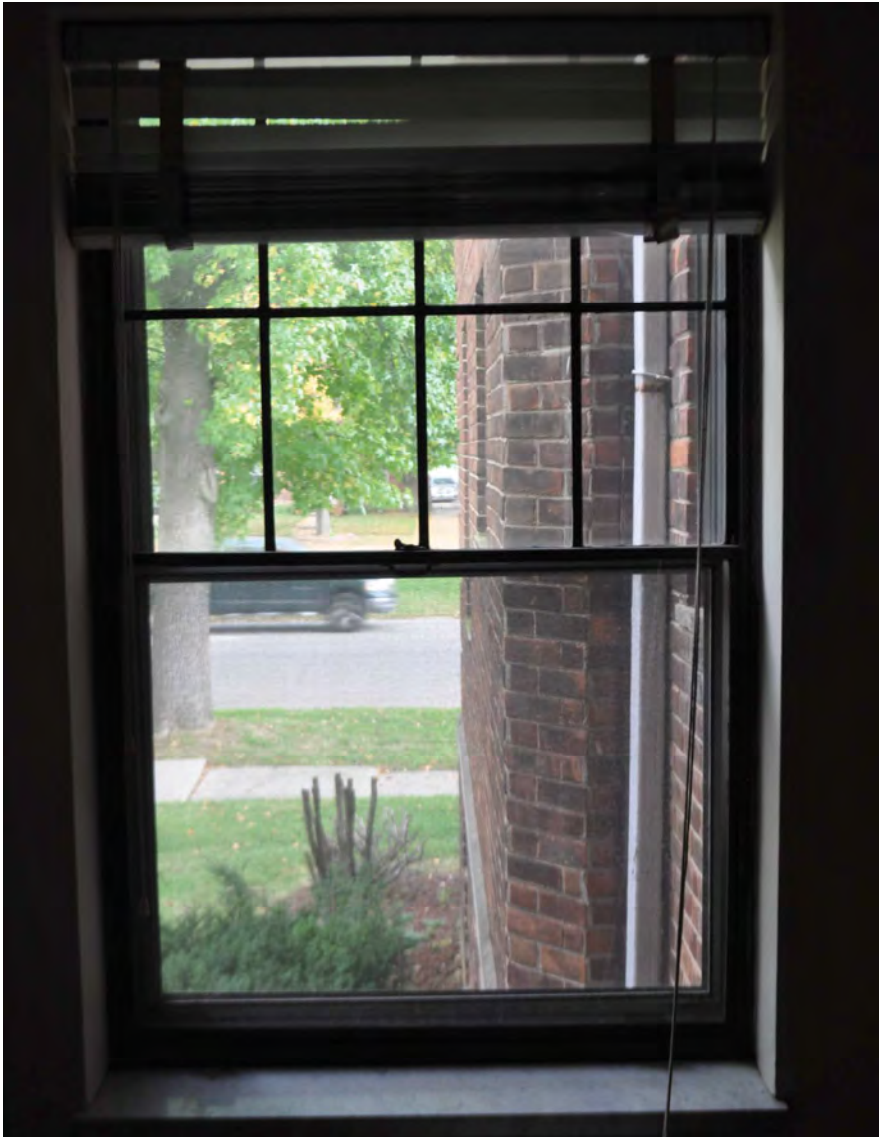
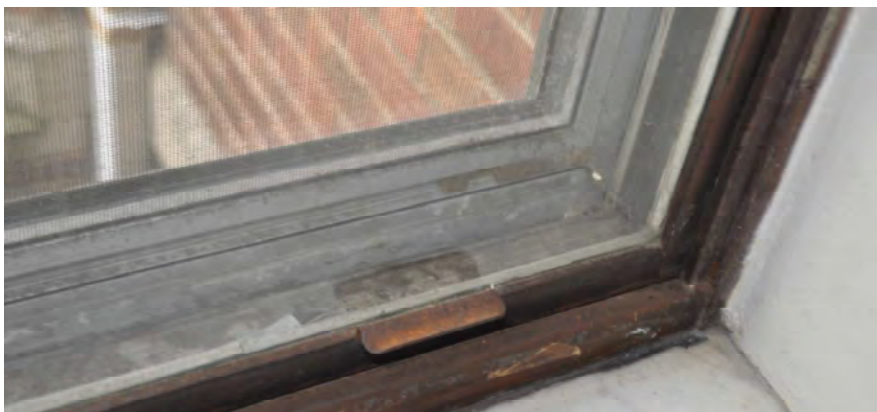
### Window T8, Type R1

- Note: Extent of exterior deterioration, corrosion, and loss of operability is not fully apparent in interior photos. Replacement parts for existing windows are unavailable, making restoration of thermal and operable functionality impossible, and long-term maintenance infeasible. Recommendation is for replacement, for quality of life of future tenants and for feasibility of long-term maintenance.
- See Window Assessment (Blackberry) in appendix for further detail and information, including further notes on deterioration beyond repair
- See Appendix for Window Schedule & Measurements

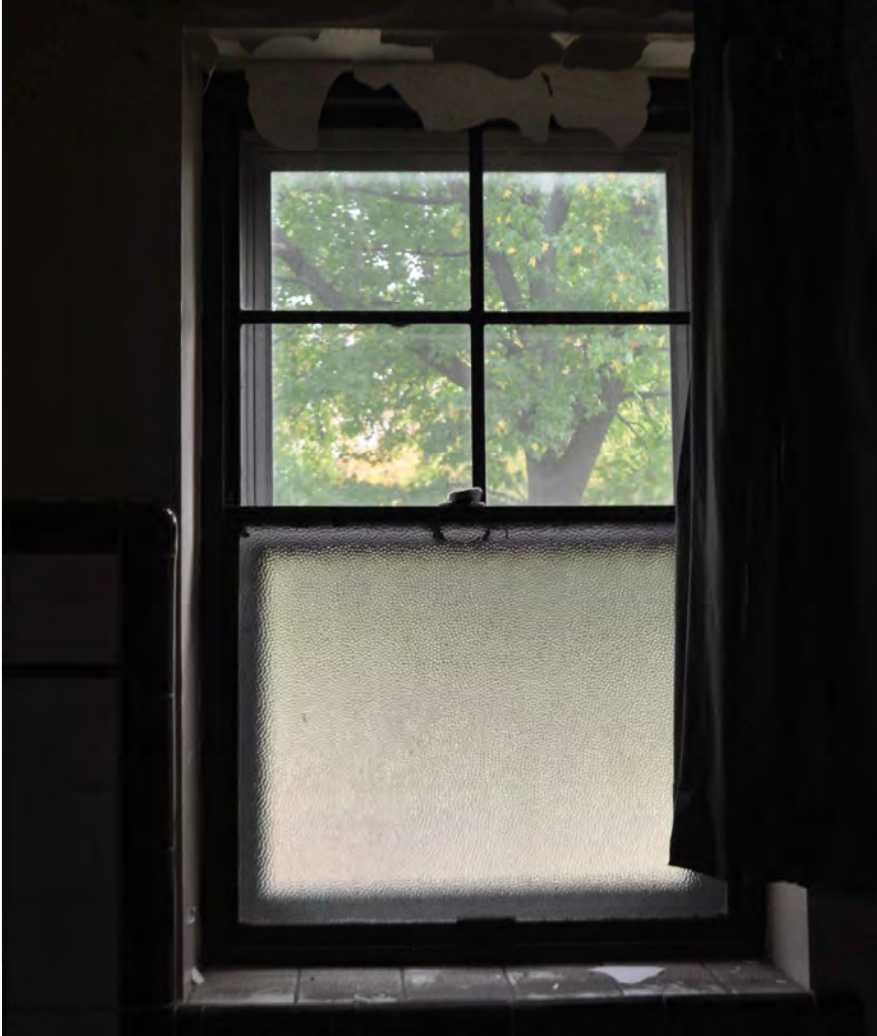
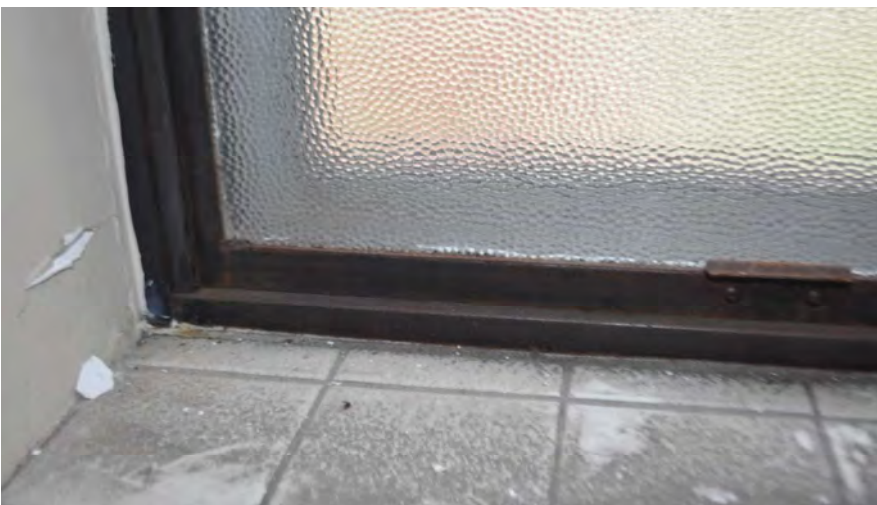
### Window T9, Type U1

- Note: Extent of exterior deterioration, corrosion, and loss of operability is not fully apparent in interior photos. Replacement parts for existing windows are unavailable, making restoration of thermal and operable functionality impossible, and long-term maintenance infeasible. Recommendation is for replacement, for quality of life of future tenants and for feasibility of long-term maintenance.
- See Window Assessment (Blackberry) in appendix for further detail and information, including further notes on deterioration beyond repair
- See Appendix for Window Schedule & Measurements

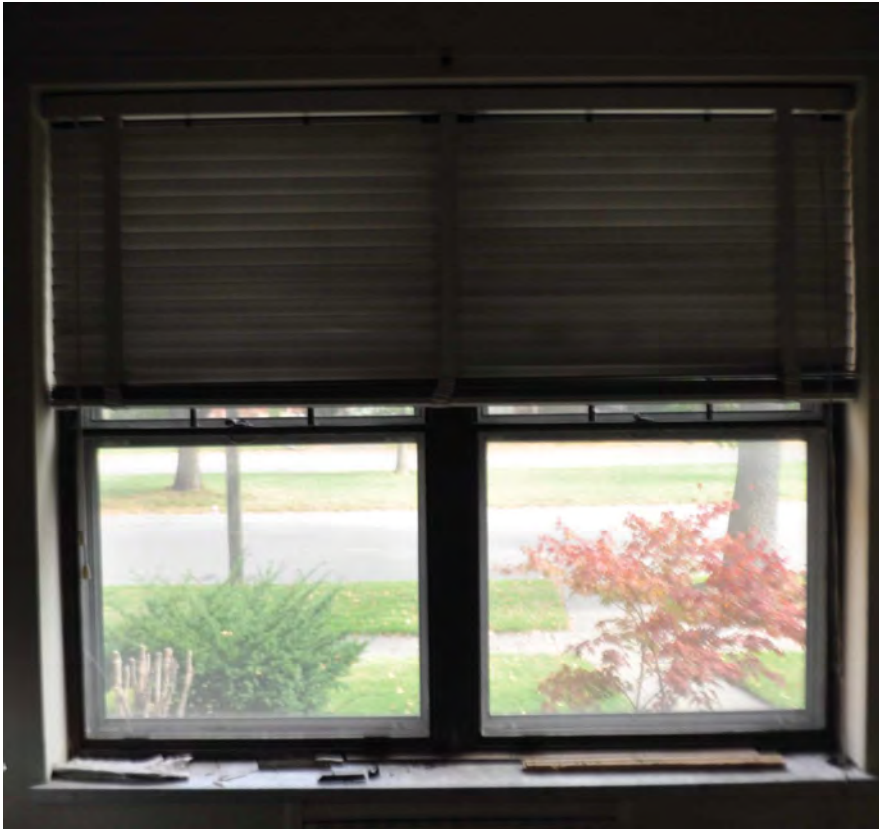
### Window T10, Type P1

- Broken Glass
- Note: Extent of exterior deterioration, corrosion, and loss of operability is not fully apparent in interior photos. Replacement parts for existing windows are unavailable, making restoration of thermal and operable functionality impossible, and long-term maintenance infeasible. Recommendation is for replacement, for quality of life of future tenants and for feasibility of long-term maintenance.
- See Window Assessment (Blackberry) in appendix for further detail and information, including further notes on deterioration beyond repair
- See Appendix for Window Schedule & Measurements

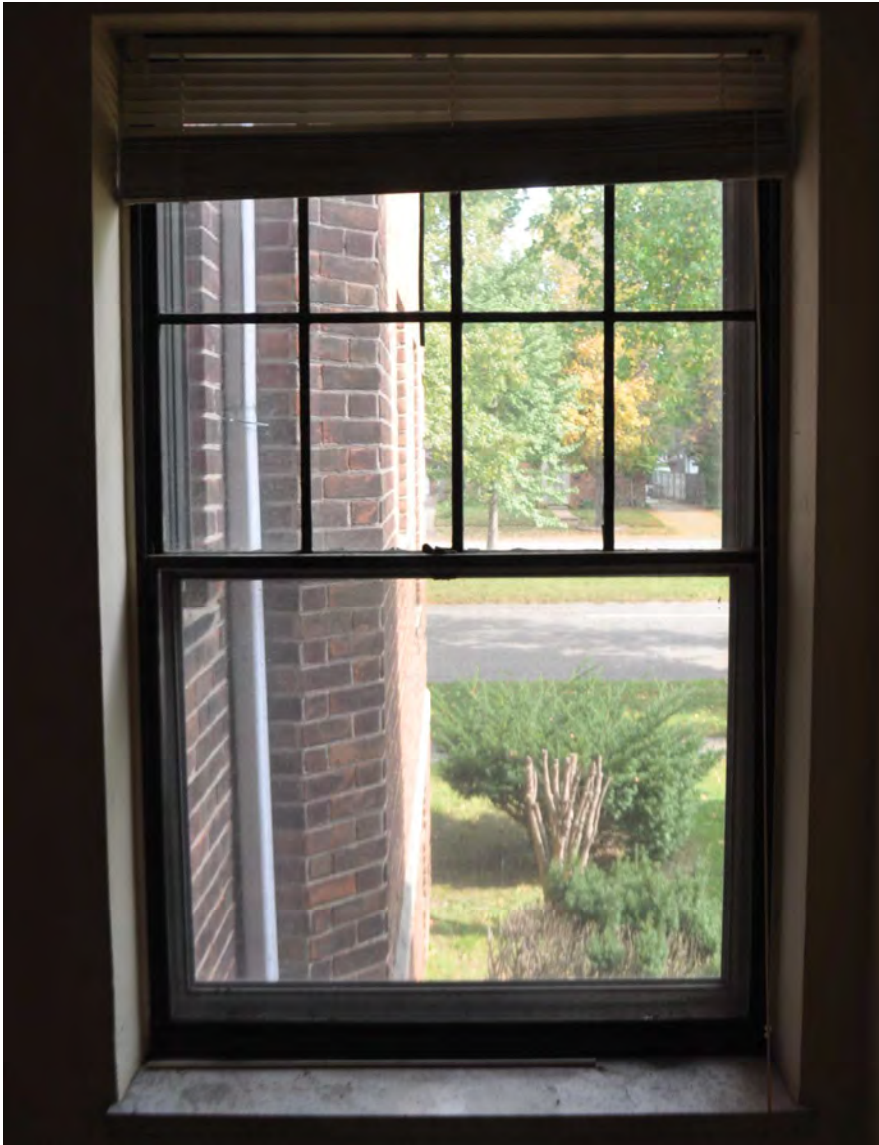
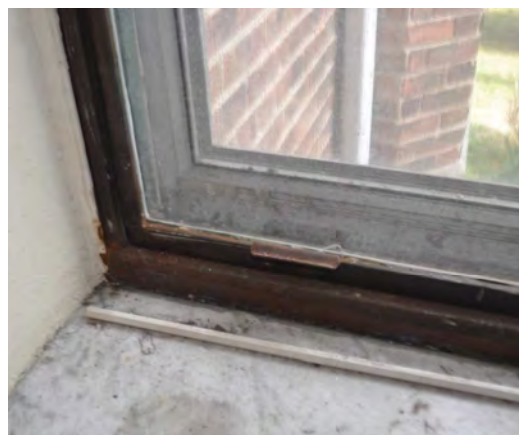
### Window T11, Type R1

- Badly Corroded
- Note: Extent of exterior deterioration, corrosion, and loss of operability is not fully apparent in interior photos. Replacement parts for existing windows are unavailable, making restoration of thermal and operable functionality impossible, and long-term maintenance infeasible. Recommendation is for replacement, for quality of life of future tenants and for feasibility of long-term maintenance.
- See Window Assessment (Blackberry) in appendix for further detail and information, including further notes on deterioration beyond repair
- See Appendix for Window Schedule & Measurements
