# 9710 W Outer Dr

## Existing Condition Photos

# 9730 W Outer Dr

# Detailed Scope of Work

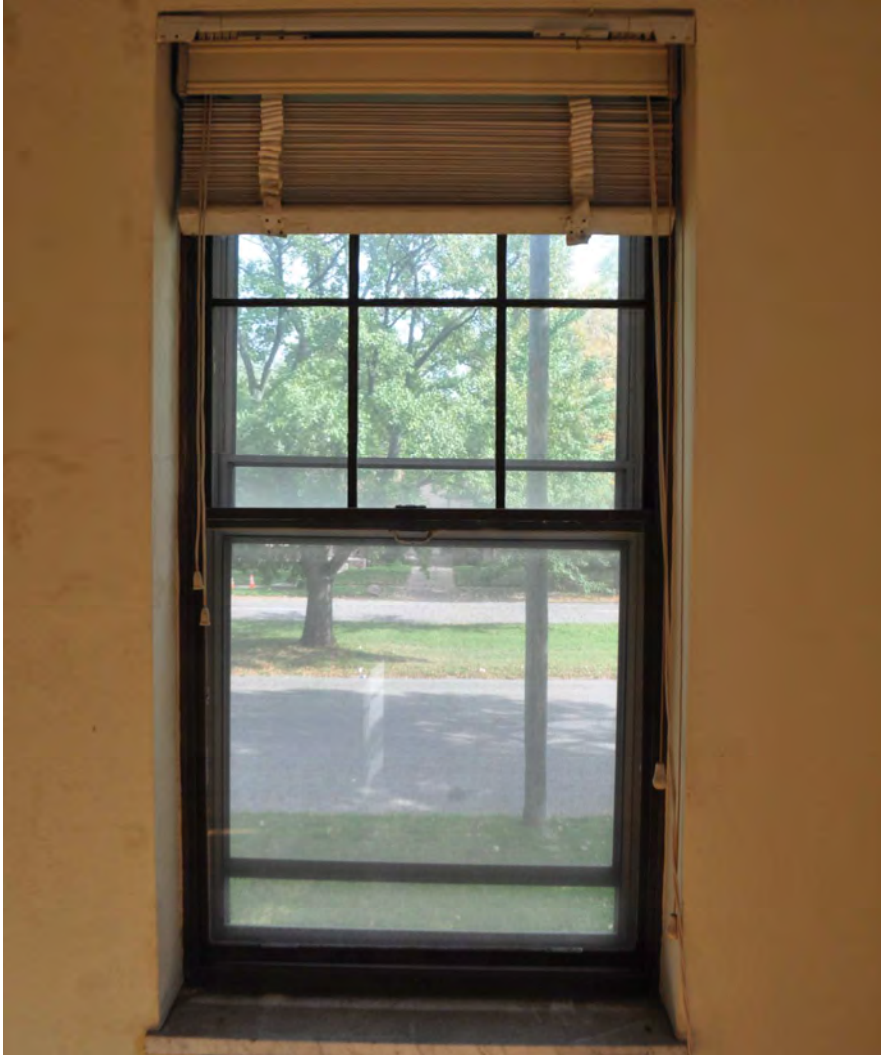
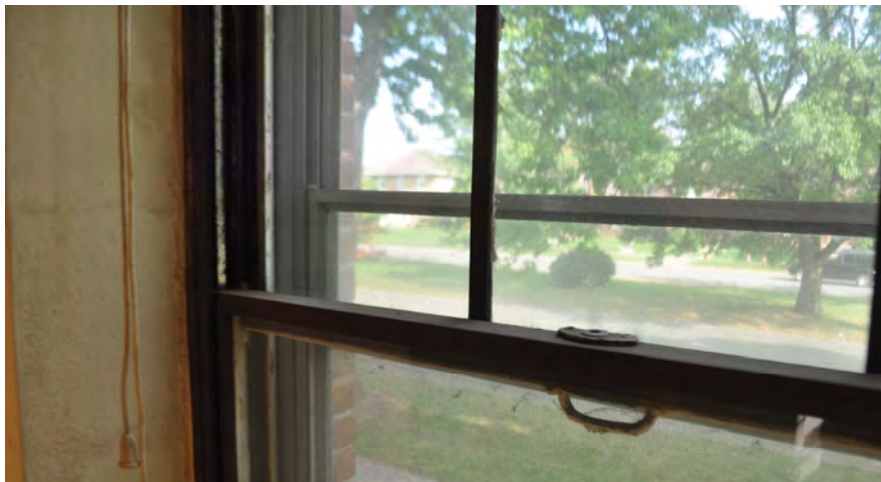
### Window T15, Type N1

- Missing Hardware
- Note: Extent of exterior deterioration, corrosion, and loss of operability is not fully apparent in interior photos. Replacement parts for existing windows are unavailable, making restoration of thermal and operable functionality impossible, and long-term maintenance infeasible. Recommendation is for replacement, for quality of life of future tenants and for feasibility of long-term maintenance.
- See Window Assessment (Blackberry) in appendix for further detail and information, including further notes on deterioration beyond repair
- See Appendix for Window Schedule & Measurements

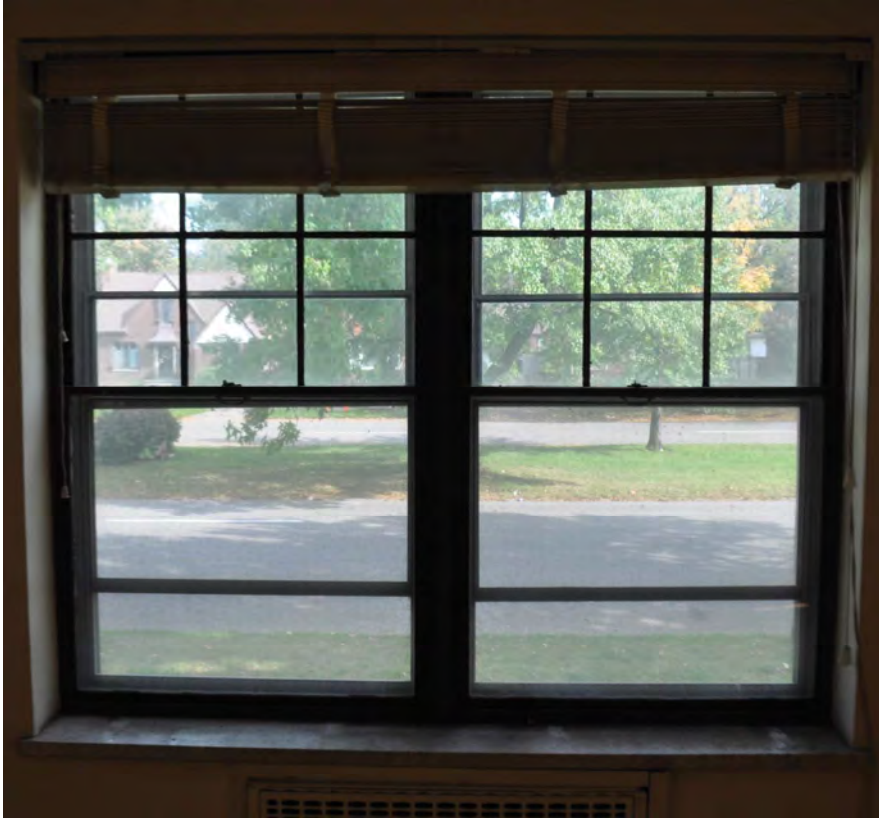
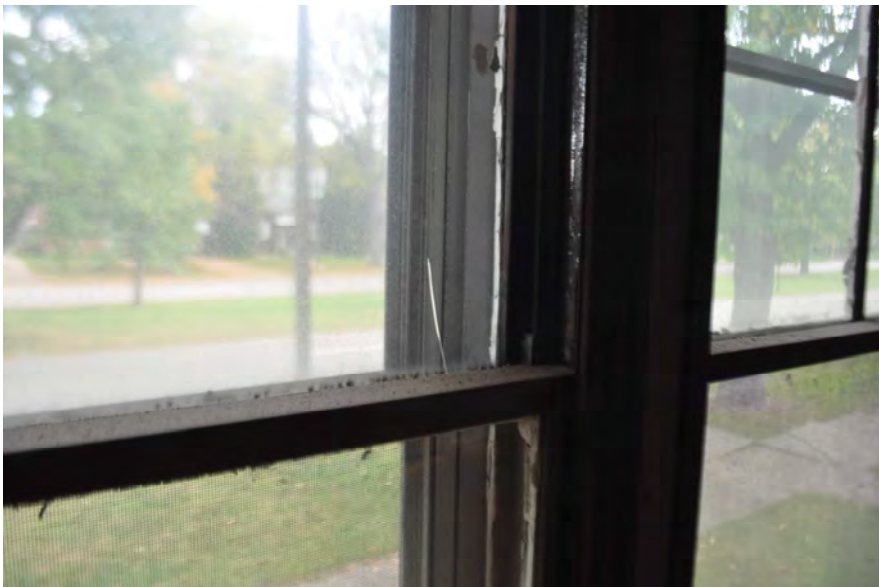
### Window T16, Type P1

- Broken Glass
- Note: Extent of exterior deterioration, corrosion, and loss of operability is not fully apparent in interior photos. Replacement parts for existing windows are unavailable, making restoration of thermal and operable functionality impossible, and long-term maintenance infeasible. Recommendation is for replacement, for quality of life of future tenants and for feasibility of long-term maintenance.
- See Window Assessment (Blackberry) in appendix for further detail and information, including further notes on deterioration beyond repair
- See Appendix for Window Schedule & Measurements

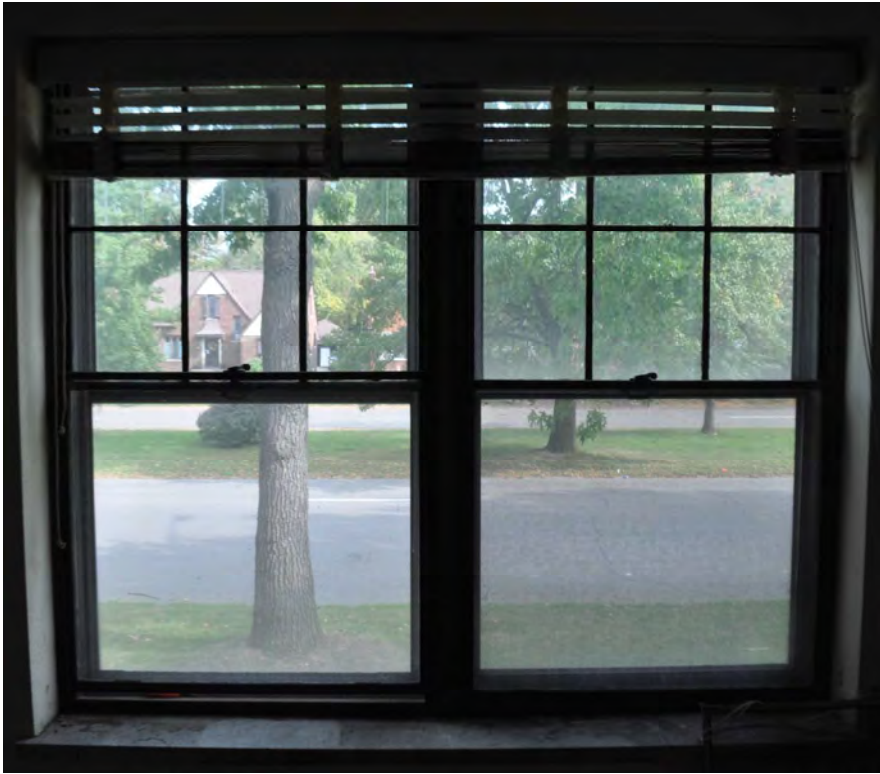
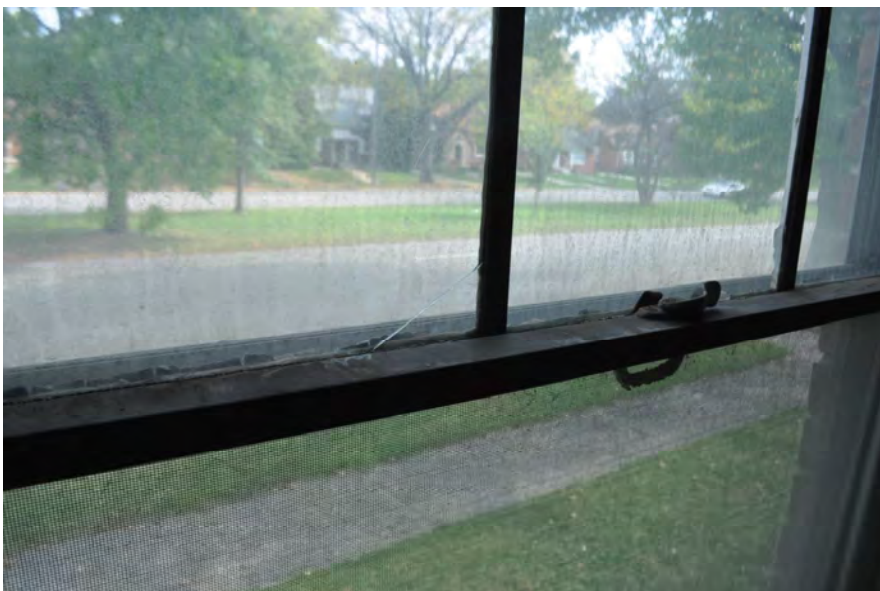
### Window T17, Type P1

- Broken Glass
- Note: Extent of exterior deterioration, corrosion, and loss of operability is not fully apparent in interior photos. Replacement parts for existing windows are unavailable, making restoration of thermal and operable functionality impossible, and long-term maintenance infeasible. Recommendation is for replacement, for quality of life of future tenants and for feasibility of long-term maintenance.
- See Window Assessment (Blackberry) in appendix for further detail and information, including further notes on deterioration beyond repair
- See Appendix for Window Schedule & Measurements

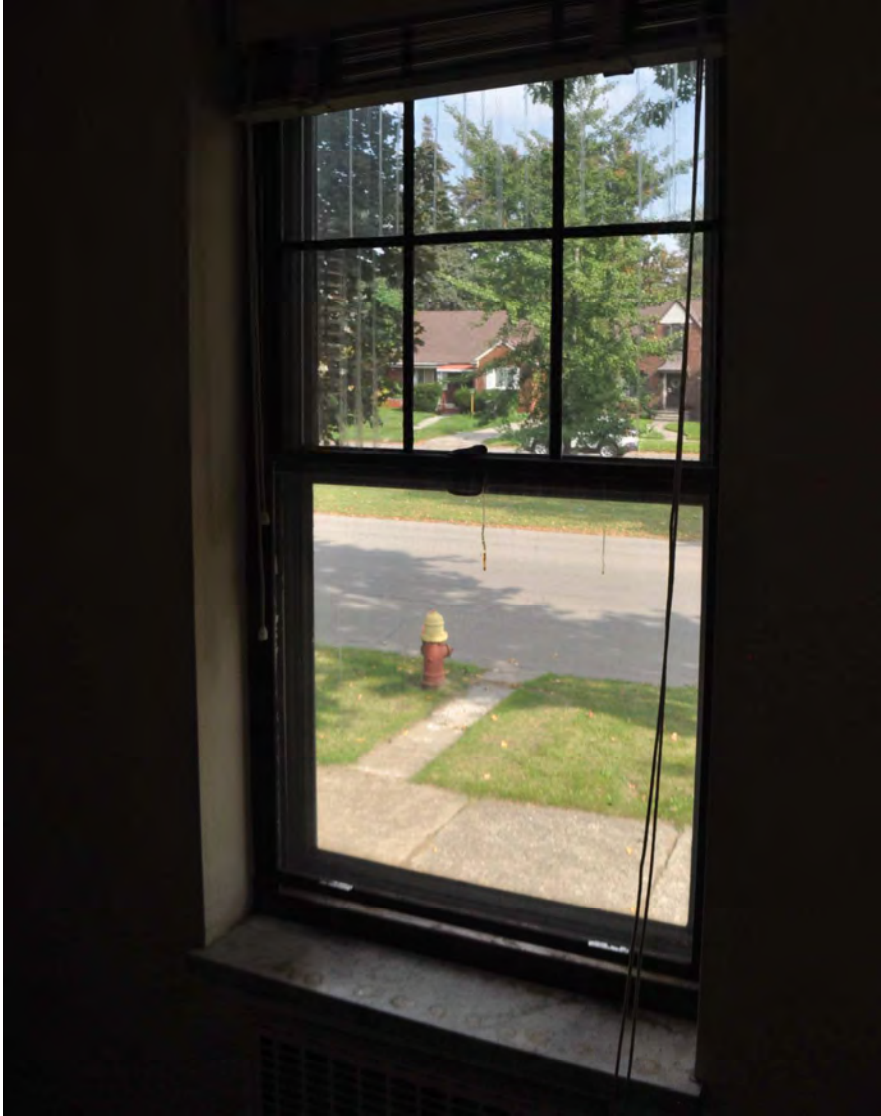
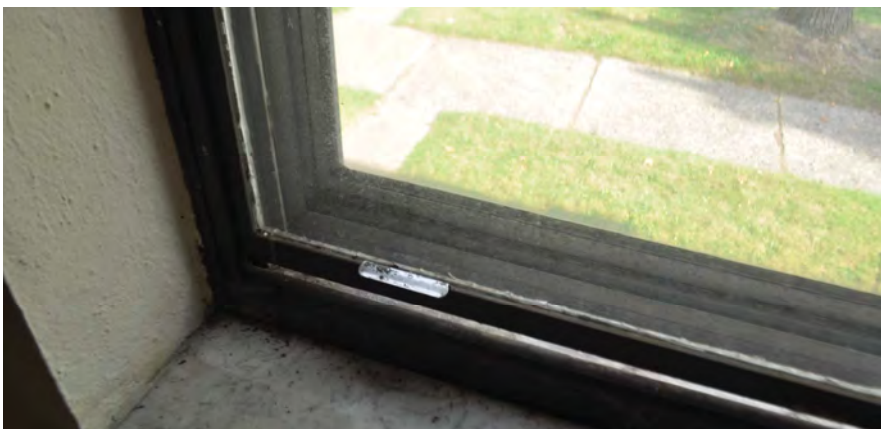
### Window T18, Type N1

- Note: Extent of exterior deterioration, corrosion, and loss of operability is not fully apparent in interior photos. Replacement parts for existing windows are unavailable, making restoration of thermal and operable functionality impossible, and long-term maintenance infeasible. Recommendation is for replacement, for quality of life of future tenants and for feasibility of long-term maintenance.
- See Window Assessment (Blackberry) in appendix for further detail and information, including further notes on deterioration beyond repair
- See Appendix for Window Schedule & Measurements

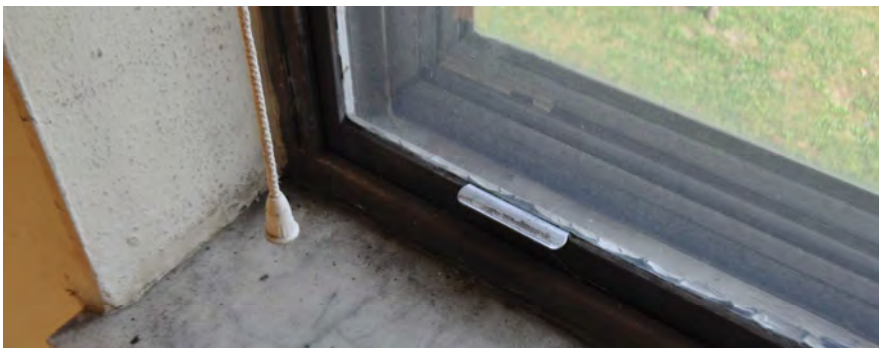
### Window U1, Type N1

- Note: Extent of exterior deterioration, corrosion, and loss of operability is not fully apparent in interior photos. Replacement parts for existing windows are unavailable, making restoration of thermal and operable functionality impossible, and long-term maintenance infeasible. Recommendation is for replacement, for quality of life of future tenants and for feasibility of long-term maintenance.
- See Window Assessment (Blackberry) in appendix for further detail and information, including further notes on deterioration beyond repair
- See Appendix for Window Schedule & Measurements

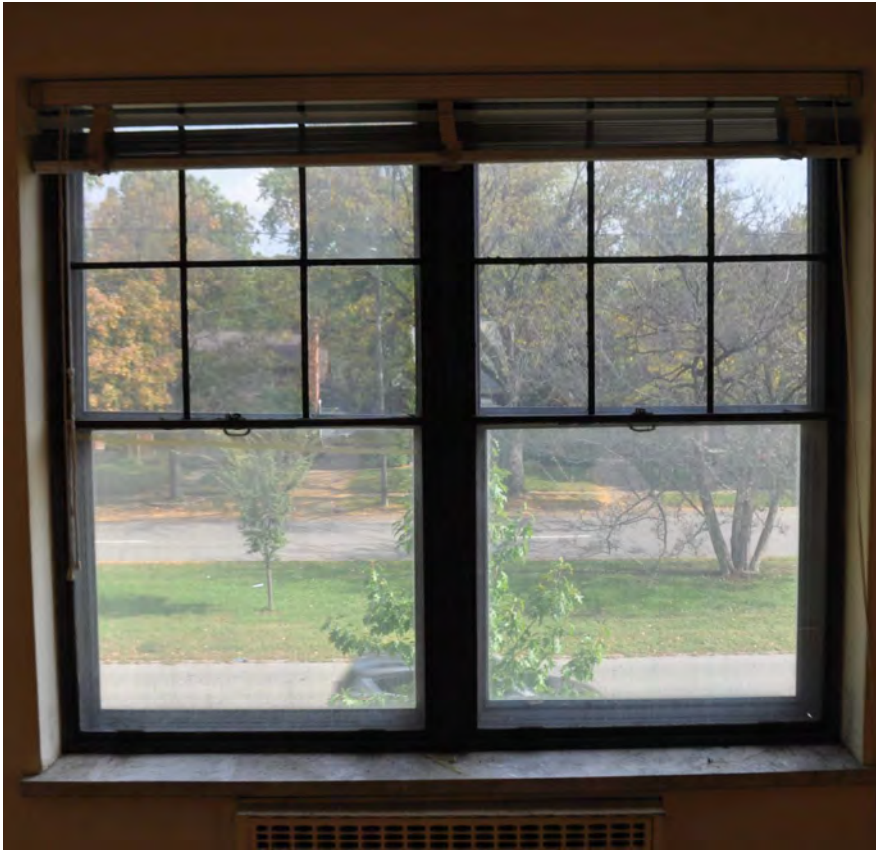
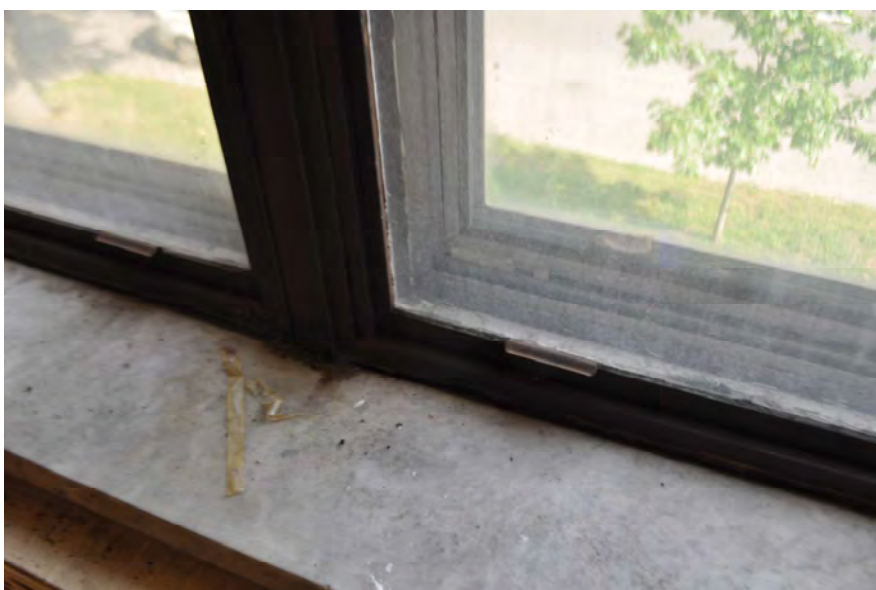
### Window U2, Type P1

- Note: Extent of exterior deterioration, corrosion, and loss of operability is not fully apparent in interior photos. Replacement parts for existing windows are unavailable, making restoration of thermal and operable functionality impossible, and long-term maintenance infeasible. Recommendation is for replacement, for quality of life of future tenants and for feasibility of long-term maintenance.
- See Window Assessment (Blackberry) in appendix for further detail and information, including further notes on deterioration beyond repair
- See Appendix for Window Schedule & Measurements

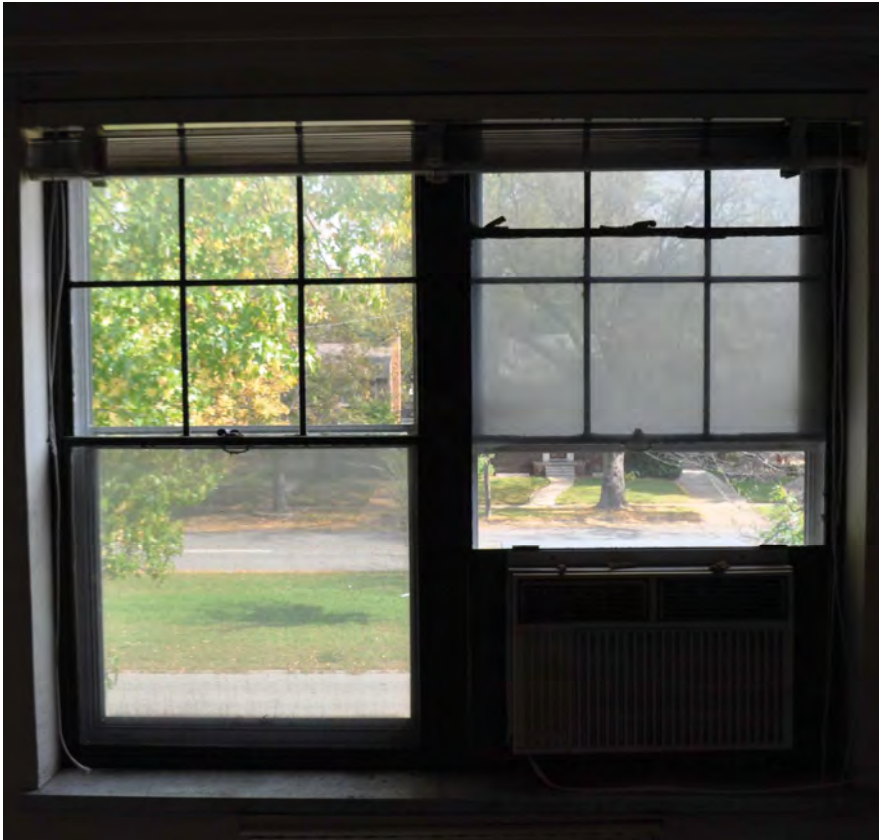
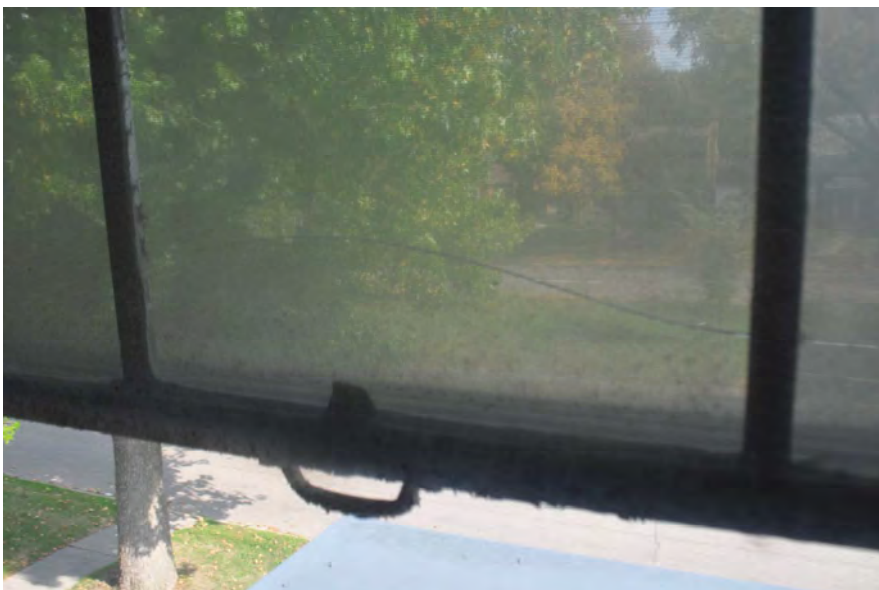
### Window U3, Type P1

- Broken Glass
- Note: Extent of exterior deterioration, corrosion, and loss of operability is not fully apparent in interior photos. Replacement parts for existing windows are unavailable, making restoration of thermal and operable functionality impossible, and long-term maintenance infeasible. Recommendation is for replacement, for quality of life of future tenants and for feasibility of long-term maintenance.
- See Window Assessment (Blackberry) in appendix for further detail and information, including further notes on deterioration beyond repair
- See Appendix for Window Schedule & Measurements

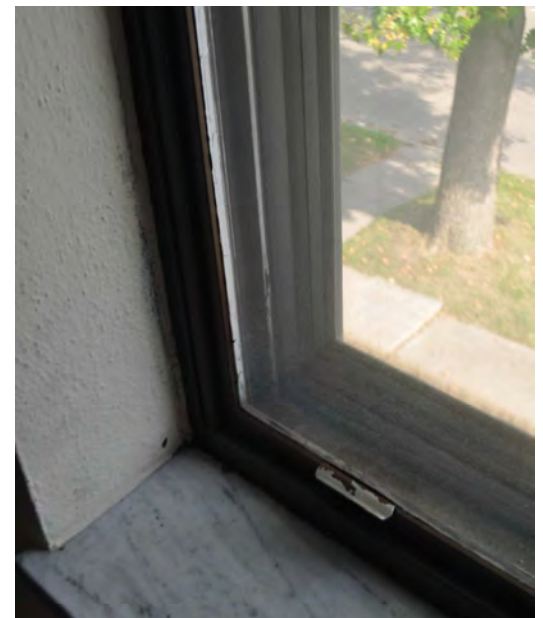
### Window U4, Type N1

- Note: Extent of exterior deterioration, corrosion, and loss of operability is not fully apparent in interior photos. Replacement parts for existing windows are unavailable, making restoration of thermal and operable functionality impossible, and long-term maintenance infeasible. Recommendation is for replacement, for quality of life of future tenants and for feasibility of long-term maintenance.
- See Window Assessment (Blackberry) in appendix for further detail and information, including further notes on deterioration beyond repair
- See Appendix for Window Schedule & Measurements

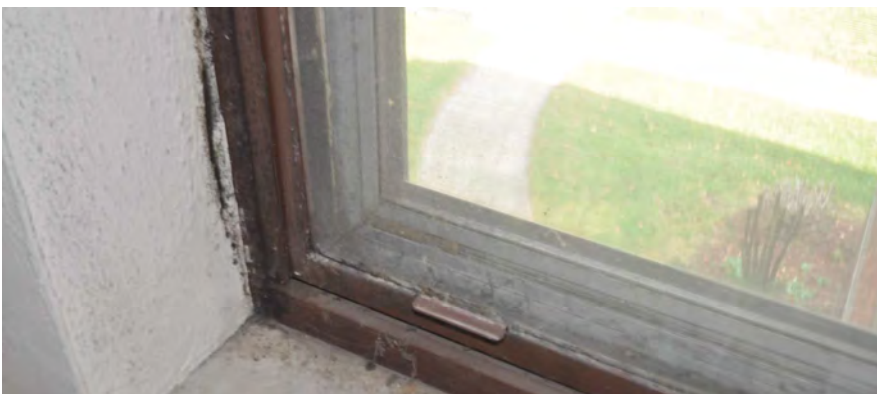
### Window U8, Type R1

- Note: Extent of exterior deterioration, corrosion, and loss of operability is not fully apparent in interior photos. Replacement parts for existing windows are unavailable, making restoration of thermal and operable functionality impossible, and long-term maintenance infeasible. Recommendation is for replacement, for quality of life of future tenants and for feasibility of long-term maintenance.
- See Window Assessment (Blackberry) in appendix for further detail and information, including further notes on deterioration beyond repair
- See Appendix for Window Schedule & Measurements

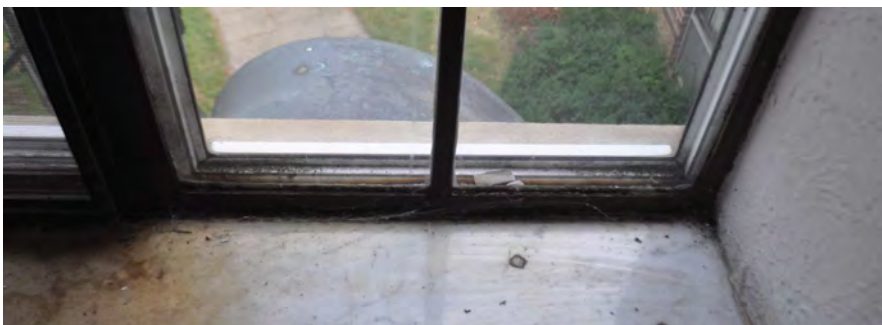
### Window U9, Type S5

- Existing Fixed Window at Common Area Stairwell to be repaired
- See Appendix for Window Schedule & Measurements
- See Window Assessment & Survey by Blackberry in appendices for further details and information

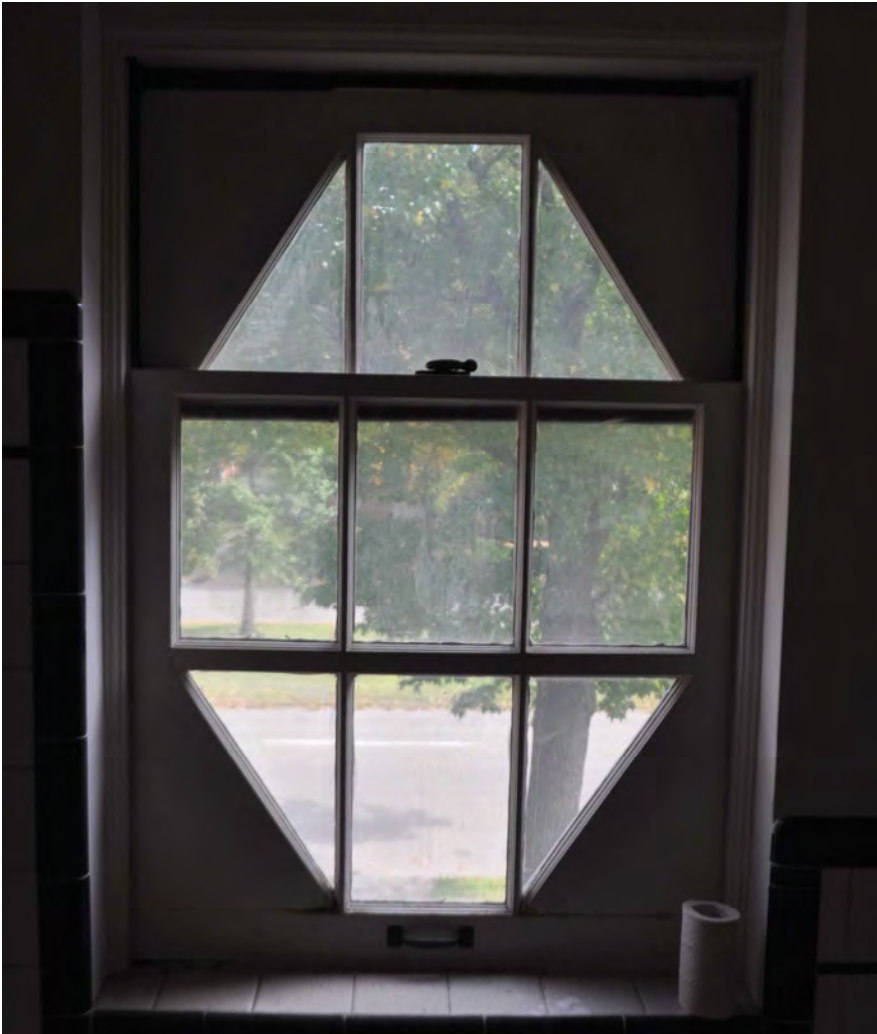
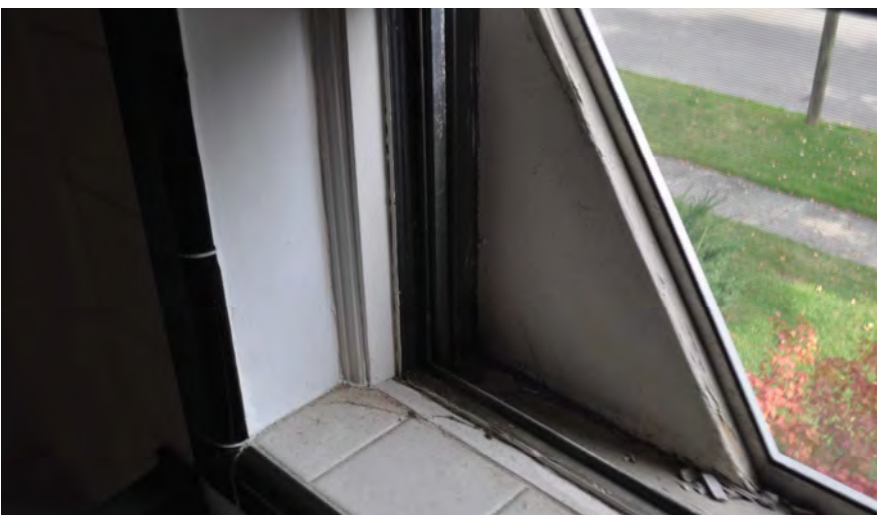
### Window U10, Type S6

- Note: Extent of exterior deterioration, corrosion, and loss of operability is not fully apparent in interior photos. Replacement parts for existing windows are unavailable, making restoration of thermal and operable functionality impossible, and long-term maintenance infeasible. Recommendation is for replacement, for quality of life of future tenants and for feasibility of long-term maintenance.
- See Window Assessment (Blackberry) in appendix for further detail and information, including further notes on deterioration beyond repair
- See Appendix for Window Schedule & Measurements

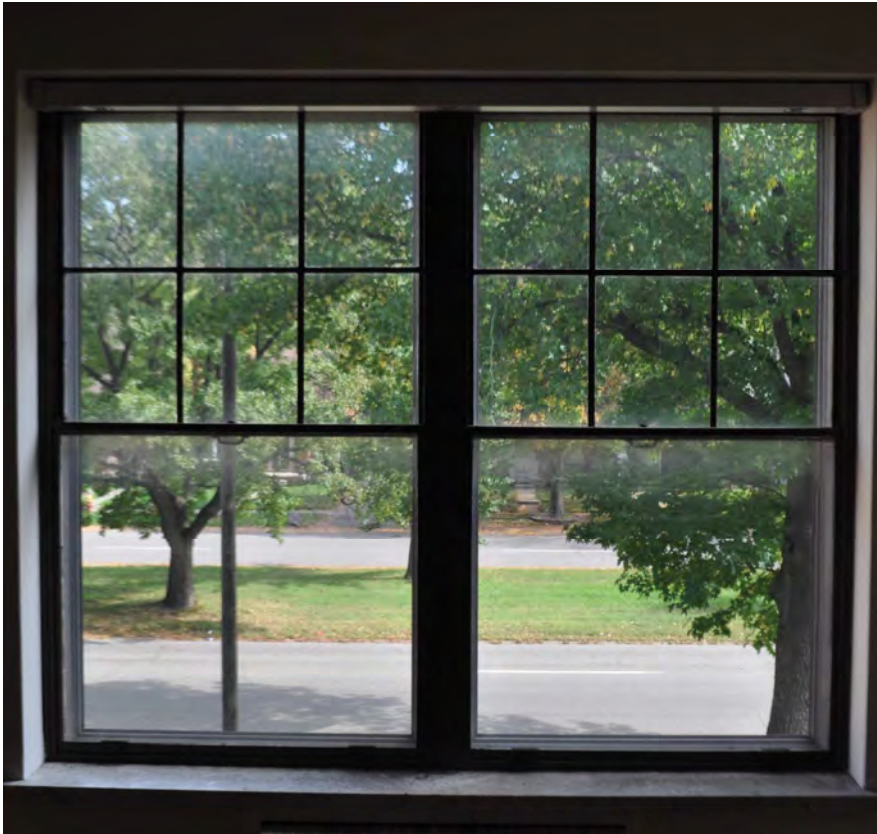
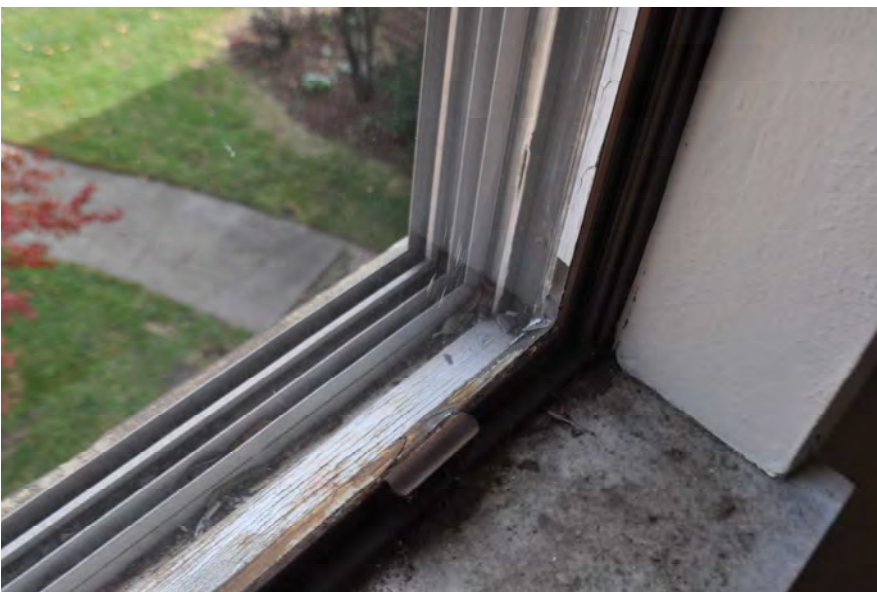
### Window U11, Type P1

- Note: Extent of exterior deterioration, corrosion, and loss of operability is not fully apparent in interior photos. Replacement parts for existing windows are unavailable, making restoration of thermal and operable functionality impossible, and long-term maintenance infeasible. Recommendation is for replacement, for quality of life of future tenants and for feasibility of long-term maintenance.
- See Window Assessment (Blackberry) in appendix for further detail and information, including further notes on deterioration beyond repair
- See Appendix for Window Schedule & Measurements

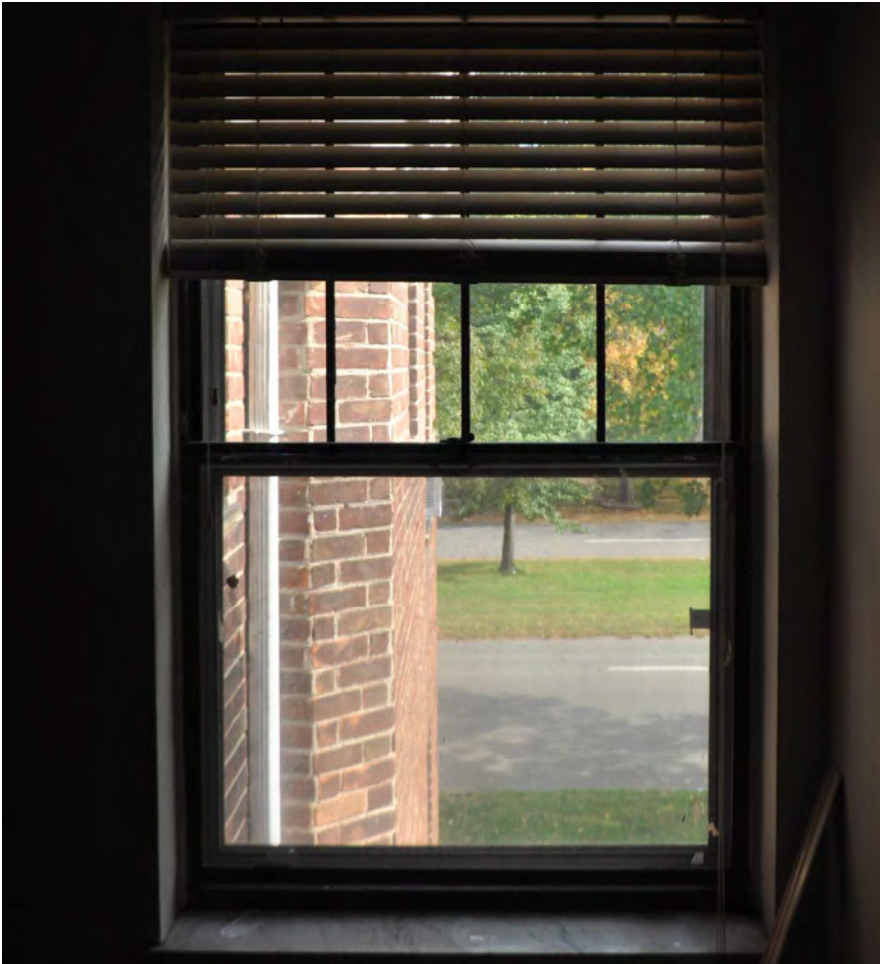
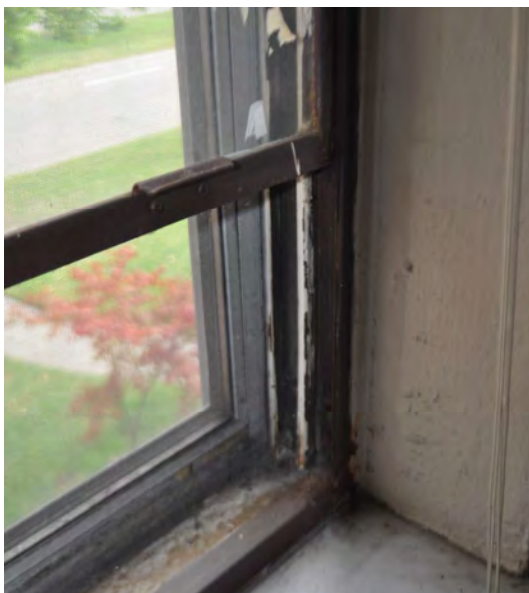
### Window U12, Type R1

- Note: Extent of exterior deterioration, corrosion, and loss of operability is not fully apparent in interior photos. Replacement parts for existing windows are unavailable, making restoration of thermal and operable functionality impossible, and long-term maintenance infeasible. Recommendation is for replacement, for quality of life of future tenants and for feasibility of long-term maintenance.
- See Window Assessment (Blackberry) in appendix for further detail and information, including further notes on deterioration beyond repair
- See Appendix for Window Schedule & Measurements

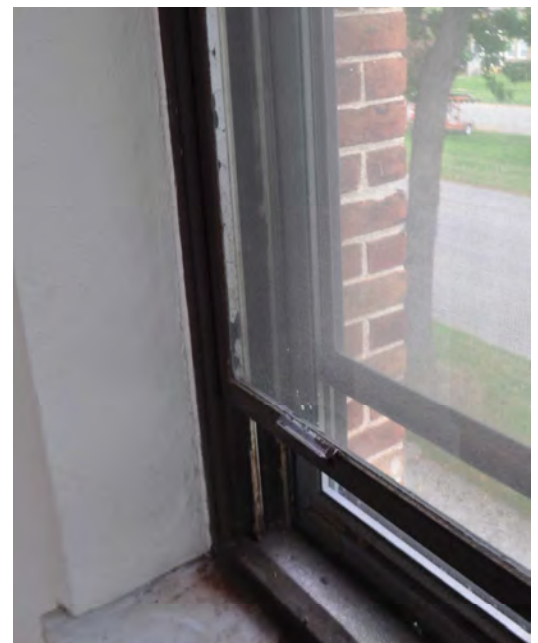
### Window U16, Type N1

- Note: Extent of exterior deterioration, corrosion, and loss of operability is not fully apparent in interior photos. Replacement parts for existing windows are unavailable, making restoration of thermal and operable functionality impossible, and long-term maintenance infeasible. Recommendation is for replacement, for quality of life of future tenants and for feasibility of long-term maintenance.
- See Window Assessment (Blackberry) in appendix for further detail and information, including further notes on deterioration beyond repair
- See Appendix for Window Schedule & Measurements

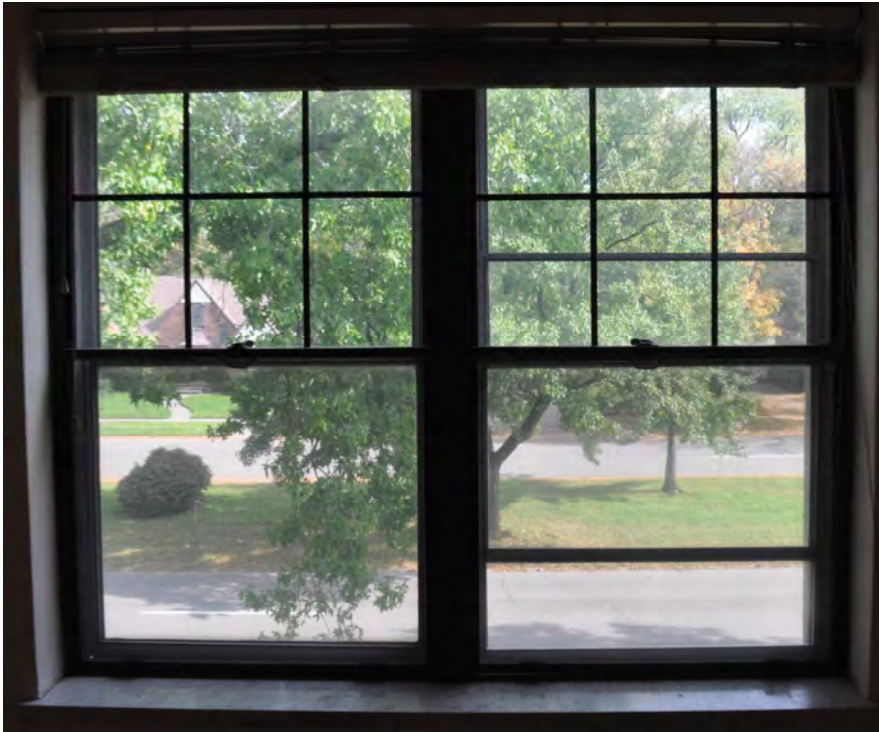
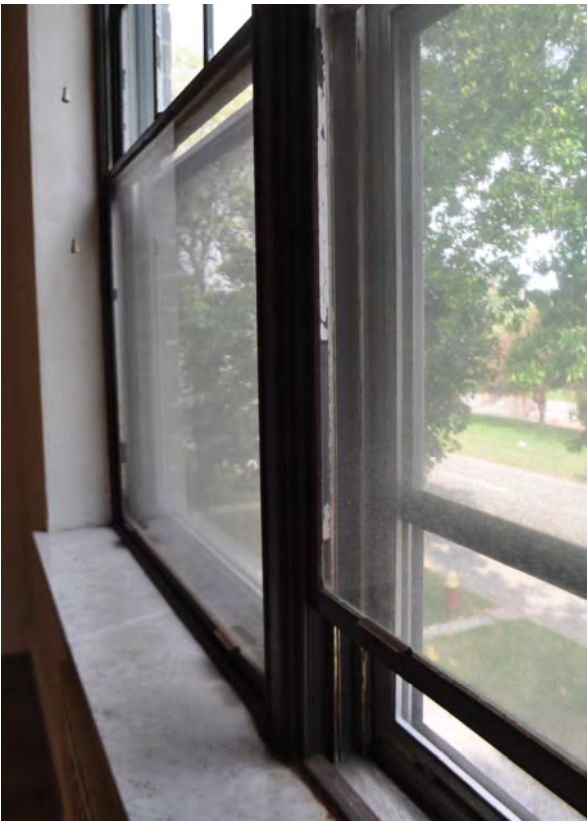
### Window U17, Type P1

- Note: Extent of exterior deterioration, corrosion, and loss of operability is not fully apparent in interior photos. Replacement parts for existing windows are unavailable, making restoration of thermal and operable functionality impossible, and long-term maintenance infeasible. Recommendation is for replacement, for quality of life of future tenants and for feasibility of long-term maintenance.
- See Window Assessment (Blackberry) in appendix for further detail and information, including further notes on deterioration beyond repair
- See Appendix for Window Schedule & Measurements

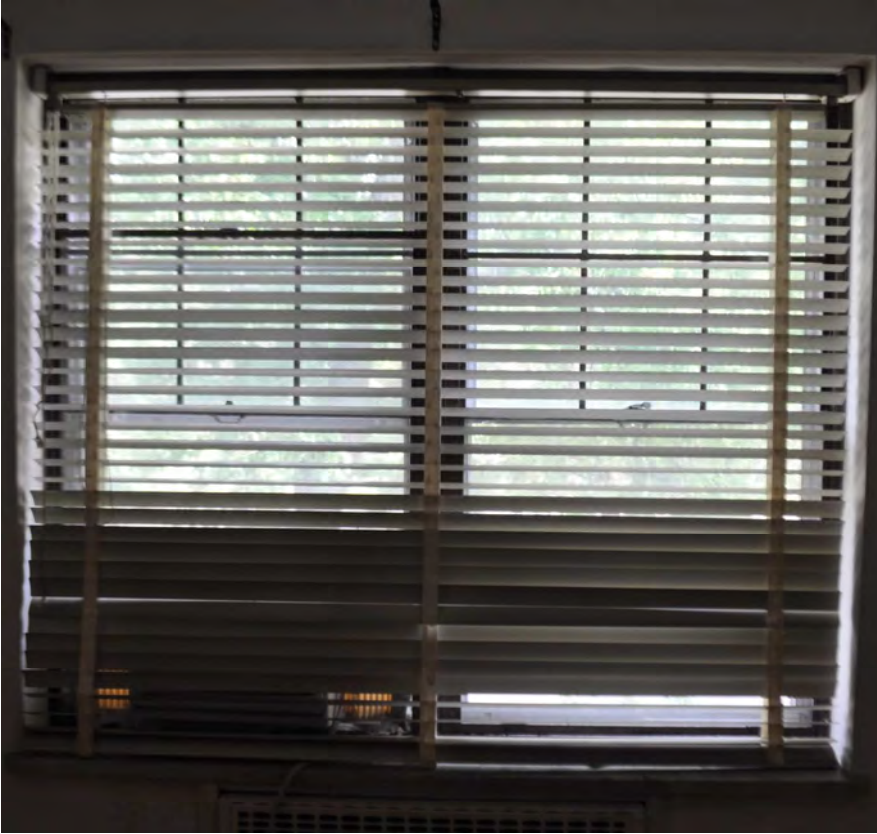
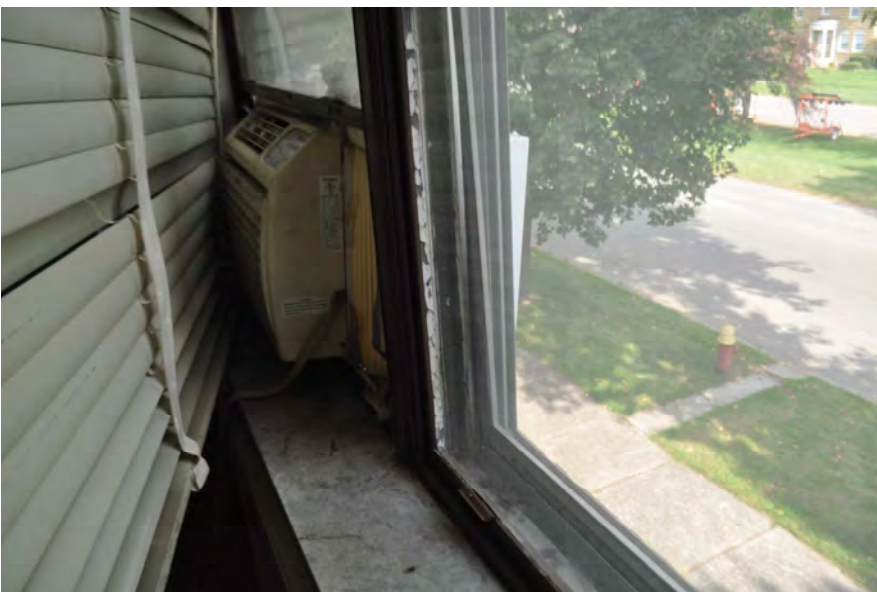
### Window U18, Type P1

- Note: Extent of exterior deterioration, corrosion, and loss of operability is not fully apparent in interior photos. Replacement parts for existing windows are unavailable, making restoration of thermal and operable functionality impossible, and long-term maintenance infeasible. Recommendation is for replacement, for quality of life of future tenants and for feasibility of long-term maintenance.
- See Window Assessment (Blackberry) in appendix for further detail and information, including further notes on deterioration beyond repair
- See Appendix for Window Schedule & Measurements

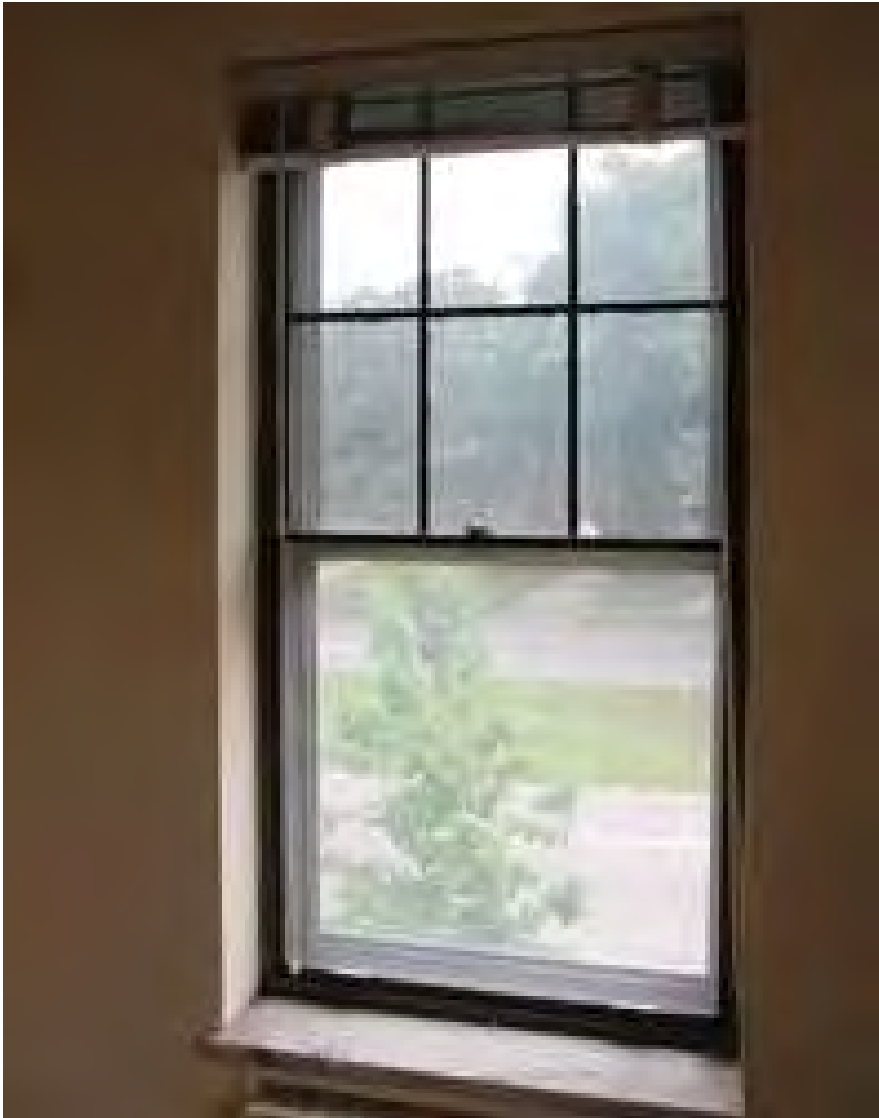
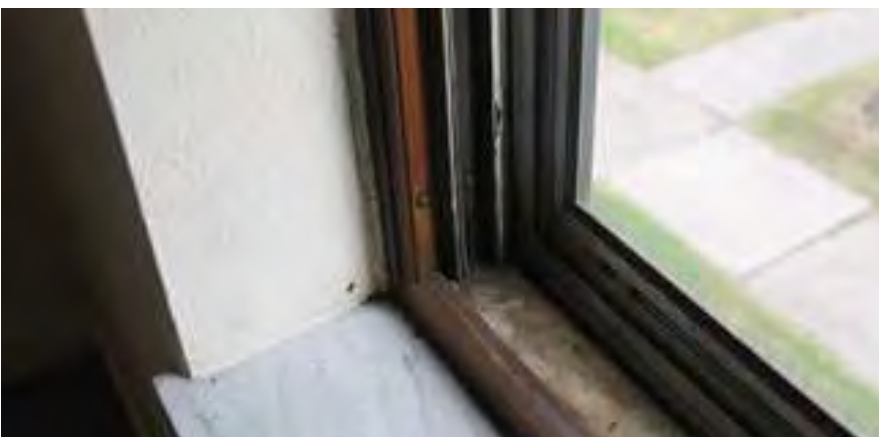
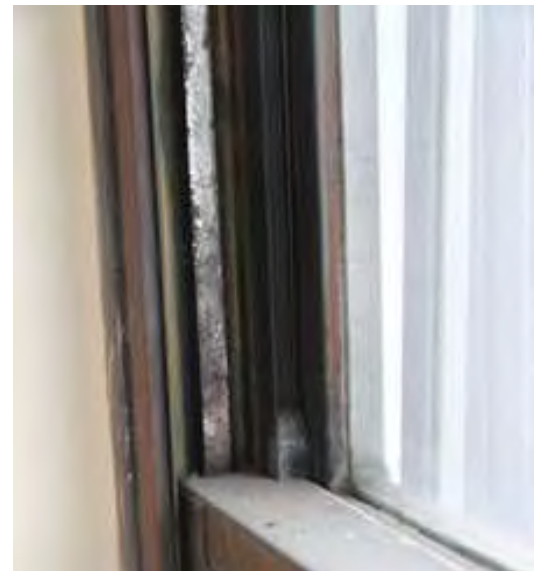
### Window U19, Type N1

- Interior Rusted Balance Tape
- See Jamb Track
- Note: Extent of exterior deterioration, corrosion, and loss of operability is not fully apparent in interior photos. Replacement parts for existing windows are unavailable, making restoration of thermal and operable functionality impossible, and long-term maintenance infeasible. Recommendation is for replacement, for quality of life of future tenants and for feasibility of long-term maintenance.
- See Window Assessment (Blackberry) in appendix for further detail and information, including further notes on deterioration beyond repair
- See Appendix for Window Schedule & Measurements

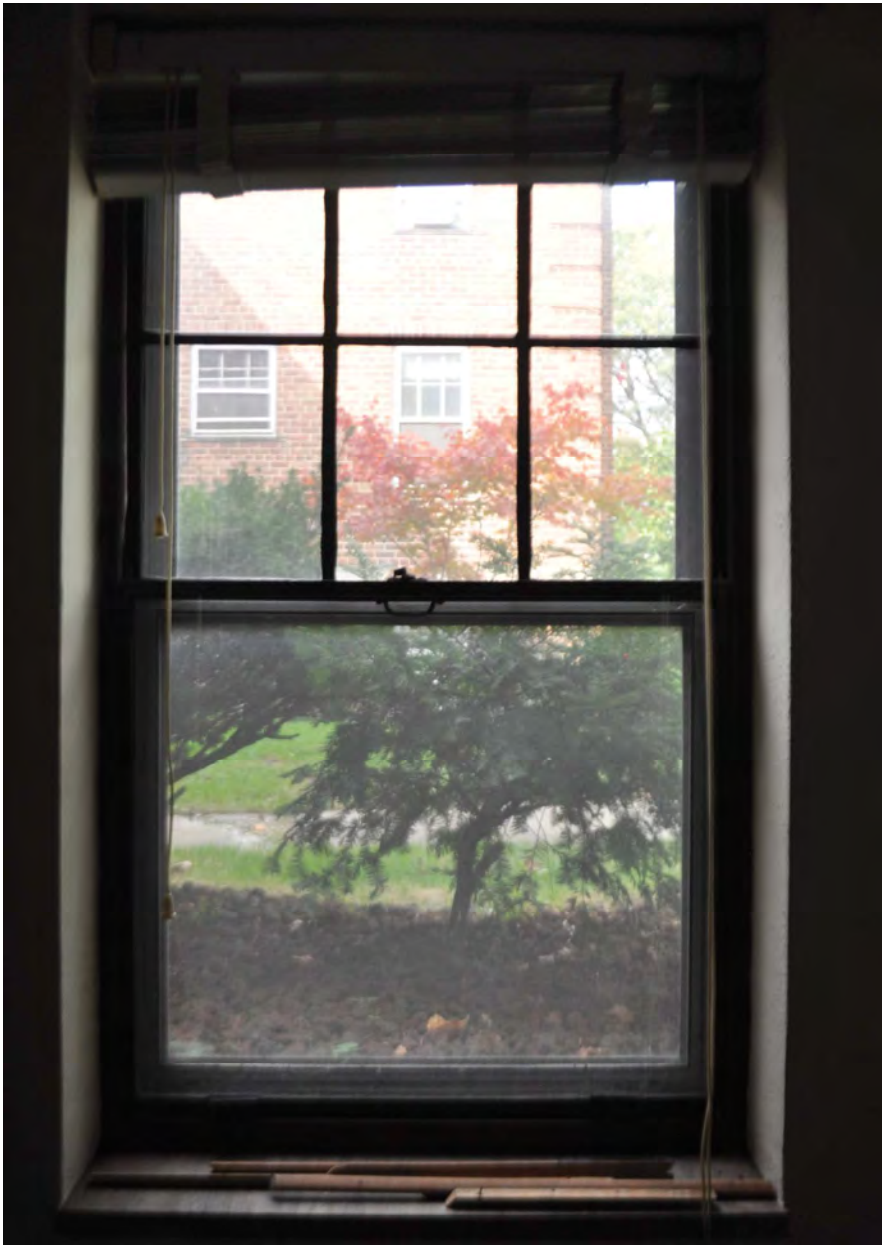
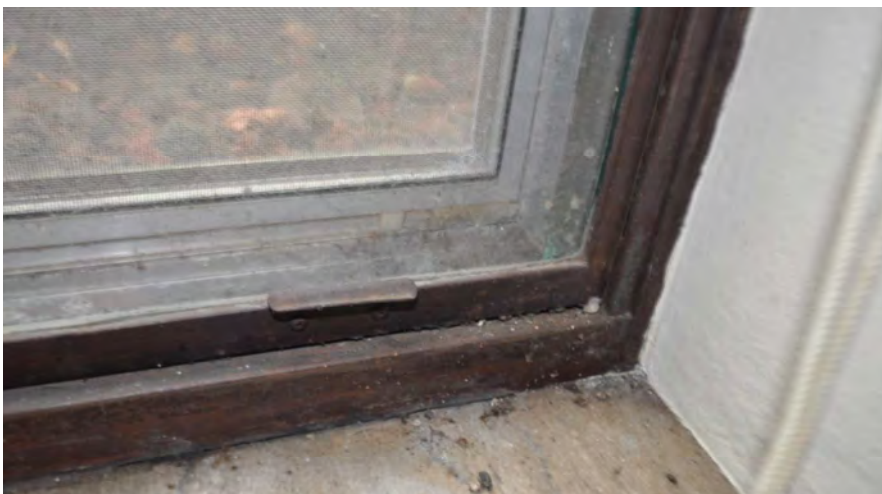
### Window S5, Type U1

- Badly Corroded
- Note: Extent of exterior deterioration, corrosion, and loss of operability is not fully apparent in interior photos. Replacement parts for existing windows are unavailable, making restoration of thermal and operable functionality impossible, and long-term maintenance infeasible. Recommendation is for replacement, for quality of life of future tenants and for feasibility of long-term maintenance.
- See Window Assessment (Blackberry) in appendix for further detail and information, including further notes on deterioration beyond repair
- See Appendix for Window Schedule & Measurements
