# 9710 W Outer Dr

## Existing Condition Photos

# 9730 W Outer Dr

# Detailed Scope of Work

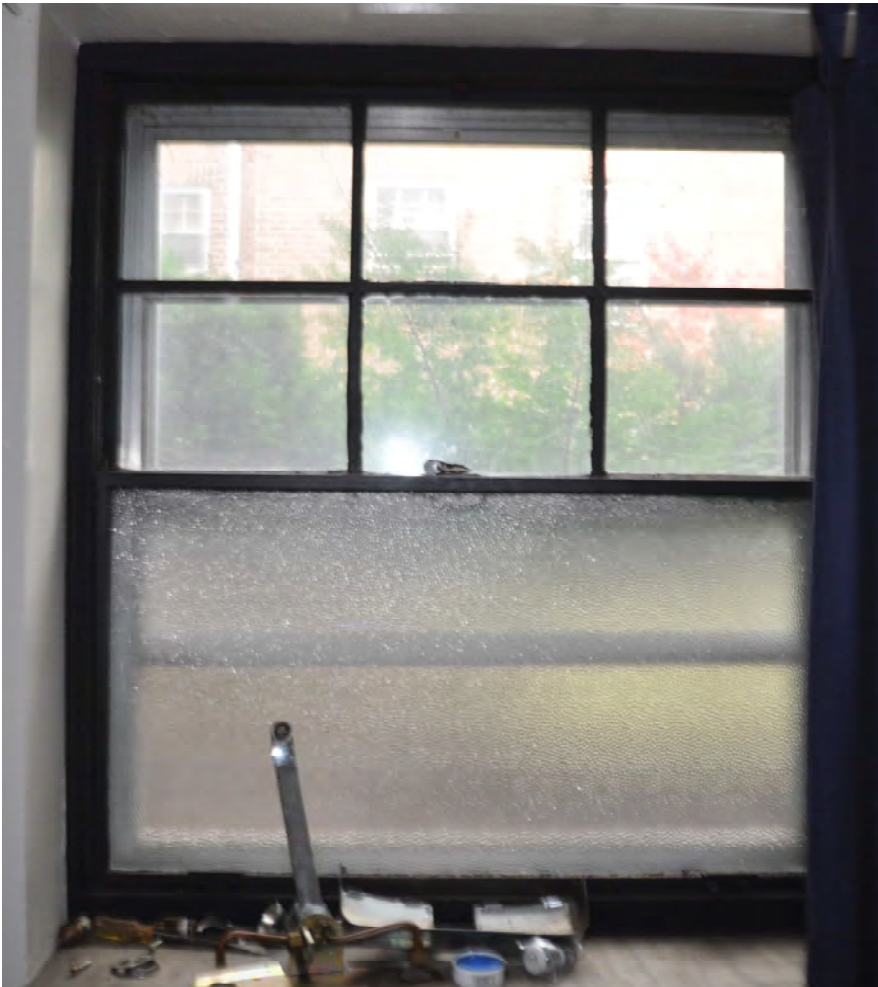
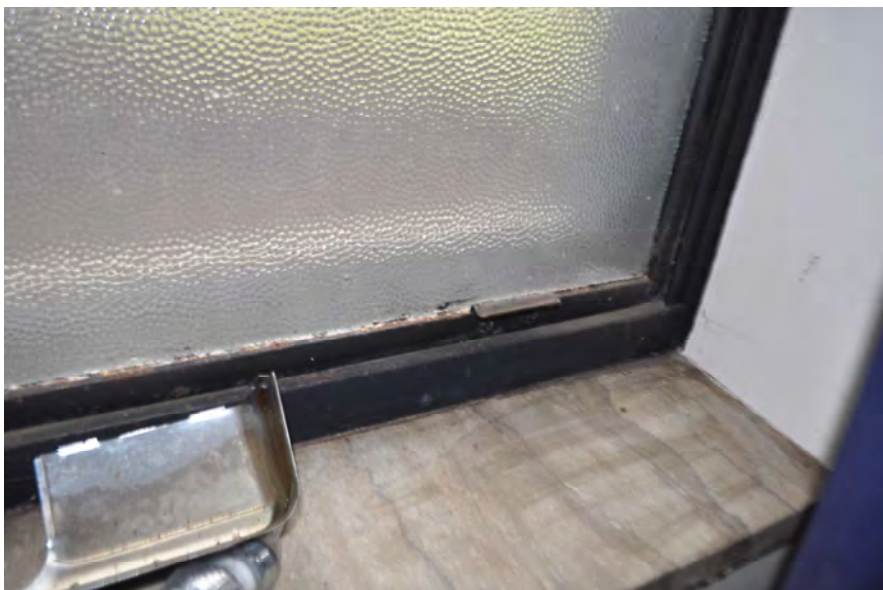
### Window S6, Type T1

- Badly Corroded
- Note: Extent of exterior deterioration, corrosion, and loss of operability is not fully apparent in interior photos. Replacement parts for existing windows are unavailable, making restoration of thermal and operable functionality impossible, and long-term maintenance infeasible. Recommendation is for replacement, for quality of life of future tenants and for feasibility of long-term maintenance.
- See Window Assessment (Blackberry) in appendix for further detail and information, including further notes on deterioration beyond repair
- See Appendix for Window Schedule & Measurements

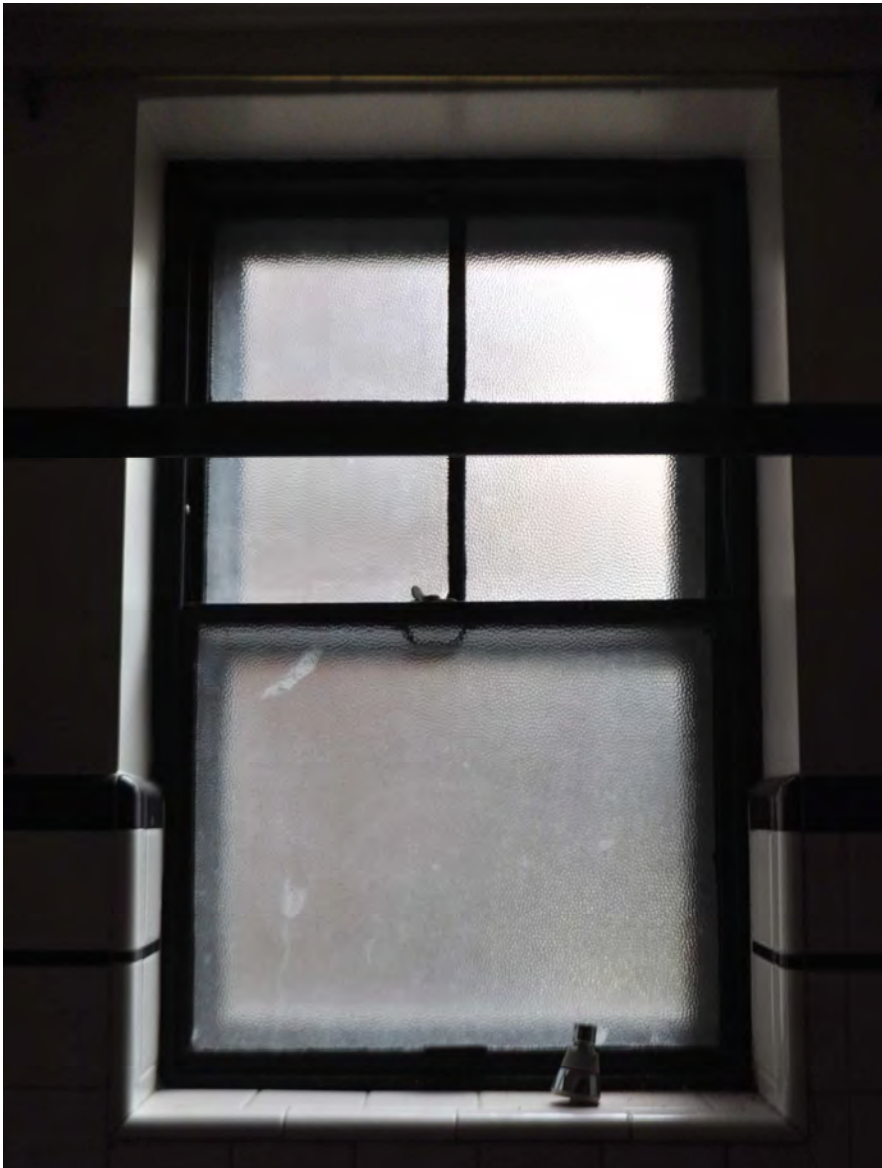
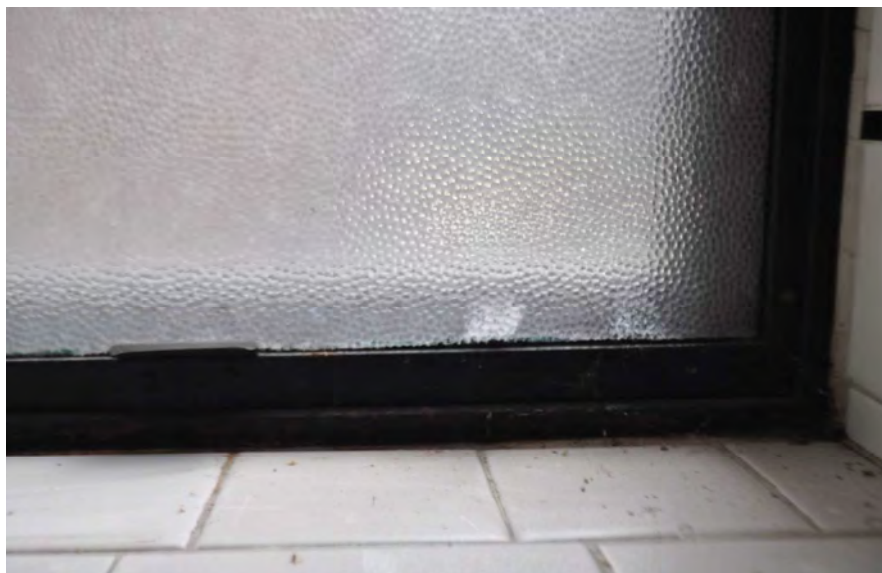
### Window S7, Type M1

- Badly Corroded
- Note: Extent of exterior deterioration, corrosion, and loss of operability is not fully apparent in interior photos. Replacement parts for existing windows are unavailable, making restoration of thermal and operable functionality impossible, and long-term maintenance infeasible. Recommendation is for replacement, for quality of life of future tenants and for feasibility of long-term maintenance.
- See Window Assessment (Blackberry) in appendix for further detail and information, including further notes on deterioration beyond repair
- See Appendix for Window Schedule & Measurements

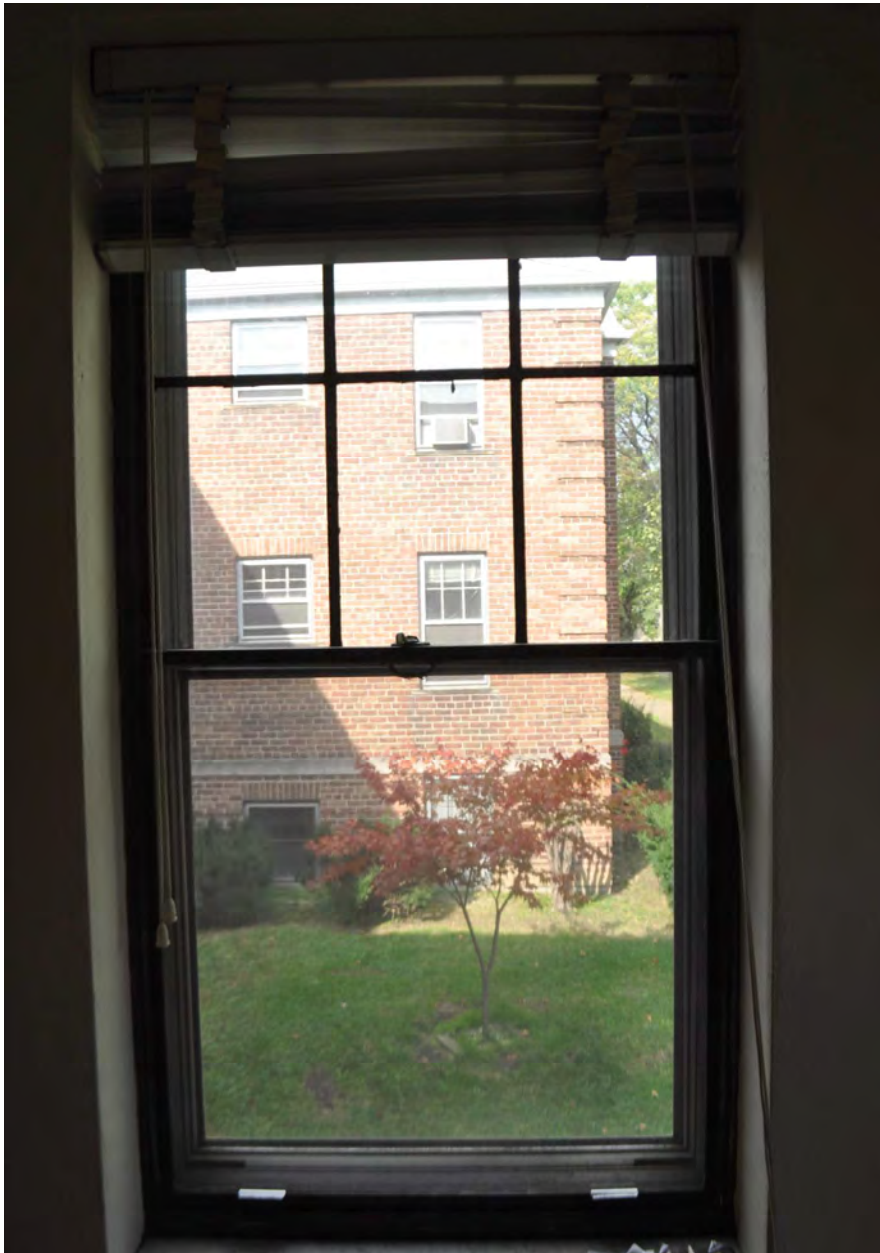
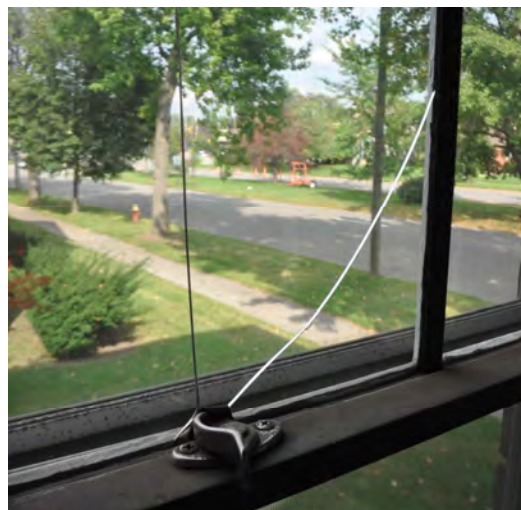
### Window T5, Type U1

- Broken Glass
- Note: Extent of exterior deterioration, corrosion, and loss of operability is not fully apparent in interior photos. Replacement parts for existing windows are unavailable, making restoration of thermal and operable functionality impossible, and long-term maintenance infeasible. Recommendation is for replacement, for quality of life of future tenants and for feasibility of long-term maintenance.
- See Window Assessment (Blackberry) in appendix for further detail and information, including further notes on deterioration beyond repair
- See Appendix for Window Schedule & Measurements

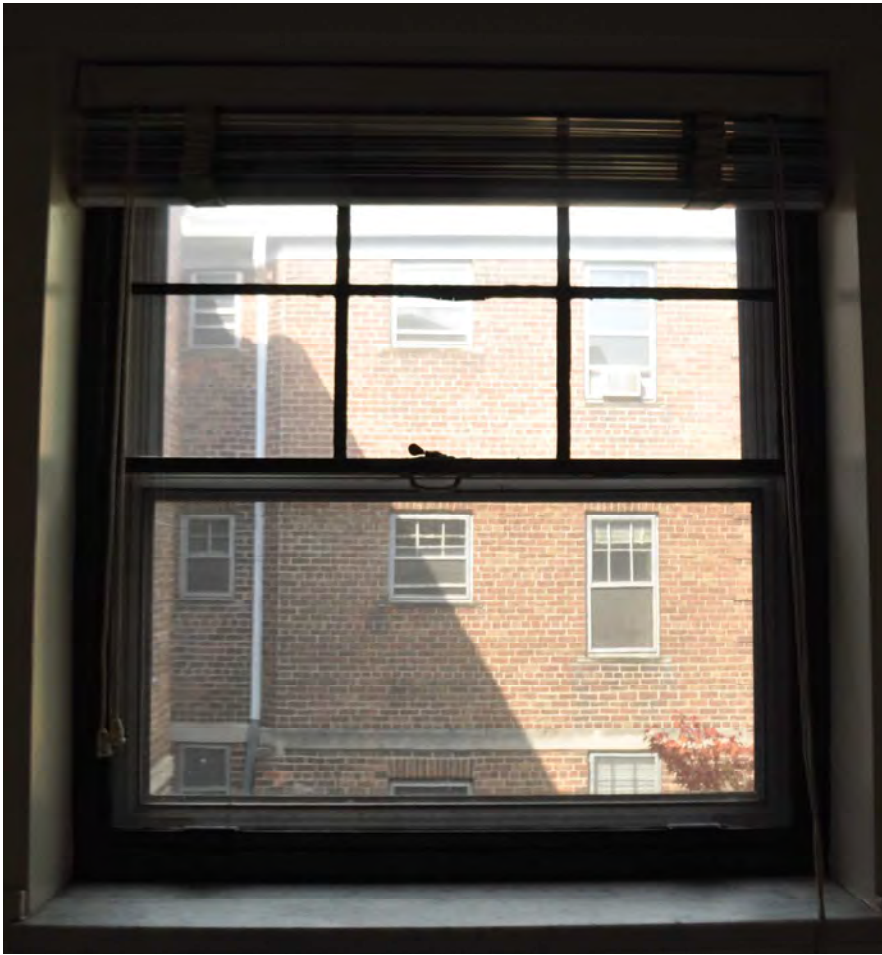
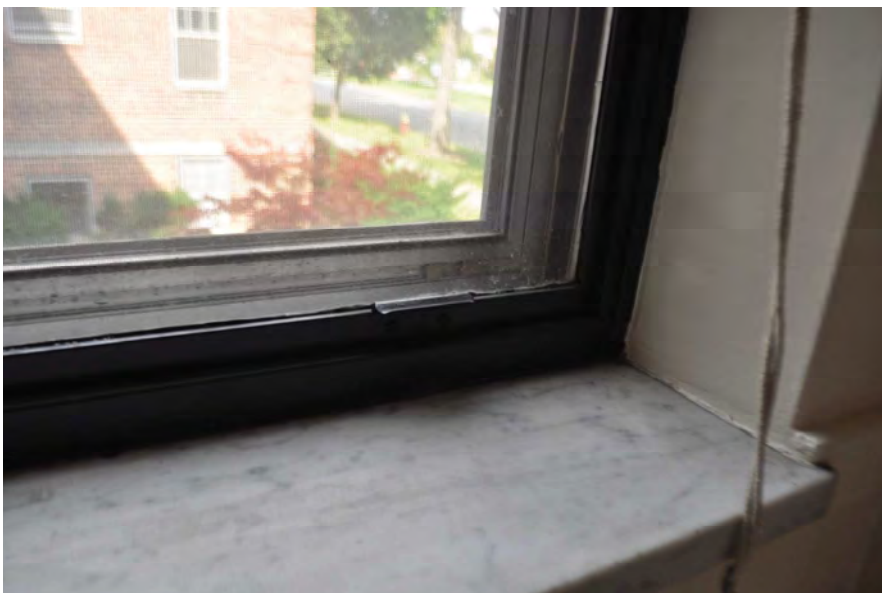
### Window T6, Type T1

- Note: Extent of exterior deterioration, corrosion, and loss of operability is not fully apparent in interior photos. Replacement parts for existing windows are unavailable, making restoration of thermal and operable functionality impossible, and long-term maintenance infeasible. Recommendation is for replacement, for quality of life of future tenants and for feasibility of long-term maintenance.
- See Window Assessment (Blackberry) in appendix for further detail and information, including further notes on deterioration beyond repair
- See Appendix for Window Schedule & Measurements

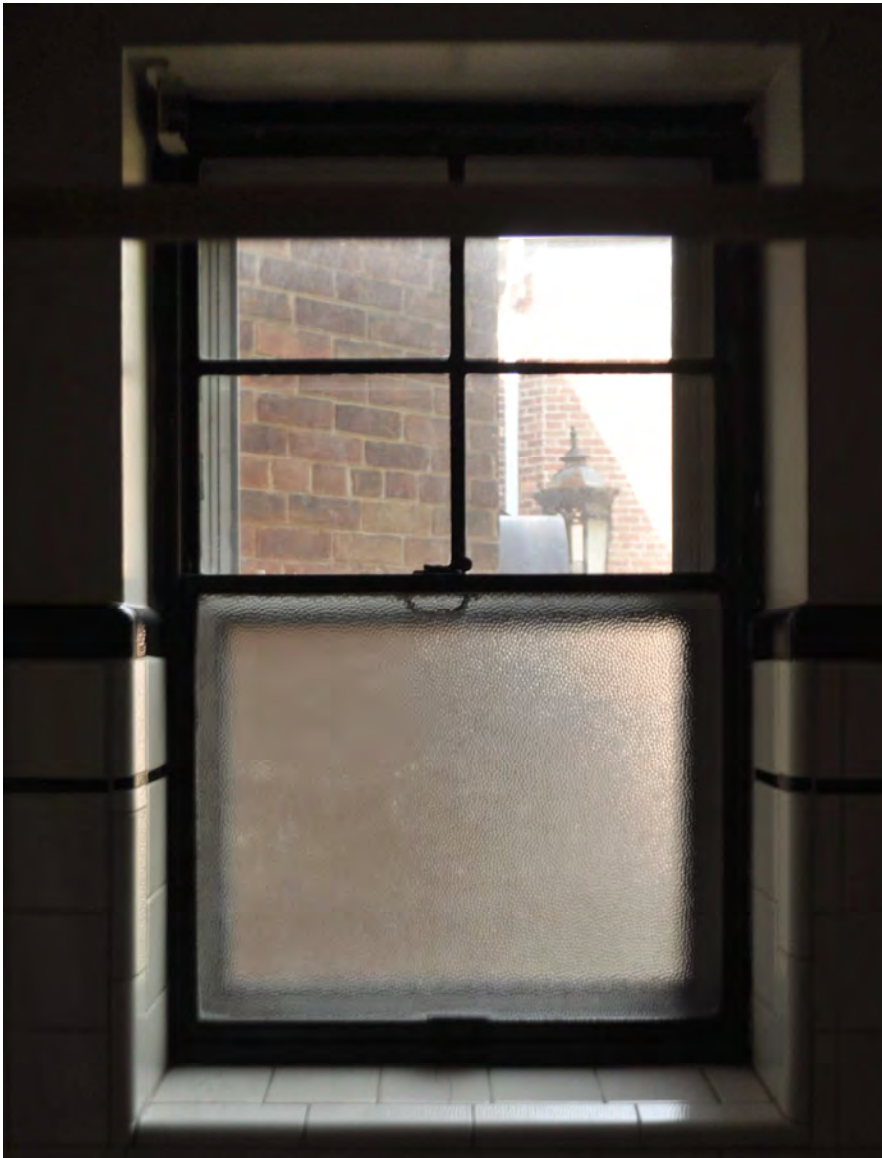
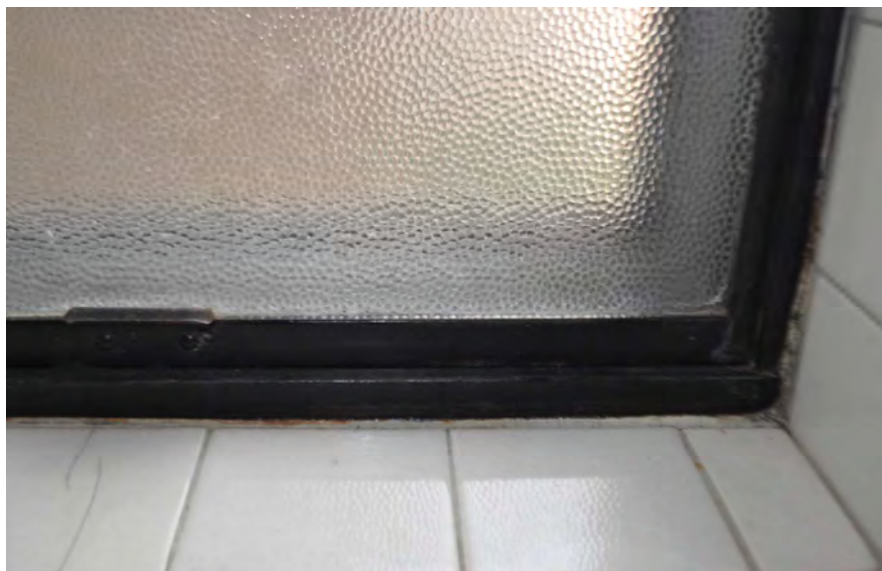
### Window T7, Type N1

- Note: Extent of exterior deterioration, corrosion, and loss of operability is not fully apparent in interior photos. Replacement parts for existing windows are unavailable, making restoration of thermal and operable functionality impossible, and long-term maintenance infeasible. Recommendation is for replacement, for quality of life of future tenants and for feasibility of long-term maintenance.
- See Window Assessment (Blackberry) in appendix for further detail and information, including further notes on deterioration beyond repair
- See Appendix for Window Schedule & Measurements

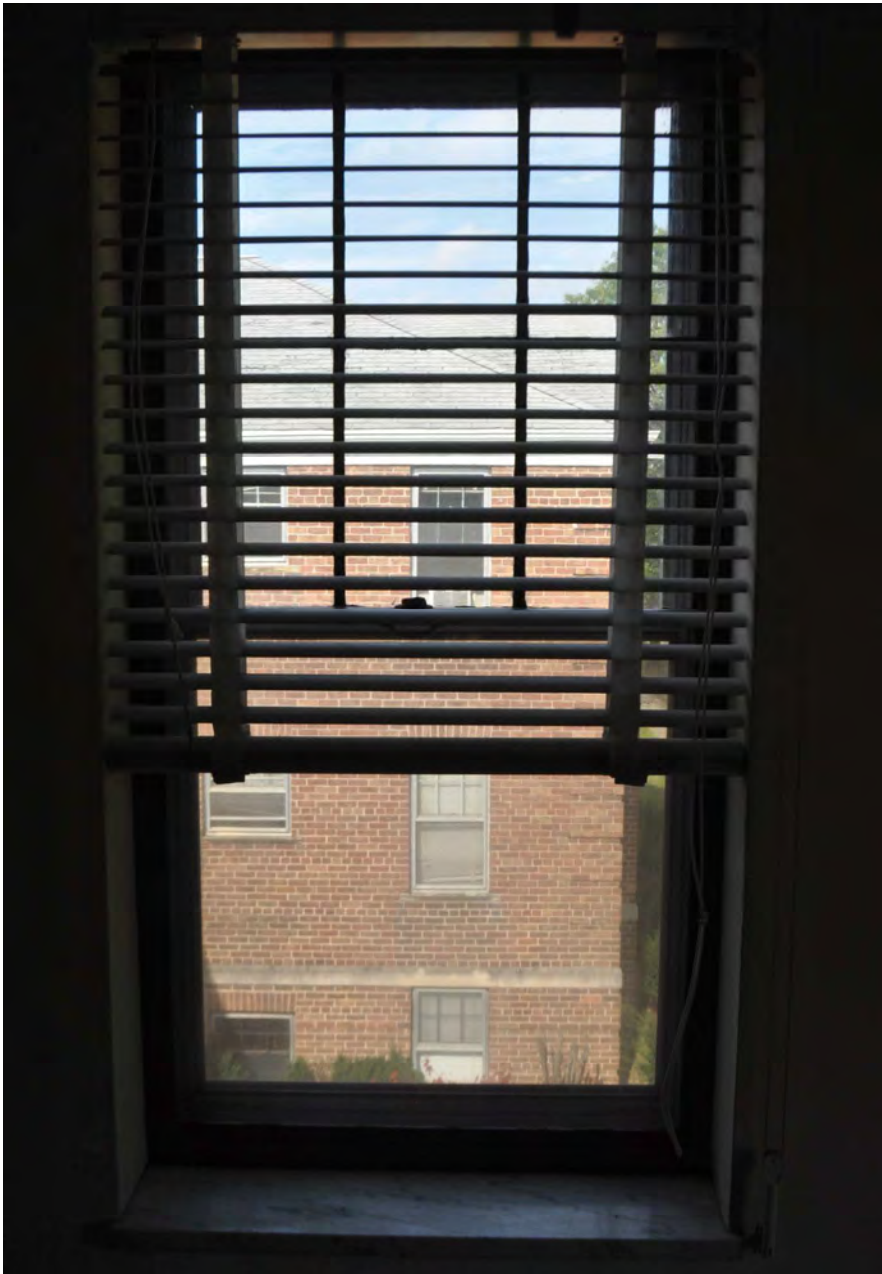
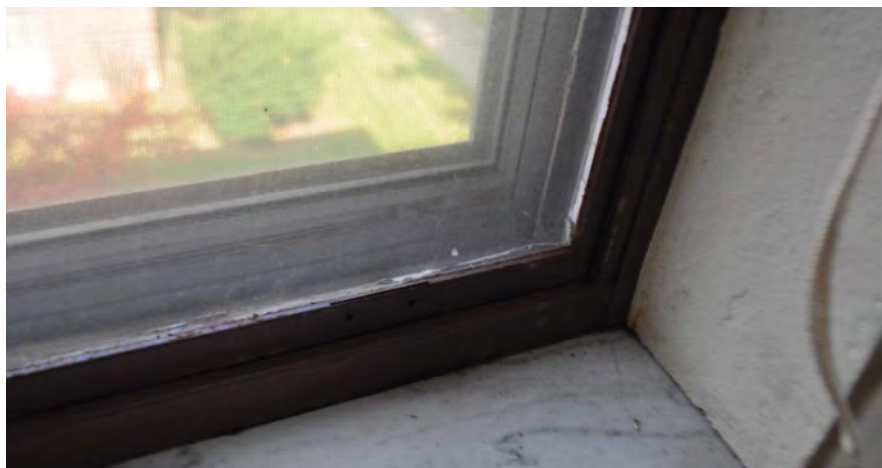
### Window U5, Type U1

- Note: Extent of exterior deterioration, corrosion, and loss of operability is not fully apparent in interior photos. Replacement parts for existing windows are unavailable, making restoration of thermal and operable functionality impossible, and long-term maintenance infeasible. Recommendation is for replacement, for quality of life of future tenants and for feasibility of long-term maintenance.
- See Window Assessment (Blackberry) in appendix for further detail and information, including further notes on deterioration beyond repair
- See Appendix for Window Schedule & Measurements

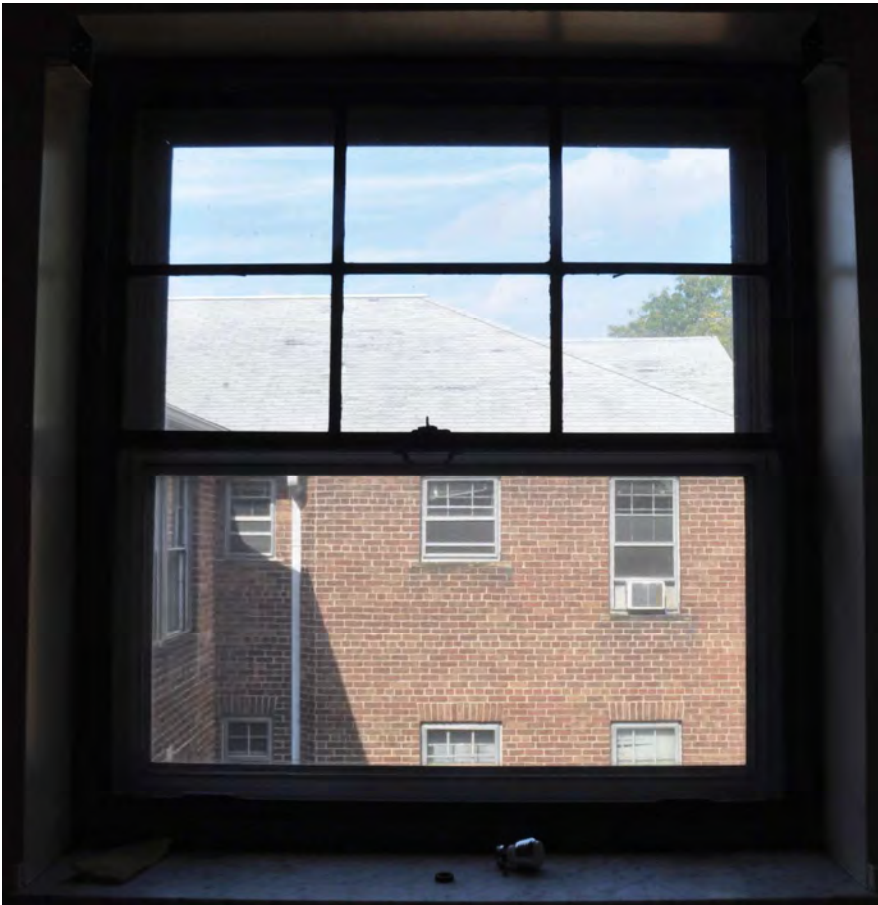
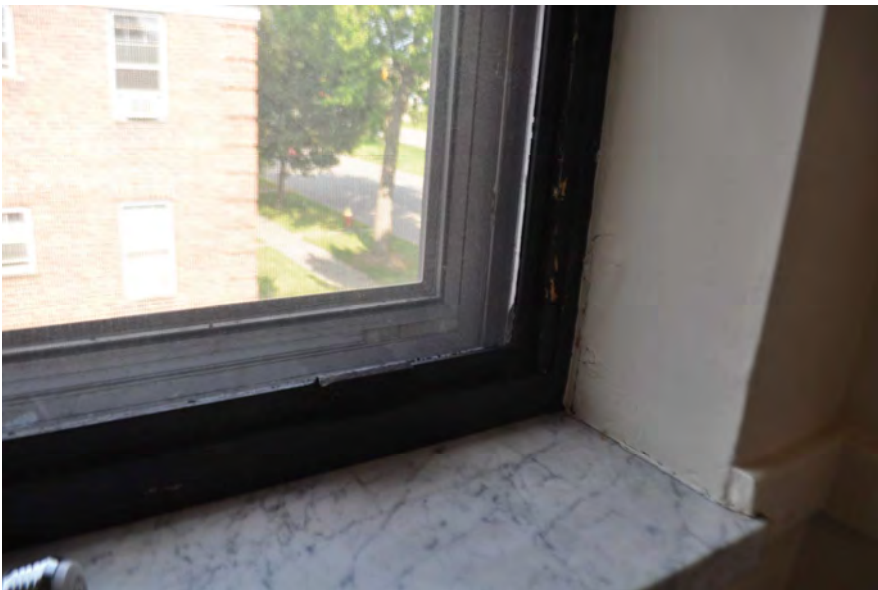
### Window U6, Type T1

- Note: Extent of exterior deterioration, corrosion, and loss of operability is not fully apparent in interior photos. Replacement parts for existing windows are unavailable, making restoration of thermal and operable functionality impossible, and long-term maintenance infeasible. Recommendation is for replacement, for quality of life of future tenants and for feasibility of long-term maintenance.
- See Window Assessment (Blackberry) in appendix for further detail and information, including further notes on deterioration beyond repair
- See Appendix for Window Schedule & Measurements

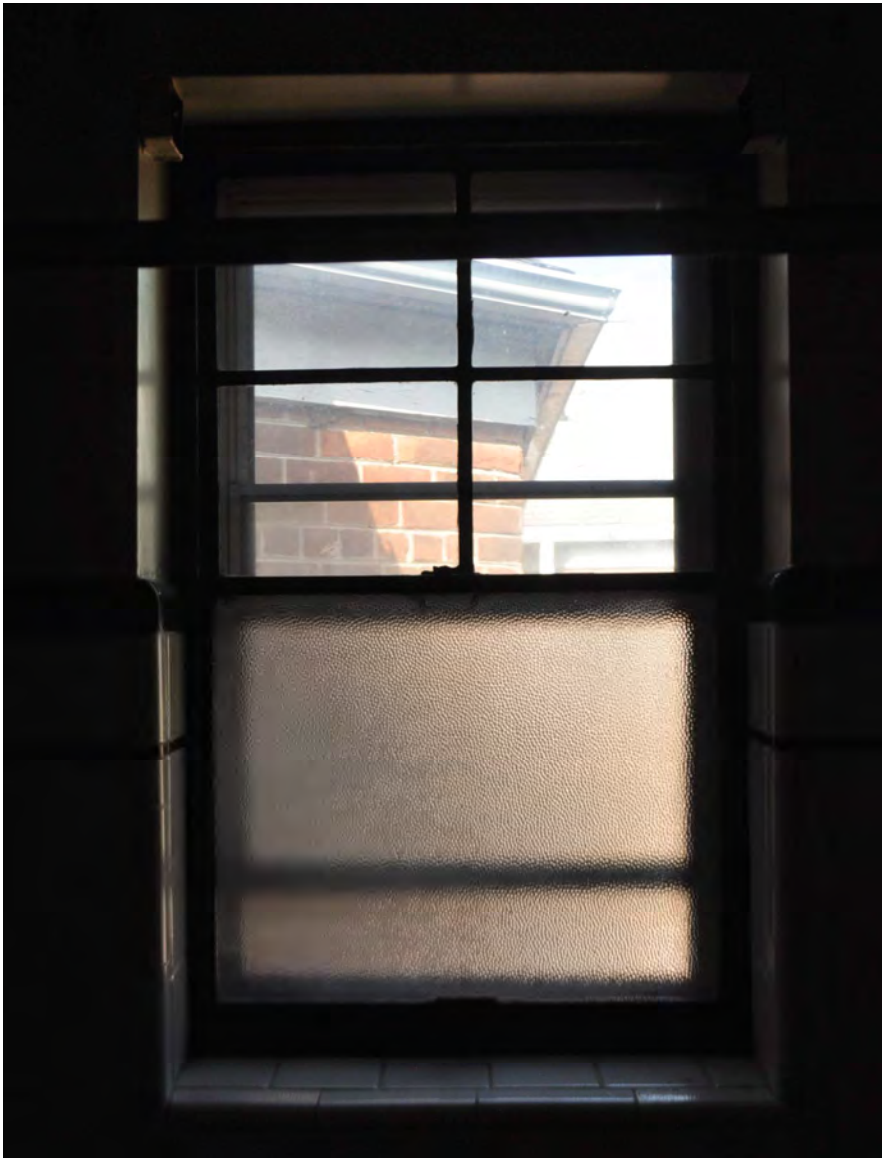
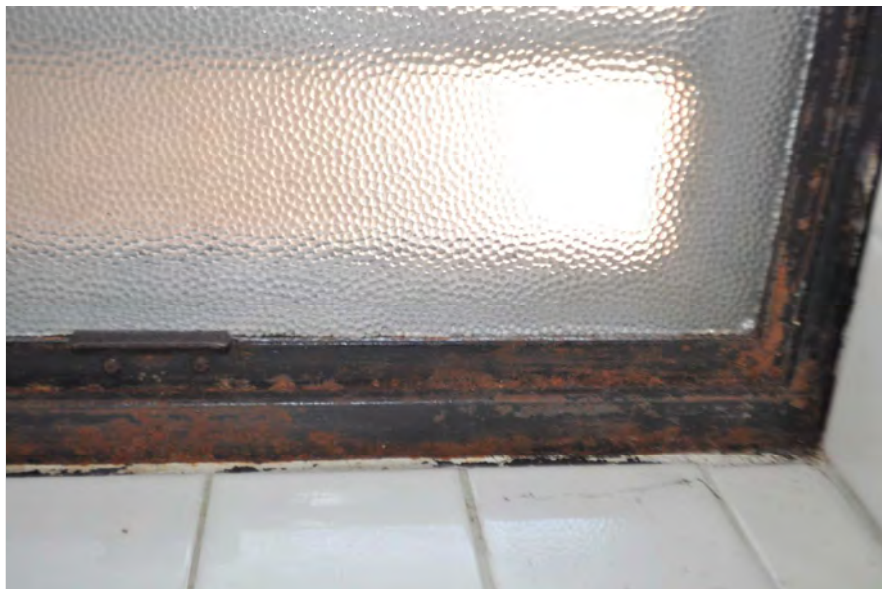
### Window U7, Type N1

- Badly Corroded
- Note: Extent of exterior deterioration, corrosion, and loss of operability is not fully apparent in interior photos. Replacement parts for existing windows are unavailable, making restoration of thermal and operable functionality impossible, and long-term maintenance infeasible. Recommendation is for replacement, for quality of life of future tenants and for feasibility of long-term maintenance.
- See Window Assessment (Blackberry) in appendix for further detail and information, including further notes on deterioration beyond repair
- See Appendix for Window Schedule & Measurements

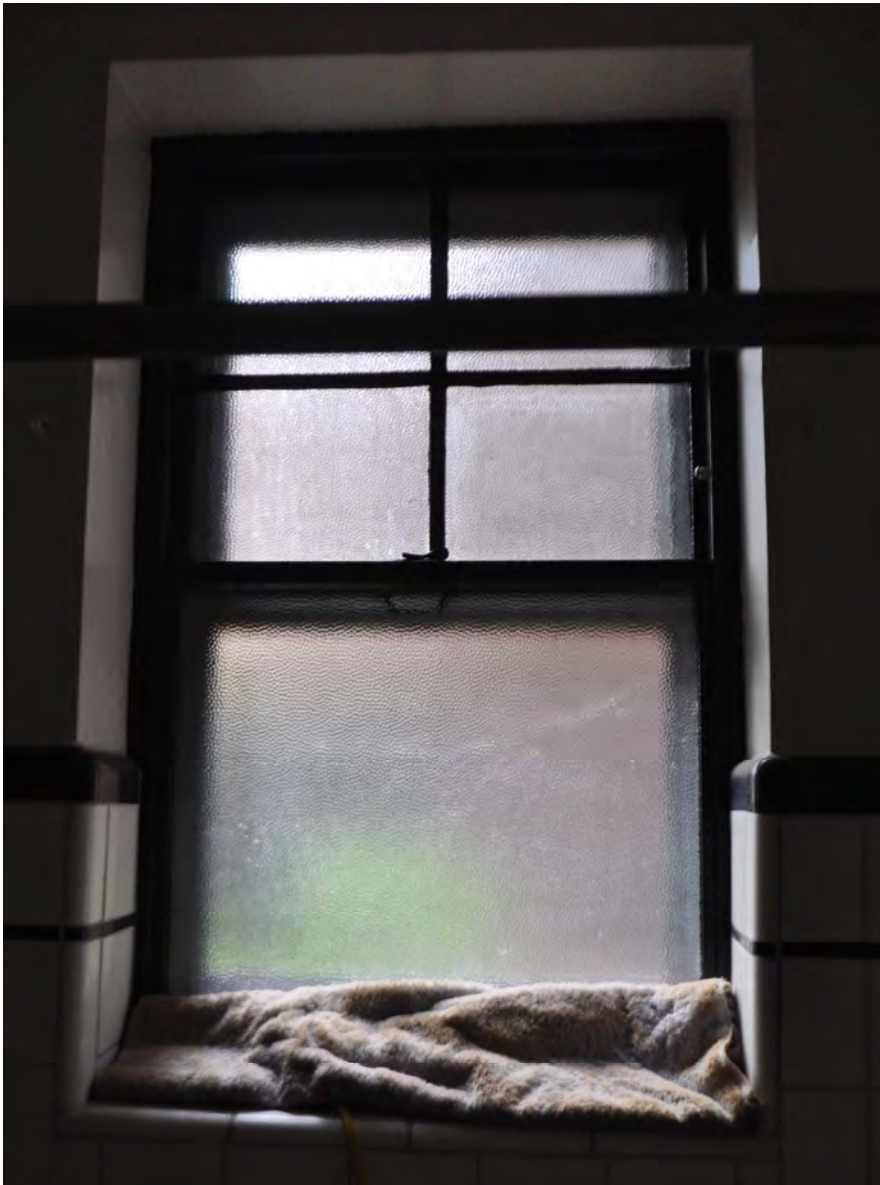
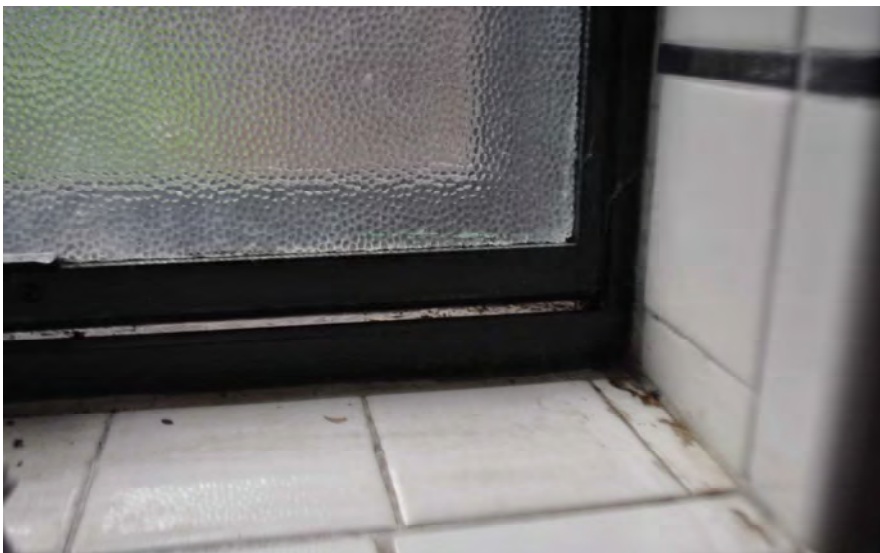
### Window S12, Type M1

- Badly Corroded
- Note: Extent of exterior deterioration, corrosion, and loss of operability is not fully apparent in interior photos. Replacement parts for existing windows are unavailable, making restoration of thermal and operable functionality impossible, and long-term maintenance infeasible. Recommendation is for replacement, for quality of life of future tenants and for feasibility of long-term maintenance.
- See Window Assessment (Blackberry) in appendix for further detail and information, including further notes on deterioration beyond repair
- See Appendix for Window Schedule & Measurements

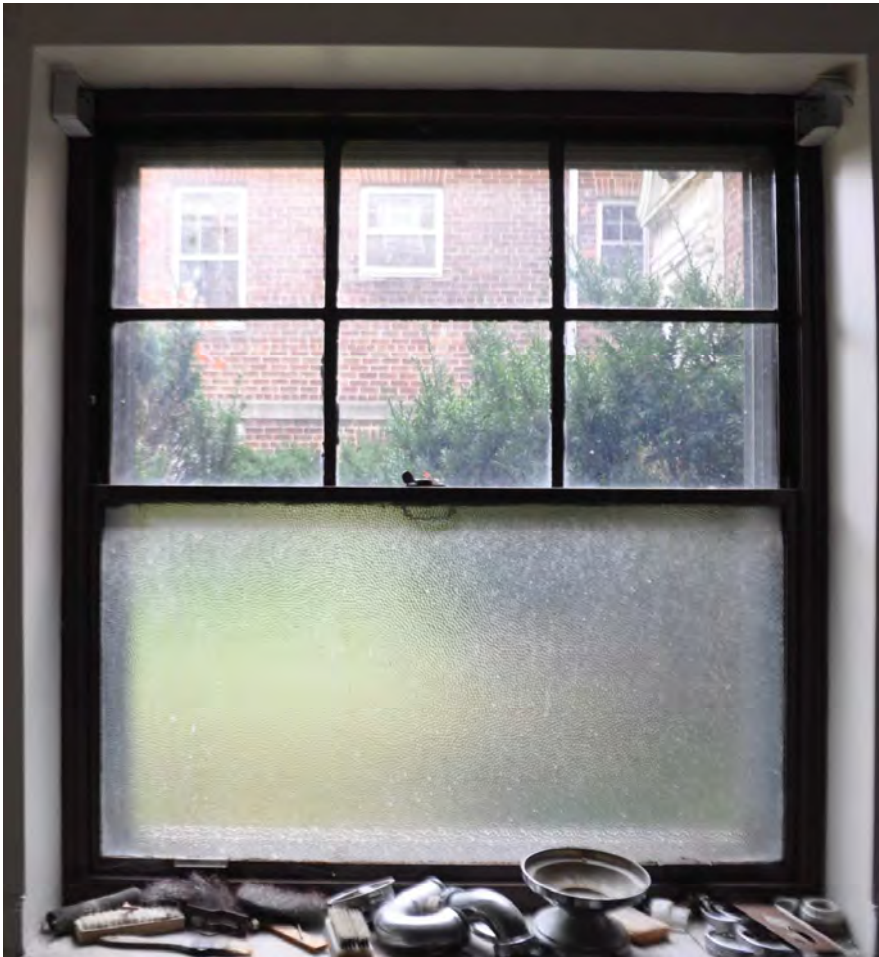
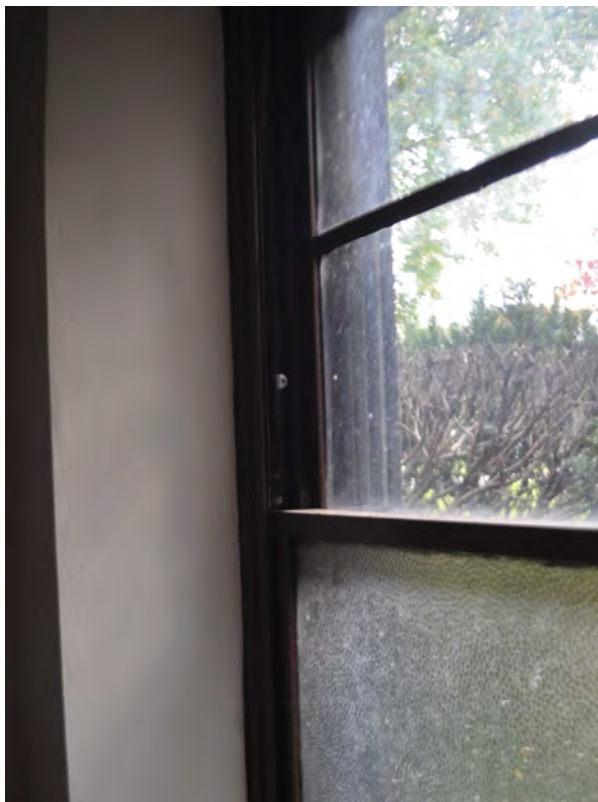
### Window S13, Type T1

- Badly Corroded
- Note: Extent of exterior deterioration, corrosion, and loss of operability is not fully apparent in interior photos. Replacement parts for existing windows are unavailable, making restoration of thermal and operable functionality impossible, and long-term maintenance infeasible. Recommendation is for replacement, for quality of life of future tenants and for feasibility of long-term maintenance.
- See Window Assessment (Blackberry) in appendix for further detail and information, including further notes on deterioration beyond repair
- See Appendix for Window Schedule & Measurements

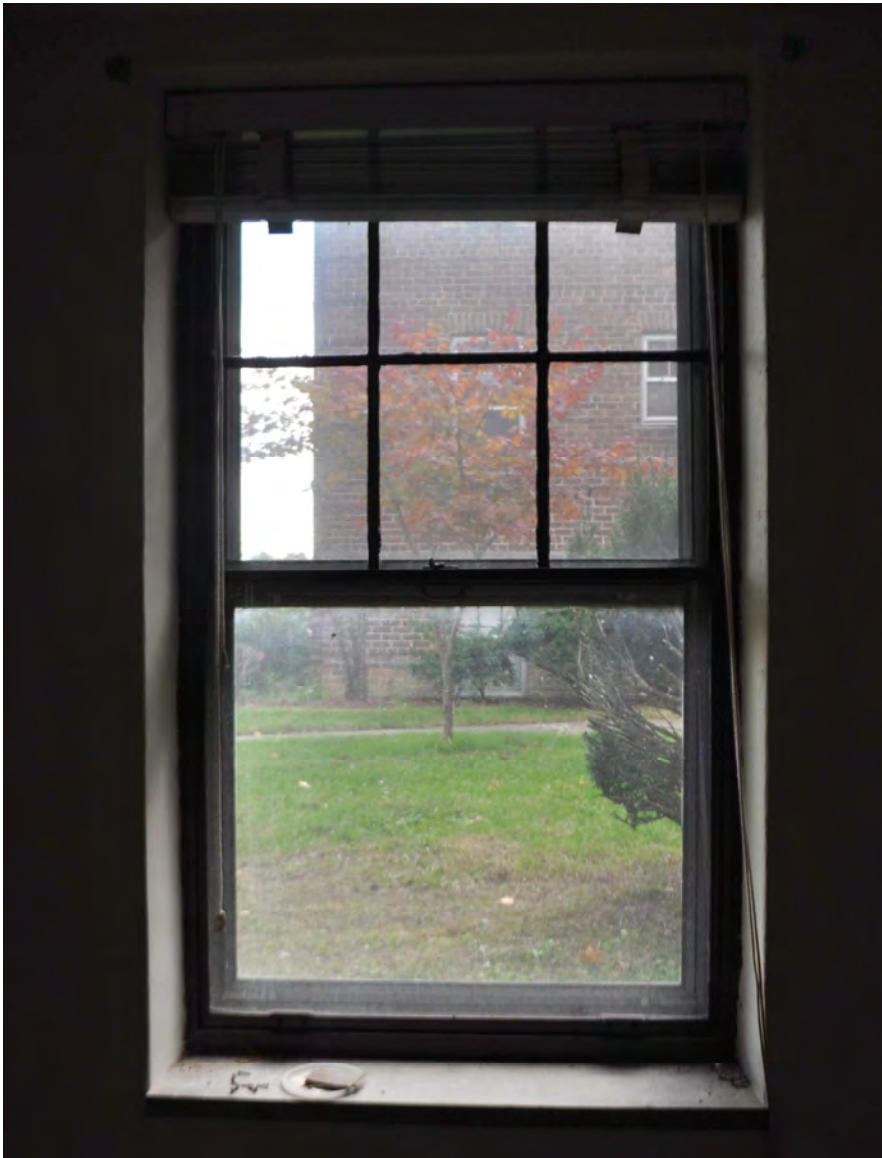
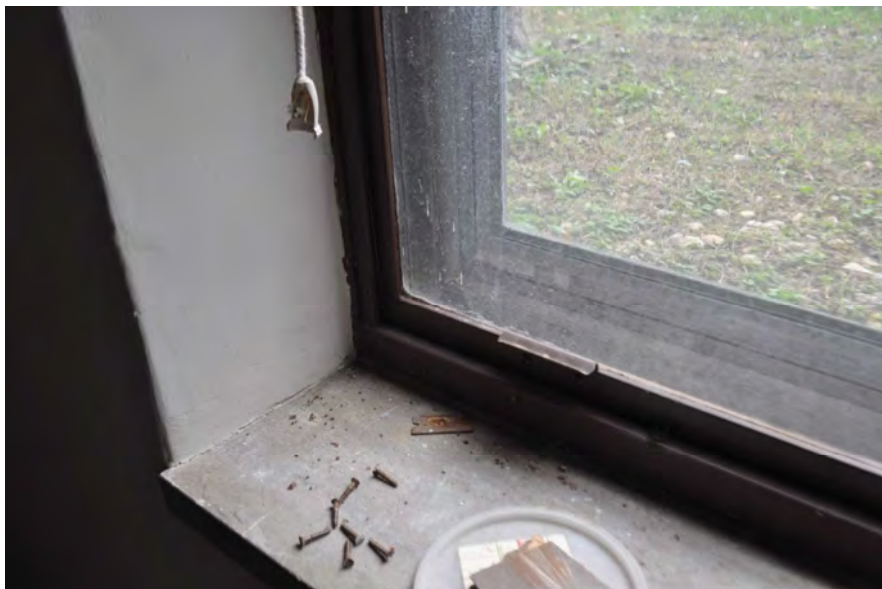
### Window S14, Type U1

- Badly Corroded
- Note: Extent of exterior deterioration, corrosion, and loss of operability is not fully apparent in interior photos. Replacement parts for existing windows are unavailable, making restoration of thermal and operable functionality impossible, and long-term maintenance infeasible. Recommendation is for replacement, for quality of life of future tenants and for feasibility of long-term maintenance.
- See Window Assessment (Blackberry) in appendix for further detail and information, including further notes on deterioration beyond repair
- See Appendix for Window Schedule & Measurements

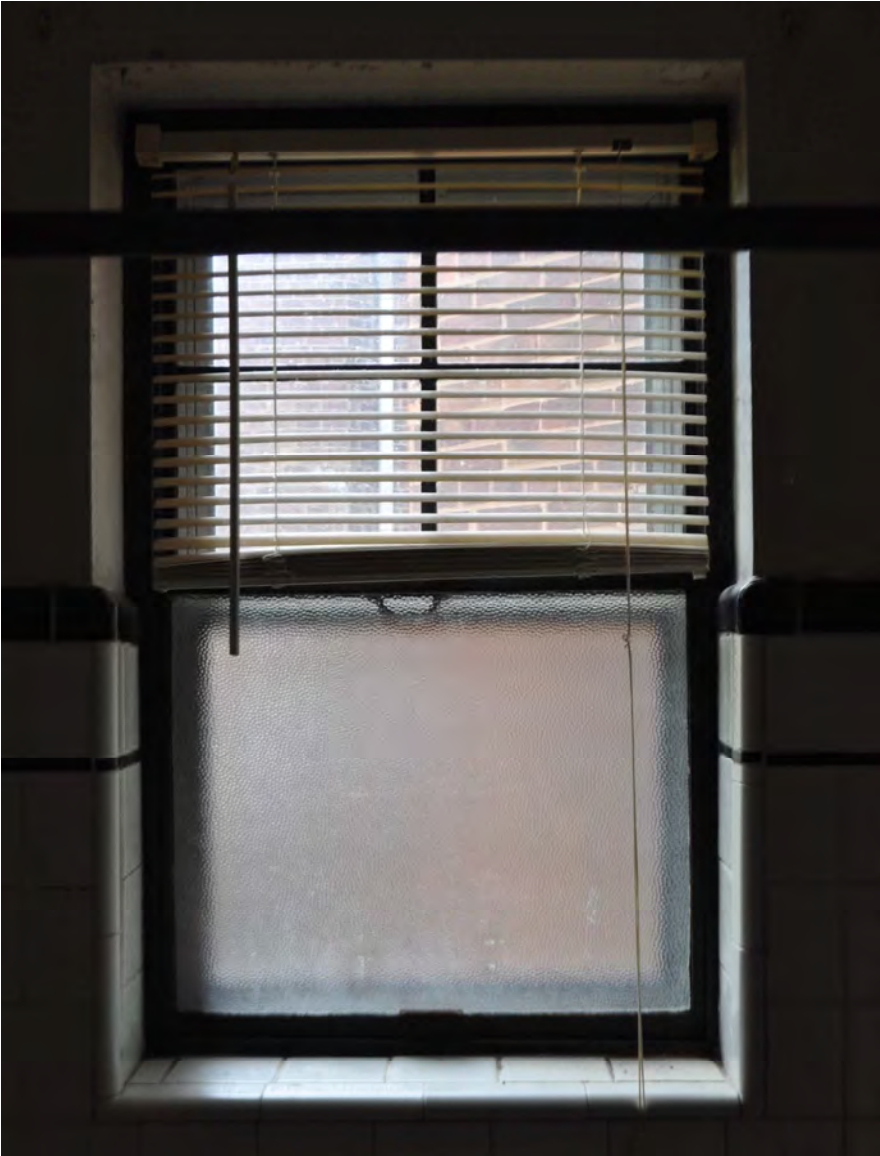
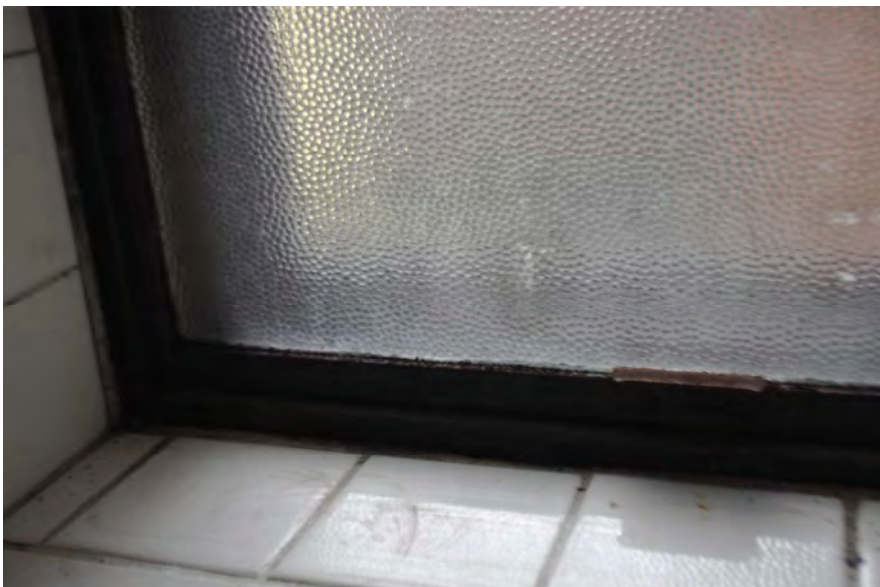
### Window T12, Type N1

- Note: Extent of exterior deterioration, corrosion, and loss of operability is not fully apparent in interior photos. Replacement parts for existing windows are unavailable, making restoration of thermal and operable functionality impossible, and long-term maintenance infeasible. Recommendation is for replacement, for quality of life of future tenants and for feasibility of long-term maintenance.
- See Window Assessment (Blackberry) in appendix for further detail and information, including further notes on deterioration beyond repair
- See Appendix for Window Schedule & Measurements

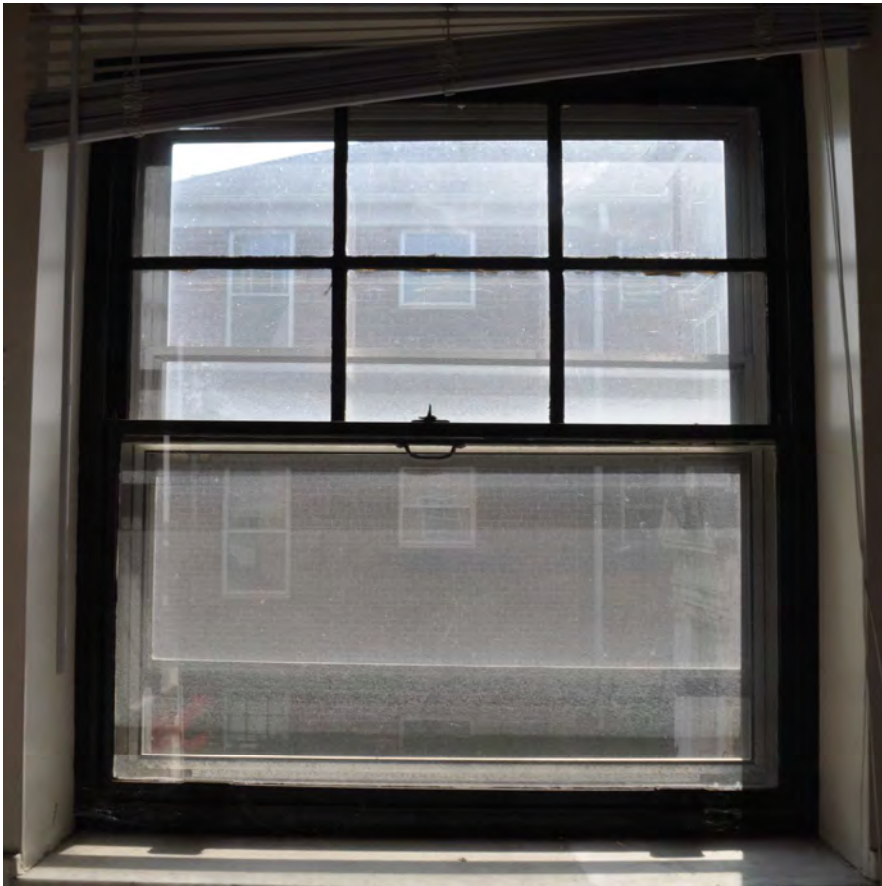
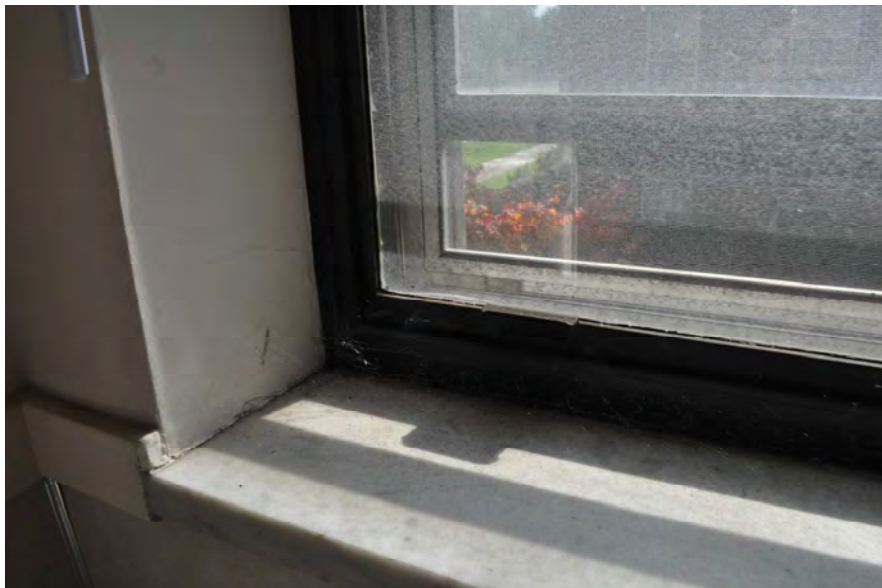
### Window T13, Type T1

- Note: Extent of exterior deterioration, corrosion, and loss of operability is not fully apparent in interior photos. Replacement parts for existing windows are unavailable, making restoration of thermal and operable functionality impossible, and long-term maintenance infeasible. Recommendation is for replacement, for quality of life of future tenants and for feasibility of long-term maintenance.
- See Window Assessment (Blackberry) in appendix for further detail and information, including further notes on deterioration beyond repair
- See Appendix for Window Schedule & Measurements

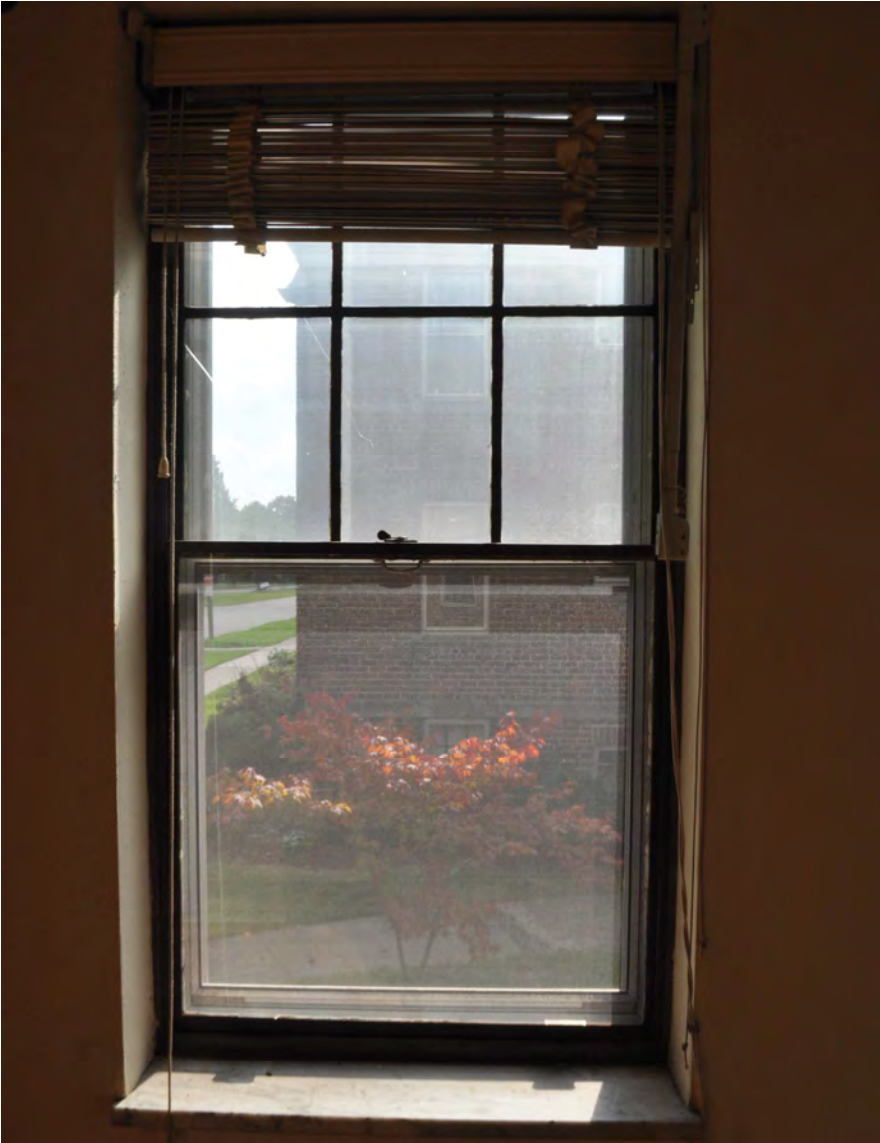
### Window T14, Type U1

- Broken Glass
- Note: Extent of exterior deterioration, corrosion, and loss of operability is not fully apparent in interior photos. Replacement parts for existing windows are unavailable, making restoration of thermal and operable functionality impossible, and long-term maintenance infeasible. Recommendation is for replacement, for quality of life of future tenants and for feasibility of long-term maintenance.
- See Window Assessment (Blackberry) in appendix for further detail and information, including further notes on deterioration beyond repair
- See Appendix for Window Schedule & Measurements
