# 9710 W Outer Dr

## Existing Condition Photos

# 9730 W Outer Dr

# Detailed Scope of Work

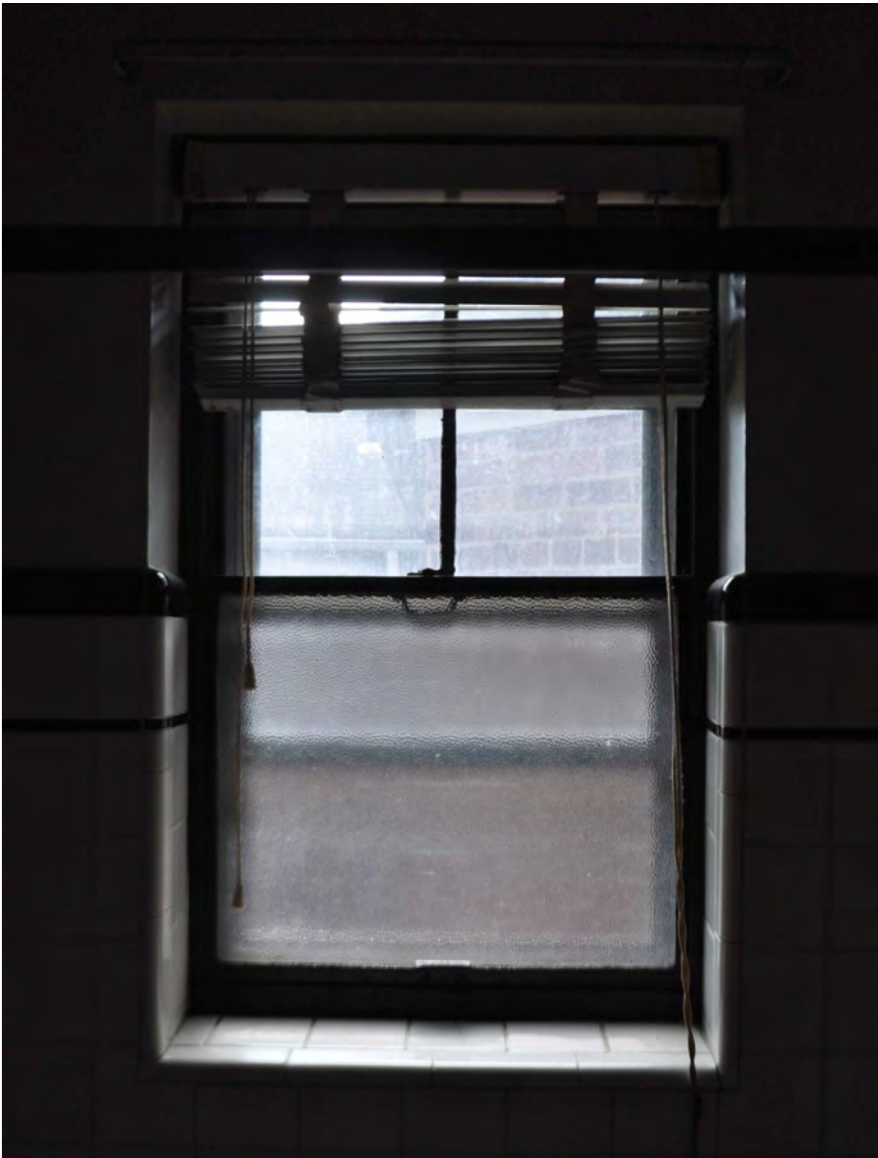
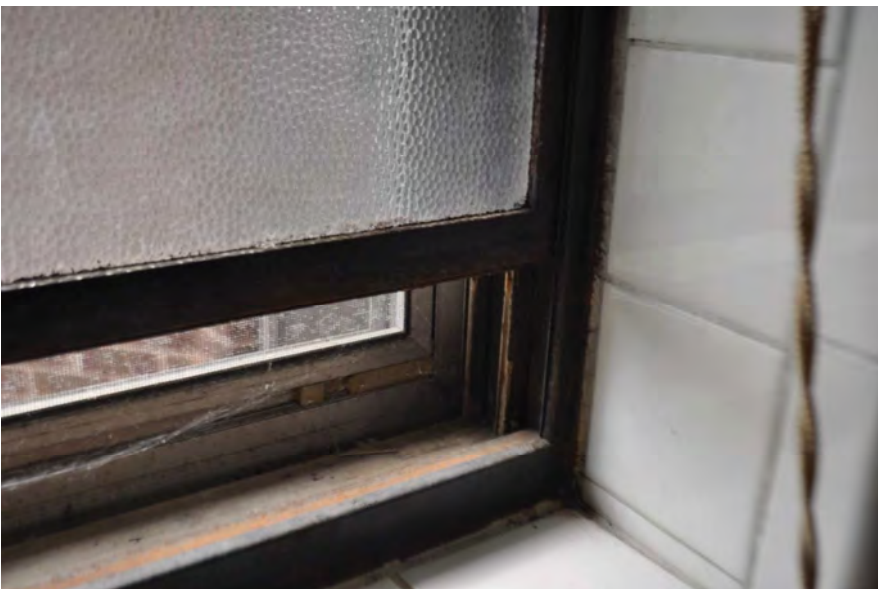
### Window U13, Type N1

- Note: Extent of exterior deterioration, corrosion, and loss of operability is not fully apparent in interior photos. Replacement parts for existing windows are unavailable, making restoration of thermal and operable functionality impossible, and long-term maintenance infeasible. Recommendation is for replacement, for quality of life of future tenants and for feasibility of long-term maintenance.
- See Window Assessment (Blackberry) in appendix for further detail and information, including further notes on deterioration beyond repair
- See Appendix for Window Schedule & Measurements

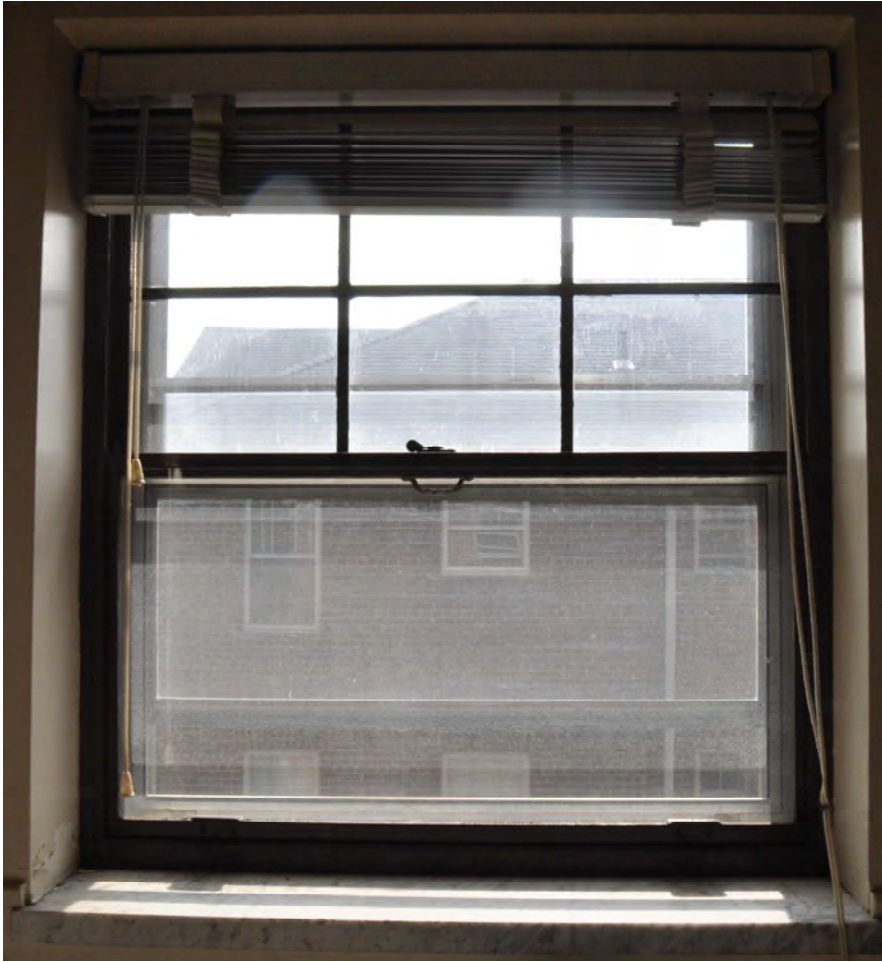
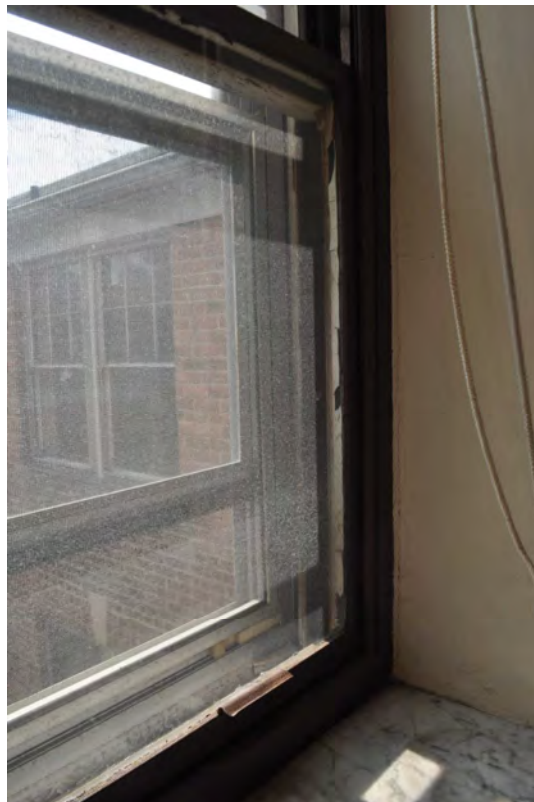
### Window U14, Type T1

- Note: Extent of exterior deterioration, corrosion, and loss of operability is not fully apparent in interior photos. Replacement parts for existing windows are unavailable, making restoration of thermal and operable functionality impossible, and long-term maintenance infeasible. Recommendation is for replacement, for quality of life of future tenants and for feasibility of long-term maintenance.
- See Window Assessment (Blackberry) in appendix for further detail and information, including further notes on deterioration beyond repair
- See Appendix for Window Schedule & Measurements

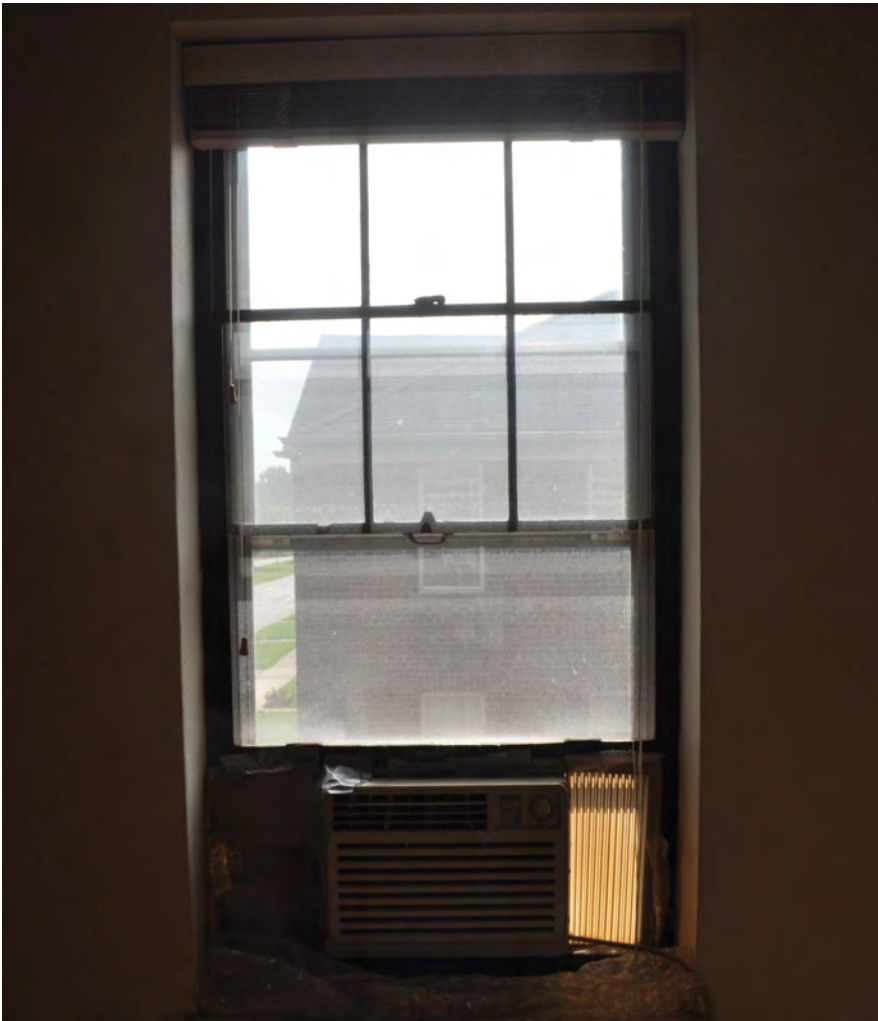
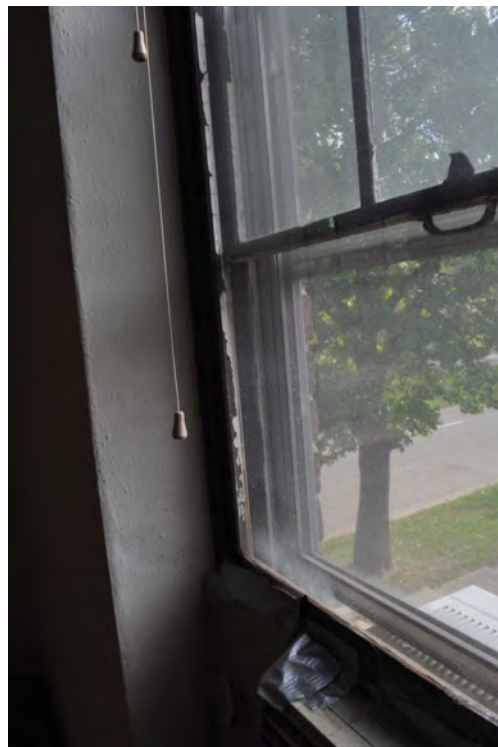
### Window U15, Type U1

- Note: Extent of exterior deterioration, corrosion, and loss of operability is not fully apparent in interior photos. Replacement parts for existing windows are unavailable, making restoration of thermal and operable functionality impossible, and long-term maintenance infeasible. Recommendation is for replacement, for quality of life of future tenants and for feasibility of long-term maintenance.
- See Window Assessment (Blackberry) in appendix for further detail and information, including further notes on deterioration beyond repair
- See Appendix for Window Schedule & Measurements

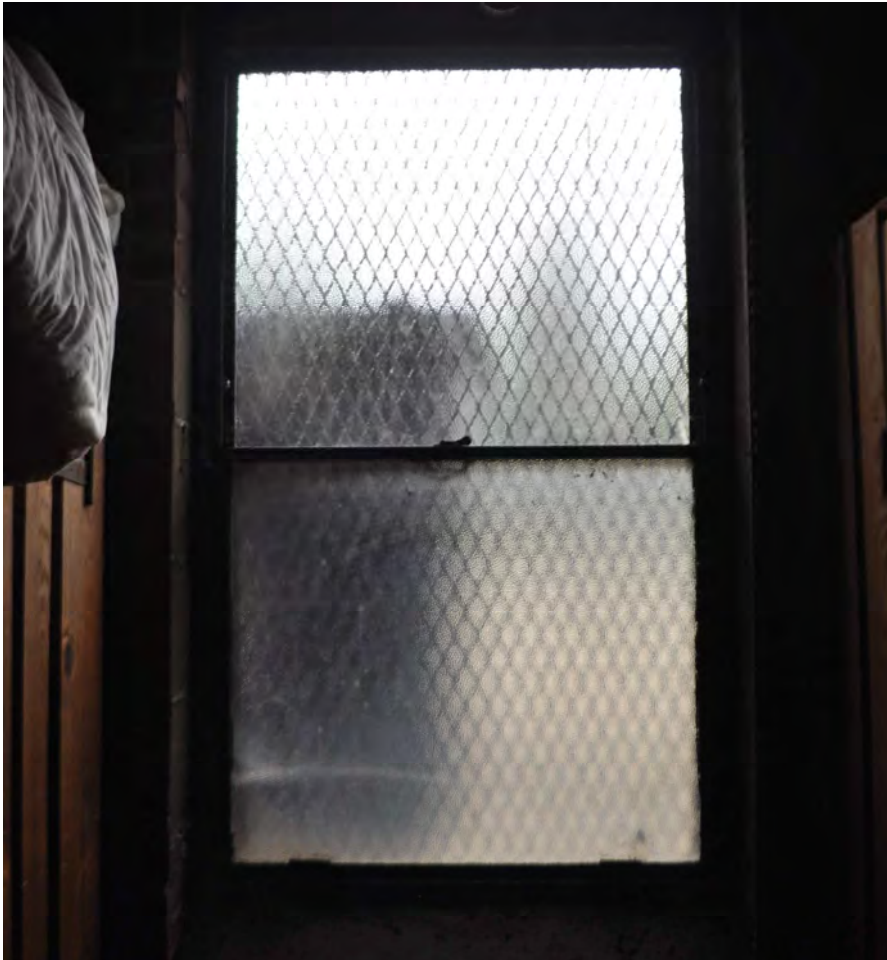
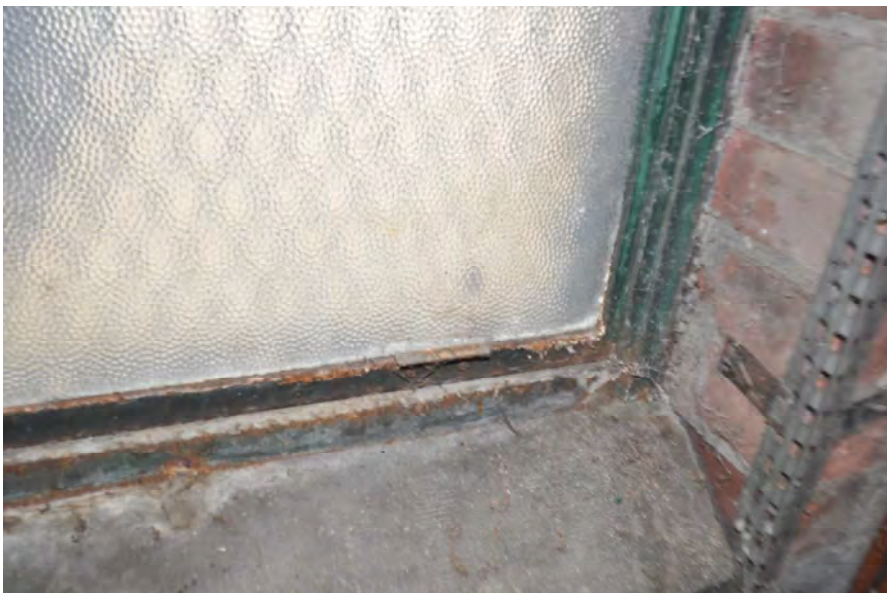
### Window V1, Type M2

- Badly Corroded
- Note: Extent of exterior deterioration, corrosion, and loss of operability is not fully apparent in interior photos. Replacement parts for existing windows are unavailable, making restoration of thermal and operable functionality impossible, and long-term maintenance infeasible. Recommendation is for replacement, for quality of life of future tenants and for feasibility of long-term maintenance.
- See Window Assessment (Blackberry) in appendix for further detail and information, including further notes on deterioration beyond repair
- See Appendix for Window Schedule & Measurements

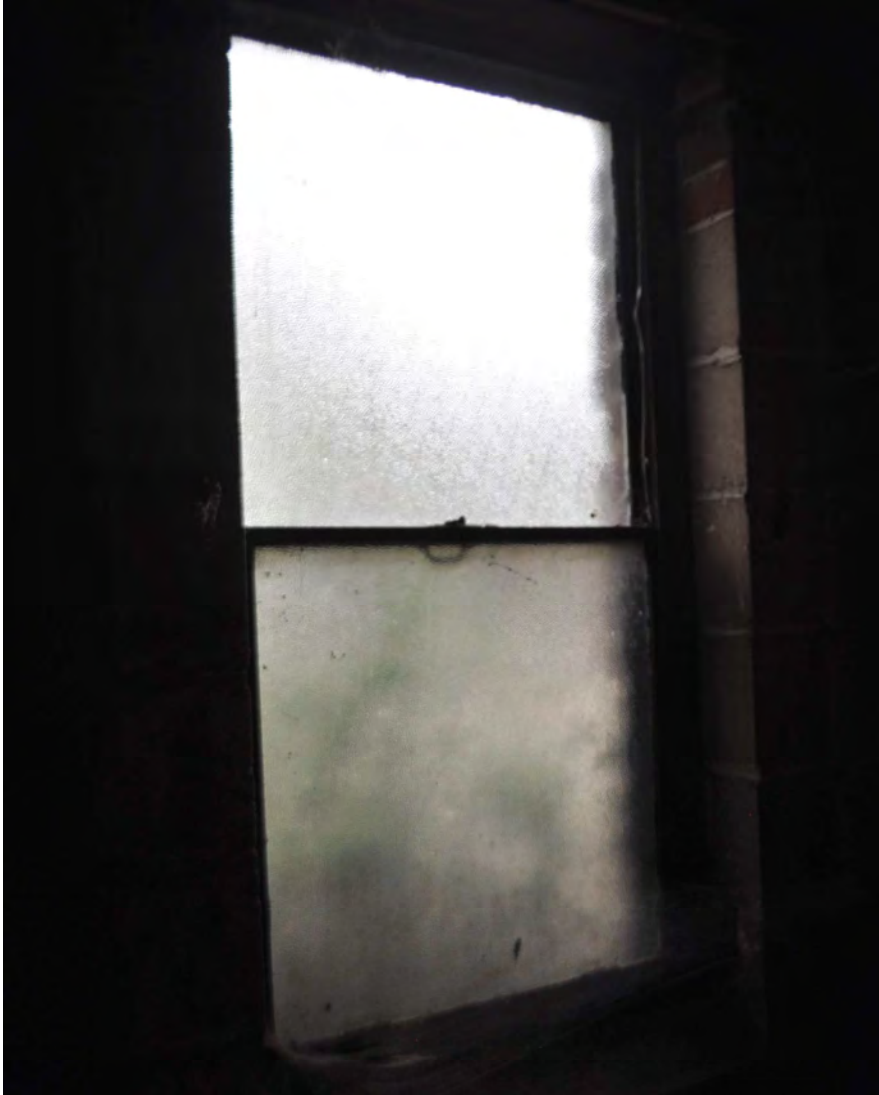
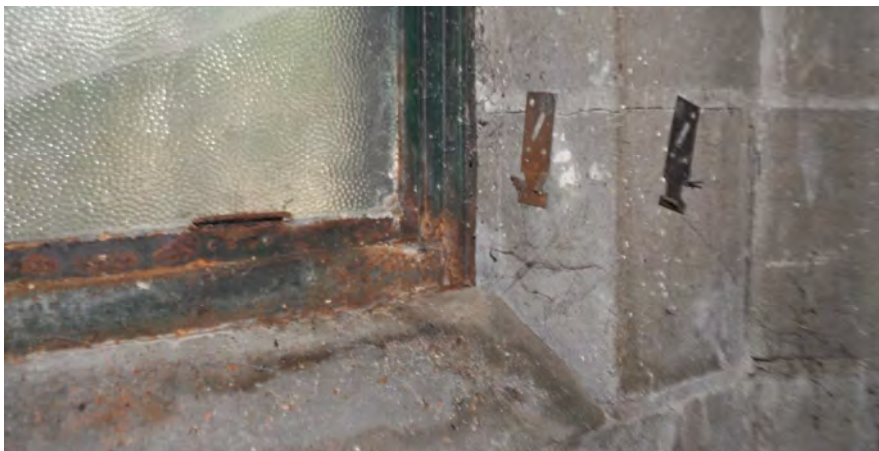
### Window V6, Type M2

- Badly Corroded
- Note: Extent of exterior deterioration, corrosion, and loss of operability is not fully apparent in interior photos. Replacement parts for existing windows are unavailable, making restoration of thermal and operable functionality impossible, and long-term maintenance infeasible. Recommendation is for replacement, for quality of life of future tenants and for feasibility of long-term maintenance.
- See Window Assessment (Blackberry) in appendix for further detail and information, including further notes on deterioration beyond repair
- See Appendix for Window Schedule & Measurements

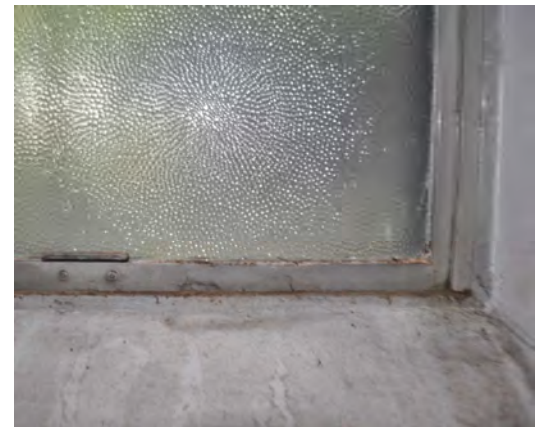
### Window DEMO 01, Type Q2

- Badly Corroded
- Note: Extent of exterior deterioration, corrosion, and loss of operability is not fully apparent in interior photos. Replacement parts for existing windows are unavailable, making restoration of thermal and operable functionality impossible, and long-term maintenance infeasible. Recommendation is for replacement, for quality of life of future tenants and for feasibility of long-term maintenance.
- See Window Assessment (Blackberry) in appendix for further detail and information, including further notes on deterioration beyond repair
- See Appendix for Window Schedule & Measurements

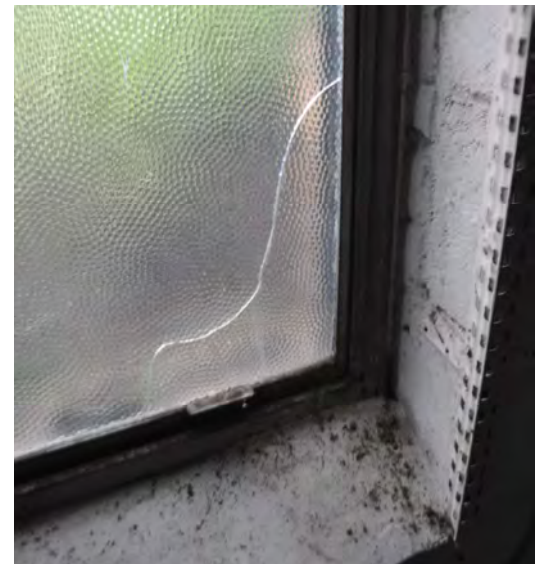
### Window V9, Type M2

- Broken Glass
- Badly Corroded
- Note: Extent of exterior deterioration, corrosion, and loss of operability is not fully apparent in interior photos. Replacement parts for existing windows are unavailable, making restoration of thermal and operable functionality impossible, and long-term maintenance infeasible. Recommendation is for replacement, for quality of life of future tenants and for feasibility of long-term maintenance.
- See Window Assessment (Blackberry) in appendix for further detail and information, including further notes on deterioration beyond repair
- See Appendix for Window Schedule & Measurements

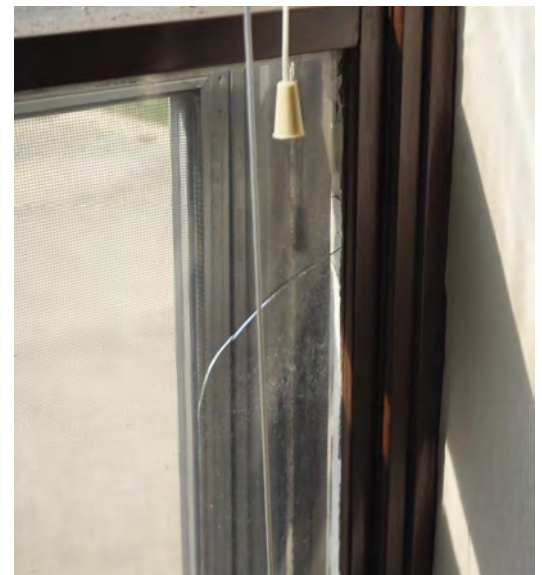
### Window W1, Type N2

- Broken Glass
- Note: Extent of exterior deterioration, corrosion, and loss of operability is not fully apparent in interior photos. Replacement parts for existing windows are unavailable, making restoration of thermal and operable functionality impossible, and long-term maintenance infeasible. Recommendation is for replacement, for quality of life of future tenants and for feasibility of long-term maintenance.
- See Window Assessment (Blackberry) in appendix for further detail and information, including further notes on deterioration beyond repair
- See Appendix for Window Schedule & Measurements

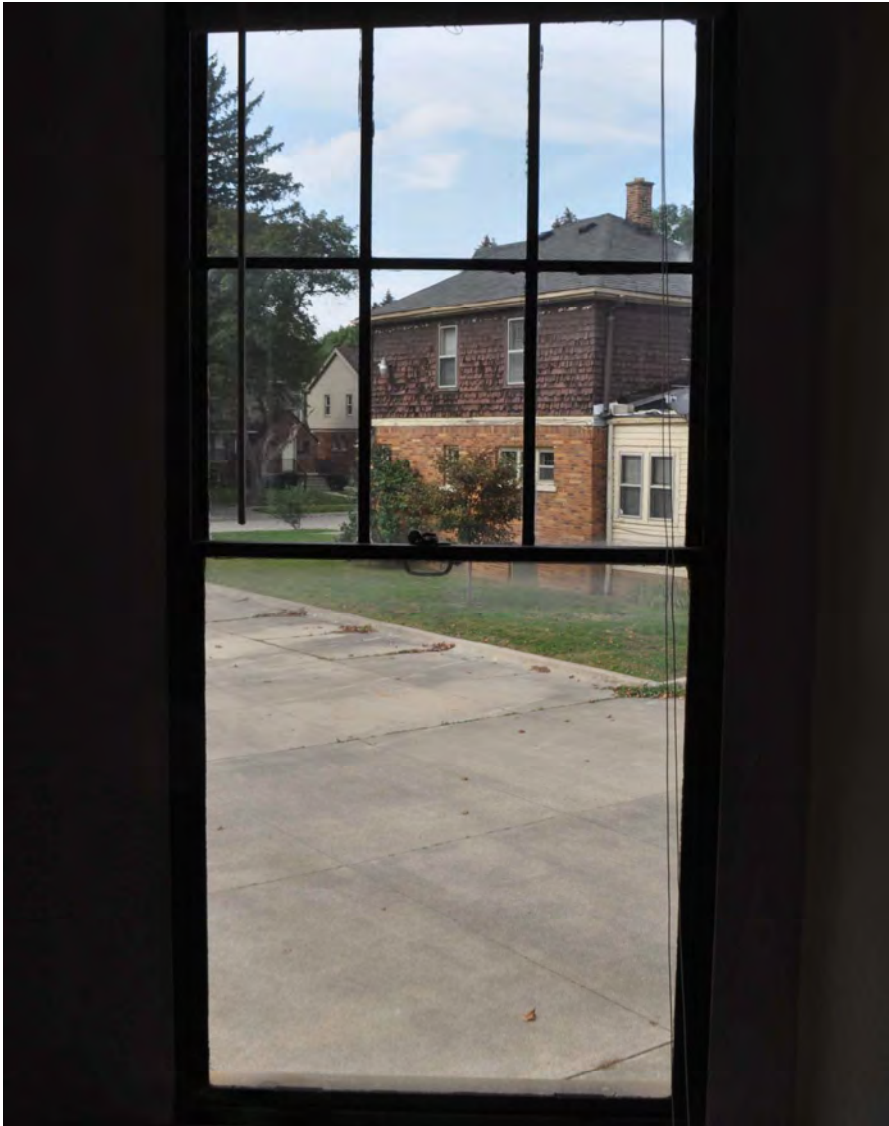
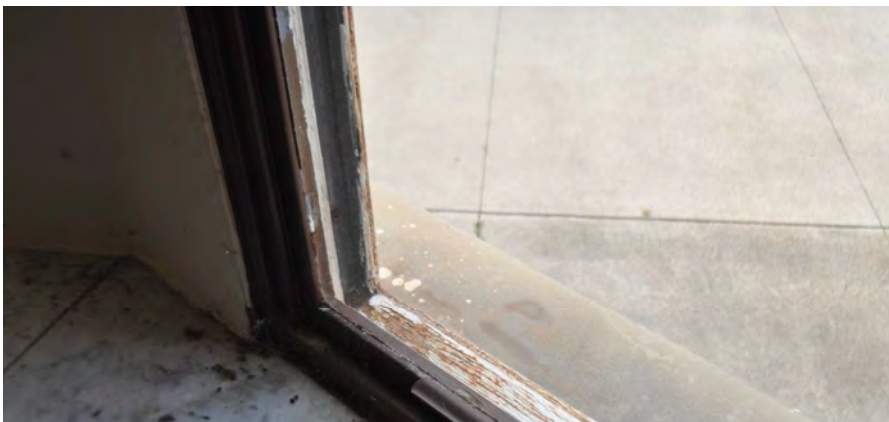
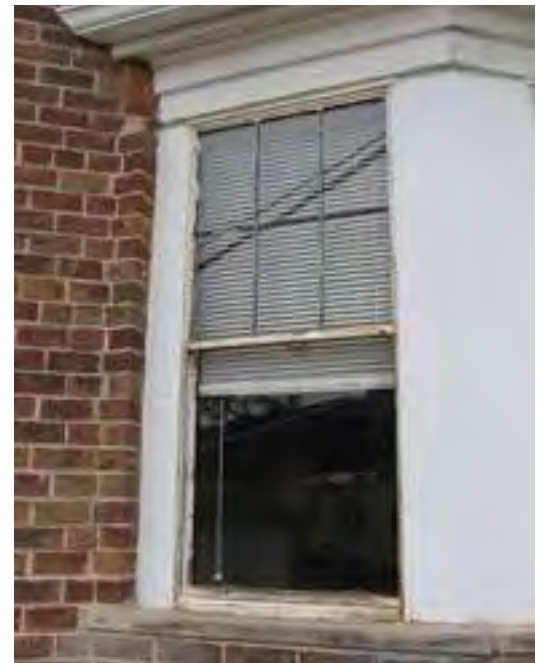
### Window W2, Type V1

- Note: Extent of exterior deterioration, corrosion, and loss of operability is not fully apparent in interior photos. Replacement parts for existing windows are unavailable, making restoration of thermal and operable functionality impossible, and long-term maintenance infeasible. Recommendation is for replacement, for quality of life of future tenants and for feasibility of long-term maintenance.
- See Window Assessment (Blackberry) in appendix for further detail and information, including further notes on deterioration beyond repair
- See Appendix for Window Schedule & Measurements

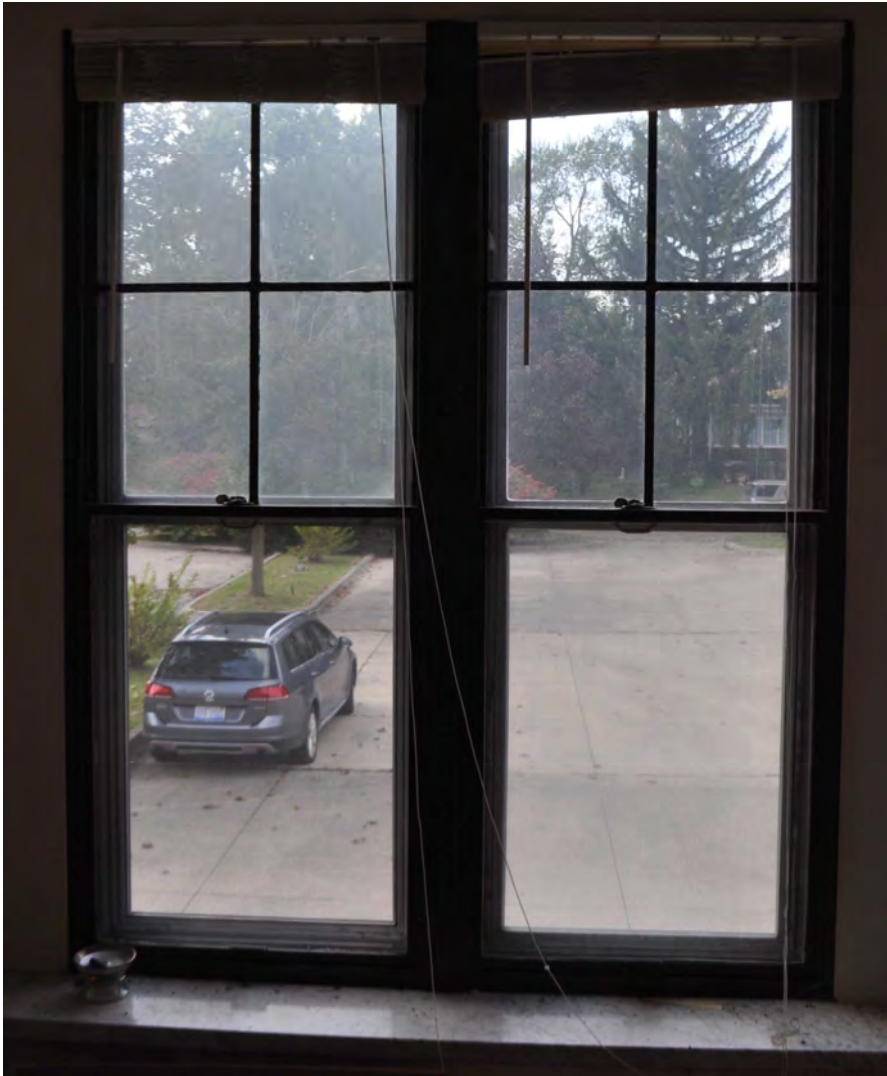
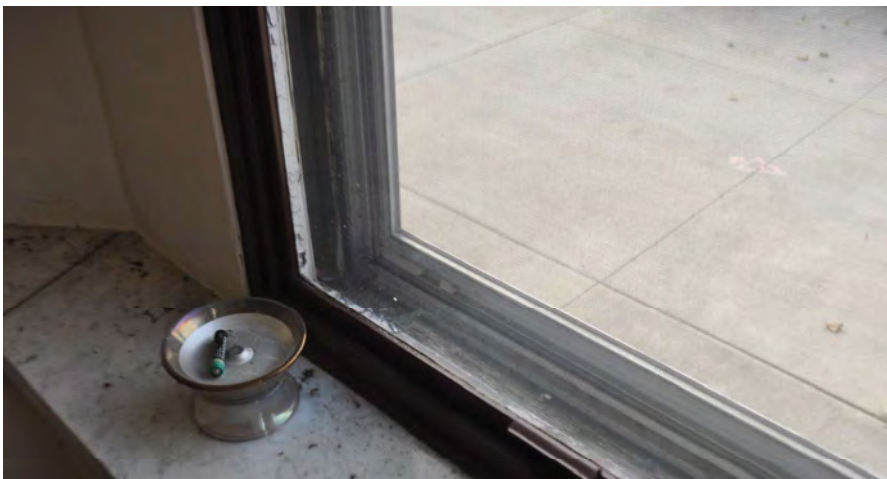
### Window W3 & W4, Type X1

- Note: Extent of exterior deterioration, corrosion, and loss of operability is not fully apparent in interior photos. Replacement parts for existing windows are unavailable, making restoration of thermal and operable functionality impossible, and long-term maintenance infeasible. Recommendation is for replacement, for quality of life of future tenants and for feasibility of long-term maintenance.
- See Window Assessment (Blackberry) in appendix for further detail and information, including further notes on deterioration beyond repair
- See Appendix for Window Schedule & Measurements

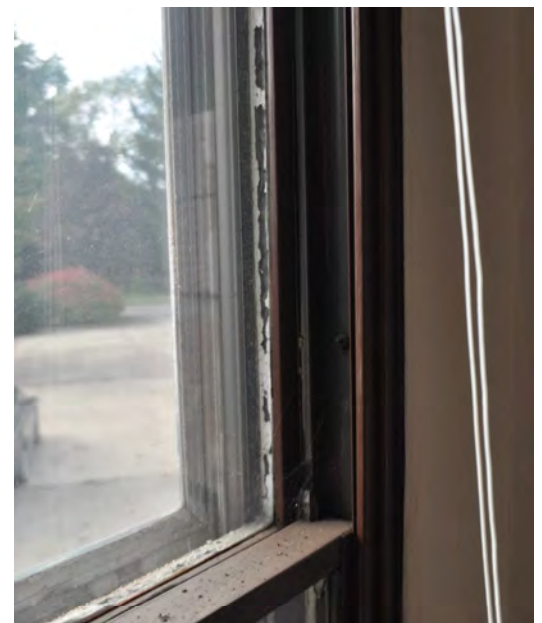
### Window W5, Type V1

- Missing Balance
- Note: Extent of exterior deterioration, corrosion, and loss of operability is not fully apparent in interior photos. Replacement parts for existing windows are unavailable, making restoration of thermal and operable functionality impossible, and long-term maintenance infeasible. Recommendation is for replacement, for quality of life of future tenants and for feasibility of long-term maintenance.
- See Window Assessment (Blackberry) in appendix for further detail and information, including further notes on deterioration beyond repair
- See Appendix for Window Schedule & Measurements

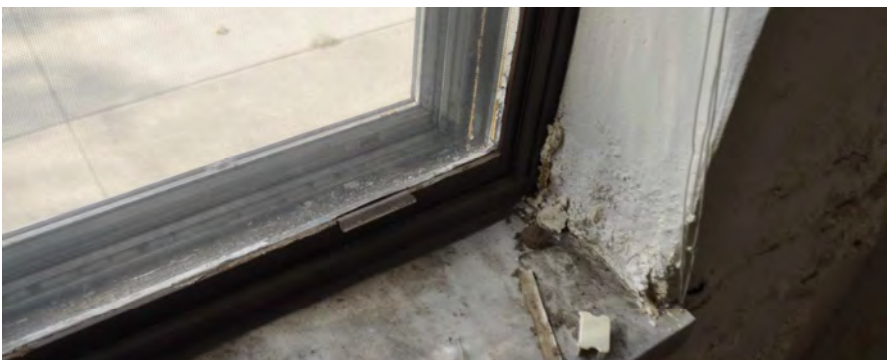
### Window W6, Type R2

- Note: Extent of exterior deterioration, corrosion, and loss of operability is not fully apparent in interior photos. Replacement parts for existing windows are unavailable, making restoration of thermal and operable functionality impossible, and long-term maintenance infeasible. Recommendation is for replacement, for quality of life of future tenants and for feasibility of long-term maintenance.
- See Window Assessment (Blackberry) in appendix for further detail and information, including further notes on deterioration beyond repair
- See Appendix for Window Schedule & Measurements

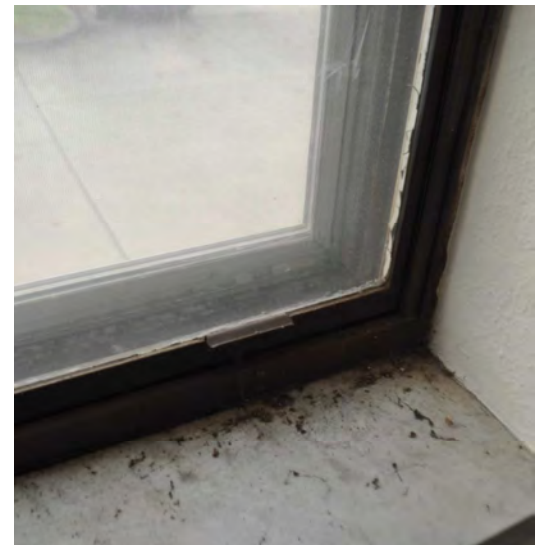
### Window W7, Type R2

- Note: Extent of exterior deterioration, corrosion, and loss of operability is not fully apparent in interior photos. Replacement parts for existing windows are unavailable, making restoration of thermal and operable functionality impossible, and long-term maintenance infeasible. Recommendation is for replacement, for quality of life of future tenants and for feasibility of long-term maintenance.
- See Window Assessment (Blackberry) in appendix for further detail and information, including further notes on deterioration beyond repair
- See Appendix for Window Schedule & Measurements

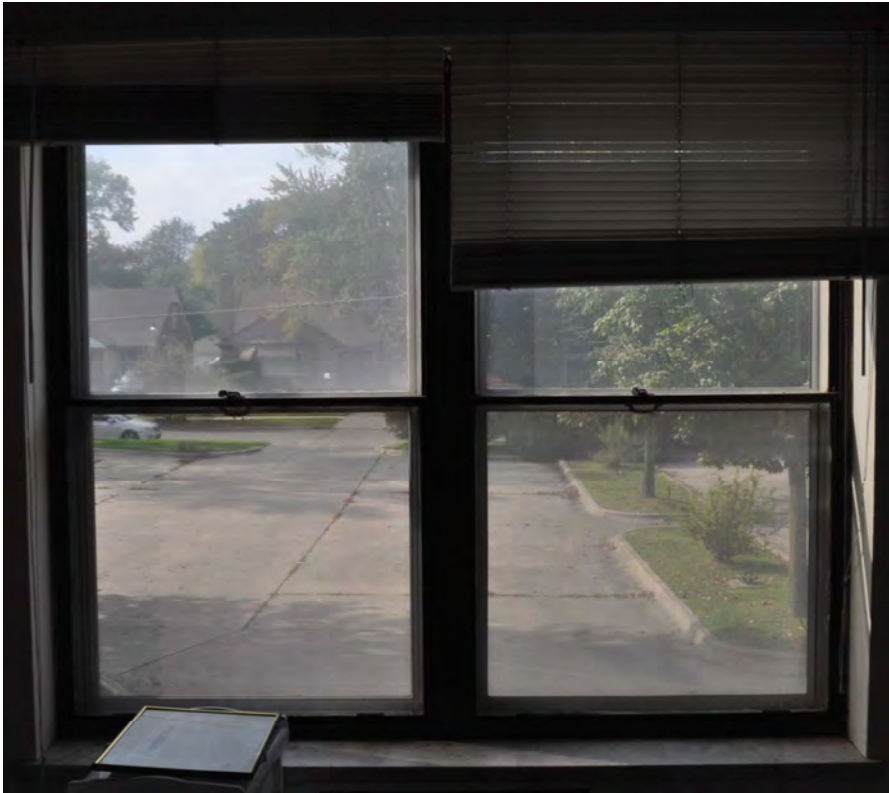
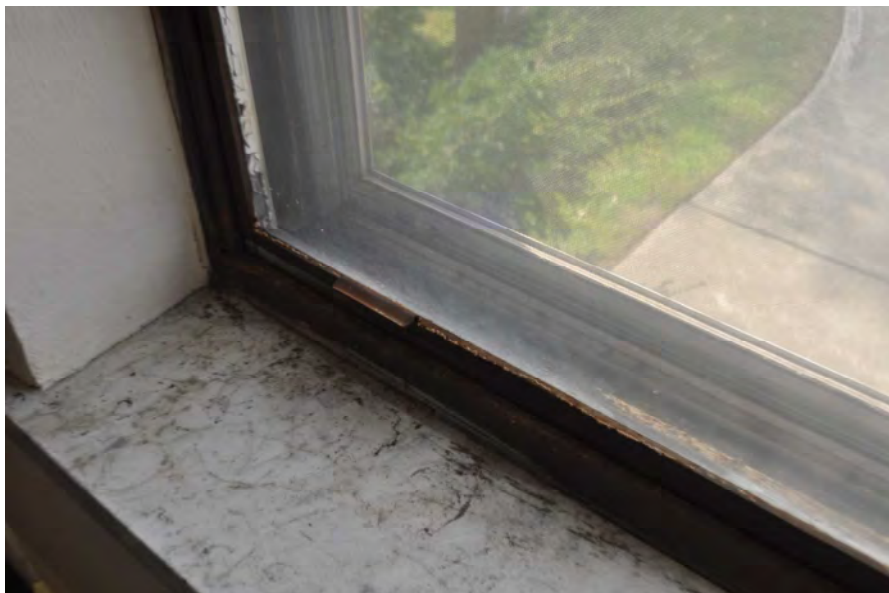
### Window W8, Type P2

- Note: Extent of exterior deterioration, corrosion, and loss of operability is not fully apparent in interior photos. Replacement parts for existing windows are unavailable, making restoration of thermal and operable functionality impossible, and long-term maintenance infeasible. Recommendation is for replacement, for quality of life of future tenants and for feasibility of long-term maintenance.
- See Window Assessment (Blackberry) in appendix for further detail and information, including further notes on deterioration beyond repair
- See Appendix for Window Schedule & Measurements

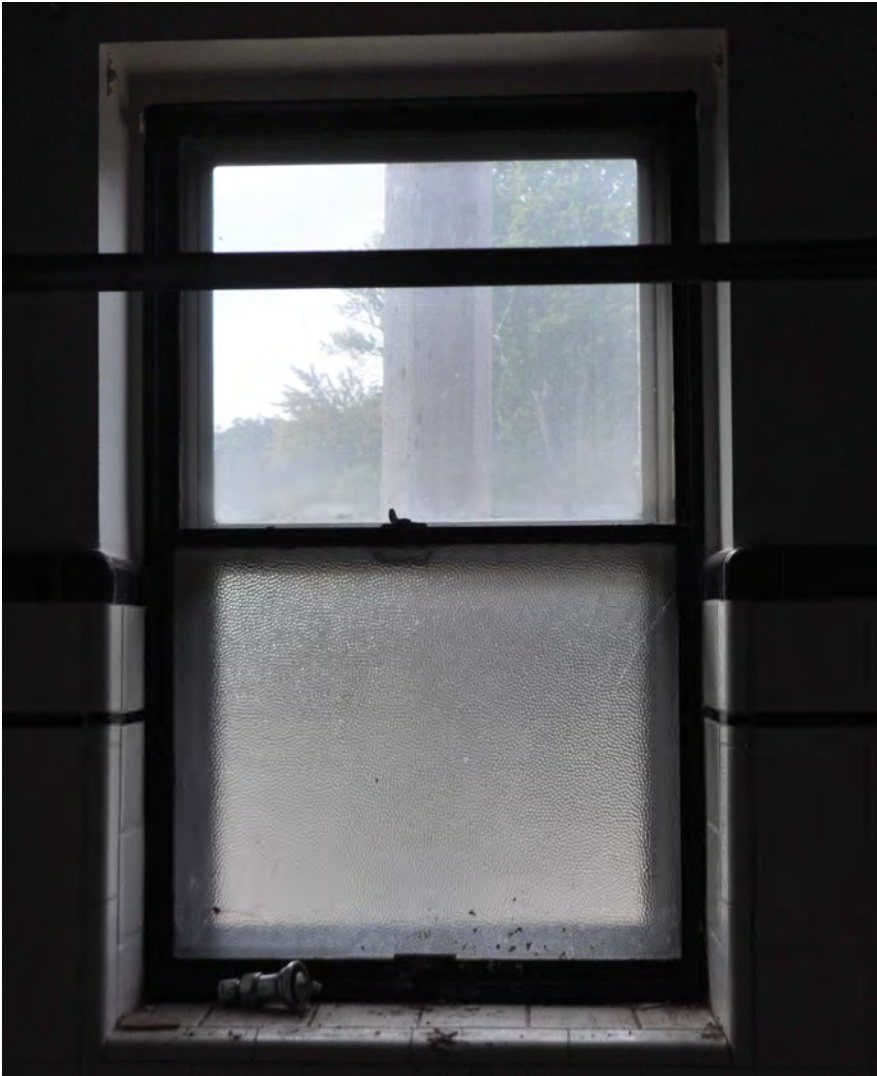
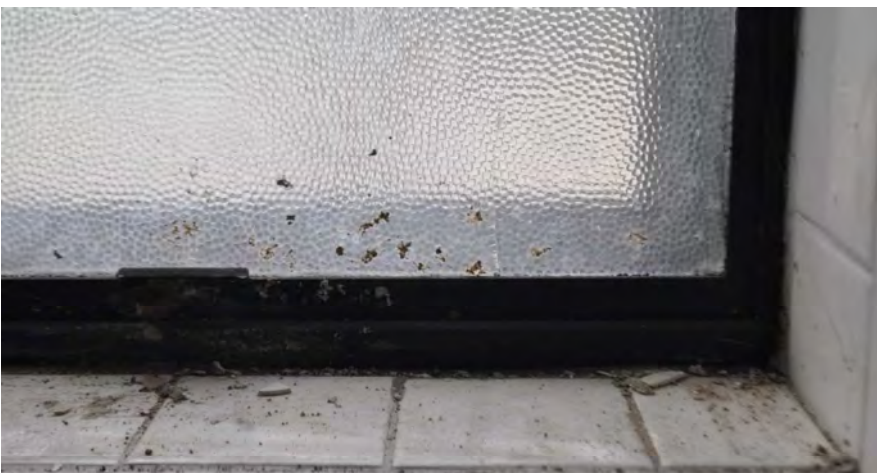
### Window W9, Type U2

- Broken Glass
- Note: Extent of exterior deterioration, corrosion, and loss of operability is not fully apparent in interior photos. Replacement parts for existing windows are unavailable, making restoration of thermal and operable functionality impossible, and long-term maintenance infeasible. Recommendation is for replacement, for quality of life of future tenants and for feasibility of long-term maintenance.
- See Window Assessment (Blackberry) in appendix for further detail and information, including further notes on deterioration beyond repair
- See Appendix for Window Schedule & Measurements

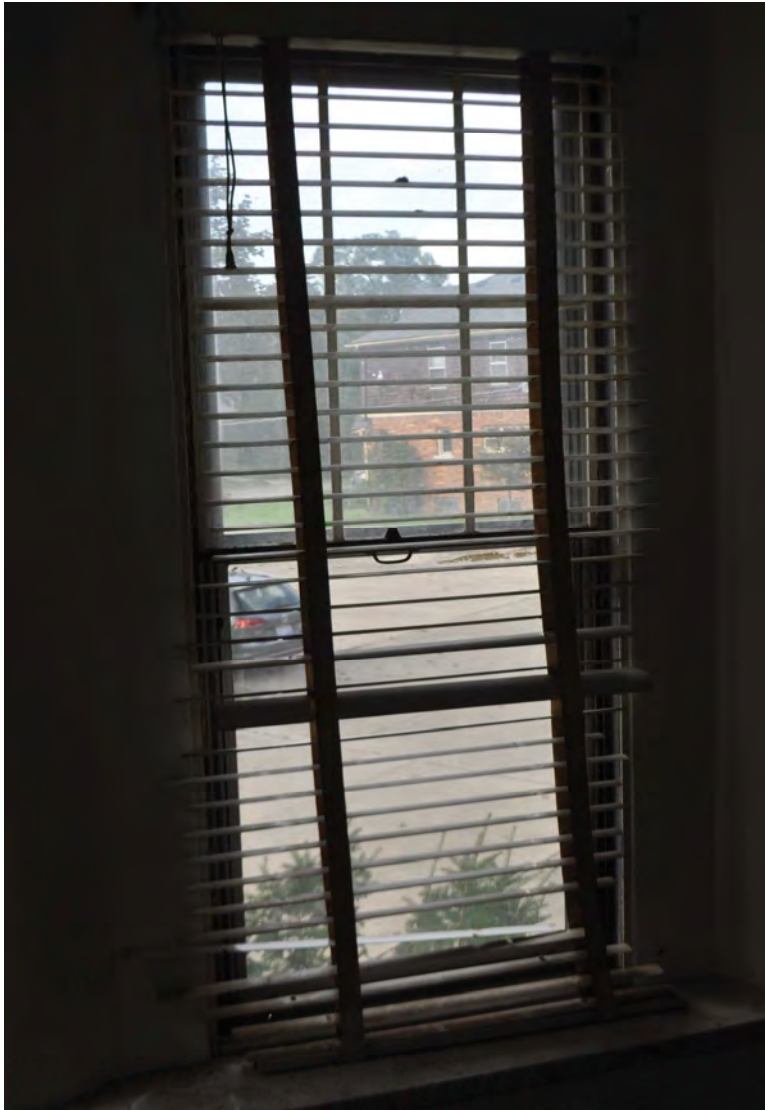
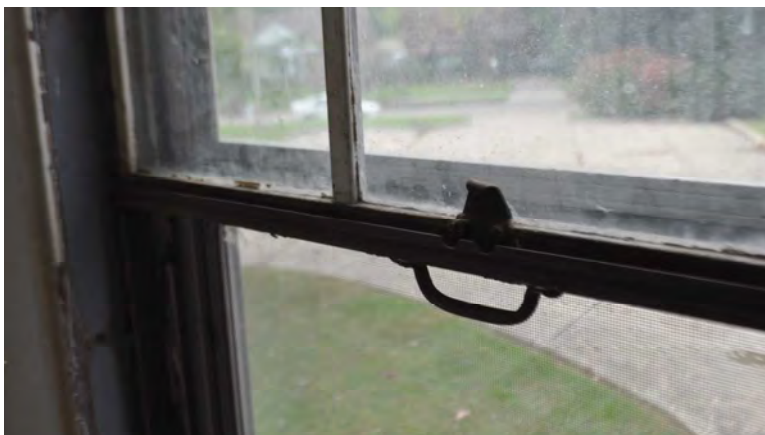
### Window W10, Type V1

- Missing part of Sash Frame
- Note: Extent of exterior deterioration, corrosion, and loss of operability is not fully apparent in interior photos. Replacement parts for existing windows are unavailable, making restoration of thermal and operable functionality impossible, and long-term maintenance infeasible. Recommendation is for replacement, for quality of life of future tenants and for feasibility of long-term maintenance.
- See Window Assessment (Blackberry) in appendix for further detail and information, including further notes on deterioration beyond repair
- See Appendix for Window Schedule & Measurements

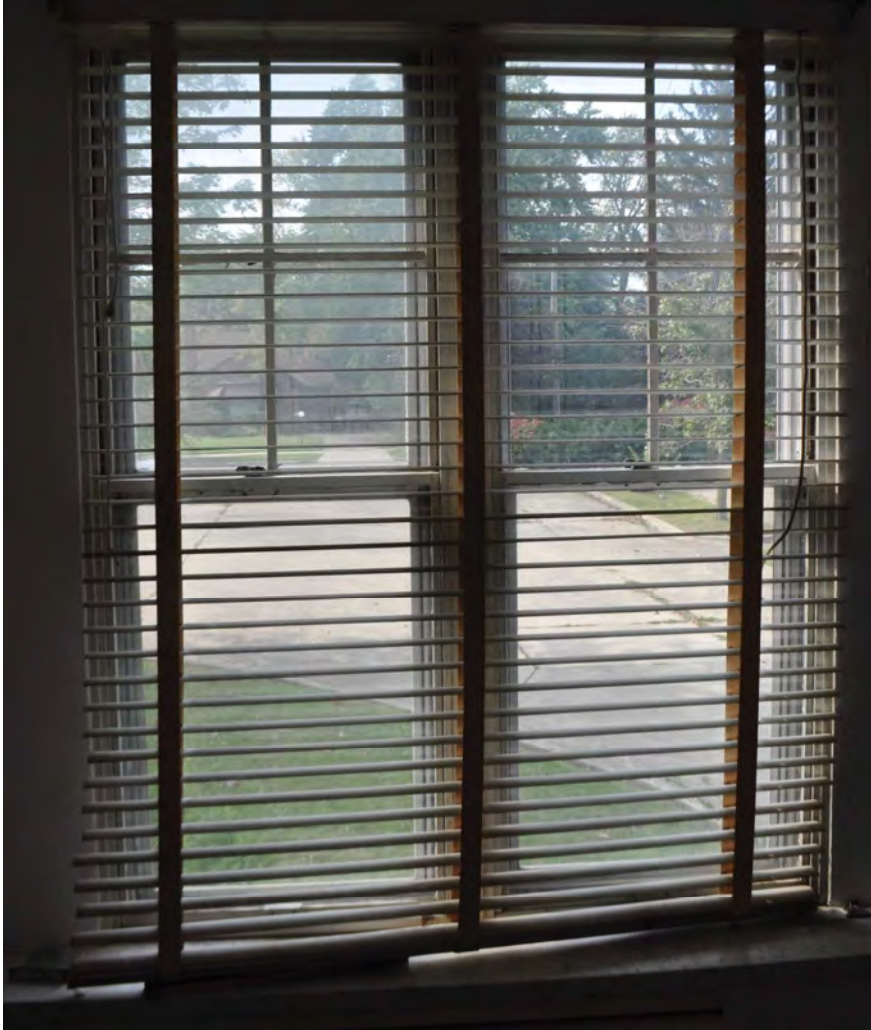
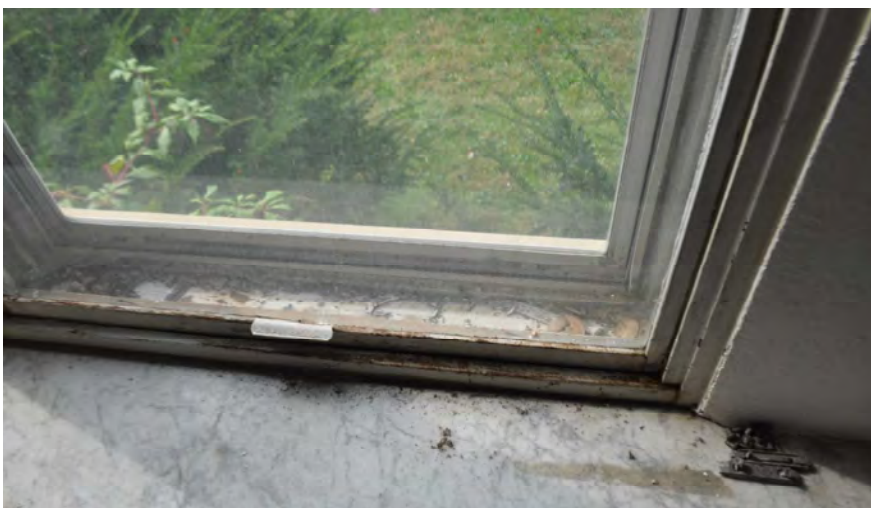
### Window W11 & W12, Type X1

- Note: Extent of exterior deterioration, corrosion, and loss of operability is not fully apparent in interior photos. Replacement parts for existing windows are unavailable, making restoration of thermal and operable functionality impossible, and long-term maintenance infeasible. Recommendation is for replacement, for quality of life of future tenants and for feasibility of long-term maintenance.
- See Window Assessment (Blackberry) in appendix for further detail and information, including further notes on deterioration beyond repair
- See Appendix for Window Schedule & Measurements

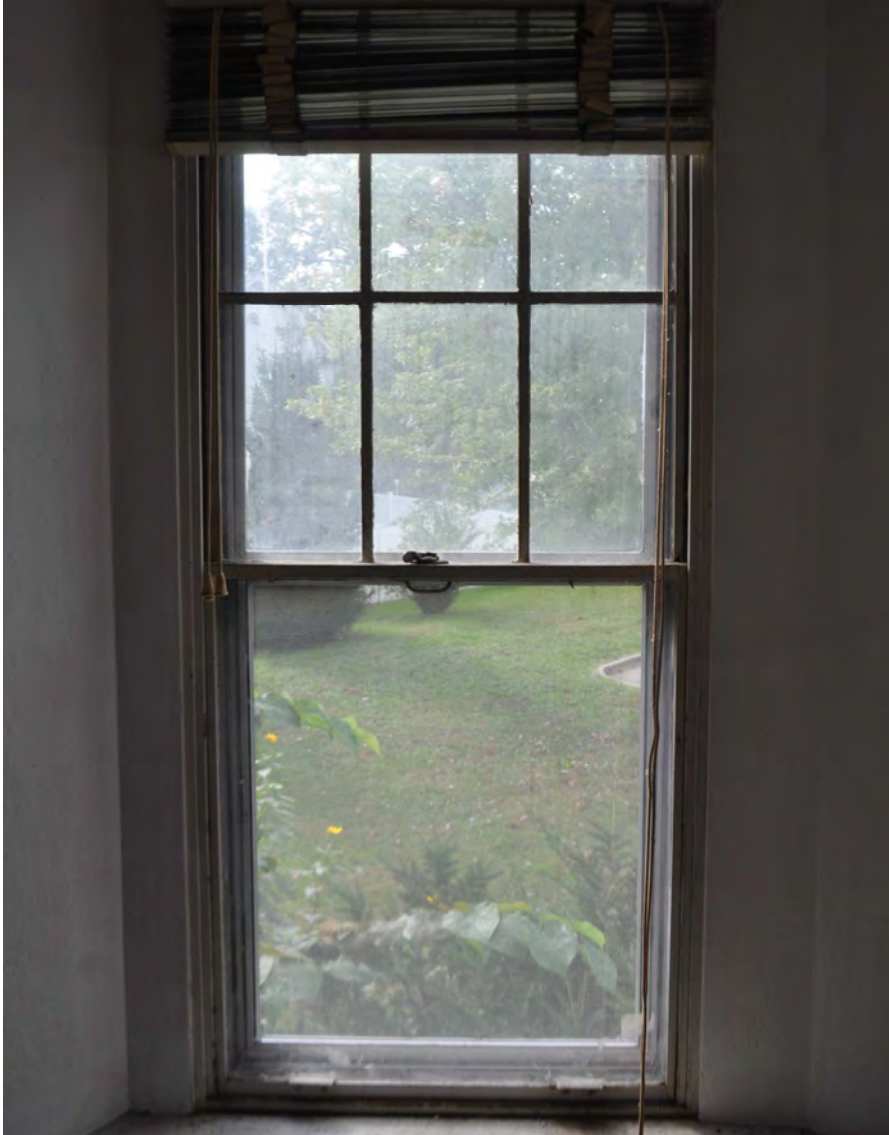
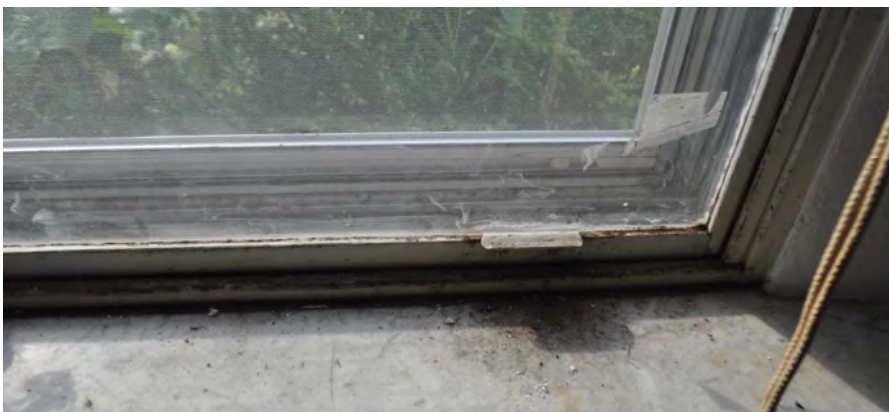
### Window W13, Type V1

- Note: Extent of exterior deterioration, corrosion, and loss of operability is not fully apparent in interior photos. Replacement parts for existing windows are unavailable, making restoration of thermal and operable functionality impossible, and long-term maintenance infeasible. Recommendation is for replacement, for quality of life of future tenants and for feasibility of long-term maintenance.
- See Window Assessment (Blackberry) in appendix for further detail and information, including further notes on deterioration beyond repair
- See Appendix for Window Schedule & Measurements

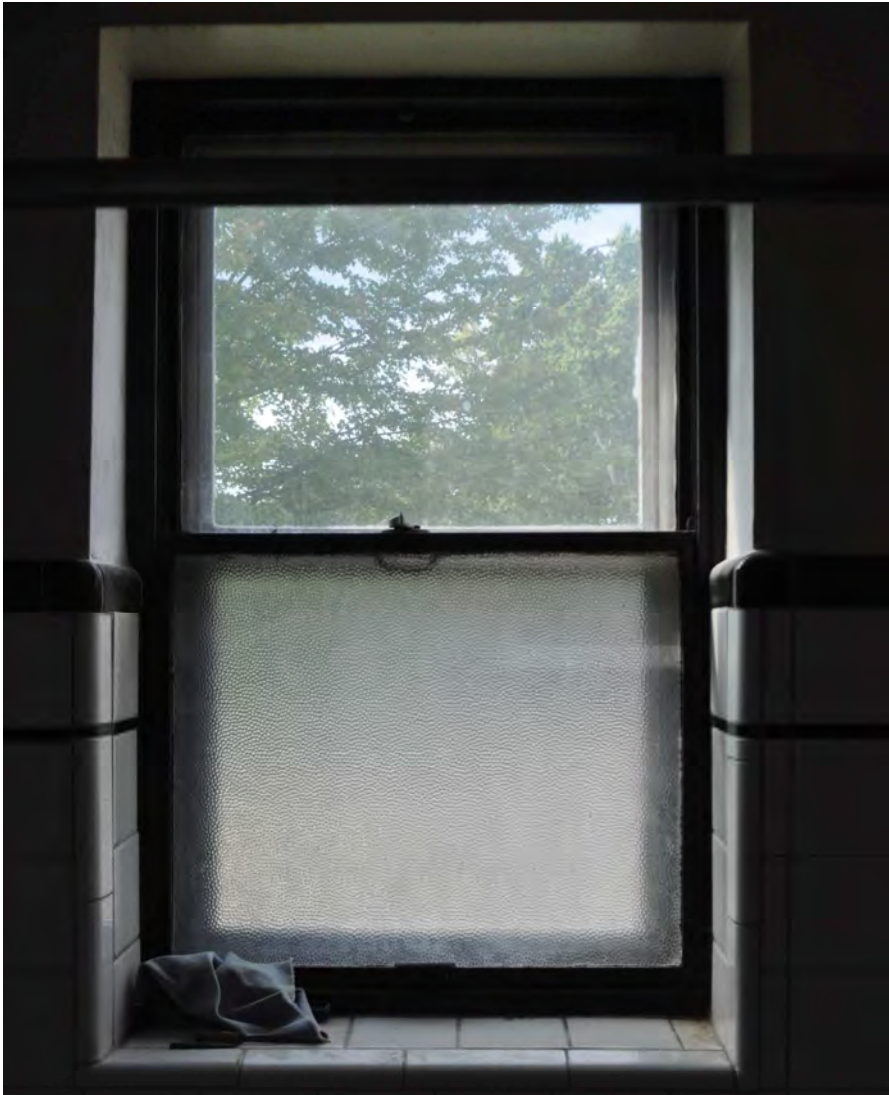
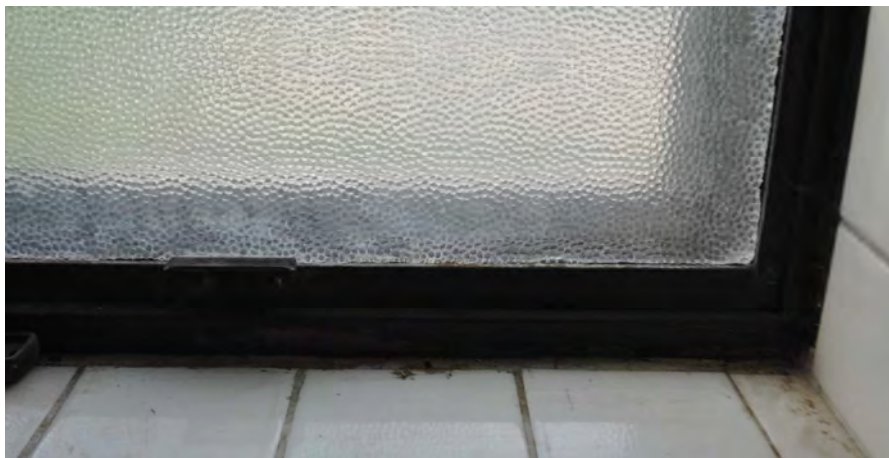
### Window W14, Type U2

- Note: Extent of exterior deterioration, corrosion, and loss of operability is not fully apparent in interior photos. Replacement parts for existing windows are unavailable, making restoration of thermal and operable functionality impossible, and long-term maintenance infeasible. Recommendation is for replacement, for quality of life of future tenants and for feasibility of long-term maintenance.
- See Window Assessment (Blackberry) in appendix for further detail and information, including further notes on deterioration beyond repair
- See Appendix for Window Schedule & Measurements
