# 9710 W Outer Dr

## Existing Condition Photos

# 9730 W Outer Dr

# Detailed Scope of Work

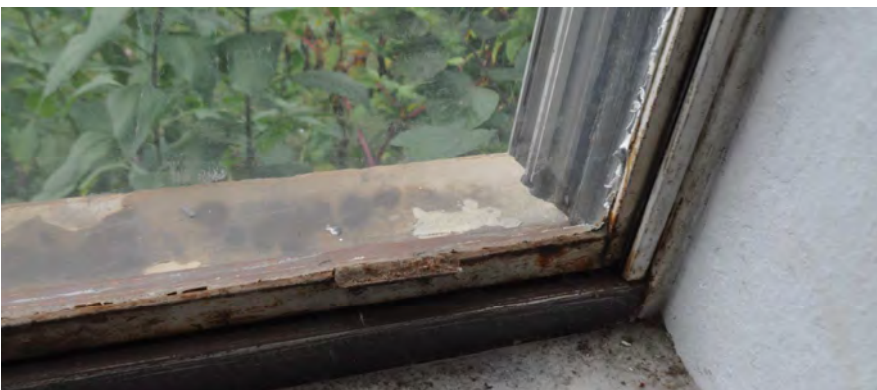
### Window W15, Type R2

- Badly Corroded
- Note: Extent of exterior deterioration, corrosion, and loss of operability is not fully apparent in interior photos. Replacement parts for existing windows are unavailable, making restoration of thermal and operable functionality impossible, and long-term maintenance infeasible. Recommendation is for replacement, for quality of life of future tenants and for feasibility of long-term maintenance.
- See Window Assessment (Blackberry) in appendix for further detail and information, including further notes on deterioration beyond repair
- See Appendix for Window Schedule & Measurements

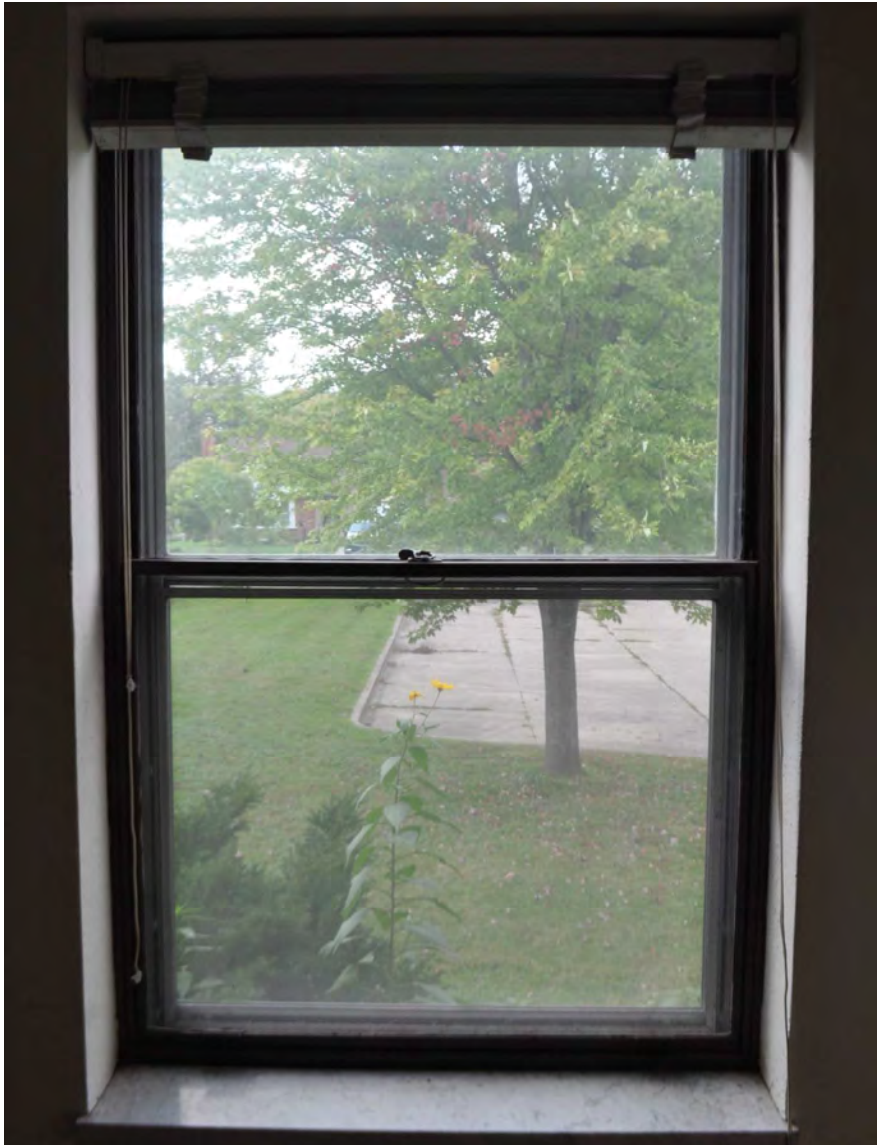
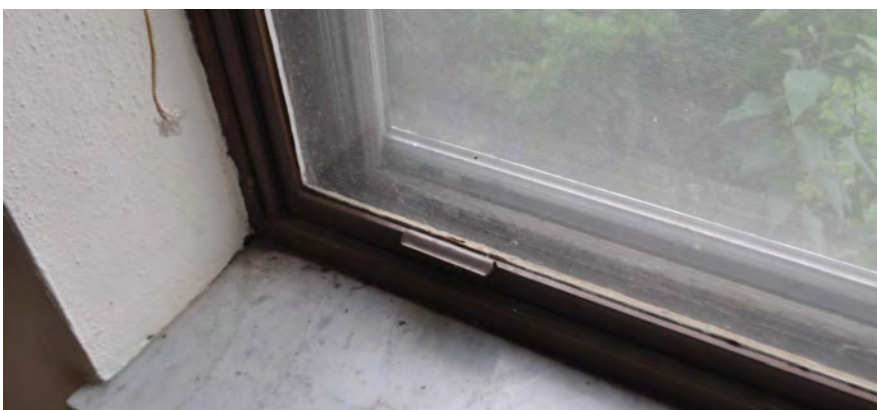
### Window DEMO 02, Type R2

- Note: Extent of exterior deterioration, corrosion, and loss of operability is not fully apparent in interior photos. Replacement parts for existing windows are unavailable, making restoration of thermal and operable functionality impossible, and long-term maintenance infeasible. Recommendation is for replacement, for quality of life of future tenants and for feasibility of long-term maintenance.
- See Window Assessment (Blackberry) in appendix for further detail and information, including further notes on deterioration beyond repair
- See Appendix for Window Schedule & Measurements

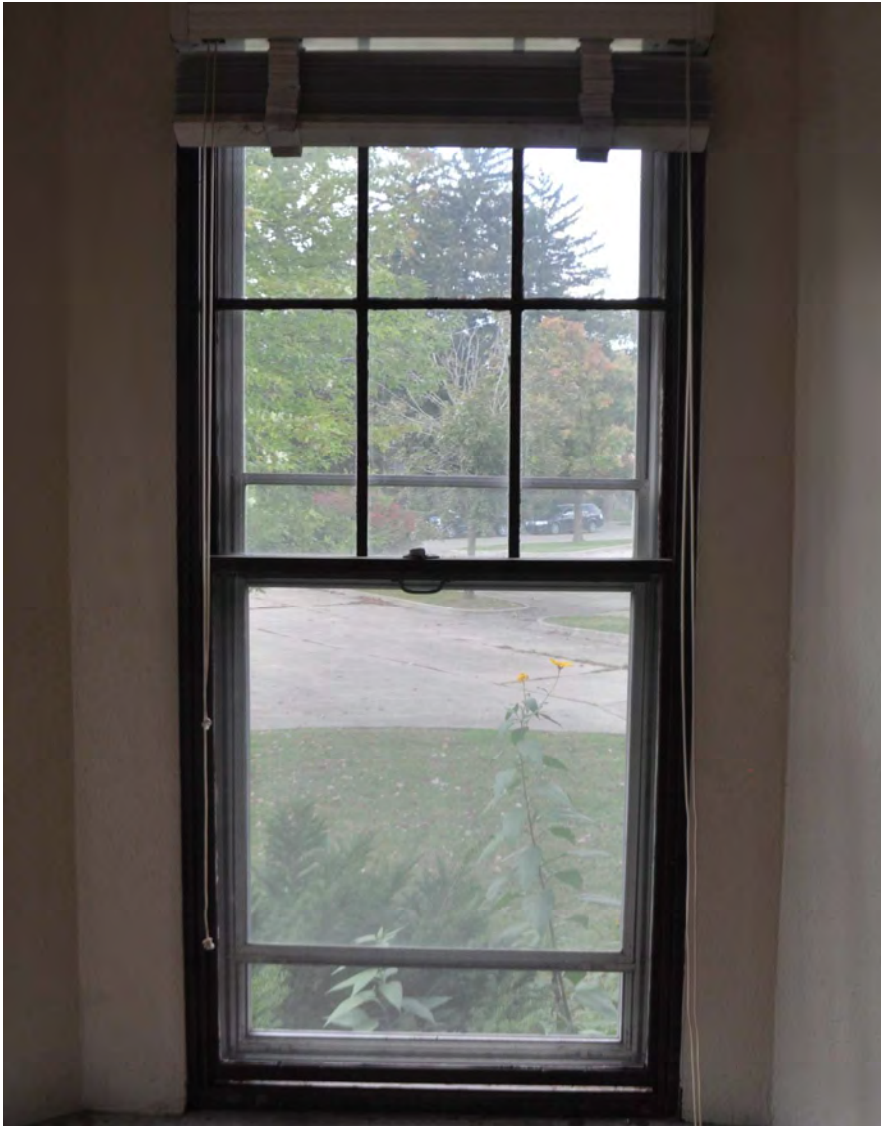
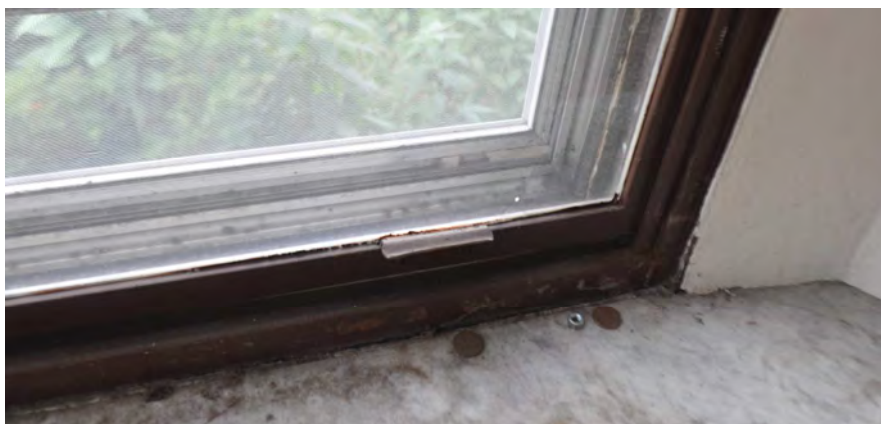
### Window W16, Type V1

- Note: Extent of exterior deterioration, corrosion, and loss of operability is not fully apparent in interior photos. Replacement parts for existing windows are unavailable, making restoration of thermal and operable functionality impossible, and long-term maintenance infeasible. Recommendation is for replacement, for quality of life of future tenants and for feasibility of long-term maintenance.
- See Window Assessment (Blackberry) in appendix for further detail and information, including further notes on deterioration beyond repair
- See Appendix for Window Schedule & Measurements

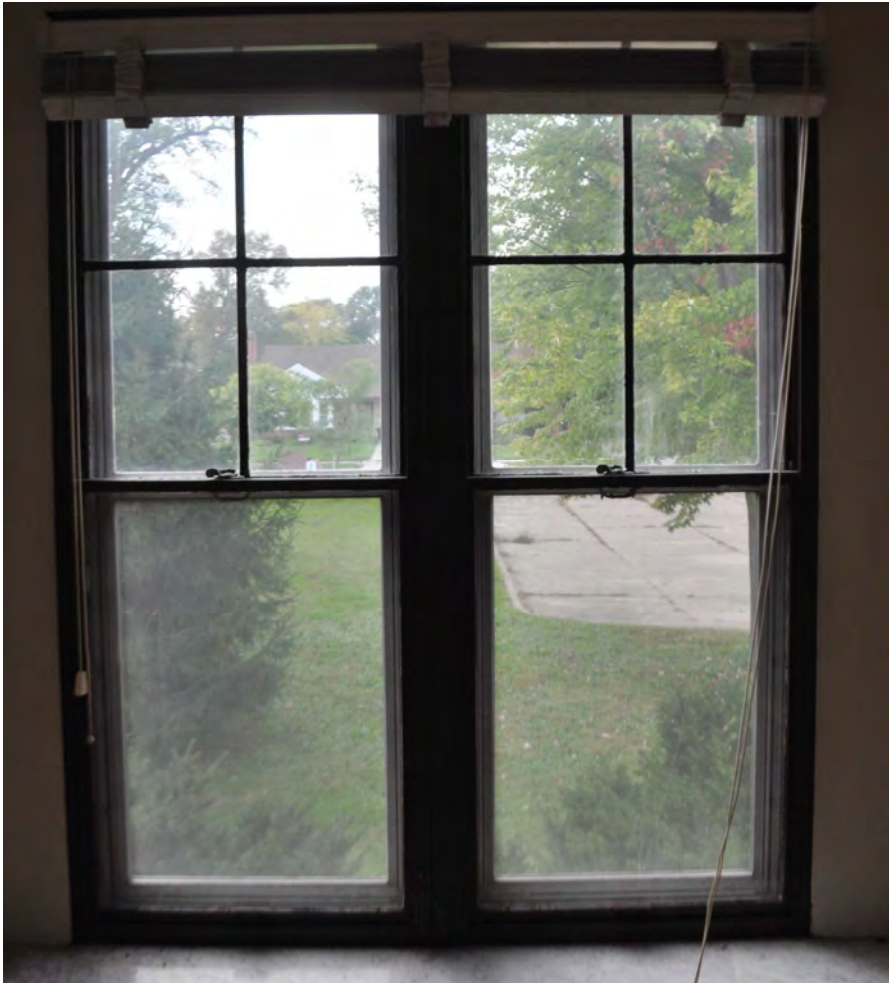
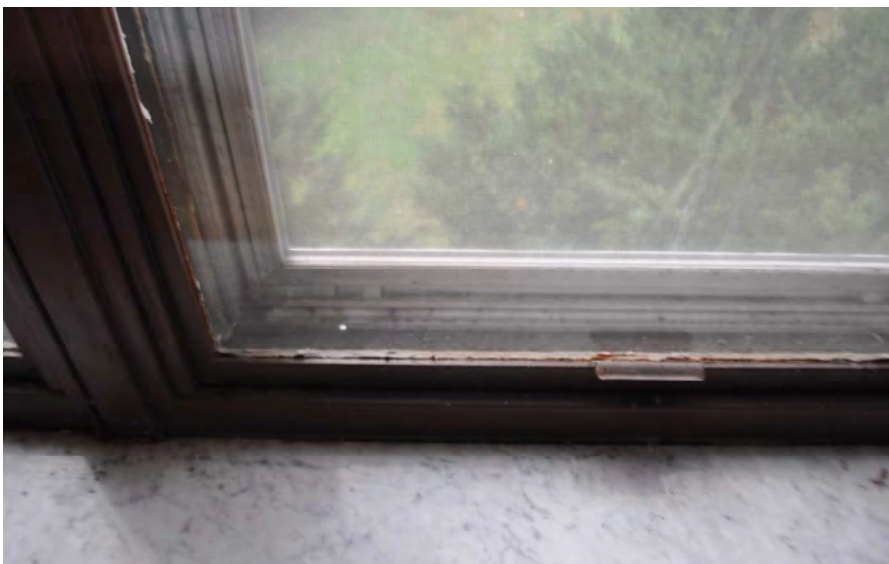
### Window W17 & W18, Type X1

- Note: Extent of exterior deterioration, corrosion, and loss of operability is not fully apparent in interior photos. Replacement parts for existing windows are unavailable, making restoration of thermal and operable functionality impossible, and long-term maintenance infeasible. Recommendation is for replacement, for quality of life of future tenants and for feasibility of long-term maintenance.
- See Window Assessment (Blackberry) in appendix for further detail and information, including further notes on deterioration beyond repair
- See Appendix for Window Schedule & Measurements

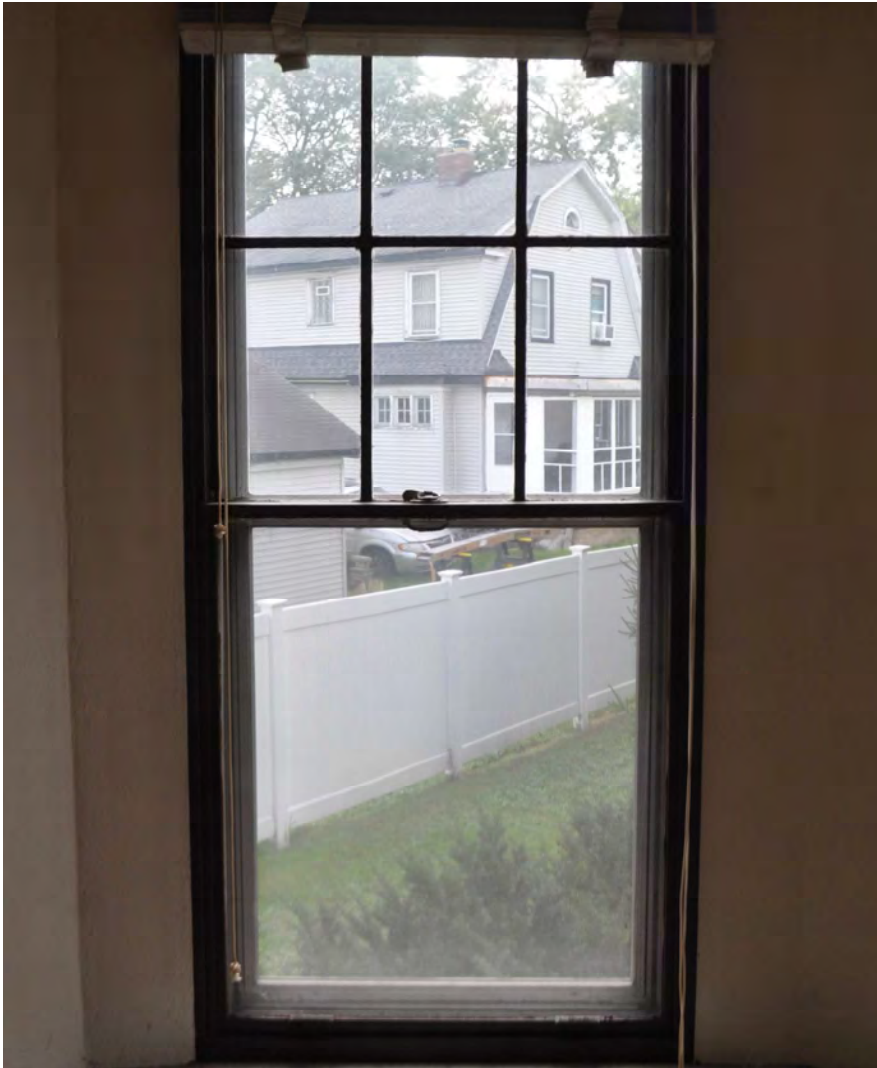
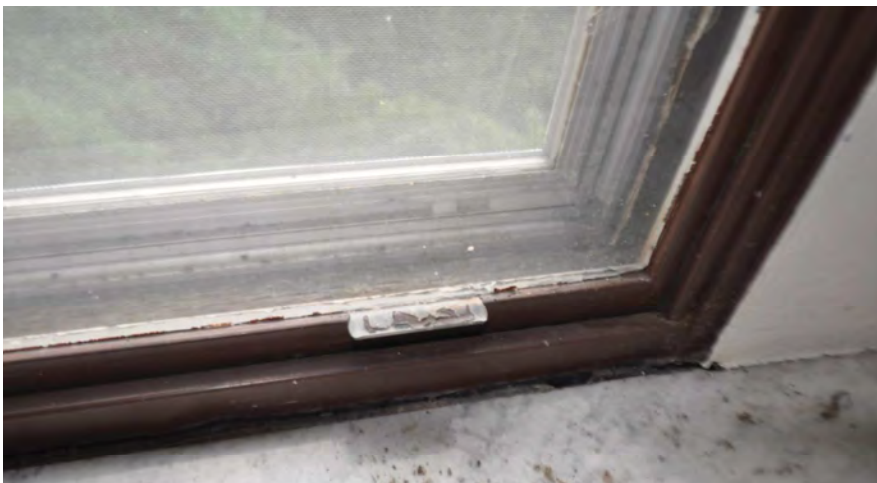
### Window W19, Type V1

- Note: Extent of exterior deterioration, corrosion, and loss of operability is not fully apparent in interior photos. Replacement parts for existing windows are unavailable, making restoration of thermal and operable functionality impossible, and long-term maintenance infeasible. Recommendation is for replacement, for quality of life of future tenants and for feasibility of long-term maintenance.
- See Window Assessment (Blackberry) in appendix for further detail and information, including further notes on deterioration beyond repair
- See Appendix for Window Schedule & Measurements

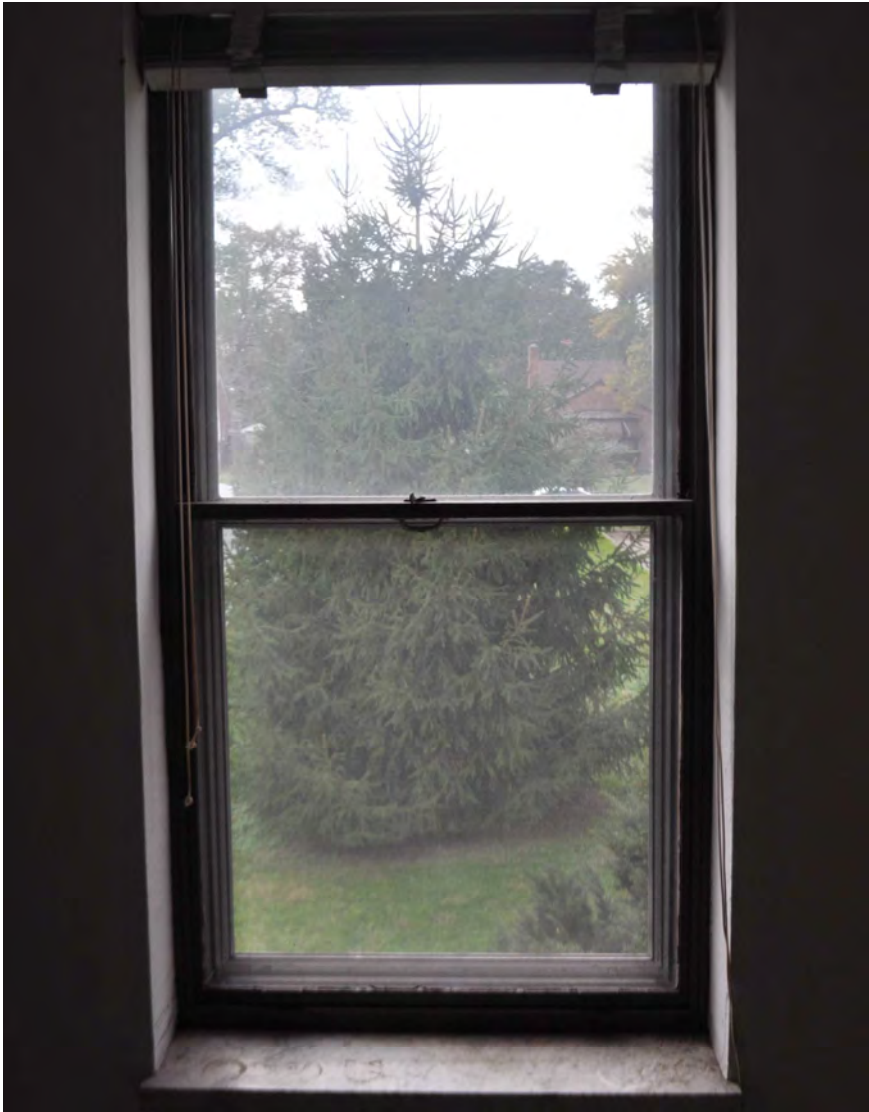
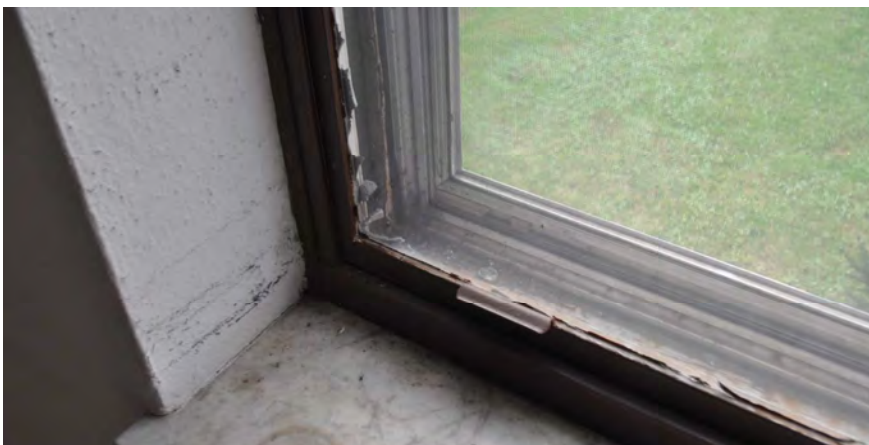
### Window W20, Type N2

- Note: Extent of exterior deterioration, corrosion, and loss of operability is not fully apparent in interior photos. Replacement parts for existing windows are unavailable, making restoration of thermal and operable functionality impossible, and long-term maintenance infeasible. Recommendation is for replacement, for quality of life of future tenants and for feasibility of long-term maintenance.
- See Window Assessment (Blackberry) in appendix for further detail and information, including further notes on deterioration beyond repair
- See Appendix for Window Schedule & Measurements

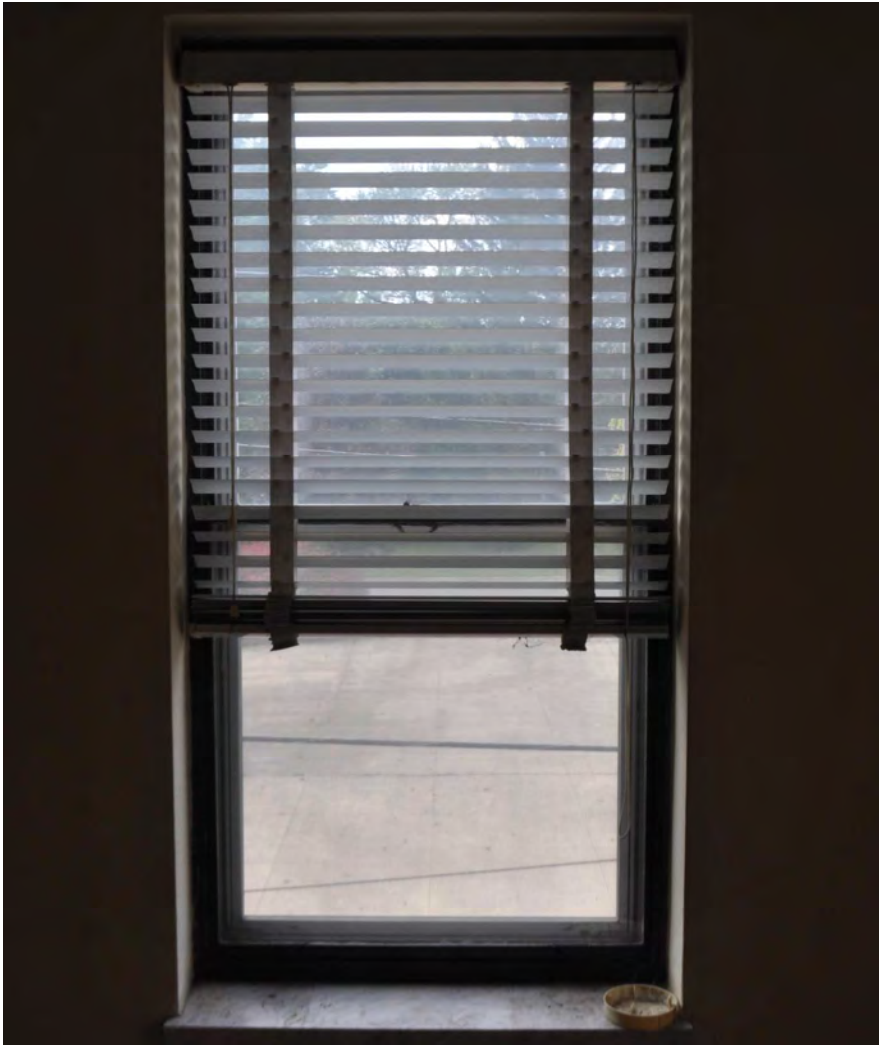
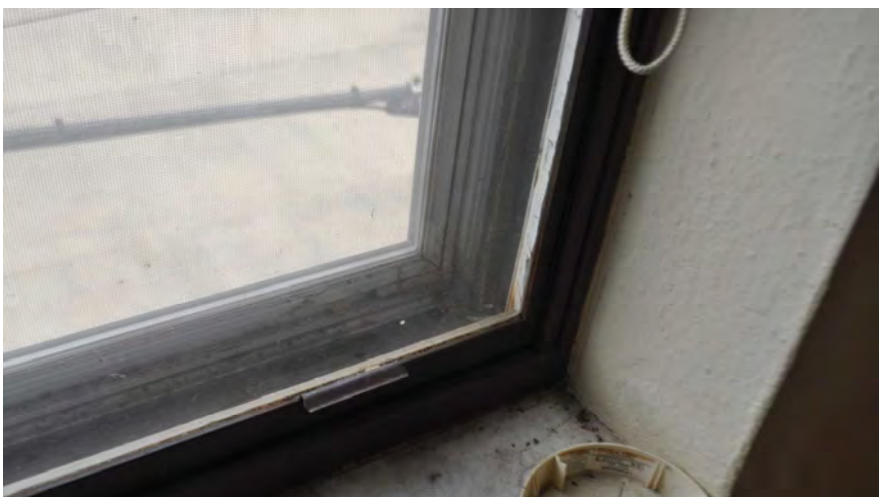
### Window X1, Type N2

- Note: Extent of exterior deterioration, corrosion, and loss of operability is not fully apparent in interior photos. Replacement parts for existing windows are unavailable, making restoration of thermal and operable functionality impossible, and long-term maintenance infeasible. Recommendation is for replacement, for quality of life of future tenants and for feasibility of long-term maintenance.
- See Window Assessment (Blackberry) in appendix for further detail and information, including further notes on deterioration beyond repair
- See Appendix for Window Schedule & Measurements

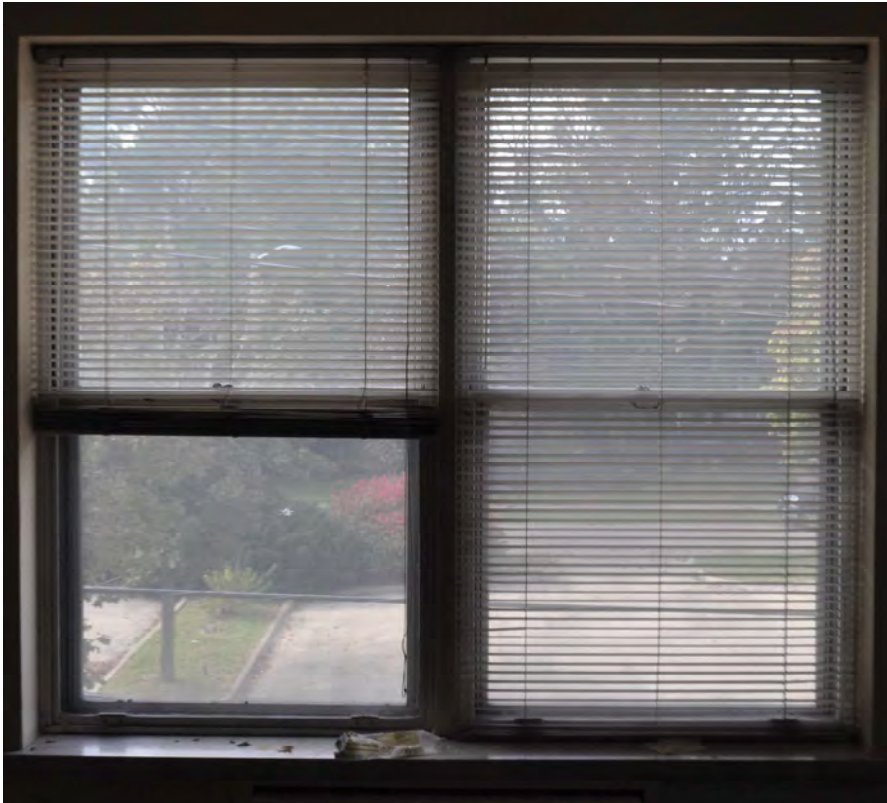
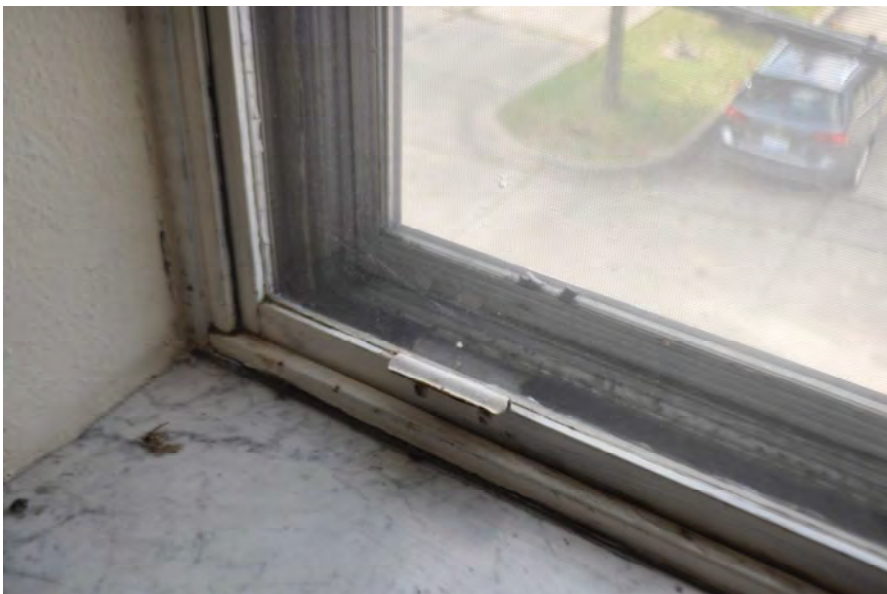
### Window X2, Type P2

- Note: Extent of exterior deterioration, corrosion, and loss of operability is not fully apparent in interior photos. Replacement parts for existing windows are unavailable, making restoration of thermal and operable functionality impossible, and long-term maintenance infeasible. Recommendation is for replacement, for quality of life of future tenants and for feasibility of long-term maintenance.
- See Window Assessment (Blackberry) in appendix for further detail and information, including further notes on deterioration beyond repair
- See Appendix for Window Schedule & Measurements

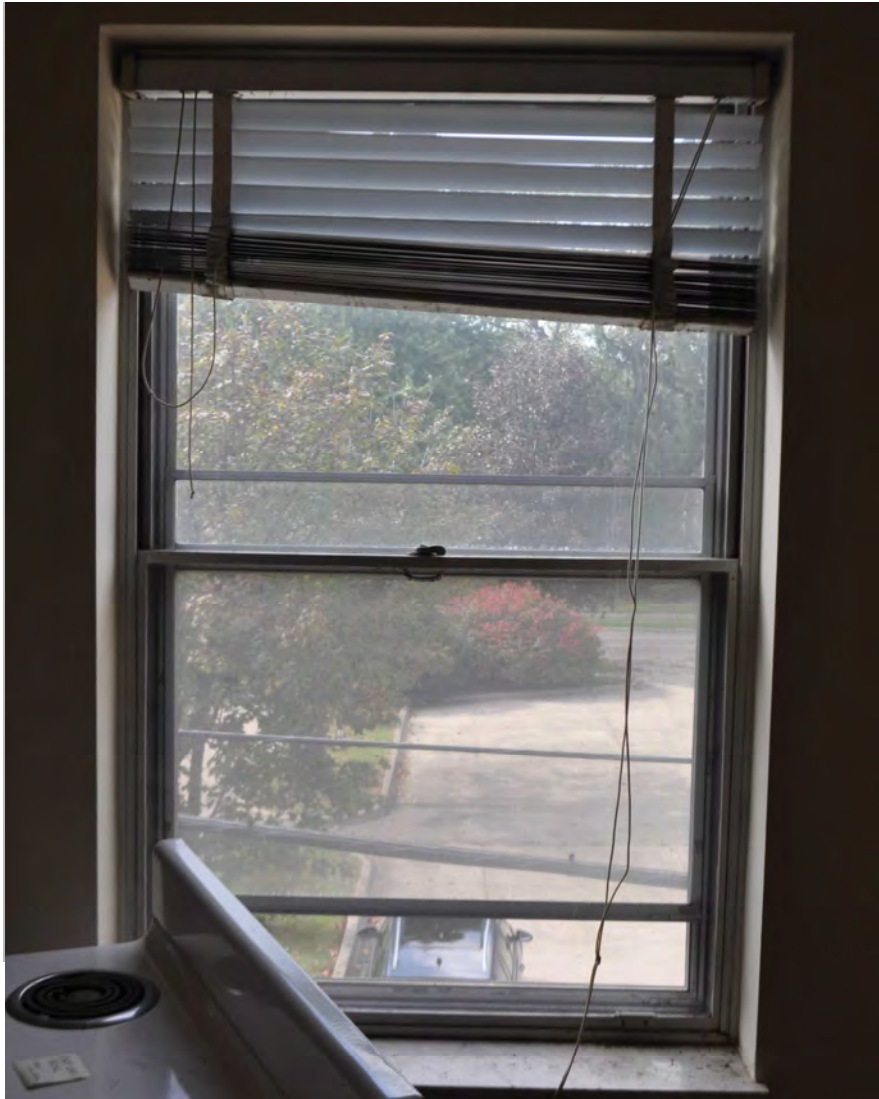
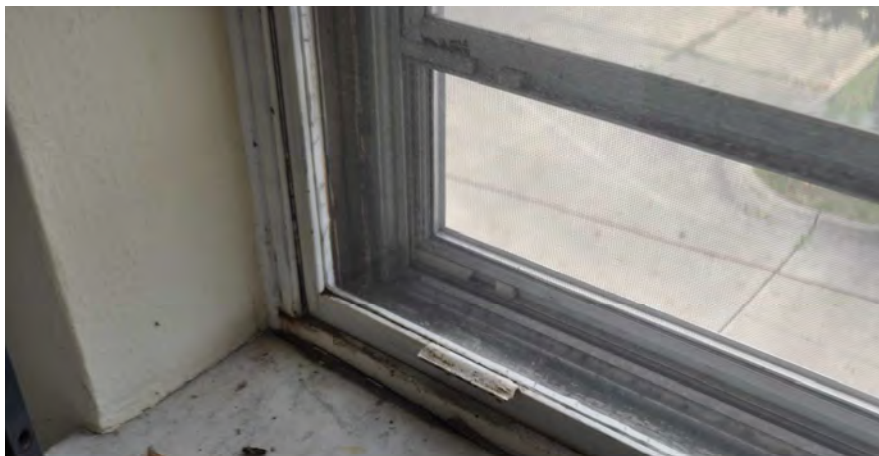
### Window X3, Type R2

- Note: Extent of exterior deterioration, corrosion, and loss of operability is not fully apparent in interior photos. Replacement parts for existing windows are unavailable, making restoration of thermal and operable functionality impossible, and long-term maintenance infeasible. Recommendation is for replacement, for quality of life of future tenants and for feasibility of long-term maintenance.
- See Window Assessment (Blackberry) in appendix for further detail and information, including further notes on deterioration beyond repair
- See Appendix for Window Schedule & Measurements

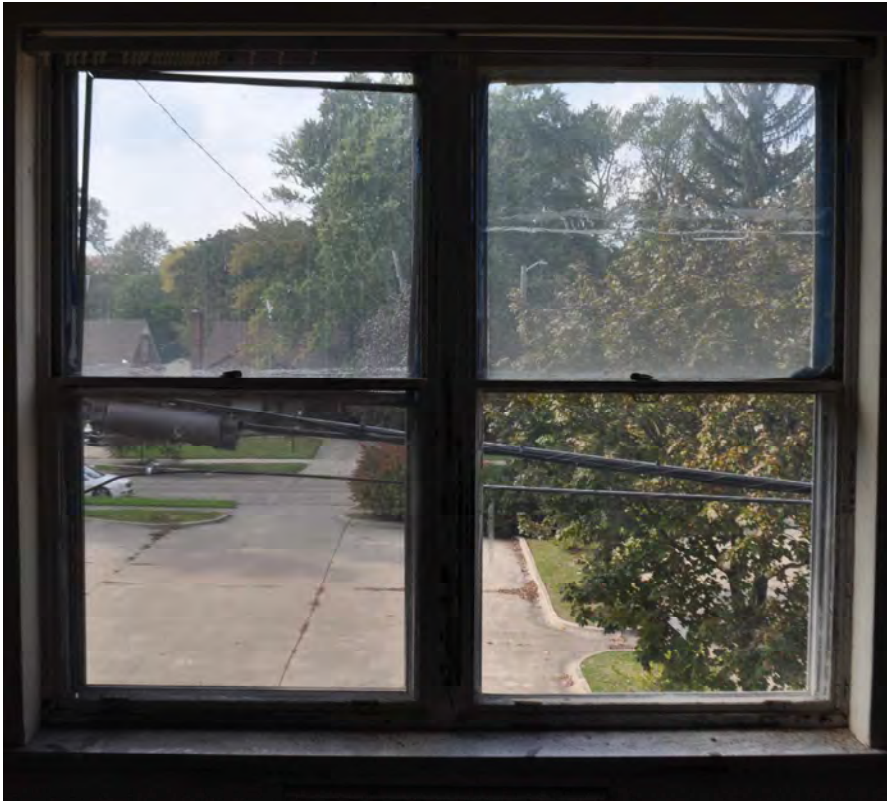
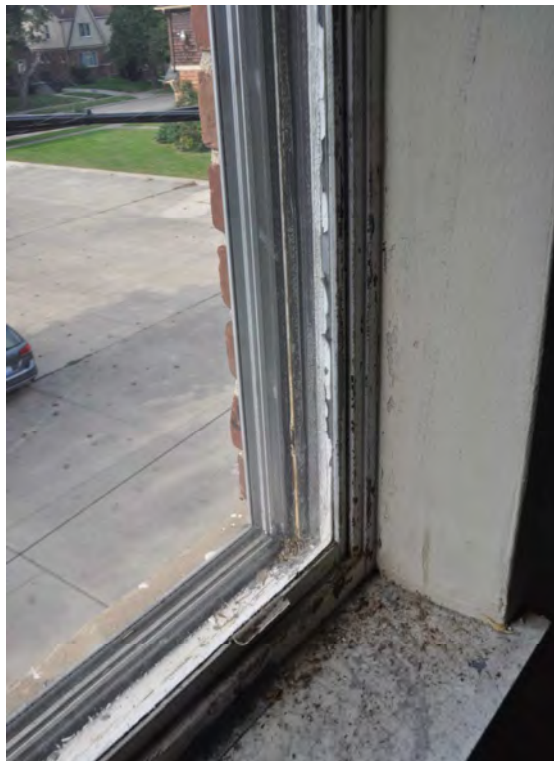
### Window X6, Type P2

- Note: Extent of exterior deterioration, corrosion, and loss of operability is not fully apparent in interior photos. Replacement parts for existing windows are unavailable, making restoration of thermal and operable functionality impossible, and long-term maintenance infeasible. Recommendation is for replacement, for quality of life of future tenants and for feasibility of long-term maintenance.
- See Window Assessment (Blackberry) in appendix for further detail and information, including further notes on deterioration beyond repair
- See Appendix for Window Schedule & Measurements

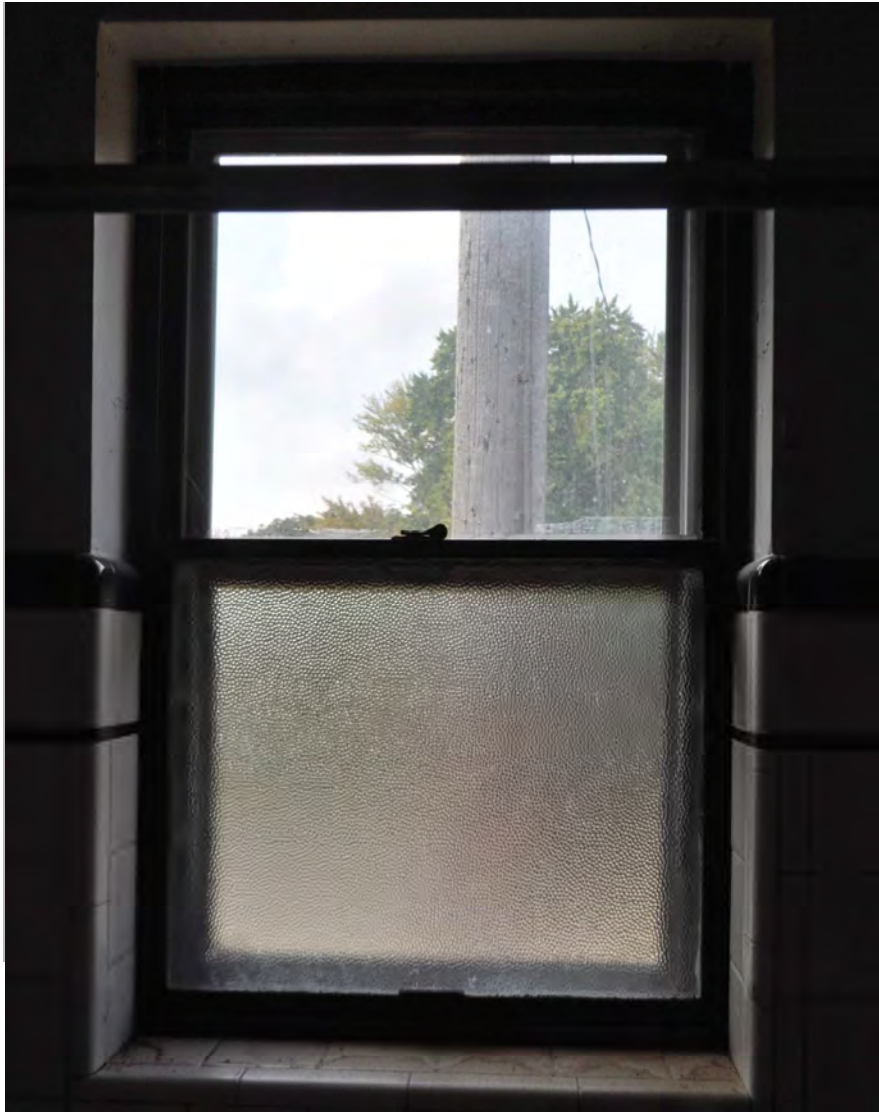
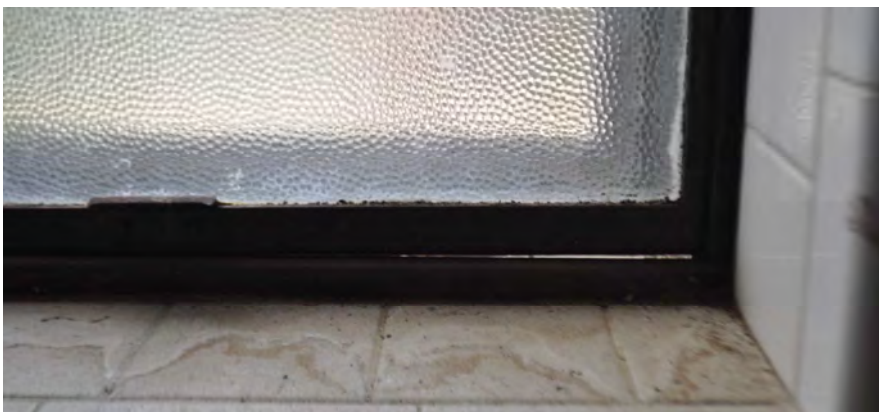
### Window X7, Type U2

- Note: Extent of exterior deterioration, corrosion, and loss of operability is not fully apparent in interior photos. Replacement parts for existing windows are unavailable, making restoration of thermal and operable functionality impossible, and long-term maintenance infeasible. Recommendation is for replacement, for quality of life of future tenants and for feasibility of long-term maintenance.
- See Window Assessment (Blackberry) in appendix for further detail and information, including further notes on deterioration beyond repair
- See Appendix for Window Schedule & Measurements

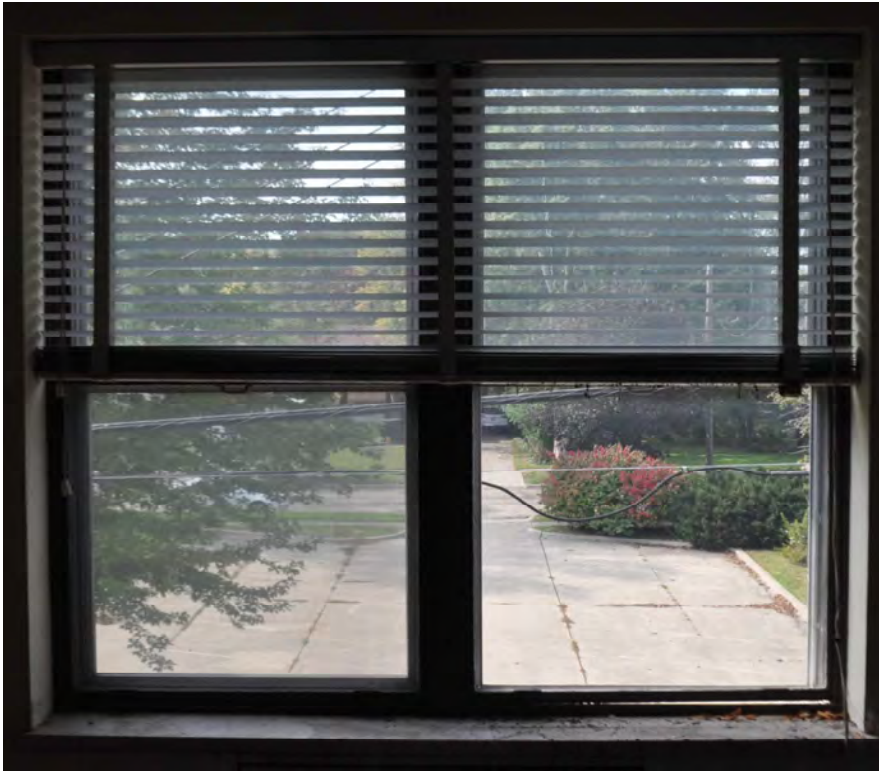
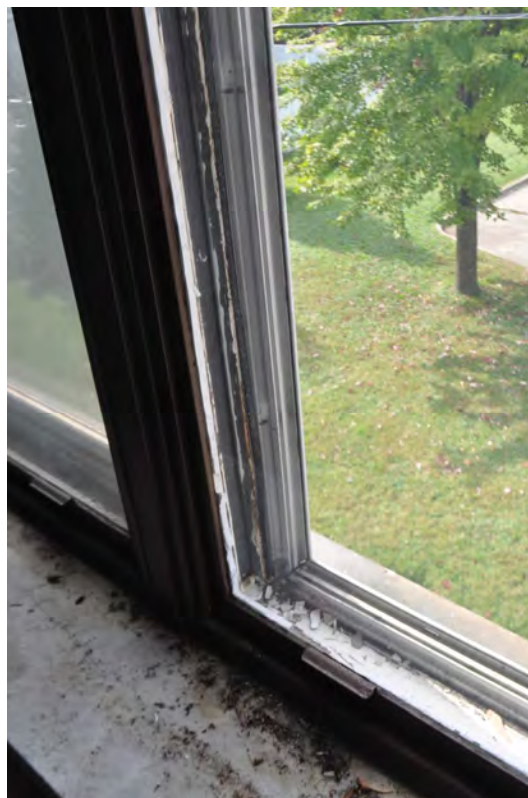
### Window X8, Type P2

- Note: Extent of exterior deterioration, corrosion, and loss of operability is not fully apparent in interior photos. Replacement parts for existing windows are unavailable, making restoration of thermal and operable functionality impossible, and long-term maintenance infeasible. Recommendation is for replacement, for quality of life of future tenants and for feasibility of long-term maintenance.
- See Window Assessment (Blackberry) in appendix for further detail and information, including further notes on deterioration beyond repair
- See Appendix for Window Schedule & Measurements

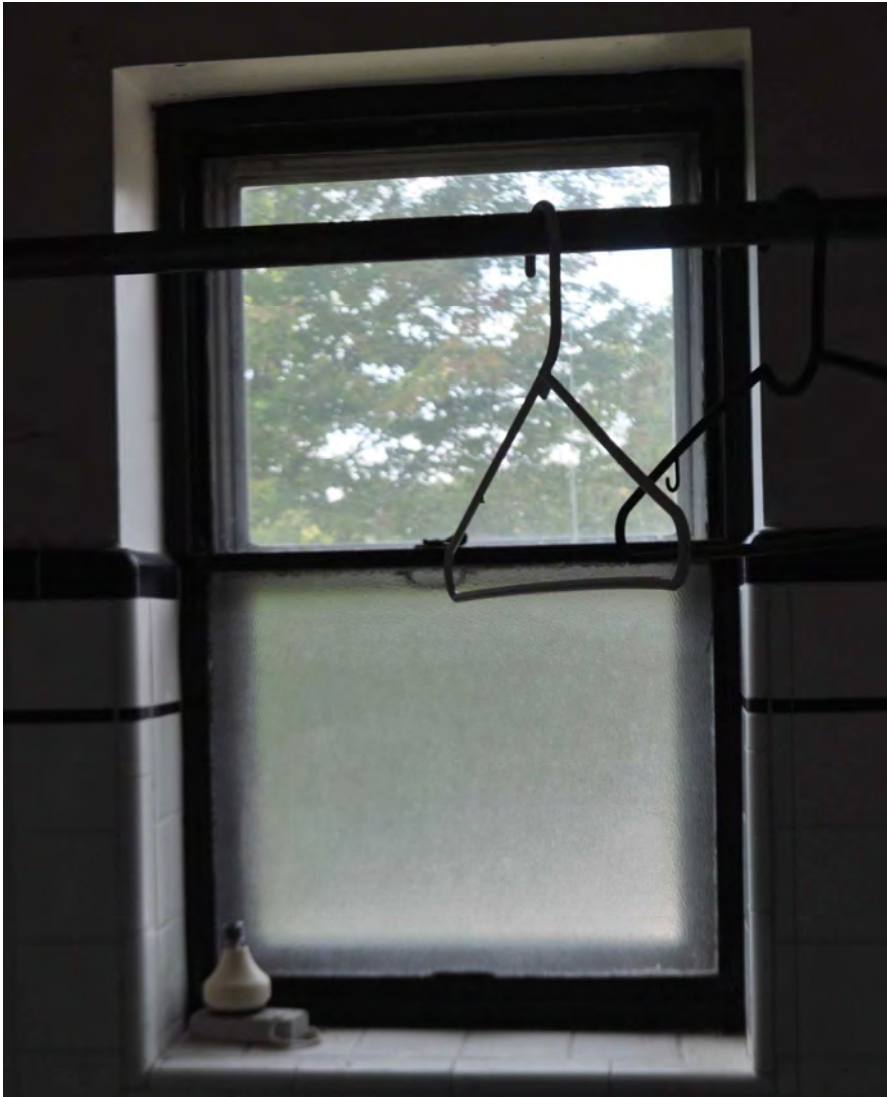
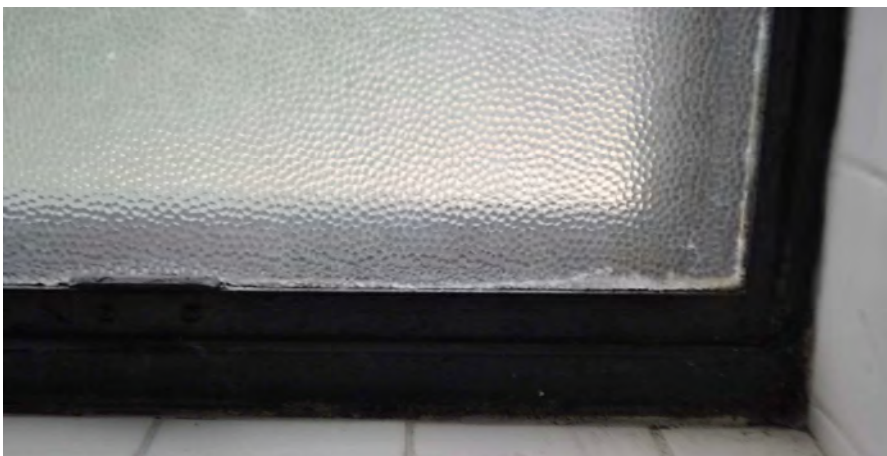
### Window X9, Type U2

- Note: Extent of exterior deterioration, corrosion, and loss of operability is not fully apparent in interior photos. Replacement parts for existing windows are unavailable, making restoration of thermal and operable functionality impossible, and long-term maintenance infeasible. Recommendation is for replacement, for quality of life of future tenants and for feasibility of long-term maintenance.
- See Window Assessment (Blackberry) in appendix for further detail and information, including further notes on deterioration beyond repair
- See Appendix for Window Schedule & Measurements

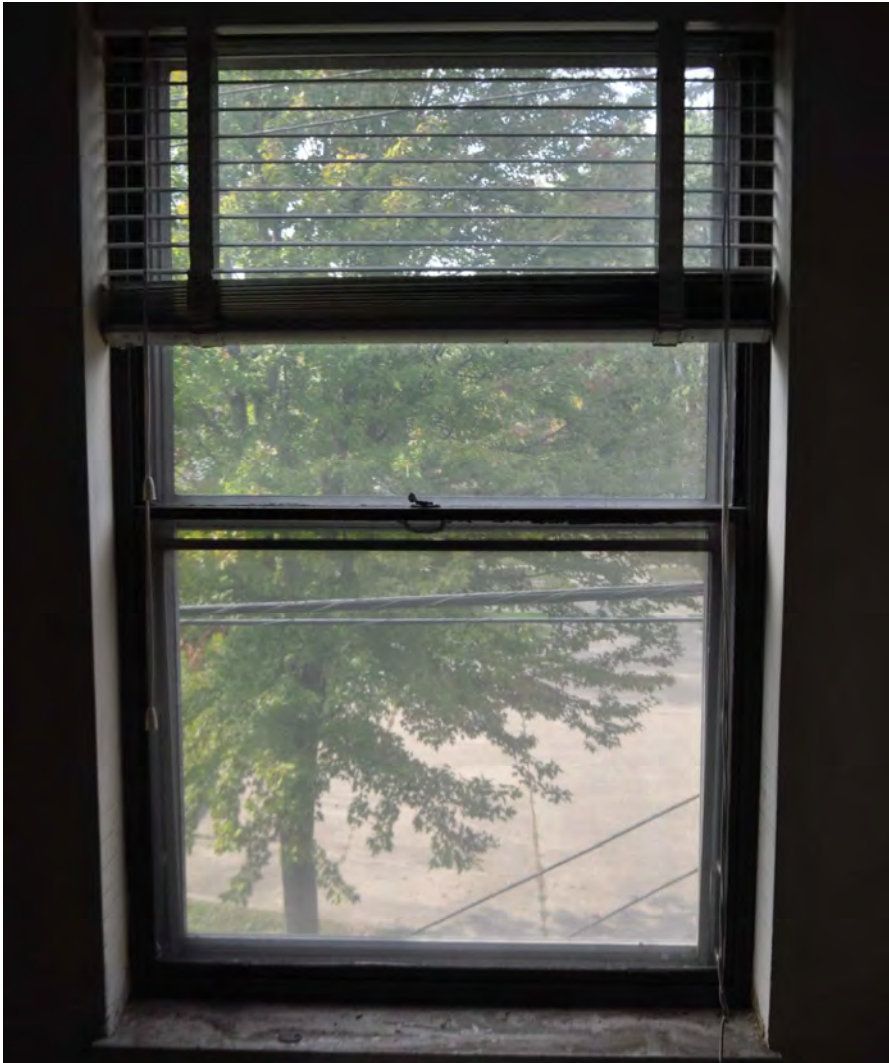
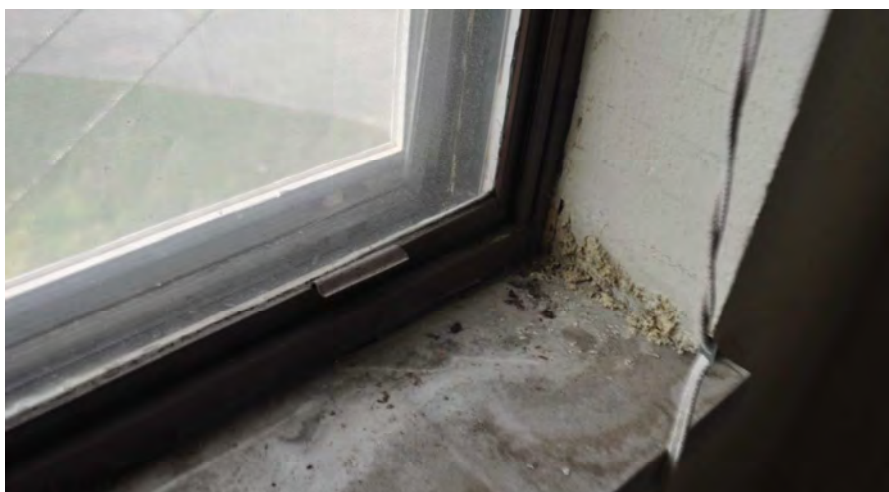
### Window X10, Type R2

- Note: Extent of exterior deterioration, corrosion, and loss of operability is not fully apparent in interior photos. Replacement parts for existing windows are unavailable, making restoration of thermal and operable functionality impossible, and long-term maintenance infeasible. Recommendation is for replacement, for quality of life of future tenants and for feasibility of long-term maintenance.
- See Window Assessment (Blackberry) in appendix for further detail and information, including further notes on deterioration beyond repair
- See Appendix for Window Schedule & Measurements

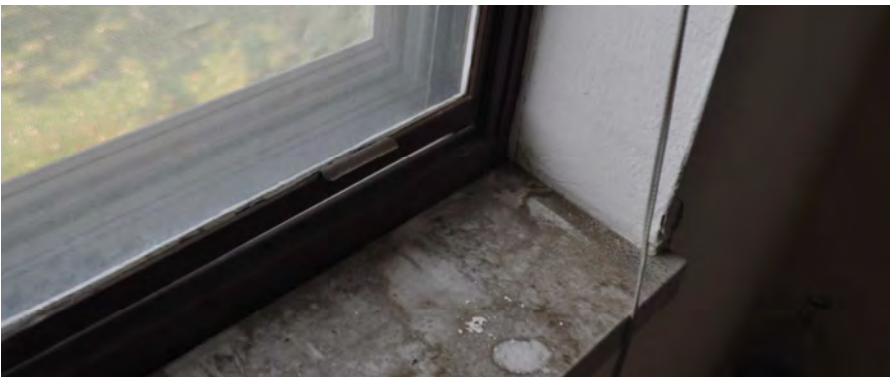
### Window X11, Type R2

- Note: Extent of exterior deterioration, corrosion, and loss of operability is not fully apparent in interior photos. Replacement parts for existing windows are unavailable, making restoration of thermal and operable functionality impossible, and long-term maintenance infeasible. Recommendation is for replacement, for quality of life of future tenants and for feasibility of long-term maintenance.
- See Window Assessment (Blackberry) in appendix for further detail and information, including further notes on deterioration beyond repair
- See Appendix for Window Schedule & Measurements

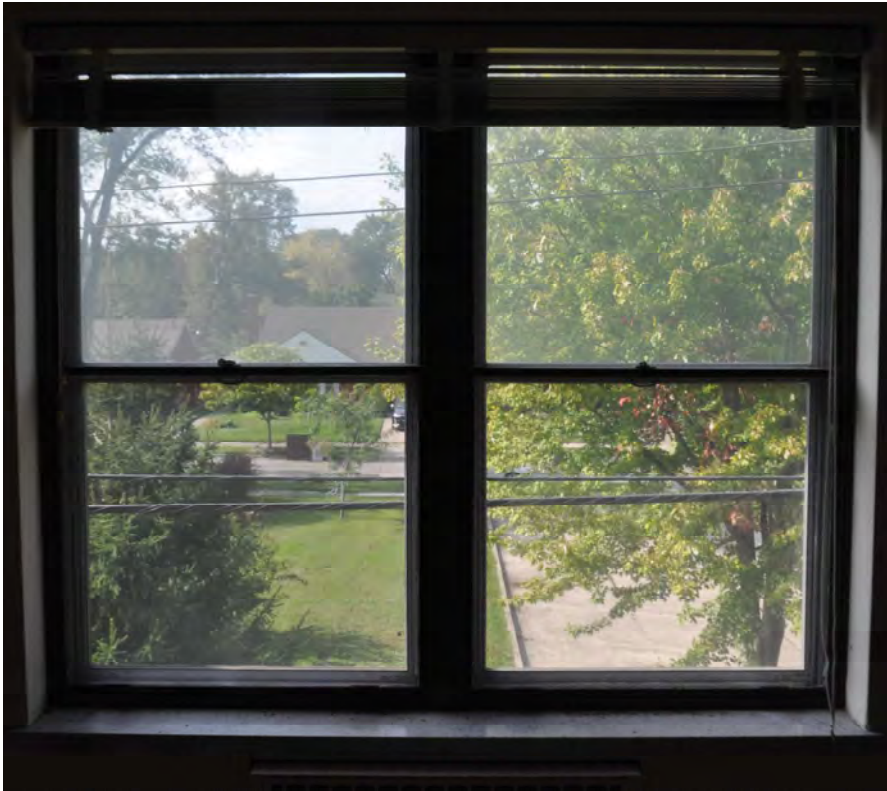
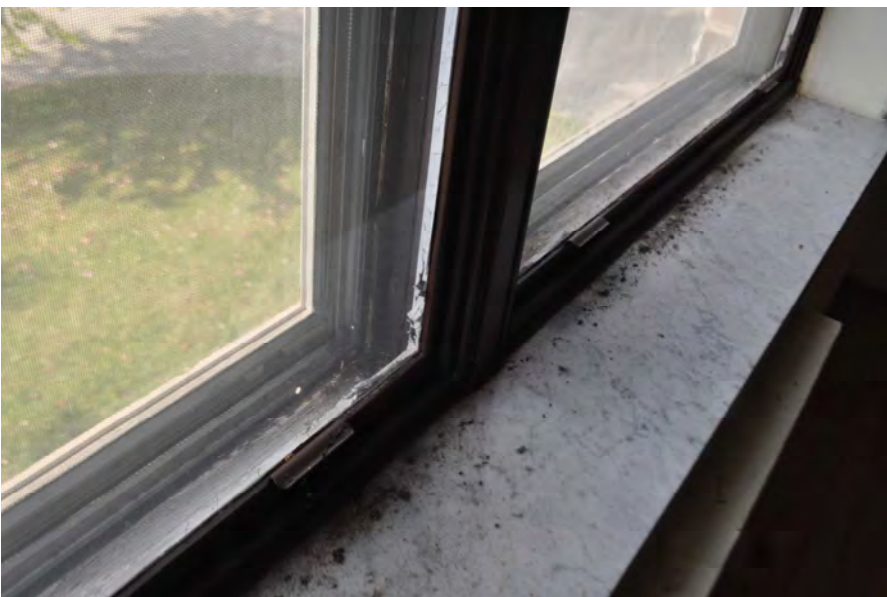
### Window X12, Type P2

- Note: Extent of exterior deterioration, corrosion, and loss of operability is not fully apparent in interior photos. Replacement parts for existing windows are unavailable, making restoration of thermal and operable functionality impossible, and long-term maintenance infeasible. Recommendation is for replacement, for quality of life of future tenants and for feasibility of long-term maintenance.
- See Window Assessment (Blackberry) in appendix for further detail and information, including further notes on deterioration beyond repair
- See Appendix for Window Schedule & Measurements

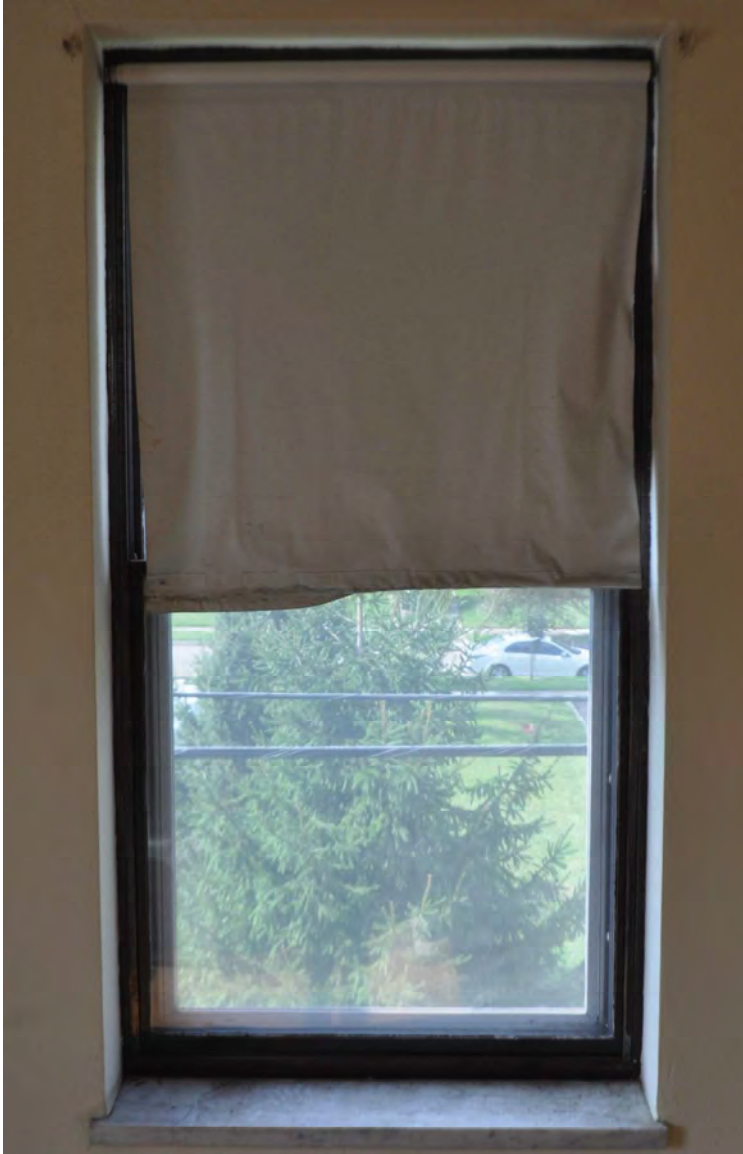
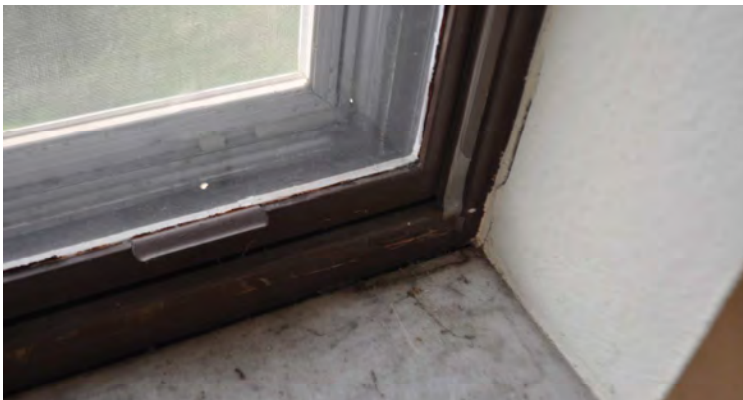
### Window X13, Type N2

- Note: Extent of exterior deterioration, corrosion, and loss of operability is not fully apparent in interior photos. Replacement parts for existing windows are unavailable, making restoration of thermal and operable functionality impossible, and long-term maintenance infeasible. Recommendation is for replacement, for quality of life of future tenants and for feasibility of long-term maintenance.
- See Window Assessment (Blackberry) in appendix for further detail and information, including further notes on deterioration beyond repair
- See Appendix for Window Schedule & Measurements
