# 9710 W Outer Dr

## Existing Condition Photos

# 9730 W Outer Dr

# Detailed Scope of Work

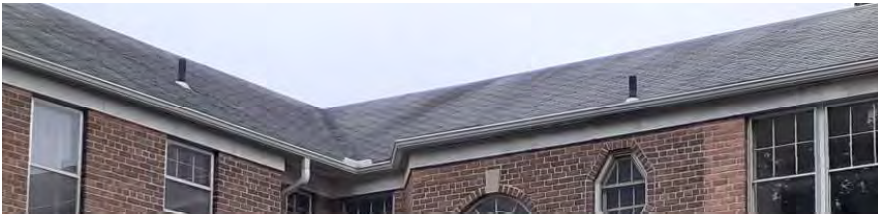
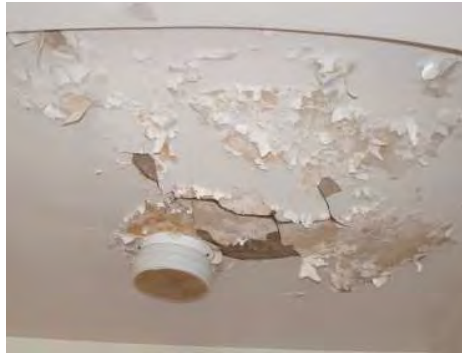
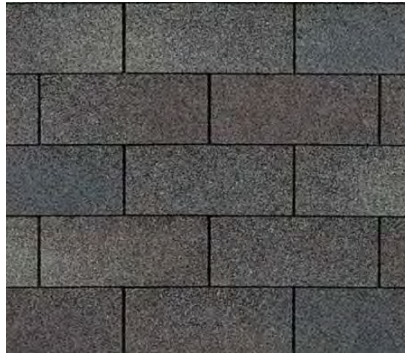
Level 02 ceiling, water damage    proposed asphalt shingle type

- Due to existing roof leaks in multiple locations and the age of the existing roof, the gray asphalt shingle roof will be replaced in kind
- See photo of one of several instances of water damage caused by roof leaks (left)
- See photo of existing roof color & materials (top)

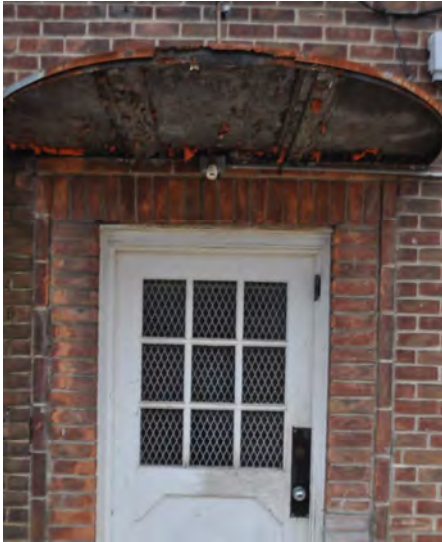
existing conditions

- New fixture; original is missing
- Replace bulb with 3000K LED
- Proposed Product: Generation Lighting, 8753EN3-15 One Light Outdoor Wall Lantern, 9.3 Watt LED bulb, 800 Lumens, White Glass, Black Polycarbonate finish, Dimensions: 6" W X 7.25" H
- See appendix for cut sheet

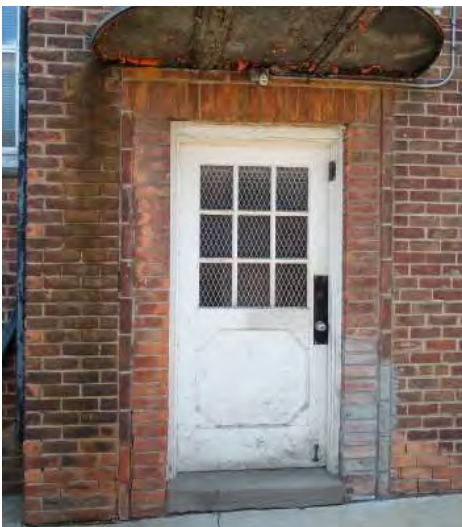
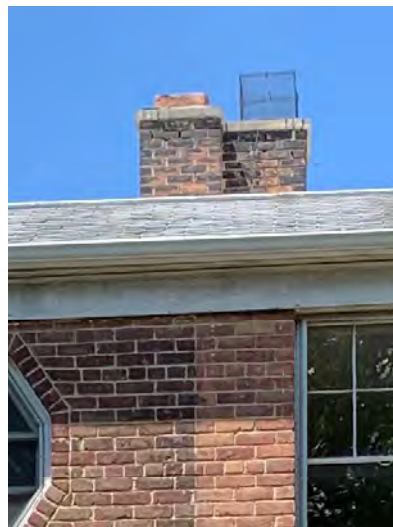
- Tuckpointing is needed in small areas throughout the brick facades of both buildings
- Examples of areas in need of tuckpointing\_9710 W Outer Dr
- (see photos of existing conditions, left)

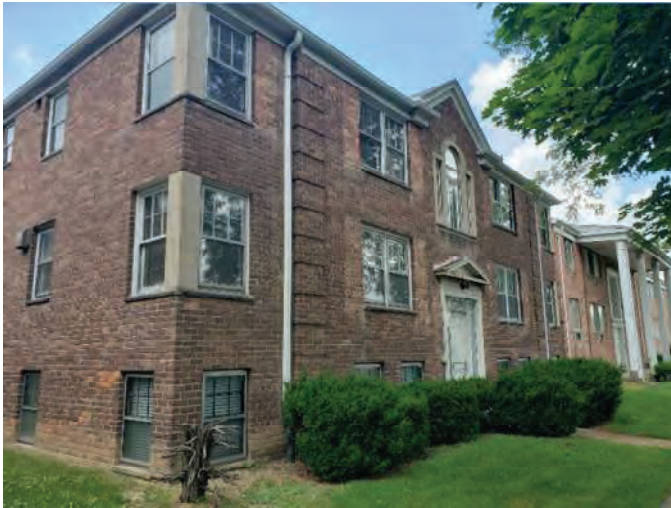
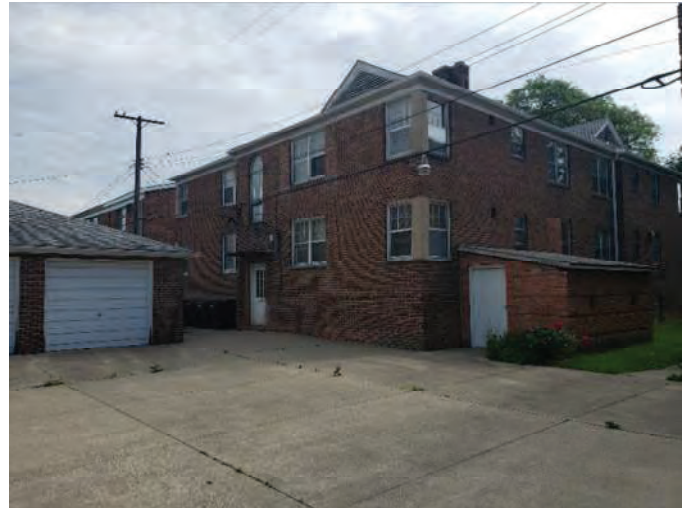
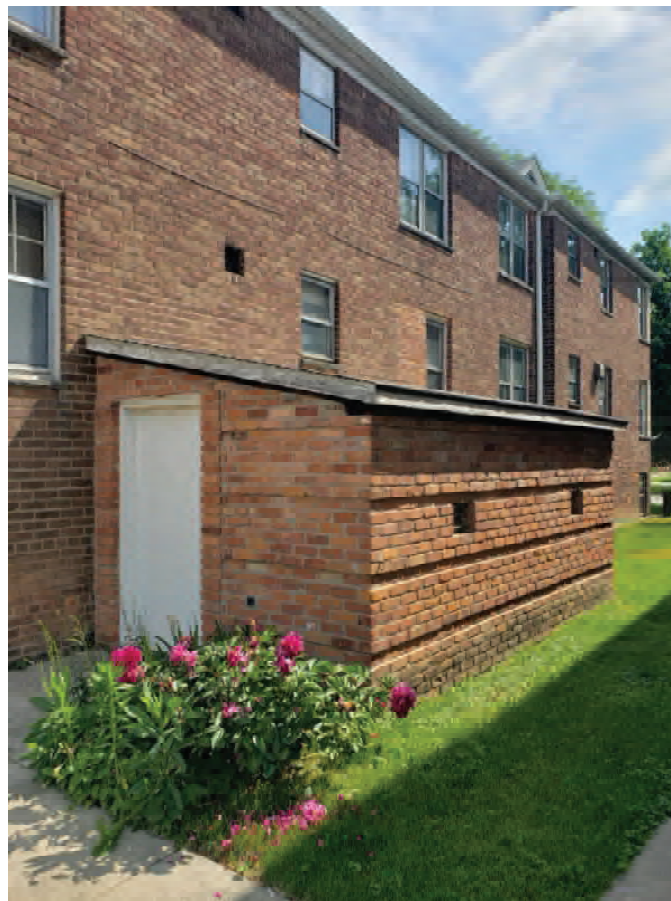
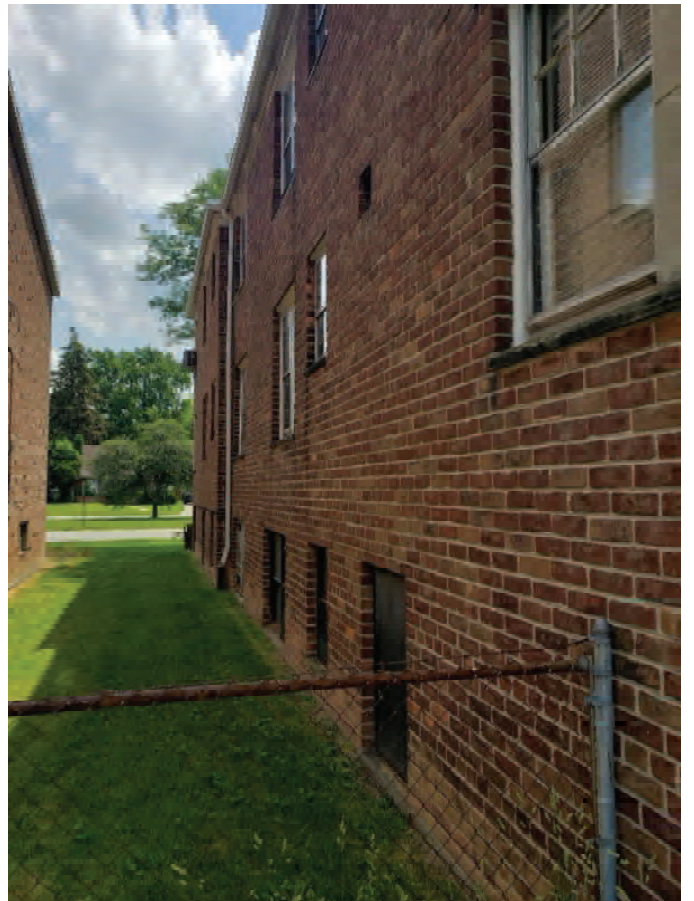
*In general, masonry is uncracked. Mortar joints appear to be sound. There is no evidence of excessive repointing. Bricks do not appear to be distressed. Refer to Fig-1 through Fig-4 on previous page.*

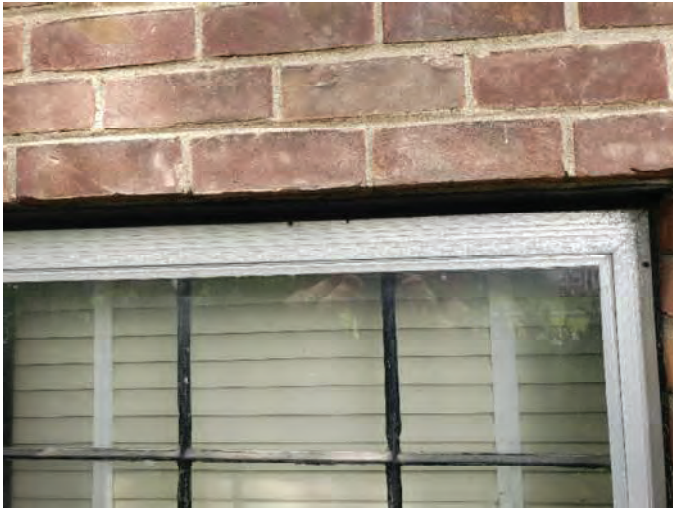
Fig-5 Typical lintel condition

In general, the exterior walls of common clay brick or stone are in good condition. The steel lintels above openings are in good condition.

*Steel lintels at observable windows were painted. There was no evidence of cracking or repair at window corners. The steel lintels do not appear to be flaking, warped, or delaminated.*

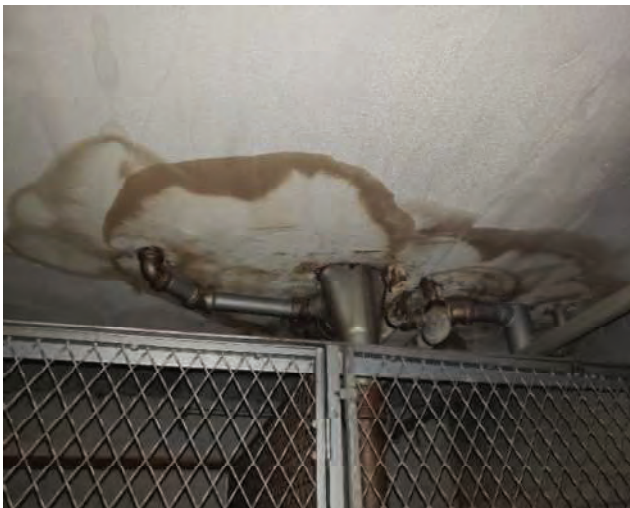
Fig-6 Water-damaged plaster ceiling in locker room

*Visible water damage is most likely caused by the visible plumbing stacks. It is anticipated that any structural damage to joists would be localized to the plumbing run.*

The ceiling in the storage locker areas shows signs of water damage. The ceiling should be removed to expose the existing joists. The joists should be assessed for localized water damage. If joists are in fair condition or worse a new member should be sistered to the existing damaged member.

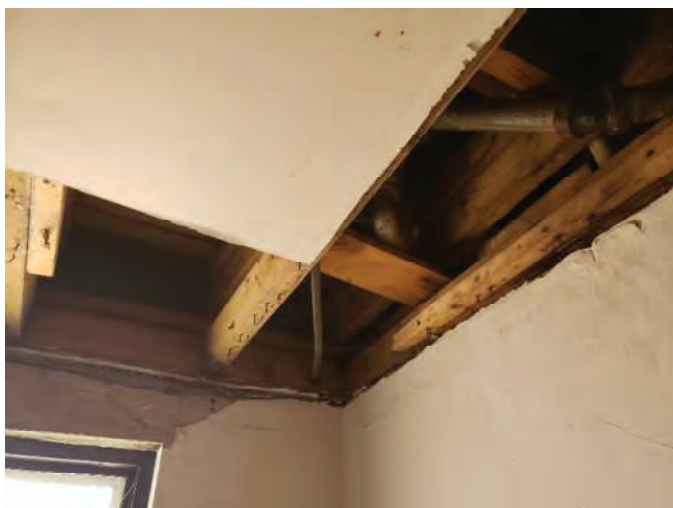
Fig-7 Exposed joists at previous area of water damage

Where exposed, the joists visually appear to be in good condition.

*Joists bear directly on or are pocketed into the masonry wall. Pocketed joists would deteriorate when exposed to a wet masonry wall. Where visible, there was some slight water staining to the joists, but the joists did not appear to be water damaged.*

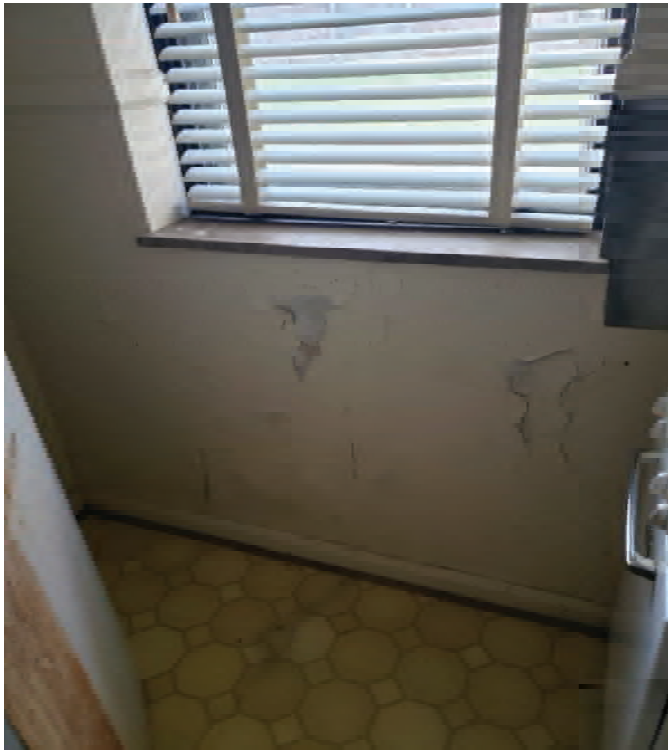
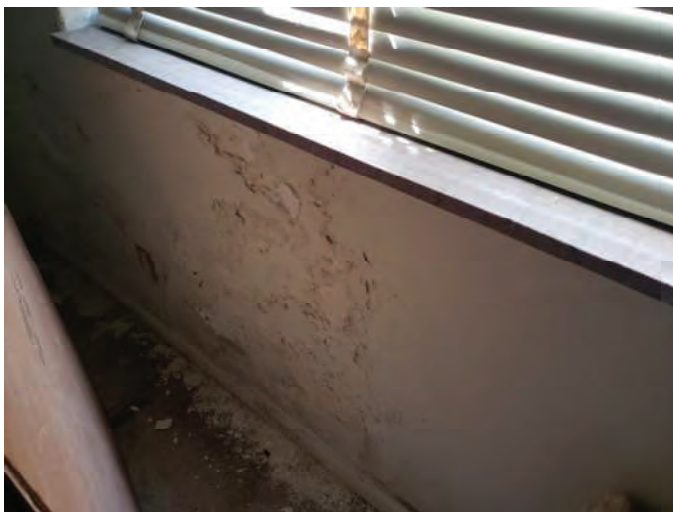
Fig-8 Damaged sill wall

Fig-9 Damaged sill wall with electrical outlet

*Given the extent of damage, it is unlikely open windows caused the observed damage. Since the damage is concentrated under the sills, it is likely a combination of improperly sloped site and sill detailing.*

*Some windows have existing electrical outlets below them, and some of these outlets were visibly corroded.. While electrical systems are outside the scope of this report, we strongly recommend that an electrical engineer or electrician provide guidance on removal or repair of these outlets.*

- The exterior grade slopes toward the building in some locations. These semibasement areas have interior water damage below windowsills. Plaster should be removed, the condition of the masonry or concrete wall assessed, and site should be sloped away from the building. An electrical engineer or electrician should be consulted to address the outlets below the windowsills which have possibly been exposed to moisture.

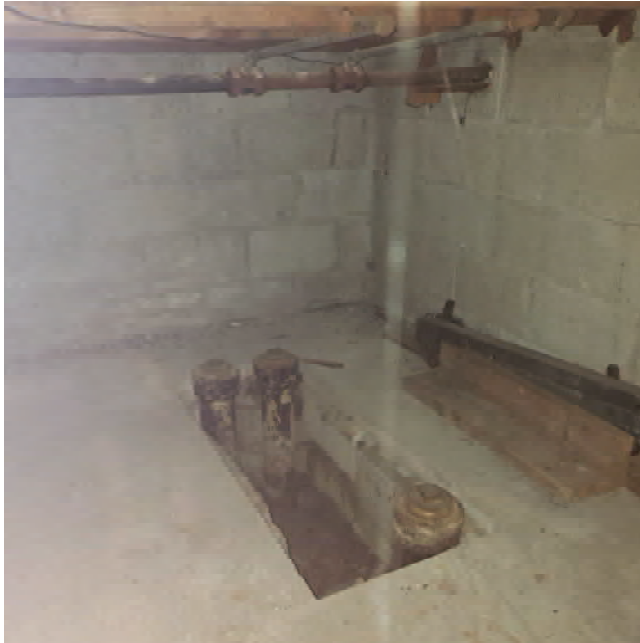
Fig-10 Sump pit

There is what appears to be a sump pit below the front entry stairs. The pit appeared dry and in good condition during the walkthrough. The framing supporting the entry was in good condition. There was no sign of water infiltration in this space.

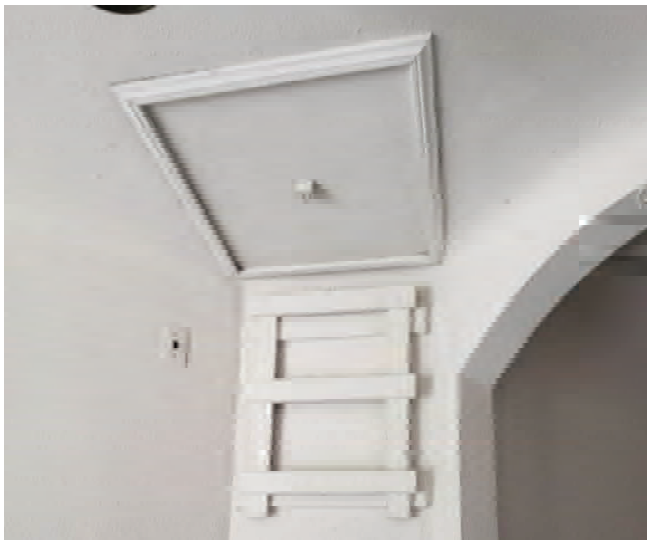
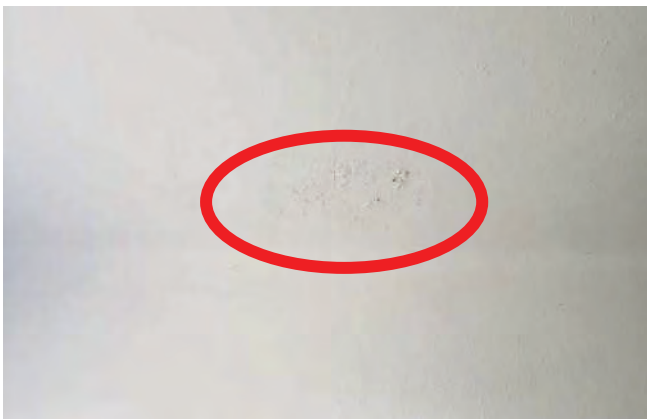
Fig-11 Attic access hatch is directly adjacent to stair landing.

*The observed area of damage was small (2-4 sf). It is possible that roof, roof sheathing, or roof trusses could be damaged due to long-term water infiltration.*

Fig-12 Damaged plaster indicates roof water infiltration.

*Safe access to the attic should be provided. The area of damaged plaster should be removed, and any adjacent structural material should be checked for water damage.*

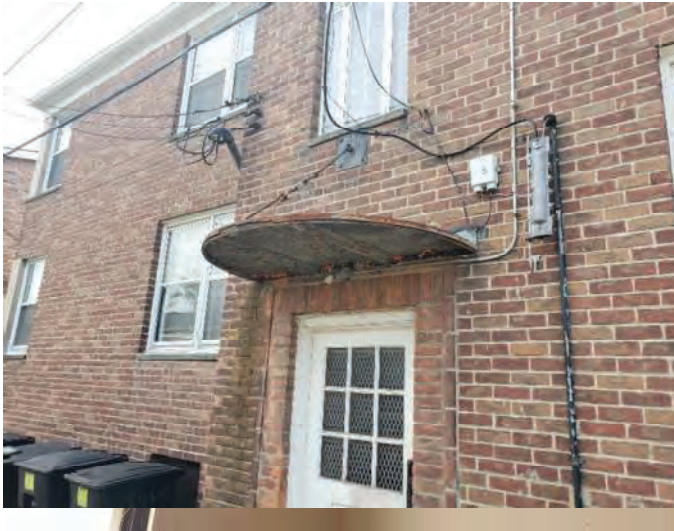
Fig-13 Rear canopy

*The rear entry canopy is severely corroded. The deck edge has rusted away in some places. The ribs supporting the canopy have also deteriorated.*

*The adequacy of the canopy connection to the structure was not analyzed as part of this assessment. We recommend a one-for-one size and weight replacement of the existing canopy to avoid structural work.*

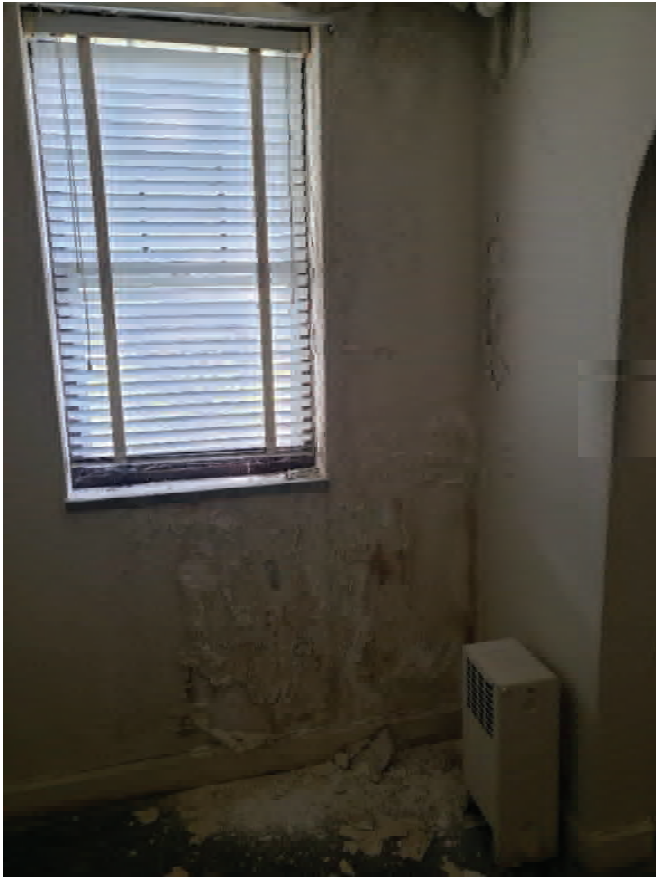
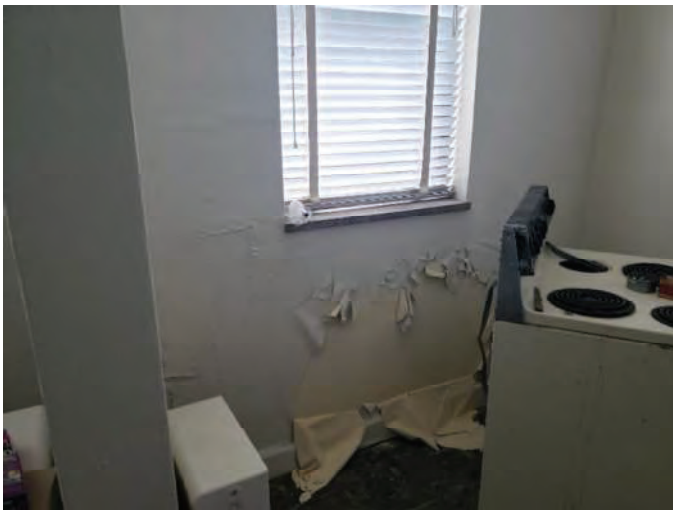
Fig-19 Damage plaster at semibasement

Fig-20 damage at semibasement

*Given the extent of damage, it is unlikely open windows caused the observed damage. Since the damage is concentrated under the sills, it is likely a combination of improperly sloped site and sill detailing.*

*Some windows have existing electrical outlets below them, and some of these outlets were visibly corroded. While electrical systems are outside the scope of this report, we strongly recommend that an electrical engineer or electrician provide guidance on removal or repair of these outlets.*

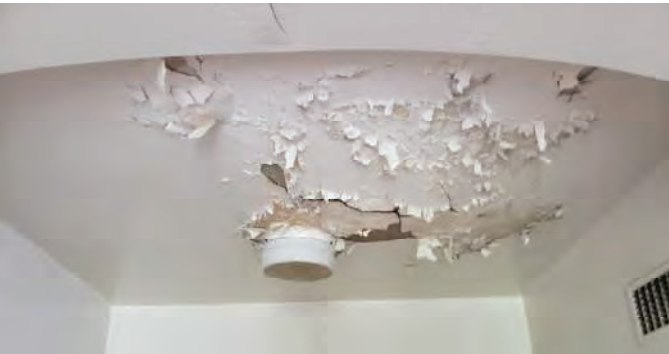
Fig-22 Apartment 209 kitchen ceiling water damage

On the highest level, water-damaged plaster ceilings are most likely caused by roof leaks. Structural damage to roof sheathing and/or roof trusses is likely at the large leaks in the living room and kitchen of unit 209.

*Water-damaged sheathing should be removed and replaced. Cut sheathing to span to next adjacent truss.*

*Water-damaged trusses require condition assessments. Solutions include sistering of damaged members and strengthening of damaged connections.*

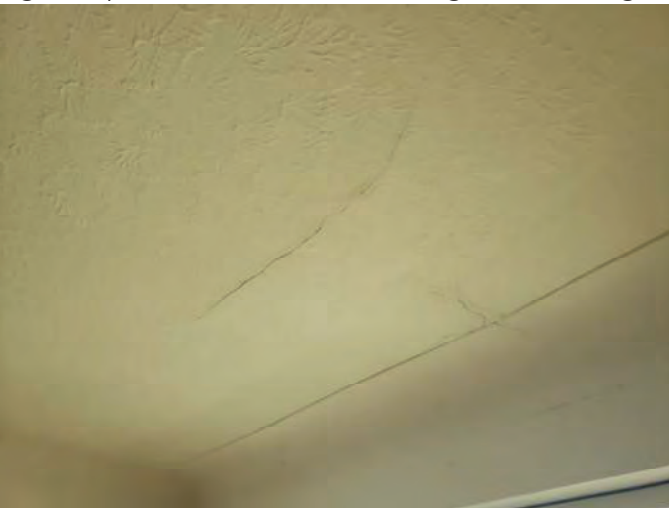
Fig-23 Apartment 209 living room damage

Without access to the attic space, the extent of roof structure damage at the water-damaged plaster is unknown. A walkthrough of the attic space should be performed after safe access is provided.

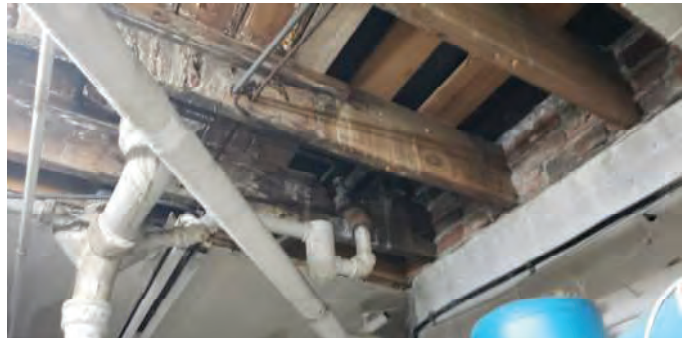
In several areas, the ceiling has been damaged and subsequently removed due to plumbing leaks. Where structure was visible in these areas, it did not appear that there was any damage to the wood joists, which would be consistent with a short-term leak. The ceiling in these areas should be repaired. Notify Intoto of any soft spots in the wood during repair.

Fig-24 Mechanical room water damage. Sister water damaged joist.

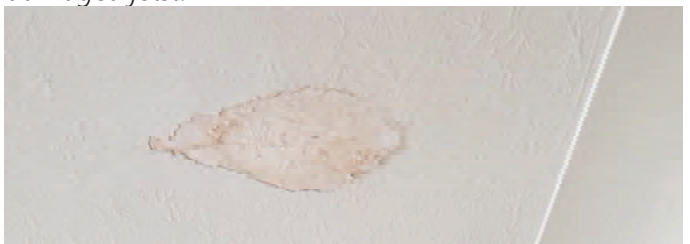
Fig-25 Ceiling water damage. Remove to expose existing structure.

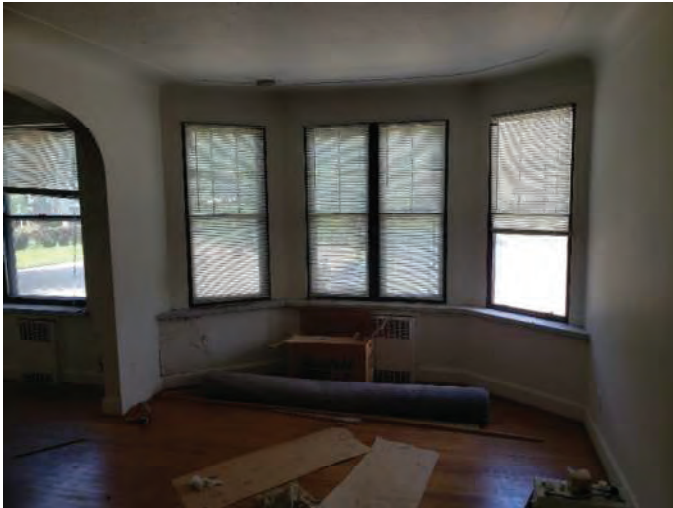
Fig-26 Water damage at corner of bay window matches exterior repointing.

In general, the bay windows are in good condition. One bay window shows signs of water damage. The exterior at this location has been repointed. Remove plaster to expose wood framing. Replace or sister damaged wood framing. Repair process should also locate and address location of water infiltration to prevent recurring damage.

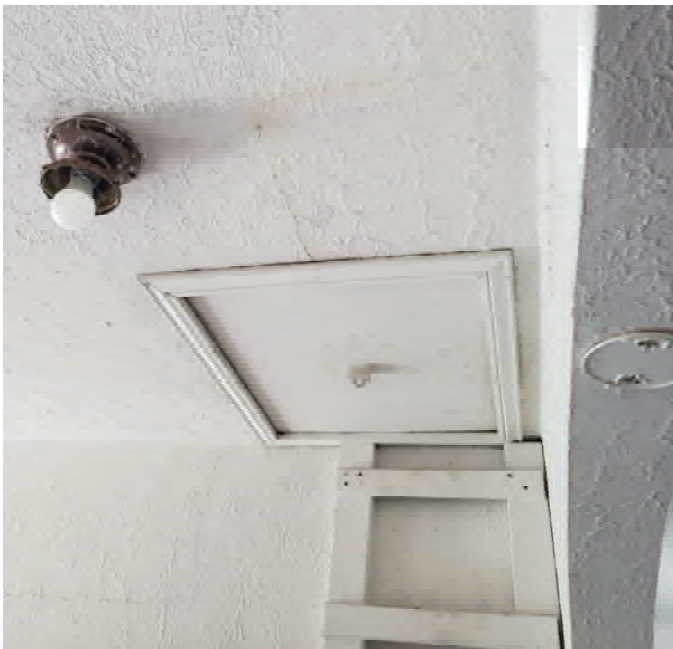
Fig-27 Attic access

*There are several areas of damaged ceiling on the second level of the building. These are likely related to roof leaks above. The extent of damage cannot be determined without either exposing the structure from below or providing safe roof access. Additionally, there was no access to any of the roof dormers during the walkthrough.*

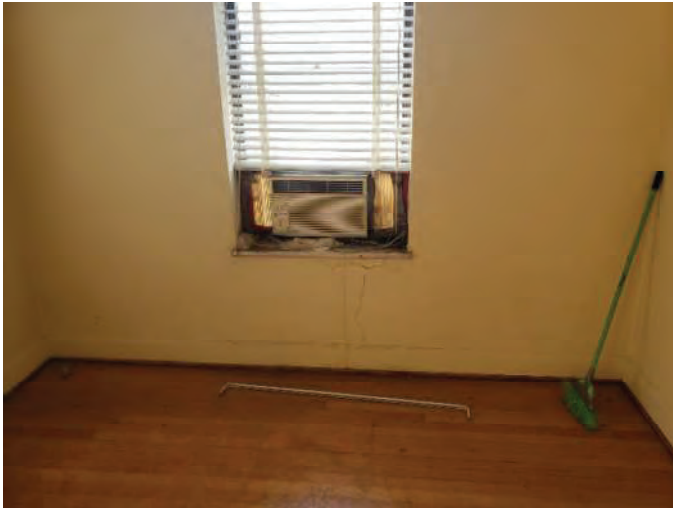
Fig-28 Water damage at window ac units

Several apartments had window mounted air conditioning units. Many of the units had signs of water damage below the sills. The damaged plaster should be removed to expose the condition of the wood stud wall.

*In most cases, removing the window air conditioner and shutting the window will remove the water entry path. Depending on how long the unit has been installed, there may be water damage to wall studs below the window.*

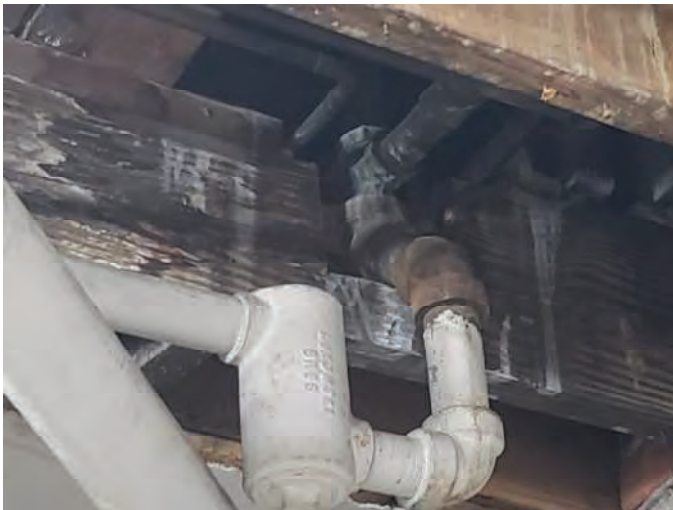
Fig-29 Damaged joist at mechanical room piping

A notched joist in the mechanical room does not have any remaining structural capacity. A new piece of 2x lumber should be sistered to the far side of the joist. Extend the new piece either to the end of the existing joist or 2 feet past areas of water staining. Glue and nail the new joist to the existing joist.

*The intent with this repair is to restore some capacity to the joist. It is understood that the depth of the new joist will be limited by plumbing conflicts. It is our experience that a single failed joist will not cause a local collapse. Above, this is likely a "soft spot" in the floor that a user would notice.*

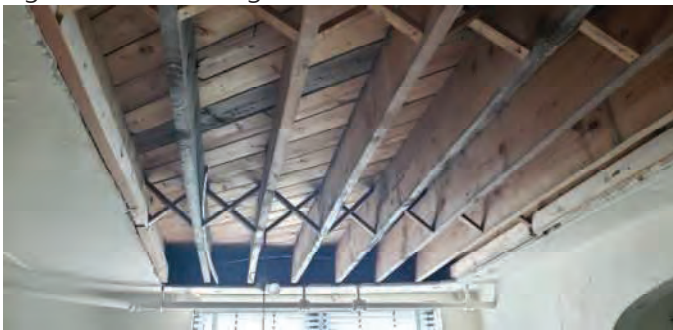
Fig-31 Typical joist condition at exposed ceilings

Overall, the building is in good condition. Even in presumed areas of previous plumbing flooding, the joists do not show signs of deterioration.

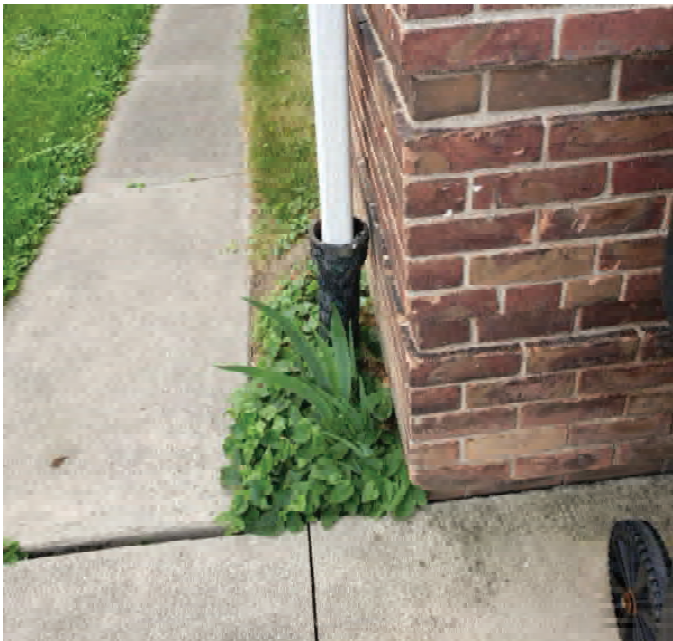
Fig-32 Downspout

*Additional water on the site may lead to increased water infiltration into the building, especially at semibasement windowsills. In all cases, grade should be sloped away from the building. However, if downspouts need to be capped, the amount of water infiltrating the building may be increased and more invasive waterproofing measures may need to be considered.*

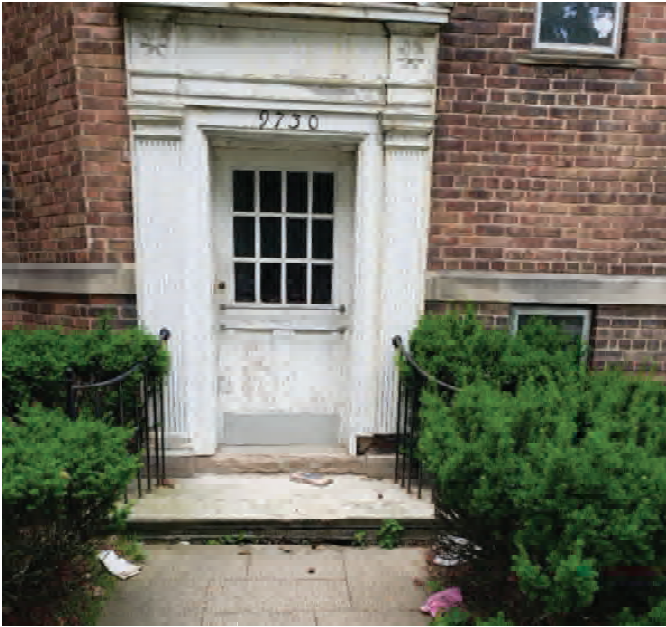
Fig-33 Entry

The front entry landing is damaged and needs repair. In general, these repairs are architectural in nature.

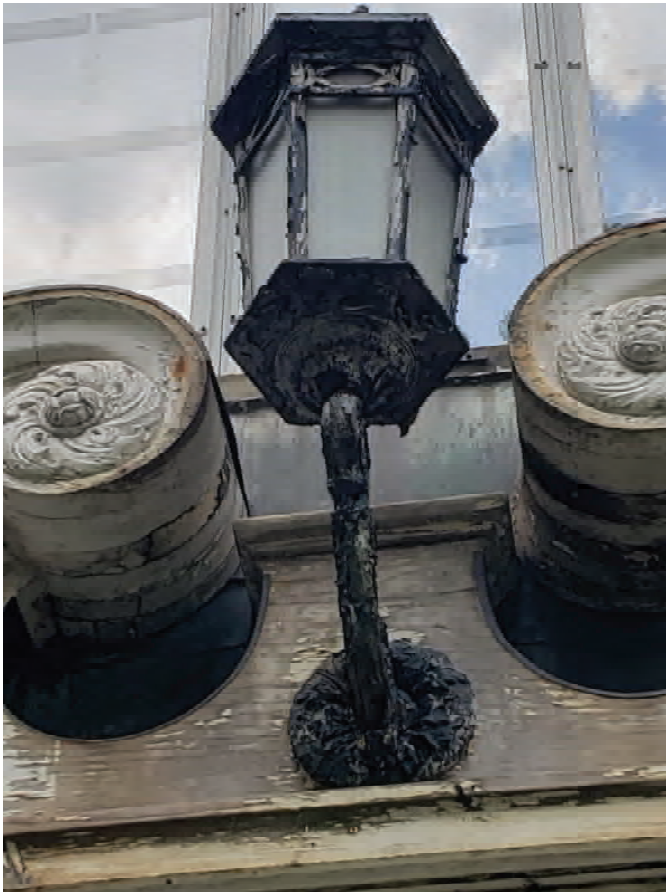
The historic light hanging above the front entry is in fair condition. Flaking paint and rust should be removed to expose remaining metal. If there is significant section loss, light should be removed until a restoration strategy can be implemented.

Fig-34 Historic light fixture with flaking paint and possible corrosion.

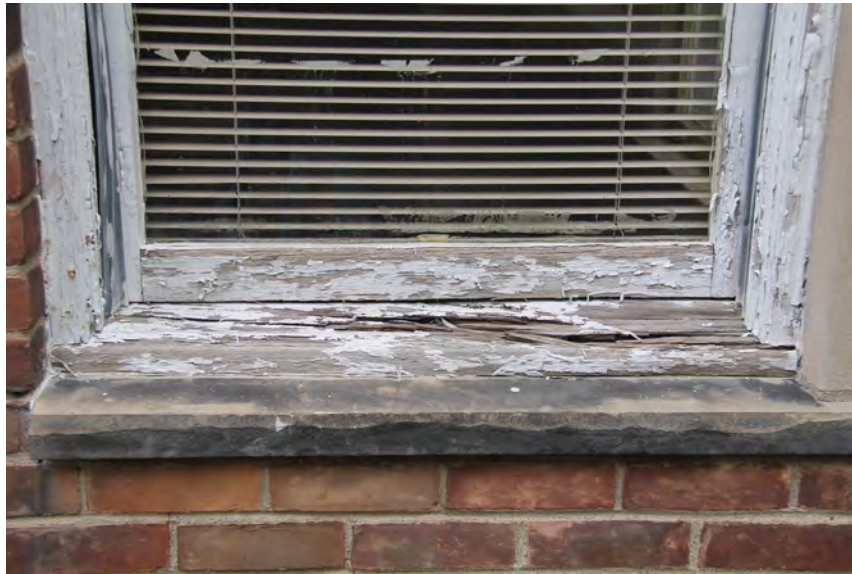
**WINDOW #17 SPLIT SILL / BOTTOM SASH RAIL**

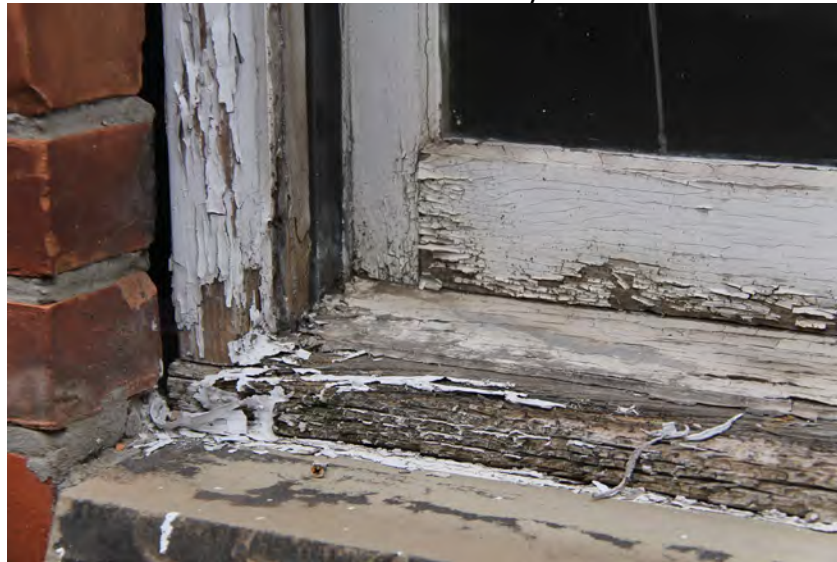
**WINDOW #H3 ROTTED SILL**

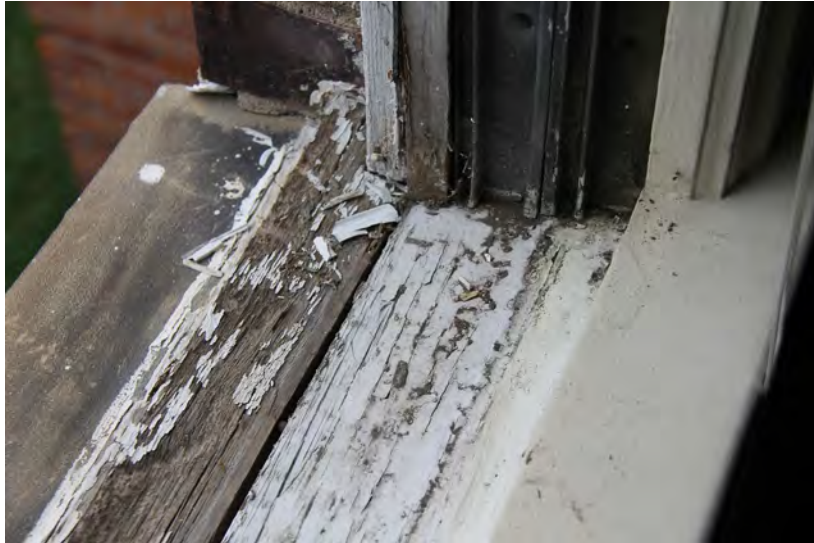
**WINDOW #E3 SPLIT SILL**

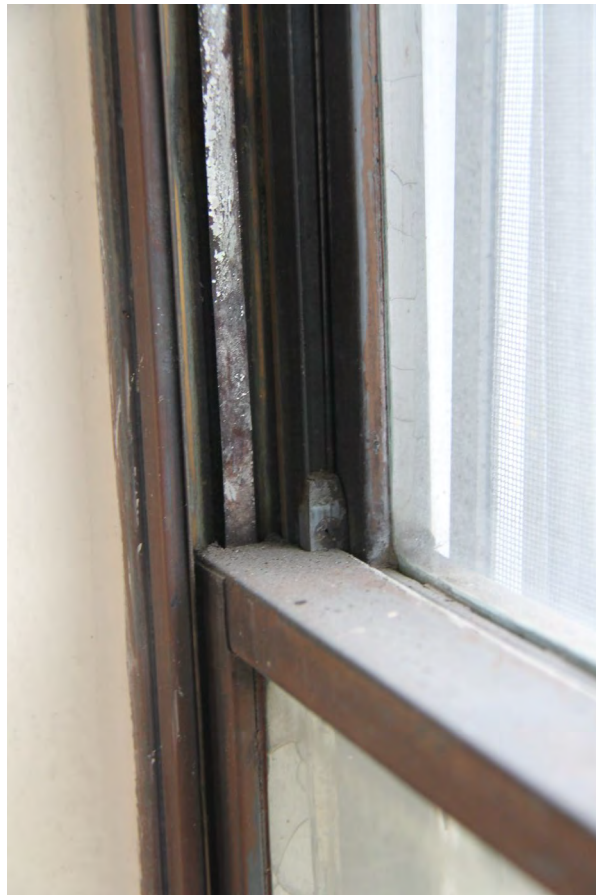
**WINDOW #U19 INTERIOR RUSTED BALANCE TAPE TYPICAL**
