Wheelchair Lifts on Transit Buses

Prepared by:
Ketron Inc.

January 1983

Summary of U. S. Experience

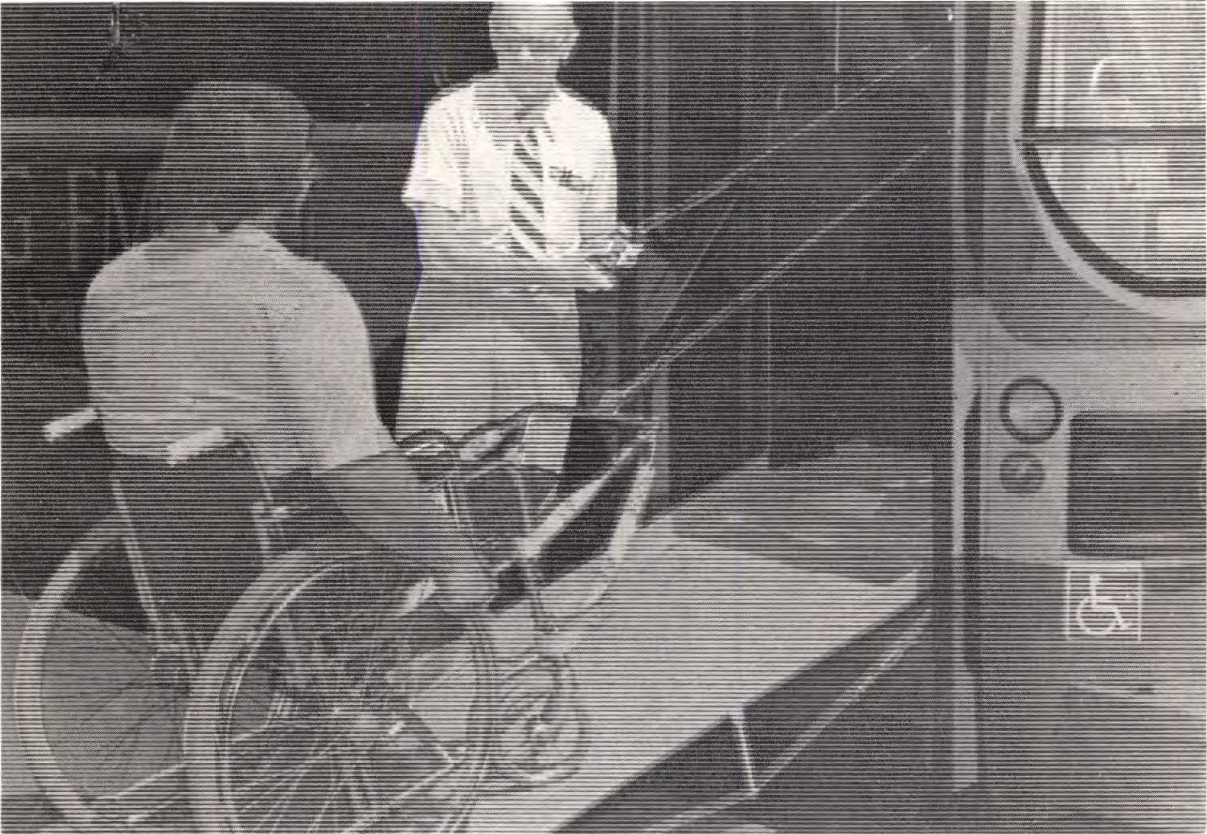
FIGURE 2.2-1: PROTOTYPE RAMP AND WINCH INSTALLATION AT SCRTO, LOS ANGELES, CALIFORNIA

manual wheelchair, and stable operation by all chairs, have proven to be excessive. A shorter ramp can be used with some form of powered assistance. A prototype power-assist ramp has been tested at the Southern California Rapid Transit District (SCRTD) in Los Angeles as shown in Figure 2.2-1. A six foot (two piece) folding ramp was stored directly ahead of the front door and was operated in conjunction with a power operated winch. The winch moved a cable which was attached to a harness that secured the wheelchair. Cable speed was 15 to 20 feet per minute. Testing of the system demonstrated that it was too slow and cumbersome for transit use.

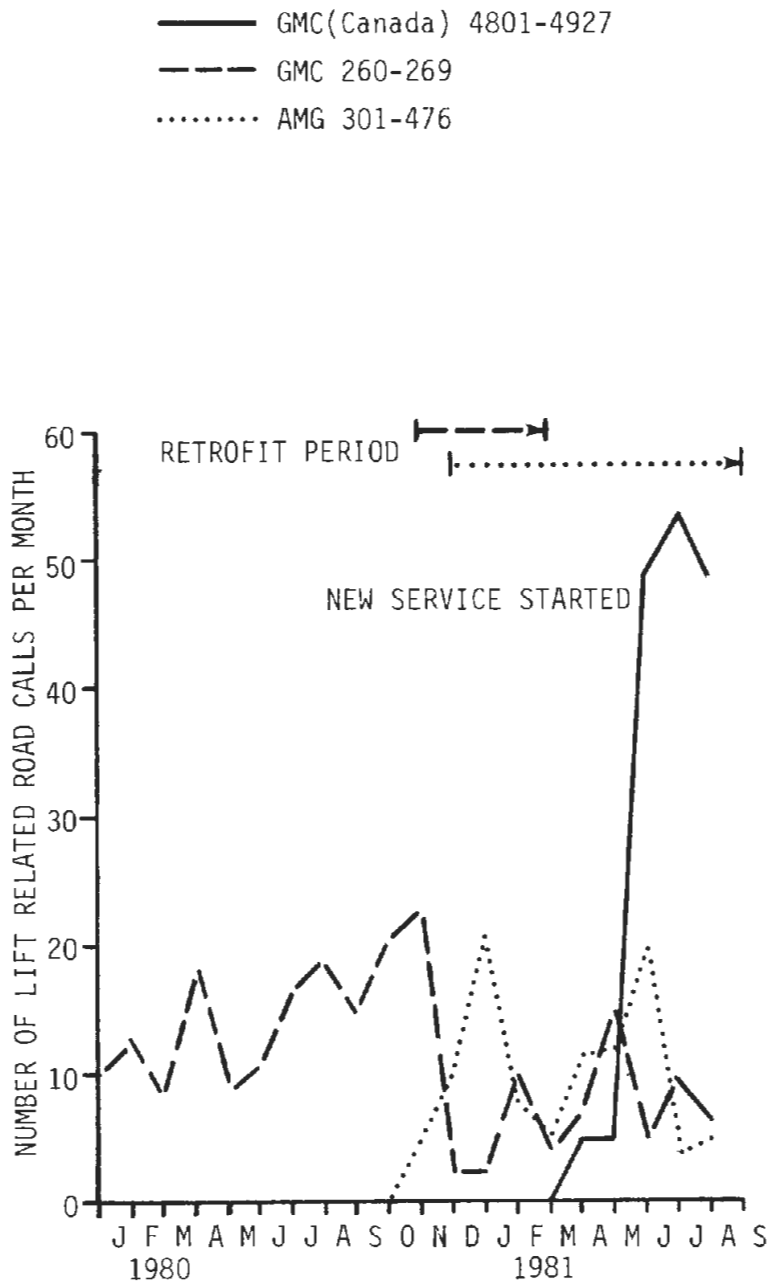
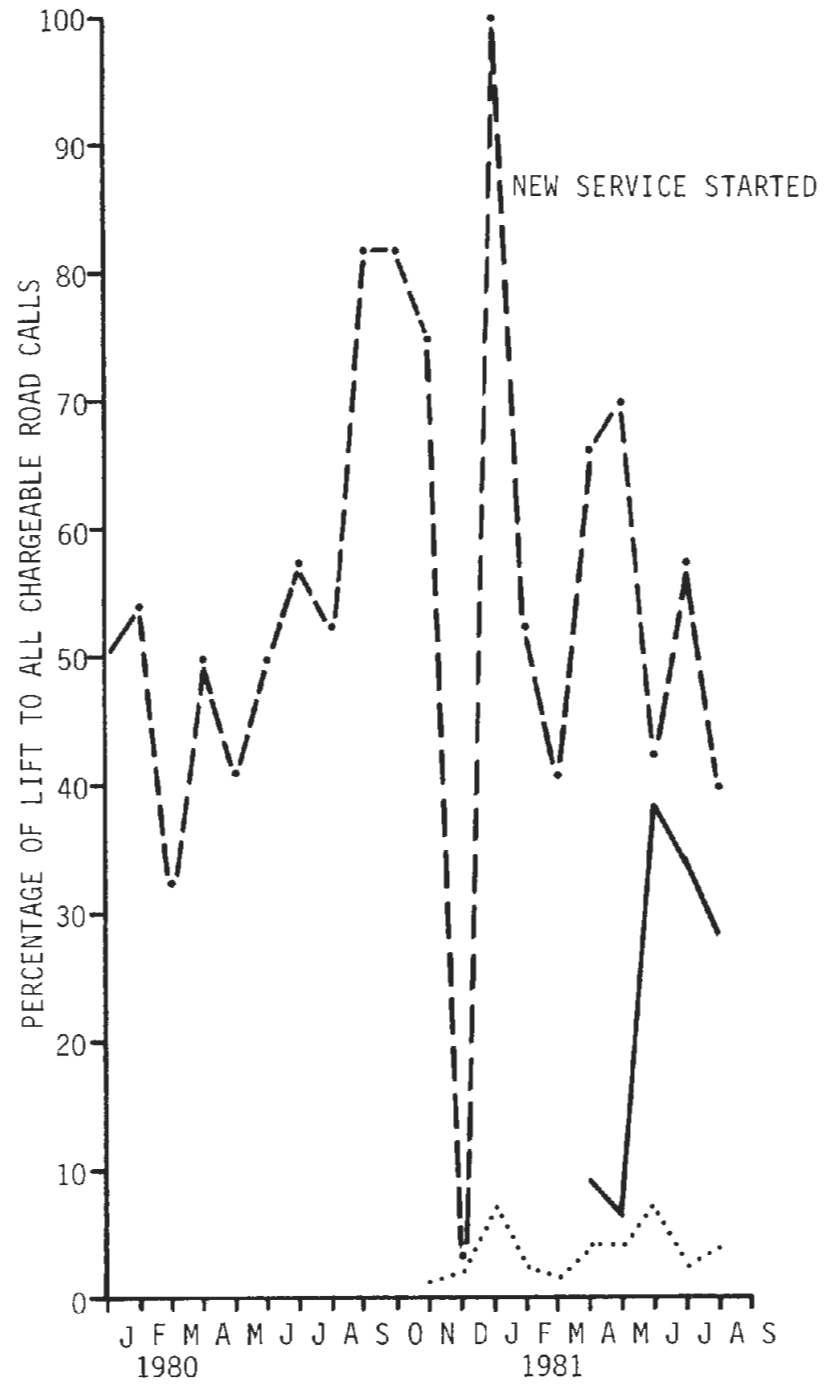
FIGURE 4.3-1: ROAD CALL PERFORMANCE OF ALL THREE LIFT BUS FLEETS AT RTD, DENVER

4.3.2.1 Ridership - Using data for the week's commencing June 7 through August 23 the on-the-road performance for the first three months of service has been estimated as shown in Table 4.3-1. Ridership was still increasing and road calls were averaging about one for every ten wheelchair trips. This appears to be on a par with the experience of operators using other EEC lift models. Figure 4.3-1 shows the history of road calls for all three of the bus groups. Because of the change in service structure in June of 1981 the prior period cannot be directly compared to the later period. It would appear, however, that the retrofitted 140 installation in the GMC's did not prove to be significantly superior to the previous lift model. The absolute number of road calls dropped a little, but this may reflect the change in service patterns. The percentage of road calls attributed to lift problems did not change appreciably. The data for the AMG buses indicate that some low level of lift-related road calls may be expected even when the lifts are not in accessible service.

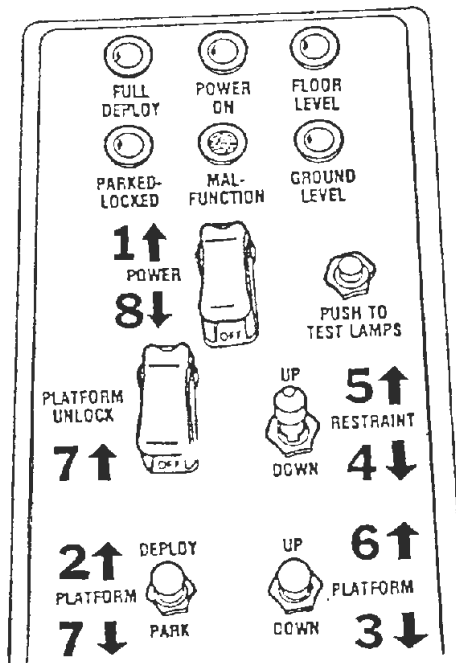
FIGURE 4.4-1: DDOT DEVELOPED DECAL AND NUMBERING SYSTEM FOR GMC LIFT

4.4.2.2 Driver Training - Driver training was conducted over a two day period and included lift operation and passenger role playing. DDOT was just starting a refresher course of driver training at the time of the site visit. As a result of their initial experiences DDOT developed their own numbered lift operating sequence and decal to replace that supplied with the bus. DDOT believes it is simpler and more easily understood by operators who only occasionally use the lift in service (Figure 4.4-1).

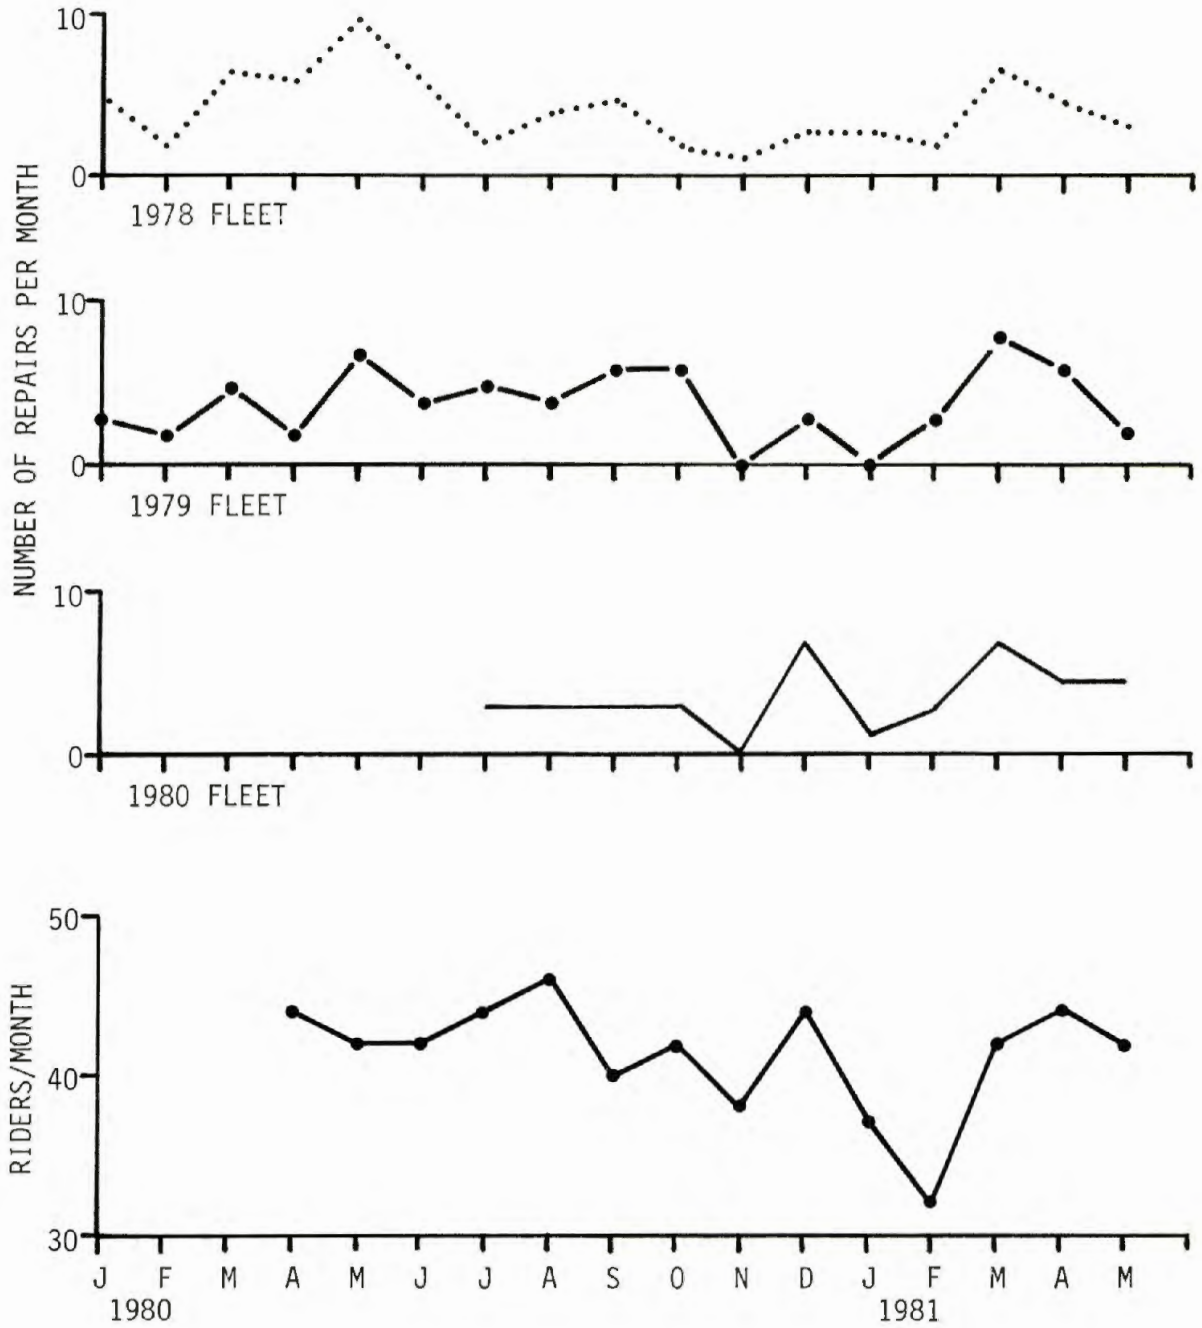
FIGURE 4.5-1: NUMBER OF REPAIRS BY BUS FLEET AND RIDERSHIP AT SEMTA-MACOMB

(Figure 4.5-1) demonstrated a variable level of monthly repairs, which seemed to reflect the overall ridership reported. The cumulative records show a steady rate of repairs for the whole fleet which averages ten repairs a month (Figure 4.5-2). A review of the figures for the different year models shows that the 1979 and 1980 buses had 20-30% fewer repairs per bus than the 1978 vehicles although the difference narrowed in 1981 (Figure 4.5-3). Initially, the 1979 buses seemed to have had a higher repair rate than the 1980 models, but the first five months of 1981 shows no difference between the 1979 and 1980 model coaches.

It must be cautioned that many of the repairs were corrective actions rather than repairs of failed components, therefore, the records required a fair degree of interpretation. For instance, many of the lift failures were related to the step locks failing to disengage. These were variously reported by different mechanics as "frozen," "stuck," and a need to "free-up." Where it appeared that the primary needs were just for lubrication, then such incidents were not counted as repairs. Similarly, in some instances the simple notation of "repaired lift" was used with no other diagnostic information or evidence of parts use. These instances were also not counted since it was felt that the probability was that the primary effort needed was lubrication. The net result was an overall repair rate of ten per month, but with fluctuations from a high of over 20 to a low of one repair per month.

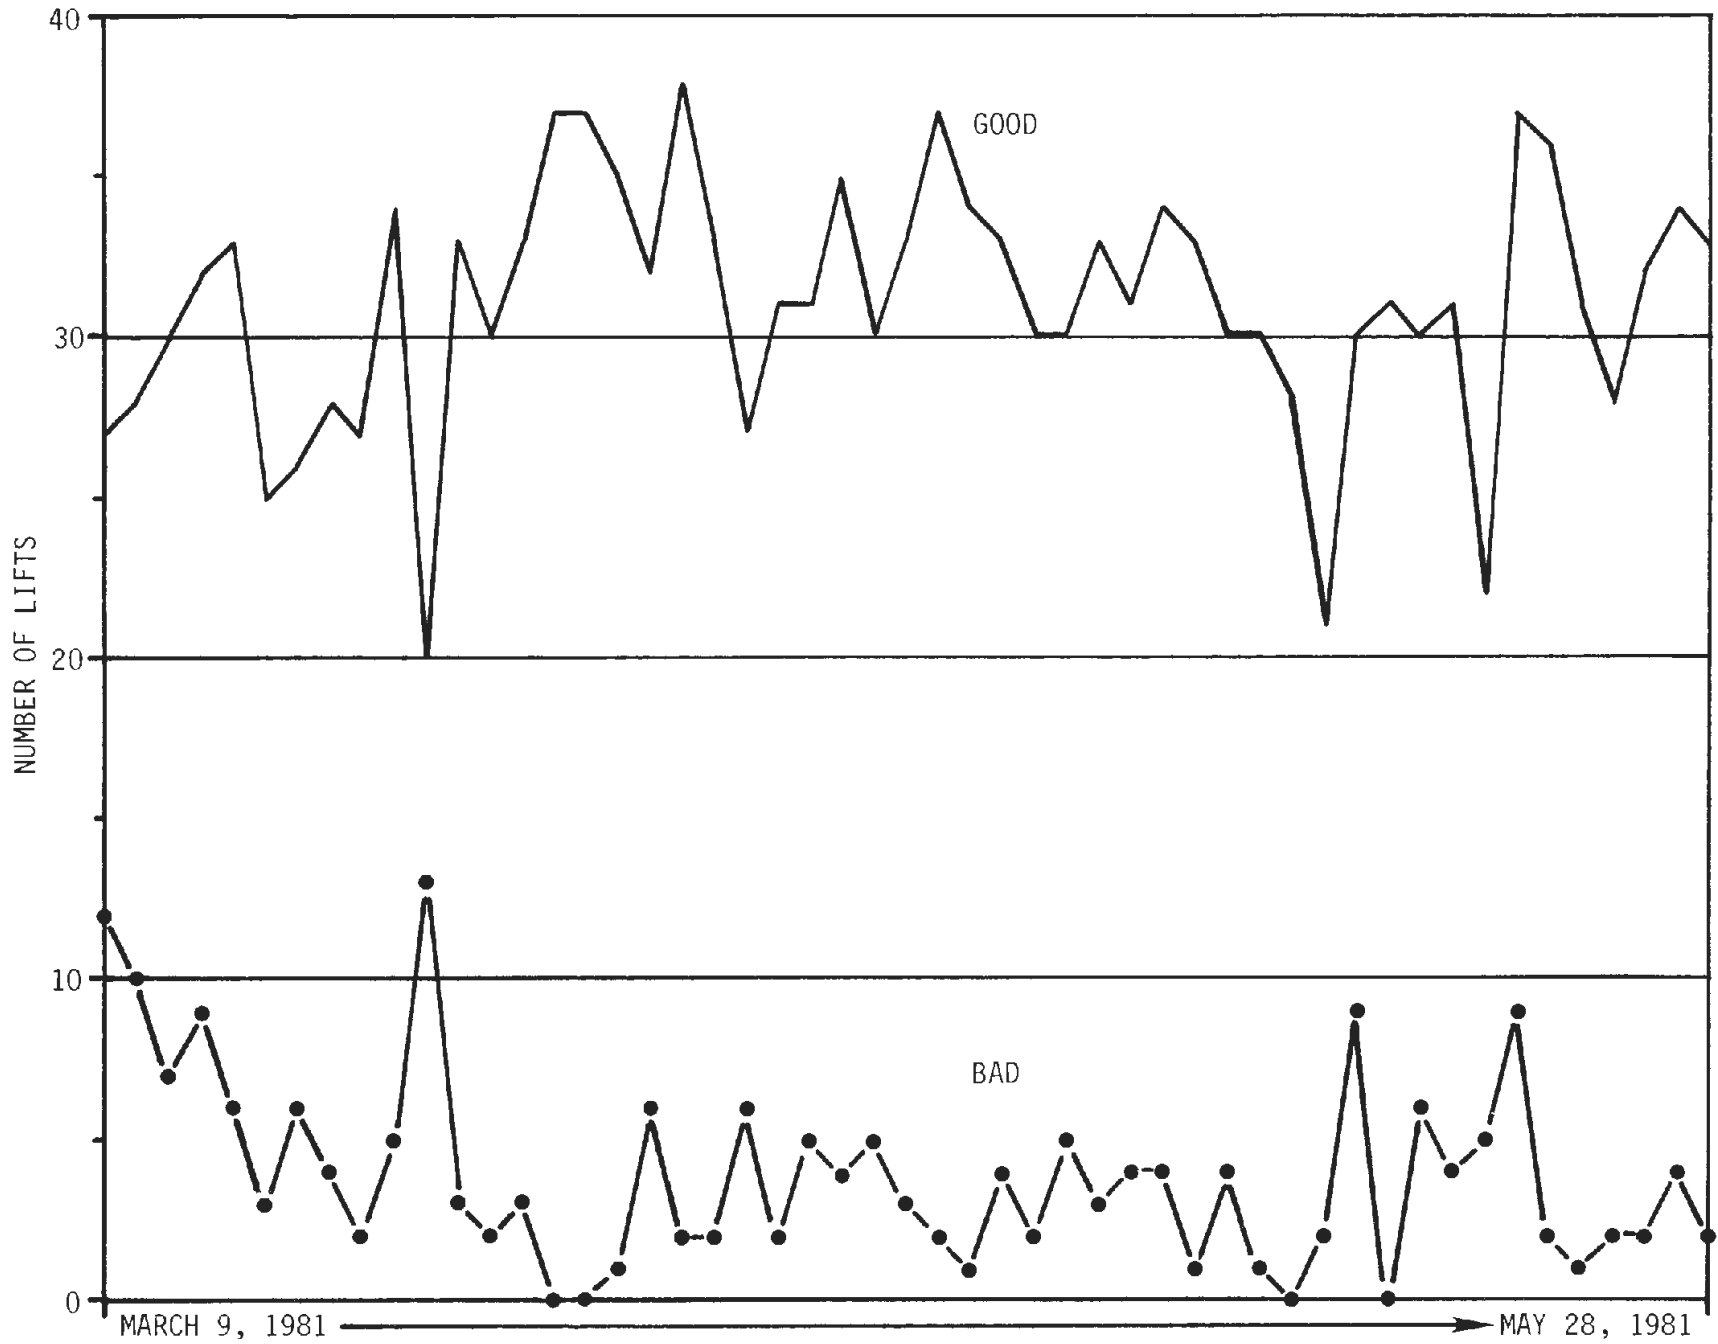
FIGURE 4.5-5: DAILY VARIATION OF "GOOD" AND "BAD" LIFTS AT SEMTA-MACOMB

Figure 4.5-5 illustrates daily fluctuations in the number of known working (OK) and bad (BAD) lift categories many lift repairs were minor and were corrected during the next day's work shift.

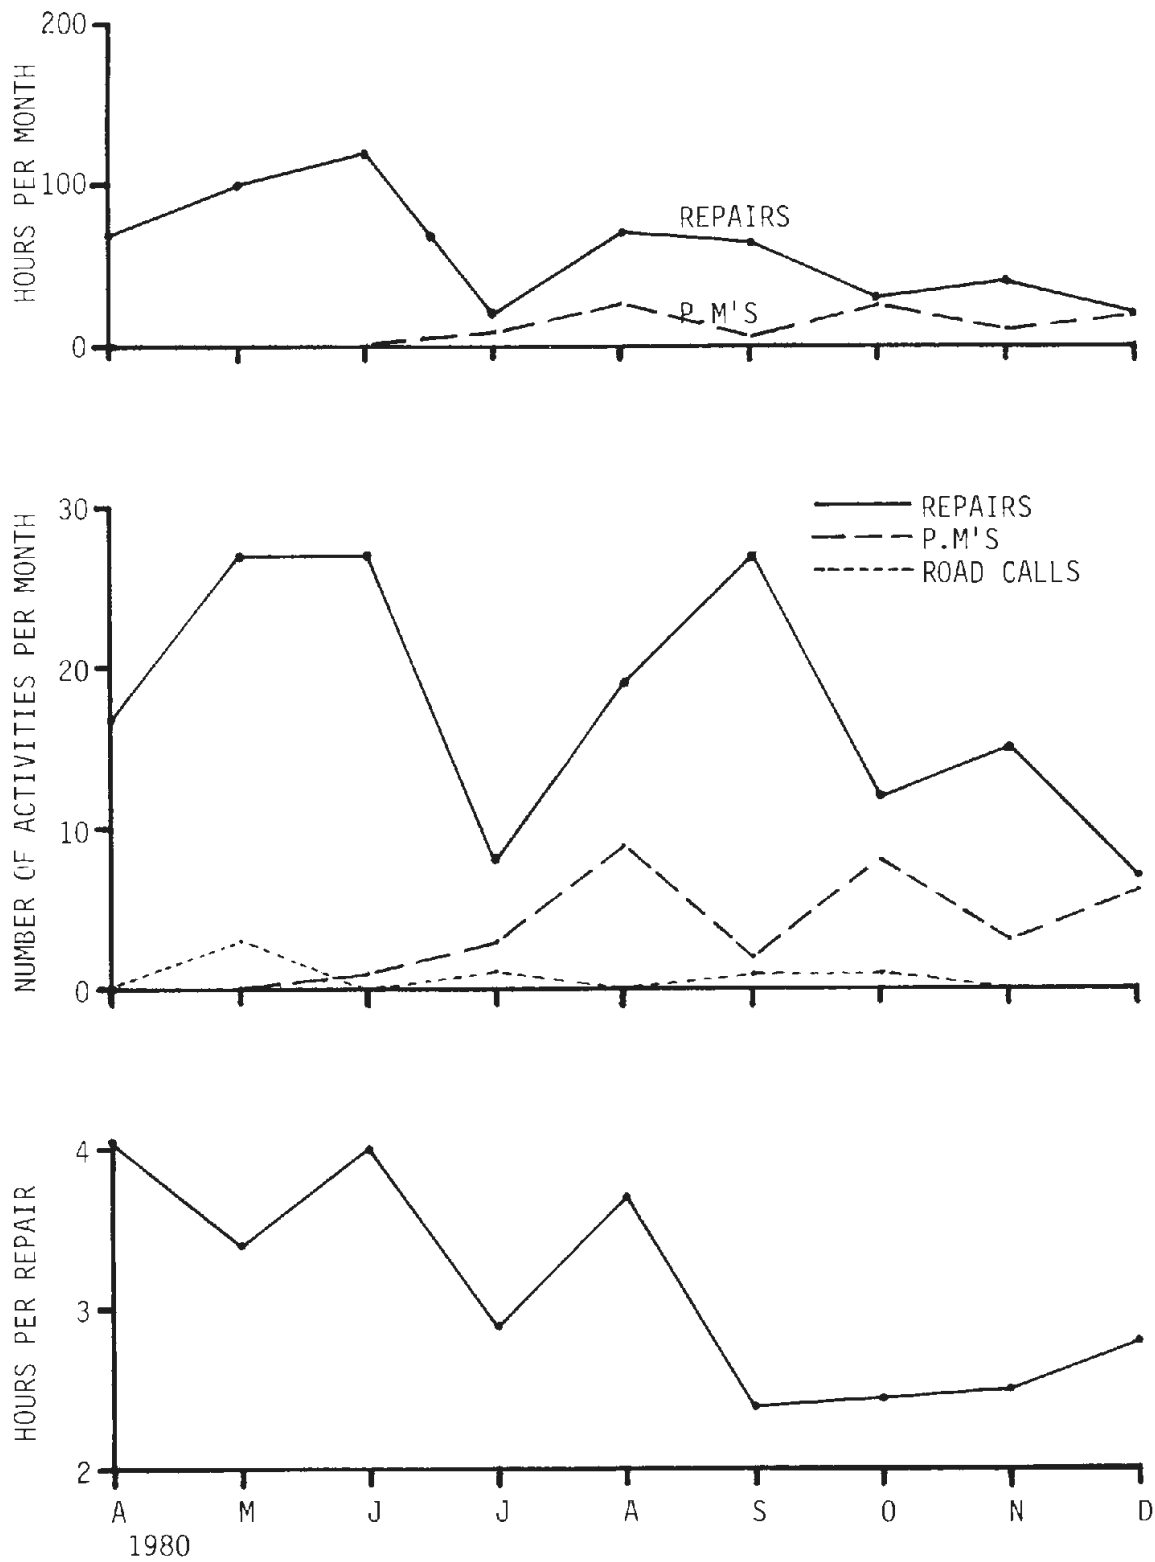
FIGURE 4.7-1: LIFT REPAIR AND MAINTENANCE TRENDS AT GRATA

Figure 4.7-1 shows the trends in repair hours, preventive maintenance hours, the number of repairs and road calls, and the hours per repair during the period of accessible service. The favorable trends undoubtedly reflect the overall learning process and the establishment of the maintenance program. The major problems encountered by GRATA may be summarized as:

- 7) Excessive pressure in the power steering pump circuits leading to hose failure.
- 8) Some faulty relays and hydraulic valves.

GRATA added a warning to the manually operated emergency system to remind operators that the manual control must be returned to neutral after use, or the system will spill hydraulic fluid the next time it is activated. Also as a result of experience, GRATA is using ATF in the system and not the SAE 10/40 weight oil specified by Flxible for the power steering system. They believe the oil degrades under the temperatures and pressures of the power system causing deposits which affect the hydraulic operation. They also indicate that the ATF provides better (faster, smoother) operation in cold weather.

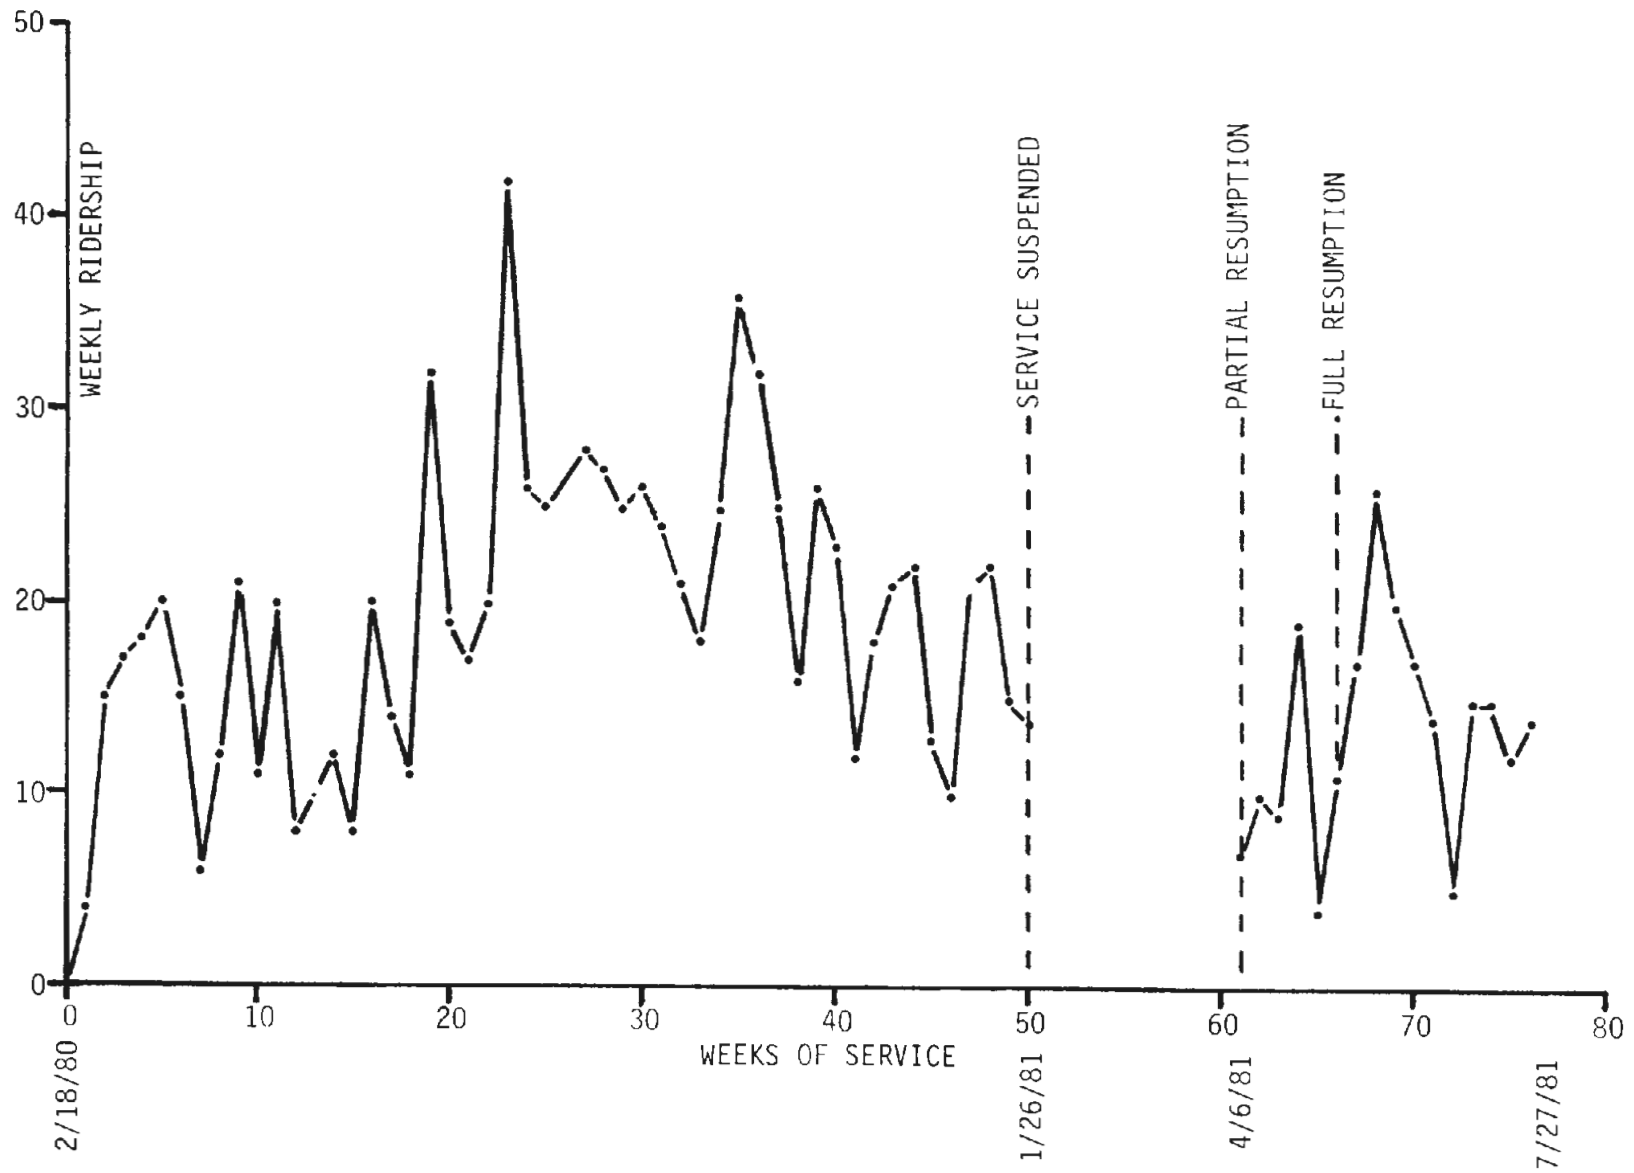
FIGURE 4.10-1: RIDERSHIP HISTORY ON SCRTD'S AMG/TDT BUS ROUTES SHOWING THE EFFECT OF SERVICE INTERRUPTION

4.10.1.2 Ridership - Ridership on the original 21 routes operated with the 200 AMG/TDT buses was relatively stable, but at a low level as shown in Figure 4.10-1. The figure also illustrates the effect of the suspension of service while major repairs were made on lift installations. Based upon later telephone conversations, the initial deployment of the RTS buses which increased the number of accessible routes from 21 to 53 also increased the ridership from 15-20 to about 40 per week.

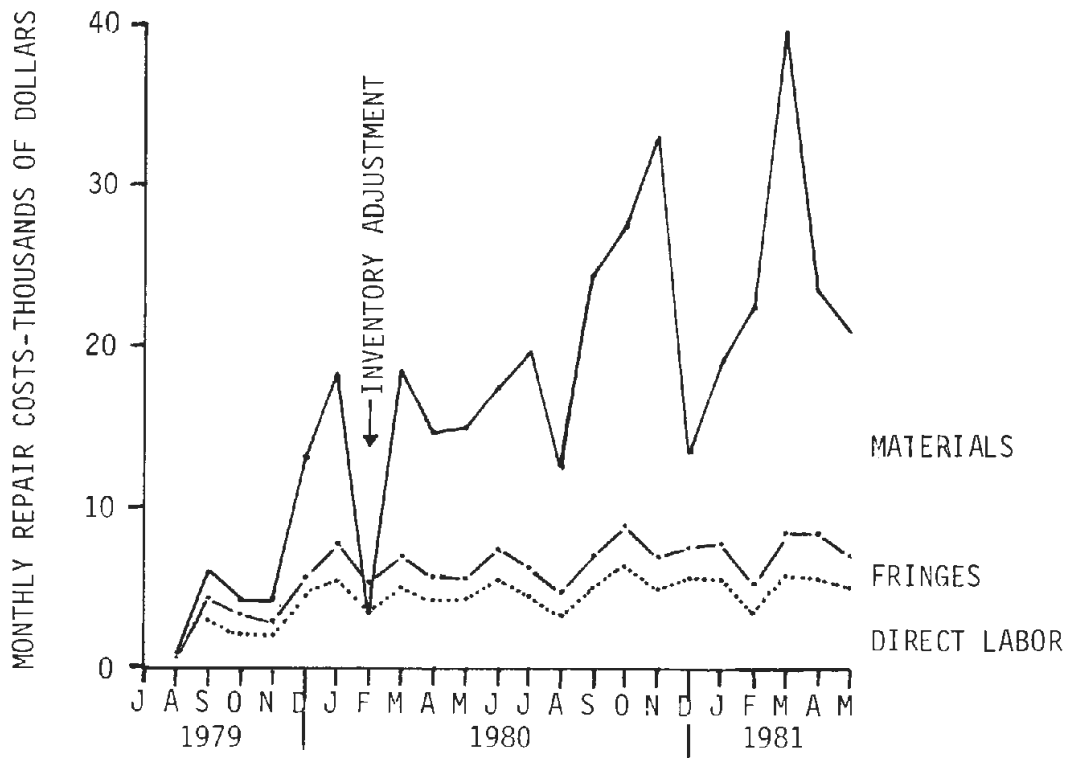
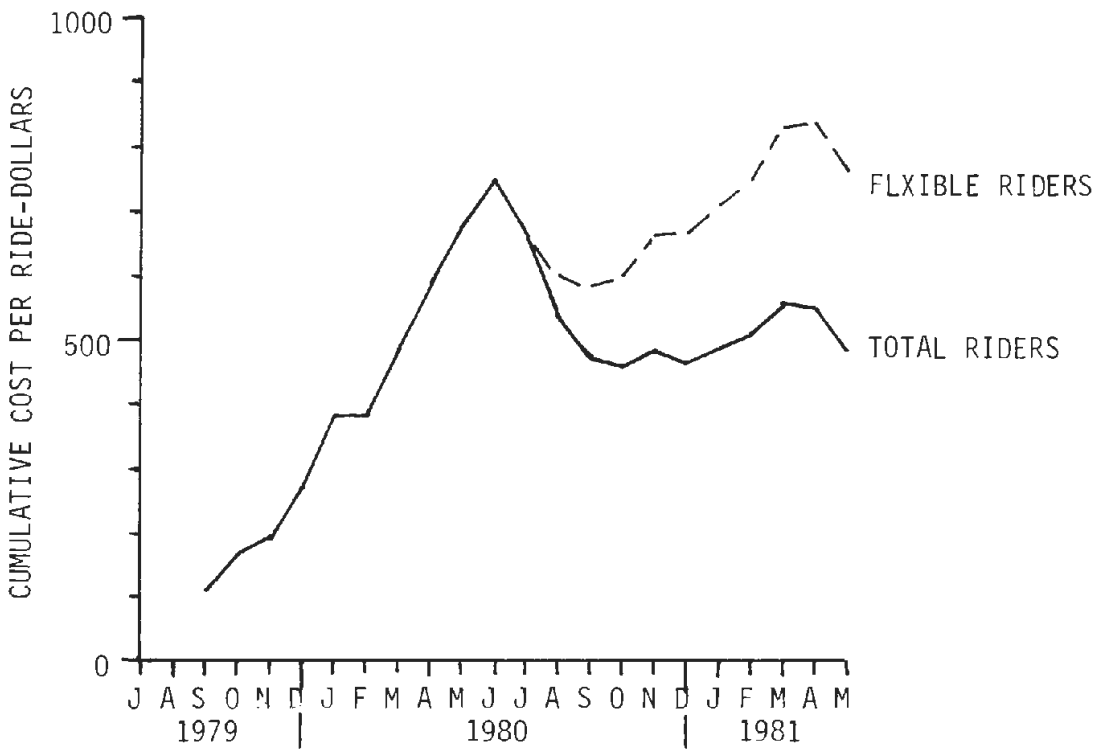
FIGURE 4.12-1: MONTHLY REPAIR AND RIDERSHIP TRENDS AT MCTS

The MCTS records on the cost of lift repairs, maintenance, and inspection consisted of labor cost and parts cost summaries. The only repair records available were the personal (and sometimes cryptic) records of two mechanics at the main shop. The cost of lift maintenance and repair was accumulated separately since August of 1979. The monthly figures through May of 1981 are presented in Figure 4.12-1. Until March of 1981, the accumulated costs represented only the Vapor/Flexible installation, but at that time the GM RTS-2 buses began to come out of warranty, consequently the MCTS cost figures would begin to reflect some GM lift costs. MCTS reported that there had been no major GM lift repairs in the three months of combined costs, and the figures provided do not show any sudden significant increase. Figure 4.12-1 also shows the cumulative cost per ride. The cumulative figures are presented because the monthly fluctuations in cost and the seasonal nature of the ridership produced large variations. Two trends are shown, for the Flexible ridership only, and for the total system.
