**Blue iQ Cummins B6.7L CNG
De-rate and Hours to Empty Calibrations
ENP-733
April 27, 2020**

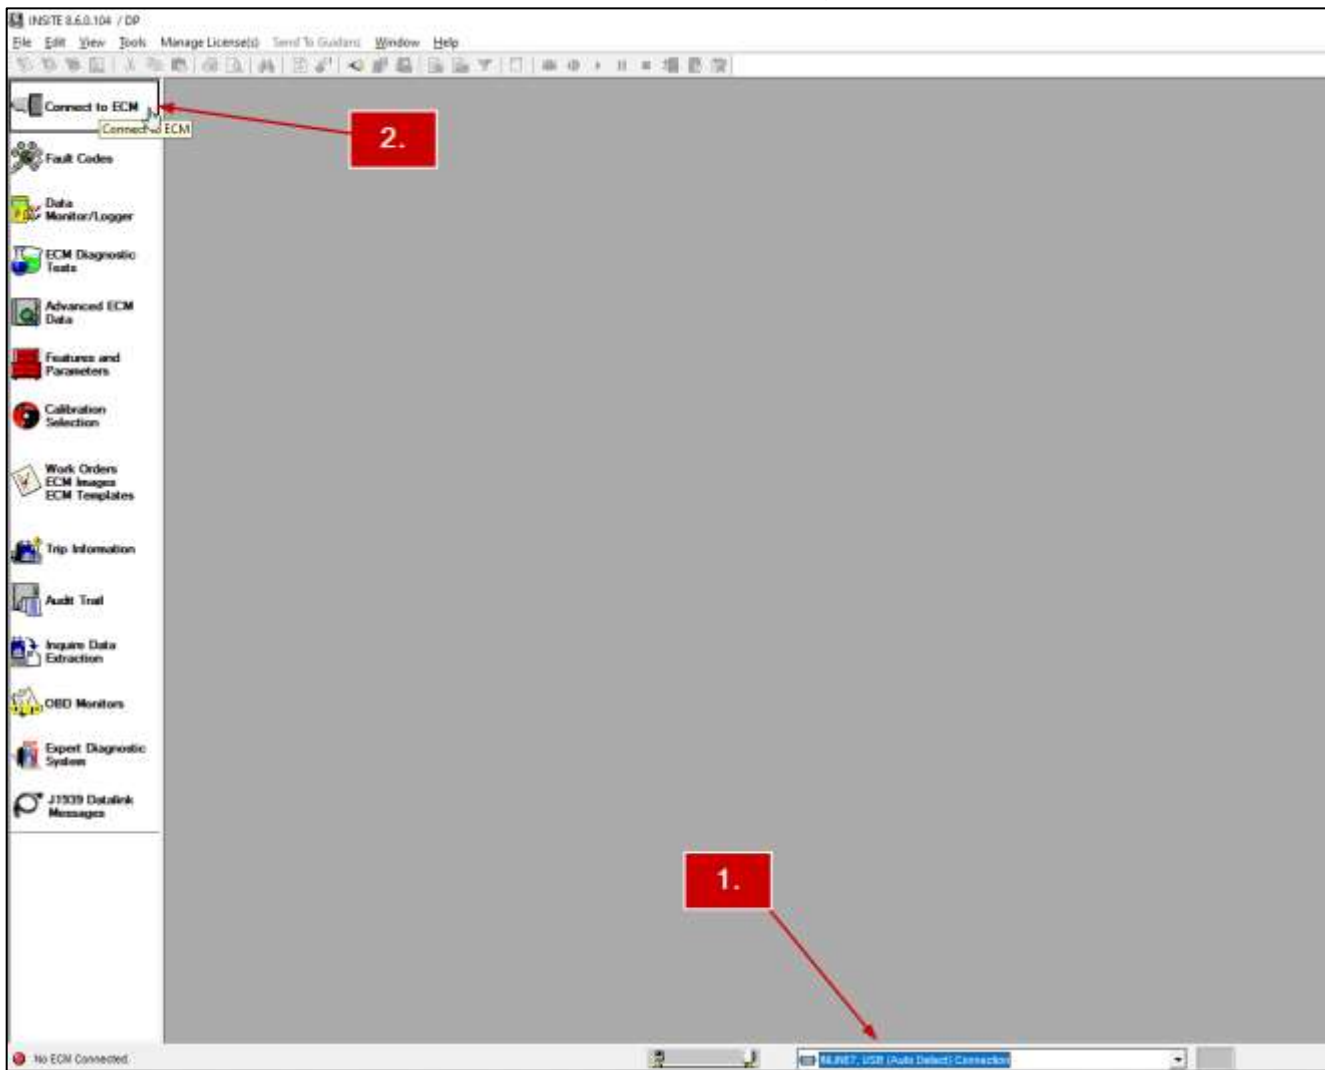
Figure 4.
Initial programming screen. INLINE7 tool connection verification (1) and Step 2 “Connect to ECM” (2).

Step 1: Using either a NEXIQ® USB-Link 2 or Cummins® INLINE7 tool, verify OBD-II connection is correctly selected. *Figure 4.*

Step 2: Click “Connect to ECM” from the left tab menu. *Figure 4*

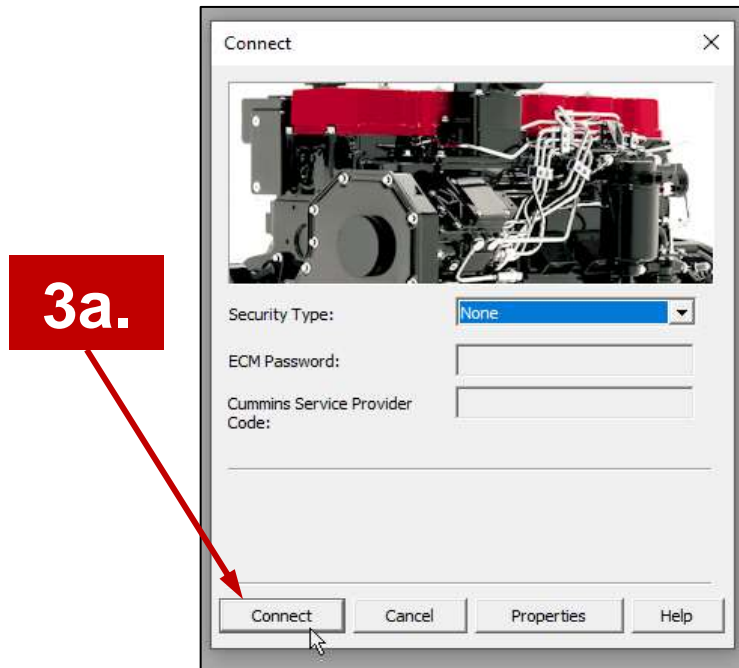
Figure 5.
Step 3a - "Connect" button.

Step 3a: Click “Connect.” NOTE: No security type or password credentials are required. *Figure 5*

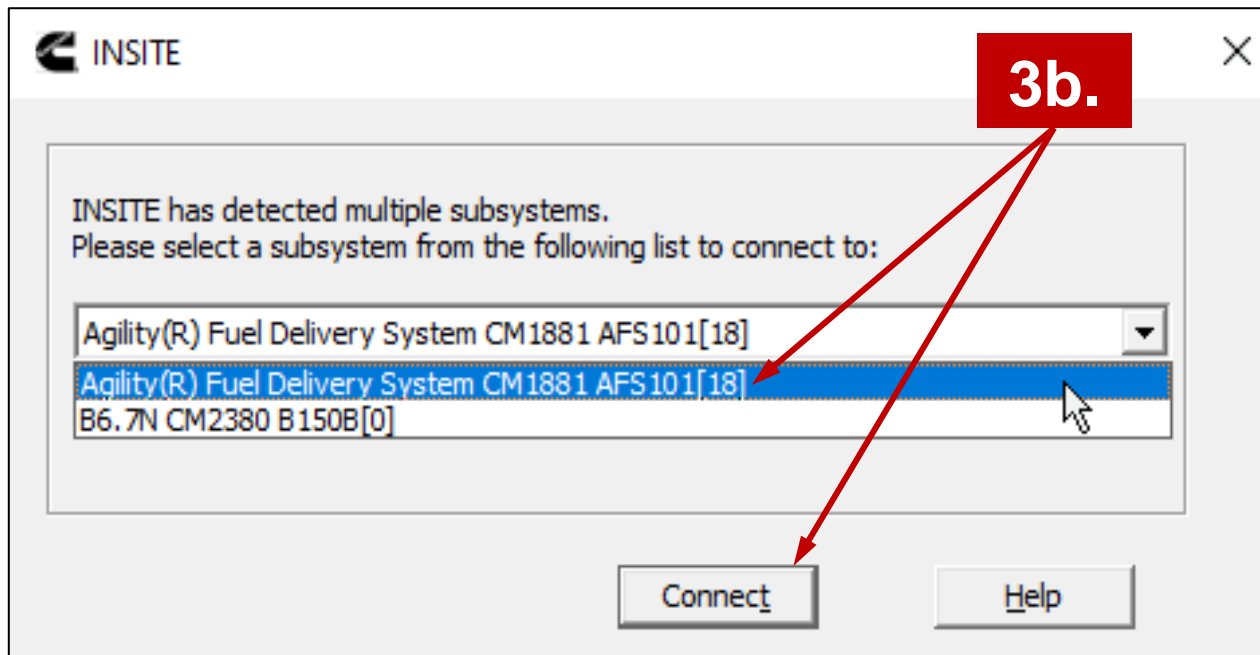
Figure 6.
Step 3b - "Agility Fuel Delivery System [18]" and "Connect" button.

Step 3b: Select "Agility Fuel Delivery System [18]" and click "Connect." Figure 6.

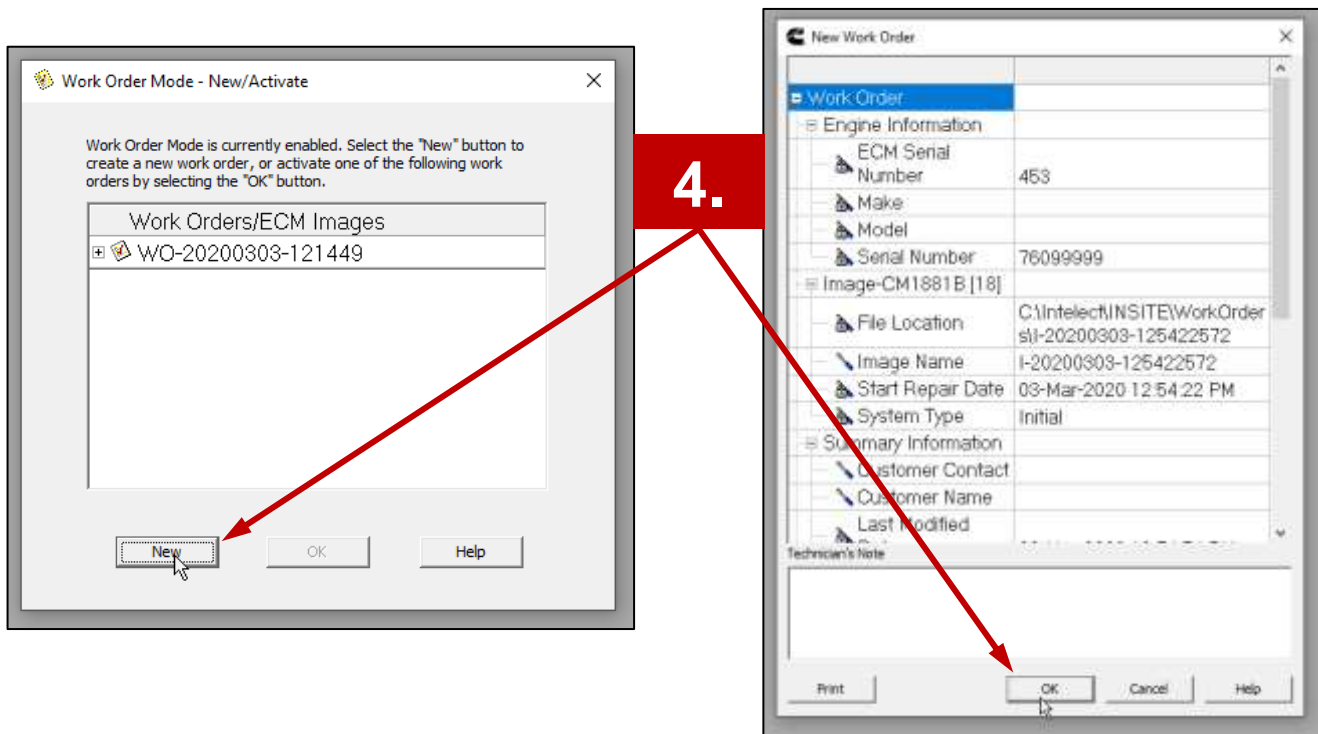
Figure 7.
Step 4 - “New” and “OK” buttons.

Step 4: Click “New” and “OK” on the pop-up menus. *Figure 7*

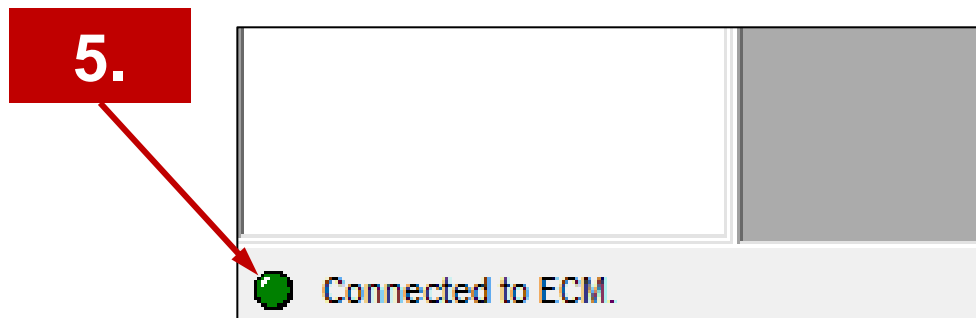
Figure 8.
Step 5 - Green circle indicates tool is connected to the ECM.

Step 5: Once connected, verify ECM connection at the bottom left of the window. *Figure 8*

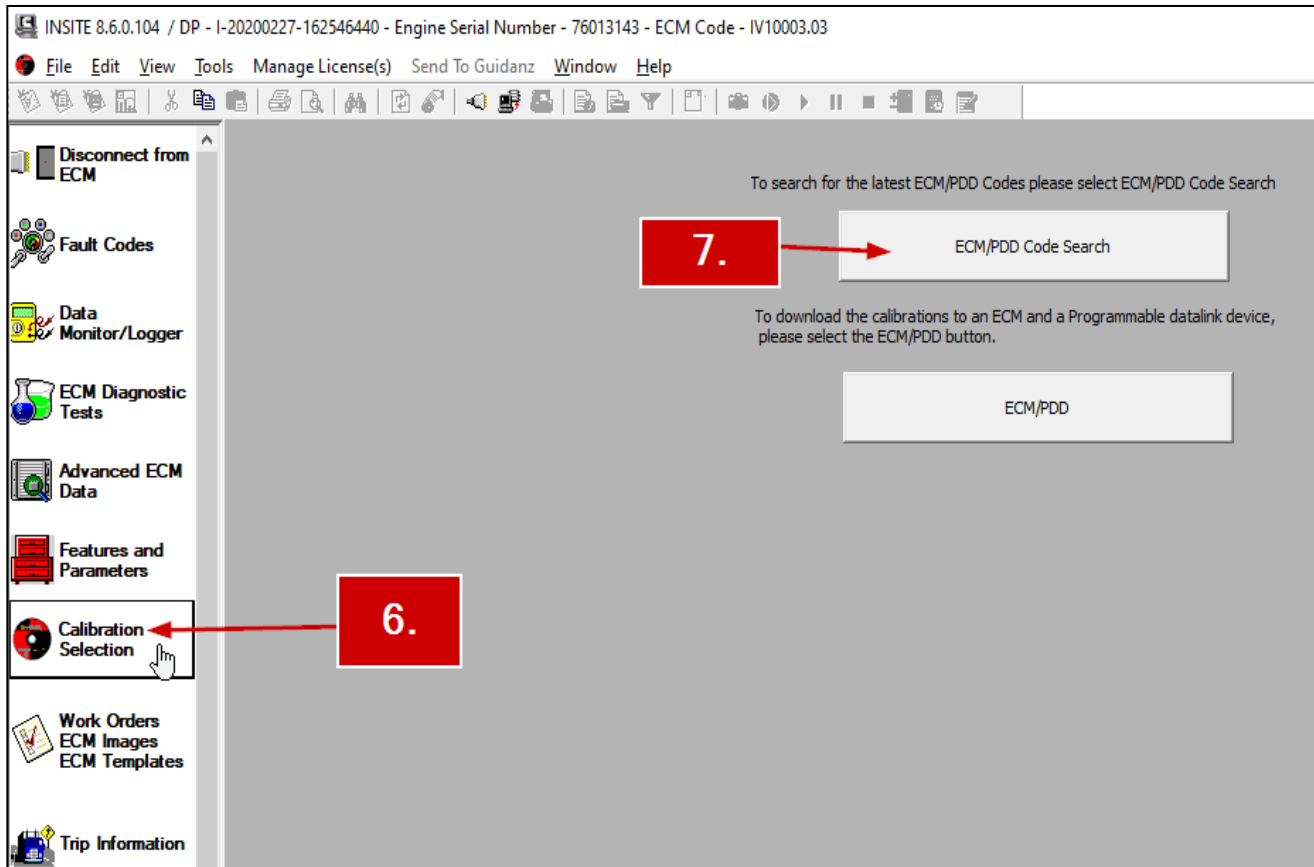
Figure 9.

Step 6 -“Calibration Selection” tab (6) and Step 7 “ECM/PDD Code Search” button (7).

Step 6: Click “Calibration Selection” from the left tab menu. *Figure 9*

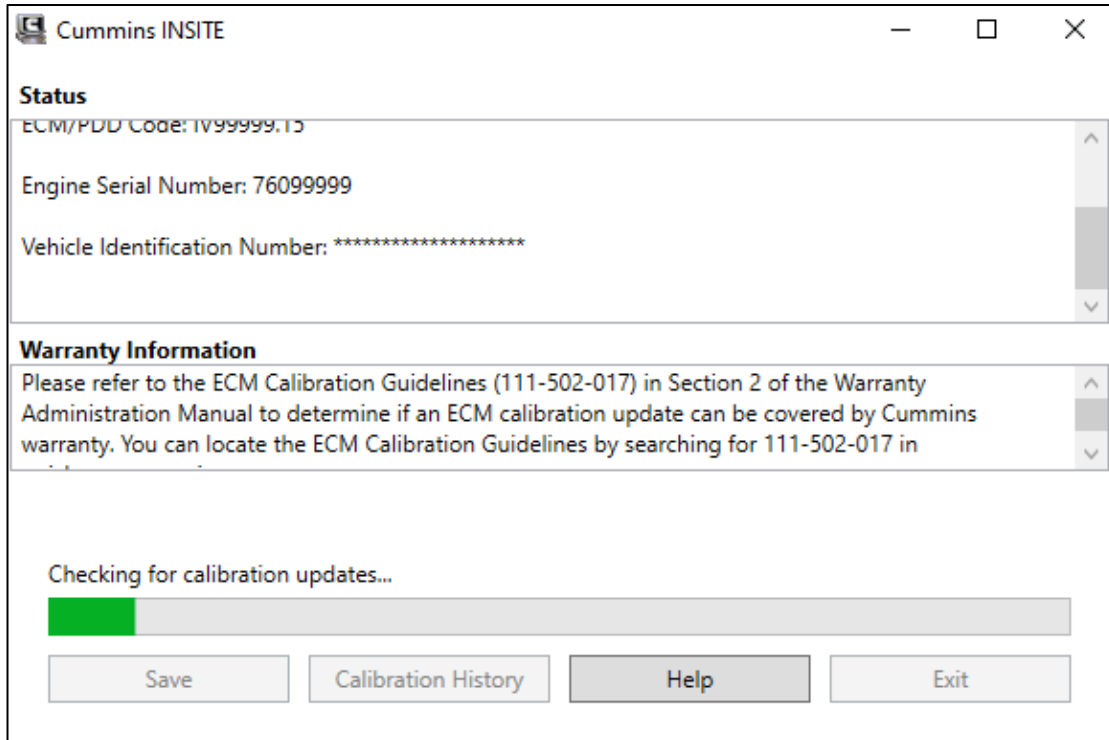
Figure 10.
Step 7 - Checking for calibration updates screen.

Step 7: Click “ECM/PDD Code Search” button (*Figure 9*) and the “Checking for calibration updates” screen will appear. *Figure 10*

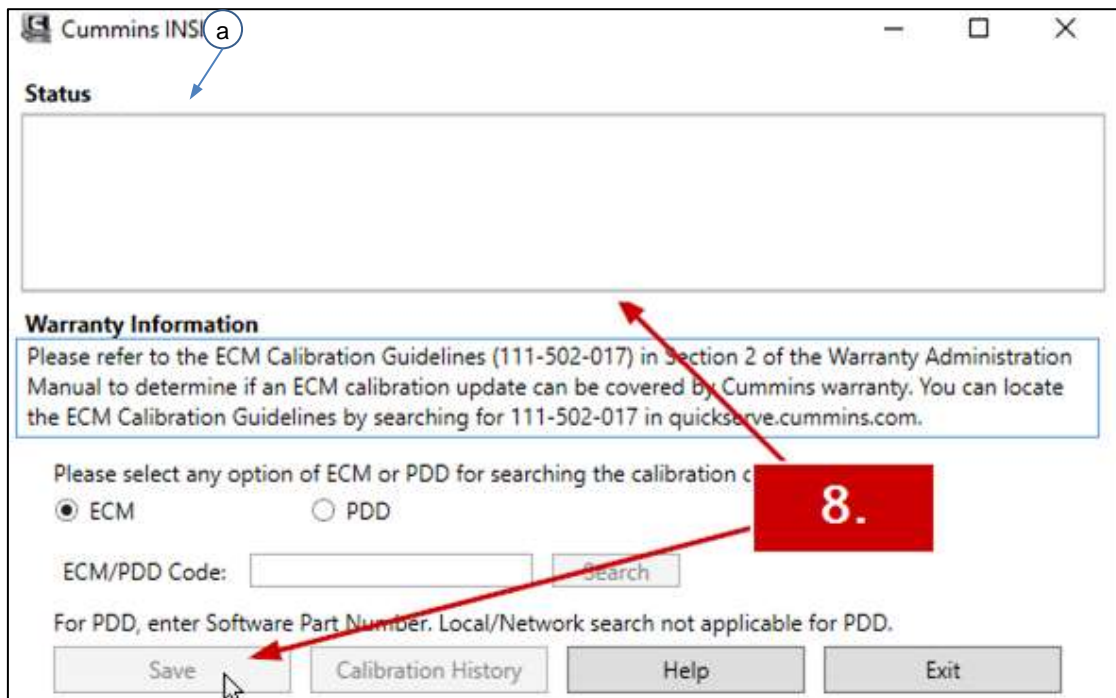
Figure 11.
Step 8 - “Successfully found (CAL ID tba)” message in Status box (a) and “Save” button (8).

Step 8: Wait for a “Successfully found (CAL ID tba)” message to appear in the status box. When the desired calibration is found, click “Save” and proceed to Step 9. Figure 11

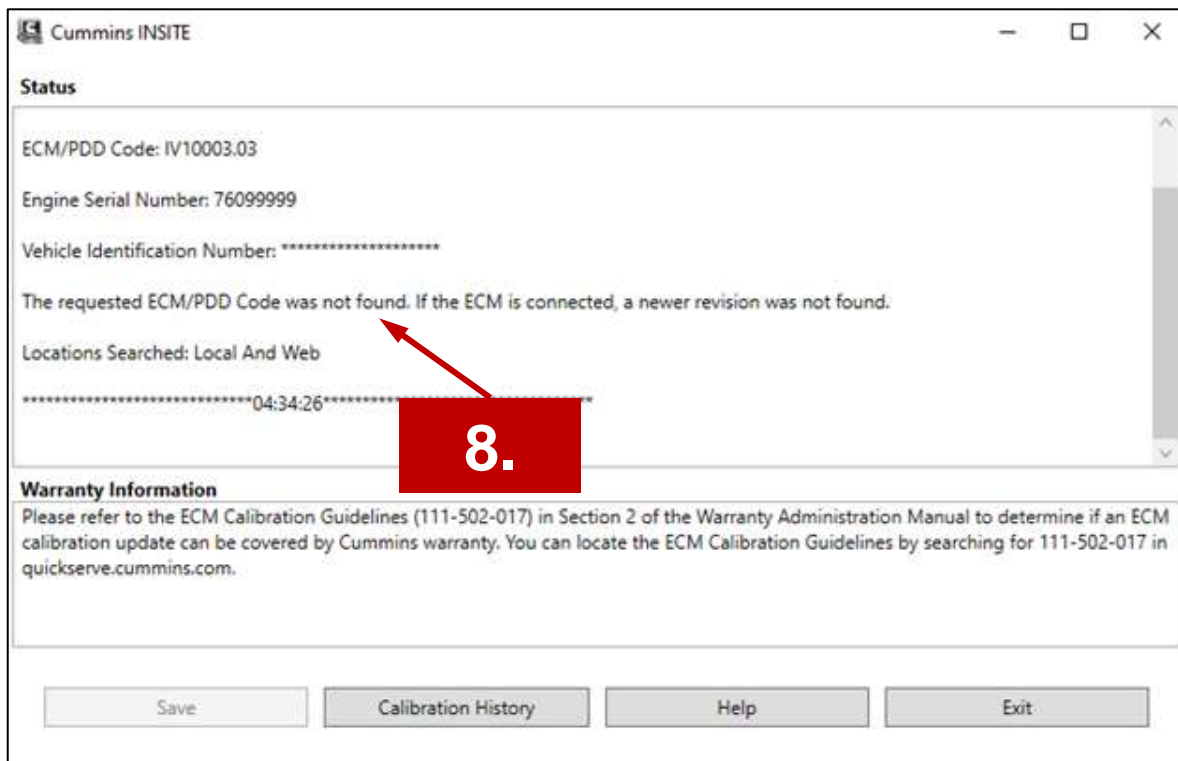
Figure 12. Step 8 - Calibration not found screen.

If the calibration was not found, double check the following connections:

- A. Verify stable Wi-Fi signal is present
- B. Confirm NEXIQ® USB-Link 2 or Cummins® INLINE7 tool is connected to OBD-II
- C. Confirm Agility ECU is connected properly to the fuel system chassis harness

Repeat Steps 6 through 8.

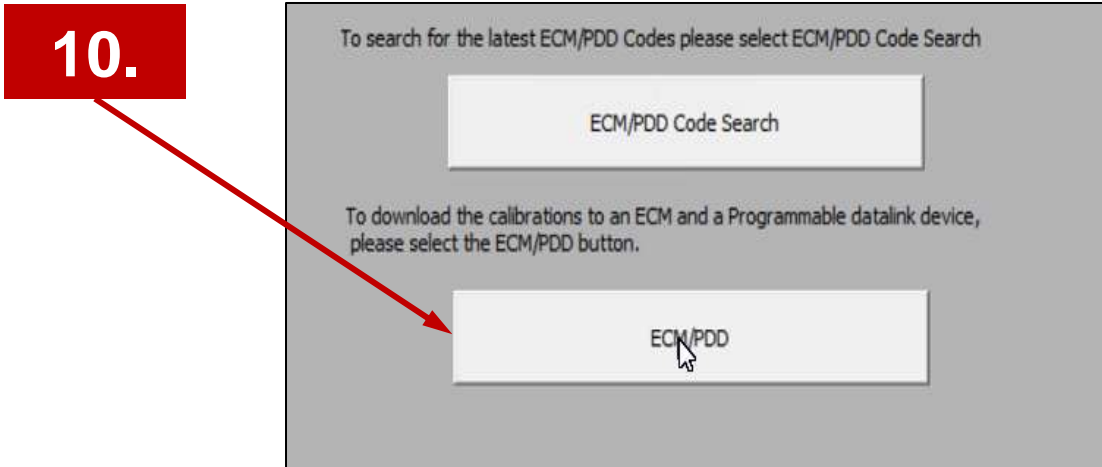
Figure 13.
Step 10 “ECM/PDD” button (10).

Step 10: Click the “ECM/PDD” button, add all, and click on the “OK” button. *Figure 13*

When these options appear, select “Add All,” and click on the “OK” button.

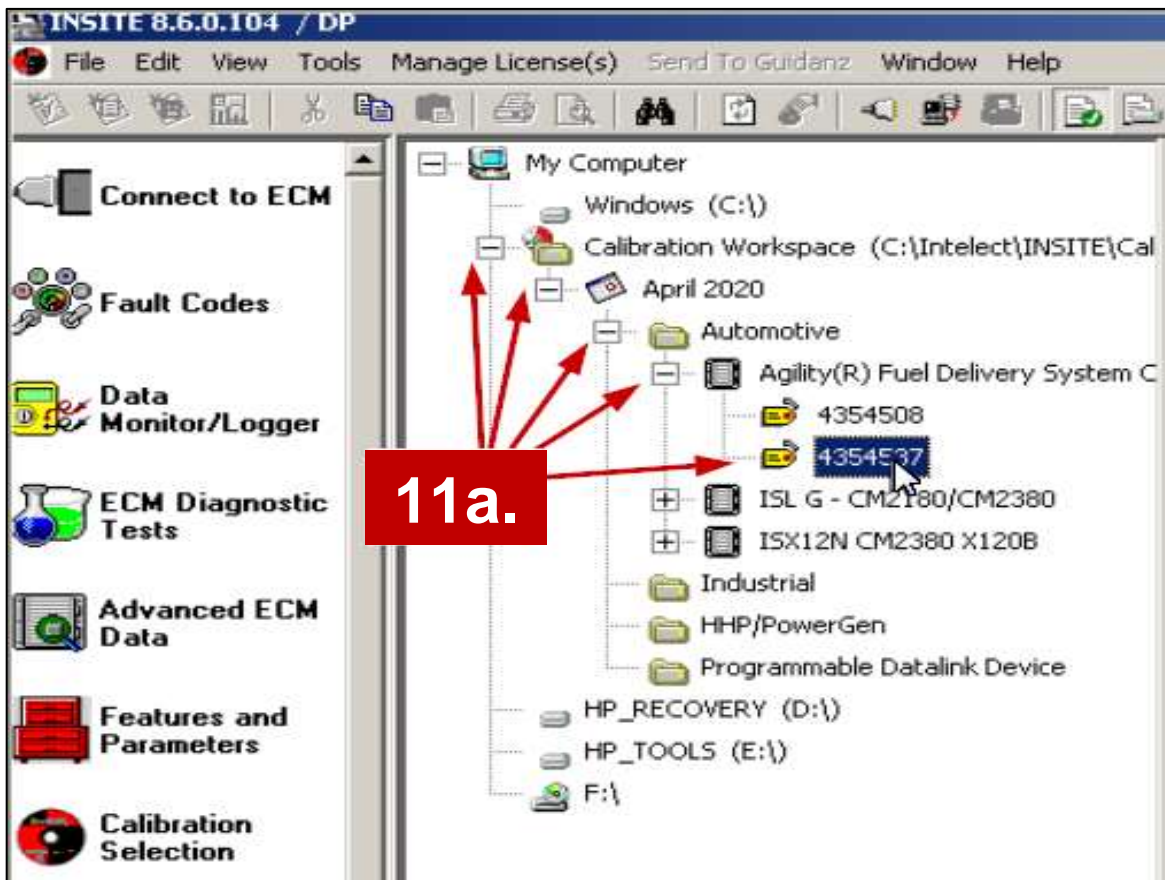
Figure 14.
Step 11a. Click to expand all folders (11a).

Step 11: Click/expand all folders (the + buttons), then click on “4354537.” Figure 14

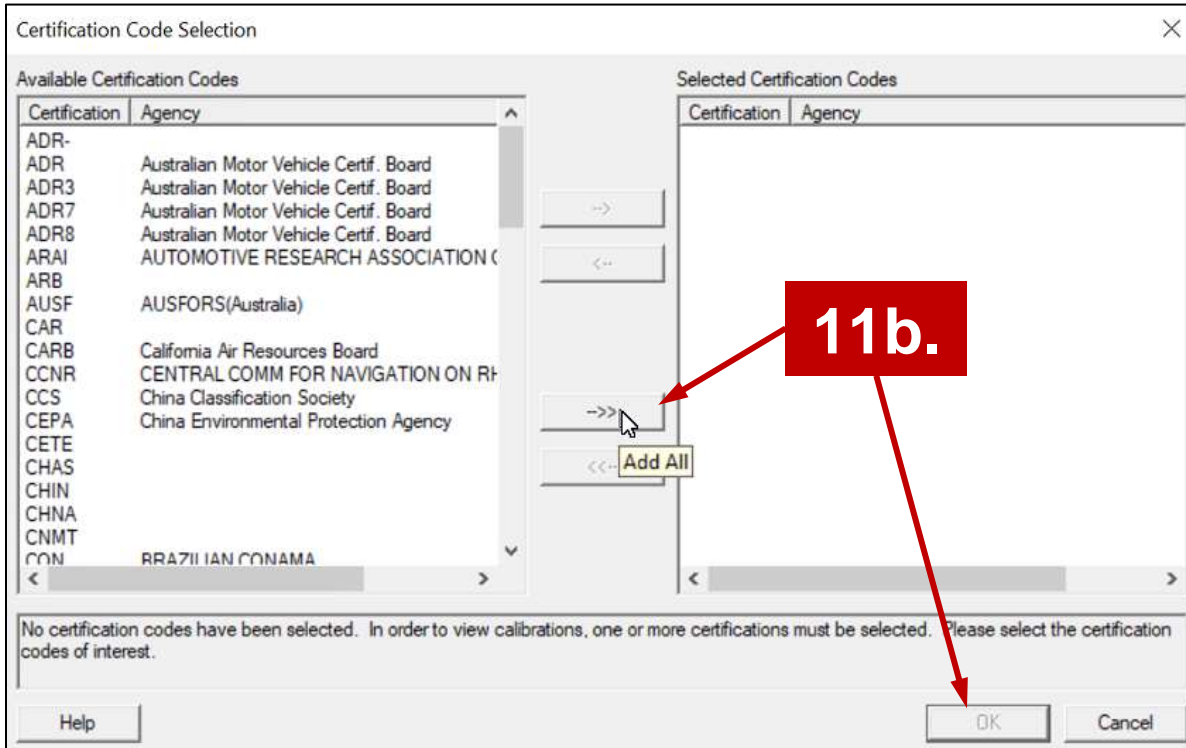
Figure 15.
Step 11b. “Add All” and “OK” buttons (11b).

Select “Add All” and click “OK.” Figure 15

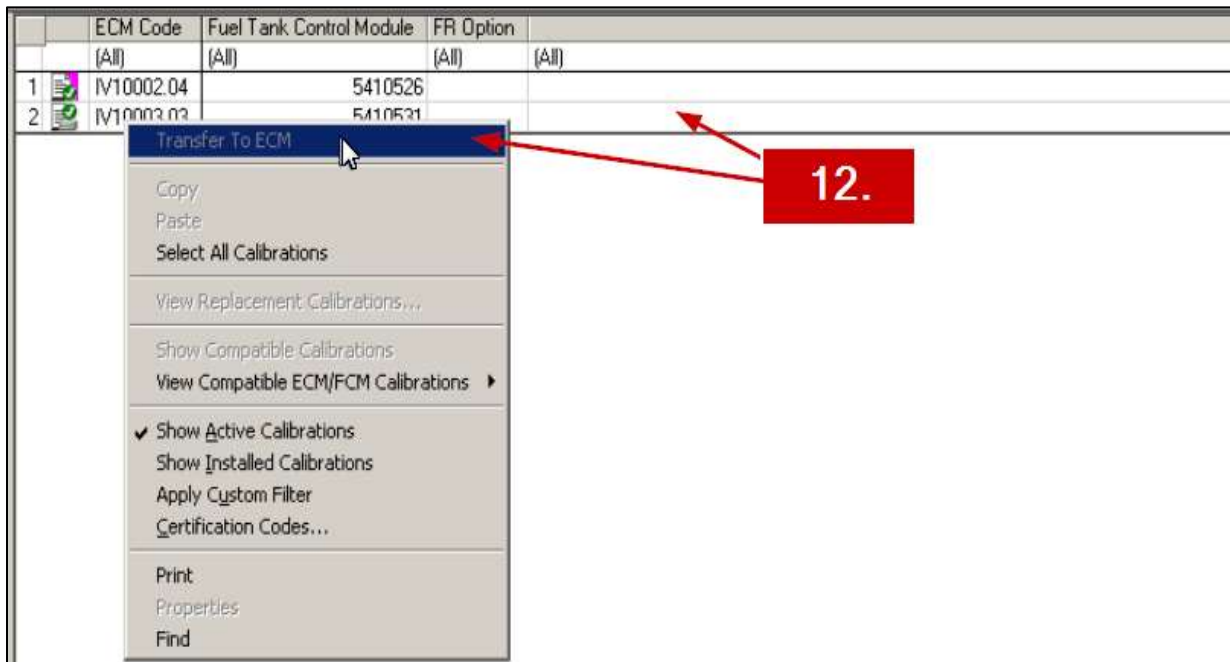
Figure 16.
Step 12. Select desired Cal ID # from the list, then click “Transfer to ECM” (12).

Step 12: Right click on the calibration ID #, then click “Transfer to ECM” in the pull down menu. Figure 16

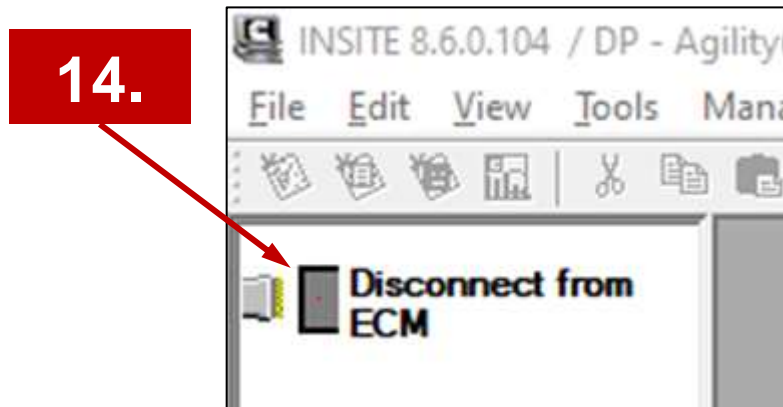
Figure 17. Step 14 Disconnect from ECM tab.

Step 14: When complete, click “Disconnect from ECM” tab at upper left menu and close out INSITE. *Figure 17*
