Learning from Earthquakes

Reconnaissance Report on the Umbria-Marche, Italy, Earthquakes of 1997

Submitted by the EERI reconnaissance team: Stephen Tobriner, team leader, and Mary Comerio, both of the Architecture Department at the University of California, Berkeley, and Mel Green, President of Melvyn Green & Associates in Torrance, California.

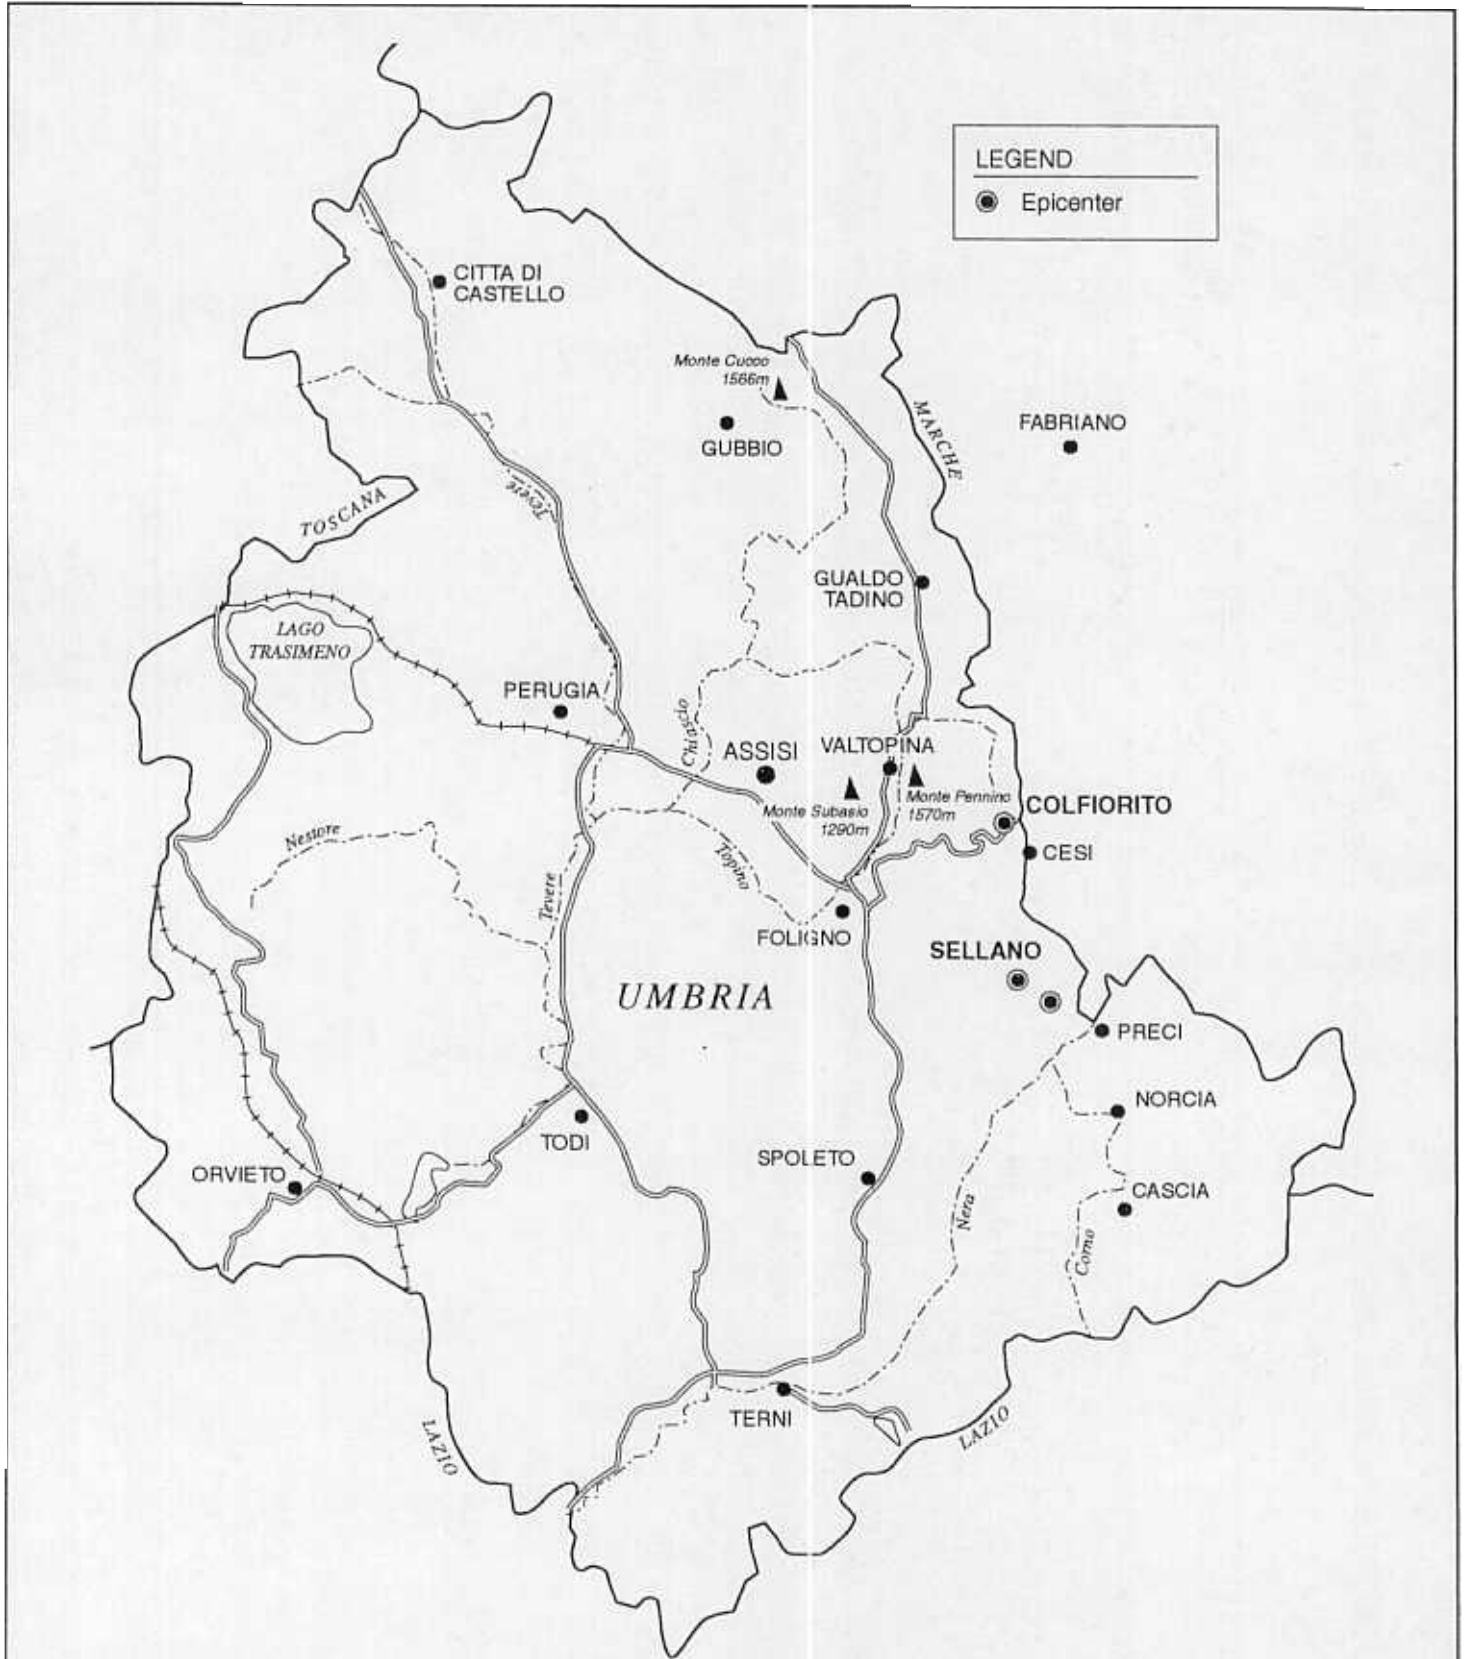
Figure 2 - Map of Umbria showing the epicentral areas of the earthquake series that affected the region throughout the fall of 1997. The epicenter for the first two shocks, on September 26, was Colfiorito. Colfiorito was the epicenter for two more shocks on October 3 and 7. Sellano was the epicenter for shocks on October 12 and 14. On November 9, the Sellano-Preci area was at the epicenter of yet another quake.
