USACE SAVANNAH IDIQ TASK ORDER 01

Guantanamo Bay
CHU Facility Condition Assessment
Final Recommendation Report

13 APRIL 2020

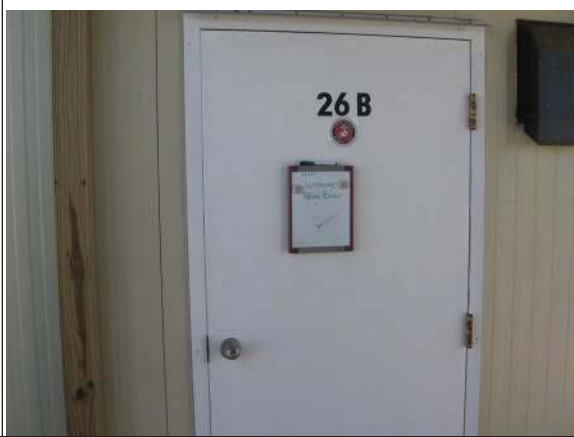
<p>Photo #19: All exterior penetrations need to be re-caulked</p>		<p>Photo #20: Re-paint all exterior doors and trim</p>

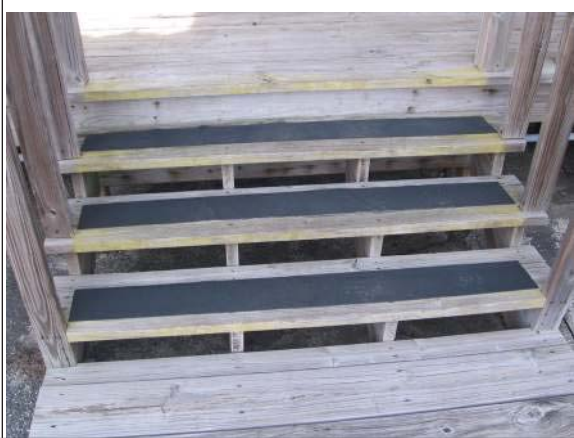
<p>Photo #45: Replace exterior covered pressure treated wood truss and metal roof system</p>		<p>Photo #46: Typical slip resistant tape at all pressure treated wood stairs</p>
