Number	A.1.
Section	General Information
Sheet	1 (of 1)
Date	January, 1960

PRELIMINARY INFORMATION

(Mark 2 Models)

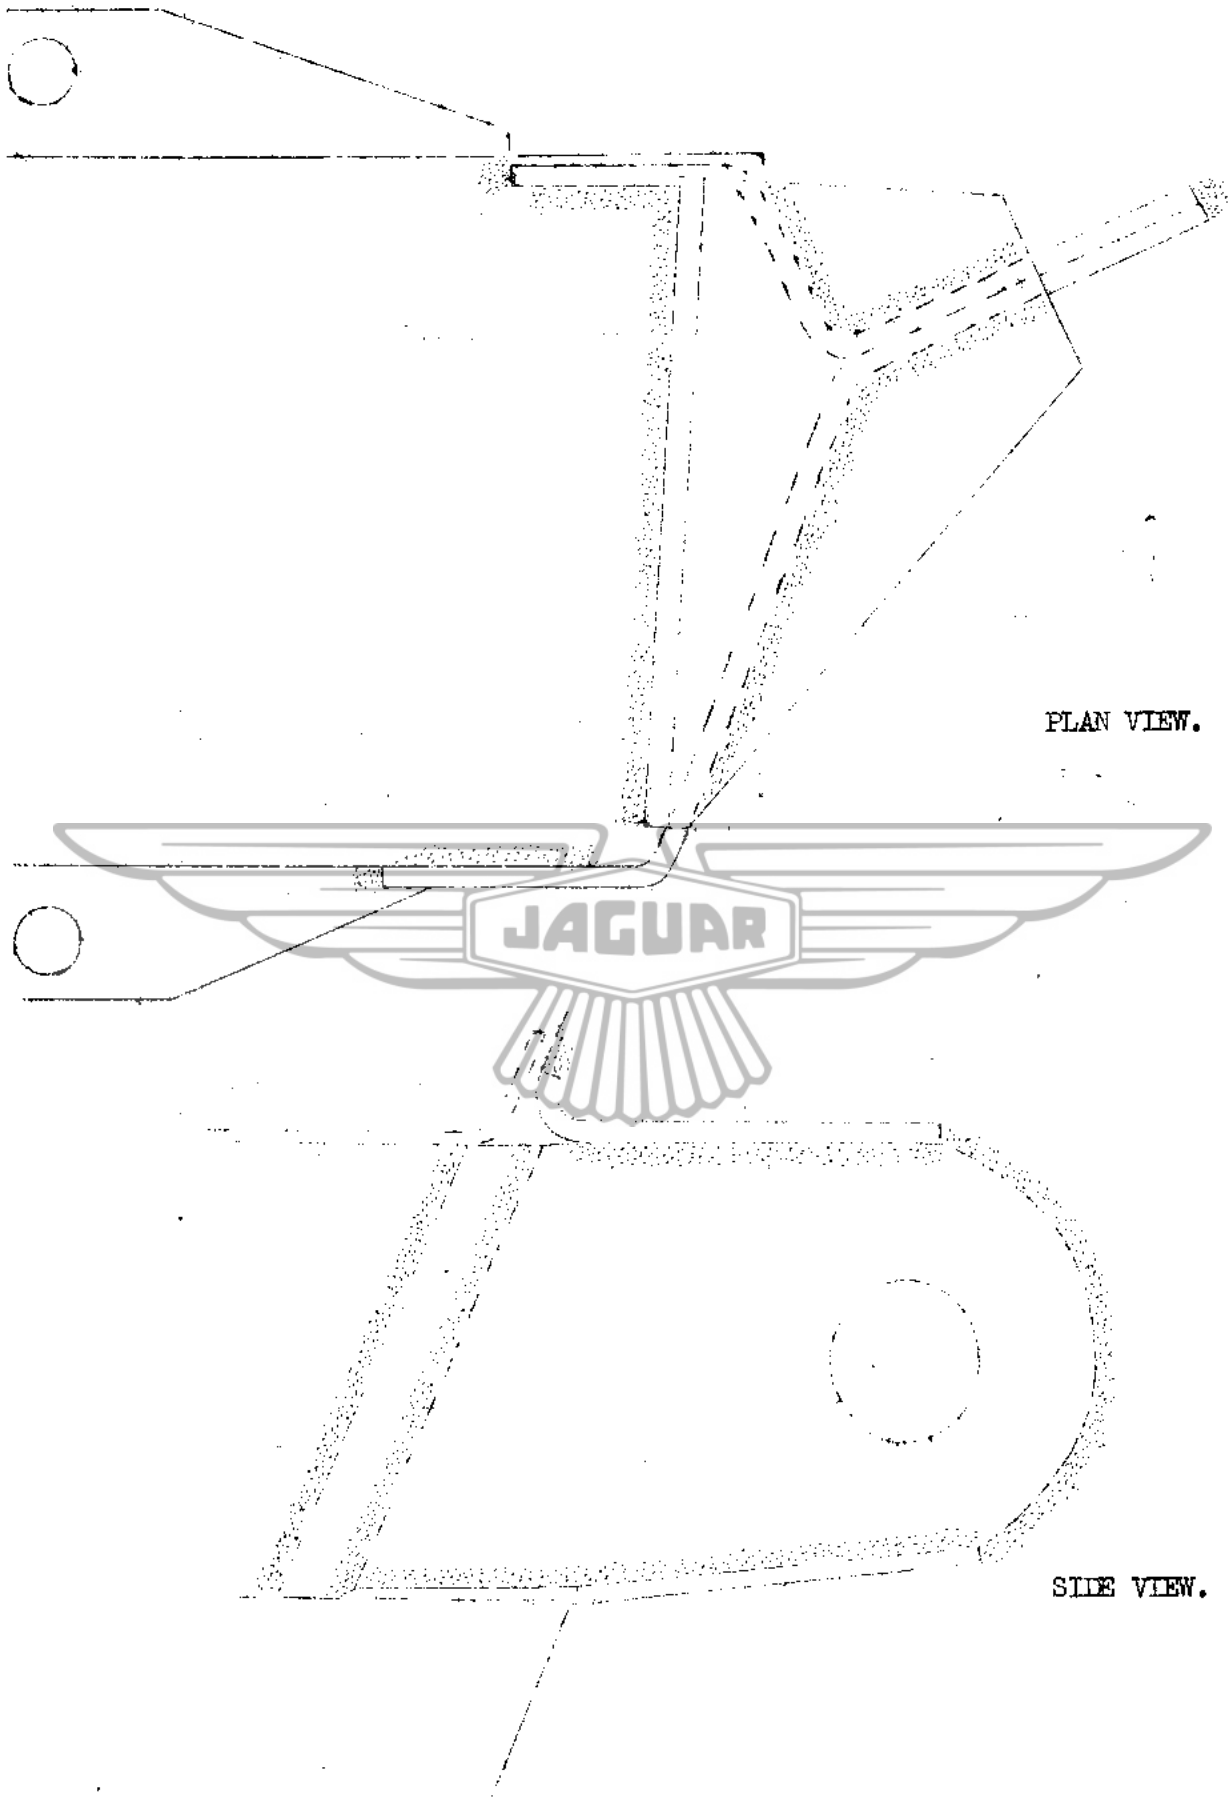
In the case of your having an actual breakage reported please take the following action:-

1. Disconnect the panhard rod from the rear axle bracket.
 2. Remove the broken piece of bracket from the panhard rod and if the two pieces of plate are not spot welded together, weld around the two rounded edges ensuring that the two holes are in line.
 3. Mate up the two parts of the broken bracket at the point of fracture and weld together.
 4. Carry out the necessary welding to ensure that the bracket is welded at all the positions indicated in the following sketches.
 5. Repaint the bracket and refit the panhard rod.

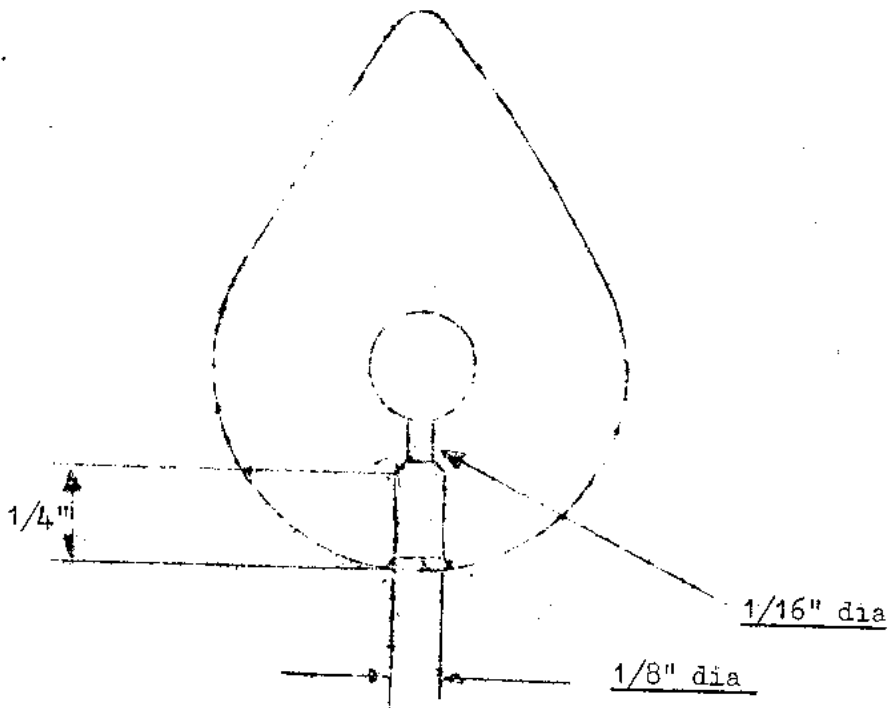
If complaints of tappet noise when starting from cold are received this modification can be carried out in service by carrying out the following procedure.

1. Support the camshaft on Vee blocks at the front and rear bearing journals and clamp down the camshaft while drilling each cam.
2. With a high speed drill make an $\frac{3}{8}$ " (3 mm) diameter hole $\frac{1}{4}$ " (6.35 mm) deep in the centre of the base of each cam and follow through with a $\frac{1}{16}$ " (1.5 mm) high speed drill until the hole breaks through into the main oilway. (see sketch). Chamfer the edge of the $\frac{3}{8}$ " hole to remove the sharp corner.
3. After drilling all the cams thoroughly wash out the oilways to remove all traces of drilling swarf.

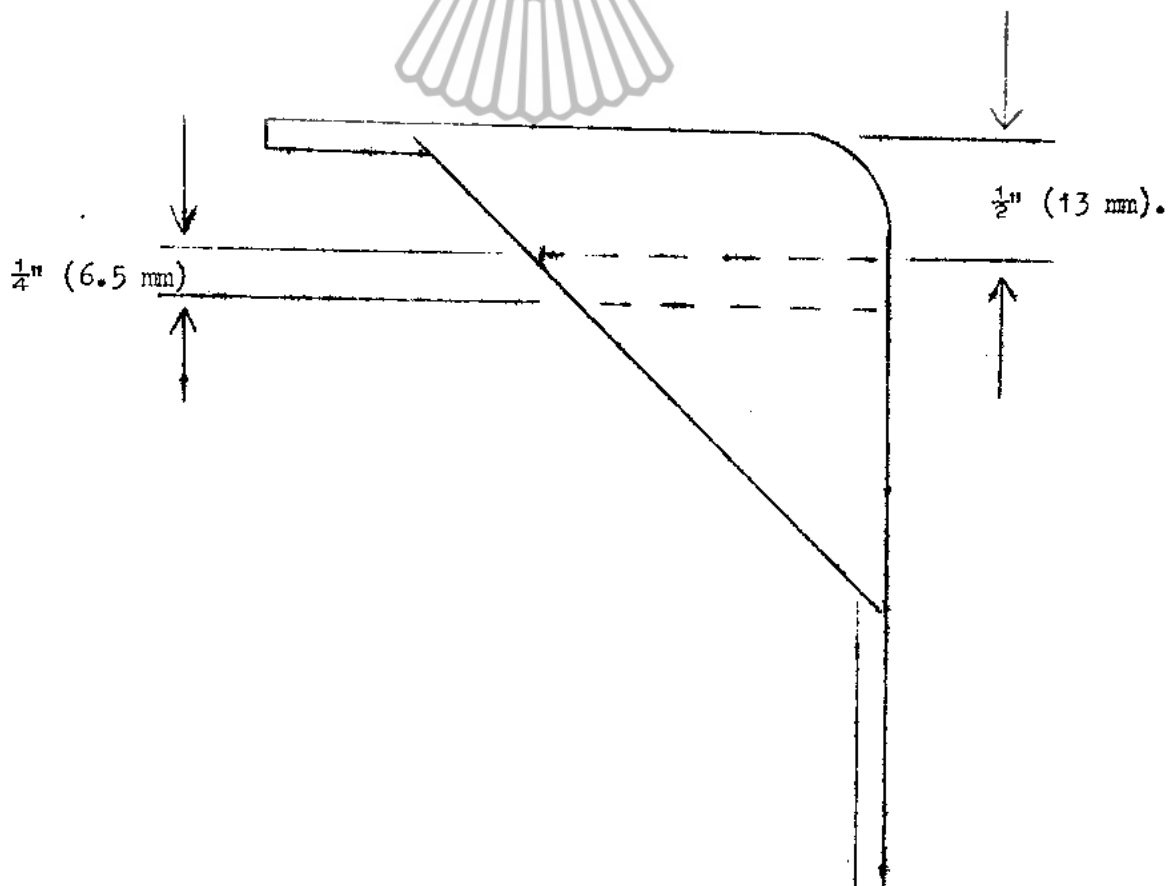
NOTE: Do not cut more than $\frac{1}{4}$ " (6 mm) from the bracket, or when assembled the cross wires may foul the torque arms.

1. Remove the handbrake compensator bracket which is secured by two of the rear axle cover screws.
2. With a hacksaw cut out a $\frac{1}{4}$ " (6 mm) strip of metal to reduce the effective height of the bracket. Weld the two halves of the bracket together. (see sketch).

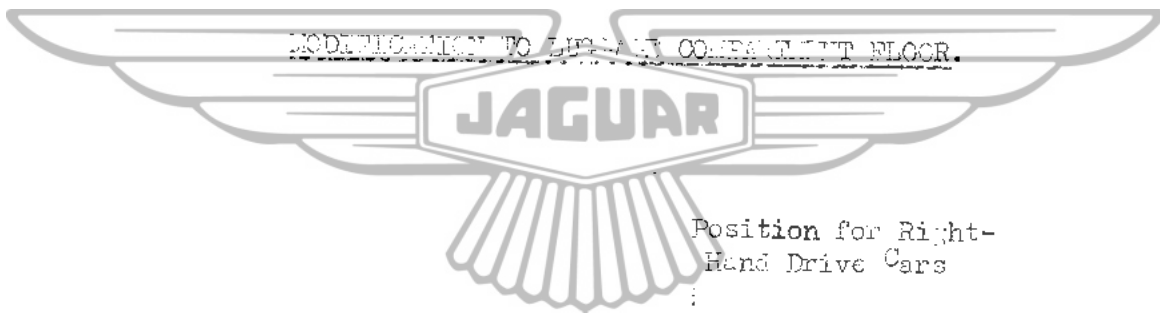
Position for Left-Hand Drive Cars

It will be noted that there are six depressions in the trunk floor; for Left hand drive cars the patch plate should be fitted to the **third** depression from the left and for right hand drive cars the patch plate should be fitted to the third depression from the right - see sketch.

Note: It is IMPORTANT to carry out the above two body modifications otherwise fouling will take place between the handbrake compensator and trunk floor, and also between the handbrake cross cables and the wheel arches.
