KAMAN *Rotor Tips*

KAMAN AIRCRAFT CORPORATION

AUGUST - OCTOBER 1966

WHAT'S WITH THE TWIN?

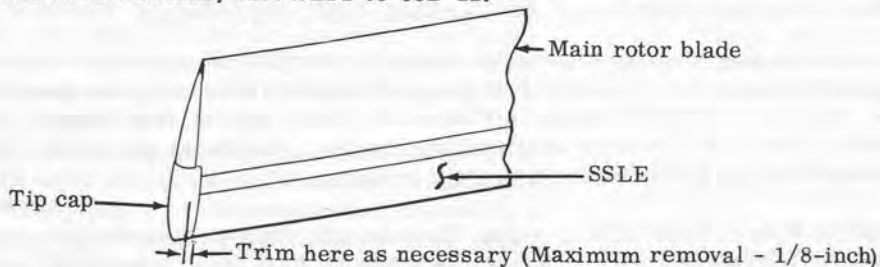
Rotor Blade Tip Cap Trimming (UH-2)

H-2 Interim Airframe Bulletin (IAB) No. 87 requires electrical isolation of the steel tip cap from the stainless steel leading edge (SSLE) on ALL UH-2 main rotor blades. If isolation cannot be achieved by loosening the four retaining screws and shifting the tip cap outboard away from the leading edge, then up to a maximum of 1/8-inch of material may be trimmed from the inboard edge of the tip cap. Do not trim the tip caps to the 1/8-inch maximum unless necessary, but remove only enough material to isolate the tip cap from the stainless steel leading edge and trim only in the area where the tip cap can butt against the SSLE. After trimming, reinstall the cap and fill the gap with sealing compound, P/N EC801, and cure in accordance with the Handbook, Structural Repair, NAVWEPS 01-260HCA-3. This data will appear in future revisions of Handbook of Maintenance Instructions, NAVWEPS 01-260HCA-2-5 and -2-9; Structural Repair, NAVWEPS 01-260HCA-3; Handbook of Inspection Requirements, NAVWEPS 01-260HCA-6; and Overhaul Instructions, NAVWEPS 03-95D-11.

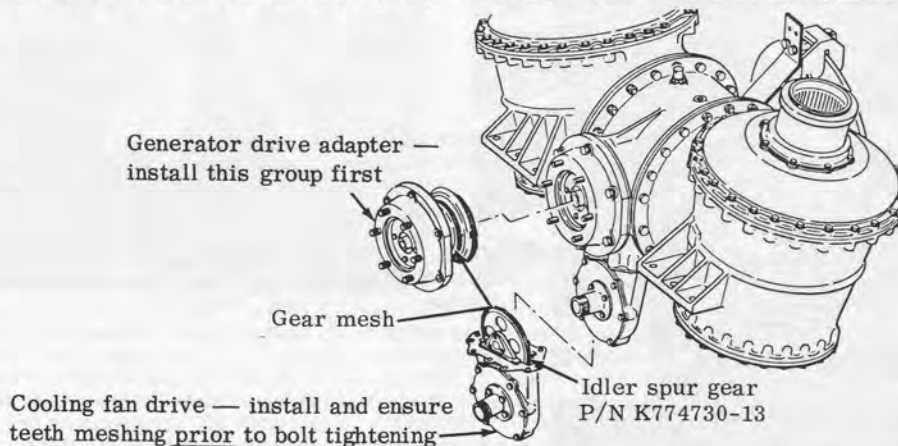
Precaution After Transmission Inspection (HH-43B, HH-43F)

To comply with the intent of T.O. 1H-43(H)-505 (Inspection of Transmission) it is necessary to remove the cooling fan drive group and the generator drive adapter group from the transmission. During reinstallation of the two groups, the idler spur gear, P/N K774730-13, on the fan drive group, must be properly meshed with the teeth on the spur gear portion of the generator drive adapter group. Ensure positive gear meshing PRIOR to tightening the attaching hardware on the cooling fan drive group. See drawing for installation sequence of the two groups.

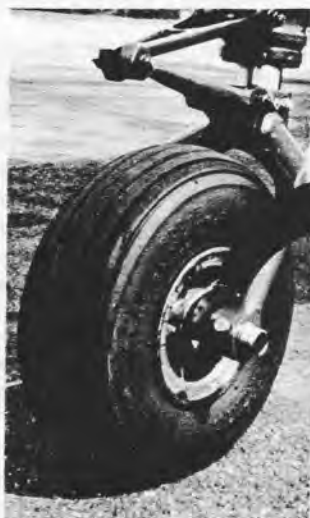
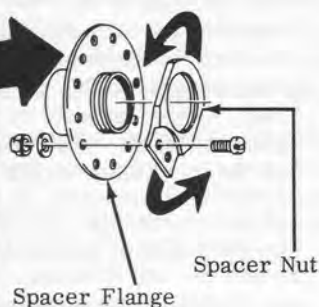
Tail Shock Strut
P/N 611800-501(Menasco)

Q. (Applies UH-2) WHAT IS THE MOST PROBABLE CAUSE OF TAIL WHEEL SHIMMY AND RESULTANT AIRCRAFT VIBRATION?

A. Tail wheel shimmy is usually caused by improper adjustment of the nut on the spacer flange. The proper installation procedure is found in the HMI, Airframe Group, NAVWEPS 01-260HCA-2-2. When a new tire and wheel assembly is installed, the adjustment nut on the spacer flange should be turned in a counterclockwise direction to properly position the axle wheel bearings and eliminate wheel side play. After adjustment, the spacer flange nut should be secured to the spacer flange with a screw and locknut (see illustration of the tail shock strut, P/N 611800-501). Indications of an improperly adjusted spacer flange nut are: (a) Excessive and erratic tire wear; (b) Aircraft tail vibration when taxiing; and (c) Tail vibration noticeable immediately after replacement of a new tire and wheel assembly.

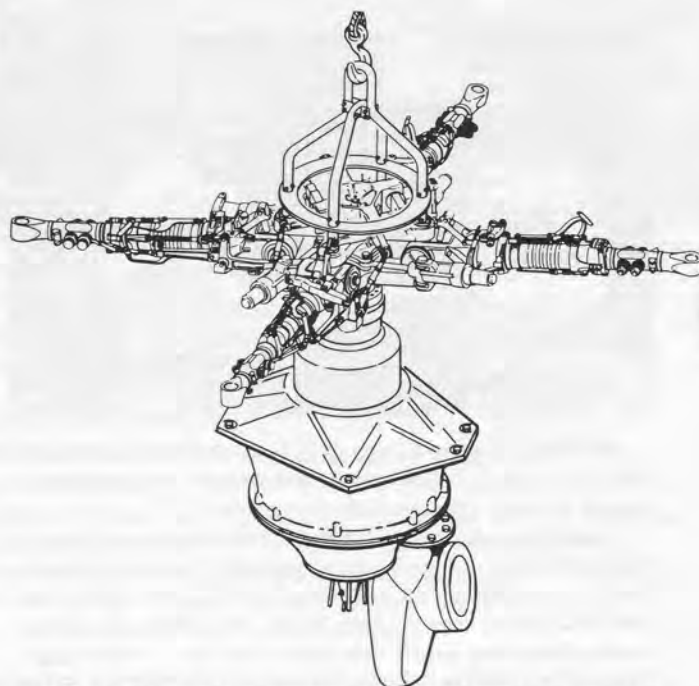
Q. (Applies UH-2) CAN THE MAIN GEARBOX, AZIMUTH, AND RETENTION ASSEMBLIES BE REMOVED FROM THE AIRCRAFT AS A SINGLE UNIT? IF THIS IS PERMISSIBLE, WHAT SAFETY PRECAUTIONS SHOULD BE OBSERVED?

A. As a maintenance aid, the main gearbox, azimuth, and retention assemblies may be removed from the aircraft as a unit. With the unit out of the helicopter and secured in the main gearbox workstand or dolly assembly, maintenance personnel will find all work areas and components more readily accessible. A point to remember is that this procedure can only be accomplished with an overhead crane. Do not attempt to remove the component unit with the portable hoist assembly, P/N K604013, because it cannot be extended high enough for this configuration to allow the bottom of the gearbox to lift clear of its mounts. The portable crane is also load-limited to 700 pounds.

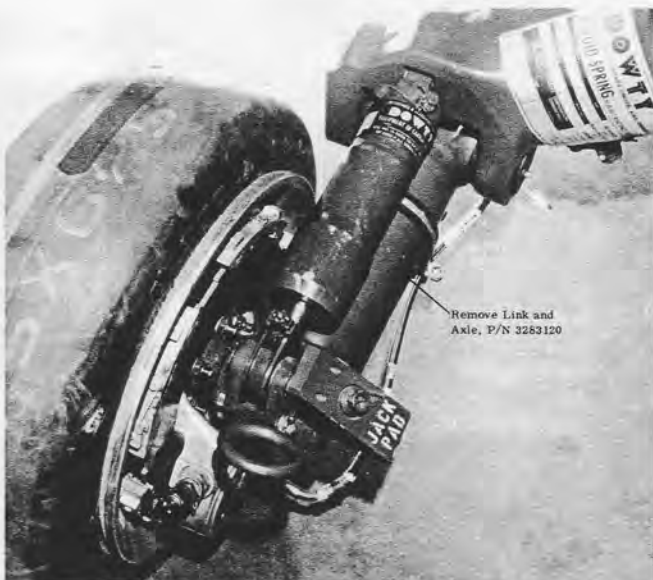
Q. (Applies UH-2) WHAT PROCEDURE MAY BE USED WHEN PREPARING A UH-2 WITH DOWTY LANDING GEAR FOR LOADING INTO A C-124?

A. A UH-2 helicopter which has the DOWTY landing gear installed can be easily loaded into a C-124 cargo aircraft for shipment by accomplishing the following: Refer to the HMI, NAVWEPS 01-260HCA-2-2, and remove the link and axle assembly, P/N 3283120, and its related hardware from the right-hand landing gear assembly. Install the removed link and axle onto the left-hand landing gear assembly and vice-versa. This will locate the wheel and tire assembly inboard a sufficient amount to clear any interference while loading the helicopter into the C-124. Upon completion of shipment, the landing gear links and axles are then returned to their original positions and secured.

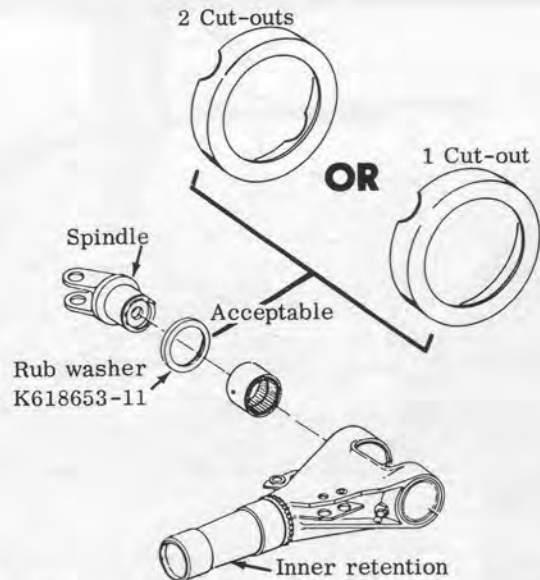
Q. (Applies UH-2) WHEN DRAWN FROM SUPPLY, SOME RUB WASHERS FOR USE ON K618080-309 AND -603 RETENTIONS HAVE ONE CUT-OUT ON THE LIP AND OTHERS HAVE TWO. ARE THEY INTERCHANGEABLE?

A. Either of these rub washers, P/N K618653-11, may be used with the retentions mentioned. If what appears to be a "two cut-out" washer is found already installed on the retention, it should be closely inspected to make sure the second indentation is actually a cut-out and not a damaged washer. Once this has been established, it is not necessary to substitute a one cut-out washer for a two cut-out washer if the latter is undamaged. See drawing for washer application.

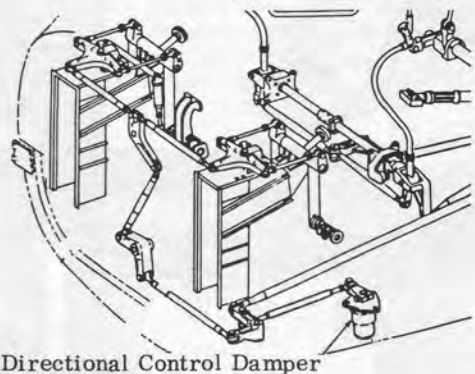
Q. (Applies UH-2) WHAT PRECAUTION SHOULD BE TAKEN WHEN SERVICING THE DIRECTIONAL CONTROL ROTARY DAMPER?

A. When servicing the directional control rotary damper, P/N 1072-550 and 1072-550-1, ensure that Dow Corning Damping Fluid, P/N DC510, 1000 CSK, is used when refilling the reservoir. Do not use MIL-H-5606 hydraulic fluid as a substitute since these two fluids are not compatible and erratic damper operation may result. The damper should be filled with Dow Corning Damping Fluid in accordance with HMI NAVWEPS 01-260HCA-2-2 servicing instructions. This data will appear in a future revision to the HMI NAVWEPS 01-260HCA-2-2.

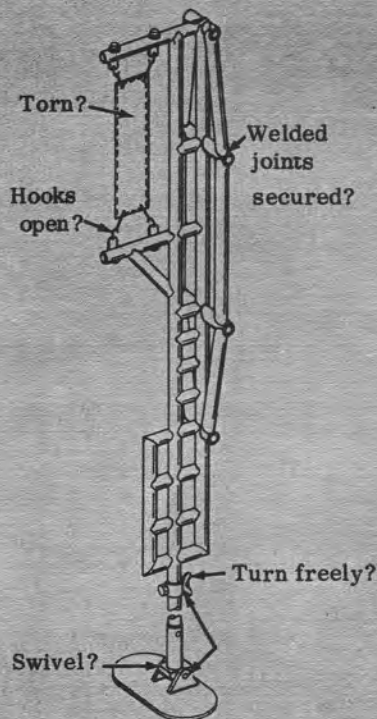
Main Rotor Blade Tracking Flag

1. Inspect the four grommets in flag for security.
2. Inspect canvas flag for rips or tears and replace if necessary. Only canvas and no other material should be used.

3. Inspect the four tension cords for deterioration or looseness. Retie knots to obtain desired tension on flag.
4. Clean oil and grease from the four tension cords. (Oil deteriorates the rubber within the cords.) String-tie or tape loose ends to prevent unraveling of cord.

5. Ensure that the four steel "S" hooks are open and have not been forced shut.
6. Extension tube must slide freely into base plate assembly.
7. Oil pivot pin on base plate and check for easy swivel action.

8. Ensure that the adjusting clamp tightens securely. Oil threads on bolt and wing nut sparingly.
9. Loosen adjusting clamp and ensure that extension tube slides easily within tracking flag frame. Apply a light film of oil to sliding surfaces.

10. Inspect all welded seams for cracks. Weld all suspected cracks in tubing frame.
11. Remove any corrosion which has formed and touch up affected areas with alodine and paint.

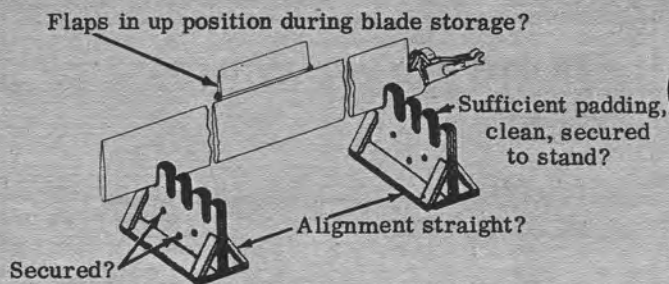
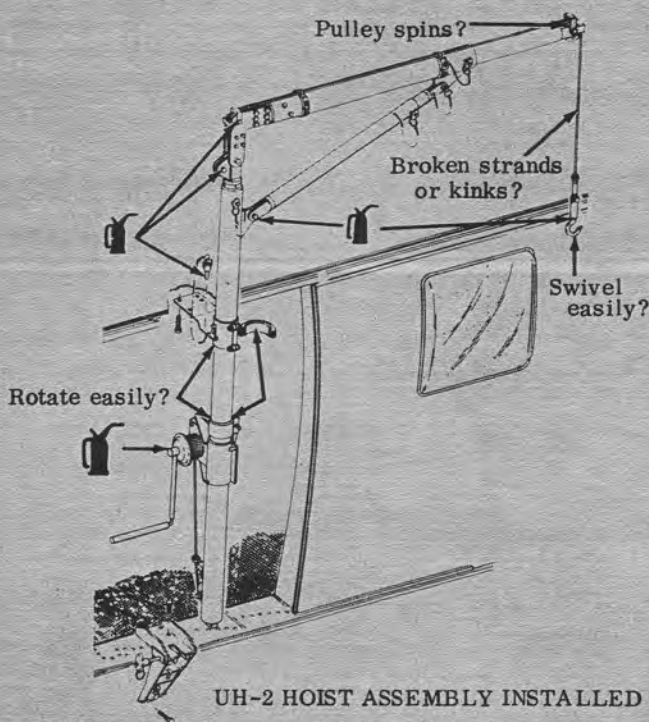
Hoist Assembly—Engine, Blade and Transmission Removal

Refer to lubrication chart in NAVWEPS 01-260HCA-2-1 for lubrication points. In addition to lube chart, take these preventive measures to ensure safe and trouble-free operation of hoist when utilized.

1. When the type of oil to be used is not specified in the lube chart or the steps below, general purpose oil should be applied during every periodic inspection or more often if necessary.

2. Clean and check all "pip pins" (ball-lok pins) for operation to ensure proper engagements. Change if necessary.
3. Check the four cable pulleys for smooth and free operation, clean and oil bolts if necessary.

4. Unwind hoist cable to its limit and check for broken strands or kinks and replace if necessary. Clean cable assembly with safety solvent, P/N P-D-680, and apply a light film of rust preventive oil, MIL-C-16173, Grade 4. Ensure that swivel attachment on end of cable does not bind and is free to rotate.

6. Clean and check winch assembly for free operation and oil as necessary.
7. Remove excess oil and grease after lubrication.
8. Remove corrosion and repaint boom assembly for protection from the elements.

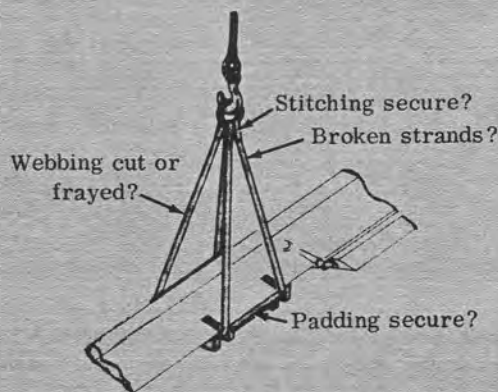
UH-2 MAIN ROTOR BLADE SLING WITH WEB STRAPS OR CABLES

1. Ensure that protective leather pad is bonded securely to retainer with adhesive and is free from abrasive particles.
2. Blend smoothly all nicks and sharp edges on the two steel rings.
3. Remove oil and grease from webbing and protective padding.
4. Replace webbing if cuts are found. Restitch seams and joints for security.
5. Ensure attaching hardware is free from sharp edges and is secured.
6. Check buckle assembly for positive locking feature.

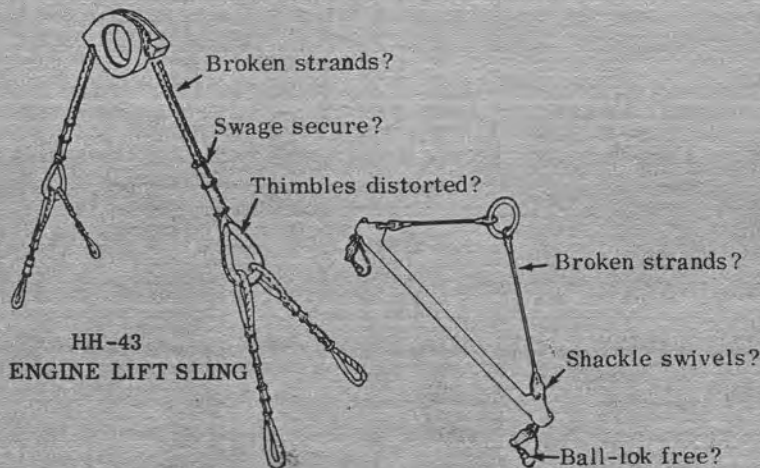
HH-43 ENGINE LIFT SLING

1. Inspect swaged areas on cables for security.
2. Check for kinked or broken cable strands. Replace cables as required.
3. Ensure that thimbles are not distorted, bent or cracked.
4. Remove all sharp edges and burrs from thimbles and all steel attaching rings.
5. Oil the attaching hardware on shackles for freedom of movement and ensure security.
6. Clean and check "pip pins" (ball-lok) for operation to ensure proper engagements. Replace if necessary.
7. Clean cables with safety solvent, P/N P-D-680, and apply a light coat of rust preventive oil, MIL-C-16173, Grade 4.

HH-43 TRANSMISSION AND HELICOPTER HOIST SLING

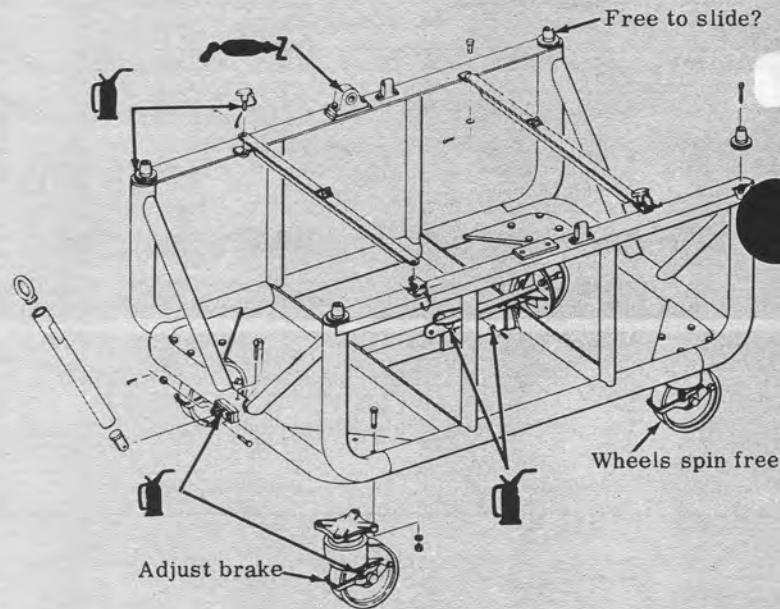
UH-2A/B/C TRANSPORT DOLLY

Refer to lubrication chart in HMI, NAVWEPS 01-260HCA-2-1. (HH-43 assembly similar — see T.O. 35D3-25-1.)

1. Lubricate tow bar assembly pivot points with general purpose oil.
2. Oil suspension coil springs and guides found on the four wheels.
3. Check "trailing locks" for free operation. Check wheel casters for free rotation and oil the bearings.
4. Check and adjust if necessary, the parking brake feature on the two forward wheel casters.
5. Clean oil and grease from rubber tired wheels.
6. Remove all foreign objects embedded in rubber tires.
7. Remove any corrosion and paint affected areas.
8. Check for cracks or damage in the trailer frame welded joints and reweld if necessary.
9. Grease the two pillow blocks in accordance with lube chart.

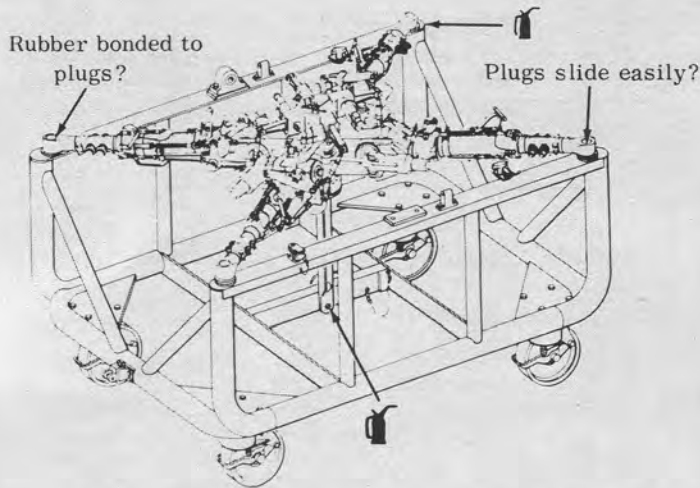
UH-2A/B/C DOLLY WITH MAIN ROTOR RETENTION

1. Oil the attaching hardware on the four retaining plugs mounted on each corner post on the trailer for freedom of movement.
2. Check hub support for alignment and freedom of operation.
3. Clean, oil and grease from leather pad on hub support and ensure bonding of pad to plate.
4. Clean and check "pip pins" (ball-lok) for attachment security and freedom of operation during installation. Replace if necessary.
5. Check bonding of the rubber on the retaining plugs.

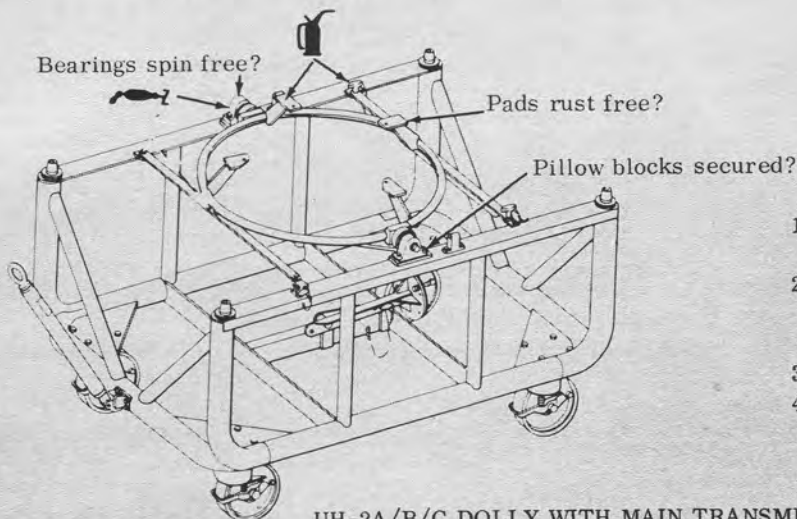
UH-2A/B/C DOLLY WITH MAIN TRANSMISSION ADAPTER

1. Clean and oil the four machined mounting pads on the adapter.
2. Clean and check "pip pins" (ball-loks) to assure freedom of operation during installation and positive locking feature. Replace if necessary.
3. Check pillow block attaching hardware for security.
4. Inspect bearings in pillow blocks for corrosion and freedom of operation.

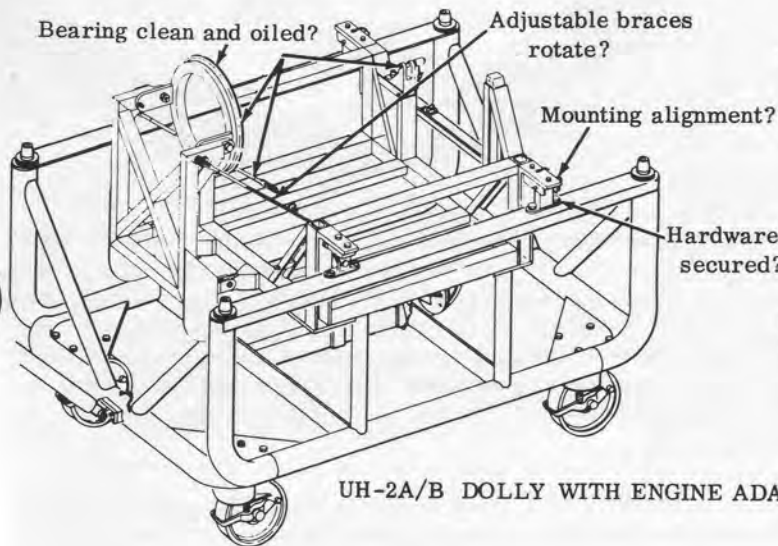
UH-2A/B DOLLY WITH ENGINE ADAPTER

1. Clean and check "pip pins" (ball-loks) for attachment security and freedom of operation during installation. Replace if necessary.
2. Clean and oil bearing race assembly. Ensure that bearing rotation is free from dirt and contaminants when rotated by hand.
3. Clean threads on the two adjustable braces. Apply a light coat of oil on threads prior to assembly.
4. Check all attaching hardware for security.
5. Ensure alignment of the adapter-to-trailer mounting points — align as necessary for ease of "pip pin" installation and security.

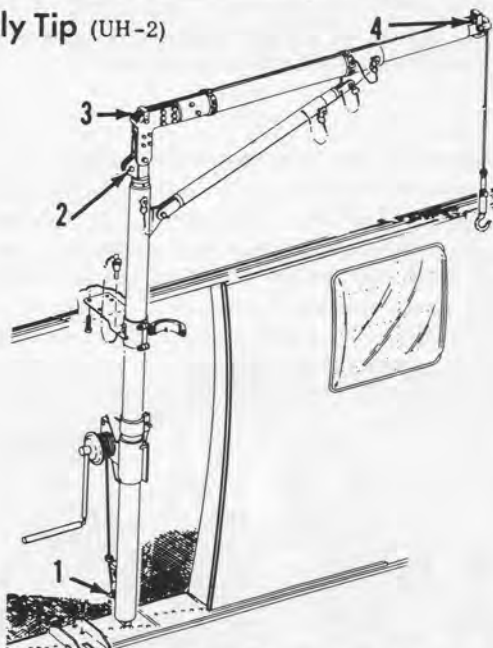
Timely Tip (UH-2)

To preclude the possibility of personnel injury or component damage — before placing a full strain on the hoist, first check to see if the cable is seated on ALL FOUR PULLEYS (see sketch). If necessary, guide the cable until a sufficient load is applied on the hook assembly to ensure proper seating on the pulleys. Caution should be observed, of course, to keep hands clear of any other moving parts. If the cable is not seated on all four pulleys and a full load is applied, the cable may be frayed or even severed.
